A47 Wansford to Sutton Dualling

Scheme Number: TR010039

Volume 6 6.3 Environmental Statement Appendices Appendix 6.1 – Cultural heritage information

Appendix 6.1 Cultural Heritage Information

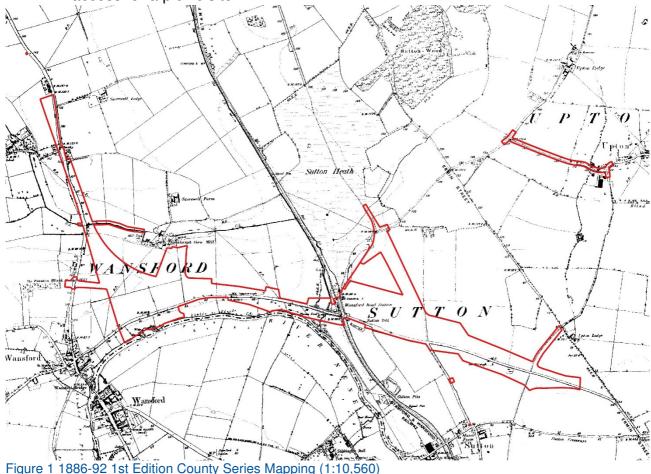
6.2.98. The 1st edition 1886-1892 County Series mapping (1:10,560 Figure 1) demonstrates the rural nature of the landscape, with the small nucleated settlements of Wansford, Thornaugh, Sibbington, Sutton and Upton visible in their respective modern locations. The land within the Proposed Scheme boundary consisted of pastoral and agricultural fields with roads throughout adhering to their modern locations. The construction of the A47 for the most part followed the footprint of the main east-west road visible on the 1st edition mapping, with the exception of following the river along the route of what is now access for a picnic site.

- 6.2.99. The former smithy (53699) is visible at the north of the Scheme, with a guidepost (WAN3) adjacent. The weir (WAN4) is shown at the River Nene, potentially linking to the towing path. A former milestone "Peterborough 7" is shown on the north side of the road (WAN5) and another (WAN7) is shown close to Wansford Road Station (WAN1) and an un-named building, the station masters house (WAN10). Details around the station are vague, given the scale of the map but, the bridge (WAN2) is clearly shown and a structure is shown which is probably the linesmans' hut.
- 6.2.100. To the east of the station, a small structure (WAN8) is labelled "Sutton Toll", with what appear to be small yards to the either side. Another milestone

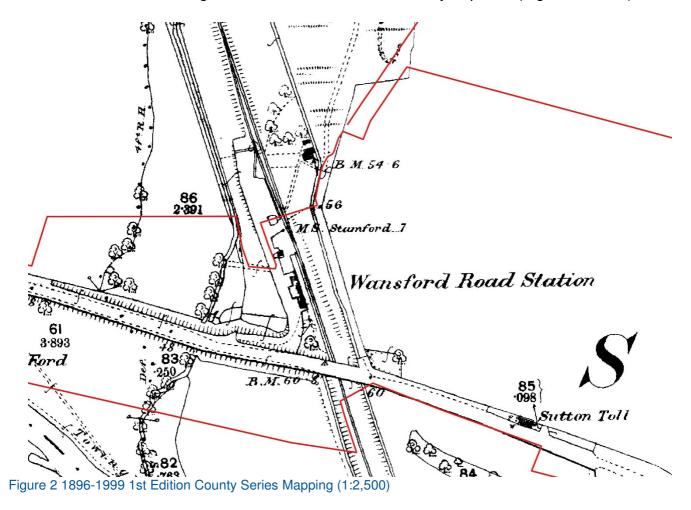
6.2.103. Very little difference is shown between the above map and this one. However, the station buildings and Sutton Toll are more clearly depicted (Figure 2 below).

6.2.104. Here, the link between the station and the station masters house is shown in the several footpaths between the track and house. The platform is shown clearly, extending from the south side of the station and approximately 10m further north. The hut is shown surrounded with presumably walls or fencing, and a single-track siding is depicted to the north, just outside the Proposed Scheme boundary.

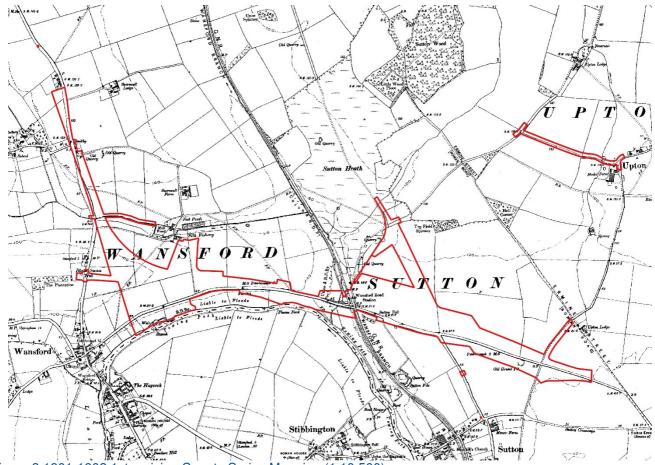
Figure 3 1901-1902 1st revision County Series Mapping (1:10,560)

6.2.105. The 1st revision 1901-1902 County Series mapping (1:10,560 Figure 3) shows very little change in the landscape during this period, save for a newly labelled footbridge at the weir and a signal post at the station.

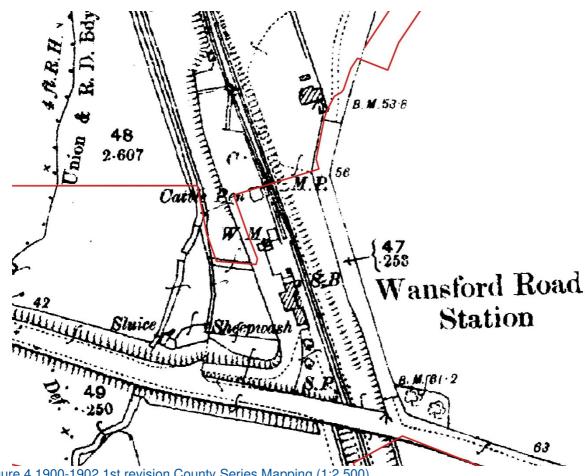
Figure 4 1900-1902 1st revision County Series Mapping (1:2,500)

location is indicated. The footpaths linking the station master's house (WAN11) to the tracks are no longer depicted.

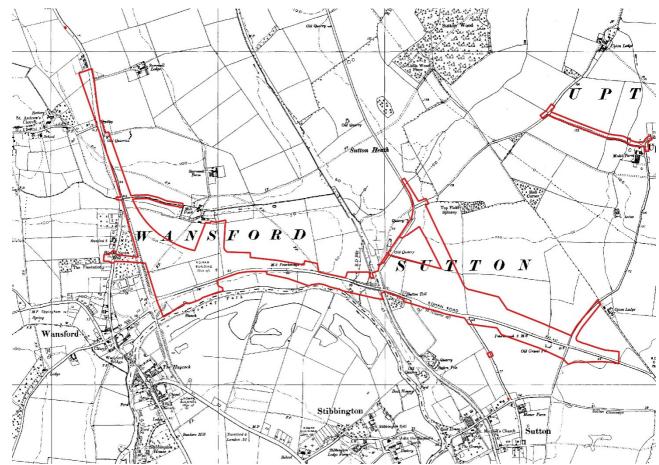
Figure 5 1958 1st imperial Edition (1:10,560)

6.2.108. The area within the scheme footprint does not appear on any updated mapping until 1958 (Figure 5). The changes of note are the absence of the weir (WAN4) and the re-routing of the Great North Road to Bypass Wansford. The station is no longer labelled, as it had fallen out of use, and the track is shown as an earthwork rather than a railway line. Sutton heath road had been extended north, past the station masters house. The label "Roman building (site of)" (00131) is shown for the first time.
