A47 Wansford to Sutton Dualling

6.3 Environmental Statement Appendices
Appendix 7.6 – Arboricultural Impact
Assessment

ENVIRONMENTAL STATEMENT APPENDICES Appendix 7.6 - Arboricultural Impact Assessment

Arboricultural Impact Assessment A47 – Wansford

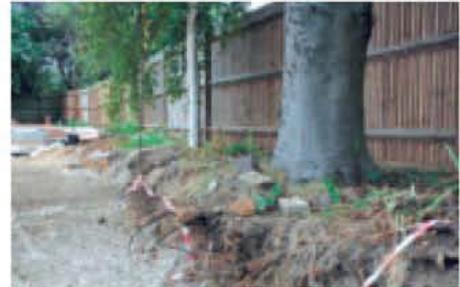
Potential loss of existing tree due to poor construction techniques.

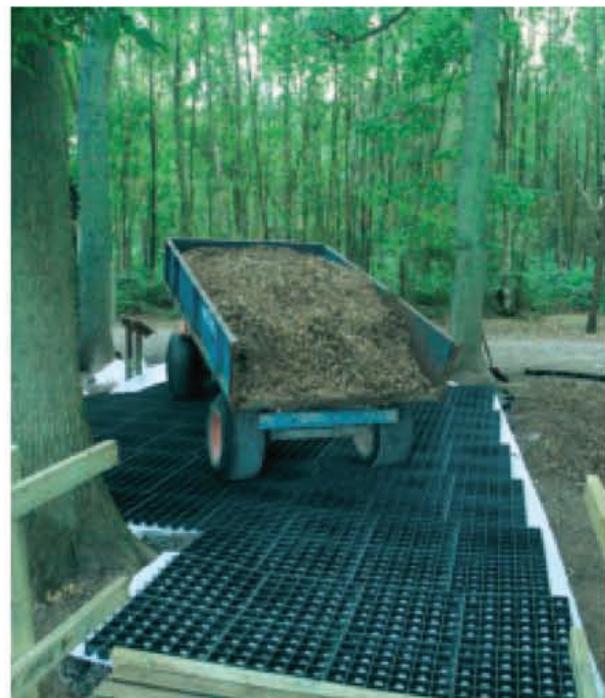
Glynebourne Wood.

Pedestrian path to recreational woodland built using a CellWeb™ foundation which was covered with DuoBlock and then filled with woodchip to create a porous surface.

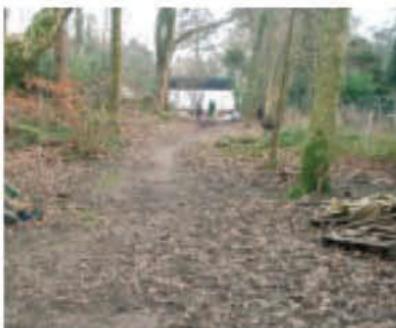
Site before construction pictured above.

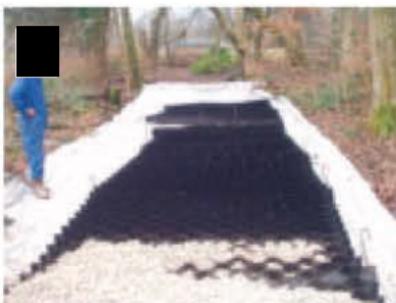
Installation of the CellWeb™ system.

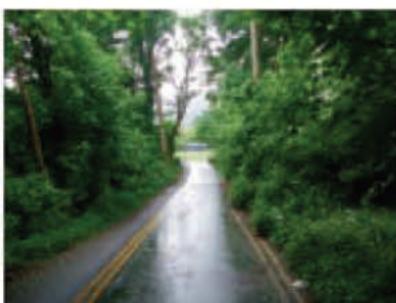
Four years later.
