A47 Wansford to Sutton Dualling

Scheme Number: TR010039

**Appendix 9.3 – Preliminary Sources Study Report
(PSSR)**

ENVIRONMENTAL STATEMENT APPENDICES
Appendix 9.3 - Preliminary Sources Study Report (PSSR)

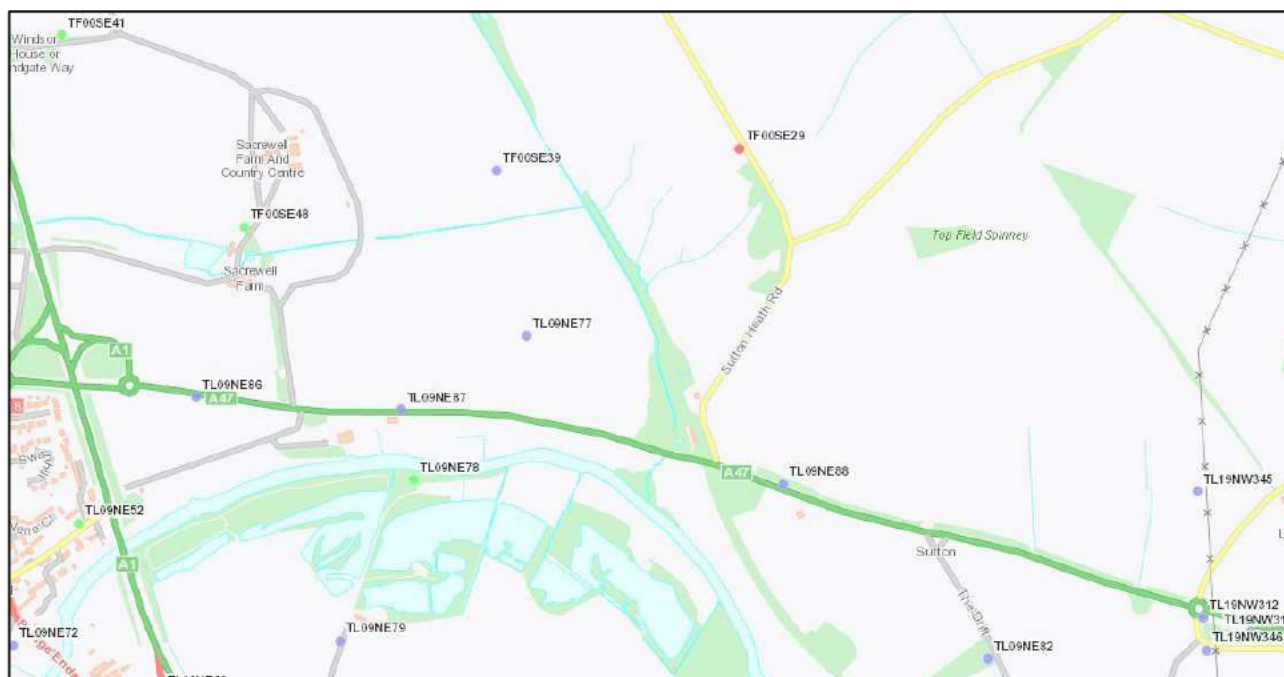
Figure 6: BGS borehole logs near the proposed route

There are 6 British Geological Survey (BGS) registered boreholes¹³ recorded on the proposed route, and 10 further usable logs within a 250m buffer zone, as shown in Figure 6. Borehole scans can be found in Appendix D.

Tables 1 to 4 summarise the groups of similar strata likely to be encountered, together with the thicknesses and general descriptions of the units encountered in the excavations noted.
