## A47 Wansford to Sutton Dualling

Scheme Number: TR010039

6.3 Environmental Statement Appendices
Appendix 8.14 – Otter and Water Vole Survey
Report

## **ENVIRONMENTAL STATEMENT APPENDICES Appendix 8.14 - Otter and Water Vole Survey Report**

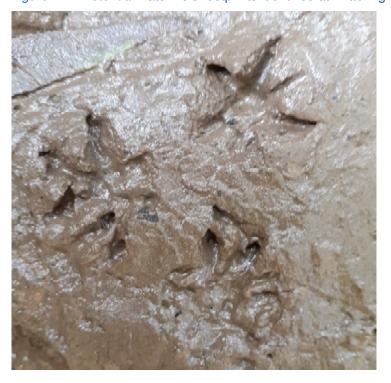
Figure 4-1: Potential water vole footprints identified at Wittering Brook, recorded in September 2020.

4.2.6. During the survey in September 2020, 2 evidences of water vole footprints (Figure 4-1), 12 potential burrows, one latrine (Figure 4-2) and one potential latrine were recorded along Wittering Brook.

- 5.2.6. Works should remain a minimum of 5m away from water courses A and B. If this not possible, and works would take place within 5m of the banks, works would require consultation with, and a licence from, Natural England. Mitigation would include displacement or trapping and translocation of water voles.

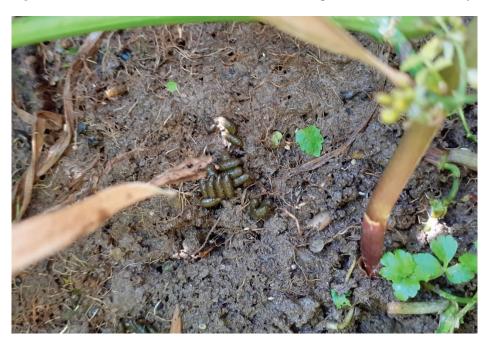
Figure 4-2: Water vole latrine identified at Wittering Brook, recorded in September 2020.

5.1.3. The presence of water vole was identified along watercourse B where a single latrine was recorded during the survey in September 2020, detailed in Table 4-2. An estimate of water vole population size for the 100m of the surveyed section has been calculated and shown in the table below.

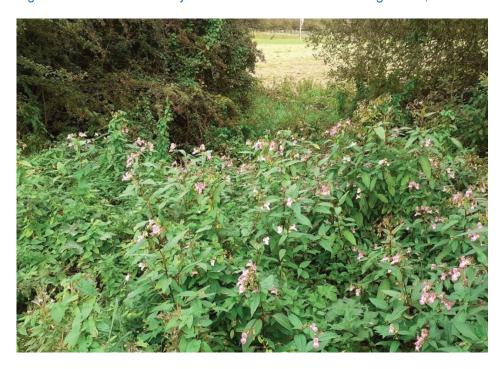
Figure 4-3: Stand of Himalayan Balsam identified at Wittering Brook, recorded in September 2020.

- 4.2.8. During the survey in September 2020, evidence of small mammals was recorded. These include, 27 small mammal burrows, ten rat droppings, three rat prints, two rat burrows and one other small mammal droppings.
- 4.2.9. One heron (*Ardea cinerea*), two kingfishers one stoat (*Mustela erminea*) and two fox (*Vulpes vulpes*) prints were recorded while surveying watercourse B.
- 4.2.10. An area, approximately 5mx5m, of Himalayan Balsam (*Impatiens glandulifera*), was recorded in September 2020 on the southern side of watercourse B (Figure 4-3).

5.2.10. Himalayan Balsam is listed on Schedule 9 of the WCA 1981 (as amended) and as such it is an offence to cause the spread of this species in the wild. The location of the Himalayan Balsam (see Section 4.1.9), along Wittering Brook is outside of the Proposed Scheme boundary and it is therefore considered unlikely that works would take place in this area. However, should the Proposed Scheme change, and works be required in the area of the Himalayan Balsam, it is recommended that an Invasive Species Management Plan is produced prior to

works, detailing methods of removal of the Himalayan Balsam and biosecurity measures to employ during works.

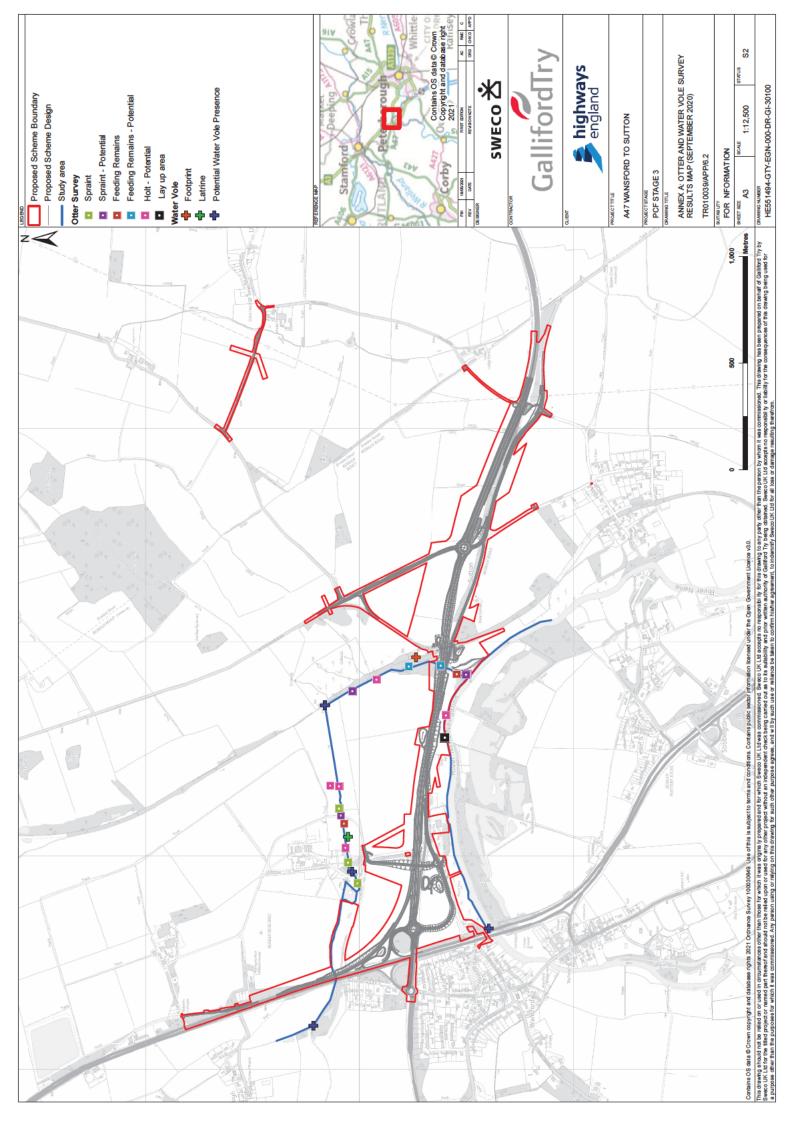
# Annex A. Otter and Water Vole Survey Results Map September 2020

- 3.1.9. The results are provided in Annex A (Otter and Water Vole Survey Results Map September 2020).
- 3.1.10. This interpretation acts as an aid for devising water vole mitigation strategies.

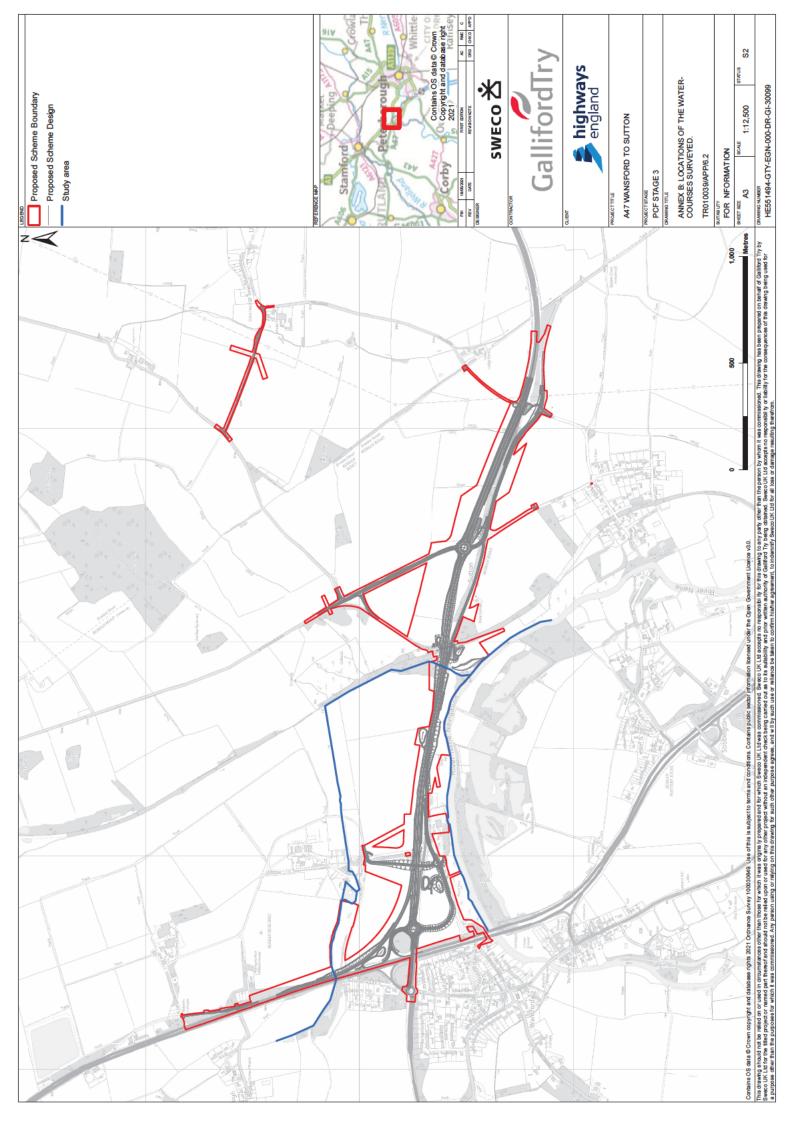
# Annex B. Locations of the watercourses surveyed

- 4.2.1. The surveys were completed from 15 September 2020 18 September 2020.
- 4.2.2. Two watercourses were surveyed: A) River Nene and B) Wittering Brook. The locations of these watercourses surveyed are provided in Annex B.
