A47 Blofield to North Burlingham Dualling

6.2 Environmental Statement Appendices
Appendix 7.6 – Arboricultural Impact
Assessment

Arboricultural Impact Assessment A47 - Wansford

Appendix 2: Arboricultural Impact Assessment Plan

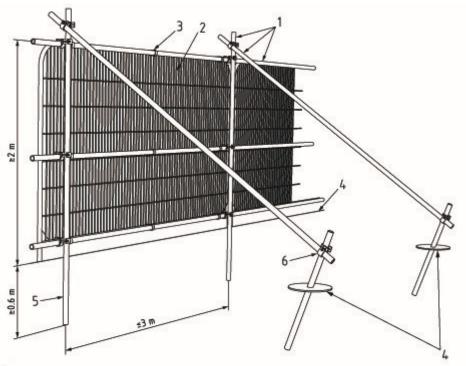
- 1 Standard scaffold poles
- 2 Heavy gauge 2 m tall galvanized tube and welded mesh infill panels
- 3 Panels secured to uprights and cross-members with wire ties
- 4 Ground level
- 5 Uprights driven into the ground until secure (minimum depth 0.6 m)
- 6 Standard scaffold clamps

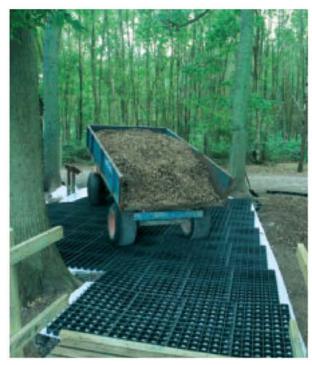
Glynebourne Wood.

Pedestrian path to recreational woodland built using a CellWebTM foundation which was covered with DuoBlock and then filled with woodchip to create a porous surface.

The CellWeb™ system overcomes these issues and helps contractors to comply with tree health guidelines by creating a load-bearing base that is water-permeable, stable and durable.

With no need for excavation, the system is quick and easy to install, reducing construction time and saving costs and making it suitable for temporary and permanent solutions.
