The Alignment of the A47 Dualling Between the
Wansford Eastern Roundabout and the Old Railway
*A Submission to the Planning Inspectorate – Scheme Ref:
TRO10039*

February 2022

Wansford Parish Council

Cropmarks of Seven Ring Ditches and a Quadrilateral
Ditched Enclosure, together with Pits and Pit
Alignment, Approximately 837m South-East of
Sacrewell Farmhouse
A Response to the Historic England Consultation Report

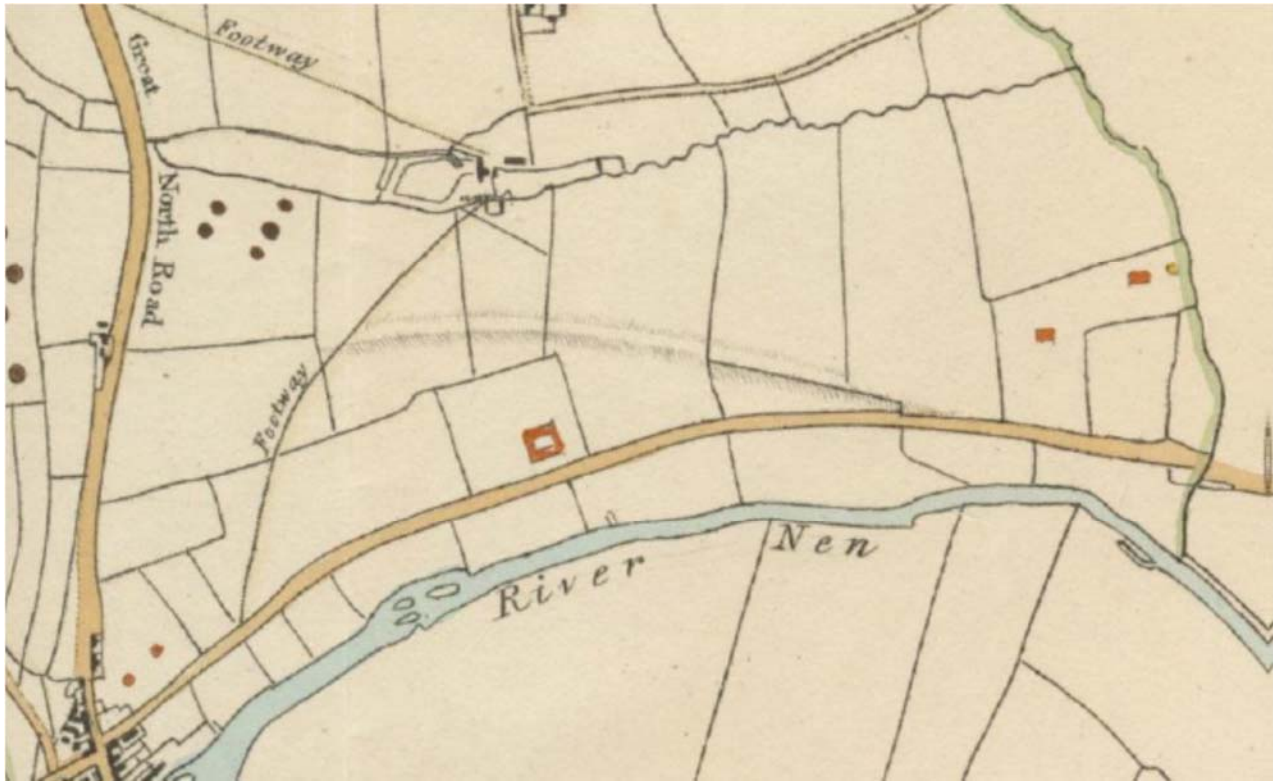
Figure 1 – Edmund Artis Map Dated 1828 Showing Roman Buildings in the area of Toll Bar Field

Several sources have referred to the work of Edmund Tyrell Artis in the 1820s. He carried out a systematic review of the Fitzwilliam Estate and recorded the existence of two Roman Buildings in Toll Bar Field. The location of these buildings is depicted in a map he drew dated 1828.

Correlating this map with other images in this report, the reader has to remember that the course of the stream on the eastern edge of Toll Bar Field was changed when the Wansford to Stamford railway was built. The larger building further west does not relate to any other reference and is probably an error.

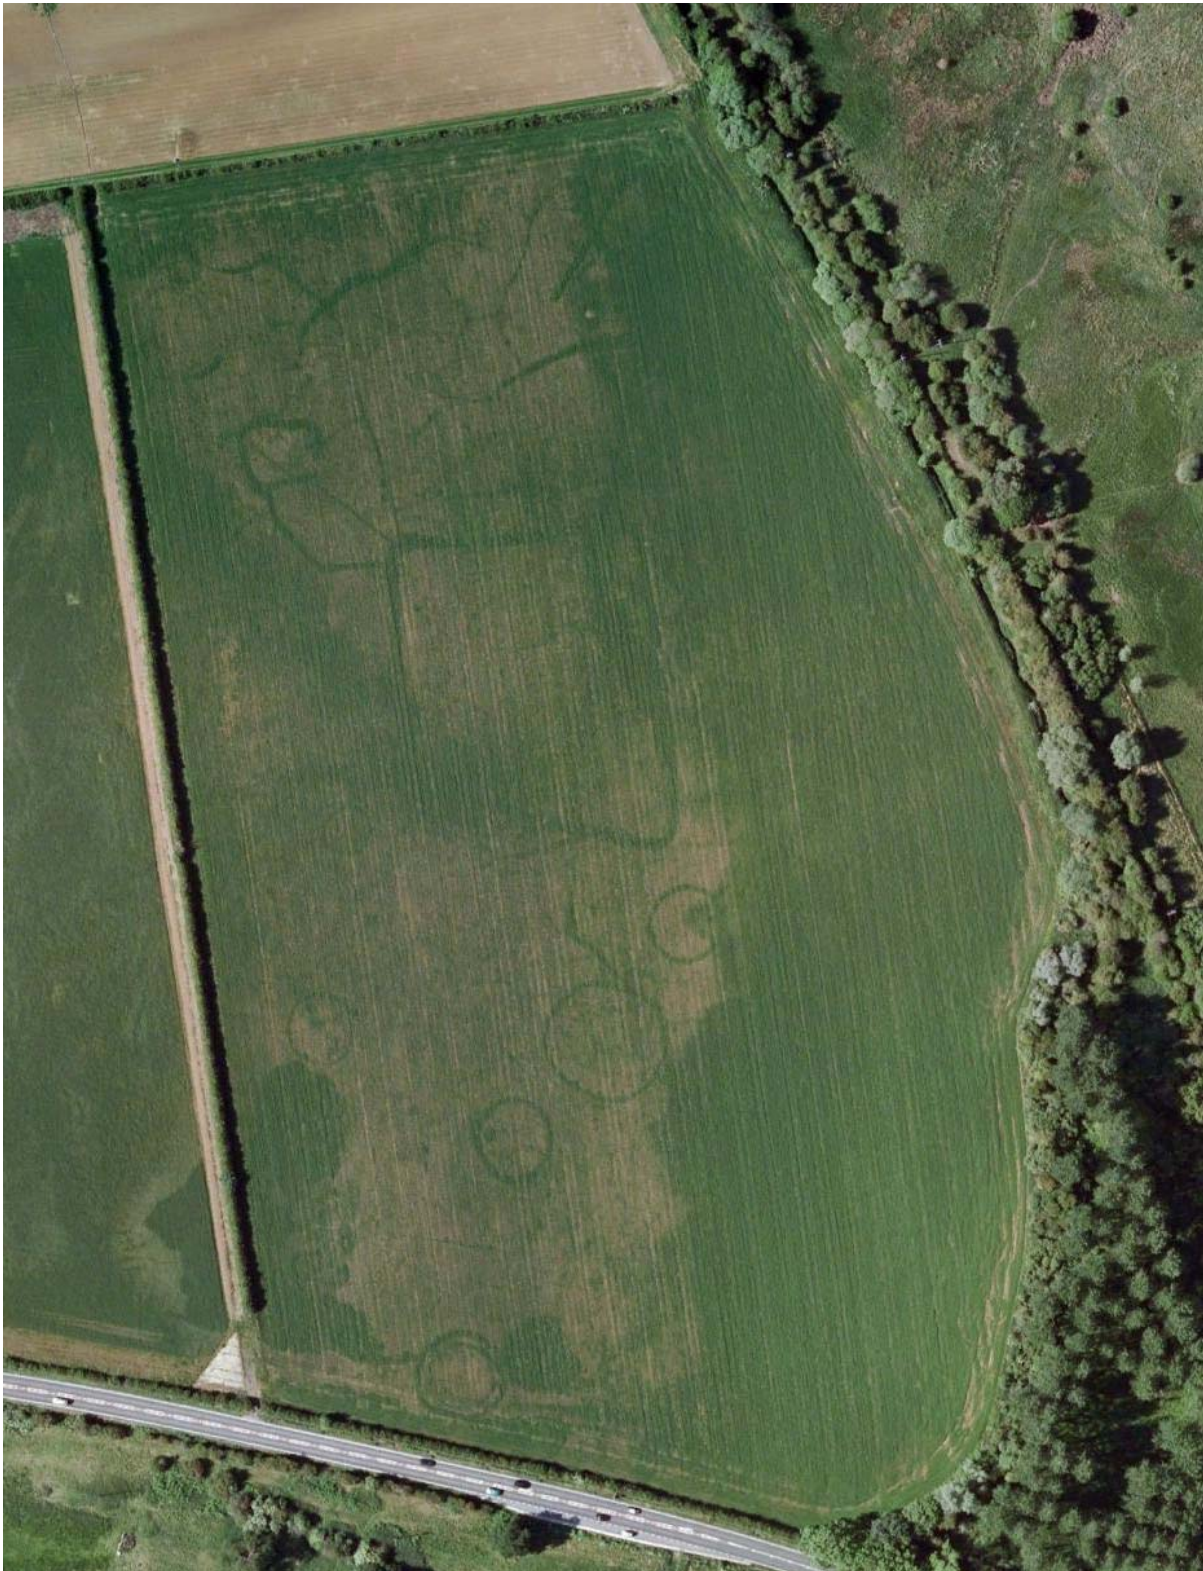
Figure 2 – Crop Marks in Toll Bar Field. Google Earth Image May 2009

The Scheduled Monument was first scheduled on the 14th June 1962. From the very sparse listing information, it appears that this was simply on the basis of crop marks appearing on a set of aerial photographs. The photographs, dating from 1959 and 1960, are listed in the Selected Sources section of the Historic England Consultation Report but are not available to the Parish Council. Fortunately, the Google Earth image from May 2009 shows the crop marks clearly and this image has been used for this document.

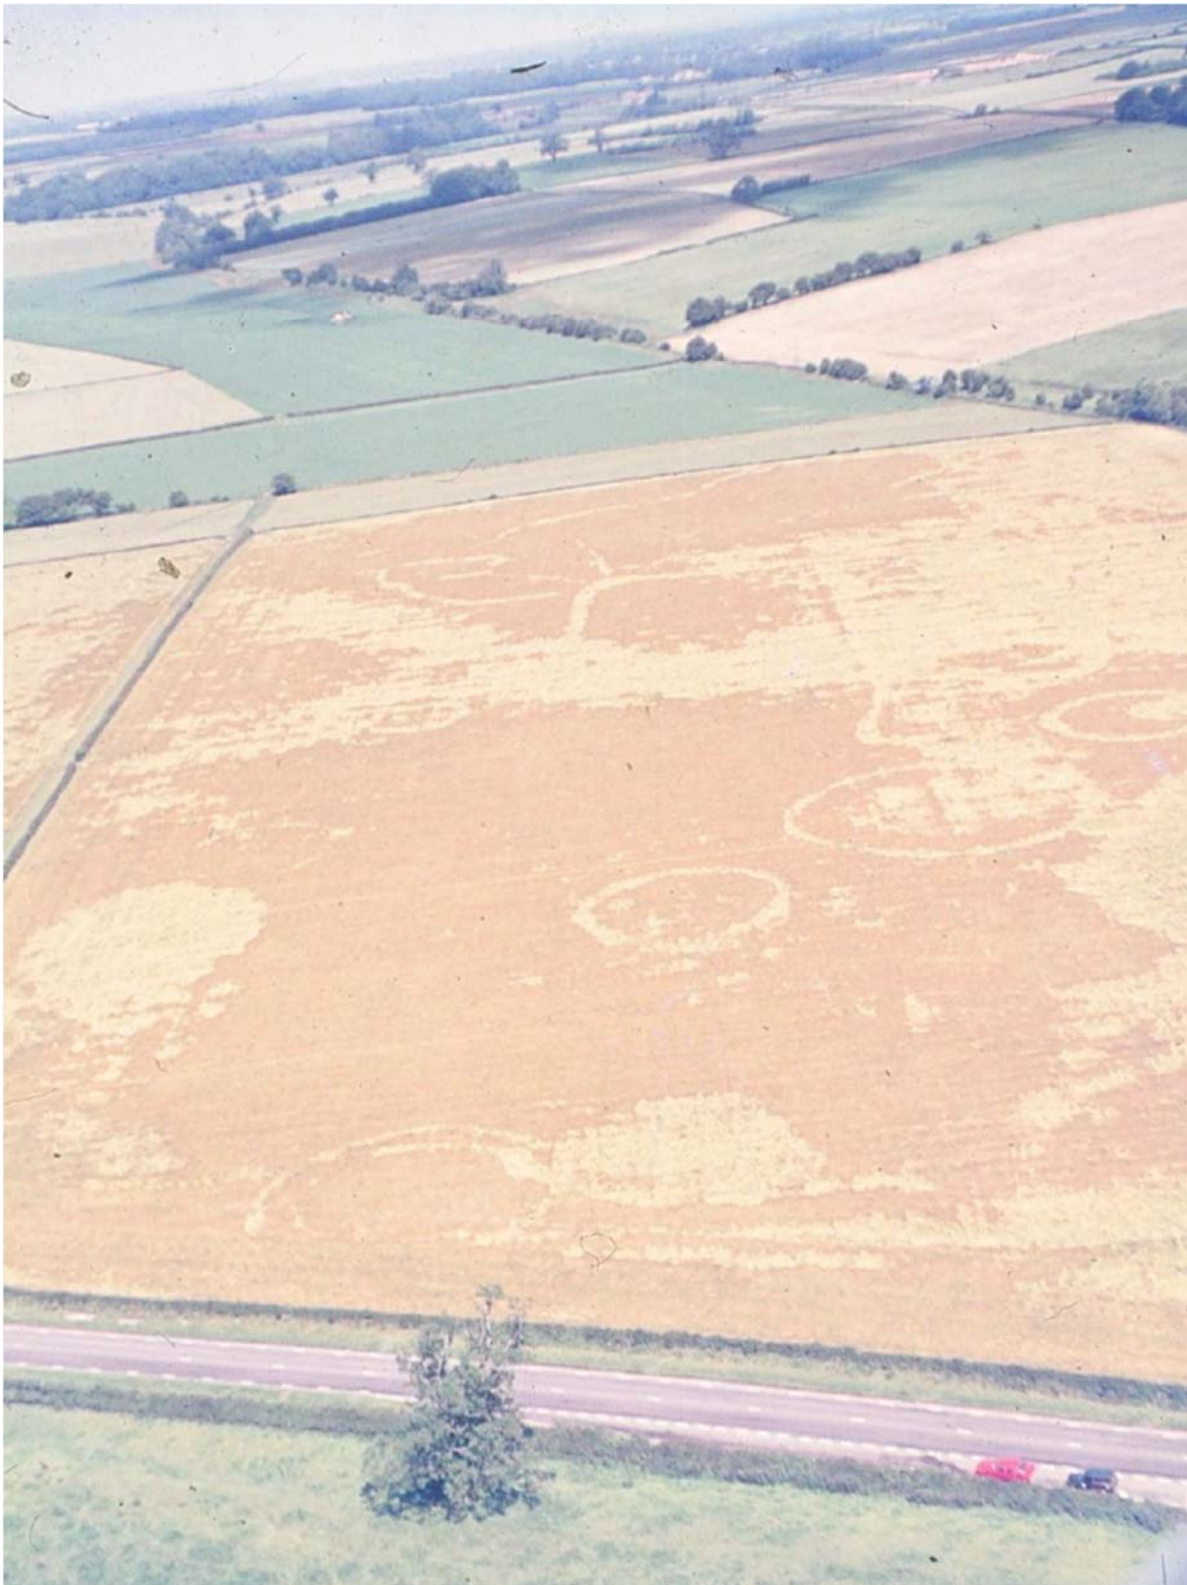
Figure 3 – Crop Marks in an Oblique View

The crop marks are also evident in the oblique image included in Dr Stephen Upex’s review of the archaeology of the area.

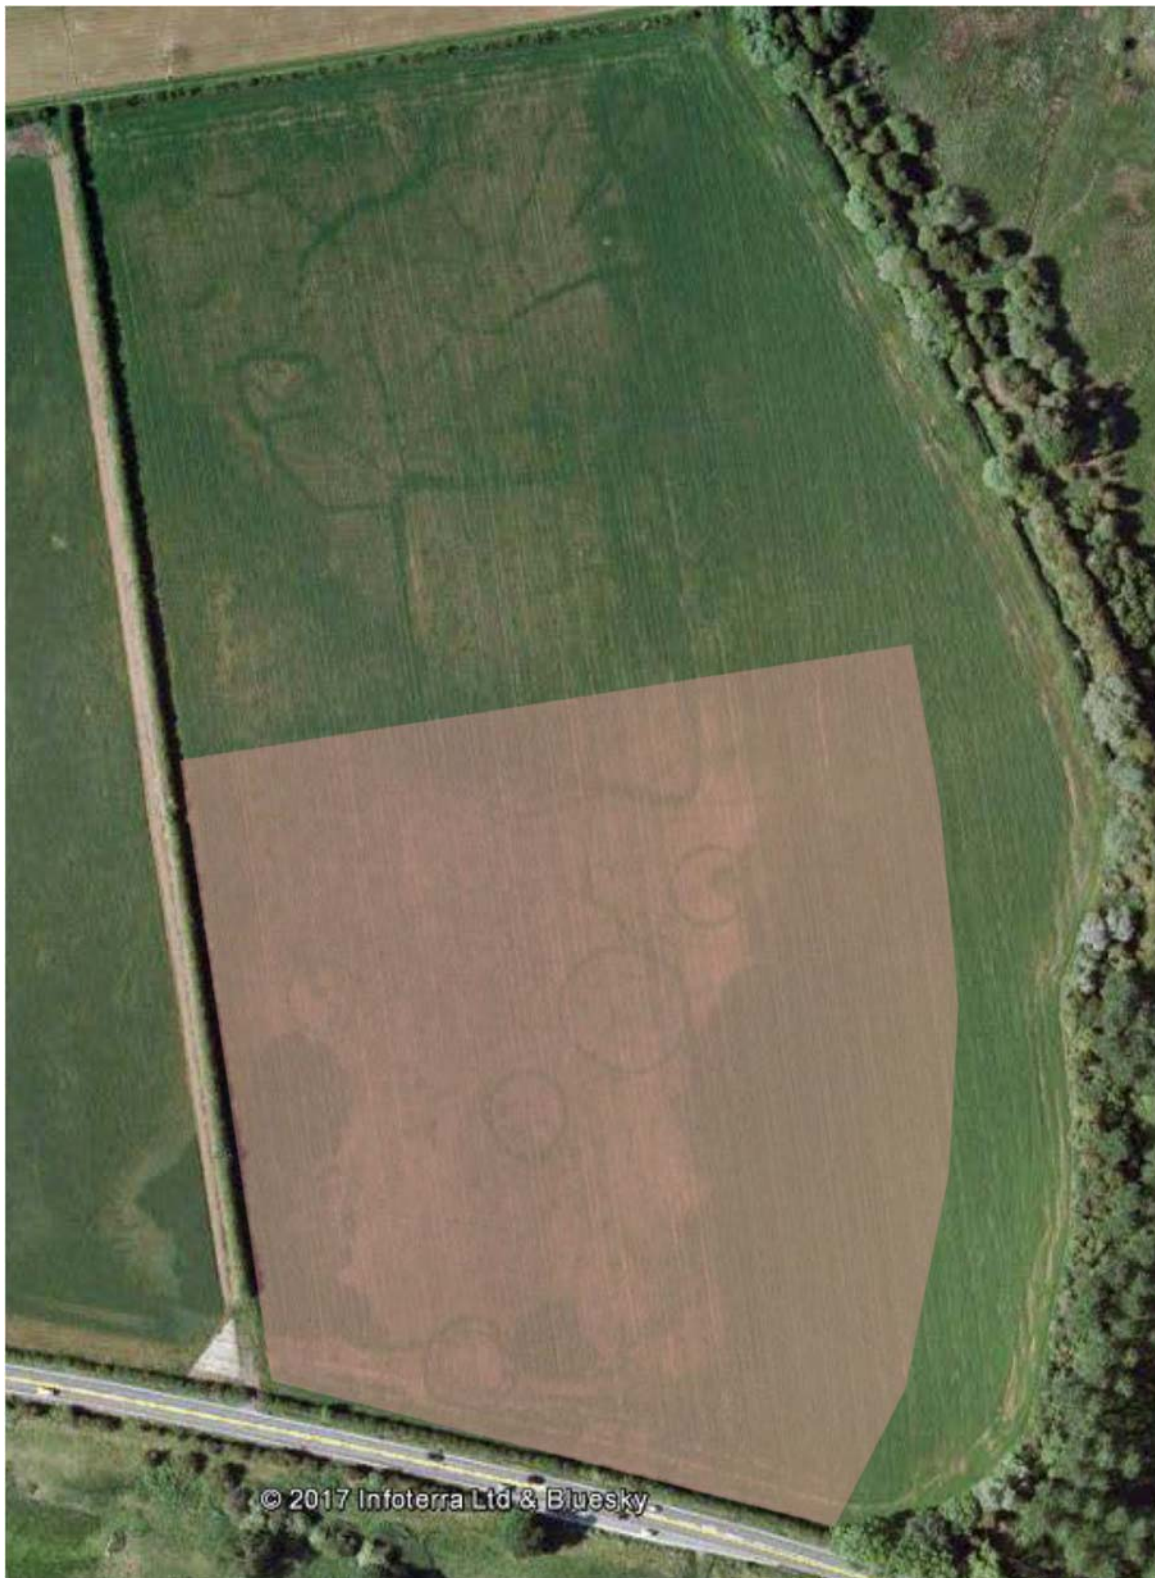
Figure 4 – The Outline of the Existing Scheduled Monument superimposed on the Crop Marks

Although actual boundaries of the existing Scheduled Monument are not precisely defined, Figure 4 shows the approximate outline superimposed on the crop marks.

It is very clear from Figure 4 that the Scheduled Monument only takes in the southern part of the crop marks and that it also includes a substantial area on the east side of the area where there are no crop
