A47 Wansford to Sutton Dualling

Appendix 7.6 – Arboricultural Impact Assessment

Arboricultural Impact Assessment A47 – Wansford

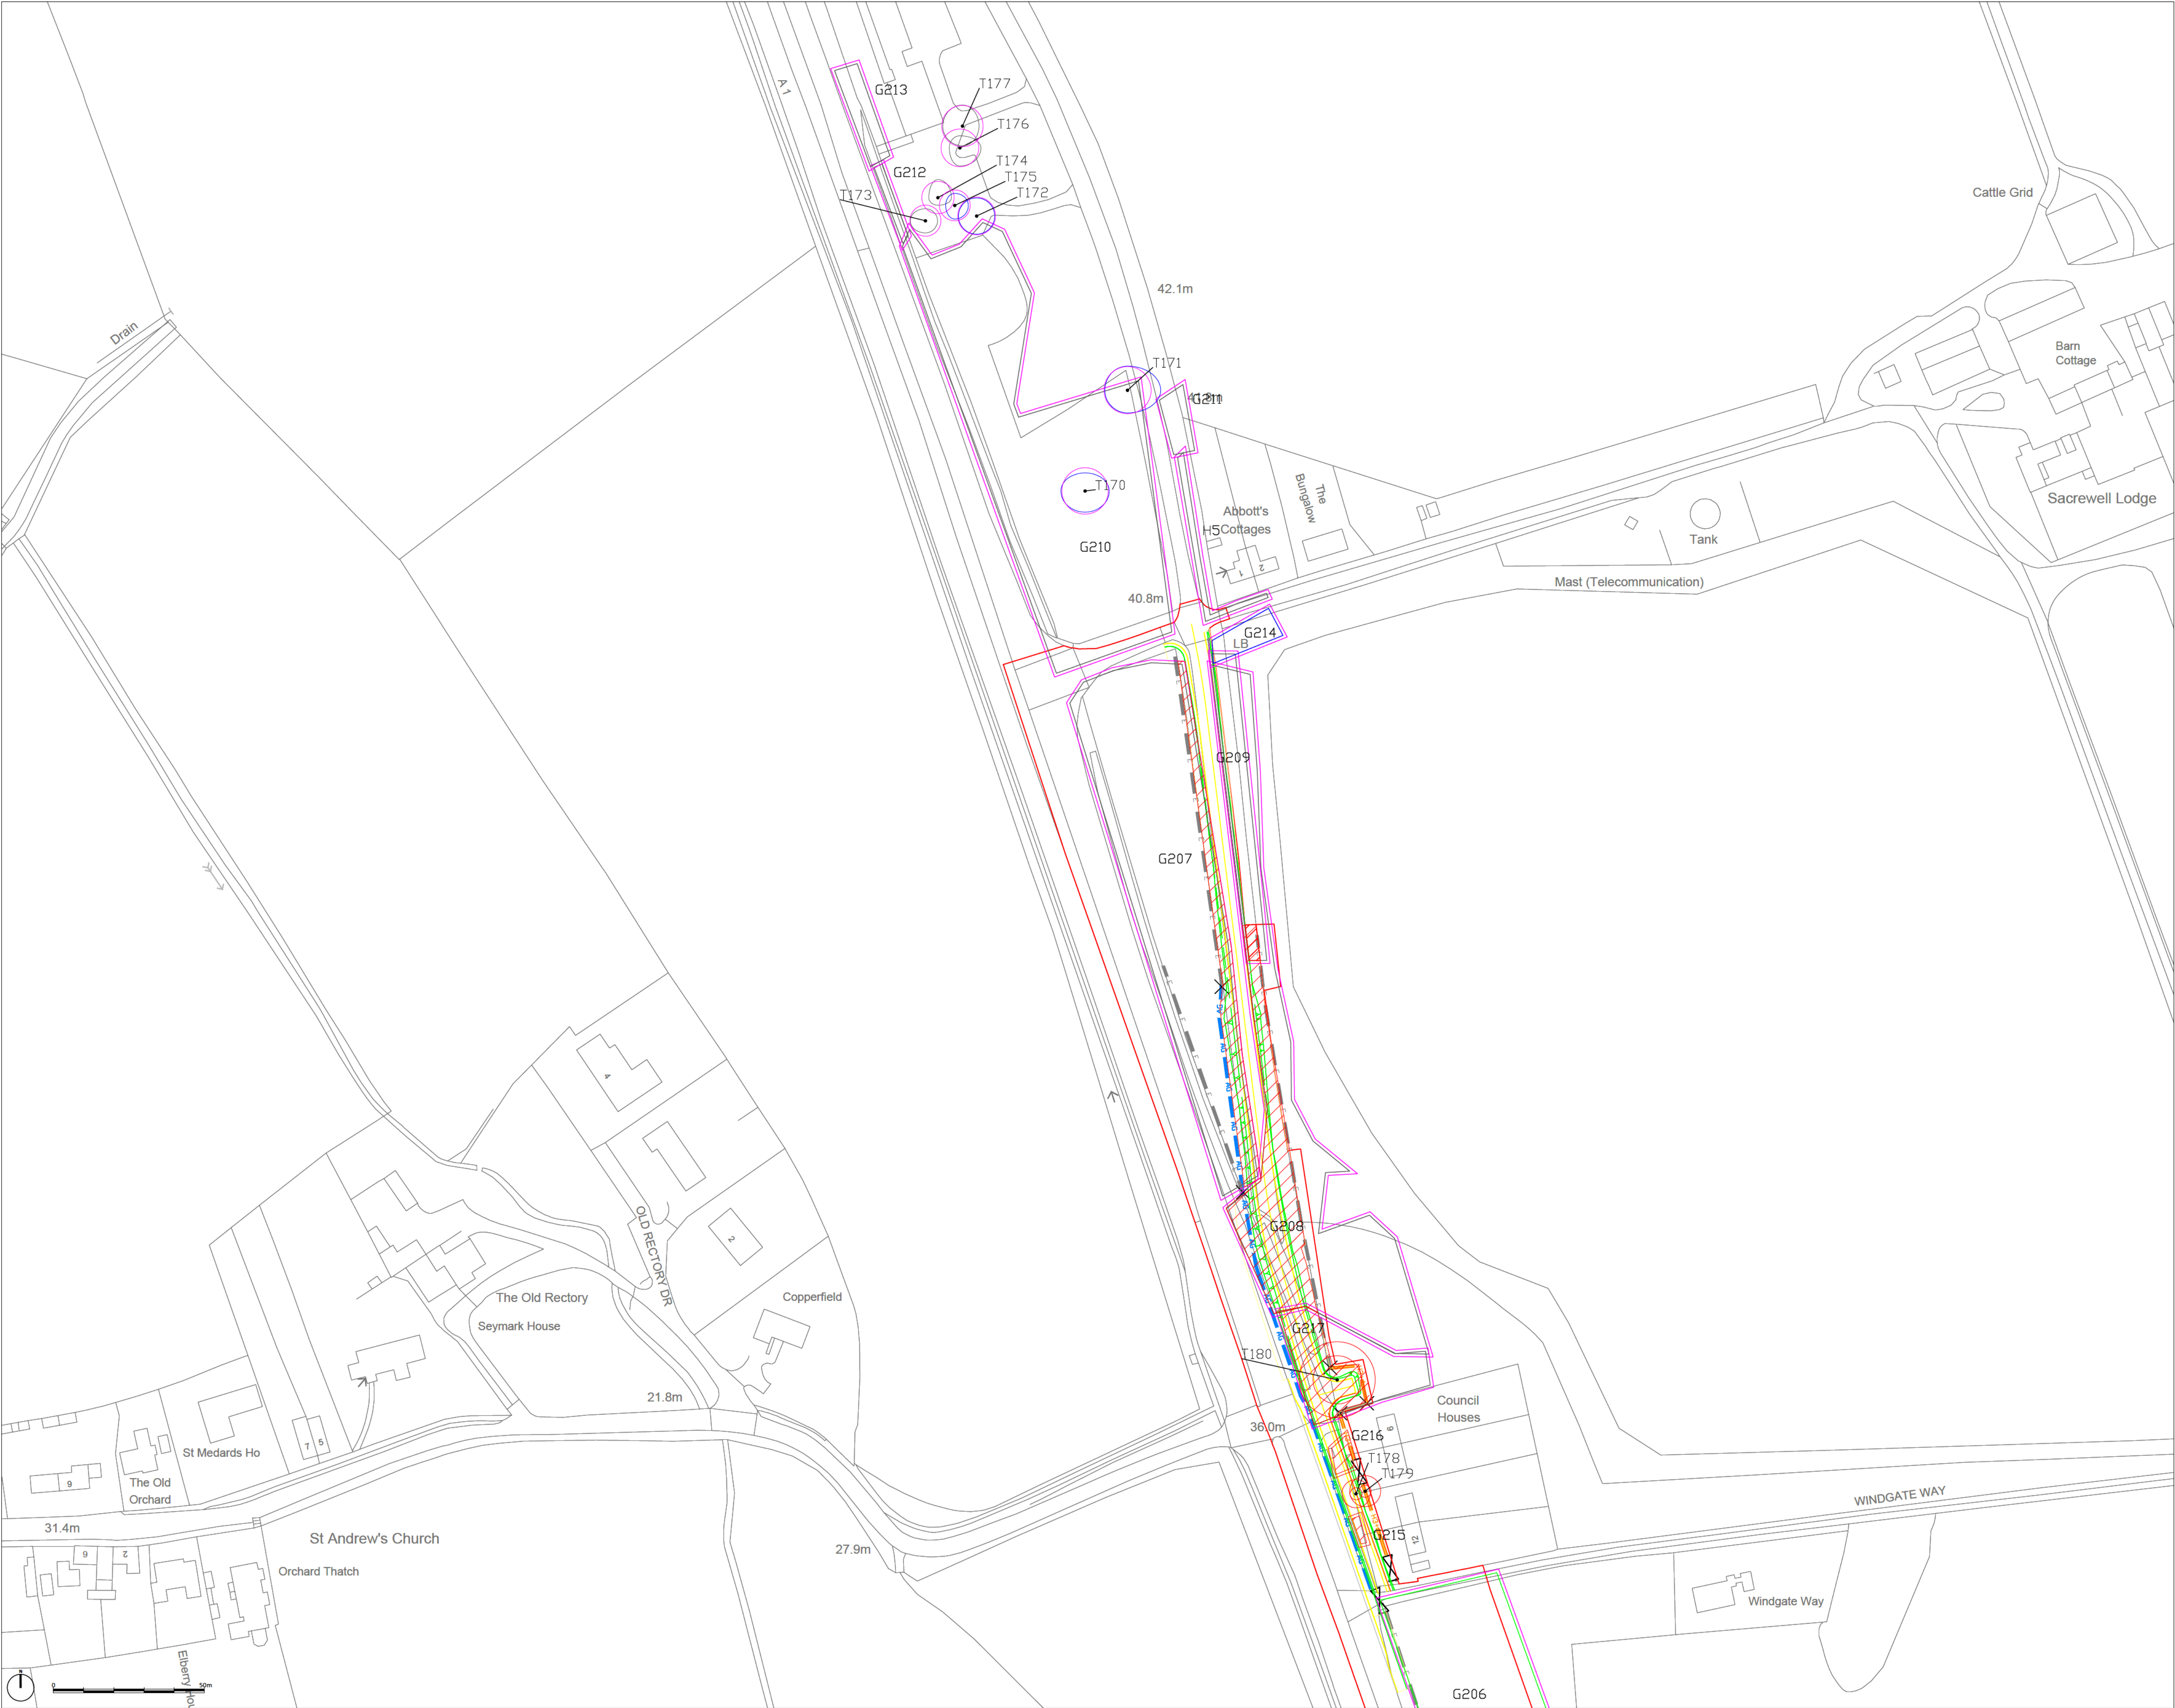
Appendix 2: Arboricultural Impact Assessment Plan

- Recommended 'Root Protection Area' (RPA) of trees/hedges considered desirable for retention calculated using the method set out in section 4.2.6 of BS5837:2012

- Individual trees to be removed
- Groups or hedgerows to be removed

The AIA contained in **Appendix 2** has been developed from the tree survey and tree location plan produced by Mott MacDonald in August 2018, along with the new data collected by ADAS in July 2020 and February 2021. ADAS has not verified the accuracy of the data collected by Mott MacDonald. Therefore it is recommended that tree locations are verified on site prior to any works being undertaken.

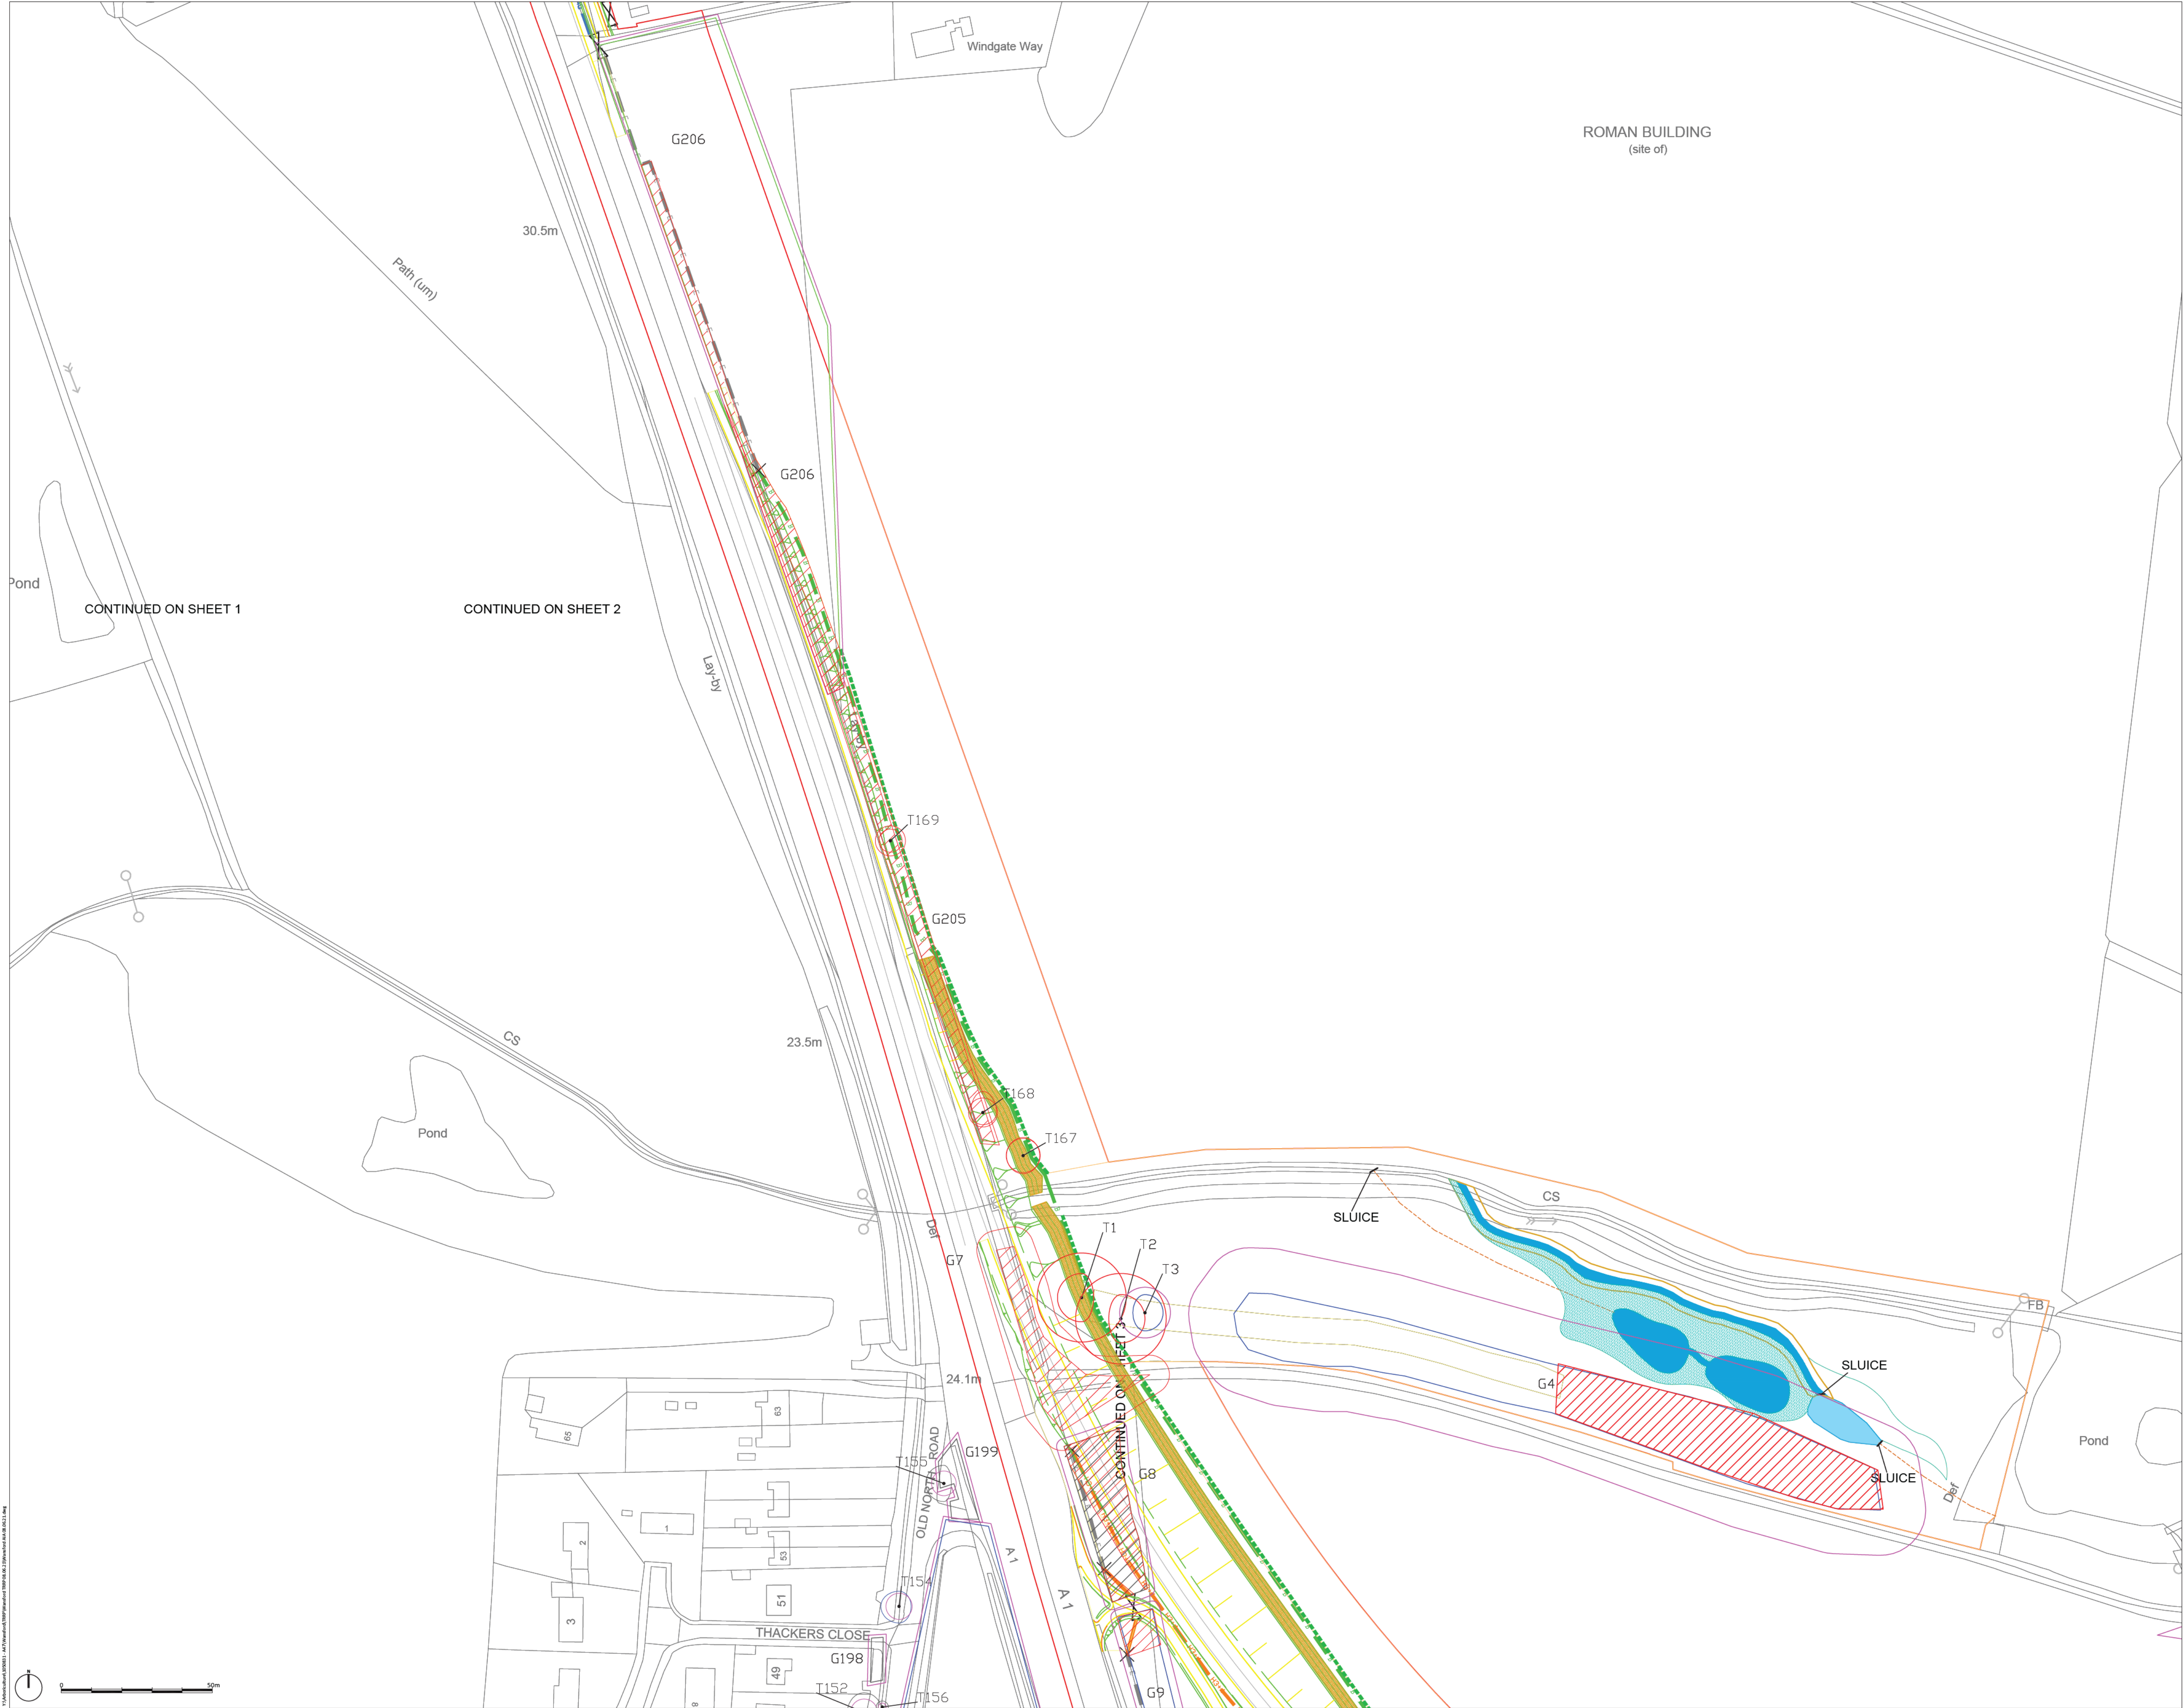
- Recommended 'Root Protection Area' (RPA) of trees/hedges considered desirable for retention calculated using the method set out in section 4.2 of BS5837:2012

- Individual trees to be removed
- Groups or hedgerows to be removed

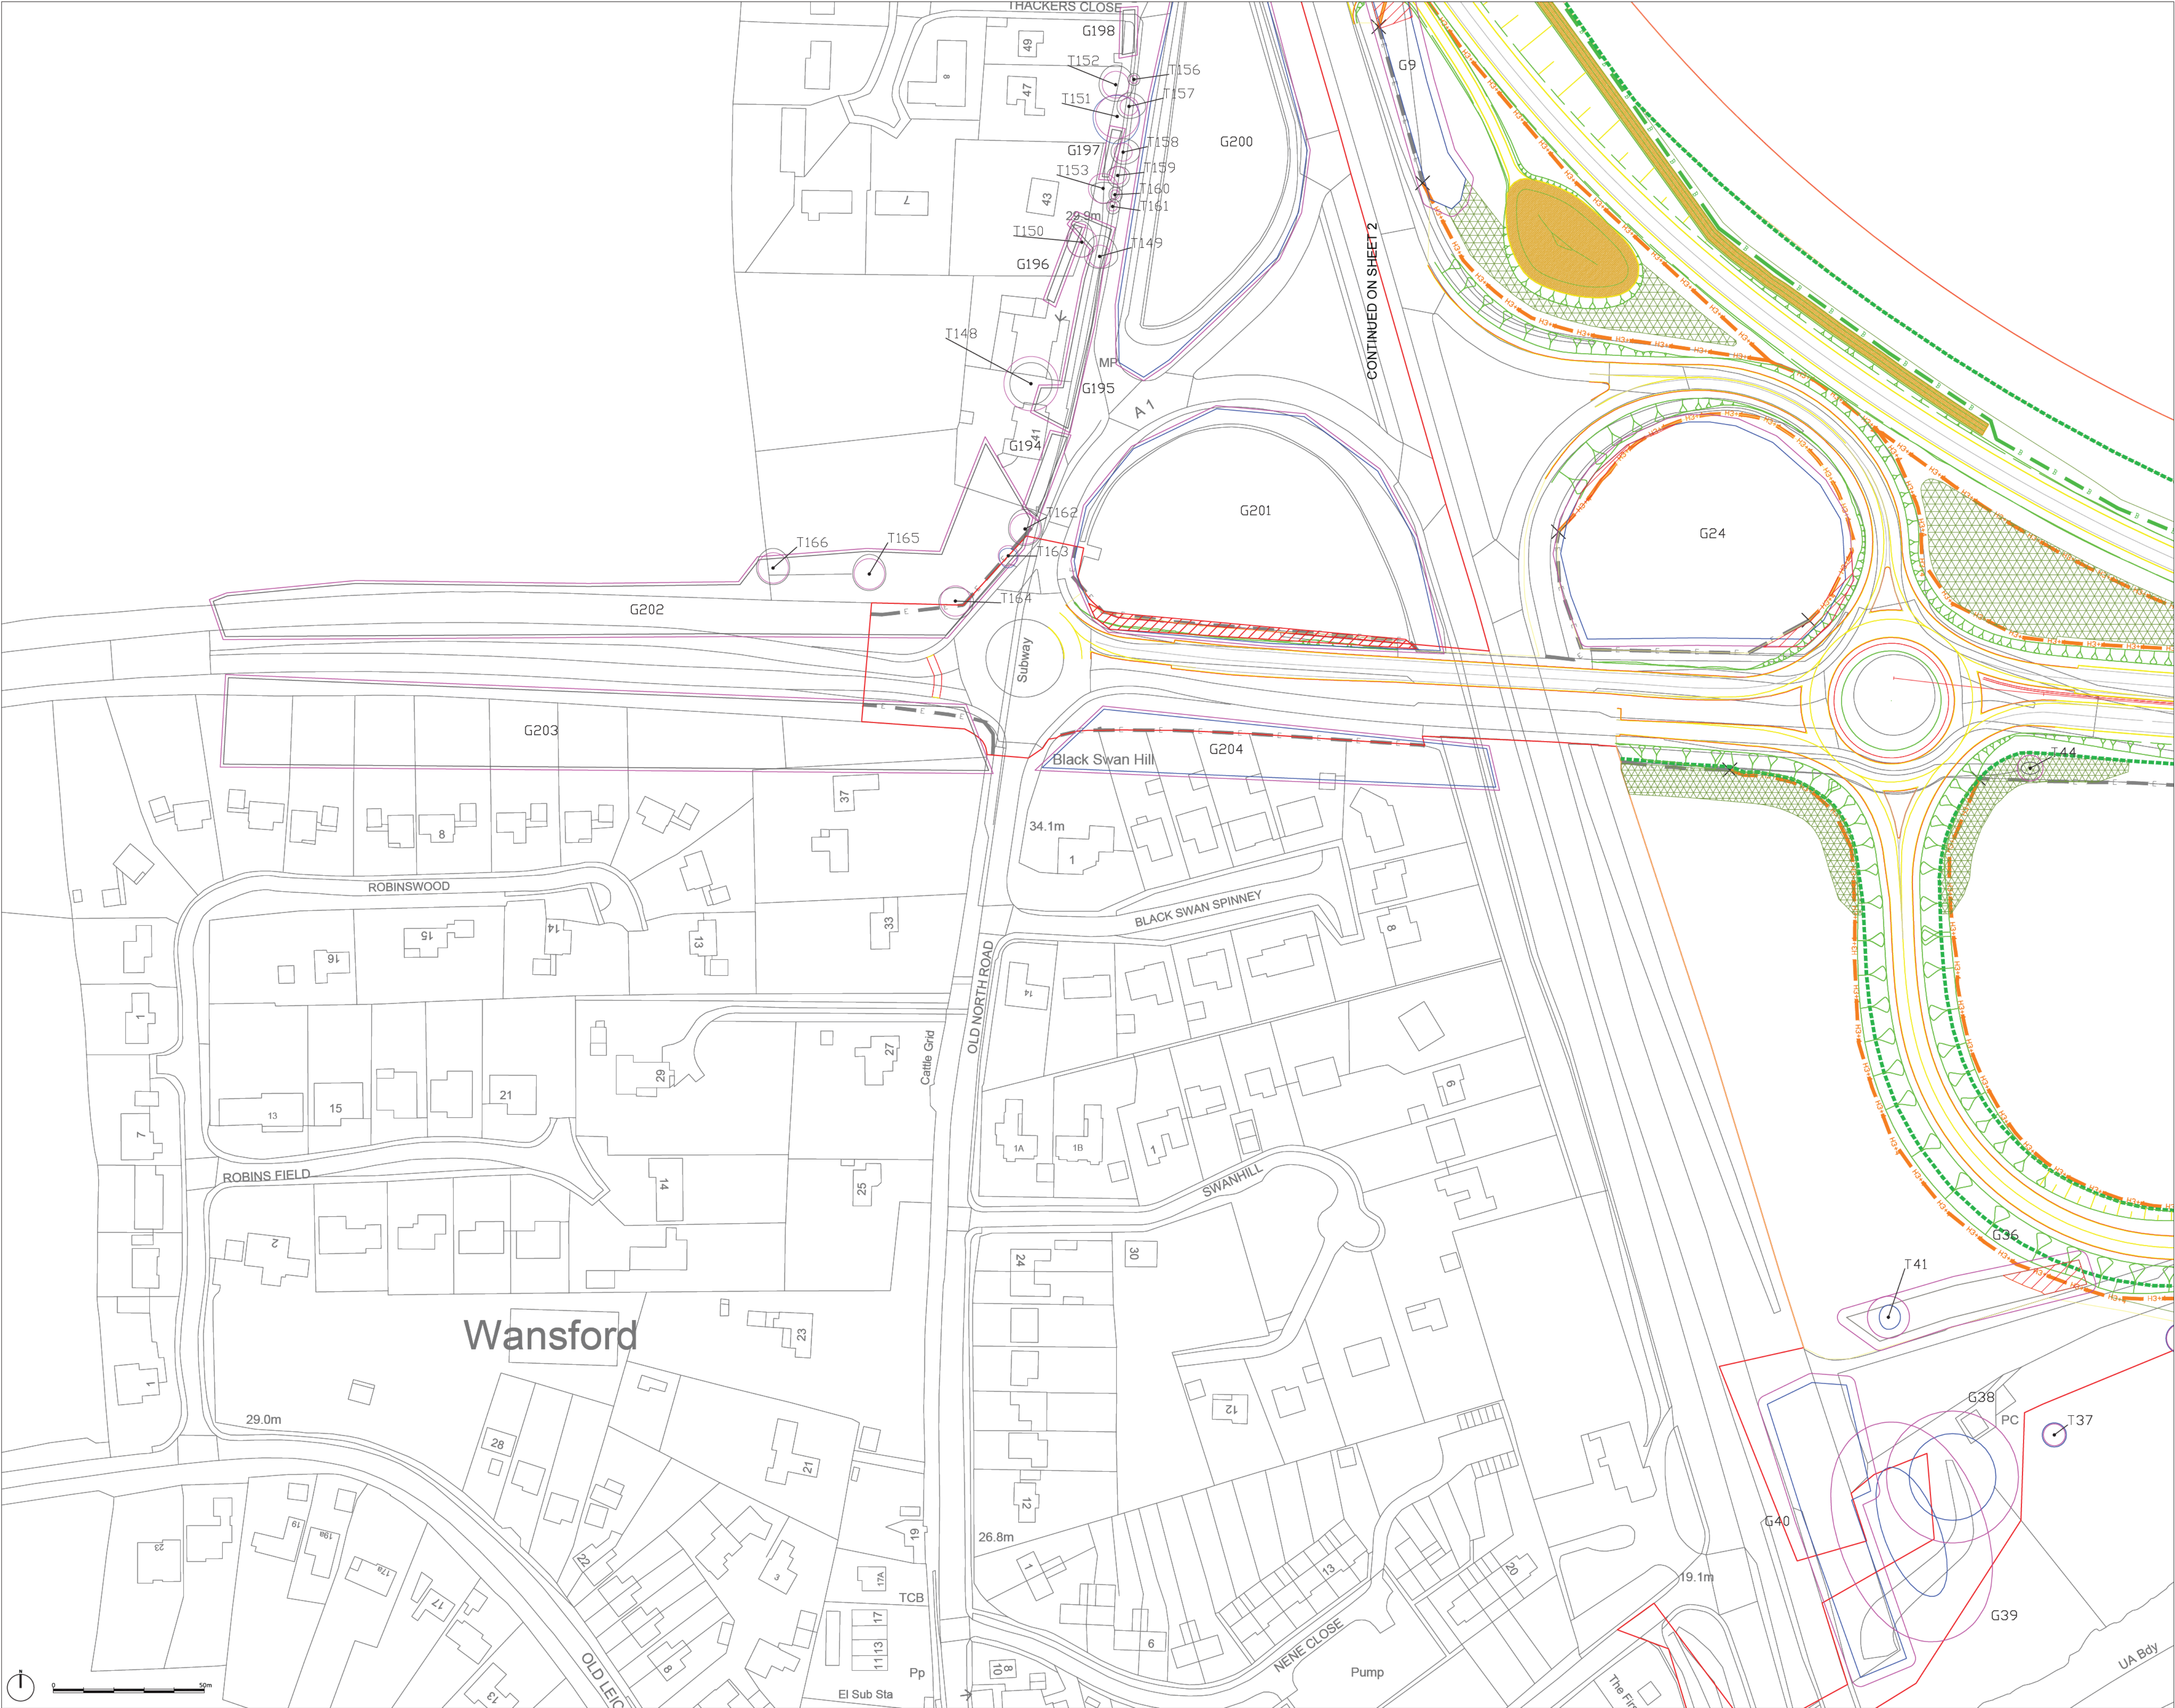
- Recommended 'Root Protection Area' (RPA) of trees/hedges considered desirable for retention calculated using the method set out in section 4.2 of BS5837:2012

- Individual trees to be removed
- Groups or hedgerows to be removed

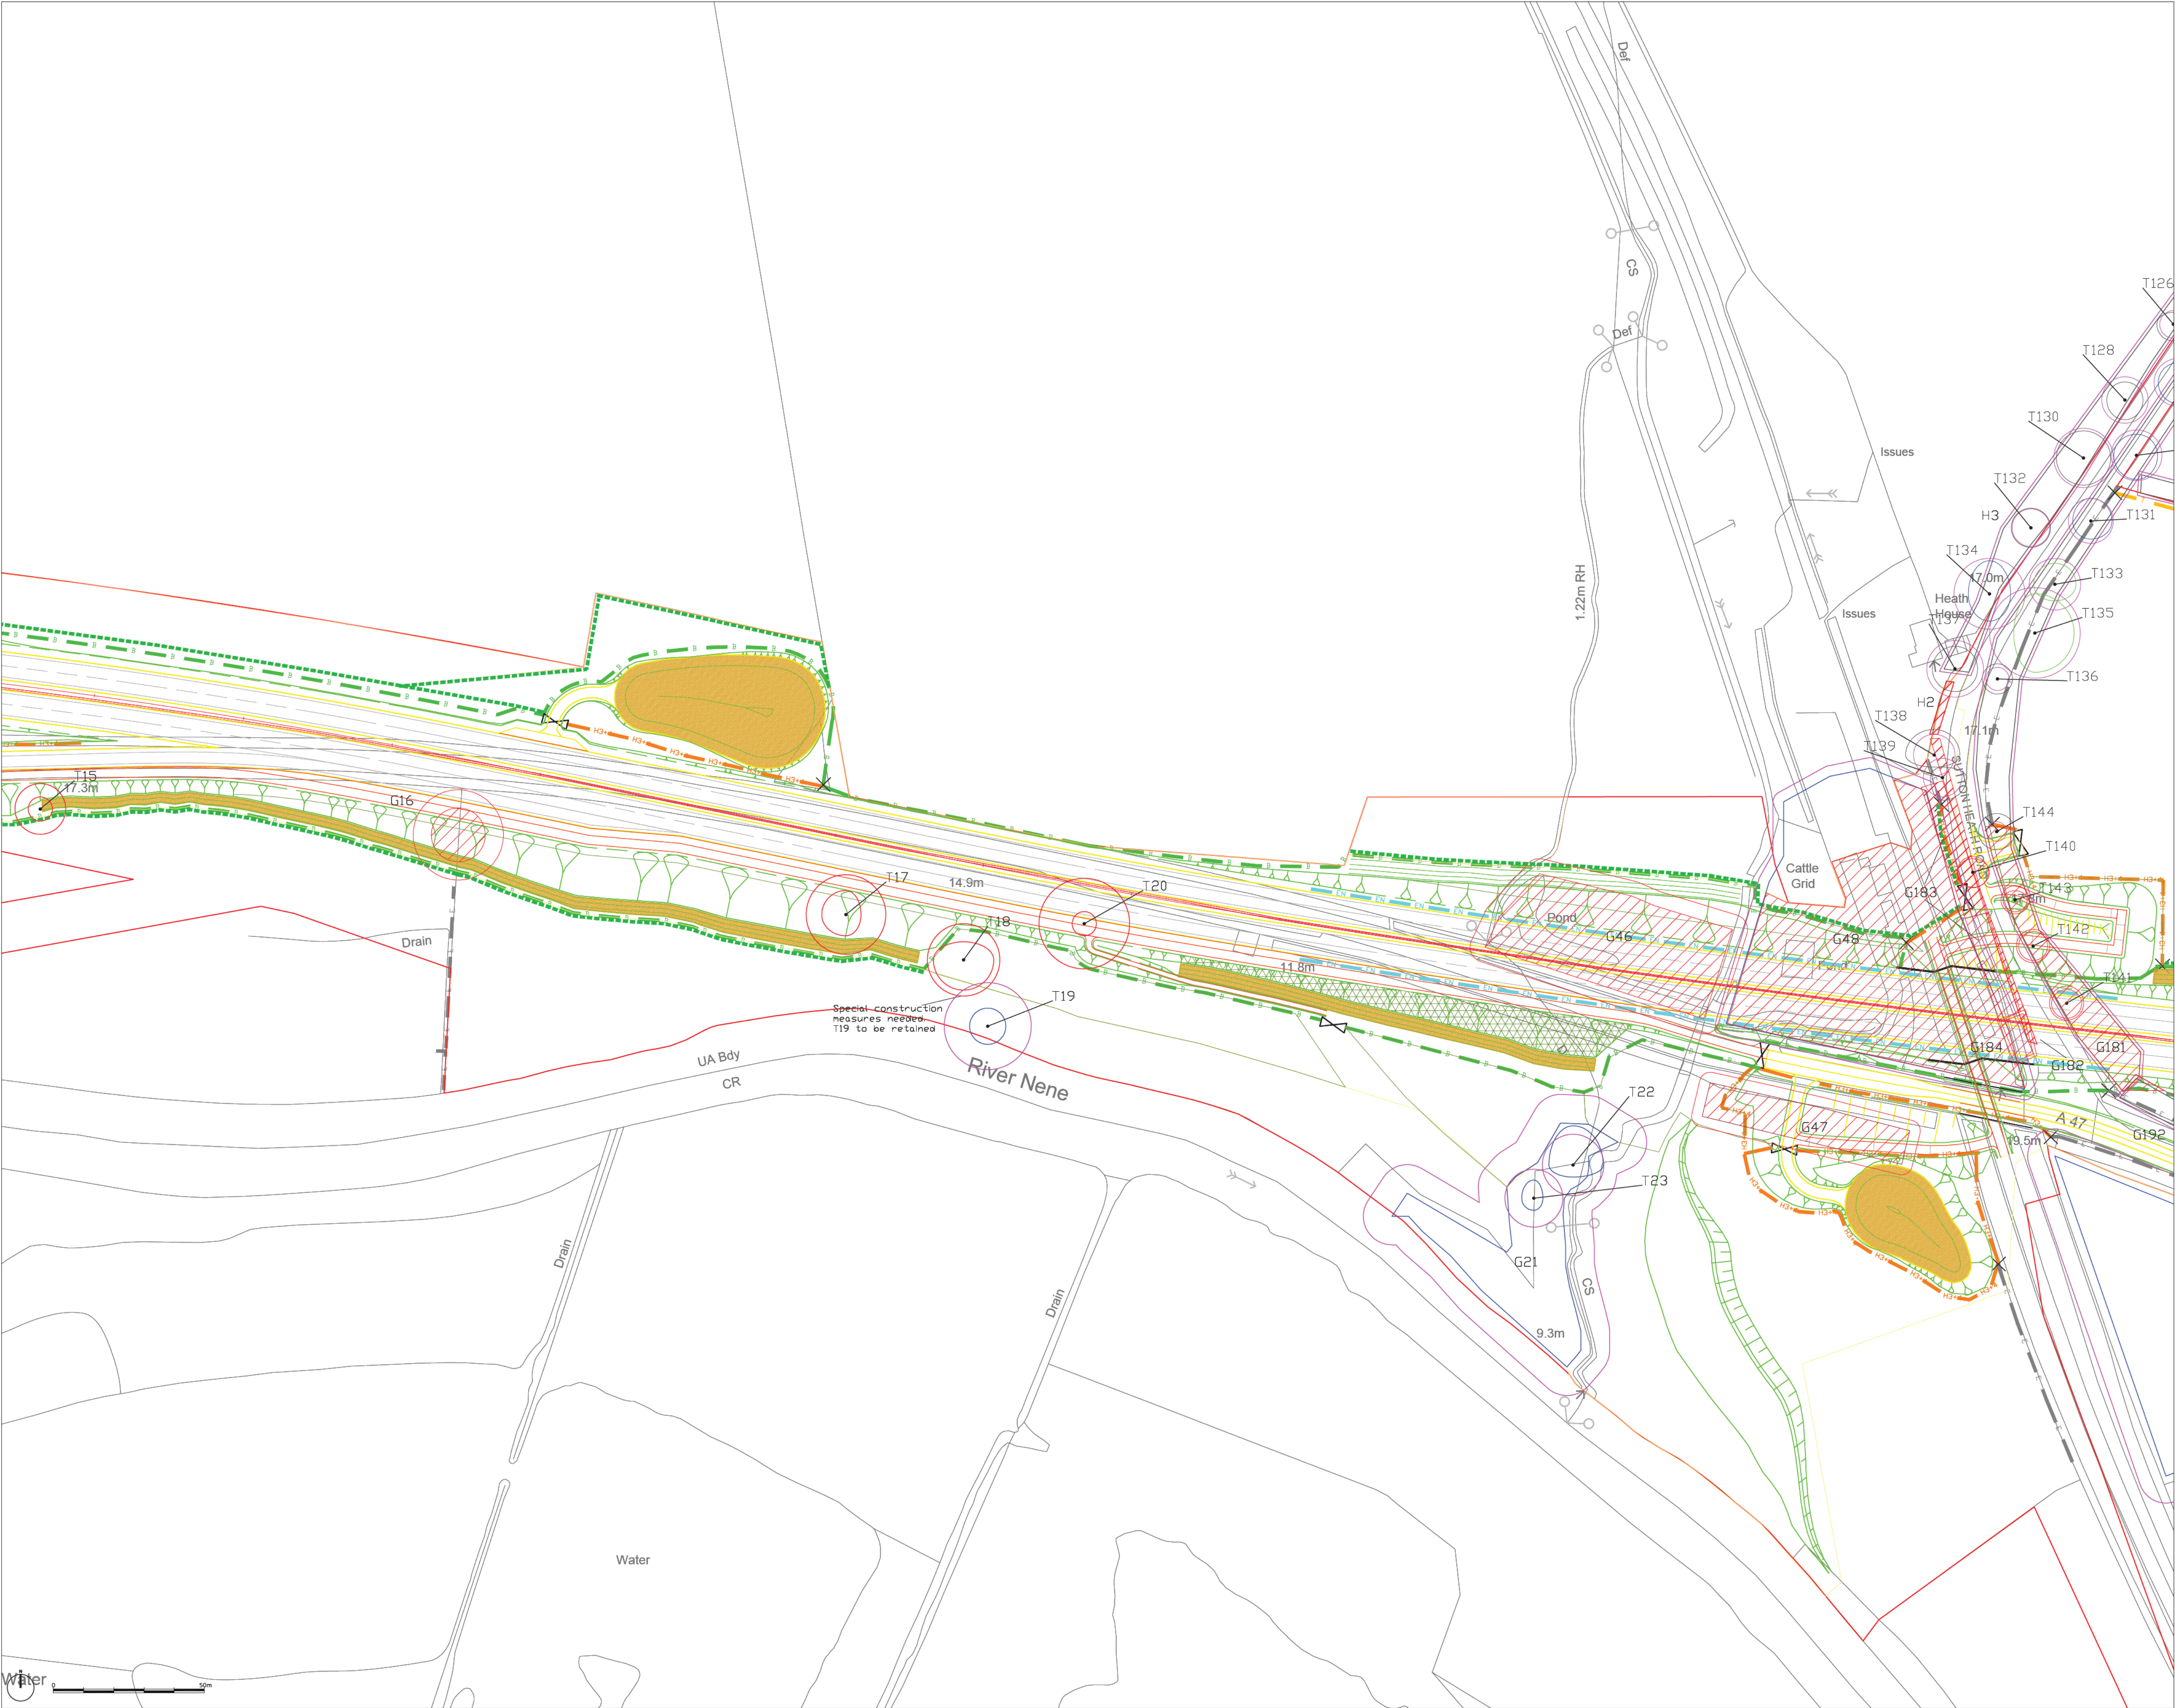
- Recommended 'Root Protection Area' (RPA) of trees/hedges considered desirable for retention calculated using the method set out in section 4.2 of BS5837:2012

- Individual trees to be removed
- Groups or hedgerows to be removed

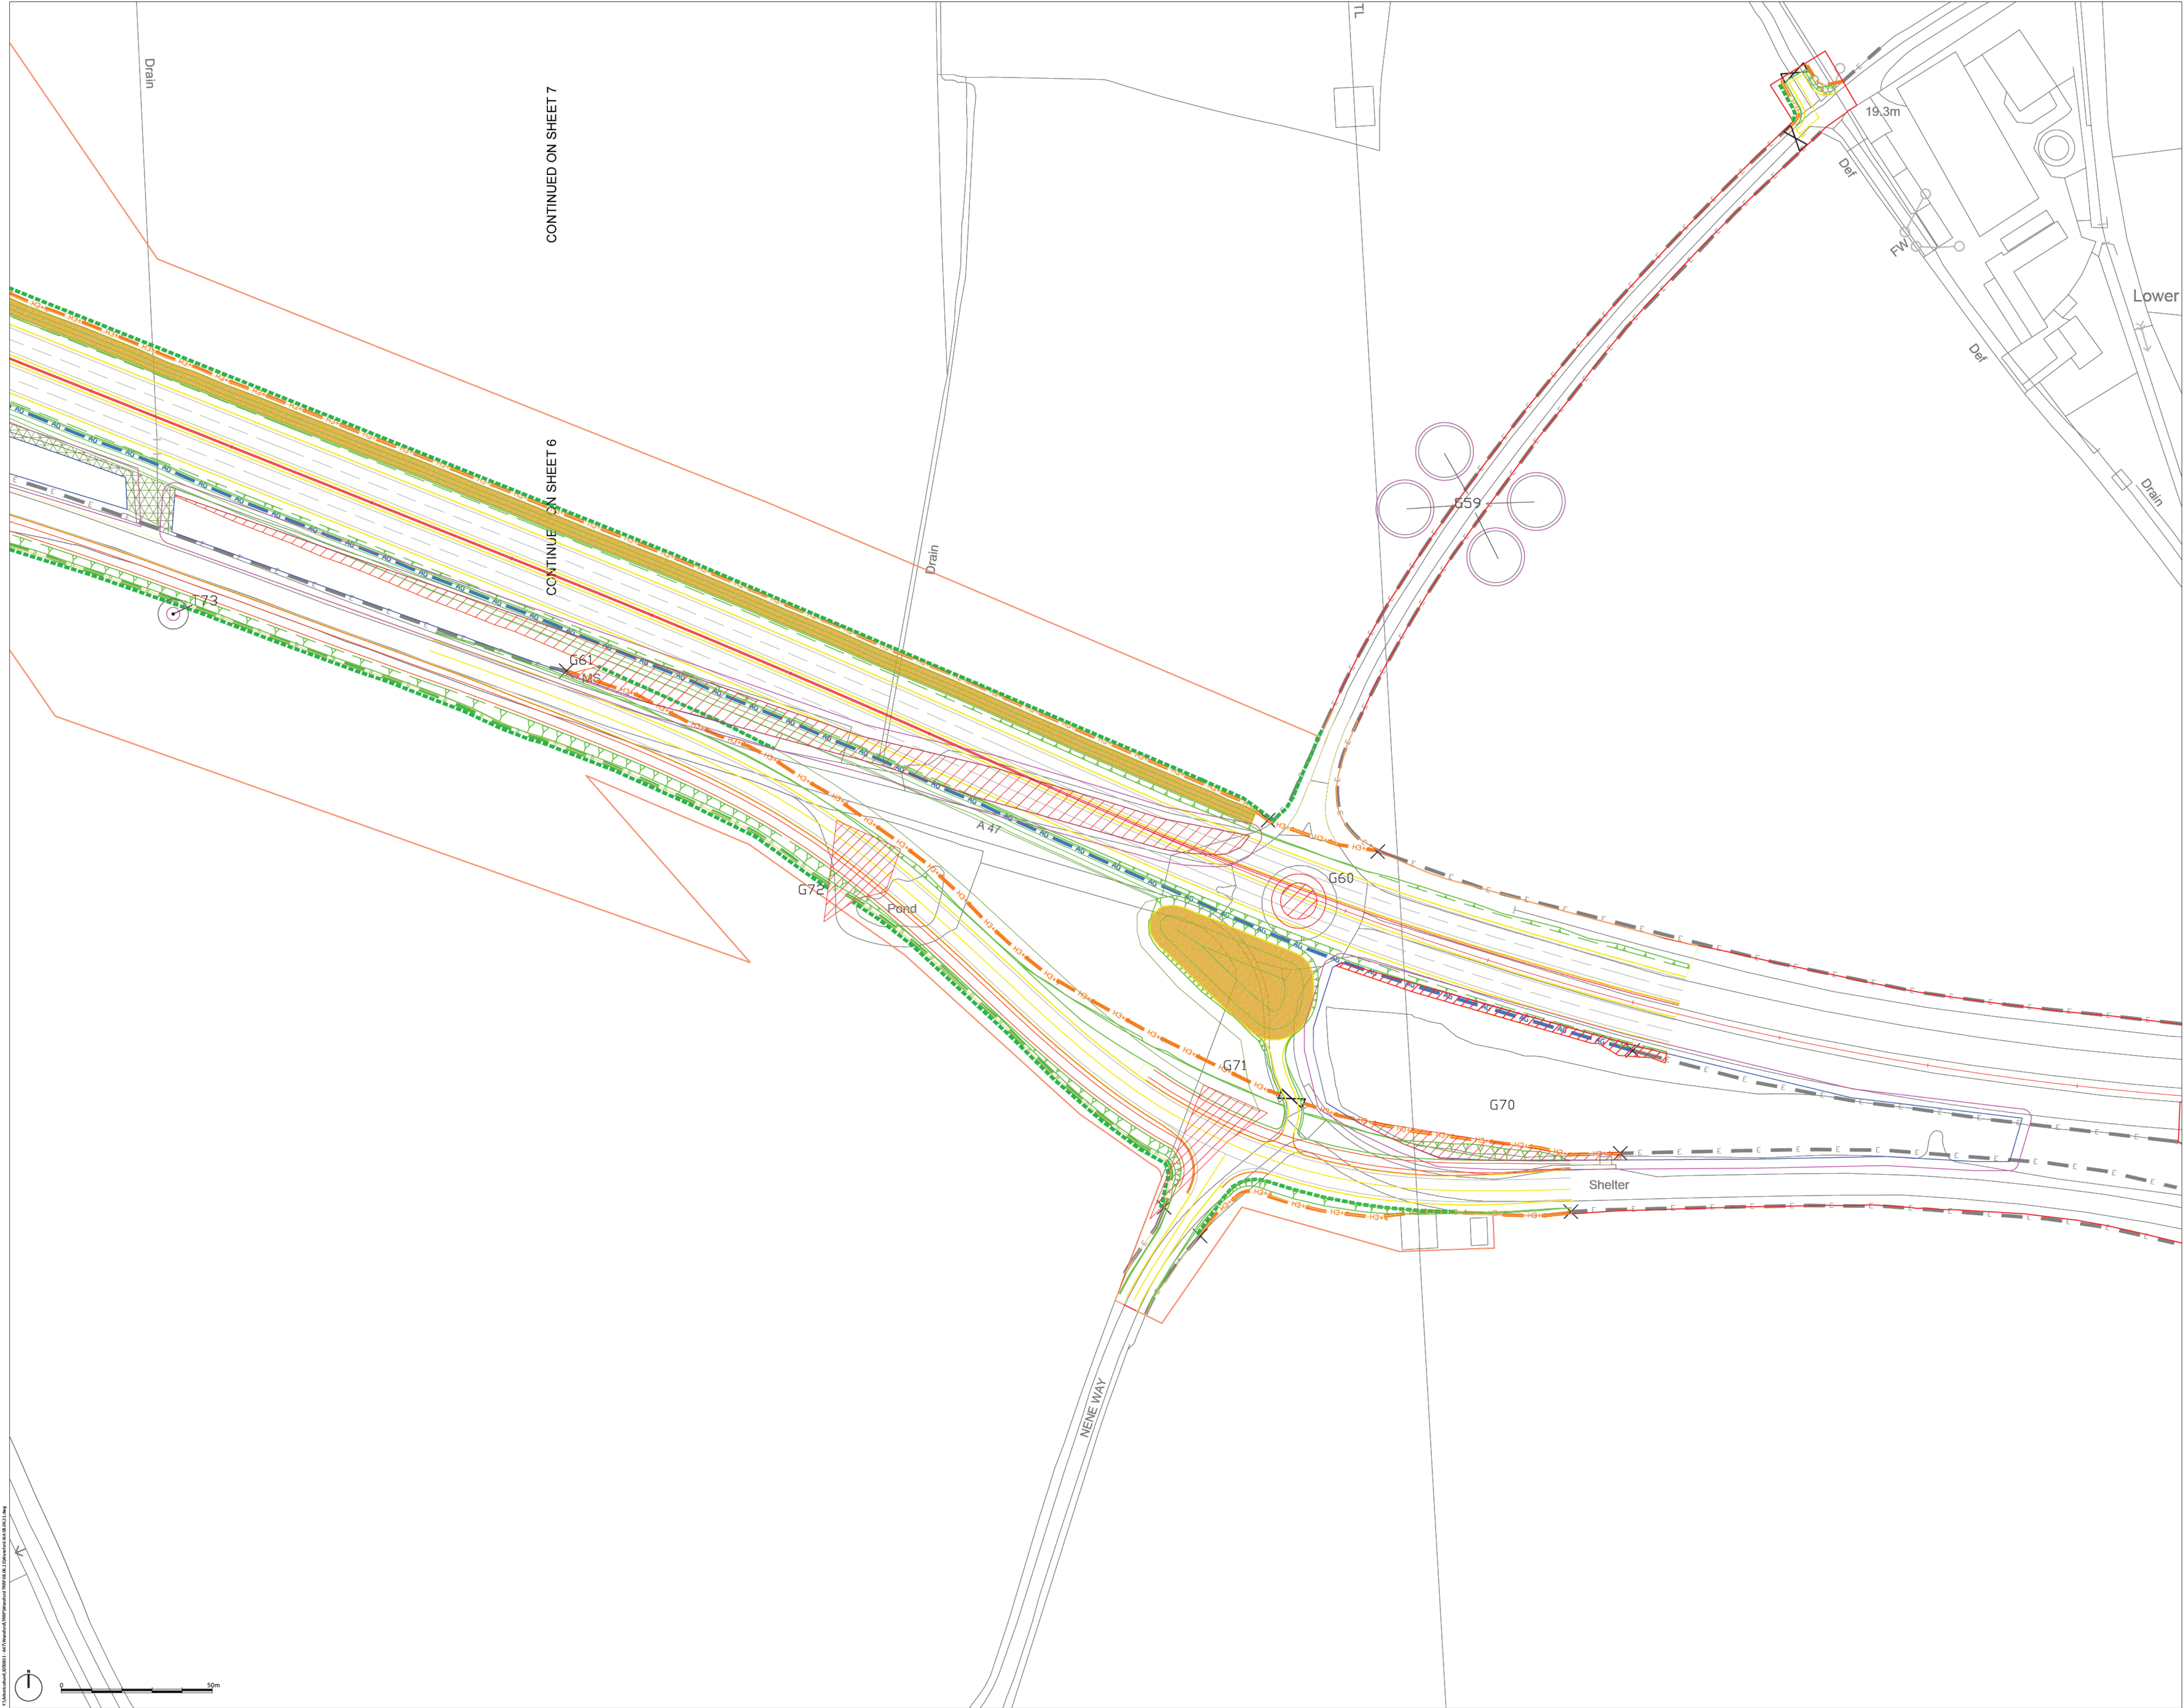
Client:
SWECO
Project:
A47 - Wansford
Drawing Title:
Arboricultural Impact Assessment Plan 5/9
Drawing No: ADAS_1050831_Sweco_A47 Wansford_AIAS
Scale: 1:1000 @ A1
Drawn by: RT
Checked by: IB
Date: 09/06/2021
Date: 09/06/2021
© Crown copyright and database rights (2020) OS G100019694
For reference purposes only. No further copies may be made.
ADAS, 11d Park House, Milton Park,
Milton, Abingdon, Oxford, OX14 4RS
Tel: 01235 355630
© RISK ADAS Ltd.

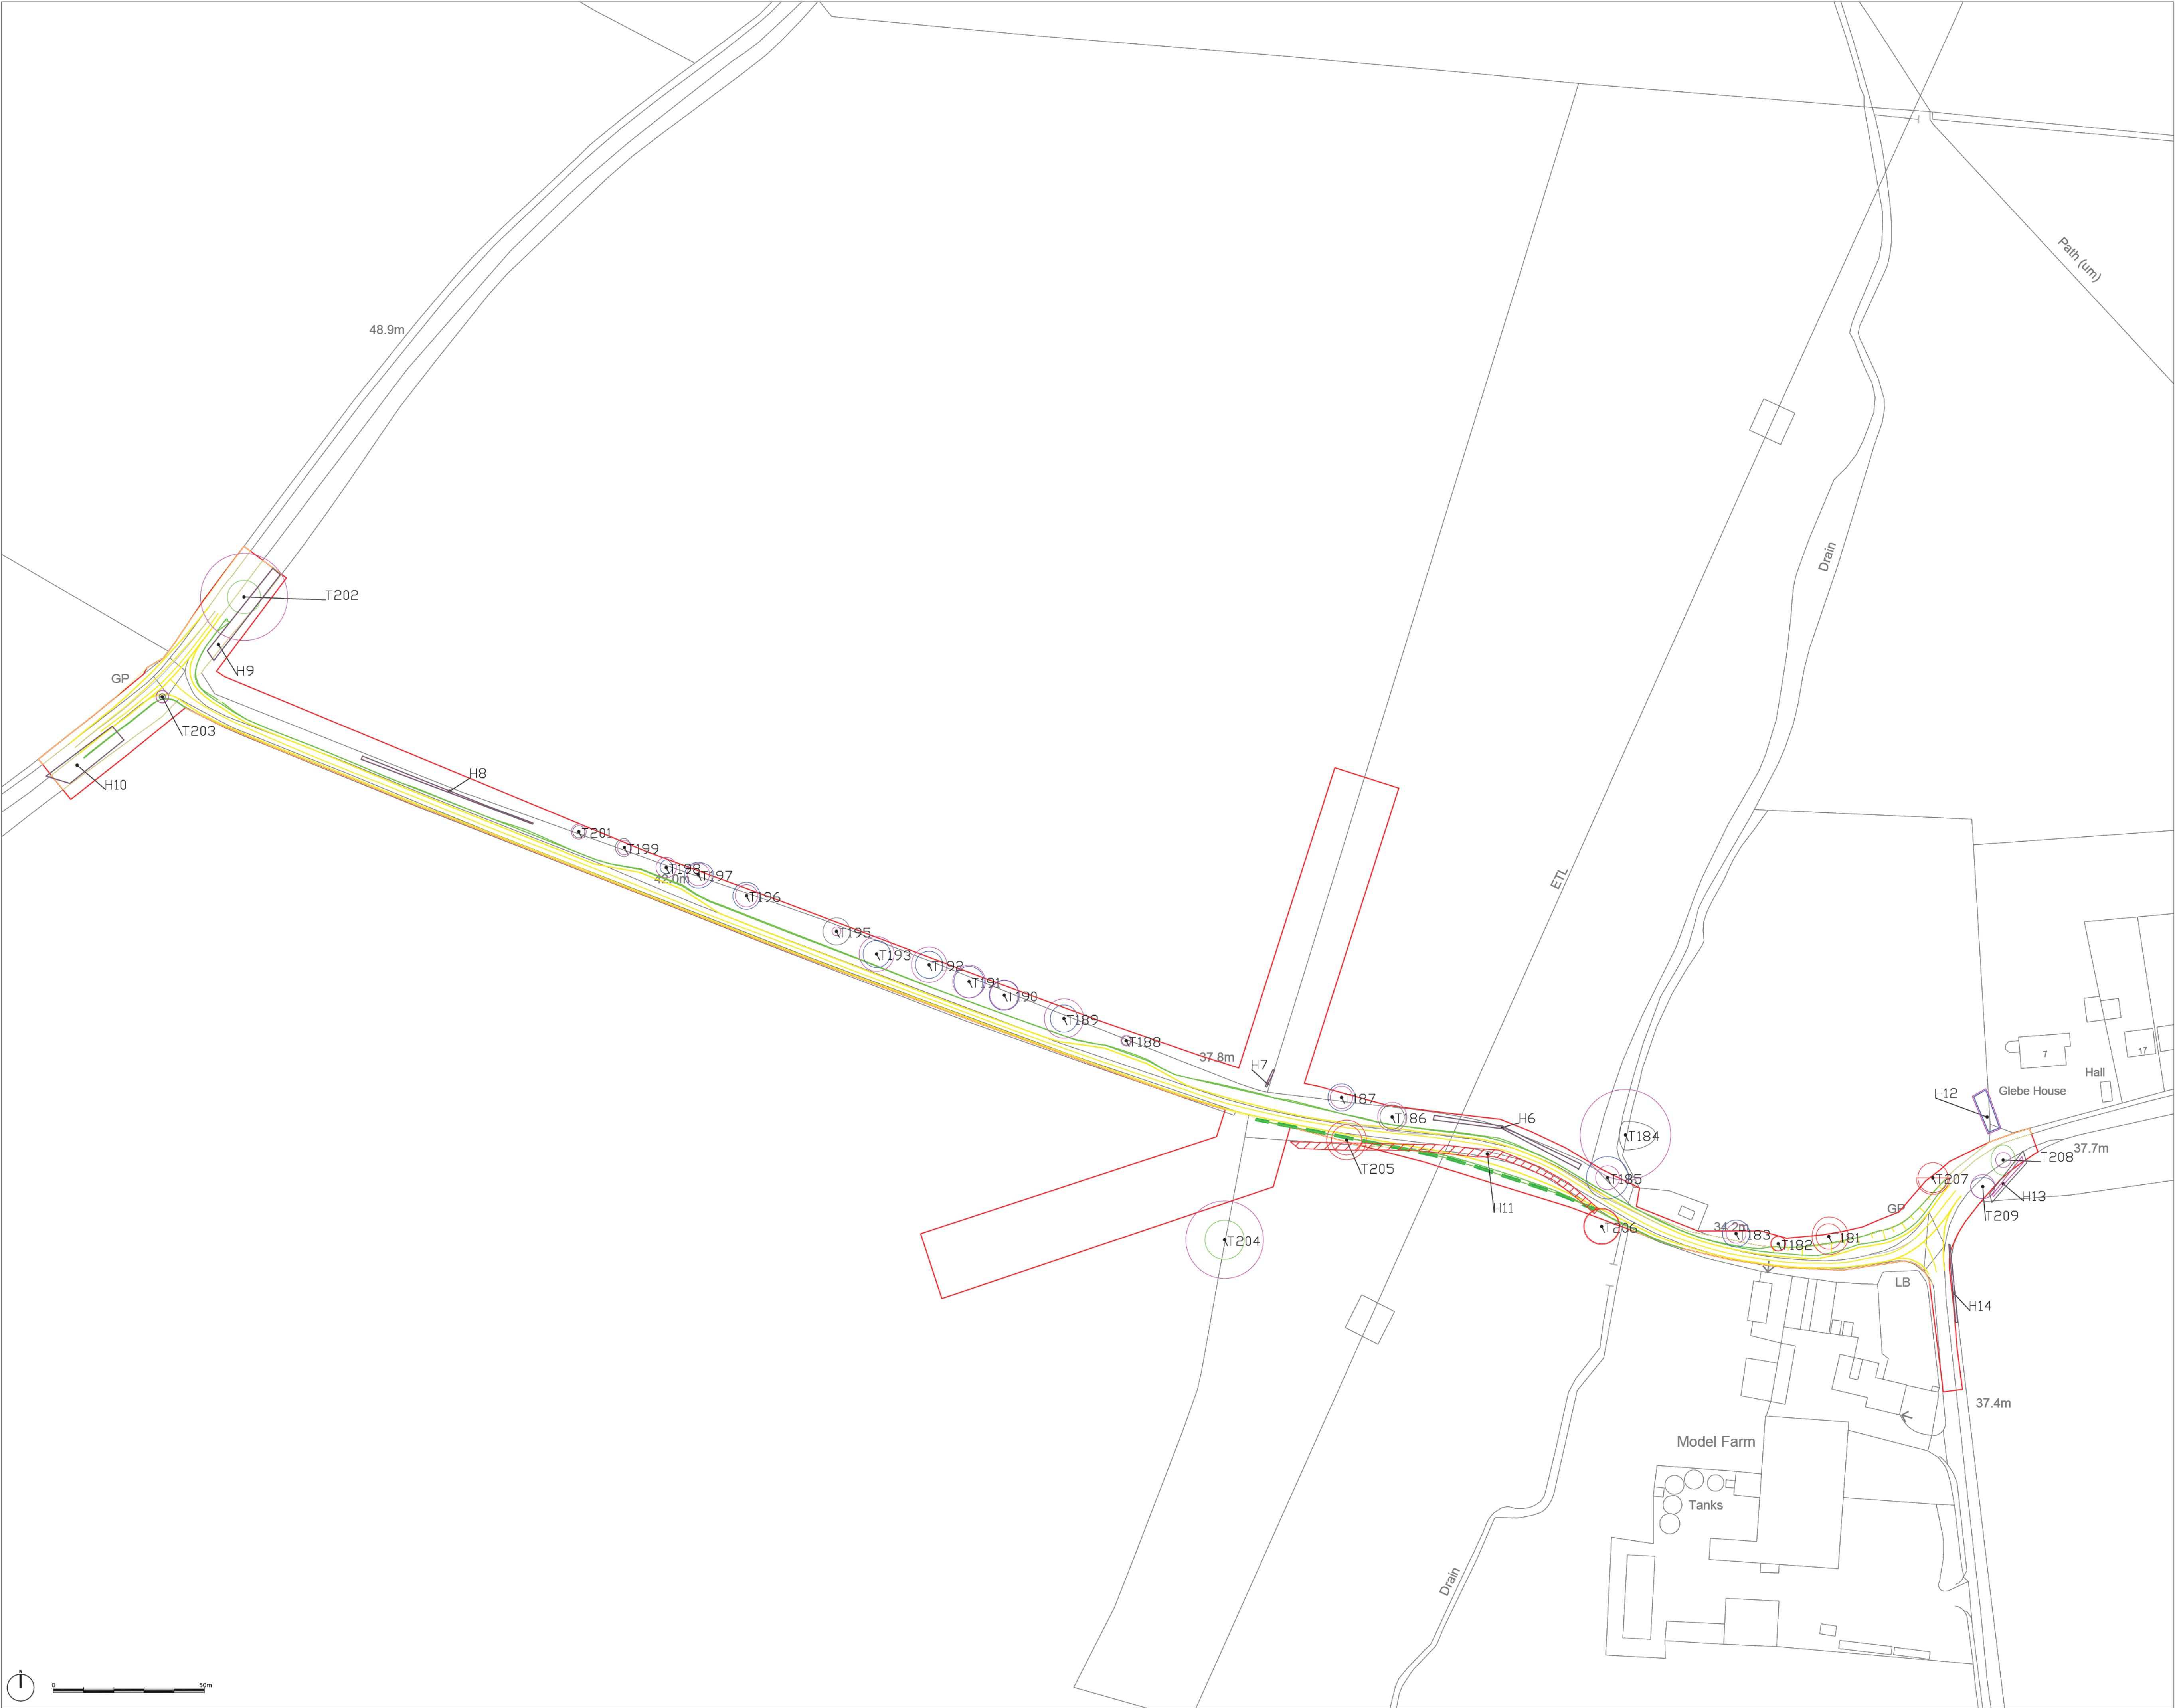
- Recommended 'Root Protection Area' (RPA) of trees/hedges considered desirable for retention calculated using the method set out in section 4.2 of BS5837:2012

- Individual trees to be removed
- Groups or hedgerows to be removed

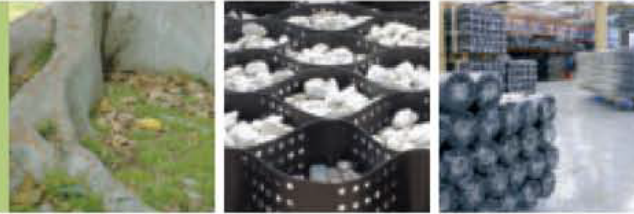
The CellWeb™ TRP cellular confinement system protects tree roots from the damaging effects of compaction and desiccation, while creating a stable, load-bearing surface for vehicular traffic.
