A47 Wansford to Sutton Dualling

Appendix 7.6 – Arboricultural Impact Assessment

Arboricultural Impact Assessment A47 – Wansford

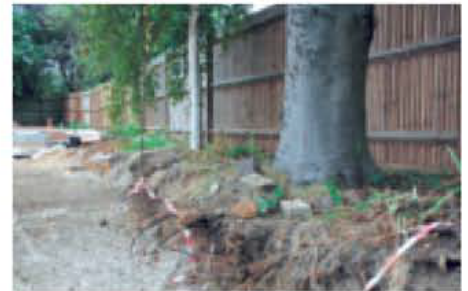
Potential loss of existing tree due to poor construction techniques.

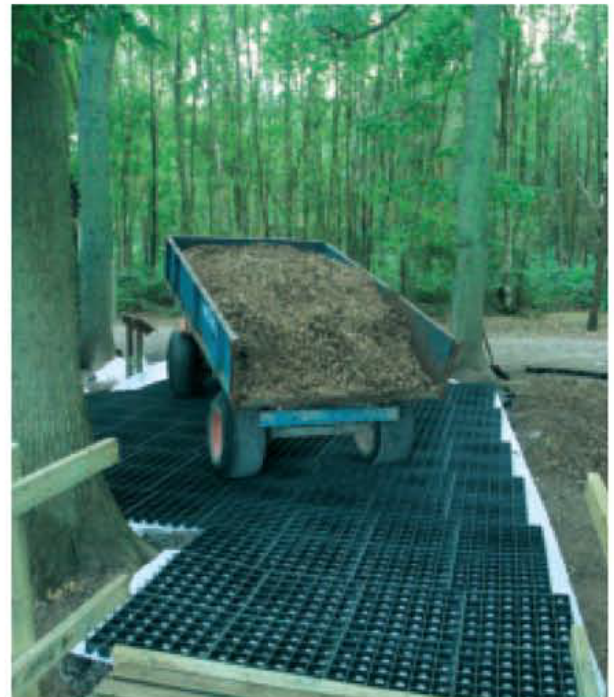
Glynebourne Wood.

Pedestrian path to recreational woodland built using a CellWeb™ foundation which was covered with DuoBlock and then filled with woodchip to create a porous surface.

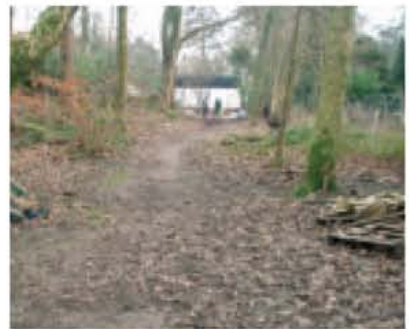
Site before construction pictured above.

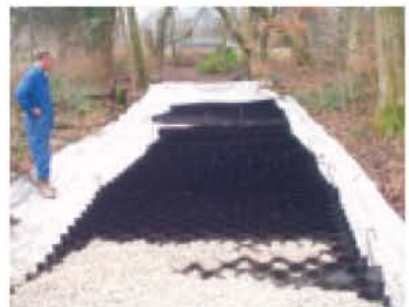
Installation of the CellWeb™ system.

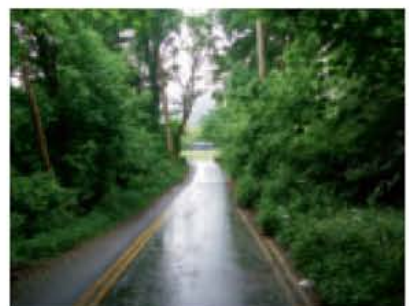
Four years later.
