A47 Blofield to North Burlingham Dualling

Scheme Number: TR010040

Appendix 11.3 Baseline Noise Survey

ENVIRONMENTAL STATEMENT APPENDICES
Appendix 11.3 Baseline Noise Survey

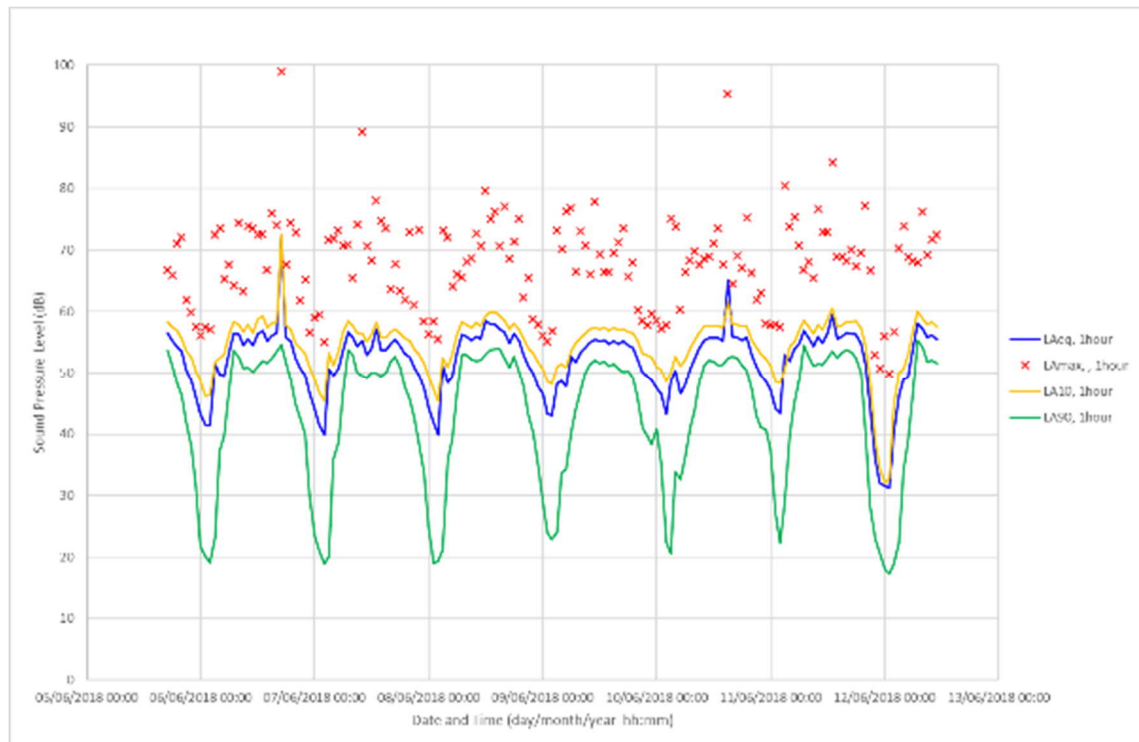
Figure 11.3.1 LT1 plot of results (façade measurement)

11.3.18. Position LT1 was located in the back garden of Izola, North Street, Blofield, NR13 4RH (refer to Figure 11.1 (Noise location plan) (**TR010040/APP/6.3**)). This is a façade measurement.

Date	$L_{Aeq,8h}$ night time dB	$L_{A10,18h}$ day time dB
06/06/2018	49.0	57.6
07/06/2018	49.1	56.0
08/06/2018	48.8	57.2
09/06/2018	48.2	55.9
10/06/2018	47.9	56.3
11/06/2018	51.3	54.9
12/06/2018	47.8	---

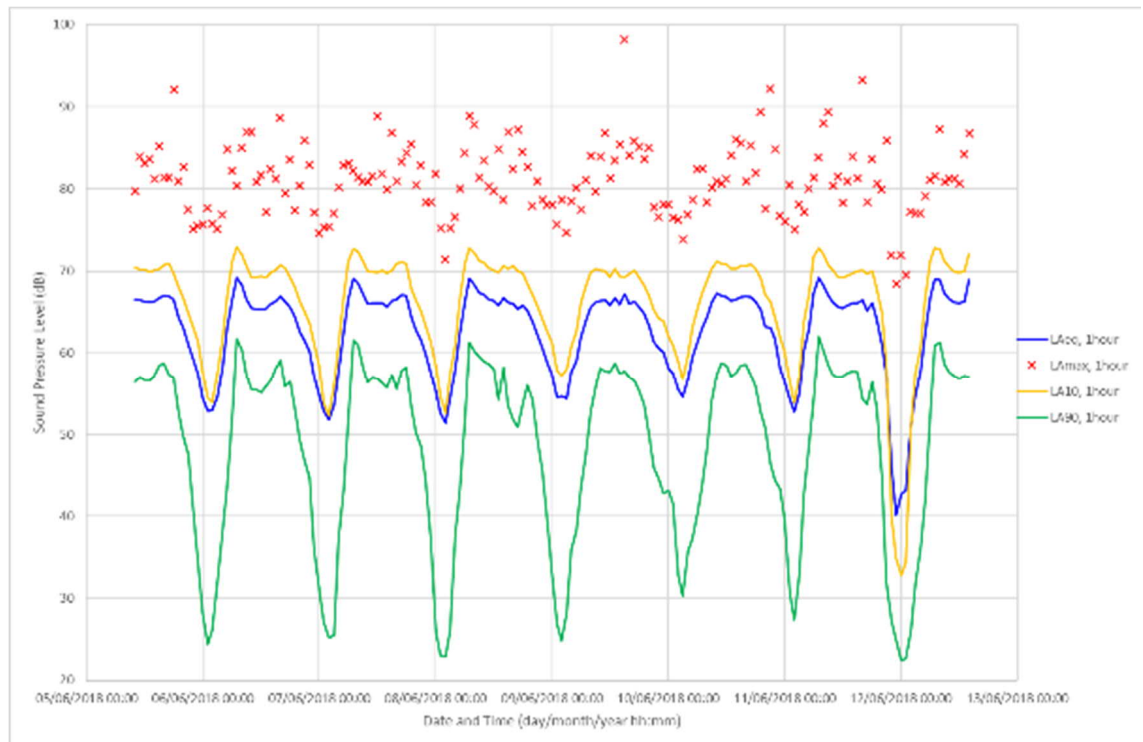
Figure 11.3.2 LT2 plot of results

11.3.19. Position LT2 was located in the back garden of no. 111 Yarmouth Road, Blofield, NR13 4LQ, close to the A47 carriageway towards Norwich (refer to Figure 11.1 (Noise location plan) (TR010040/APP/6.3)). There was a clear line of sight with the A47.

Date	L _{Aeq,8h} night time dB	L _{A10,18h} day time dB
06/06/2018	60.4	69-73*
07/06/2018	60.2	69-73*
08/06/2018	60.1	69-73*
09/06/2018	58.0	68-70*
10/06/2018	58.5	69-72*
11/06/2018	61.1	69-73*
12/06/2018	59.7	---

**Estimated from Figure 11.4 LT2 plot of results

* Estimated from Figure 11.3.4 LT2 plot of results

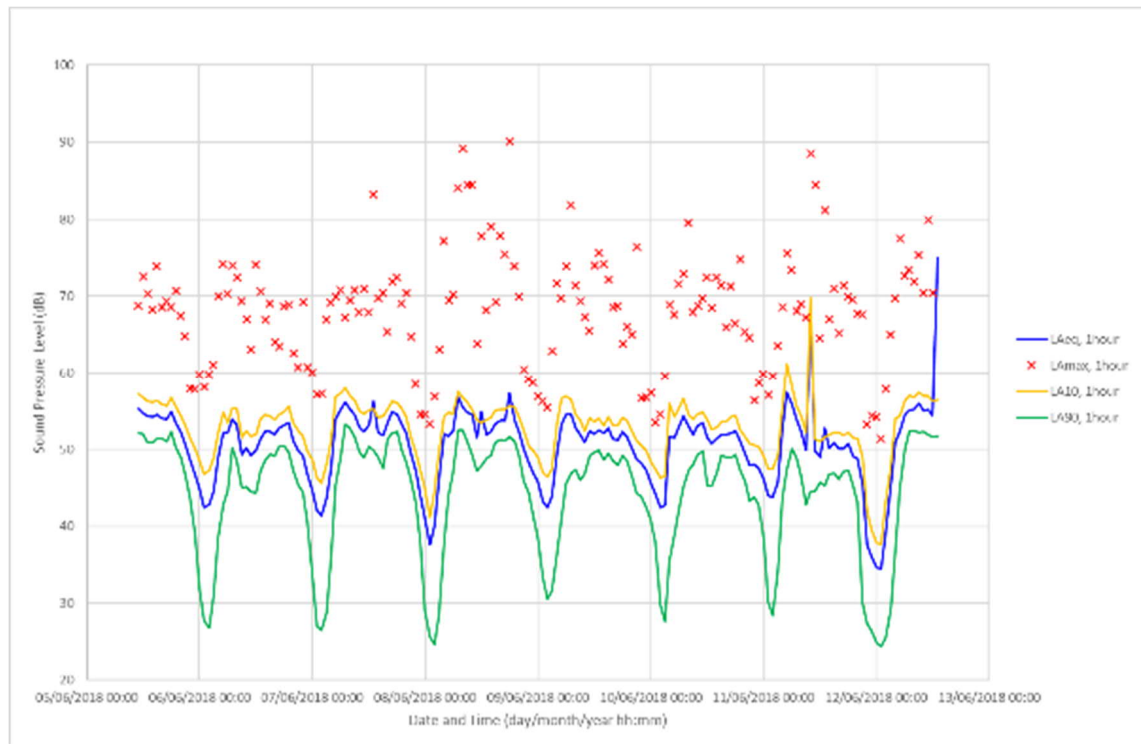
Figure 11.3.3 LT3 plot of results

11.3.20. Position LT3 was located in the back garden of Brienz, Waterlow, Blofield, NR13 4LJ (refer to Figure 11.1 (Noise location plan) (TR010040/APP/6.3)).

Date	L _{Aeq,8h} night time dB	L _{A10,18h} day time dB
06/06/2018	48.4	53.4
07/06/2018	49.8	54.6
08/06/2018	48.6	54.4
09/06/2018	49.6	53.4
10/06/2018	49.0	53.4
11/06/2018	52.1	52.1
12/06/2018	48.9	---

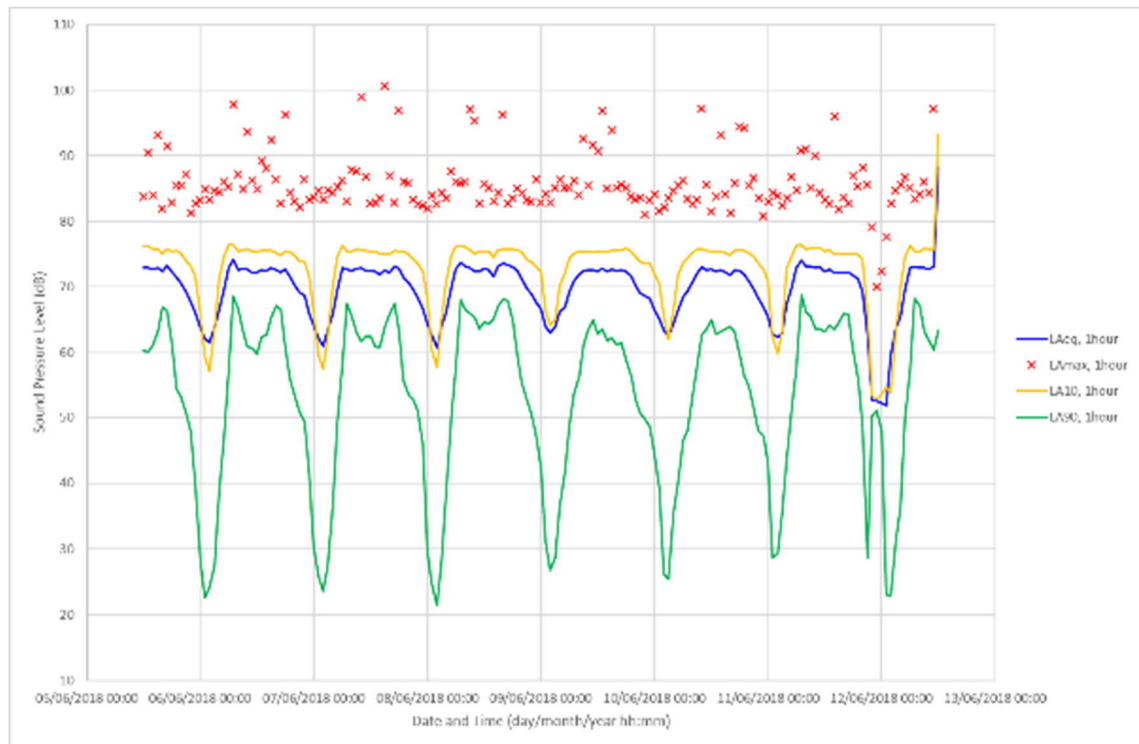
Figure 11.3.4 LT4 plot of results

11.3.21. Position LT4 was located in the front garden of the Old Post Office, North Burlingham, Norwich, NR13 4SU, close to the A47 carriageway towards Acle. There was a clear line of sight with the A47 (refer to Figure 11.1 (Noise location plan) (**TR010040/APP/6.3**)).

Date	L _{Aeq,8h} night time dB	L _{A10,18h} day time dB
06/06/2018	67.6	75.2
07/06/2018	67.4	75.1
08/06/2018	67.5	75.3
09/06/2018	66.4	75.1
10/06/2018	66.1	75.0
11/06/2018	67.9	72.4
12/06/2018	66.5	---

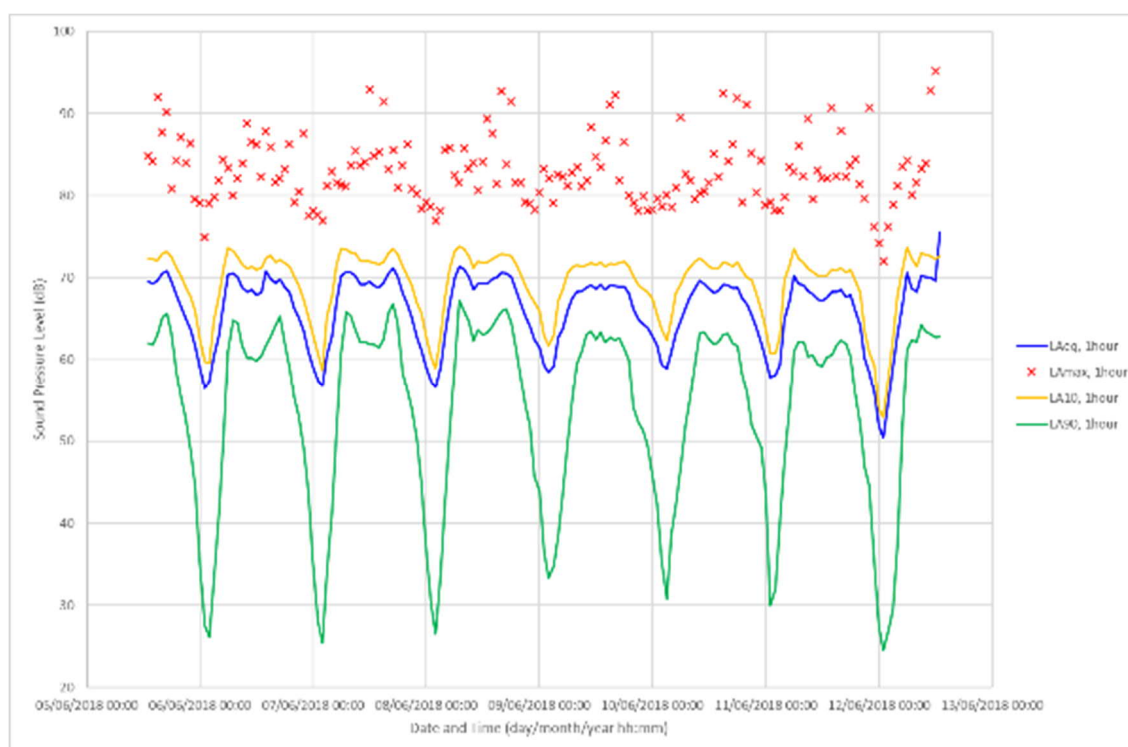
Figure 11.3.5 LT5 plot of results

11.3.22. Position LT5 was located in the lateral garden of The White House, Acle Road, North Burlingham, Norwich, NR13 4EL, close to the A47 carriageway towards Norwich (refer to Figure 11.1 (Noise location plan) (TR010040/APP/6.3)). There was a clear line of sight with the A47.

Date	L _{Aeq,8h} night time dB	L _{A10,18h} day time dB
06/06/2018	64.4	71.1
07/06/2018	64.4	71.5
08/06/2018	64.1	71.6
09/06/2018	62.4	71.0
10/06/2018	62.4	70.7
11/06/2018	64.7	69.3
12/06/2018	64.0	---

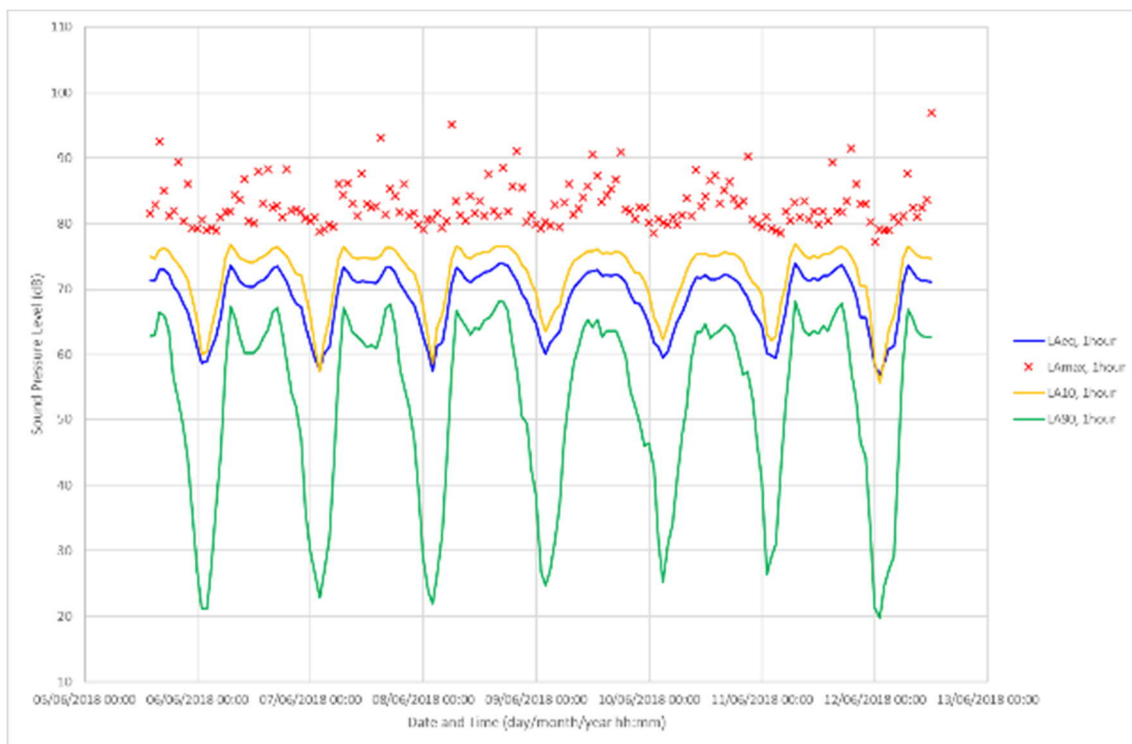
Figure 11.3.6 LT6 plot of results (façade measurement)

11.3.23. Position LT6 was located in the back garden of no. 2 Hall Cottages, The Windle, Acle, Norwich, NR13 3JT, close to the A47 carriageway towards Acle (refer to Figure 11.1 (Noise location plan) (TR010040/APP/6.3). This is a façade measurement.

Date	<u>L_{Aeq,9h} night time dB</u>	<u>L_{A10,18h} day time dB</u>
<u>06/06/2018</u>	<u>64.8</u>	<u>74.5</u>
<u>07/06/2018</u>	<u>64.5</u>	<u>74.7</u>
<u>08/06/2018</u>	<u>65.0</u>	<u>75.2</u>
<u>09/06/2018</u>	<u>63.8</u>	<u>74.4</u>
<u>10/06/2018</u>	<u>63.4</u>	<u>73.8</u>
<u>11/06/2018</u>	<u>65.4</u>	<u>74.4</u>
<u>12/06/2018</u>	<u>64.3</u>	-

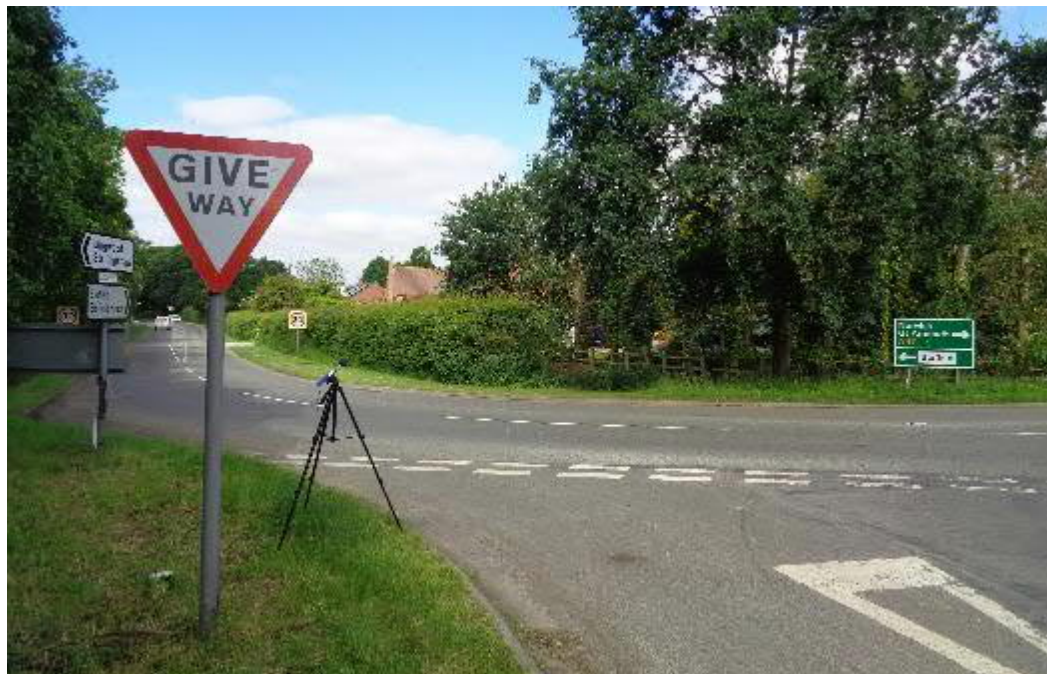
Figure 11.3.7: ST1

11.3.6. Position ST1 was located on the grass at the junction of Yarmouth Road with an Unnamed Road (leading to Waterlow and Hemblington Road), approximately 45m to the south of the A47 carriageway towards Norwich. This is the closest access to the A47 to the east of Blofield (refer to Figure 11.1 (Noise location plan) (TR010040/APP/6.3)). There was a clear line of sight with the A47.

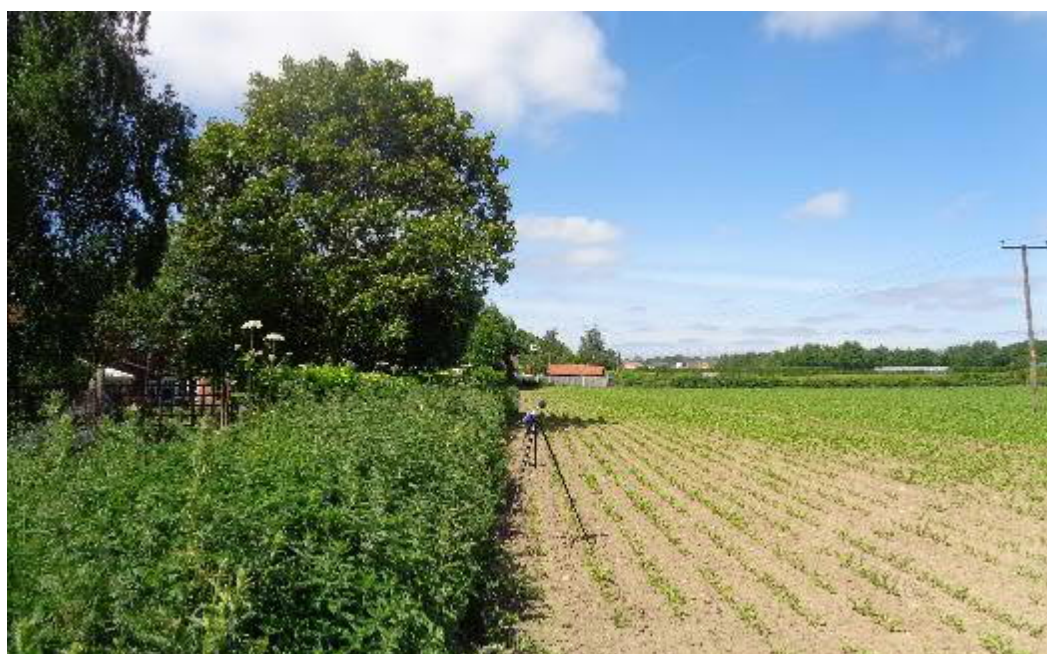
Figure 11.3.8: ST2 (photo taken towards west)

11.3.7. Position ST2 was located at the edge of a field behind Violet Bank Lingwood Road, Blofield, Norwich, NR13 4LL (refer to Figure 11.1 (Noise location plan) (TR010040/APP/6.3)).

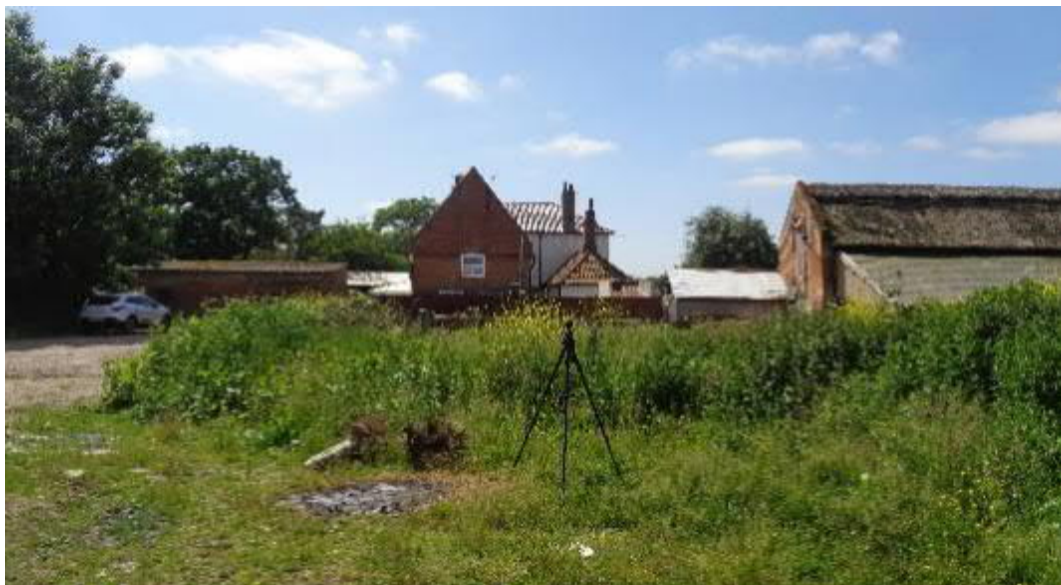
Figure 11.3.9: ST3 (photo taken towards south)

11.3.8. Position ST3 was located at the entrance of the field to the west of Lingwood Road, North Burlingham, Norwich, NR13 4ST. This field is also to the south of the A47 and to the north of Hornbeam Cottage, Lingwood Road, North Burlingham, Norwich, NR13 4ST (refer to Figure 11.1 (Noise location plan) (TR010040/APP/6.3)). There was a clear line of sight with the A47.

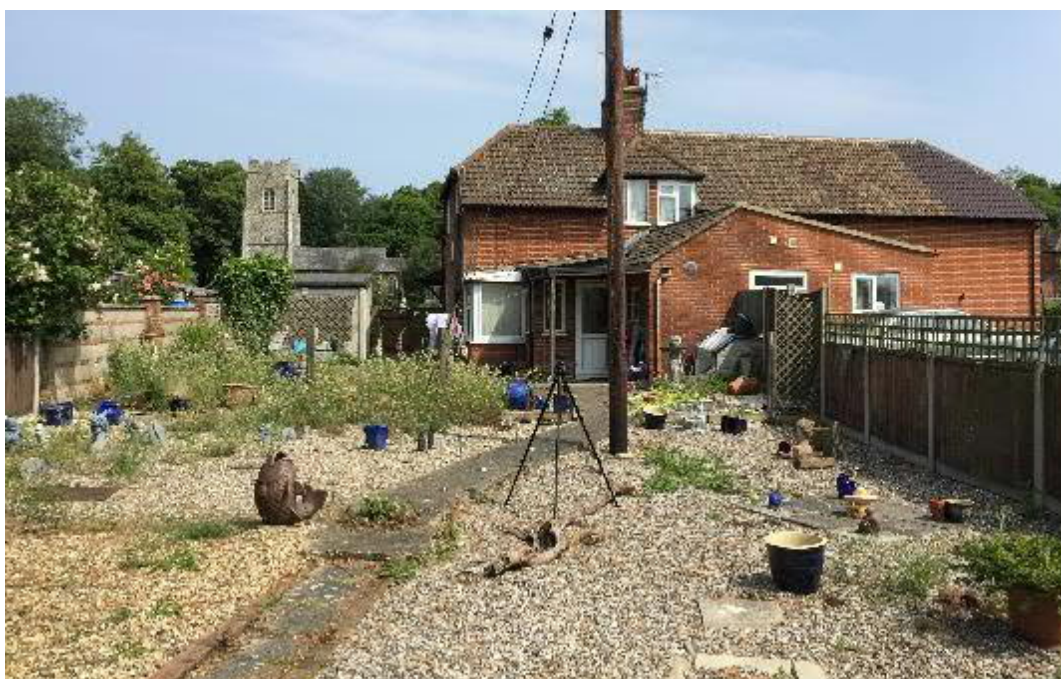
Figure 11.3.10: ST4 H

11.3.9. Position ST4 H (home) was located in the back garden of no. 6 Main Road, North Burlingham, Norwich, NR13 4TA. The back garden has clear line of sight with the A47 (refer to Figure 11.1 (Noise location plan) (TR010040/APP/6.3)).

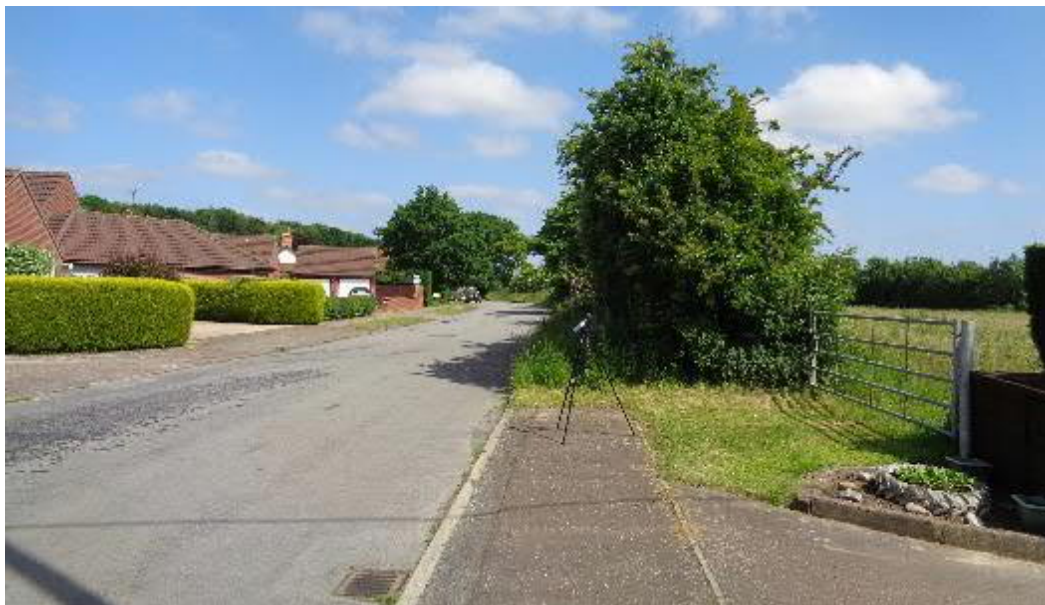
Figure 11.3.11: ST4 R (photo taken towards east)

11.3.10. Position ST4 R (road) was located on the pavement at the entrance on the field in Main Road, North Burlingham, Norwich, NR13 4TA; adjacent to house no. 16 and in front of house no. 7. There was a clear line of sight with the A47 (refer to Figure 11.1 (Noise location plan) (**TR010040/APP/6.3**)).

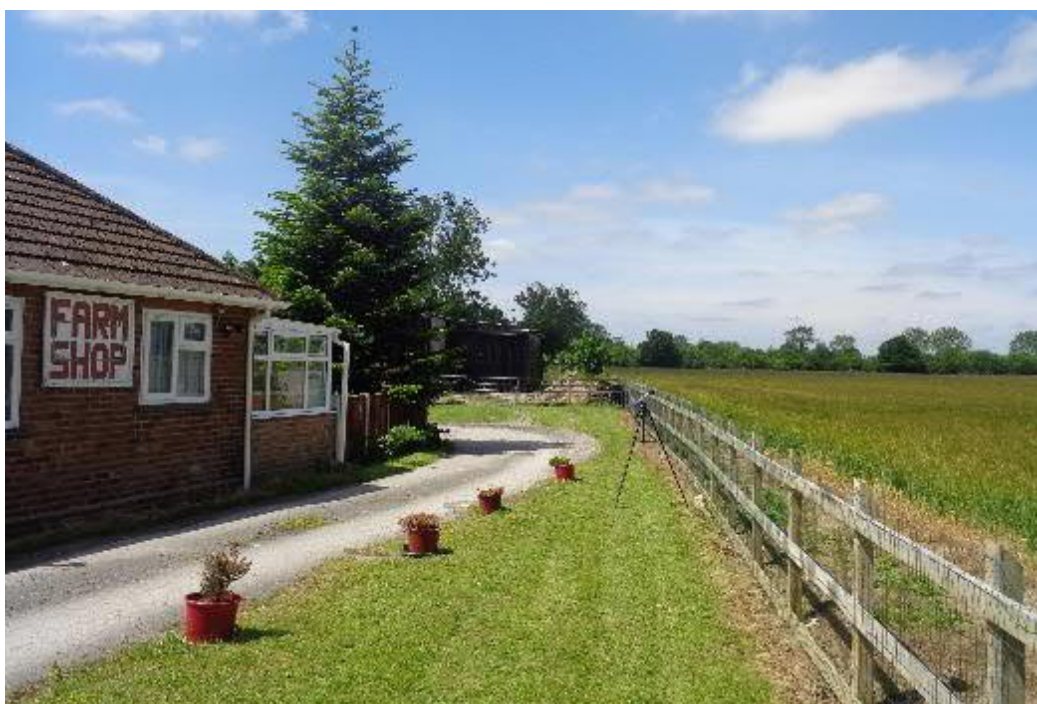
Figure 11.3.12: ST5 (photo taken towards north)

11.3.11. Position ST5 was located along the driveway to the north of the house of View Farm, Lingwood Lane, North Burlingham, Norwich, NR13 4TB (refer to Figure 11.1 (Noise location plan) (**TR010040/APP/6.3**)).

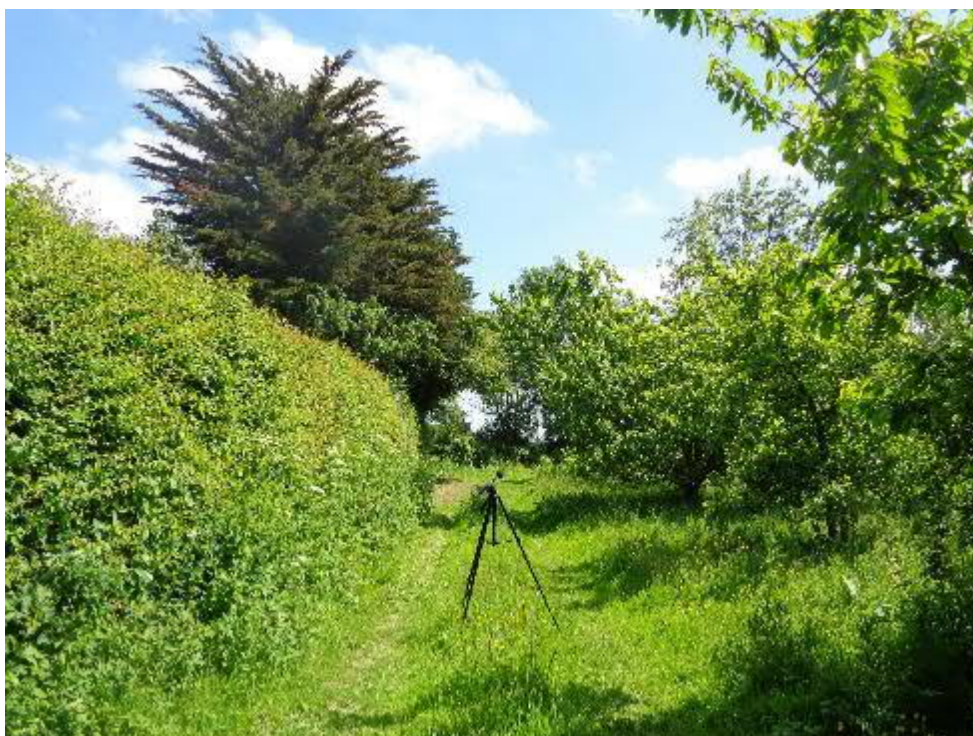
Figure 11.3.13: ST6 (photo taken towards east)

11.3.12. Position ST6 was located in the orchard to the south of the house of Nelson Place, South Walsham Road, Norwich, NR13 4EH (refer to Figure 11.1 (Noise location plan) (**TR010040/APP/6.3**)).

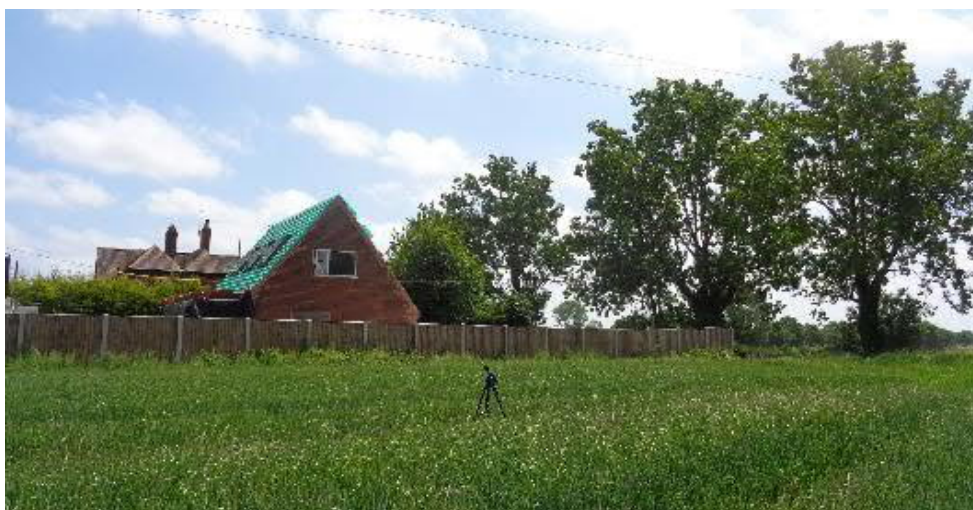
Figure 11.3.14: ST7 (photo taken towards south-east)

11.3.13. Position ST7 was located in the field adjacent to Mustard House, Coxhill Road, North Burlingham, Norwich, NR13 4EN (refer to Figure 11.1 (Noise location plan) (**TR010040/APP/6.3**)).

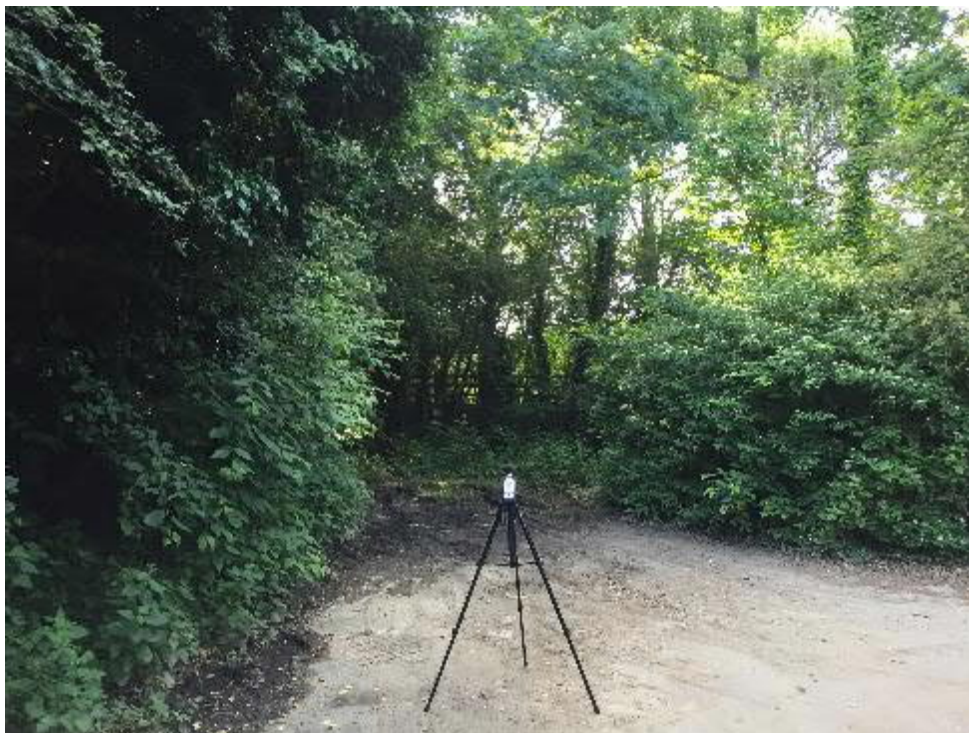
Figure 11.3.15: ST8 (photo taken towards north)

11.3.14. Position ST8 was located behind the embankment at the end of North Street, Blofield, NR13 4RA (refer to Figure 11.1 (Noise location plan) (**TR010040/APP/6.3**)).

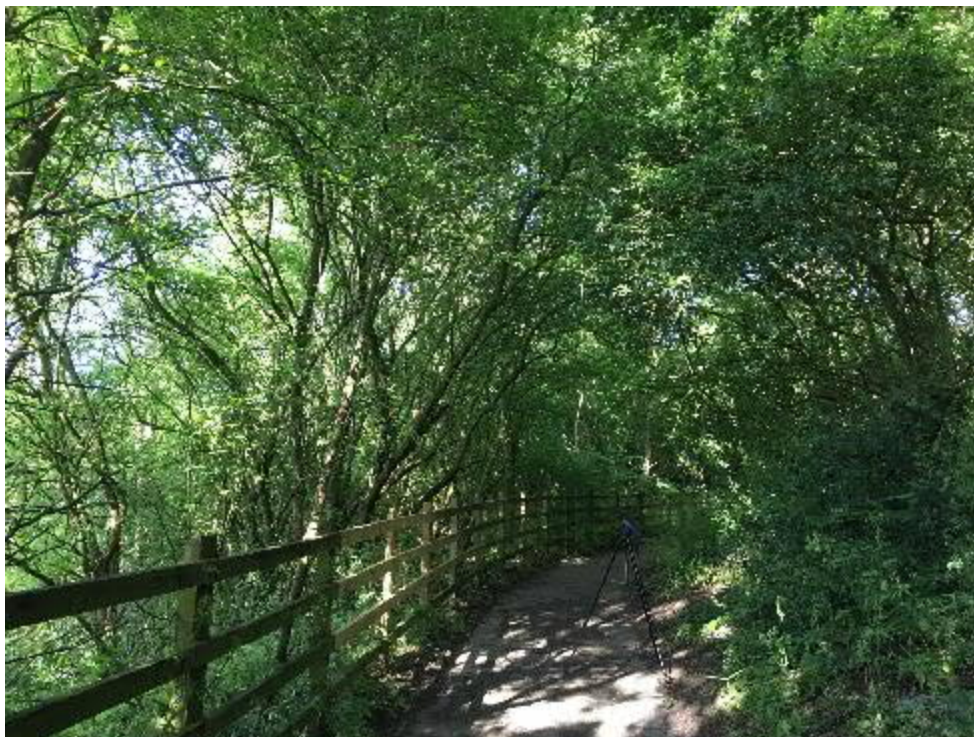
Figure 11.3.16: ST9 (photo taken towards east)

11.3.15. Position ST9 was located on a public footpath half way of the embankment facing the A47, behind no. 9 Highview Close, Blofield, NR13 4RA, close to the A47 carriageway towards Norwich (refer to Figure 11.1 (Noise location plan) (**TR010040/APP/6.3**)). There was a clear line of sight with the A47.
