M54 to M6 Link Road

TR010054

6.3 Environmental Statement

Appendix 8.10. Otter and Water Vole

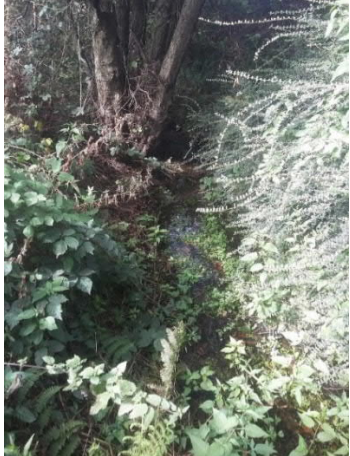
Watercourse No.	HSA	Suitability		Comments/ descriptions/ limitations	Photographs
		Otter	Water vole		
2	Y	Y Transient Suitable for dispersal (connectivity to Waterbody 24)	N	Seasonally dry

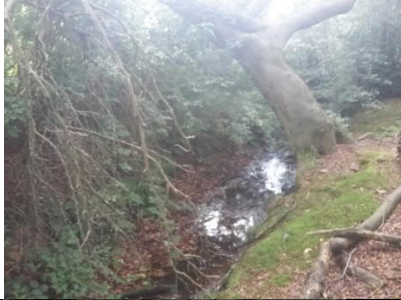
3	Y	Y Transient Suitable for dispersal (connectivity to Waterbody 29)	N	West of Dark Lane is dry

of the survey, two watercourses were found to be partially dry (Watercourse 3 was dry west of Dark Lane; Watercourse 5 was dry at sections 5a, 5b, 5c).

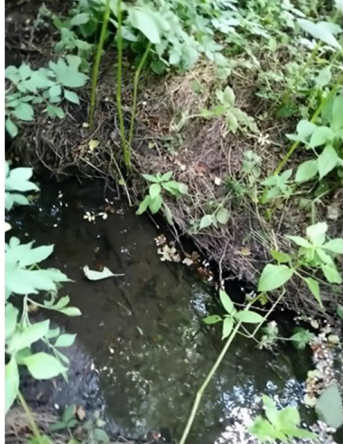
4	Y	N	N	No limitations

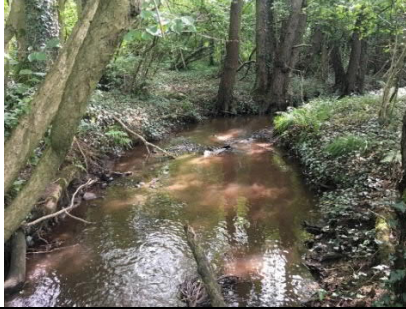
5	5	Y Transient	Y	No limitations

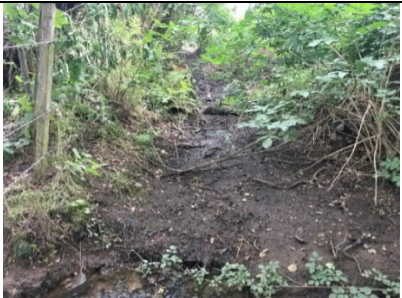
Watercourse No.	HSA	Suitability		Comments/ descriptions/ limitations	Photographs
		Otter	Water vole		
5a	Y	N	N	Dry	 
	Y	N	N	Dry	No photograph
	Y	N	N	Dry

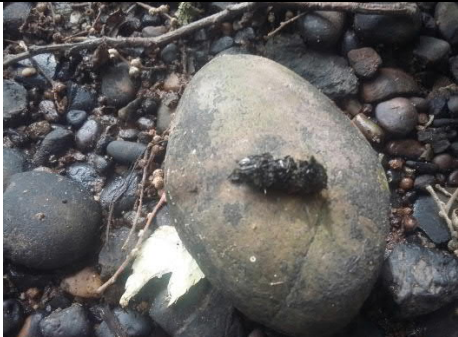
Watercourse number	OS grid ref	Type of evidence/ descriptions	Date of record	Photographs
5 (Latherford Brook)	SJ 95341 06624	Otter spraint	18/07/19	N/A
5 (Latherford Brook)	SJ 94918 06860	Otter spraint	18/07/19	N/A
5 (Latherford Brook)	SJ 95592 06448	Otter spraint	18/07/19	N/A
5 (Latherford Brook)	SJ 95721 06410	Otter spraint, fresh	18/09/19

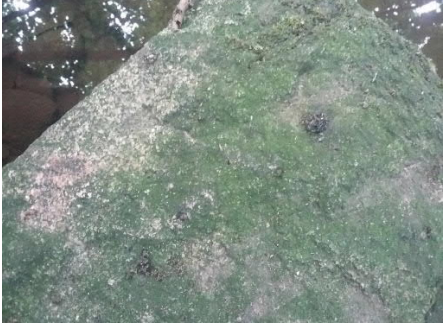
Watercourse number	OS grid ref	Type of evidence/ descriptions	Date of record	Photographs
5 (Latherford Brook)	SJ 95768 06314	Juvenile otter carcass	18/09/19	 
5 (Latherford Brook)	SJ 95847 06195 (over 200 m east from the works area)	Potential otter holt. Old spraint and claw marks-found in the vicinity.	18/09/19	 
5 (Latherford Brook)	SJ 95358 06623	Multiple otter spraints (3 old, 1 fresh)	18/09/19	 
5 (Latherford Brook)	SJ 95264 06609	Otter spraint, jelly (1 old, 1 fresh)	18/09/19

Watercourse number	OS grid ref	Type of evidence/ descriptions	Date of record	Photographs
5 (Latherford Brook)	SJ 95592 06481	Otter spraint (old)	18/09/19

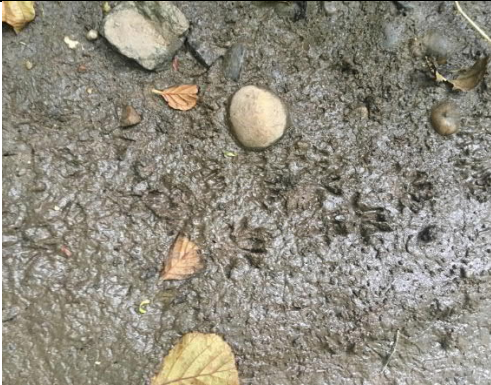
Waterbody number	OS grid ref	Type of evidence/ descriptions	Date of records	Photographs
5 (Latherford Brook)	SJ 95409 06587	Water vole footprint	17/07/19

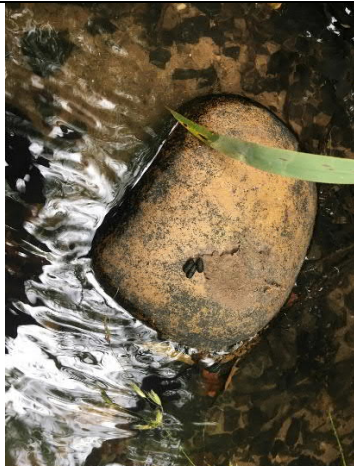
5 (Latherford Brook)	SJ 95425 06582	Water vole footprint	17/07/19	N/A
5 (Latherford Brook)	SJ 95422 06579	Water vole footprint	17/07/19	N/A
5 (Latherford Brook)	SJ 95438 06565	Water vole latrine	17/07/19	N/A
5 (Latherford Brook)	SJ 95500 06519	Water vole footprint	17/07/19	N/A
5 (Latherford Brook)	SJ 95688 06467	Water vole footprint	17/07/19	N/A
5 (Latherford Brook)	SJ 95793 06247	Water vole latrine	17/07/19	N/A
5 (Latherford Brook)	SJ 95807 06229	Water vole latrine	17/07/19

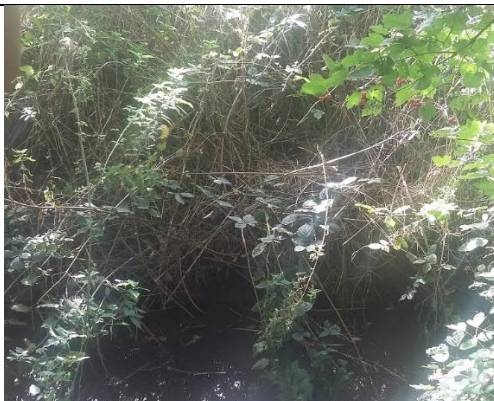
Waterbody number	OS grid ref	Type of evidence/ descriptions	Date of records	Photographs
5 (Latherford Brook)	SJ 95820 06211	Water vole latrine	17/07/19	N/A
5 (Latherford Brook)	SJ 95824 06209	Water vole latrine	17/07/19	N/A
5 (Latherford Brook)	SJ 95854 06182	Water vole footprint	17/07/19	N/A
5 (Latherford Brook)	SJ 95490 06538	Possible water vole footprint	18/09/19	N/A
5 (Latherford Brook)	SJ 95643 06496	Possible water vole footprint	18/09/19	N/A
5 (Latherford Brook)	SJ 95857 06185	Water vole burrow with feeding remains	18/09/19

4.2.11 Burrows were identified at SJ 95857 06185 at the eastern extent of the Scheme boundary. Although no burrows were found within the footprint of the works area, it is assumed that other burrow entrances may have been present in suitable habitat elsewhere at Watercourse 5 if they were located below the water or obscured by vegetation at the time of the survey. Watercourse 5 may also be used by dispersing individuals.
