M54 to M6 Link Road

TR010054

6.3 Environmental Statement

Appendix 8.11 Great Crested Newt

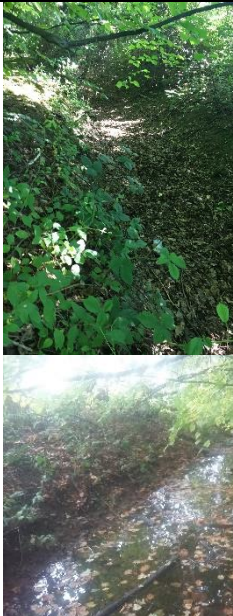
29	SJ 94357 05290	Inside	HSI not completed - waterbody found to be dry in July.		Holding water in October, identified by otter/water vole surveys. Further surveys required.

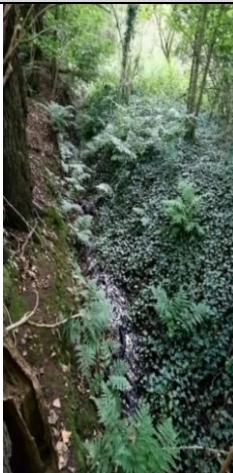
No.	Grid Ref	Distance from Scheme boundary (m)	HSI Result	Suitability	Comments/Description/ Limitations	Photograph
30	SJ 94777 05412	Inside	HSI not completed - waterbody found to be dry.		Waterbody could not be located during GCN survey season. Found to be dry by otter/water vole surveys.
