M3 Junction 9 Improvement

6.3 Environmental Statement Appendix 6.4 - Geophysical Survey Report - 2019

M3 Junction 9, Winchester, Hampshire

Survey Report

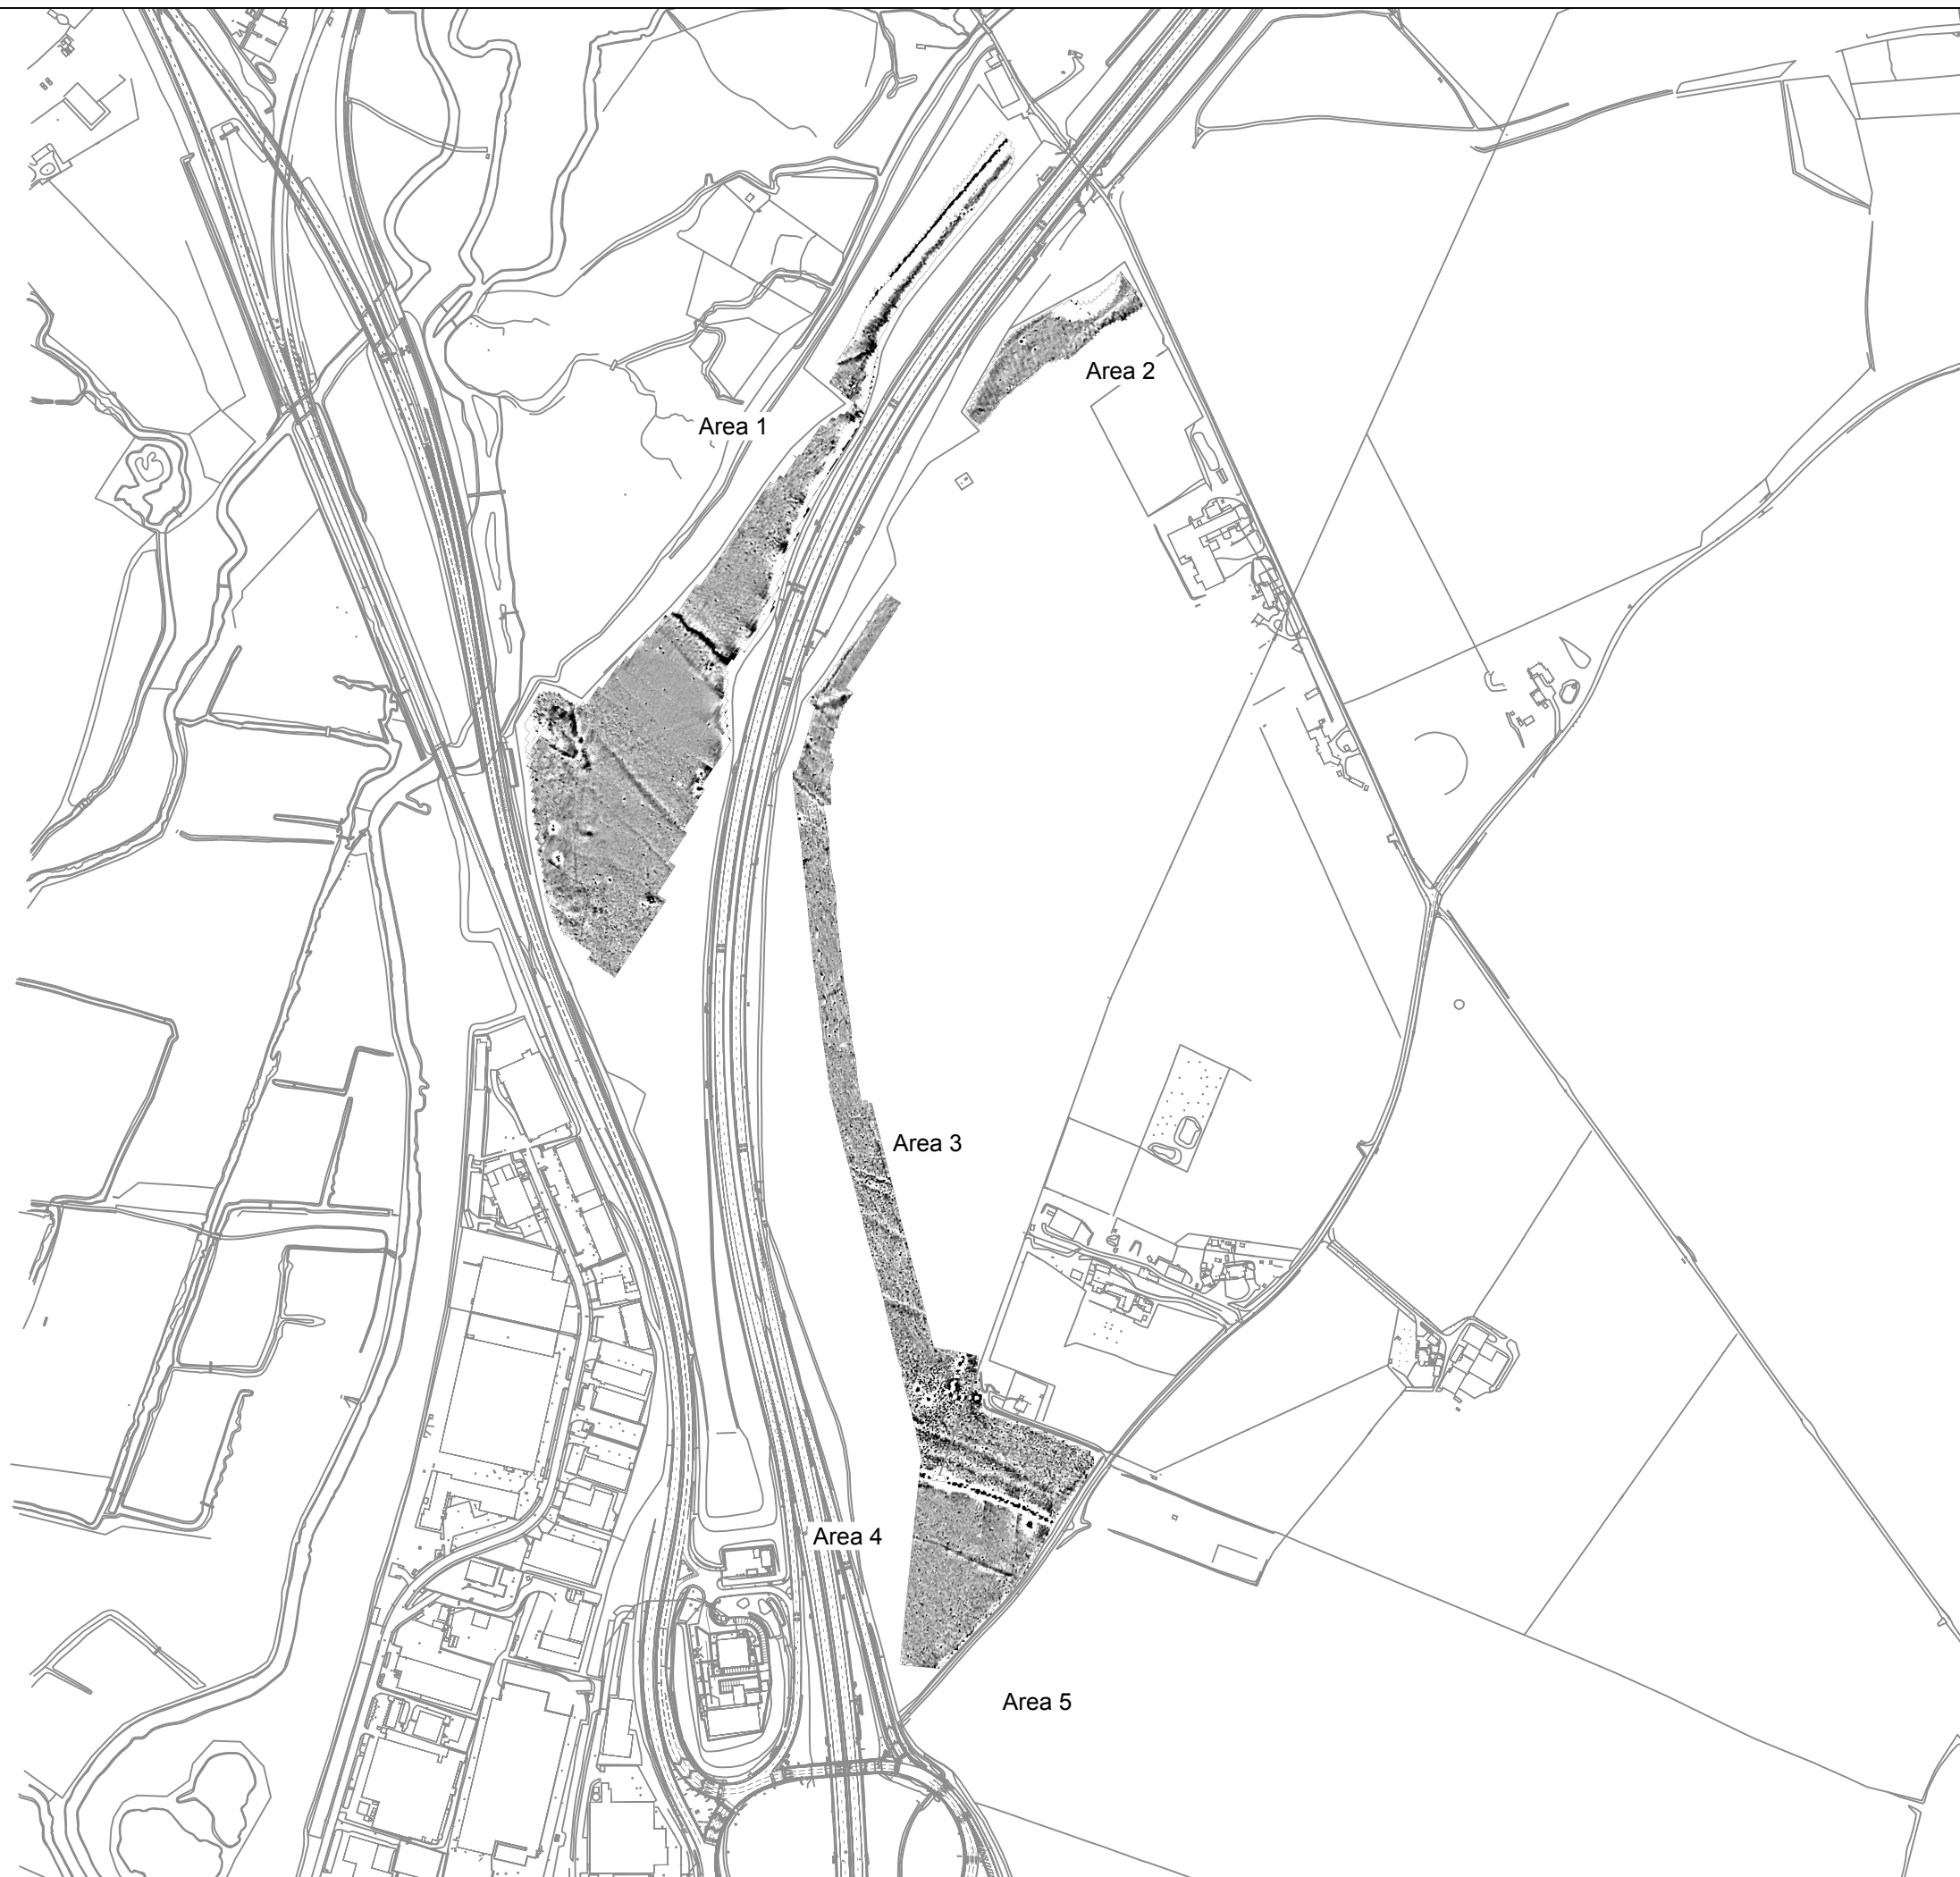
Fig No: 02

Title: Magnetometer Survey - Greyscale Plots - Overview

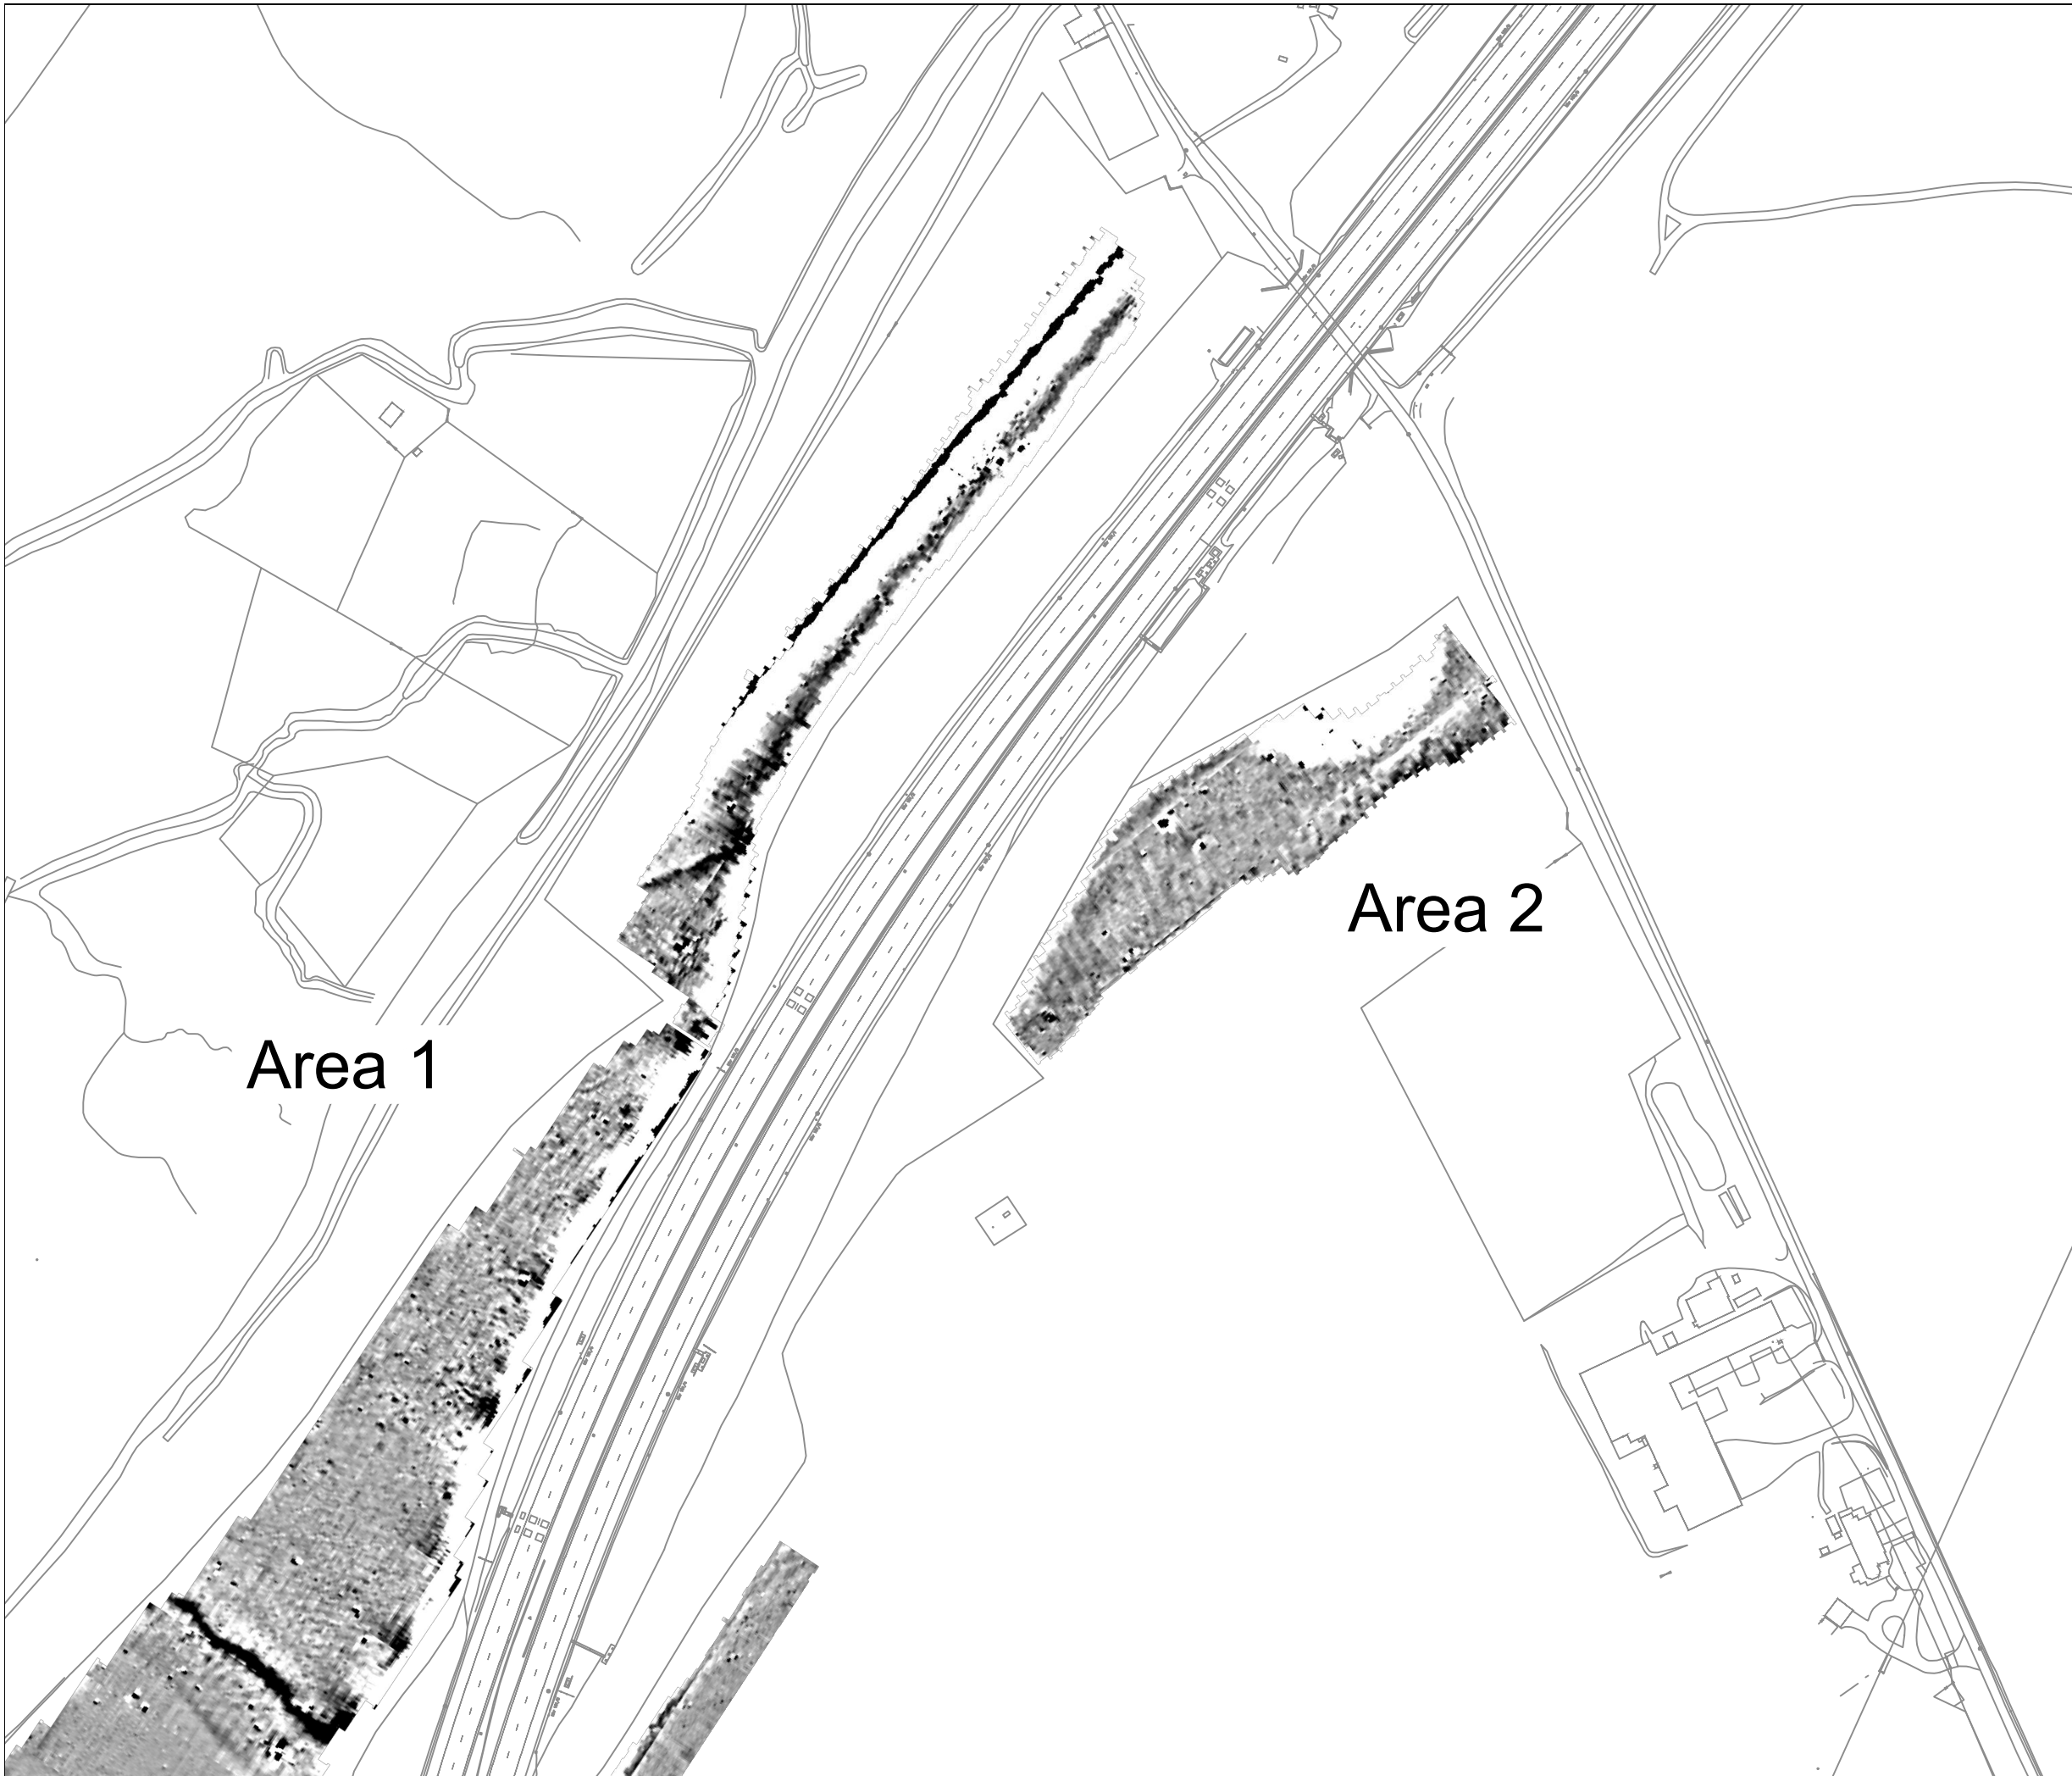
Fig No: 04

Title: Magnetometer Survey - Greyscale Plots - Viewport 1

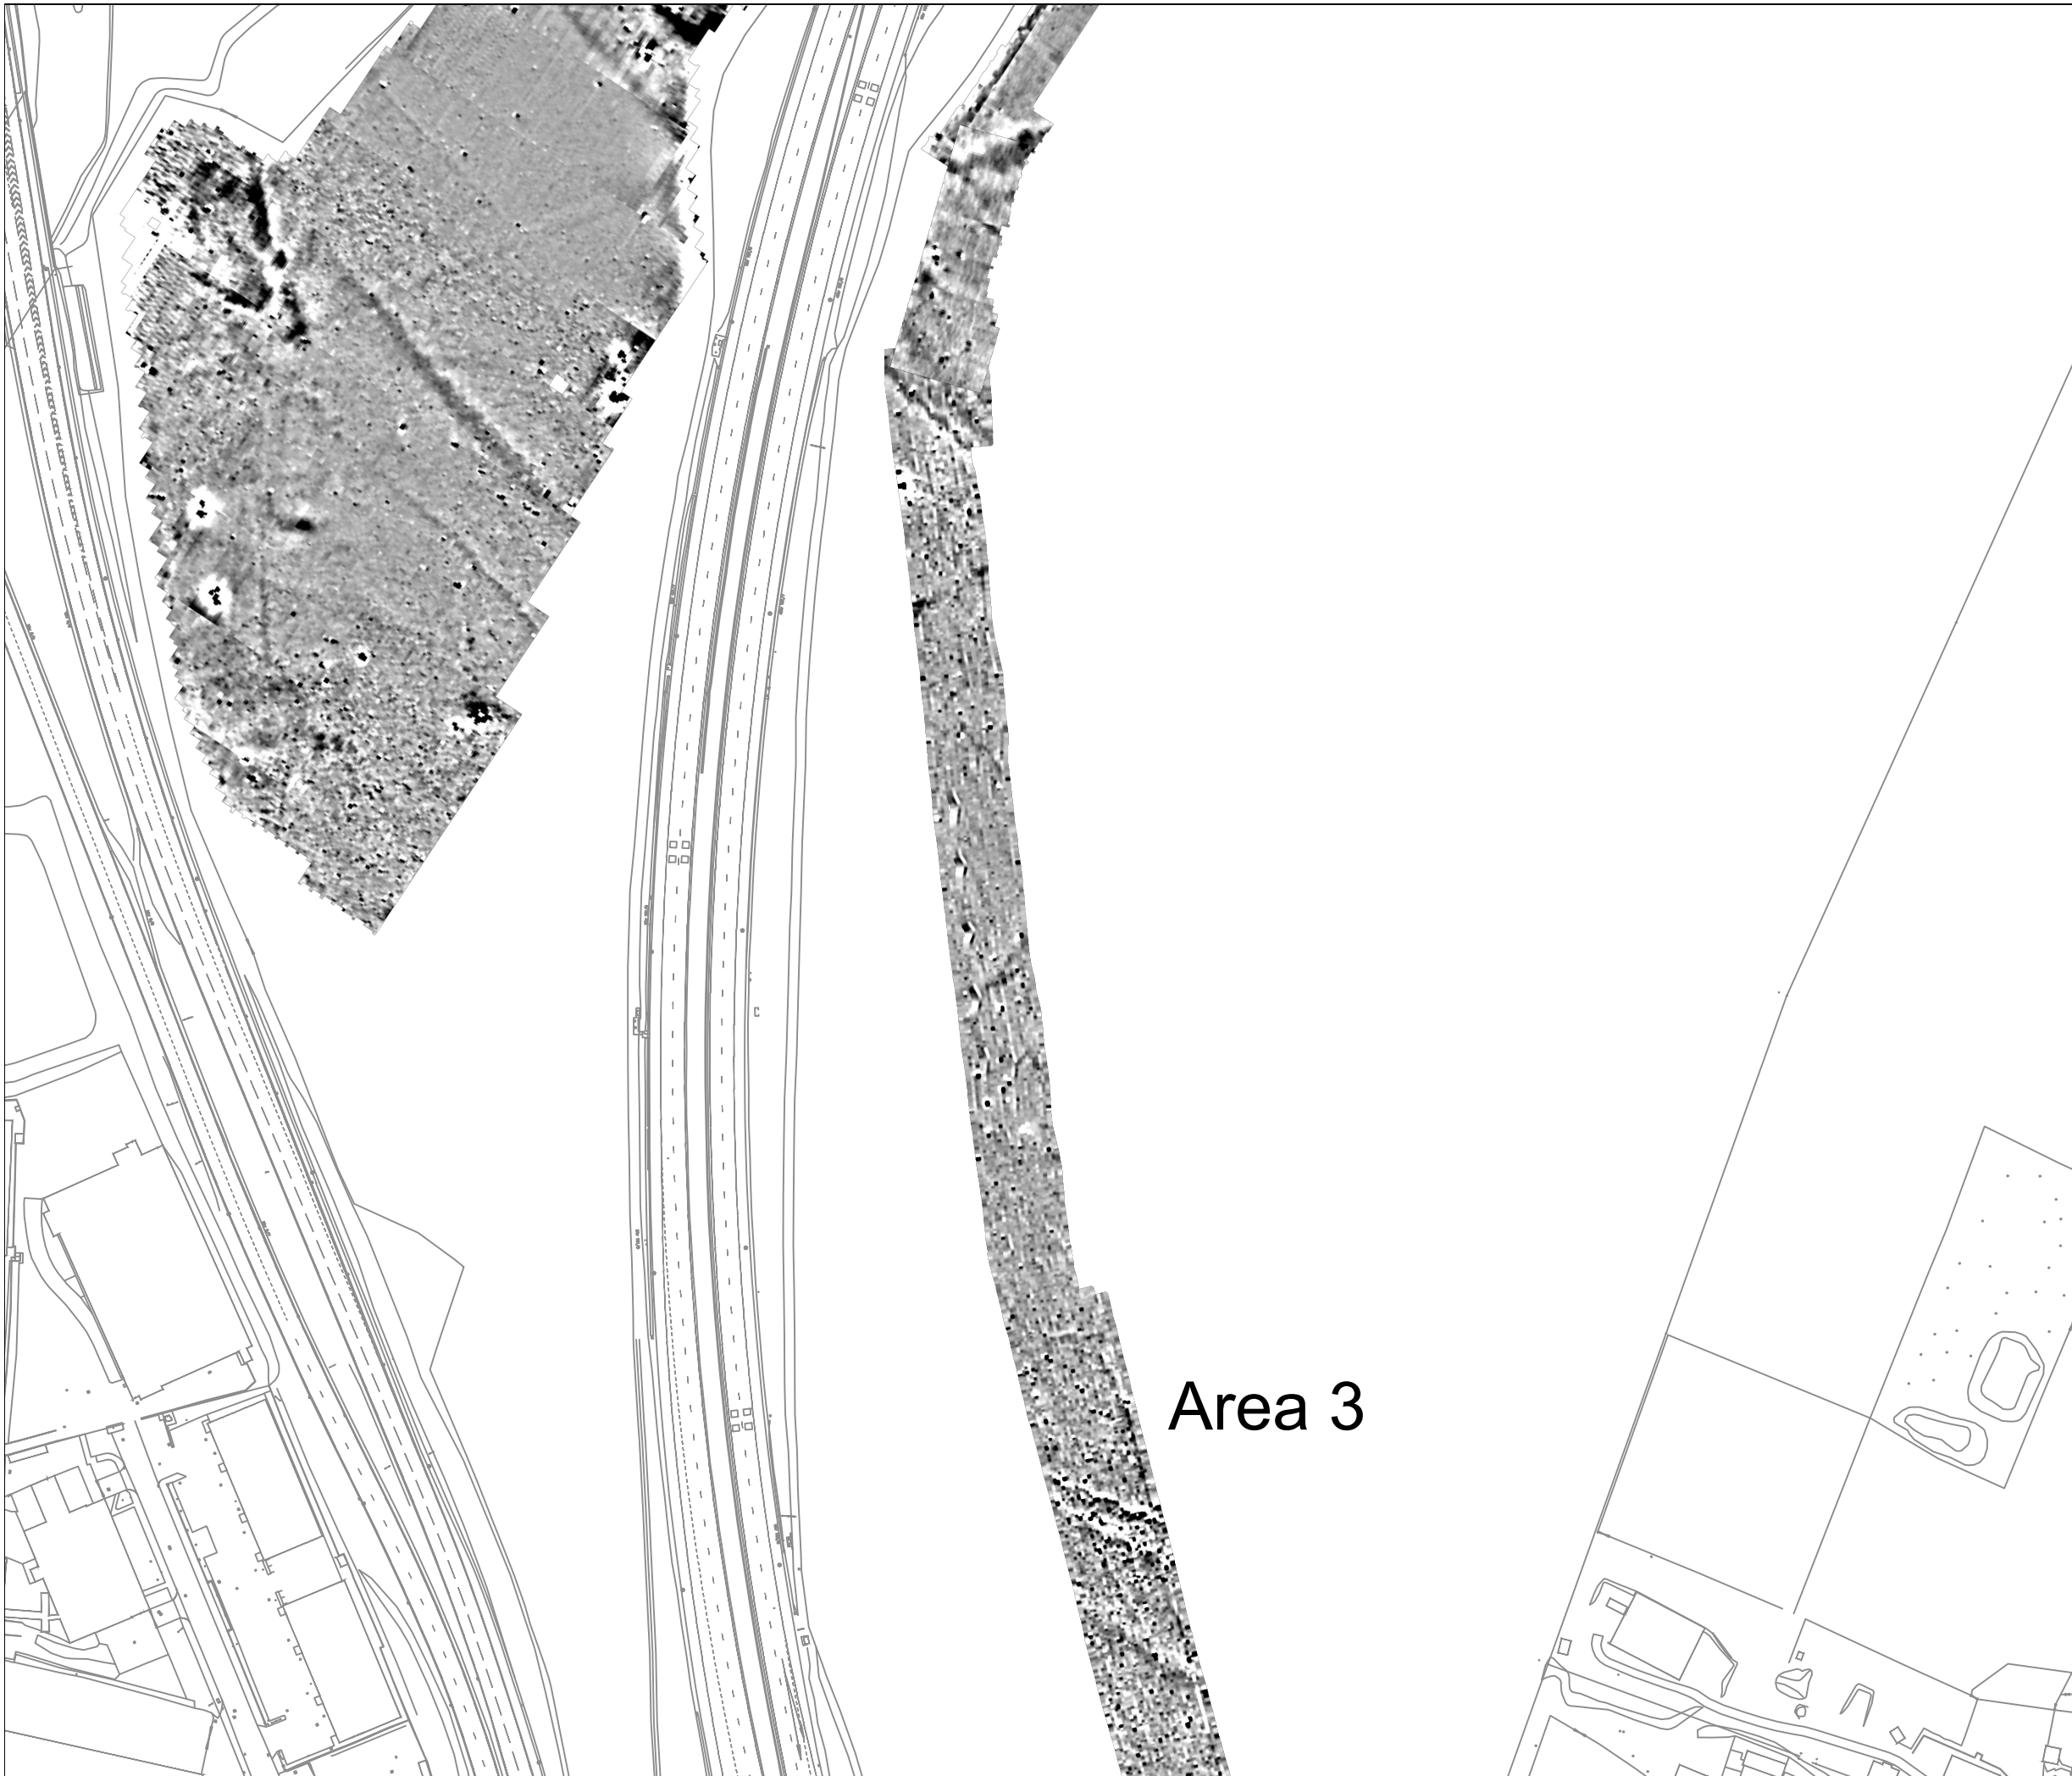
Fig No: 06

Title: Magnetometer Survey - Greyscale Plots
- Viewport 2

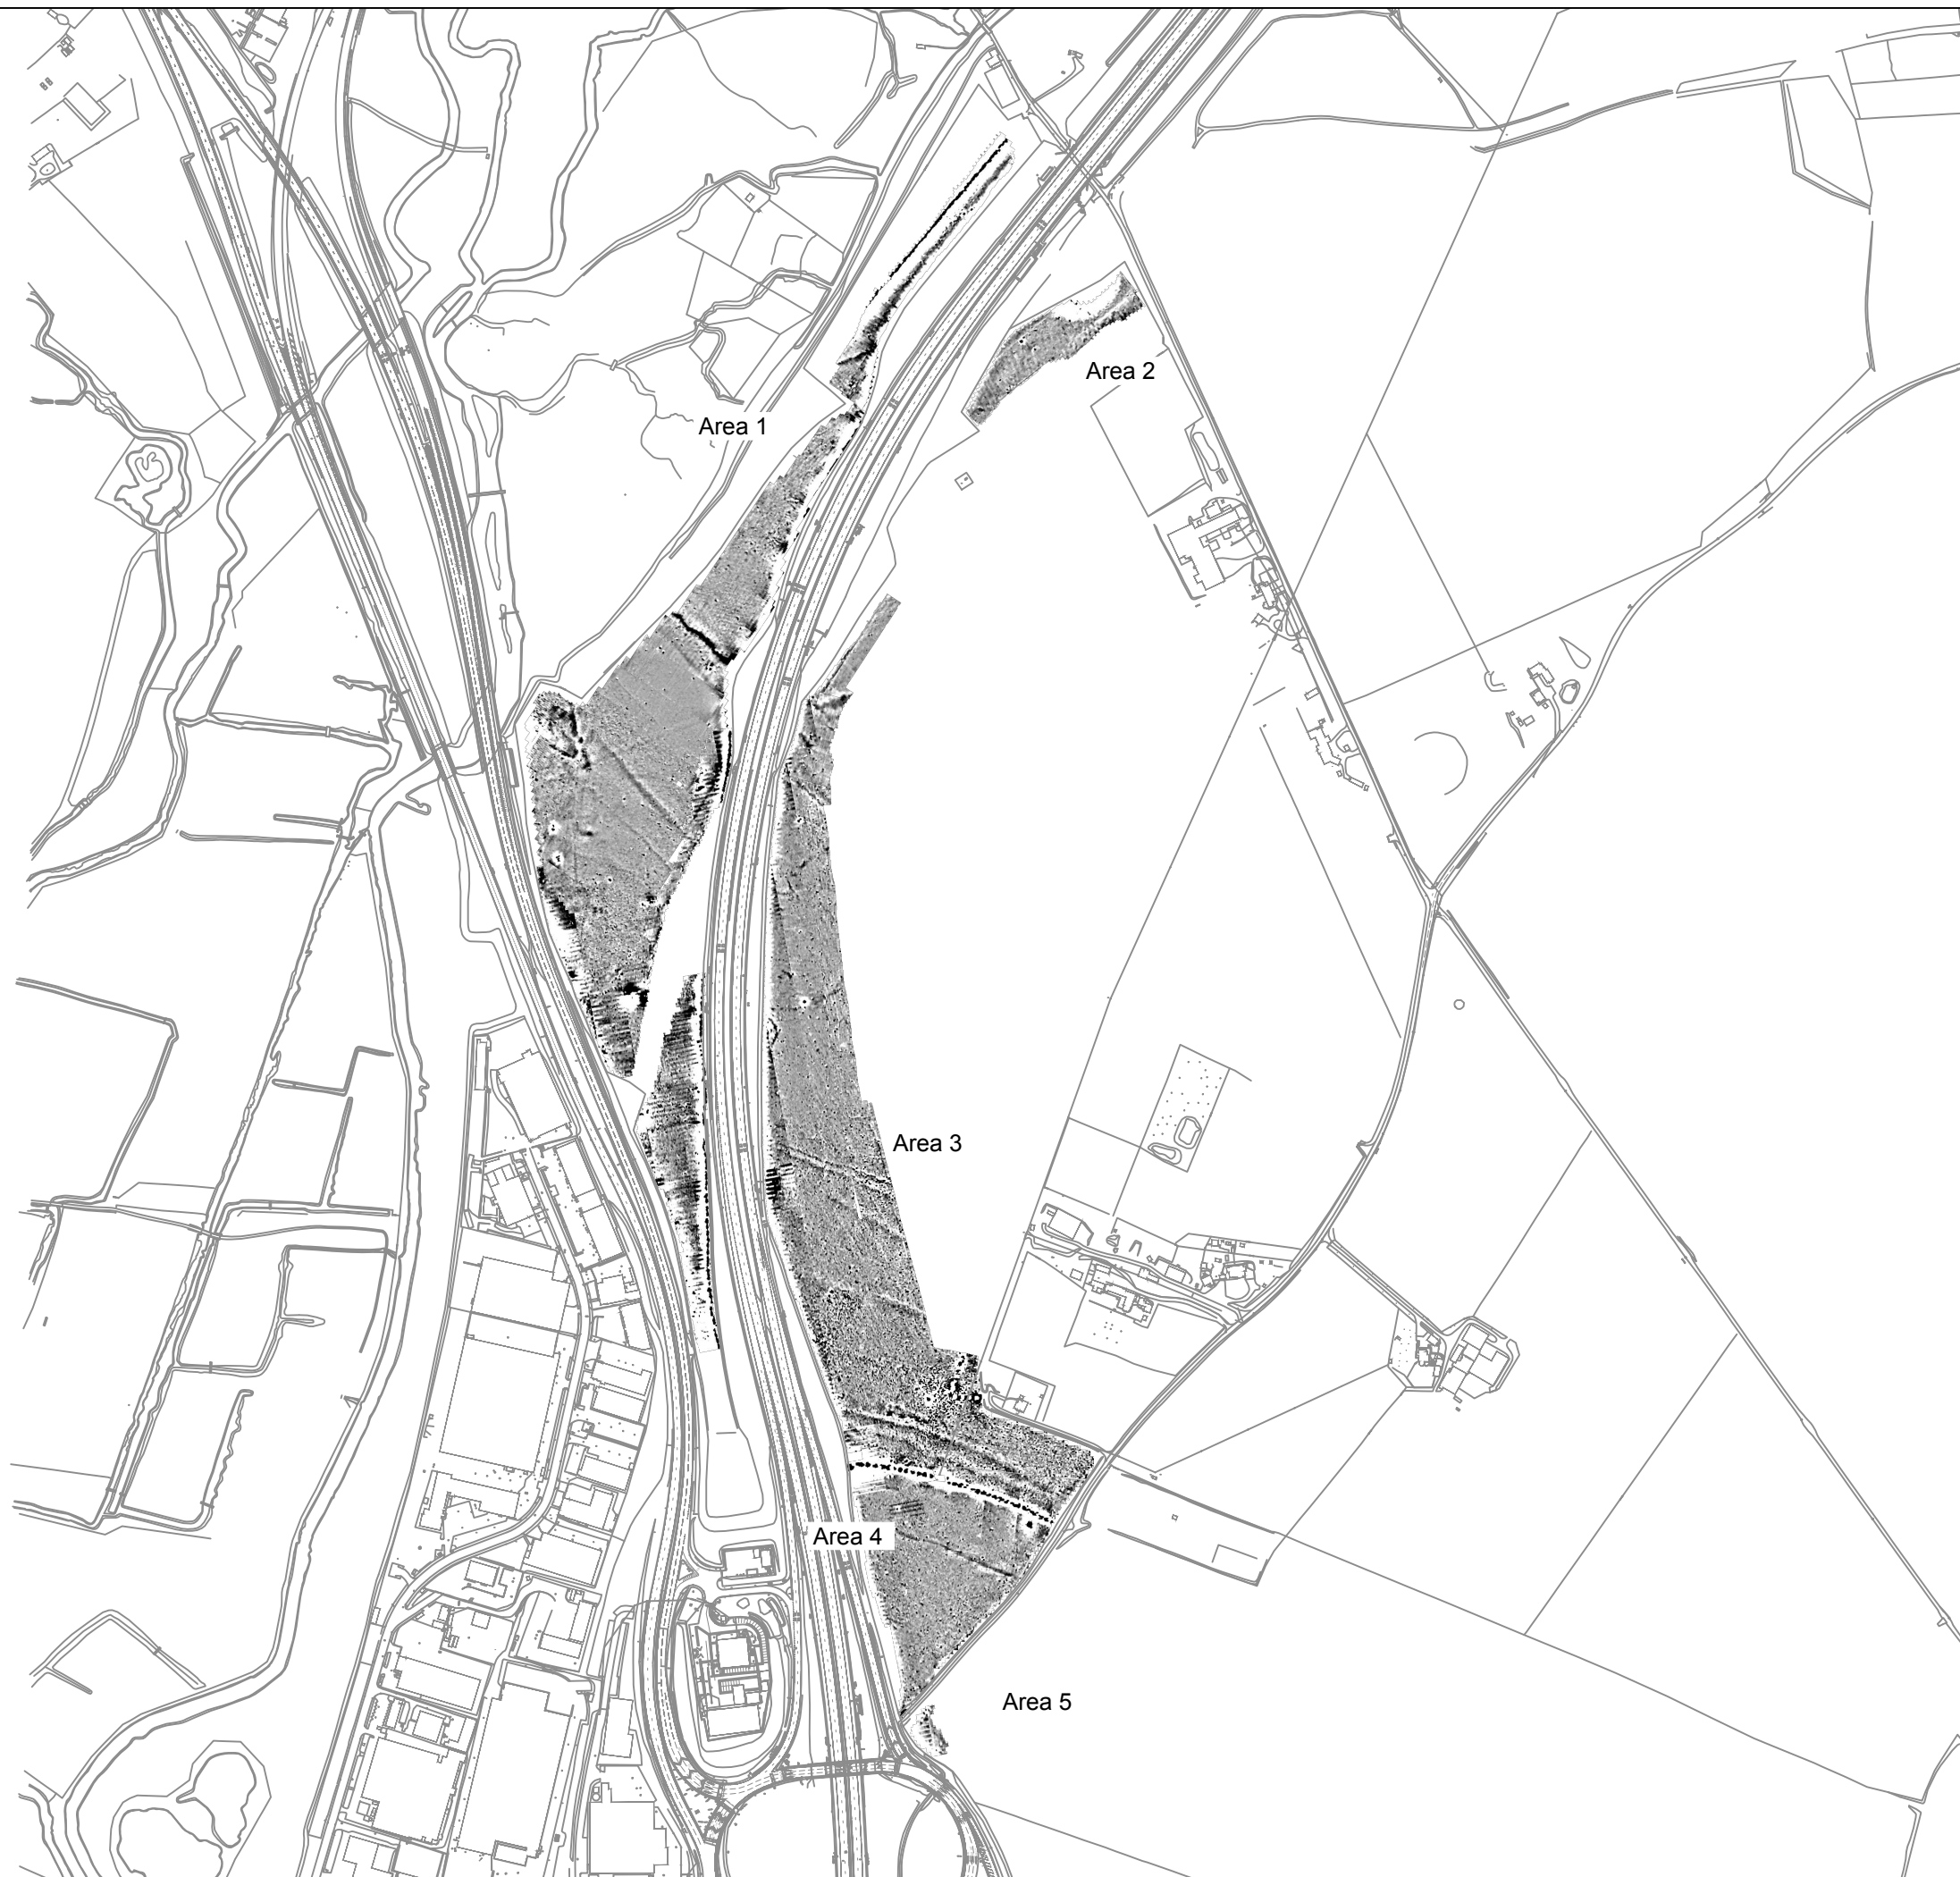
Fig No: 10

Title: Magnetometer Survey - Greyscale Plots with Previous Survey Data

5.3.1 A number of linear anomalies [7-9] have been detected in Area 3. These all correspond with the locations of former field boundaries, visible on historic OS maps from 1892. Anomaly [8] appears to form a continuation of the corroborated boundary detected in the previous geophysical survey (SUMO 2018).

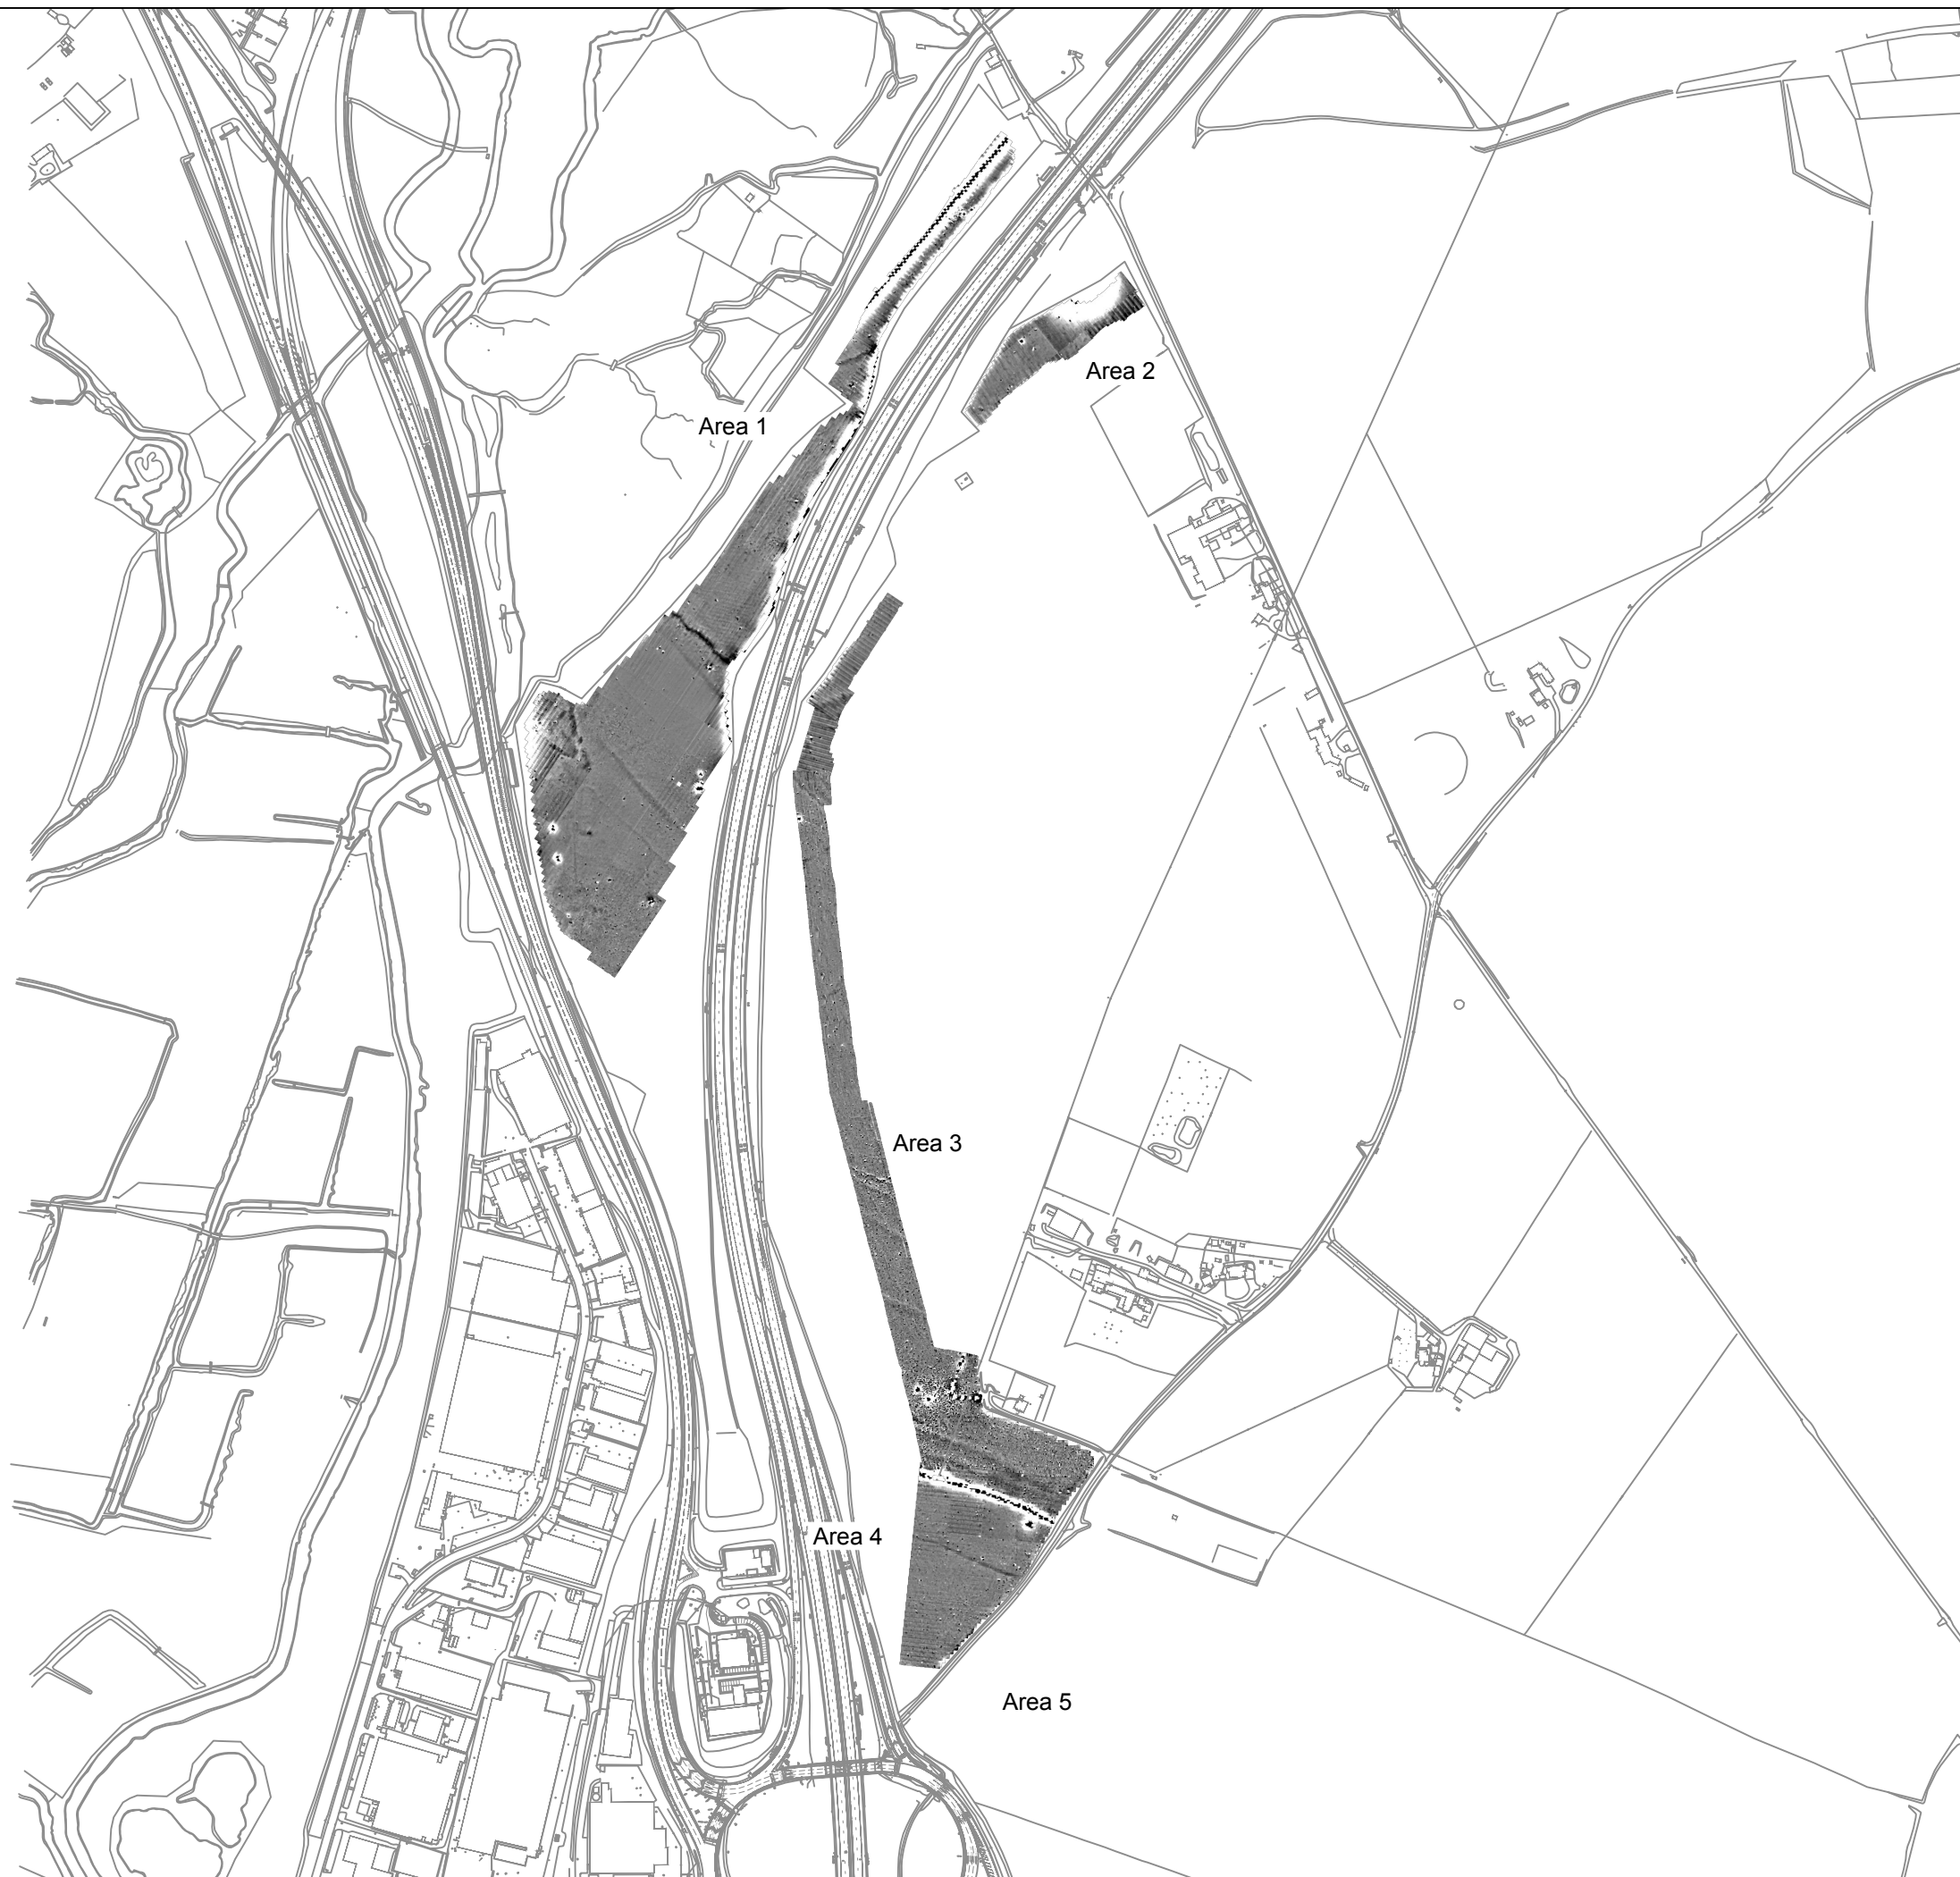
Fig No:
11

Title:
Minimally Processed Data - Greyscale Plots

The presentation of the results includes a 'minimally processed data' and a 'processed data' greyscale plot. Magnetic anomalies are identified, interpreted and plotted onto the 'Interpretation' drawings.
