# **M3 Junction 9 Improvement**

## **6.3 Environmental Statement Appendix 8.1i - Preliminary Bat Roost Assessment Report 2018**

## PRELIMINARY BAT ROOST ASSESSMENT REPORT

Project no: 70016638

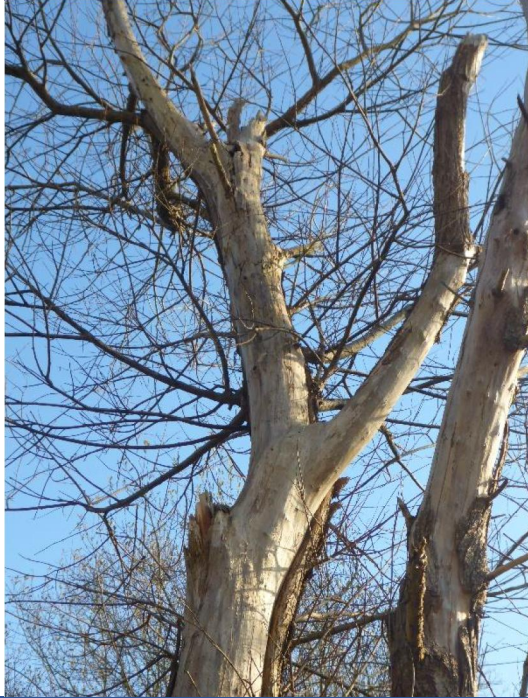
T25	Salix sp.	6	M/Dead		Hole/crack at diverged trunk, possibly leading to crevice though likely exposed to rain.	Marshy grassland	Low
T26	Salix sp.	6	M/Dead		Lifted bark ~1m H, possibly creating good crevice, though low to ground.	Marshy grassland	Moderate
T27	Salix sp.	4.5	SM		Possible hole at joined limbs ~50cm H on south side, leads to cavity with some debris in it (leaves).	Marshy grassland	Moderate
T28	Beech	10	SM		Hole at ~4m H, possibility of cavity.	Tesco car park avenue	Low
T29	Populus sp.	20	M		Thick ivy cladding creating visible crevice underneath. Further features also possible.	Woodland	Moderate
T30	Populus sp.	20	M		Thick ivy cladding possibly creating feature in its own right, and obscuring much of them. Trees of size and nature possibly supporting other features.	Woodland	Low
T31	Populus sp.	10	M		Thick ivy cladding possibly creating feature in its own right, and obscuring much of them. Trees of size and nature possibly supporting other features. Lopped at top possibly meaning dead parts.	Woodland	Low

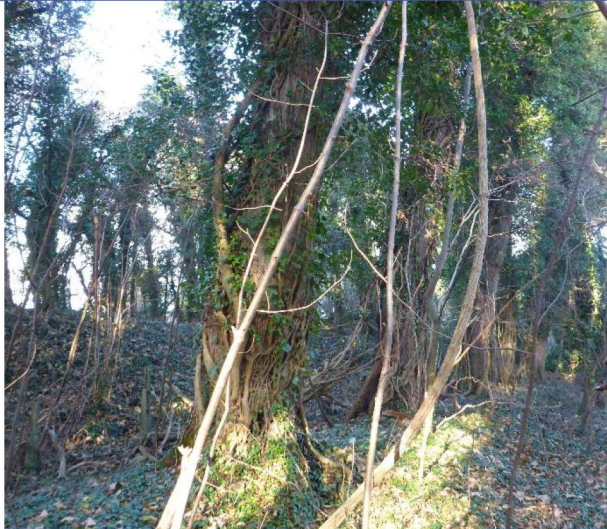
**G12**

G13	Populus sp.	20	M		Line of 10 near-identical trees. Thick ivy cladding possibly creating feature in its own right, and obscuring much of them. Trees of size and nature possibly supporting other features.	Woodland	Low
B1	N/A	N/A	N/A		A34 southbound bridge. Concrete structure crossing the Itchen tributary. Expansion gaps either side. Gaps above the support columns. Expansion foam fills the concrete beam gaps. Some holes located within the expansion foam - may lead to cavity or crevice.	Woodland	High
B2	N/A	N/A	N/A		A33 southbound concrete bridge. No features noted. No expansion gaps with crevices. Fairly cold and damp.	Woodland	Negligible
B3	N/A	N/A	N/A		Concrete over-bridge, crossing the A33/A34. No significant gaps or crevices on the structures. Fairly cold and damp.	Woodland	Negligible
B4	N/A	N/A	N/A		Drainage tunnel under railway cutting around 1.5m high. Fairly cold and damp. Not fully visible so precautionary suitability rating given. Potentially suitable for hibernating bats.	Woodland	Moderate

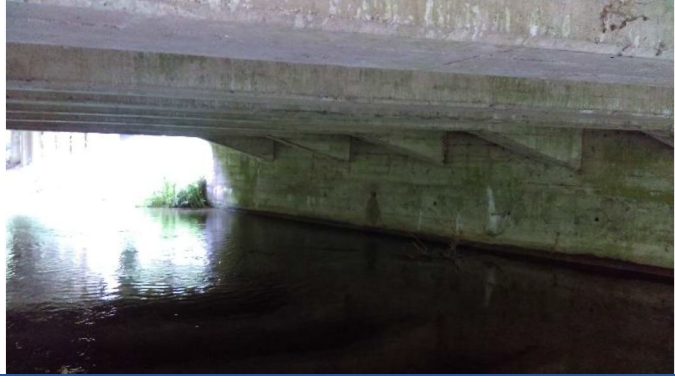
**B5**

B5	N/A	N/A	N/A		Concrete bridge, low to the water. Inspected from north. No features noted but cannot view underside so precautionary suitability rating given. Span ~1m above water. Fairly cold and damp. Potentially suitable for hibernating bats.	Woodland/ Wet Grassland	Moderate
B6	N/A	N/A	N/A		Northern concrete bridge associated with the Junction 9 M3 roundabout. No features noted. Fairly cold and damp.	Motorway/ Industrial/ Arable	Negligible
B7	N/A	N/A	N/A		Southern concrete bridge associated with the Junction 9 M3 roundabout. No features noted. Fairly cold and damp.	Motorway/ Industrial/ Arable	Negligible
B8	N/A	N/A	N/A		Concrete construction, 2-span bridge. Gaps at expansion joint above central pillar. Over a river. Fairly cold and damp. Not fully visible so precautionary suitability rating given. Potentially suitable for hibernating bats.	River with trees	Moderate
B9	N/A	N/A	N/A		Concrete construction with brick upper sides. Arched twin-span constructions with 8 beams underneath. Crevice at expansion gaps adjacent to beams (all). Over a river. Fairly cold and damp. Not fully visible so precautionary suitability rating given. Potentially suitable for hibernating bats.	River with trees	Moderate

- 5.2.2 As, at this stage, it is understood that the bridges will remain unaffected by the Proposed Works, no further survey is recommended at this stage. However should the designs change to include alterations to the bridges with roost suitability (B1, B4, B5, B8, B9), then further survey should be considered.
