# **M3 Junction 9 Improvement**

## **6.3 Environmental Statement Appendix 8.1I - Water Vole Survey Report 2017**

# M3 JUNCTION 9 IMPROVEMENT SCHEME

## PCF STAGE 3 - WATER VOLE SURVEY REPORT

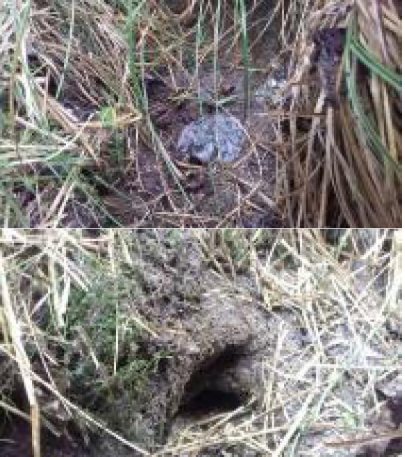
WATER COURSE	SURVEY DATE	DESCRIPTION OF EVIDENCE PRESENT	PHOTO
A	28/06/17	Mammal path through sedge and marginal vegetation. No droppings or slide present.	
B	28/06/17	Two burrows located on the east bank approximately 7-8cm in diameter. One burrow is under and filled with water, whilst the other has some collapsing.

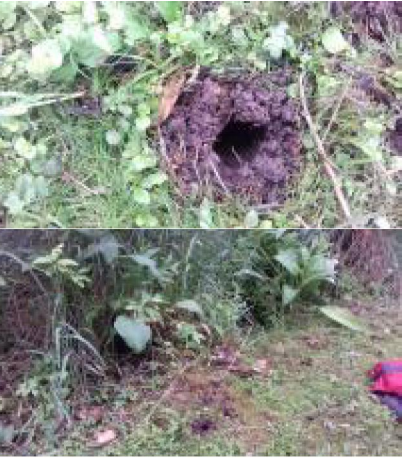
WATER COURSE	SURVEY DATE	DESCRIPTION OF EVIDENCE PRESENT	PHOTO
F	28/06/17	Burrow located 2m from the water's edge within the mowed pathway. It is approximately 4-5cm wide the lower limit to water vole burrows. The burrow leads straight to the water, however no entrance was located.

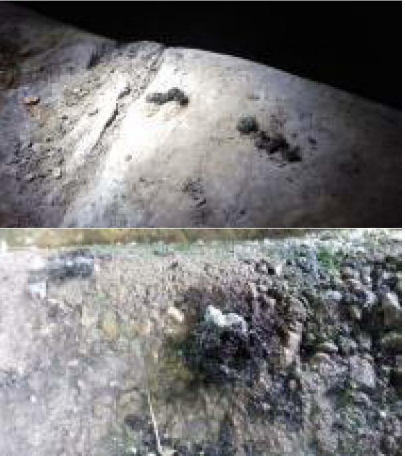
G	28/06/17	Otter spraints located under the bridges of the A34 & A33. Four spraints located under the A33 bridge along an otter ledge (668). Five spraints located under the A34 (667) these being fresher than those aforementioned.

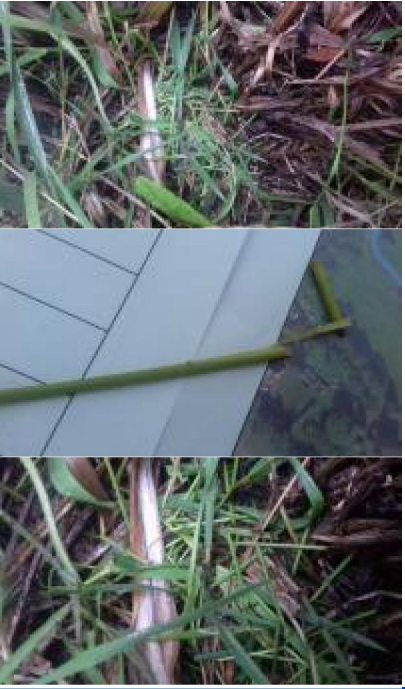
WATER COURSE	SURVEY DATE	DESCRIPTION OF EVIDENCE PRESENT	PHOTO
J	28/06/17	<p>Small mammal runs located through the bankside vegetation, likely to be used by water voles and other small mammals. Droppings of small mammals located within sedge, unlikely to be water vole.</p> <p>Water vole feeding remains located at feeding stations within the west bank. Vegetation remains include reed and Yorkshire fog cut to 10cm pieces with 45° ends.</p>

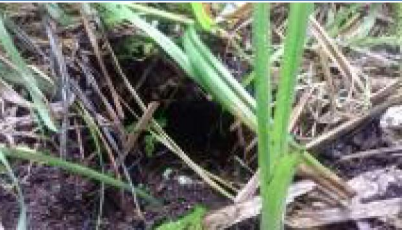
30/07/17	Feeding remains identified on the east and west banks of the stream with prominent pathways intermittent.	
K	28/06/17	Water vole burrow located in the east west bank of section K. Droppings and well used pathways also identified within the immediate vicinity.

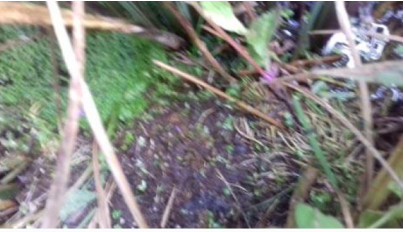
WATER COURSE	SURVEY DATE	DESCRIPTION OF EVIDENCE PRESENT	PHOTO
	30/07/17	<p>Water vole feeding stations and runs identified on the north bank of the river corner. Latrines identified within close proximity to the feeding remains. Fresh water vole droppings identified on an in stream log (K5).</p>

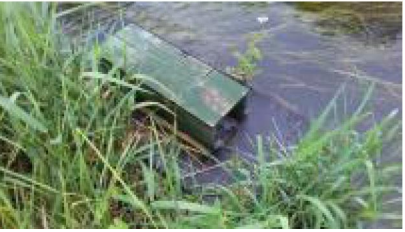
L		No evidence found	
M		No evidence found	
N	29/06/17	<p>A high density of water vole activity signs were identified all along the west bank of section N.</p> <p>Two water voles were sighted within the reed and sedge bank.</p> <p>A floating platform is located within the section, with water vole droppings identified on the platform. Water vole runs and feeding platforms are located along section N in high density.</p> <p>Water vole droppings are also located amongst the feeding remains and along the pathways.</p> <p>No burrows were identified on the west bank, however the east bank was not accessed due to water depth and dense reed bed.</p> <p>Map reference 687 is a potential otter slide. It is wide enough for otter use, however it does not exhibit other characteristics associated with otter.</p>

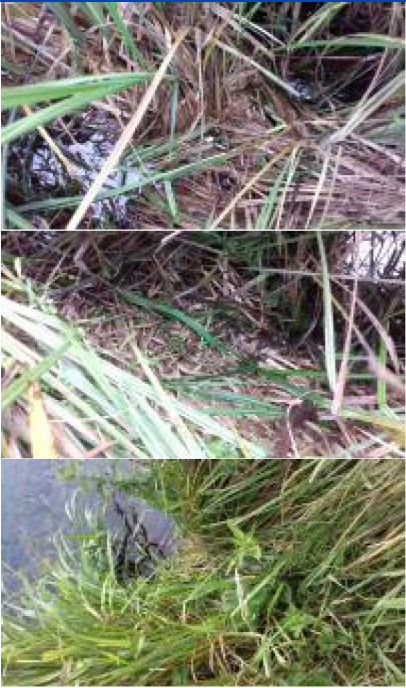
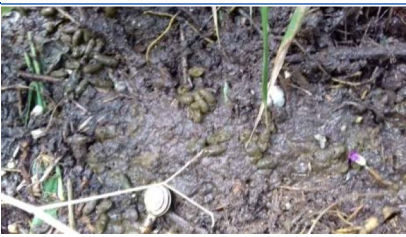
31/07/17	<p>As in Survey 1, a high density of water vole activity signs identified along the west bank of the channel.</p> <p>Seven feeding stations were identified with associated latrines in close proximity. Fresh water vole droppings present within the latrines. Fresh water vole droppings also present on the floating platform.</p> <p>Water vole burrow identified at N6, with entrance higher on the bank and tunnel leading westwards.</p> <p>Prominent runs were identified all along the west bank of the channel.</p>

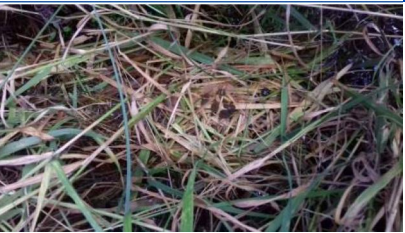
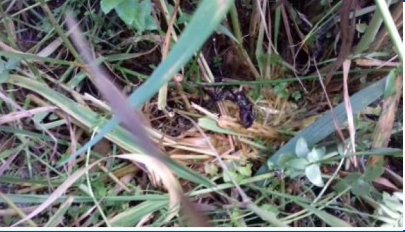
No evidence found		
P	29/06/17	Small mammal droppings identified.	
	31/08/17	<p>Water vole feeding stations identified along the west bank of the channel, with vegetation cuttings of over 10cm in length.</p> <p>One water vole latrine was identified with fresh droppings in close proximity to a large feeding station.</p> <p>Water vole runs are present along the bank connecting feeding stations together.</p>

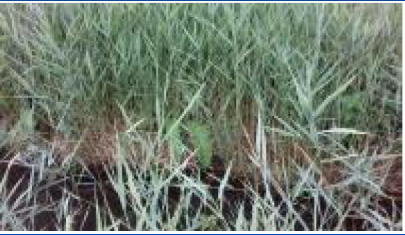
Q		No evidence found	
R	29/06/17	Potential small mammal runs identified on west bank leading to the water's edge. These were not directly accessed.

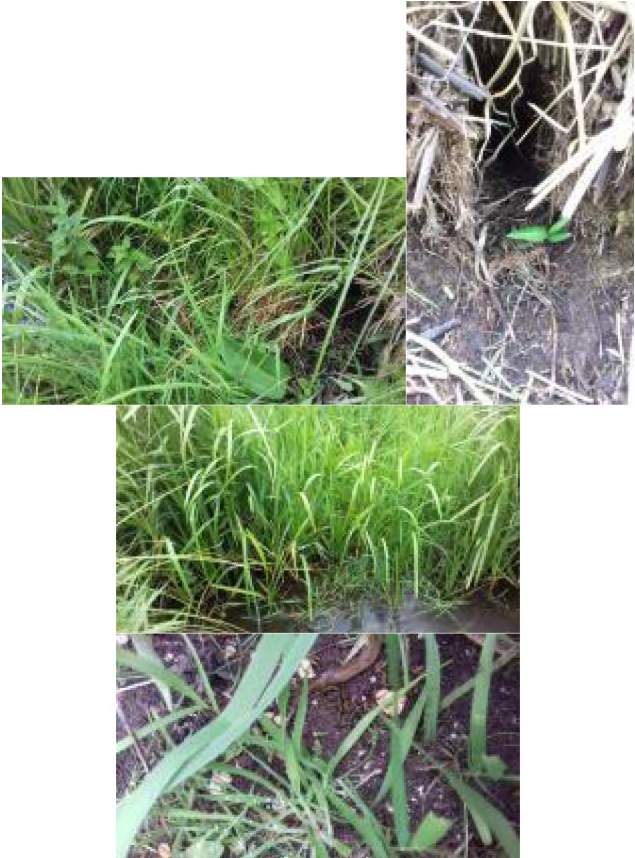
WATER COURSE	SURVEY DATE	DESCRIPTION OF EVIDENCE PRESENT	PHOTO
T	29/06/17	<p>Water vole and field vole feeding stations, prominent runs and water vole droppings identified on the north and south sides of the channel. Feeding remains include reed, sedge and horsetail.</p> <p>Water vole burrow identified within the tussock of sedge, the entrance approximately 10cm in diameter.</p>

31/08/17	Feeding remains present on both banks, however small cuttings indicate likely bank vole presence.

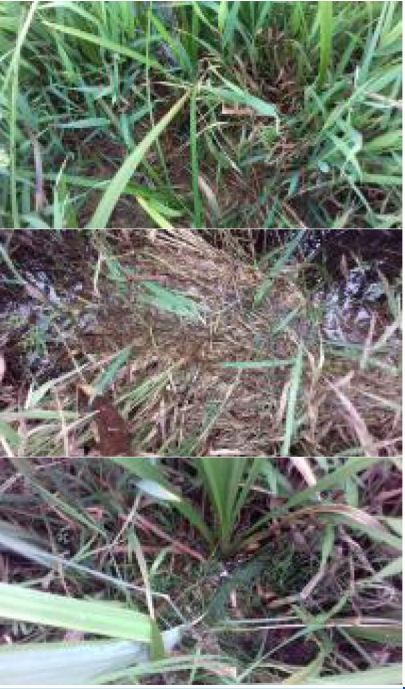
WATER COURSE	SURVEY DATE	DESCRIPTION OF EVIDENCE PRESENT	PHOTO
U	29/06/17	<p>Water vole and small mammal droppings located on the west bank of the channel.  Feeding remains of water vole and small mammals present.  Numerous water vole feeding stations identified along the length of section U.</p>

31/08/17	<p>Water vole pathway identified leading to a feeding station and latrine.</p>	
V	29/06/17	<p>Feeding remains and pathways of water vole present. Feeding remains approximately 10cm in length consisting primarily of reed.</p>	
	31/08/17	<p>A number of water vole activity signs identified along the channel, up to the wooded section. Water vole feeding stations located along the channel connected by runways. One latrine identified in close proximity a large feeding station. One water vole burrow identified at 320.</p>
