M3 Junction 9 Improvement

Scheme Number: TR010055

6.3 Environmental Statement Appendix 8.1t - Water Vole Survey Report 2020

Water Vole Survey Report

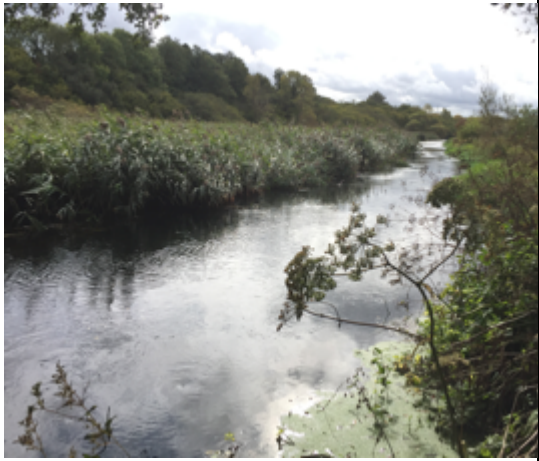
- 3.2.2 The habitats to the west of the A34 bridges (Section 1) provide banks suitable for burrowing and excellent food sources for water vole on the west side of the river. Along the east side there is a reedbed with woodland and overhanging trees lining a silty bank in the southern part of this section with lower suitability for burrowing. Overall this section was classified as having high suitability for water voles.

- 4.1.2 Although no water vole signs were found during the survey, as the habitats remain suitable for water voles and evidence of presence was confirmed during the 2017 surveys, a precautionary approach should be taken in assuming that water voles remain present, unless a second survey carried out within the suitable survey season for water voles (late April to early October) indicates likely absence.

- 4.1.3 If the proposed works will impact on any suitable habitats within 10m of the watercourse and bankside habitats, there would be the potential for impacts to water voles and their habitat. It is therefore recommended that the proposed works avoid the watercourse and river banks and habitats up to 10m from the watercourse if possible.

- 4.1.4 If this is not possible, it is recommended that a further survey be carried out once it is known where any potential impacts to the watercourse, river banks or bridges will be. If potential for impacts to water voles are identified, a detailed mitigation plan will be required prior to commencement of works.

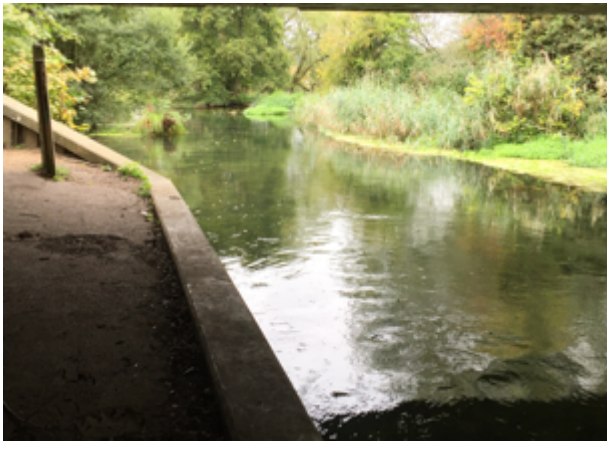
- 3.2.3 The section flowing under the A34 bridges (Section 2) comprised shallow banks (in places flat) and canalised sections, unsuitable for water vole burrowing. Woodland and overhanging trees limit the growth of bankside and emergent vegetation, so opportunities for feeding are generally poor, with the exception of the reeds/sedges present immediately to the west of the bridges. Overall this section was classified as having moderate suitability for water voles.

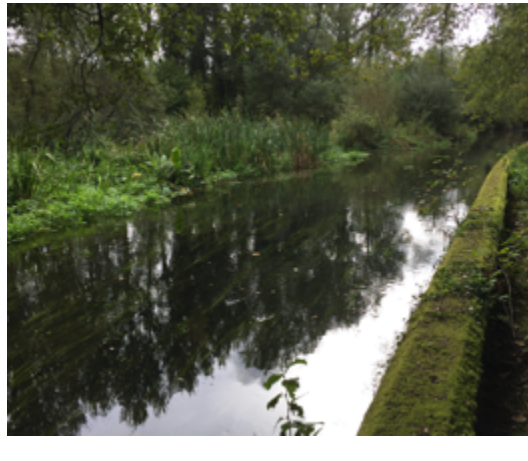
- 3.2.4 To the north-east of the bridges (Section 3) mature overhanging trees are present on the shallow east bank. Fewer trees are present on the west bank, which is canalised. The central gravel island is vegetated with scrub, reeds and sedges, providing some potential for feeding. Burrowing potential in banks in this section is low. Overall this section was classified as having moderate suitability for water voles.
