M3 Junction 9 Improvement

Scheme Number: TR010055

6.3 Environmental Statement Appendix 8.1z2 - White-clawed Crayfish Survey Report

6.3 ENVIRONMENTAL STATEMENT - APPENDIX 8.1z2: WHITE-CLAWED CRAYFISH SURVEY REPORT

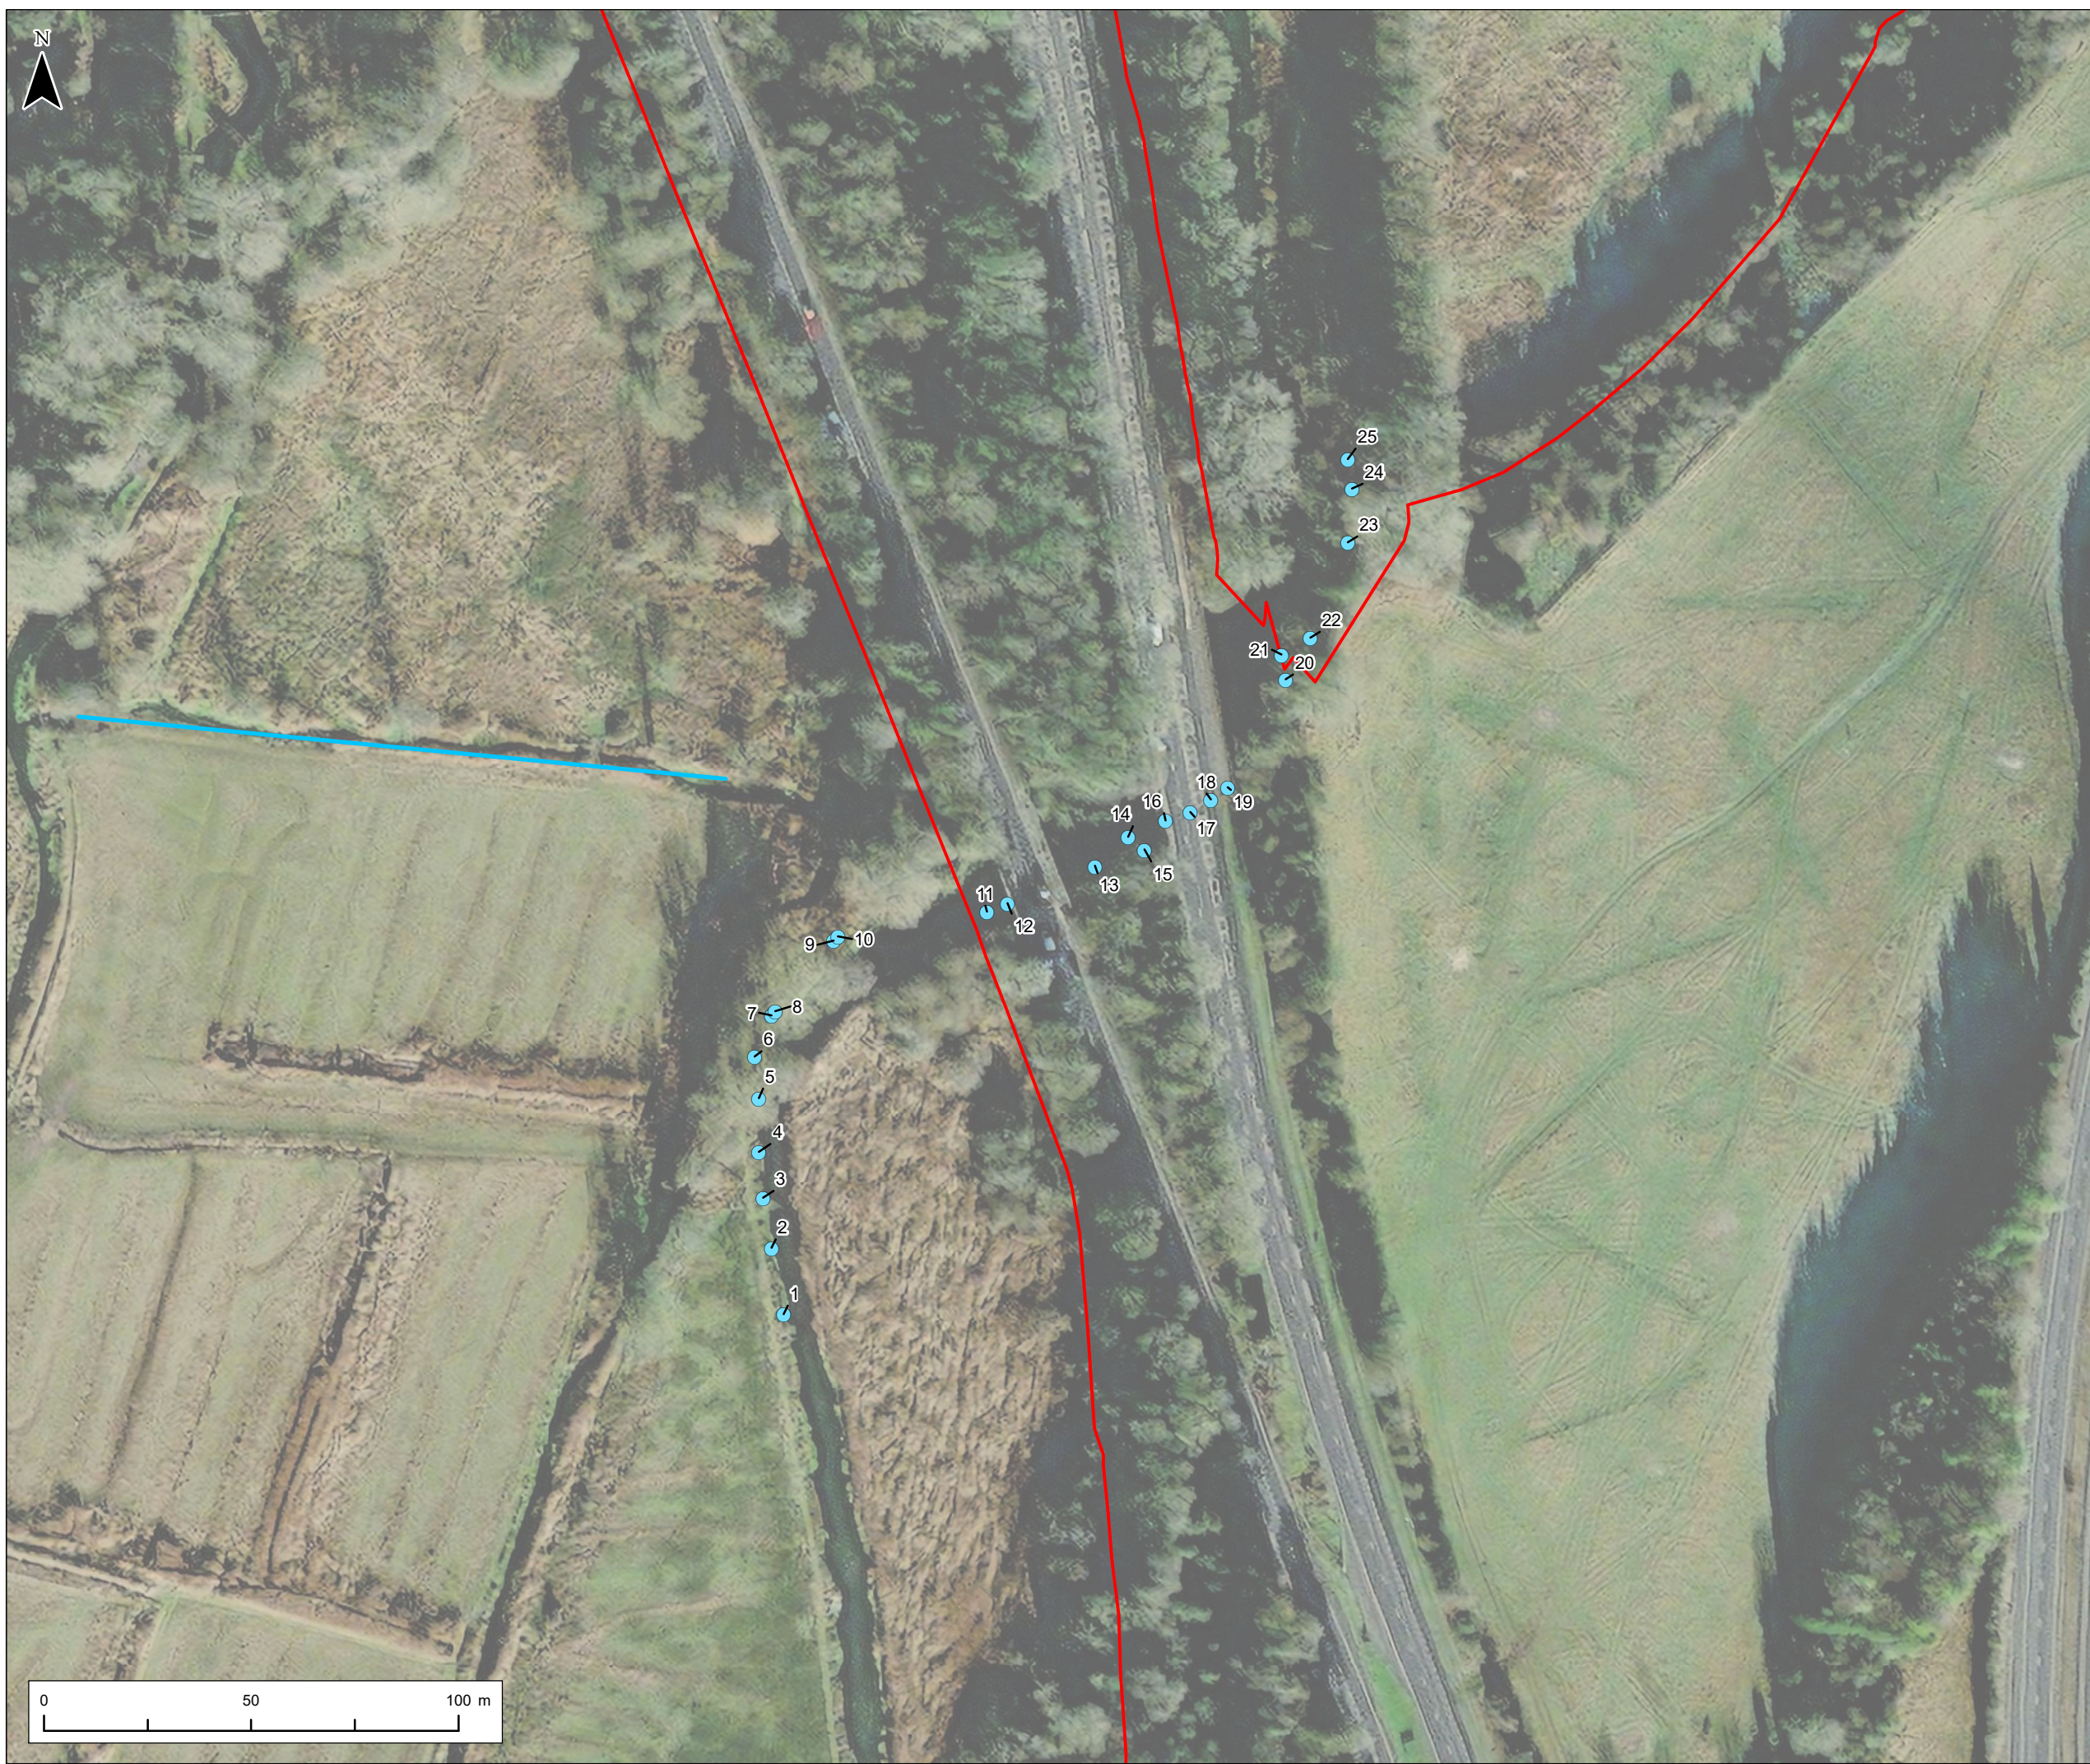
Figure 1 White-clawed Crayfish Survey Area

- Application Boundary
- White-clawed Crayfish Manual Search Area
- White-clawed Crayfish Baited Trap location

- 1.1.1 Stantec UK Ltd was appointed by National Highways and VolkerFitzpatrick to undertake a white-clawed crayfish survey of the M3 Junction 9 Improvement (hereafter referred to as the 'Scheme').
- 1.1.2 The Application Boundary along with the area subject to survey can be viewed on **Figure 1** in **Appendix A** and will be referred to as 'the Survey Area' throughout this report.
- 1.1.3 The Scheme is located to the north-east of Winchester and includes proposed improvements to Junction 9 of the M3 and the A34 around an approximate central national grid reference (NGR) of SU496308.

- 2.1.3 The survey locations can be viewed on **Figure 1** in **Appendix A**.
- 2.1.4 Baited traps were used in the deeper channel of the River Itchen, with 25 traps set over two nights from 7 September to 9 September 2022, to ensure sufficient effort and spatial coverage of the 250m survey reach. Traps were tagged and followed Environment Agency design specifications. Traps were baited with fresh mackerel. Traps were either tied to secure bankside feature, or secured using tent peg. Where possible traps were set out of the main flow, and near habitat features such as tree roots or refugia within the substrate, all traps were fully submerged.

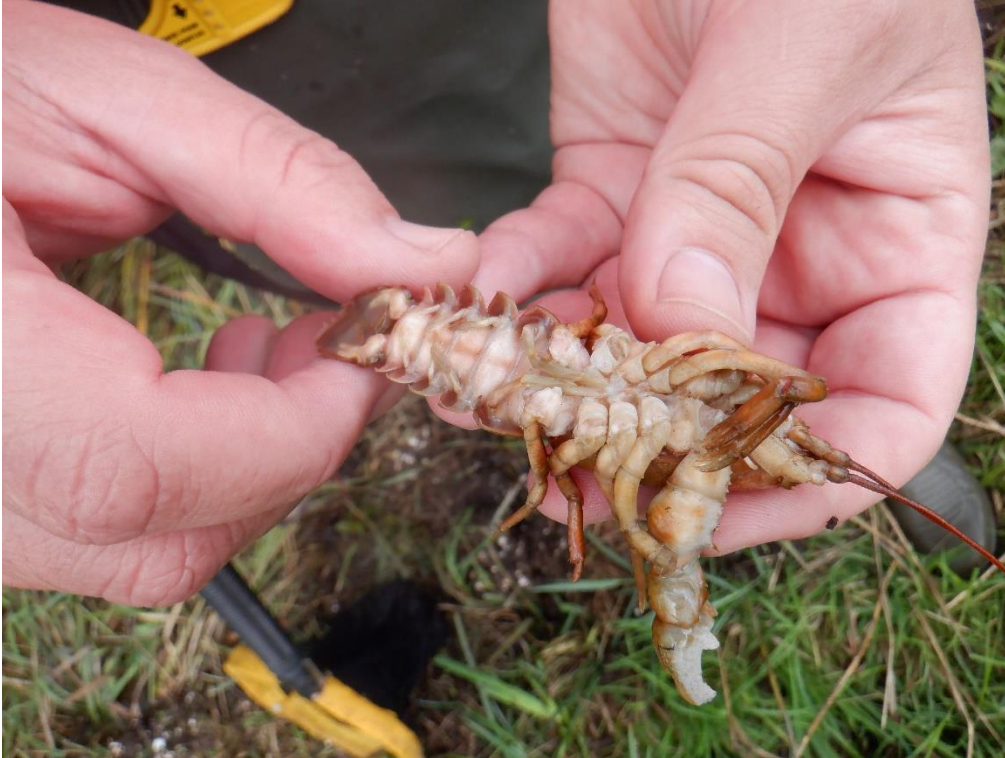
Photograph 1. Moribund white-clawed crayfish, Winnall Moors Nature Reserve

3.3.3 Manual search surveys undertaken by Stantec on the 7 September 2022 also confirmed the presence of white-clawed crayfish through the presence of a moribund specimen. No live animals were identified, but this was likely due to high water levels at the time of survey.

| Total Crayfish (By 1 method, note total(s) by other methods if applicable) | 1 | One moribund female WCC in state of decomposition |

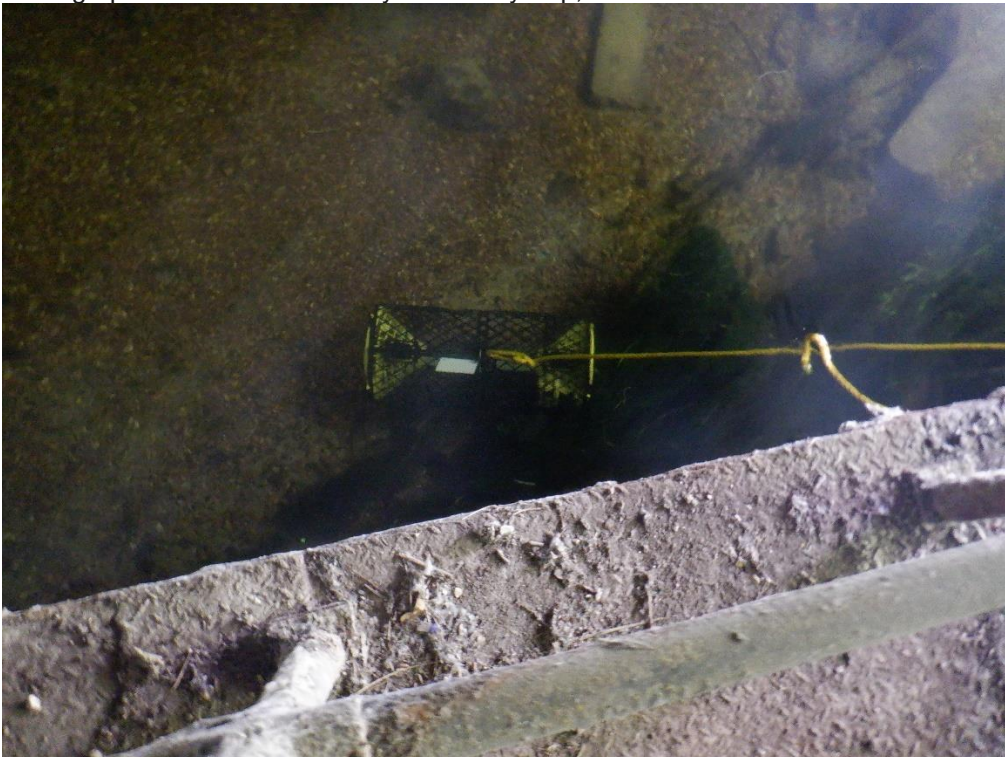
Photograph 2. White-clawed crayfish survey trap, River Itchen
