A417 Missing Link
TR010056

6.4 Environmental Statement
Appendix 13.5 Hydromorphology
Assessment

May 2021

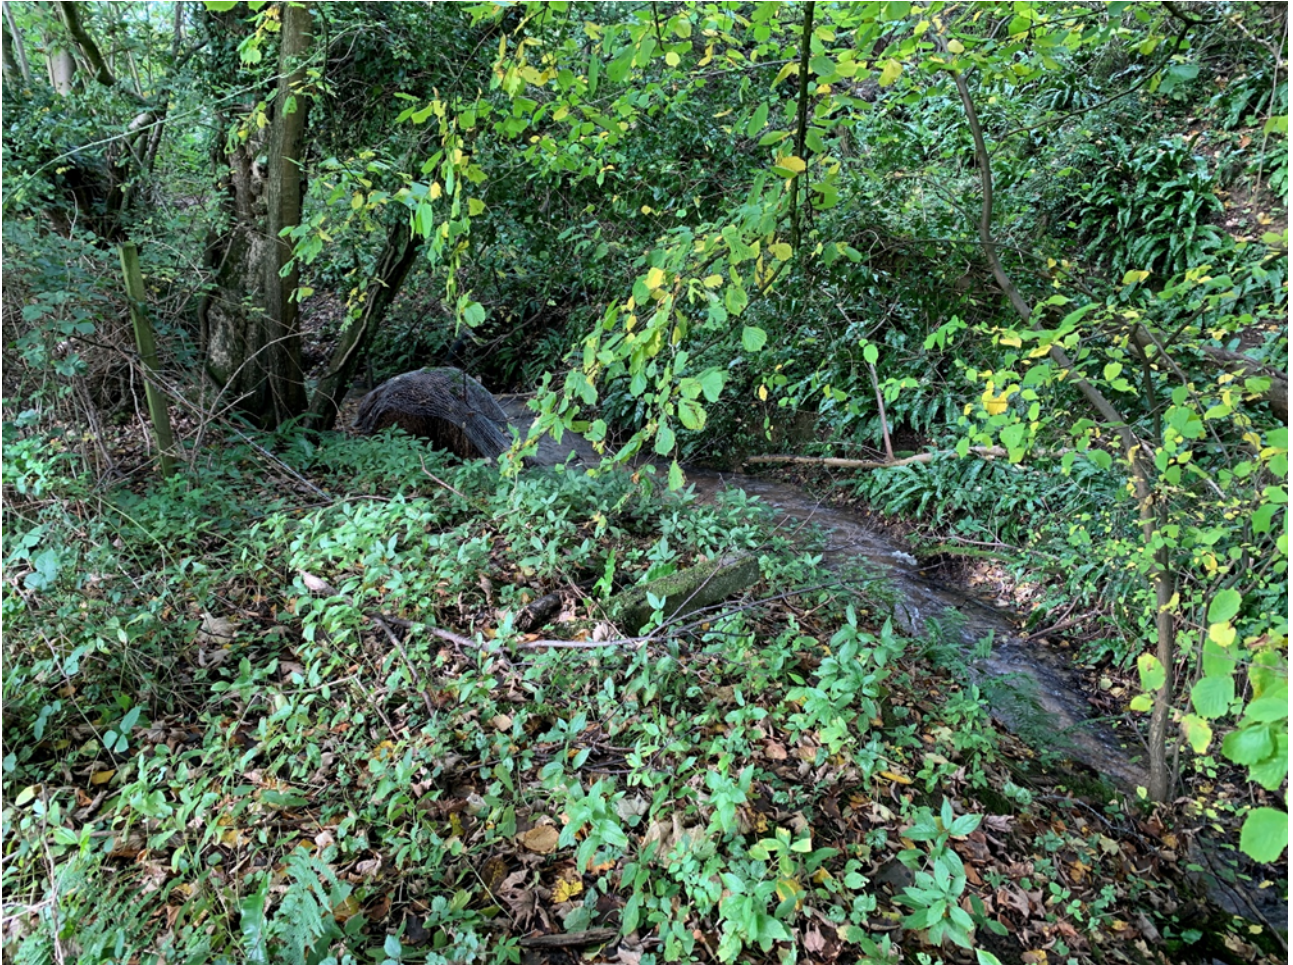
- 3.2.5 The watercourse is approximately 1m wide and is characterised by run and cascade flow types. The dominant bed material is fine gravel, with coarse gravel, cobbles, sand and clay also present. The banks are densely wooded and composed of cohesive material with limited evidence of erosion, principally by geotechnical failure.

3.2.6 A representative photo of the watercourse is shown in Photograph 3-1.

Photograph 3-1 Representative photo of characteristics of tributary of Norman's Brook

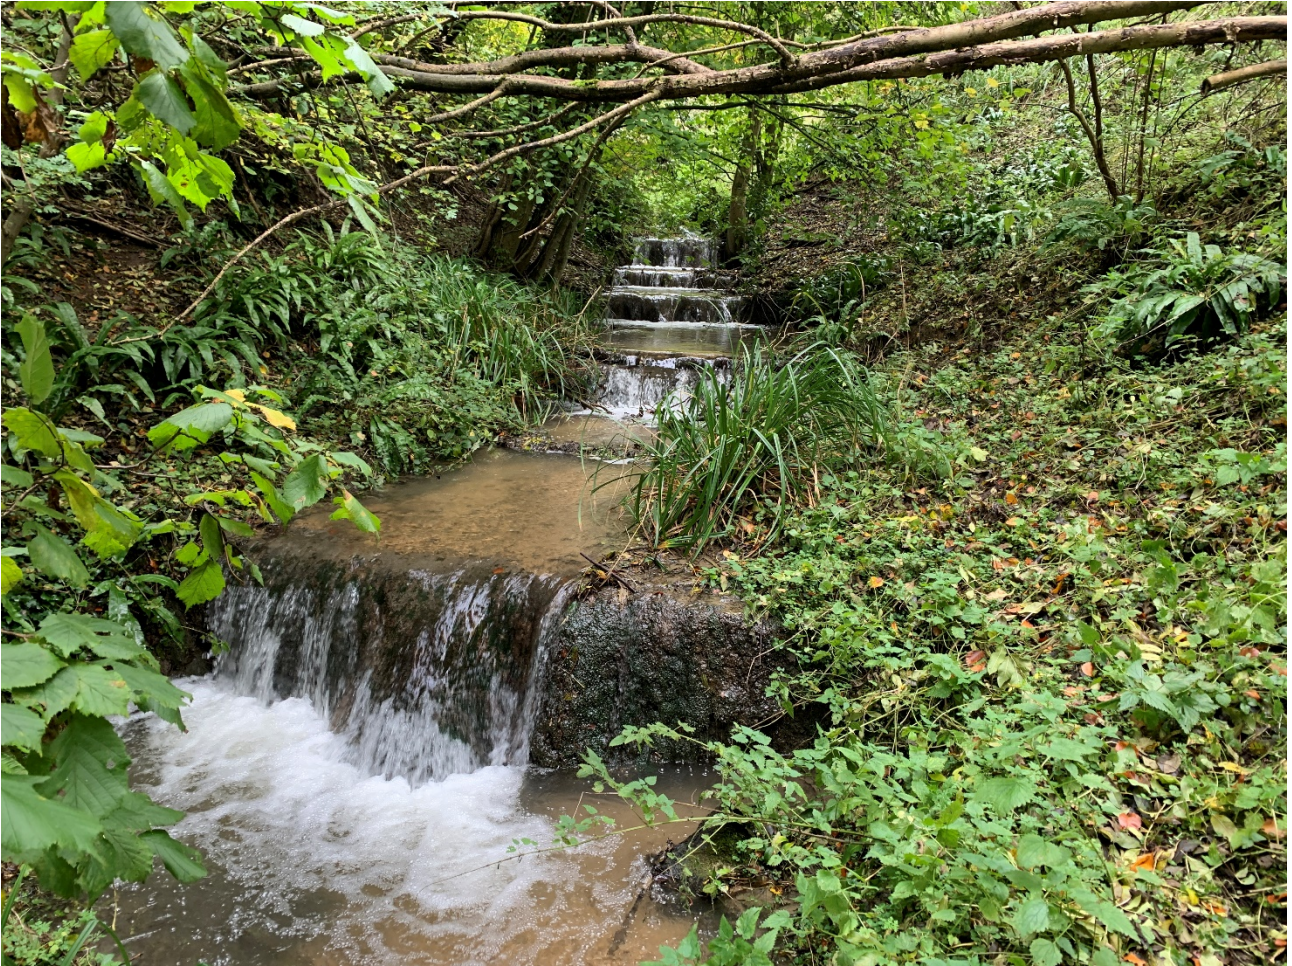
3.2.8 Tufa deposits have been identified in this section of the tributary of Norman's Brook in ES Appendix 8.24 Assessment of tufaceous material (Document Reference 6.4). Tufa is formed when carbonate is precipitated out of alkaline water. Carbonate deposits are apparent over existing concrete weir structures at this location (Photograph 3-2), where precipitation is induced by the increased air-water interaction created by the turbulent flow. There are seven cascades in total, each around 2.5m wide.

Photograph 3-2 Tufa cascades along the tributary of Norman's Brook

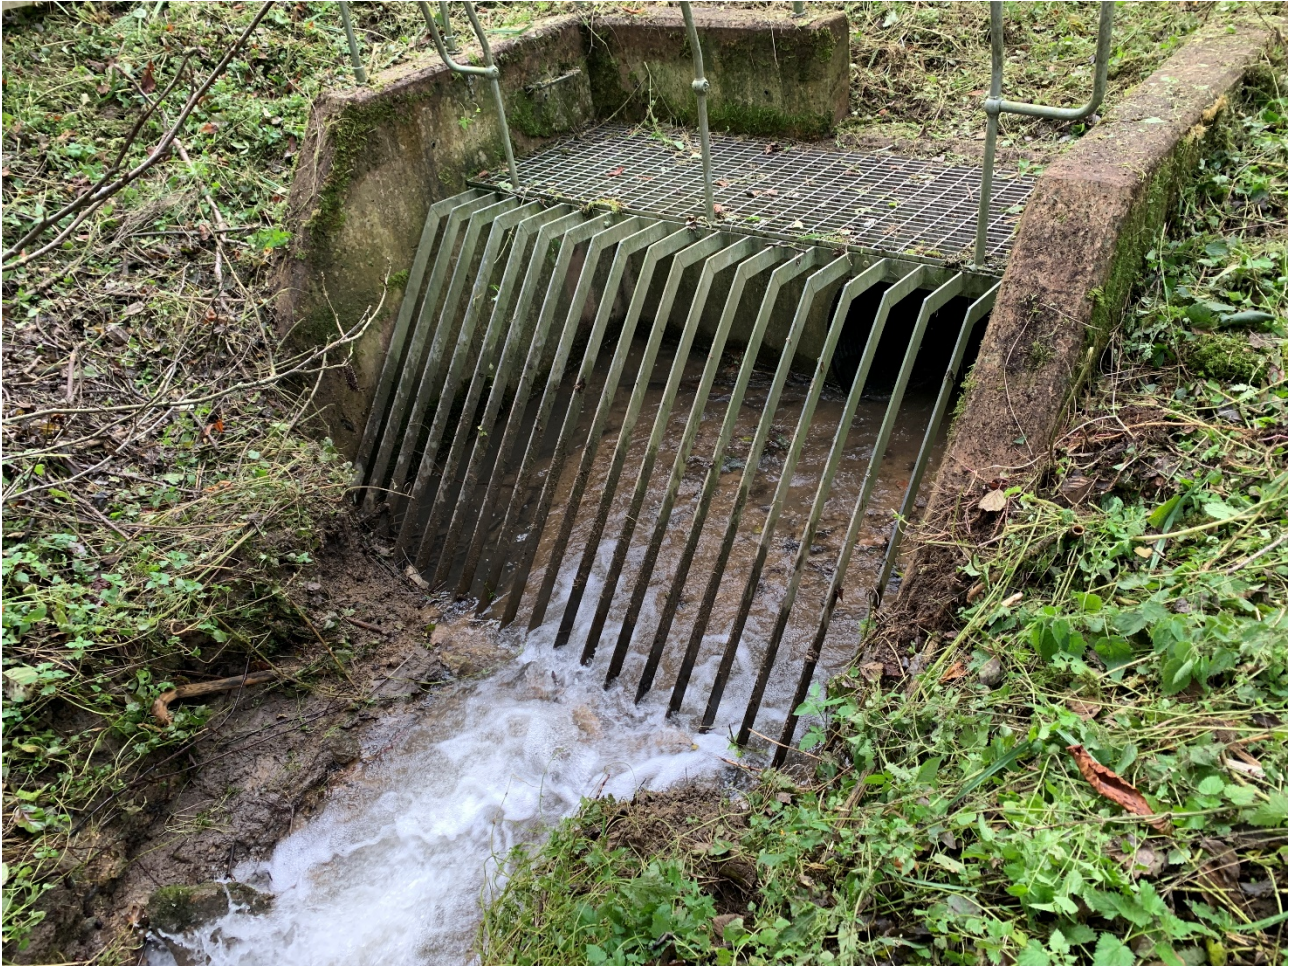
3.2.7 The watercourse enters a buried culvert via a 2.5m high concrete weir at Ch 1+200m, before re-emerging 50m downstream.

Photograph 3-3 Existing culvert entrance under A417 - tributary of Norman's Brook

- Replacement and lengthening of the existing Crickley Hill stream culvert beneath the A417 (culvert near Crickley Hill Farm (Fly Up Bike Park) in Table 4-1).

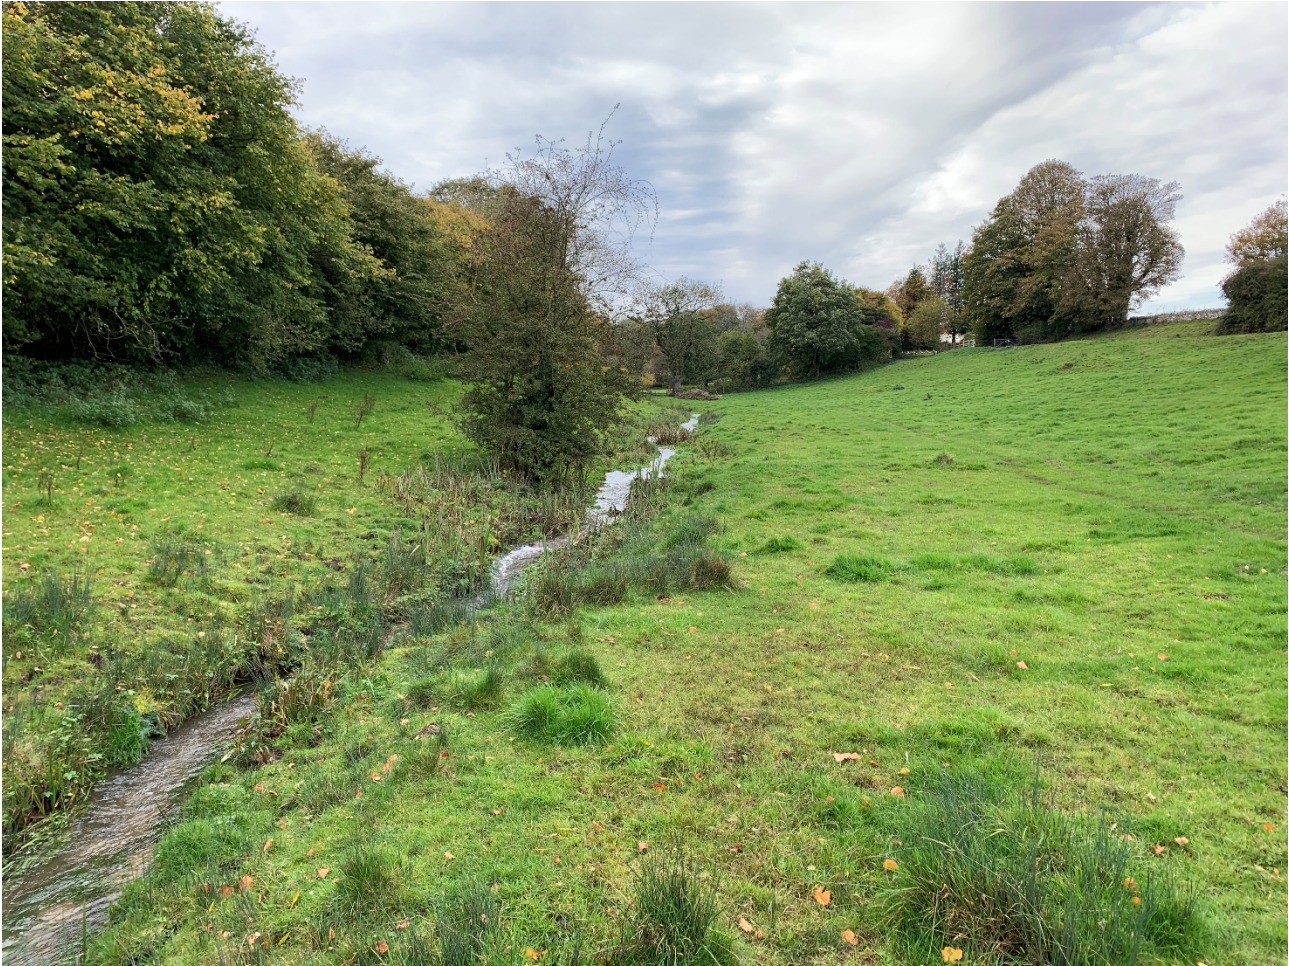
- 3.3.1 The unnamed tributary of the River Churn 1 flows eastwards away from the scheme. The watercourse is first recorded where it crosses beneath the A436 to the south-east of Ullenwood Manor Golf Course.
- 3.3.2 The road drainage discharged into this catchment would only flow directly into the watercourse during periods when the catchment was saturated and overland flow processes were active.
- 3.3.3 The watercourse has been straightened and flows through rough pasture and woodland, with some evidence of poaching (Photograph 3-4). The watercourse is approximately 2m wide with flow types of runs and glides and a gravel bed.

Photograph 3-4 Representative photo of characteristics of tributary of River Churn
1

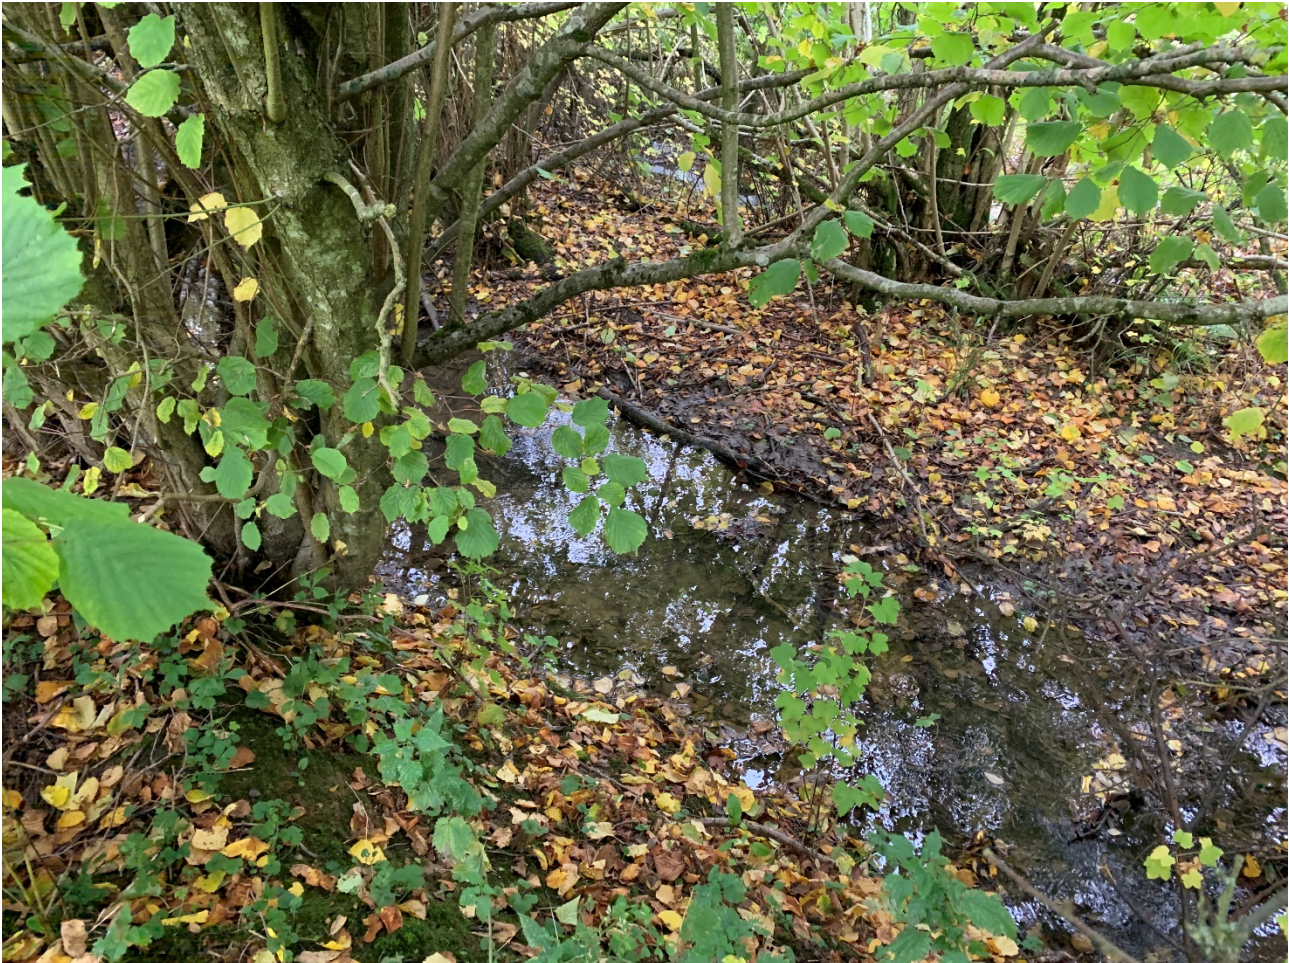
- 3.4.1 The unnamed tributary of the River Churn 2 is a dry valley feature which is crossed by the scheme at the head of the valley between Ch 3+100m and 3+300m. A watercourse is not present in the valley bottom until approximately 1.2km downstream of the scheme at NGR SO 95380 15473.
- 3.4.2 The dry valley may experience episodic surface water flows during periods of high groundwater levels but is otherwise a relict landscape feature formed by past periglacial processes.
- 3.4.3 The watercourse is ponded and flows eastwards through along a dense wooded field boundary towards the River Churn (Photograph 3-5).

Photograph 3-5 Representative photo of characteristics of tributary of River Churn 2

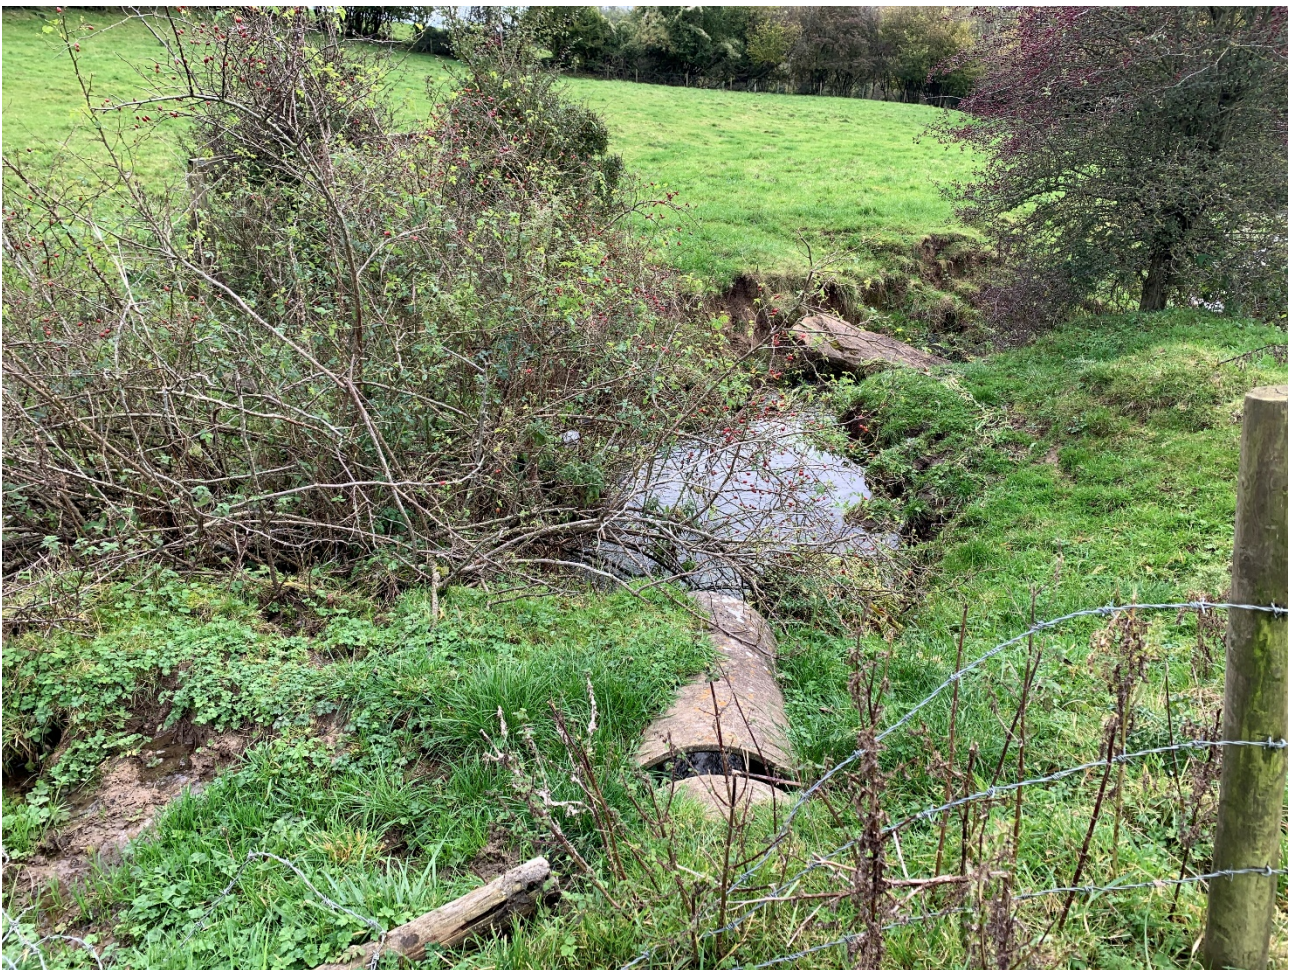
- 3.5.1 The River Frome and its unnamed tributaries emerge to the south of the eastern end of the scheme, near Nettleton. The catchment is fed by a series of springs that emerge at the boundary of the Great Oolite limestones over Fuller's Earth mudstone.
- 3.5.2 The watercourses in this catchment are not directly modified by the scheme but would receive discharges from the road drainage network.
- 3.5.3 Spot gauging has been undertaken between July – December 2020, with flows ranging from 0.001 to 0.166m³/s (Locations SW3 & SW4 in ES Appendix 13.12 Water Environment Monitoring Data (Document Reference 6.4)).
- 3.5.4 The tributary which flows southwards from Nettleton is within a piped culvert from the existing A417 until it emerges, as shown on OS mapping. The watercourse has been overdeepened and has approximately 1.5m high banks (Photograph 3-6).

Photograph 3-6 Representative photo of characteristics of tributary of River Frome at Nettleton
