A417 Missing Link
TR010056

6.4 Environmental Statement
Appendix 8.18 Water Vole Technical
Report

A417 Missing Link

**6.4 Environmental Statement
Appendix 8.18 Water Vole Technical Report**

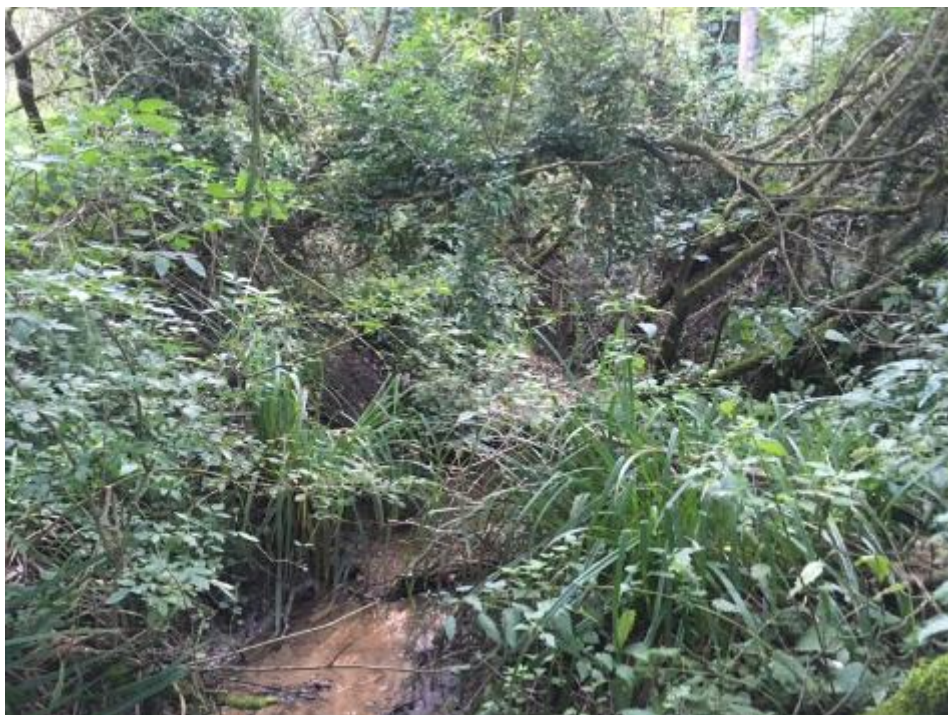
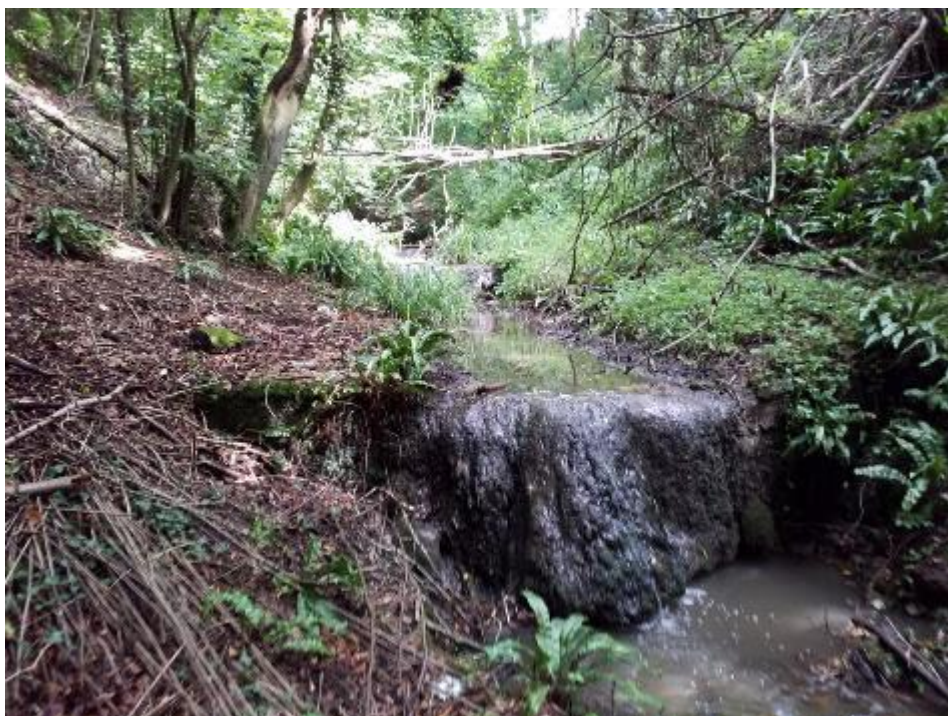
Norman's Brook
habitat assessment

3.2.7. Norman's Brook has low suitability for water voles due to its heavy shading, lack of aquatic herbaceous vegetation, poor bankside vegetation and fluctuating flows.

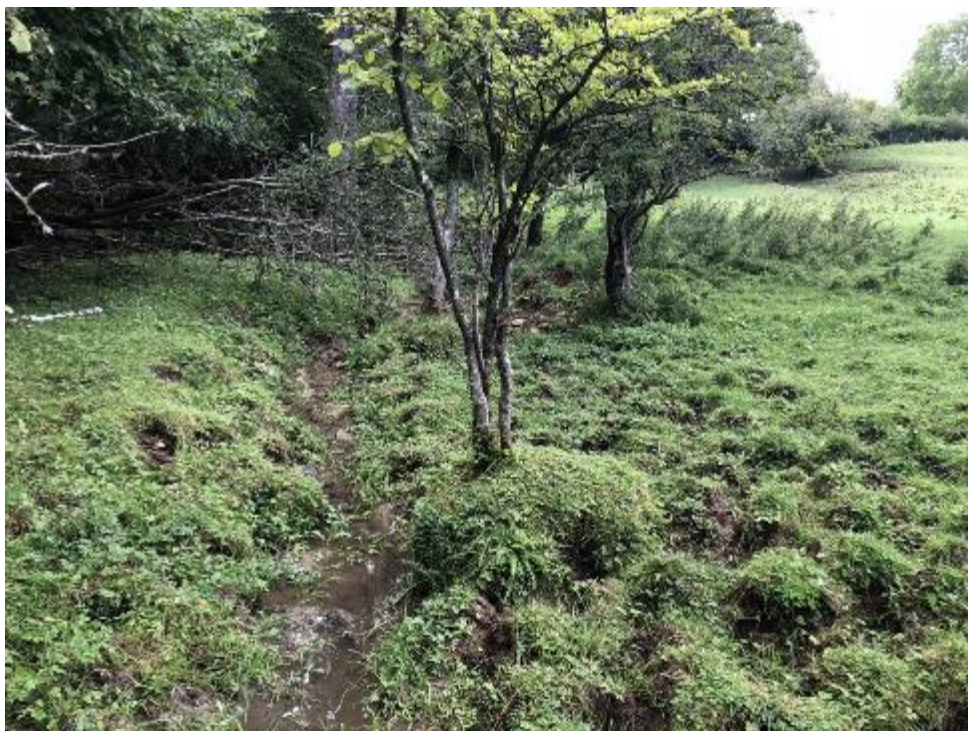
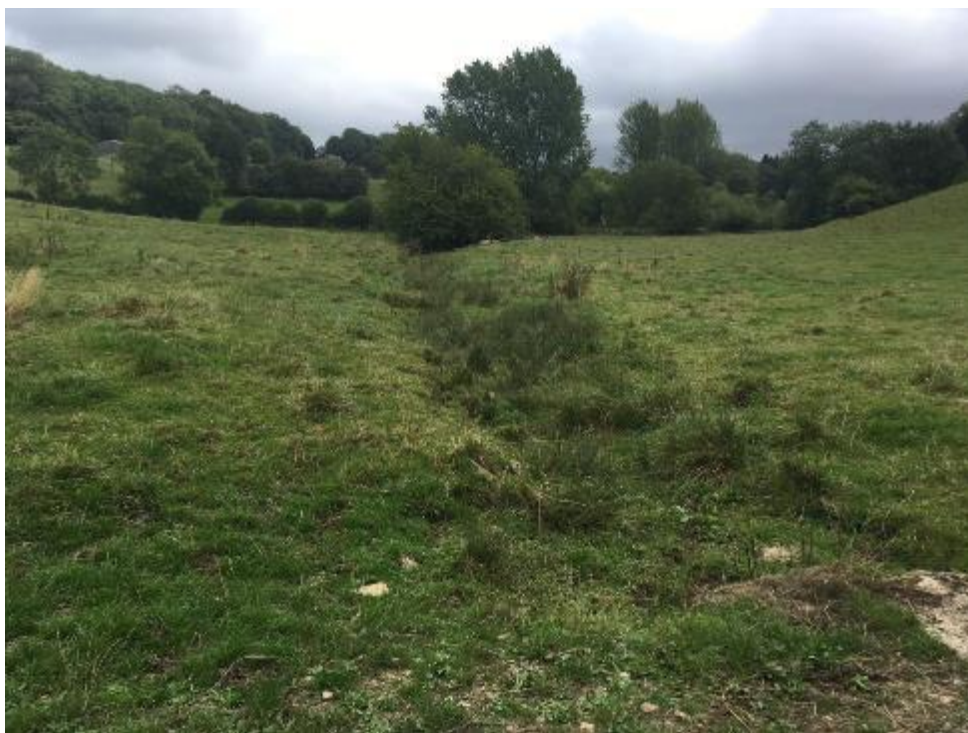
Upper Frome
(Upper tributaries)
habitat assessment

3.2.8. The Upper Frome (Upper tributaries) has negligible suitability for water voles as its banks are heavily trampled by livestock and has a very low flow with limited herbaceous vegetation. The middle and lower sections of the Upper Frome have low suitability as they are largely undisturbed by livestock but are heavily shaded and lack aquatic or bankside herbaceous vegetation.

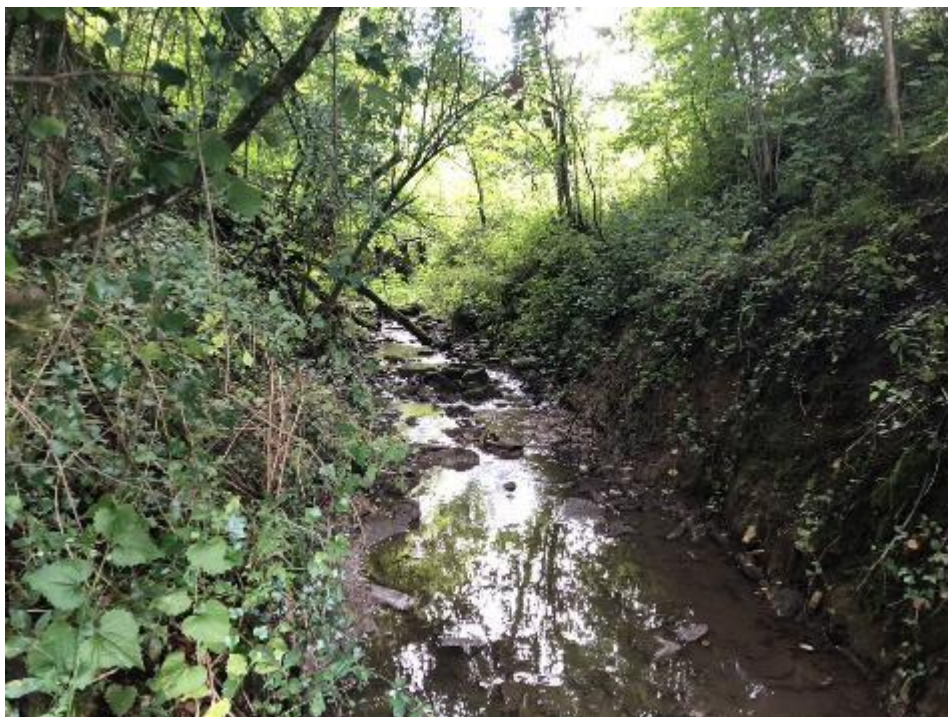
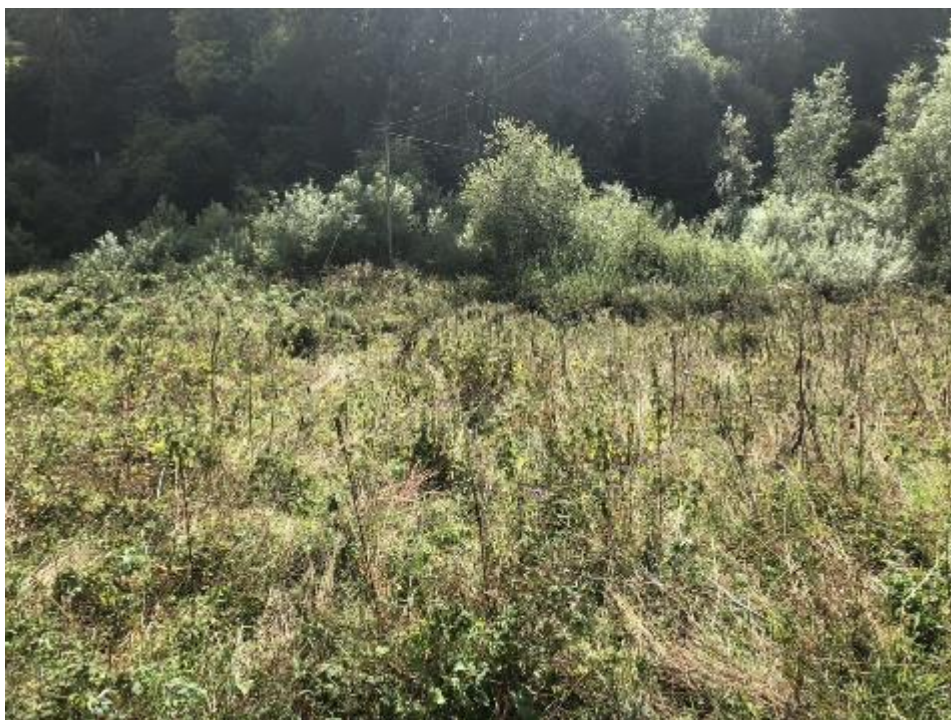
Upper Frome
(Middle section)
habitat assessment

Upper Frome (middle section) (SO 94384 13235 to SO 94584 12999), 260m	Largely steep-sided rocky banks with slow flow and average depth of 15cm. Some areas with earth bank sides and shallower depth.	Limited aquatic vegetation with banks of tall ruderal and willow scrub. Species include bramble, nettle, hogweed, dock, thistle and meadow cranesbill. Watercourse almost completely shaded along length.	Surrounding land is unmanaged scrub and tall ruderal with pasture and woodland in wider landscape. No livestock but possible disturbance from cats or dogs of local home owners.	No upstream connection, downstream more suited to water voles.	Low
Upper Frome (lower section) (SO 94584 12999 to SO 94694 12657), 370m	Shallow, slow running stream in steep-sided valley with average depth of 10cm. Low banks generally not suited to water vole burrows.	Limited aquatic vegetation with heavy shading from open woodland along majority of length. Some open areas with improved grassland and ruderal vegetation.	Stream runs through pheasant shoot with managed woodland, tall ruderal and improved grassland on valley floor. Highly disturbed by game birds and grazing cows.	Downstream connectivity to River Frome	Low

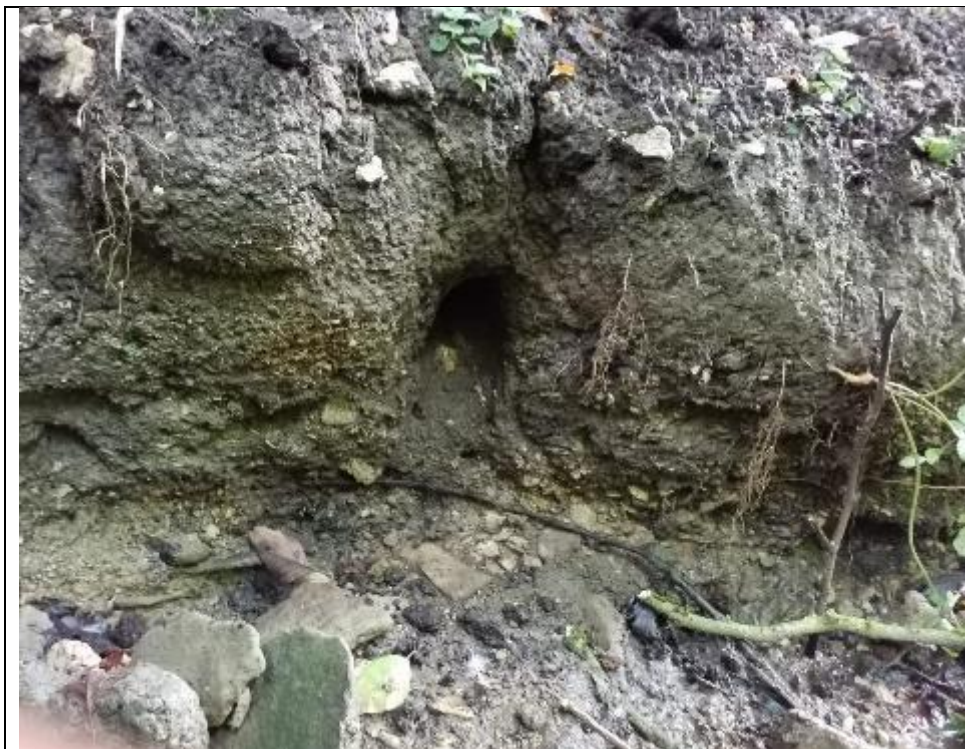
Upper Frome (lower section)	Burrow	15 August 2018	394739	212913	Likely rat burrow on earth bank side of shallow stream. 10cm diameter. No visible droppings, under woodland canopy on bankside.	Photo 4
Upper Frome (lower section)	Footprint	15 August 2018	394653	212818	Footprint of small mammal - unlikely to be water vole as digits not splayed in most indicative star configuration	Photo 5

Photo 4: Likely rat burrow on earth bank side of shallow stream. 10cm diameter. No visible droppings, under woodland canopy on bankside.

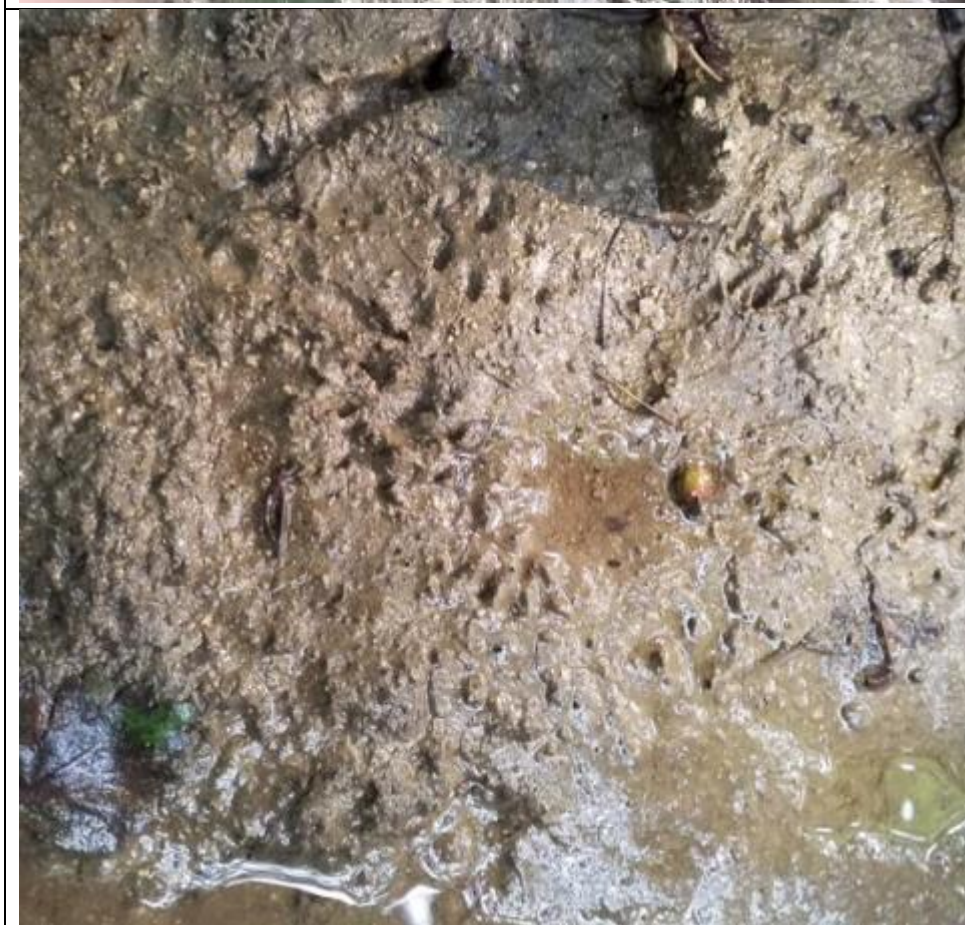
Photo 5: Footprint of small mammal - unlikely to be water vole as digits not splayed in most indicative star configuration

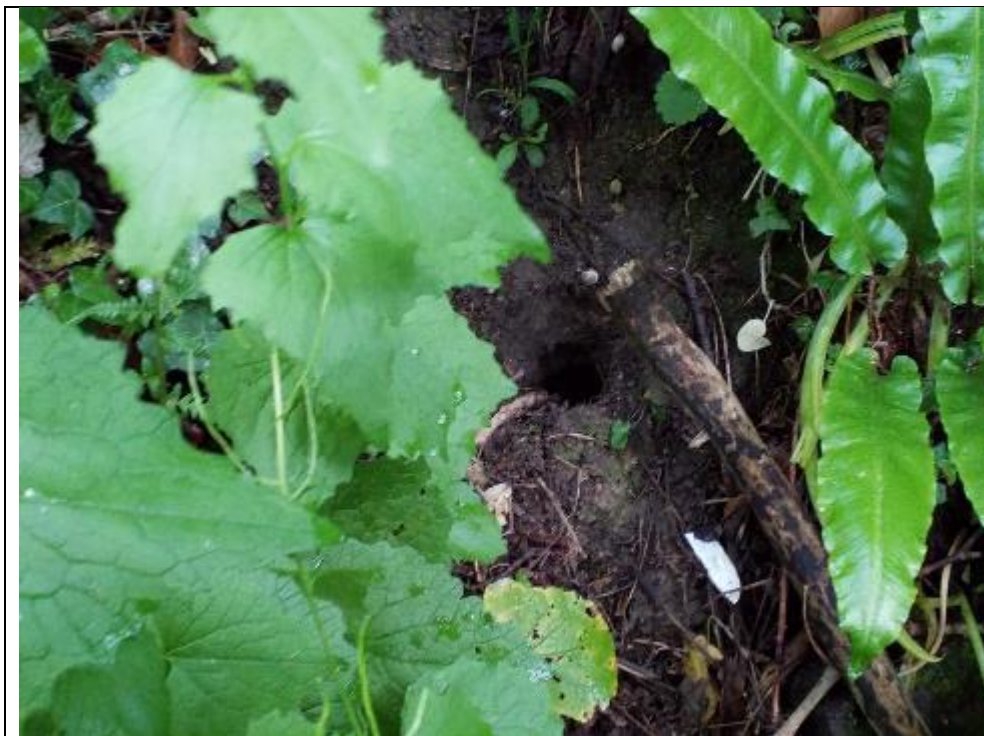
Watercourse ID	Type of Feature	Date	Easting	Northing	Notes	
Upper Frome (lower section)	Burrow	22 May 2019	394665	212787	Rat burrow in bank	
Upper Frome (lower section)	Burrow	22 May 2019	294695	212599	Rat burrow in bank of island in centre of lake	
Norman's Brook	Burrow	16 August 2018	392484	215690	Rat burrow with excavated soil in entrance	Photo 6
Norman's Brook	Feeding remains	16 August 2018	392484	215690	Feeding remains, not indicative of water vole	
Norman's Brook	Burrow	16 August 2018	392838	215726	Rat burrow

Photo 6: Rat burrow
with excavated soil
in entrance
