A417 Missing Link
TR010056

6.4 Environmental Statement
Appendix 8.19 White-Clawed Crayfish
Technical Report

A417 Missing Link

**6.4 Environmental Statement
Appendix 8.19 White-Clawed Crayfish Technical Report**

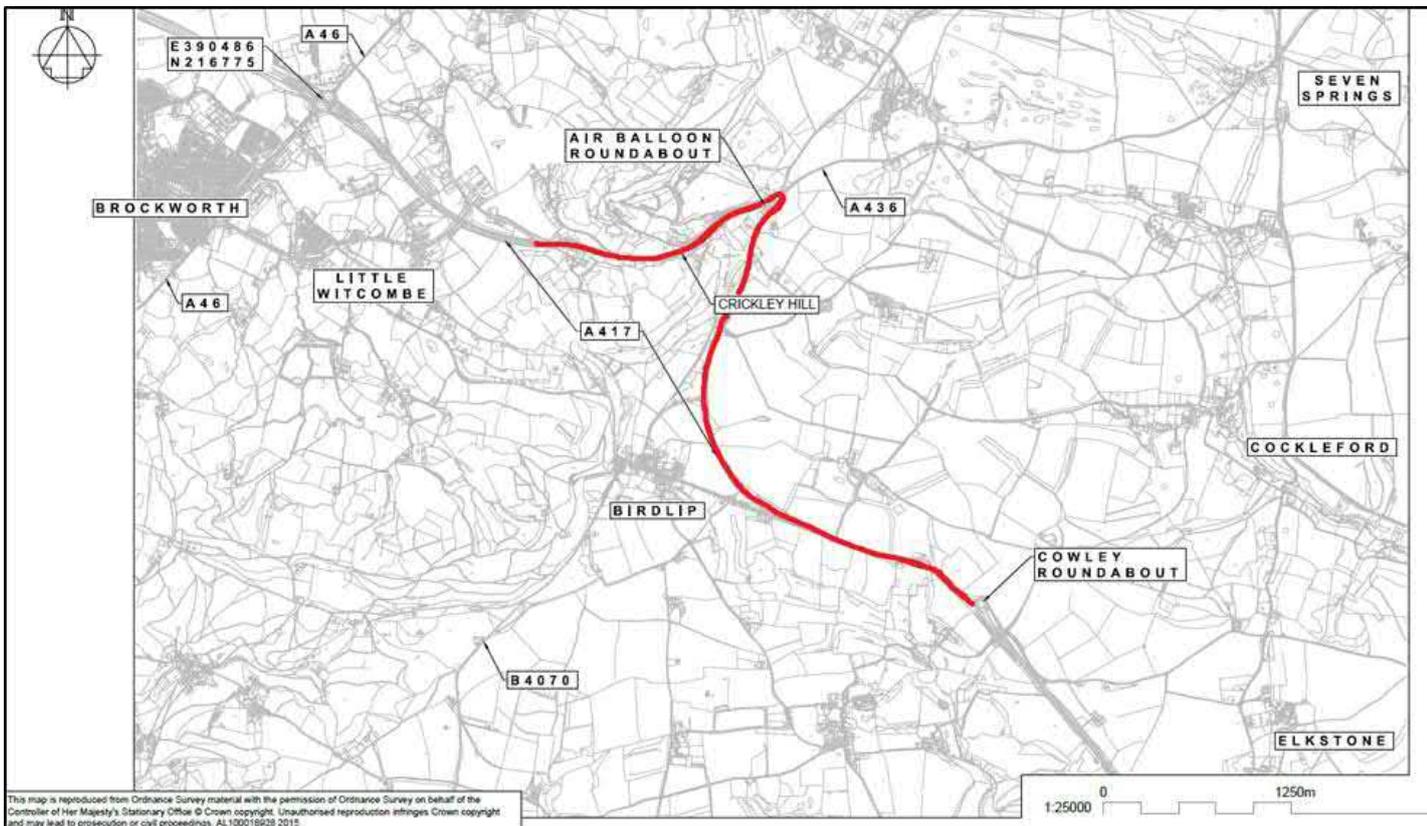
Figure 1.1 Current A417 route and scheme extent

1.1.1. The A417/A419 provides an important link between the Midlands/North and South of England, between Gloucester and Swindon, and as an alternative to the M5/M4 route via Bristol. The section of the A417 near Birdlip, known as the 'missing link', forms the only section of single carriageway along the route, with an at-grade junction located at the 'Air Balloon' public house. The single carriageway is located between the Cowley roundabout and the base of Crickley Hill, a 5.5 kilometre stretch shown on Figure 1.1 below.

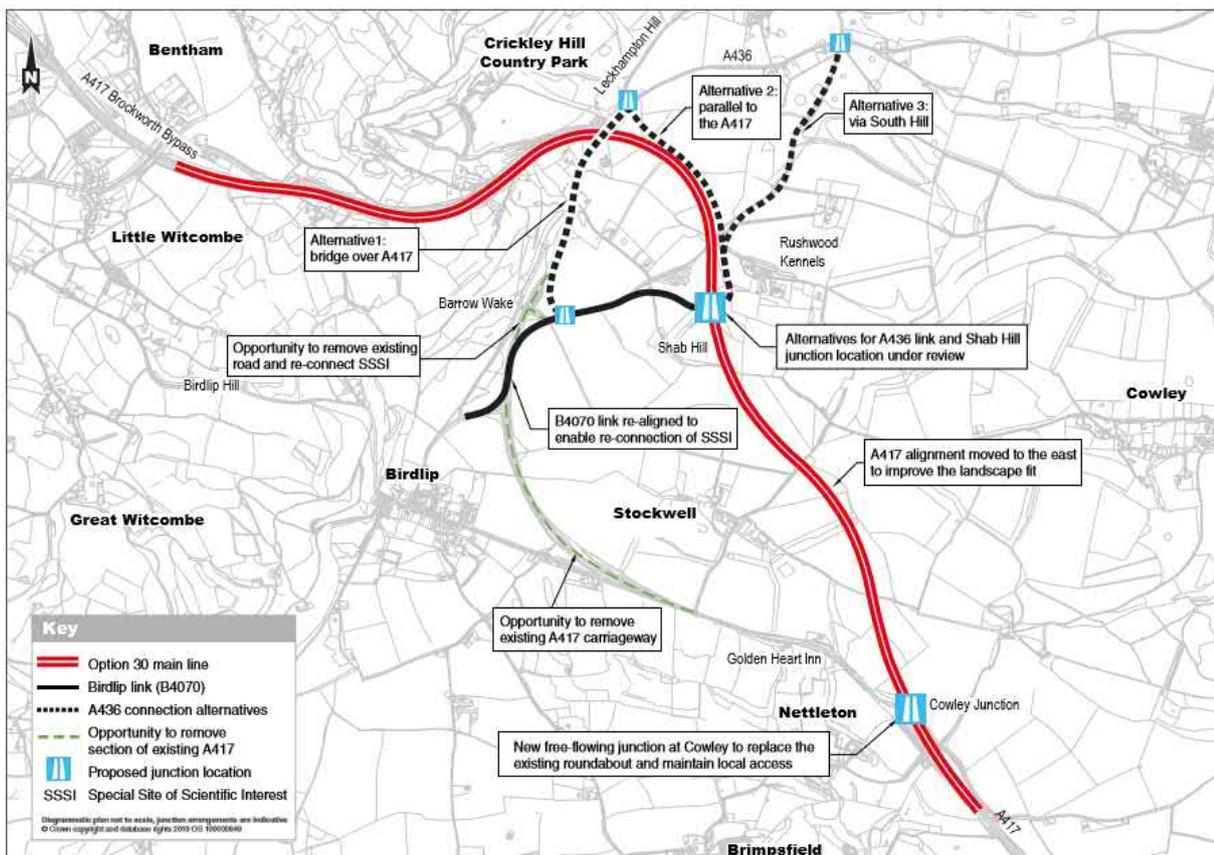
Figure 1.2 A417 Missing link proposed option 30

- 1.2.2 The preferred route for the scheme was confirmed as Option 30 by the Secretary of State in March 2019 (see Figure 1.2 below). The Scheme comprises the construction of a new dual carriageway to replace the existing single carriageway section between Brockworth bypass and Cowley Roundabout. It is predominately an “offline” Scheme but approximately a third of the route follows the existing A417 route corridor at Crickley Hill.

- 1.2.3 A new link road would be built between the slip road junction at Shab Hill and the existing A417 to connect traffic to and from Birdlip and the A436 with the new A417. This new link road would end in a new roundabout near Barrow Wake.

- 1.2.4 Figure 1.2 above shows how there are three A436 link road alternative connections. Alternative 2, parallel to the A417, is the selected route proceeded with for assessment in the Environmental Statement.

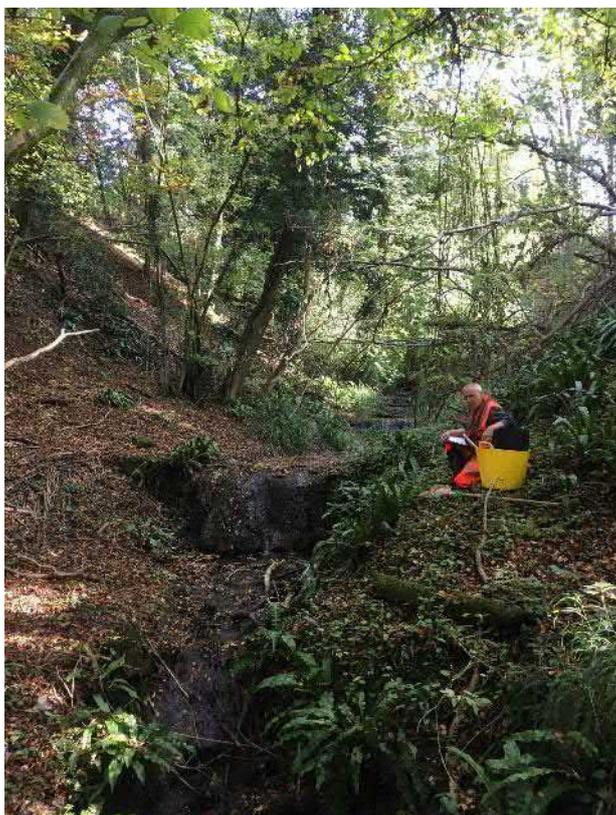
Figure 3: Normans Brook

- 3.2.1. Norman's Brook (currently shown on Ordnance Survey mapping as Horsbere brook but tracer surveys in 2018 confirmed that its Norman's Brook), is a small stream with a steep gradient, and is heavily shaded in a deeply incised channel (Figure 1). The wetted width of the stream at the time of survey was between 0.1 and 1.3 metres wide. The water level was shallow with very low flow and quite heavily silted with frequent woody debris in the stream. During the survey there were obvious issues with run-off, likely from the existing A417, with grey/oily film present in areas of slow flow.

- 3.2.2. A number of culverts were present along the surveyed section of the watercourse (up to 40 metres long) and there was a section of multiple low-head concrete weirs. The watercourse links to the open channel of Norman's Brook via a very long culvert.

- 3.2.3. The water levels within this watercourse appear to fluctuate significantly depending on rainfall and it is likely that the watercourse is dry during times of low rainfall.

- 3.2.4. The watercourse included numerous suitable refuges for crayfish including small and large cobbles, tree roots, undercut banks and woody debris in the water. The water is mineral rich with calcium deposits noted. There was however very limited aquatic or emergent vegetation. The likely ephemeral nature of the watercourse reduces its potential to support a viable population of white-clawed crayfish and the silty water with evidence of pollution reduces the overall suitability of the habitat

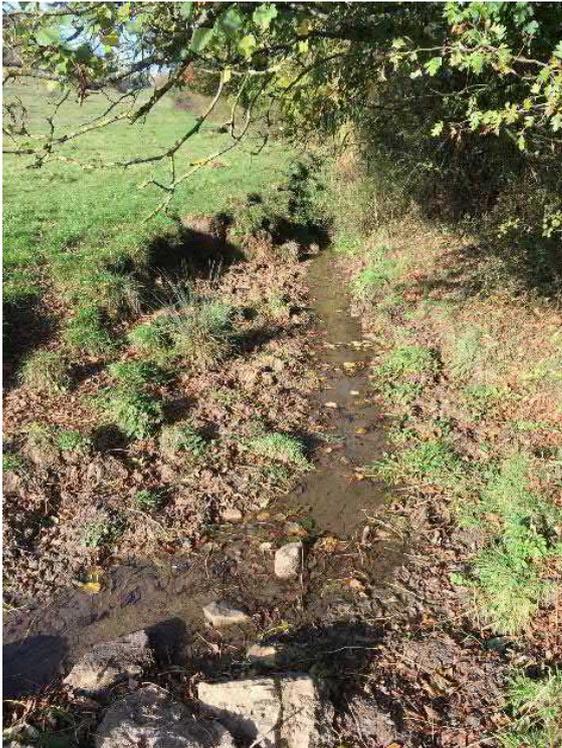
Figure 4: Upper Frome – unsuitable northern section (north of Reach 5):

- 3.2.7. The watercourse comprises a small stream largely running through a mix of coniferous plantation and semi-natural deciduous woodland. Throughout the length of the surveyed watercourse there were areas of shallow gradient with slow flowing water, pools, and areas with steeper gradient with an abundance of small drops and pools with meanders present. Calcium build-ups were recorded on water drops and areas of shallow, fast flowing water, indicating the mineral rich nature of the water. The downstream section included larger settlement ponds with deep silty substrate and deep leaf litter.

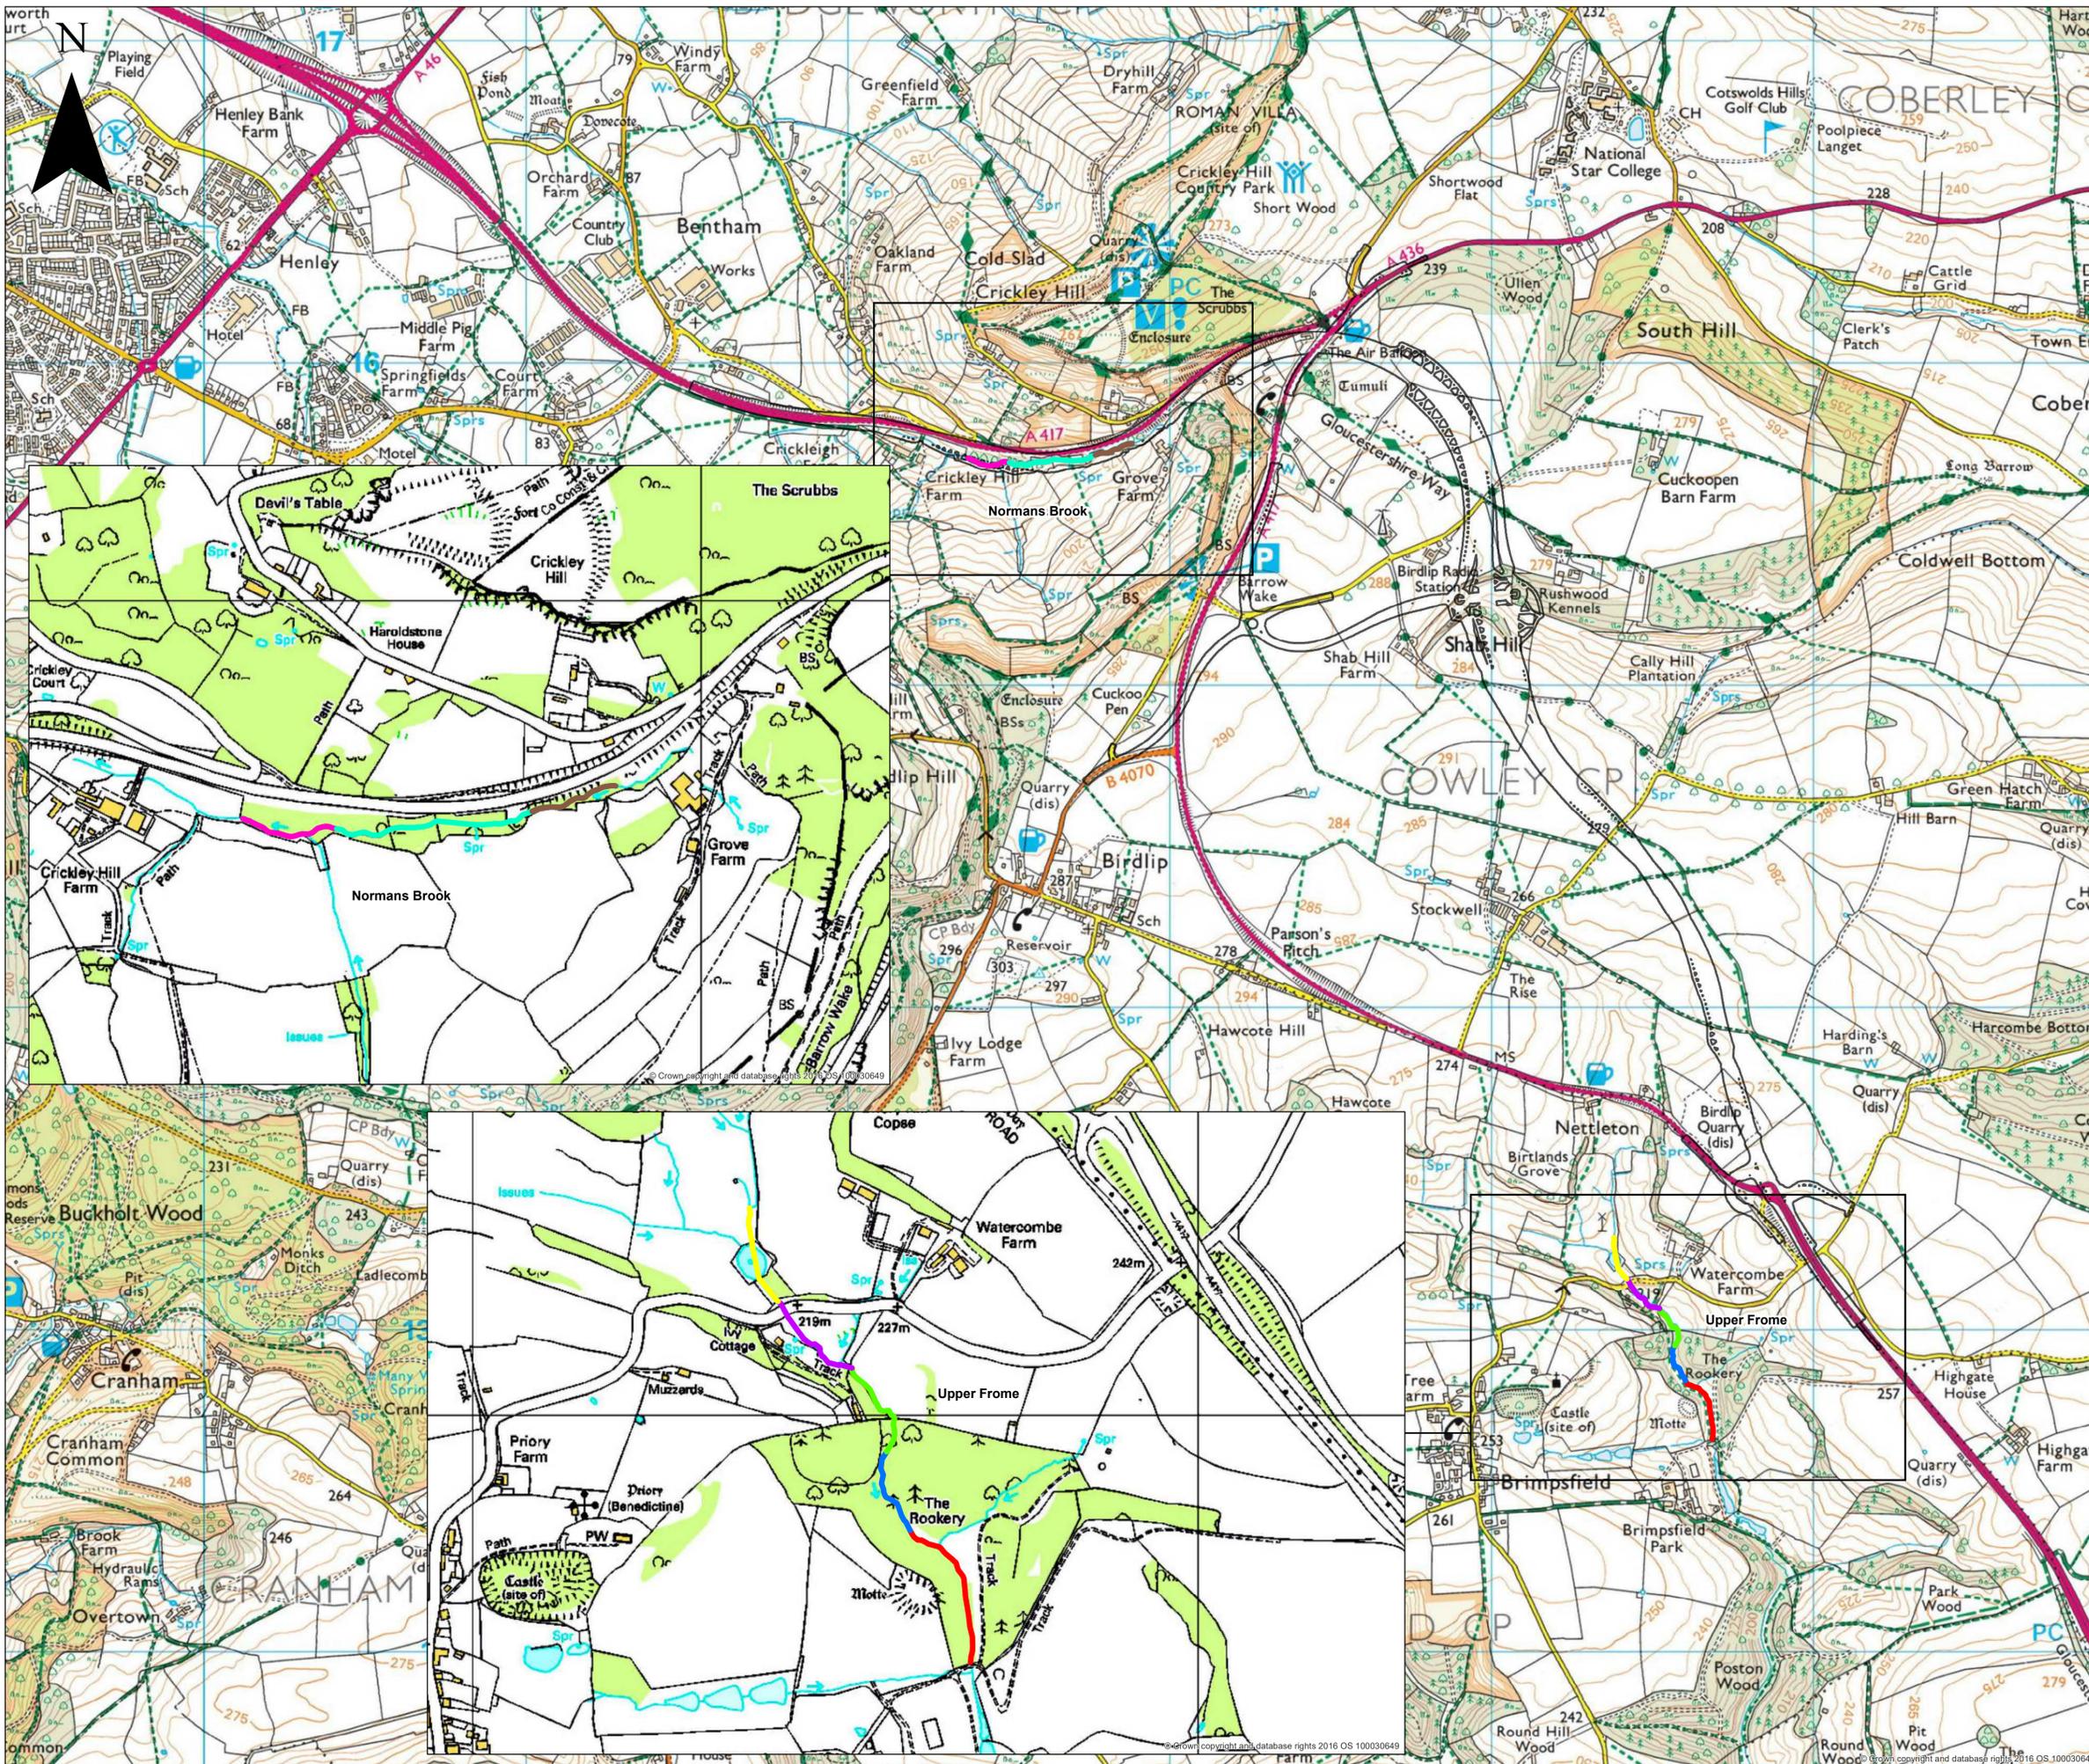
Appendix A White-clawed crayfish survey areas

Drawing Status	FOR INFORMATION	Suitability	S2
Project Title	A417 MISSING LINK		
Drawing Title	White-Clawed Crayfish Survey Reaches

- 3.3.1. The Norman's Brook survey area was divided up into 3 reaches, the locations of which are shown in Appendix A. Detailed descriptions of each reach are provided in Appendix B. Reach 1 is 155 metres in length (between SO92361570 and SO92491569). Reach 2 is 275 metres long (between SO92491569 and SO92761571). Reach 3 is 130 metres long (between SO92761571 and SO92891574).

- 3.3.4. The Upper Frome survey area was divided up into 5 reaches, the locations of which are shown in Appendix A. Detailed descriptions of each reach are
