A417 Missing Link
TR010056

6.4 Environmental Statement
Appendix 9.1 Preliminary
Sources Study Report

**6.4 Environmental Statement
Appendix 9.1 Preliminary Sources Study Report**

Regulation Number:	5(2)(a)
Planning Inspectorate Scheme Reference	TR010056
Application Document Reference	6.4
Author:	A417 Missing Link

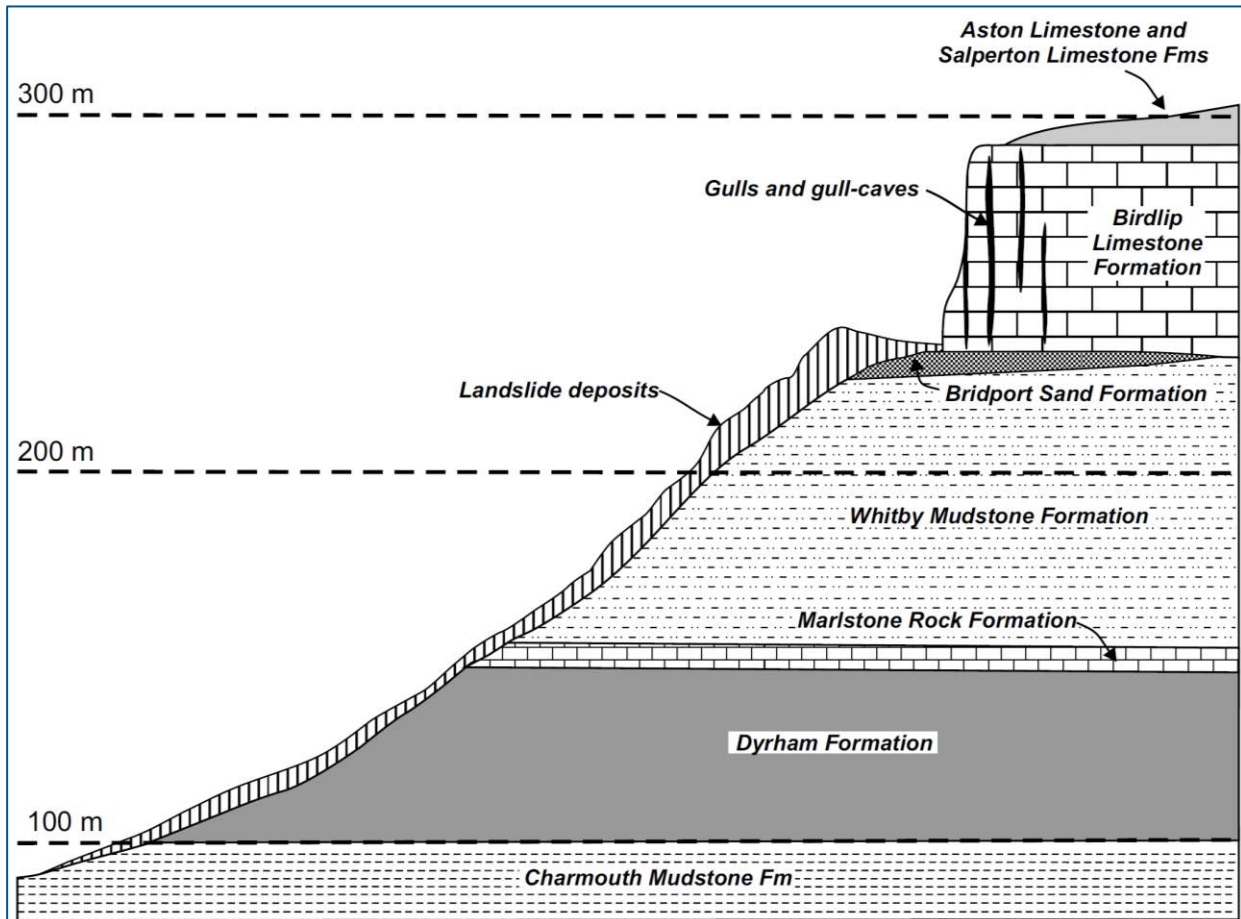
Figure 4.3: Conceptual geological cross section of the Cotswold Escarpment in the Cheltenham area (opposite orientation to Figure 4.7)

4.2.5 The stratigraphy is conceptually presented in Figure 4.3. As noted in Table 4.1 the Birdport Sand Formation may be significantly thicker than shown, and the landslide / colluvium deposits have been simplified for the purposes of presentation.

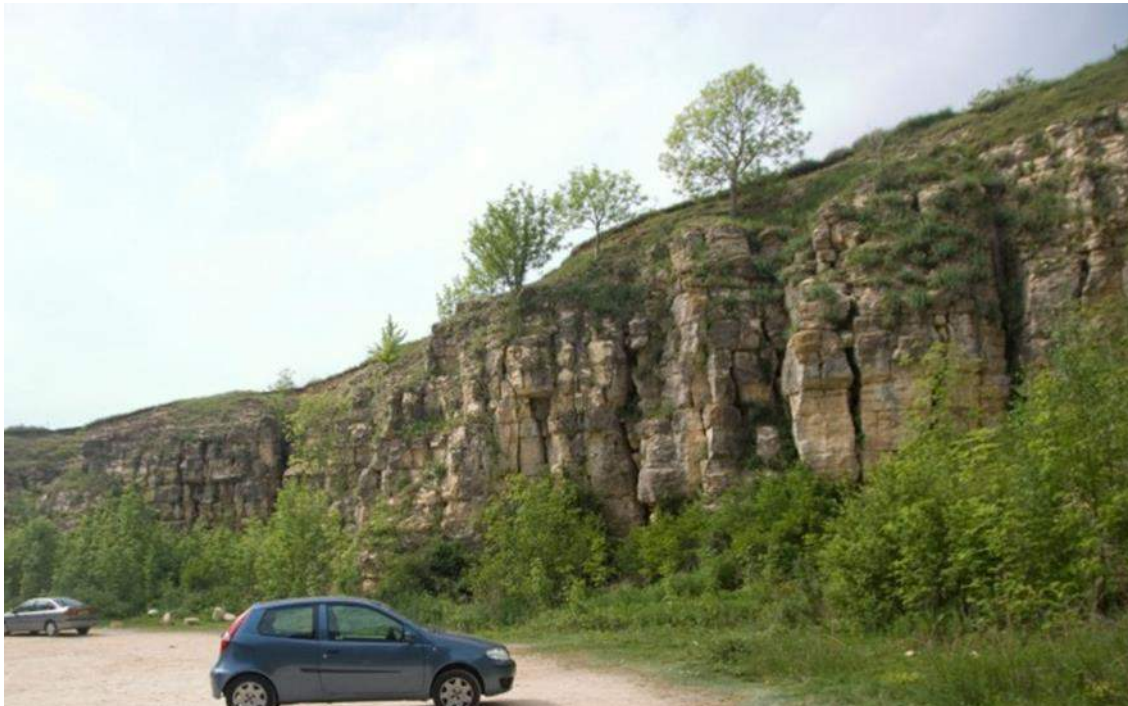
Photo 5.1: Salterley Quarry car park (Leckhampton Hill) - Good exposure of the Cleeve Cloud Member and a small section of the Crickley Member at the base

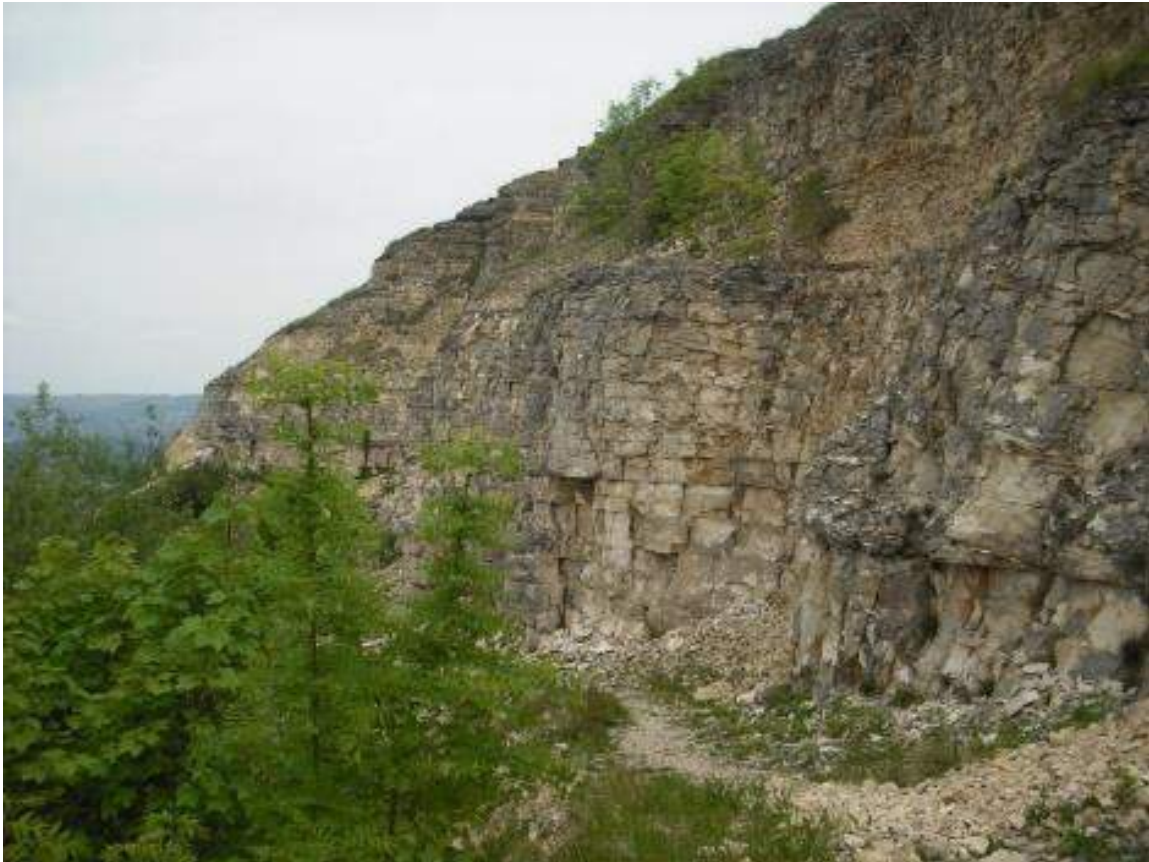
Photo 5.2: Dead Man's Quarry (Leckhampton Hill) – A sequence from the Mid Cleeve Cloud Member through to the Lower Trigonía Grit Member

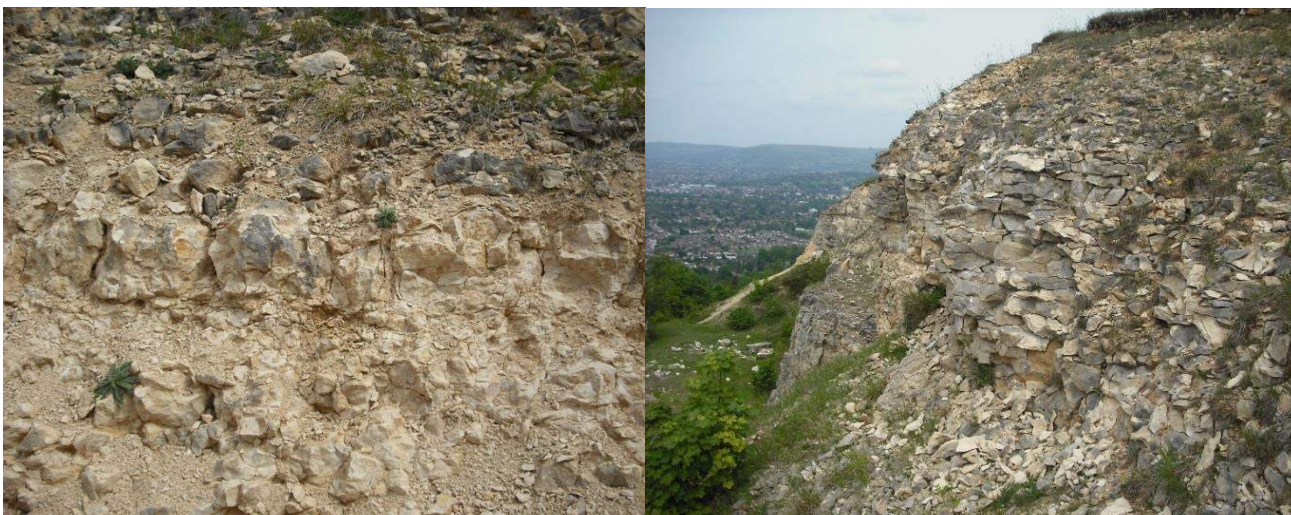
Photo 5.3: The upper part of Dead Man's Quarry (Leckhampton Hill) contains the base of the Lower Trigonía Grit Member of the Aston Limestone Formation

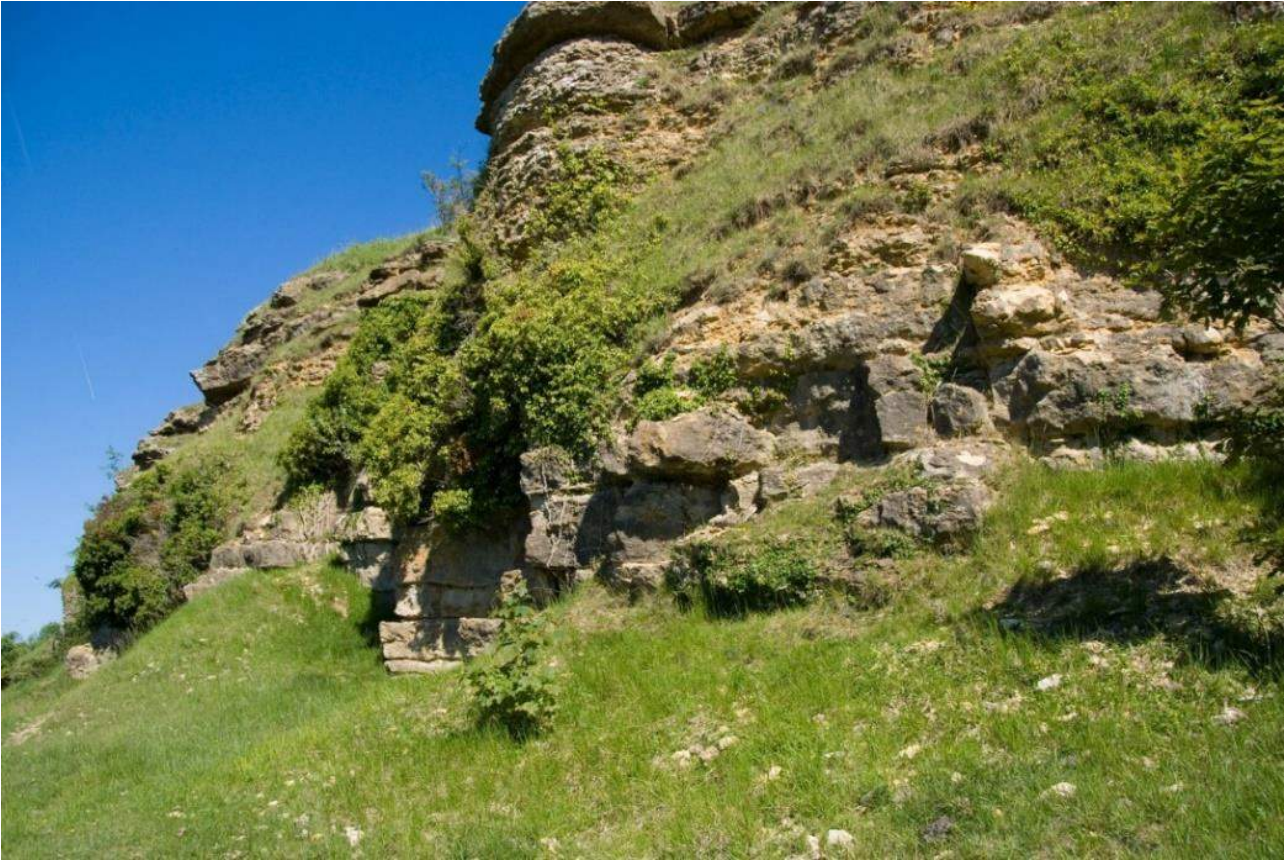
Photo 5.4: Crickley Hill – Crickley Member overlain by the Cleeve Cloud Member.

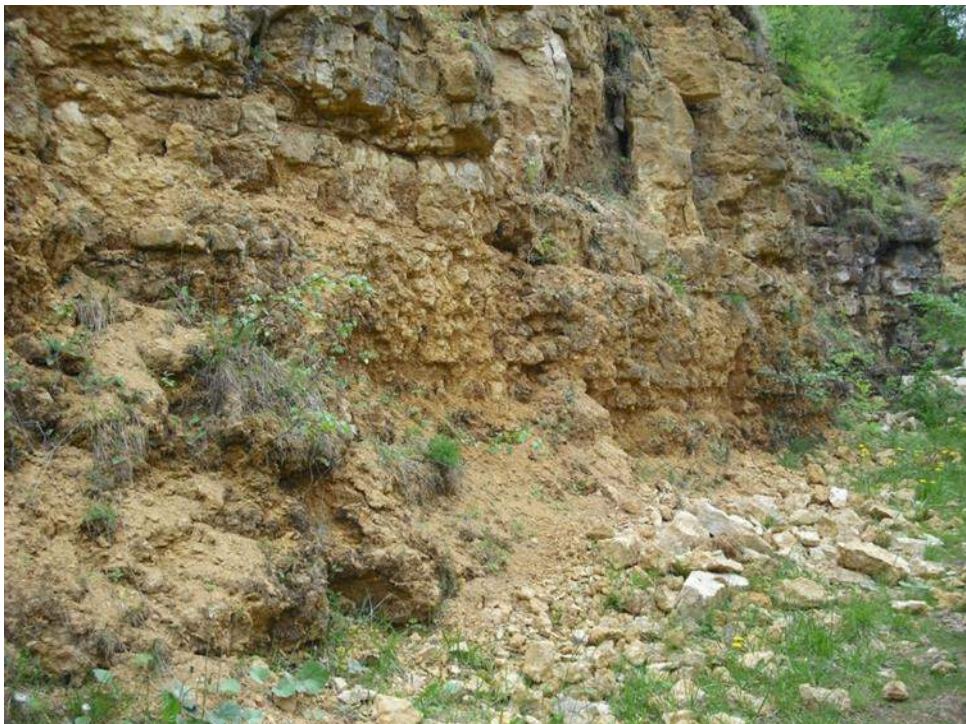
Photo 5.5: Lower Limekilns Quarry (Leckhampton Hill) – showing succession of the Leckhampton Member (base) overlain by Crickley Member.

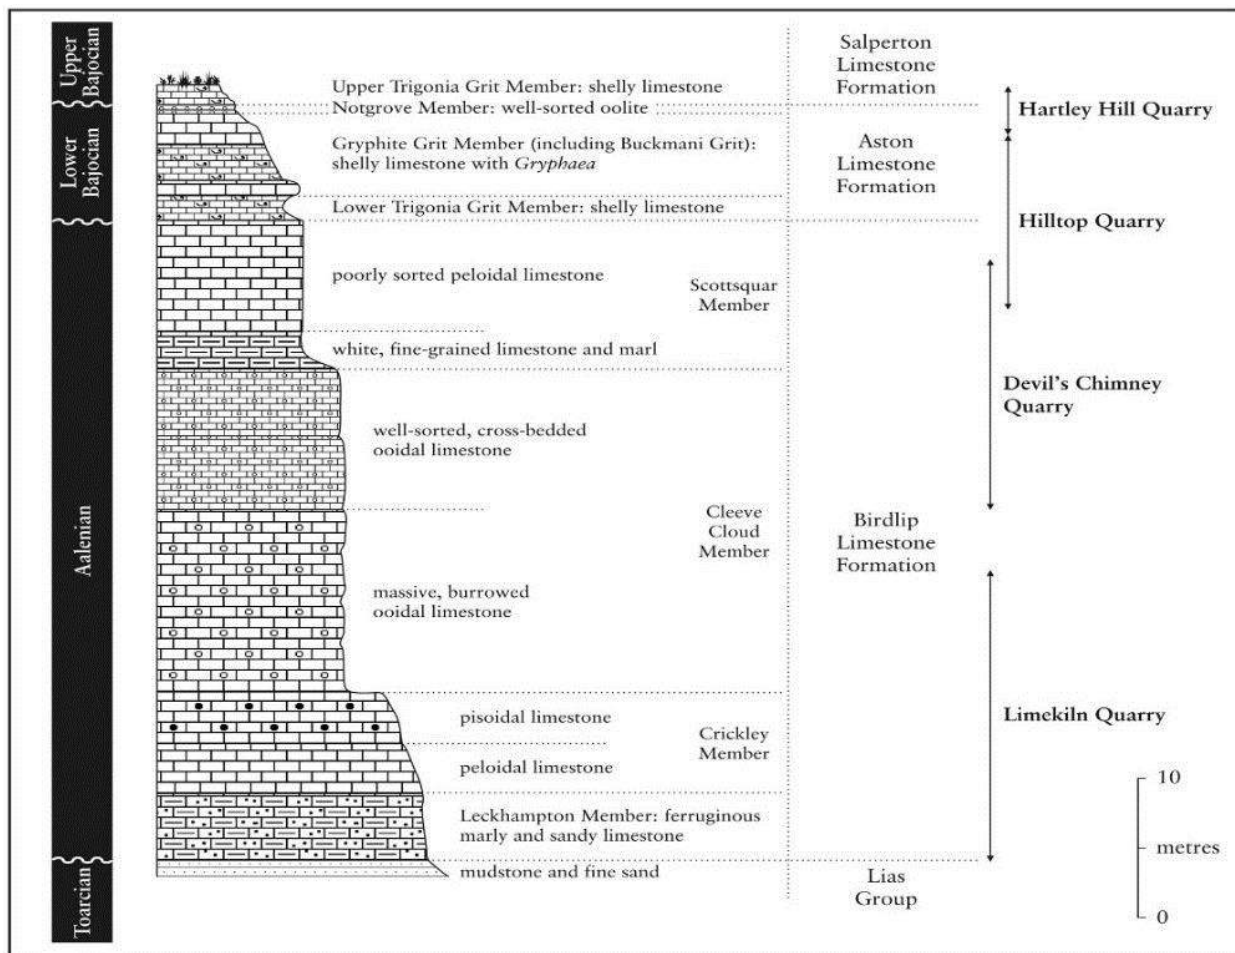
Figure 5.5: Recorded lithostratigraphy at Leckhampton Hill

5.4.39 At Leckhampton Hill the relative thicknesses of members have been detailed by some authors which provide an indication of the member thickness which could be present at Birdlip, see Figure 5.5.

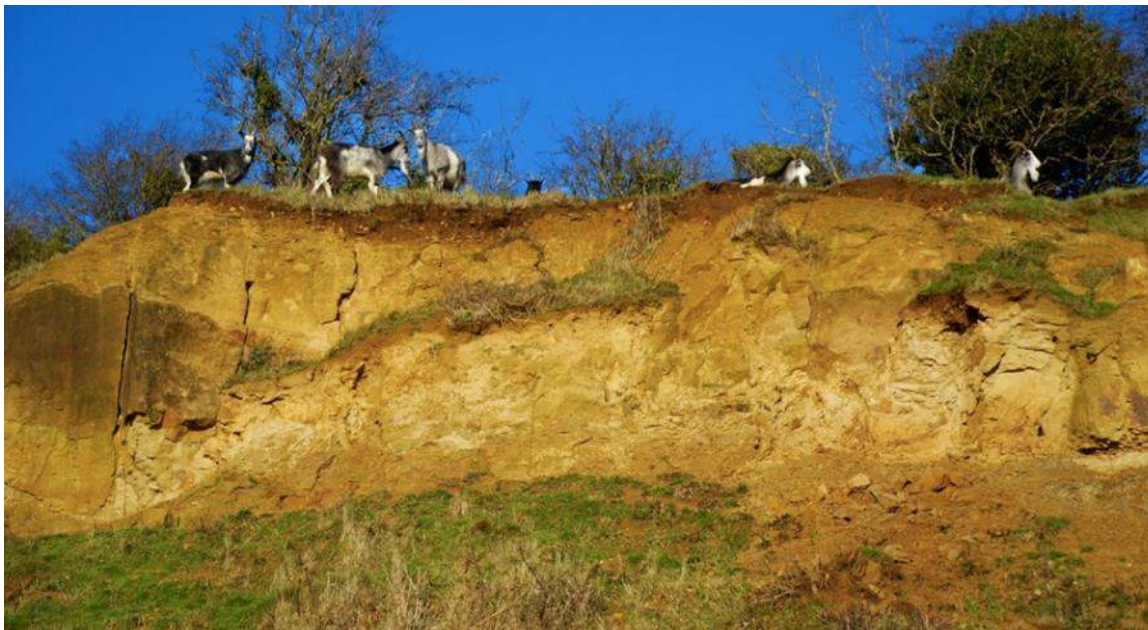
Photo 5.7 Marlstone Rock Formation underlain by the Dyrham Formation, Robins Wood Hill quarry
