A417 Missing Link  
TR010056

6.4 Environmental Statement  
Appendix 9.2 Preliminary  
Ground Investigation report

**6.4 Environmental Statement  
Appendix 9.2 Preliminary Ground Investigation report**

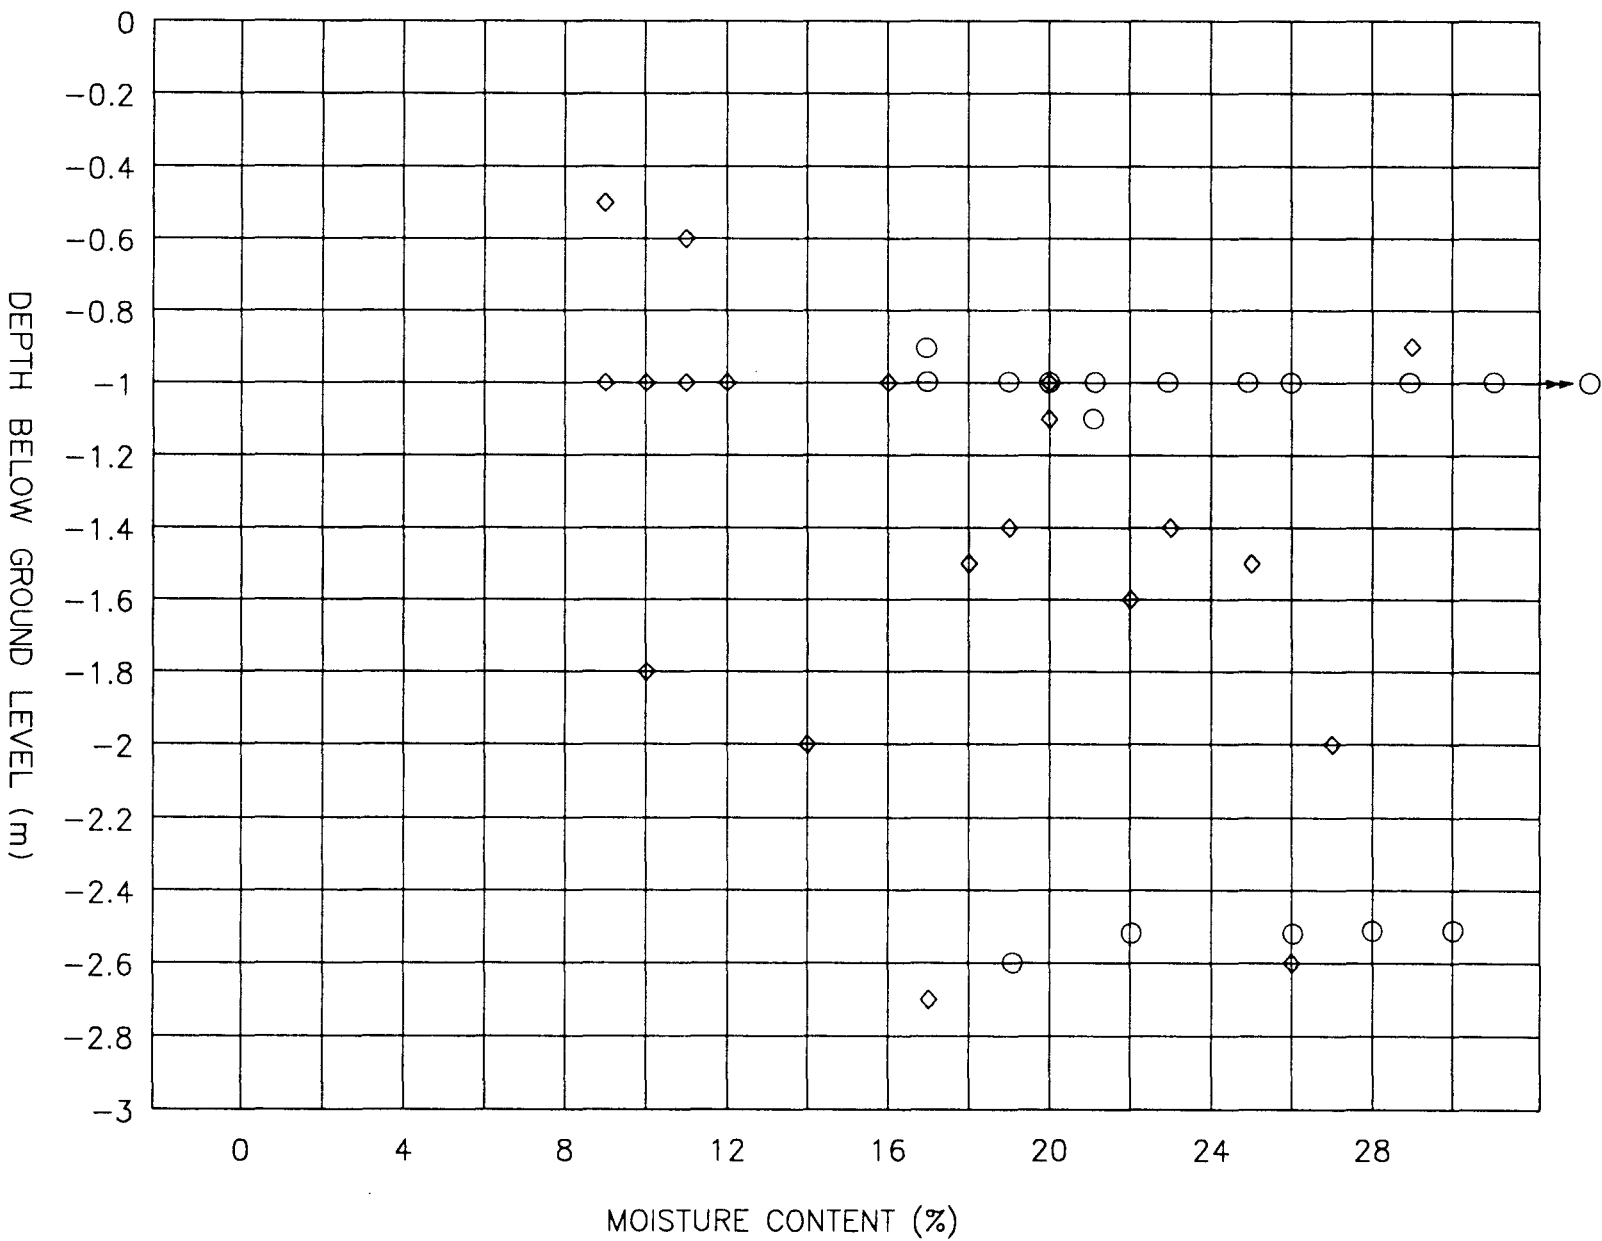
**FIGURE: F3.01**

- 5.8.10 Classification testing conducted on the CSG is presented is summarised below (refer to Appendix F, figures F3.01 to F3.04):
- Moisture content range of 9 to 29% with an average of approximately 22%

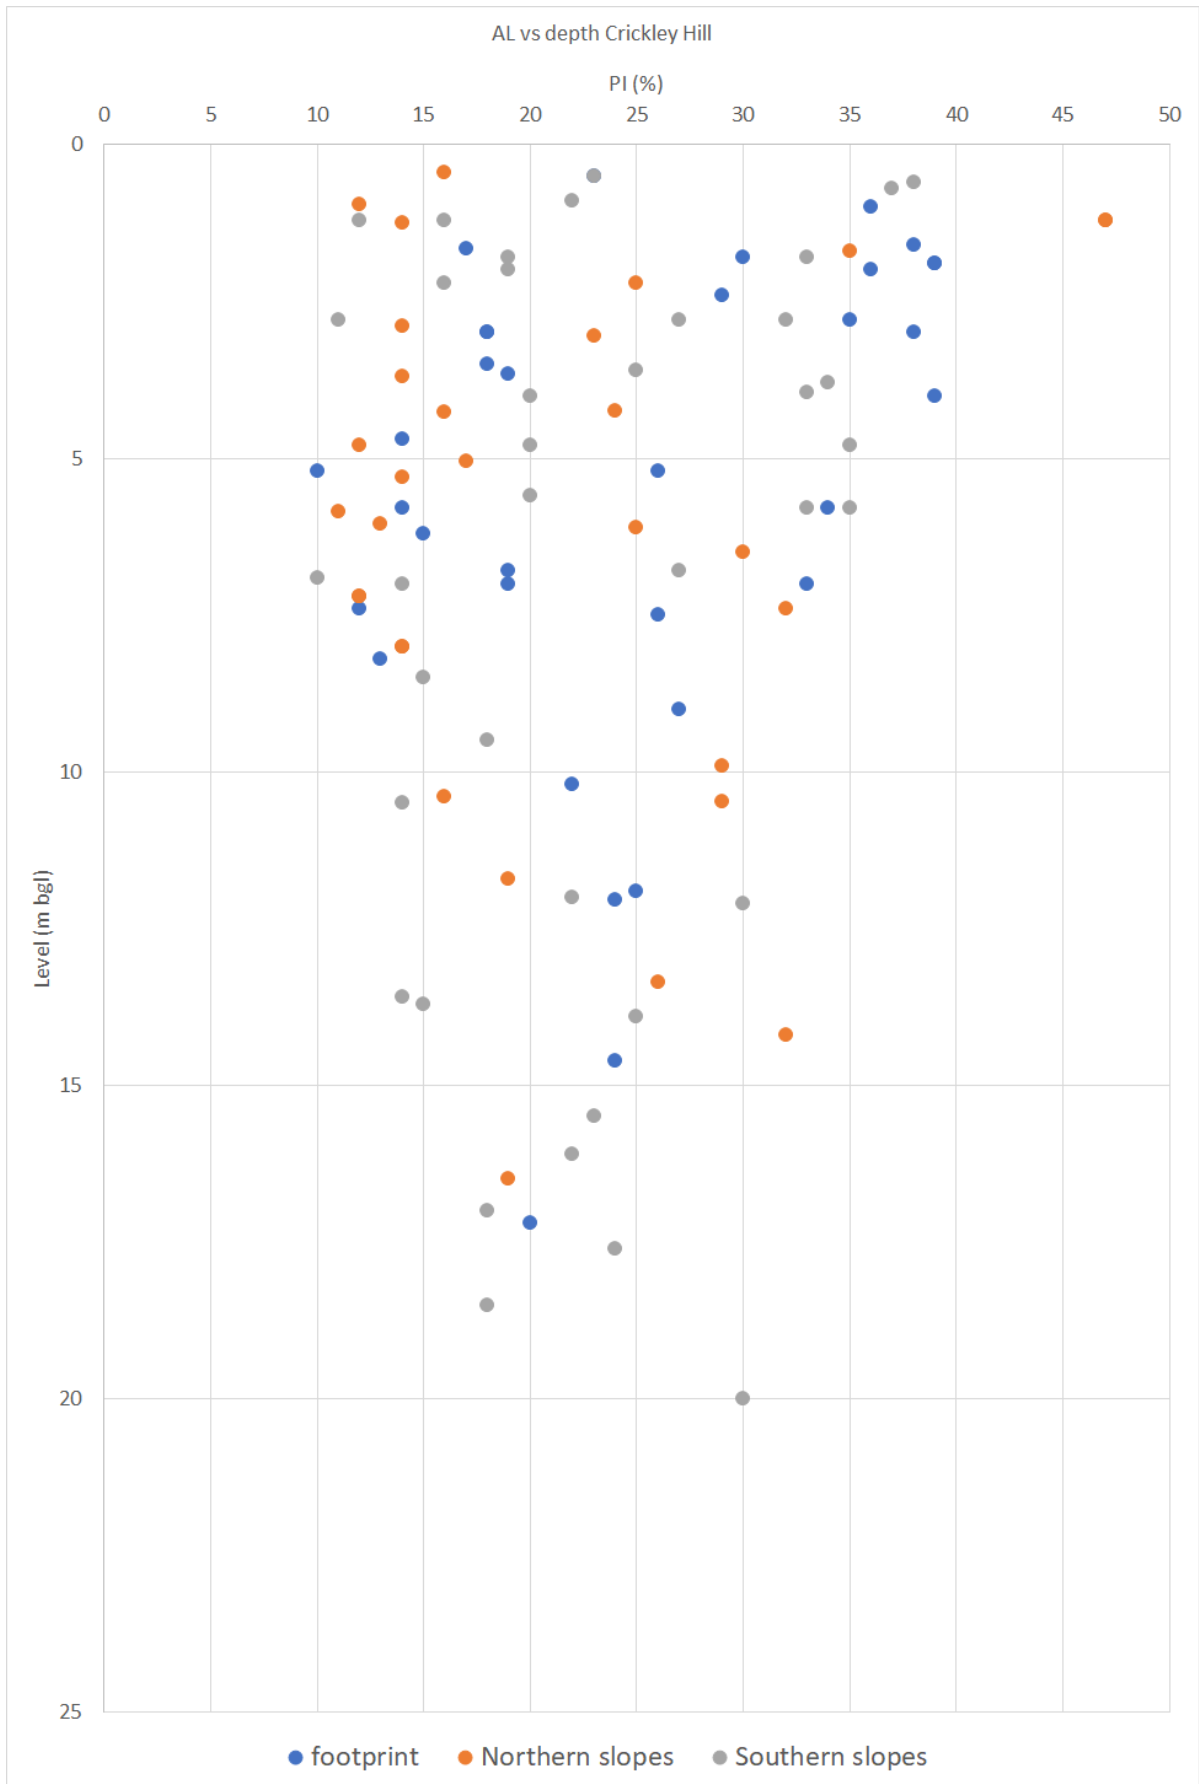
**FIGURE: F4A.03**

**A417 - MISSING LINK  
PLASTICITY INDEX  
MASS MOVEMENT DEPOSITS -  
CRICKLEY HILL**

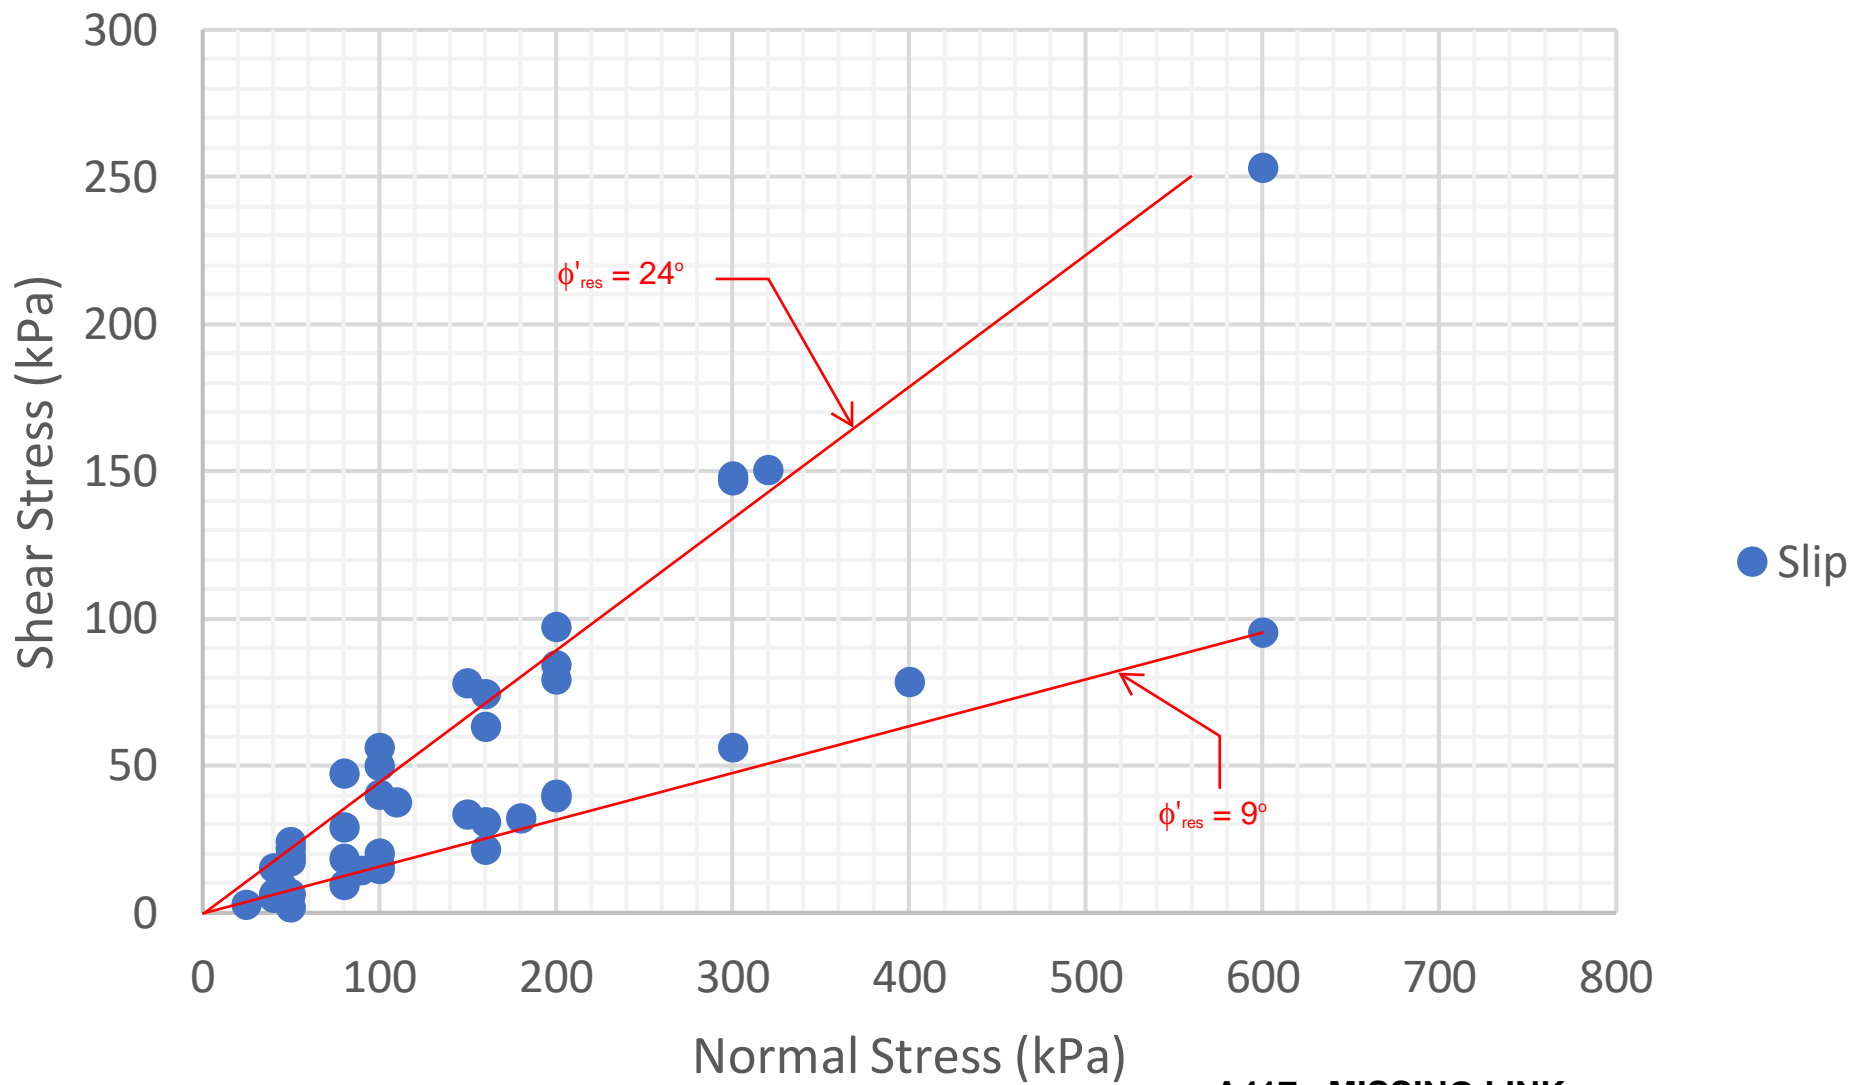
**A417 - MISSING LINK  
RING SHEAR RESULTS  
MASS MOVEMENT DEPOSITS -  
CRICKLEY HILL  
FIGURE: F4A.17**

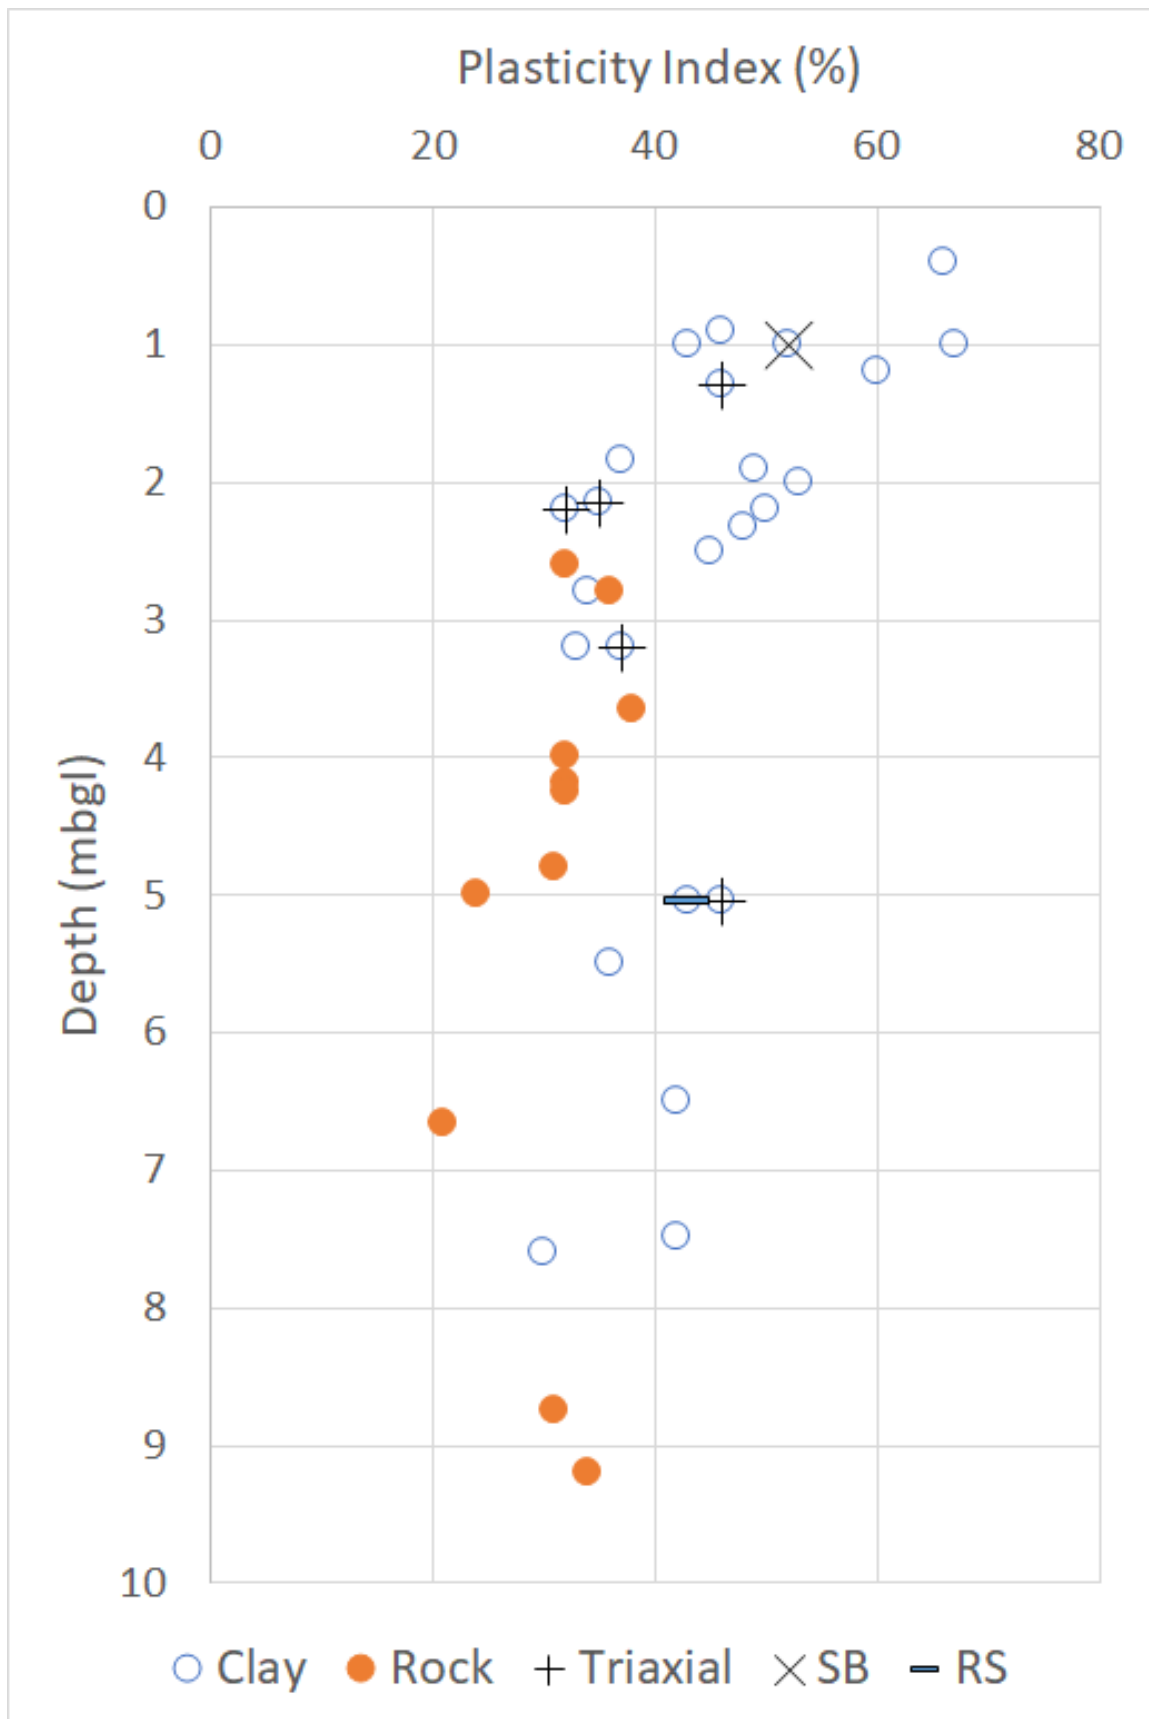
**FULLER'S EARTH FORMATION  
A417 - MISSING LINK  
PLASTICITY INDEX  
FIGURE: F7.07**

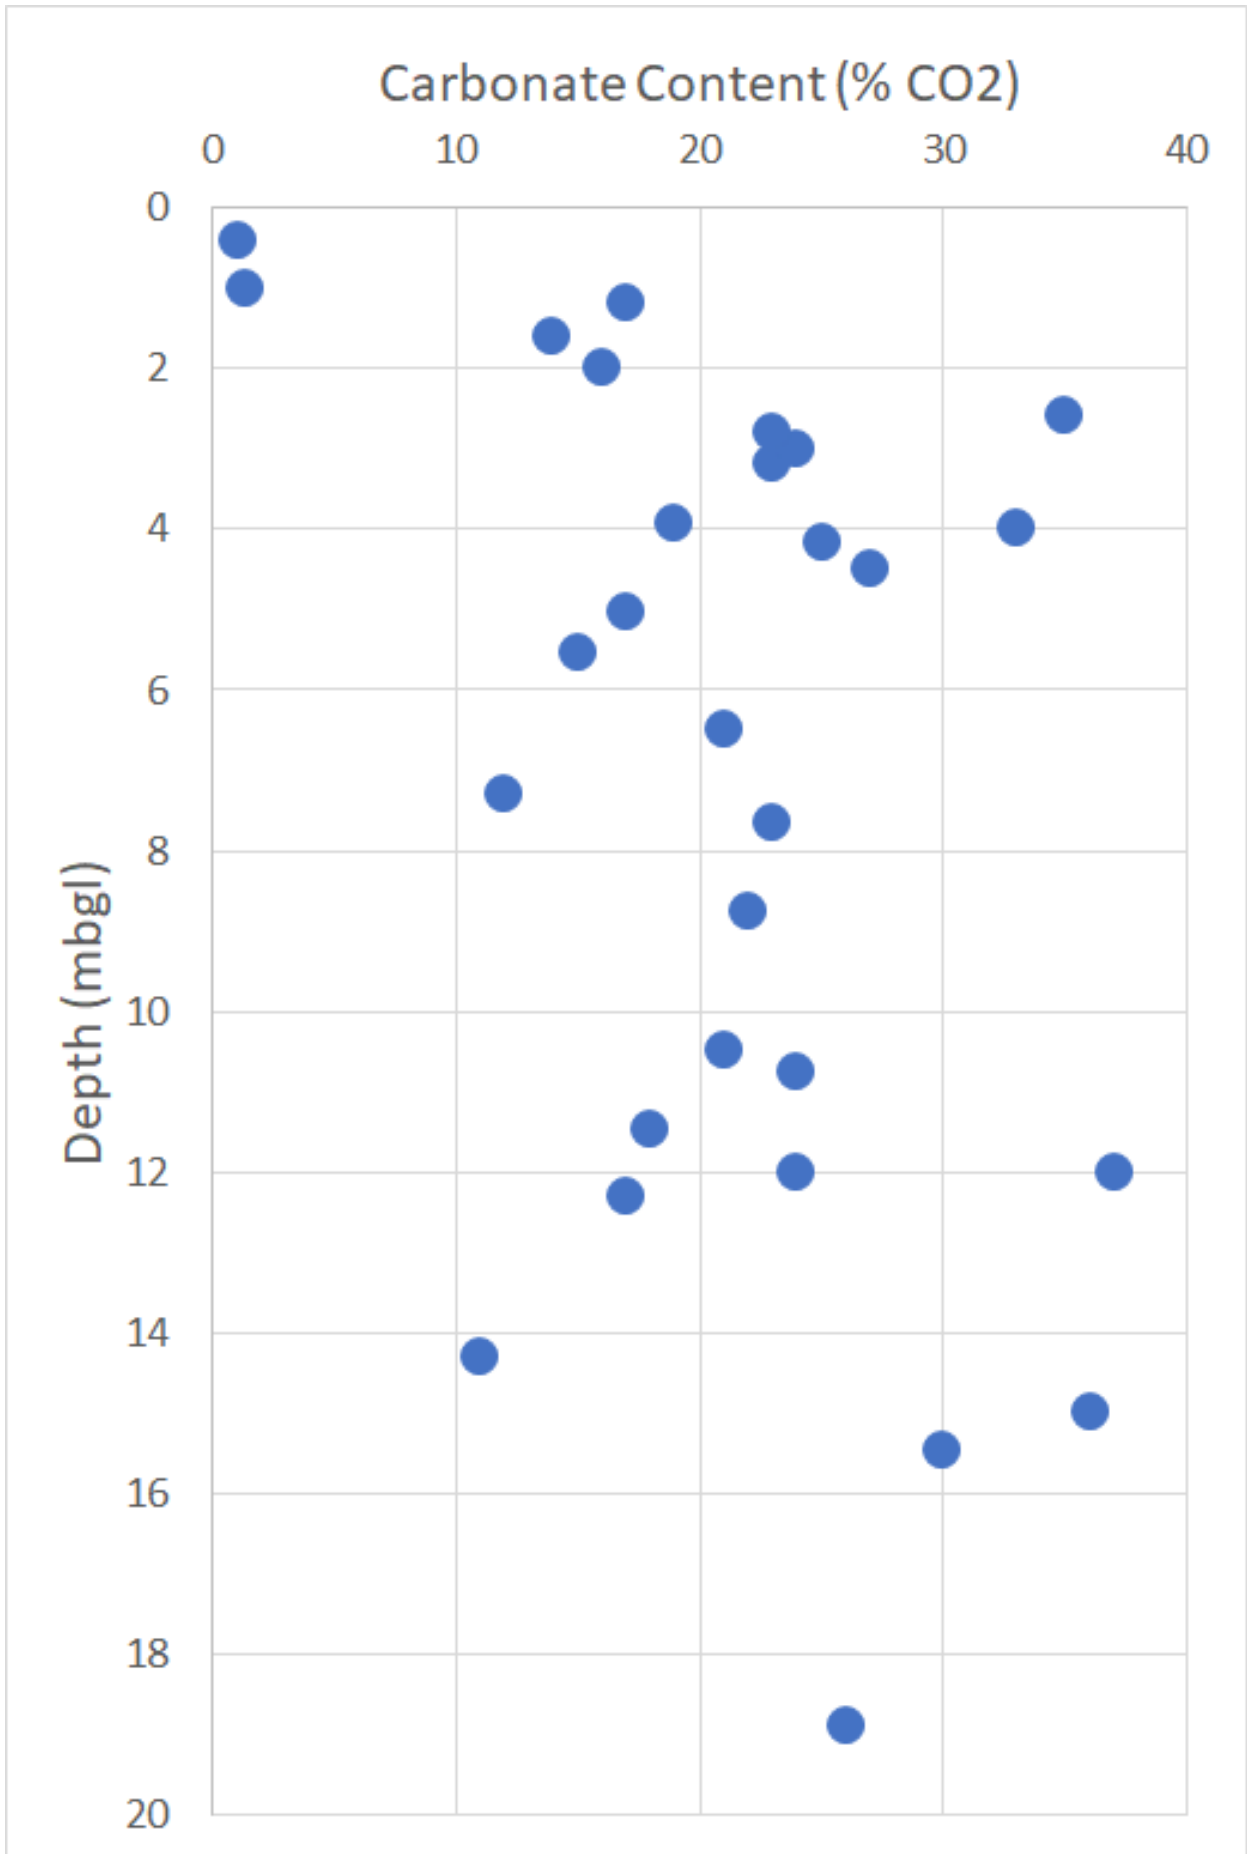
**FULLER'S EARTH FORMATION  
A417 - MISSING LINK  
CARBONATE CONTENT  
FIGURE: F7.10**

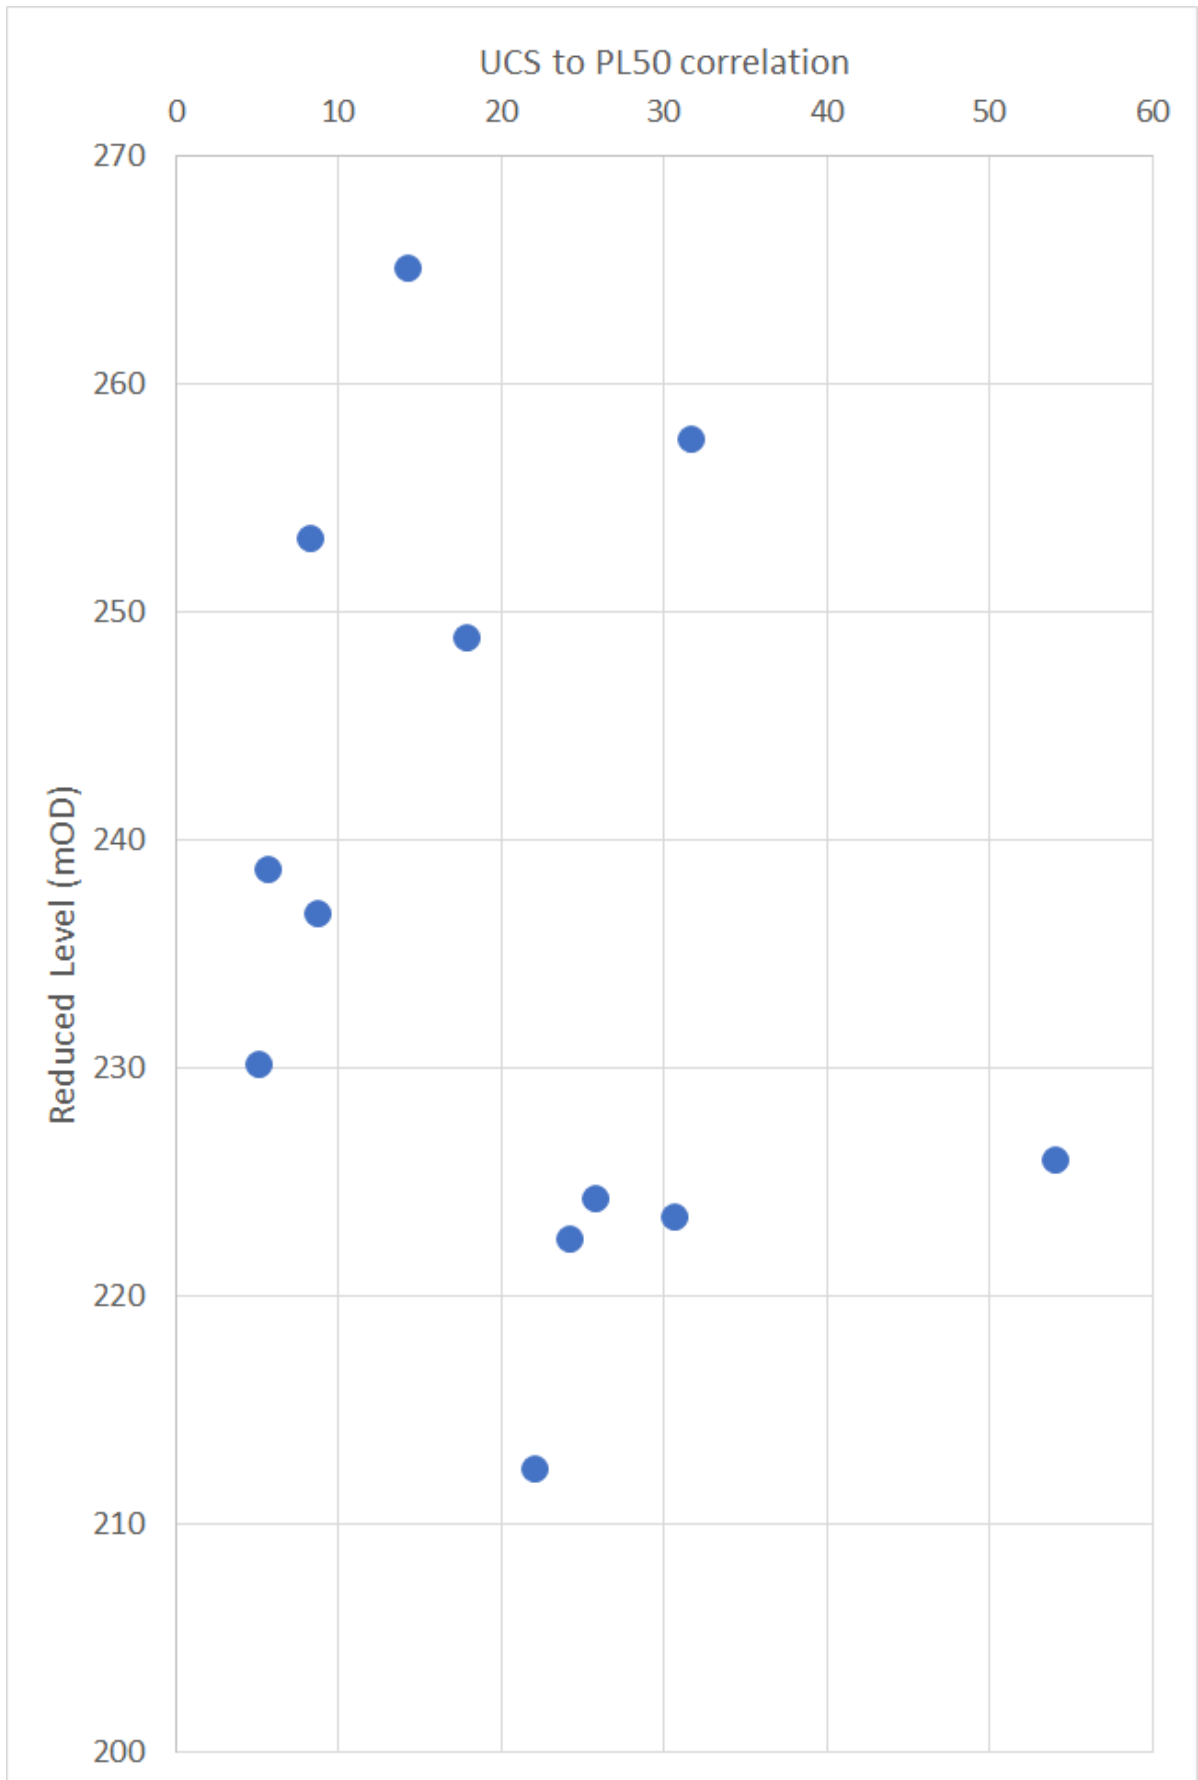
**A417 - MISSING LINK  
UCS TO PL50 CORRELATION  
INFERIOR OOLITE GROUP**

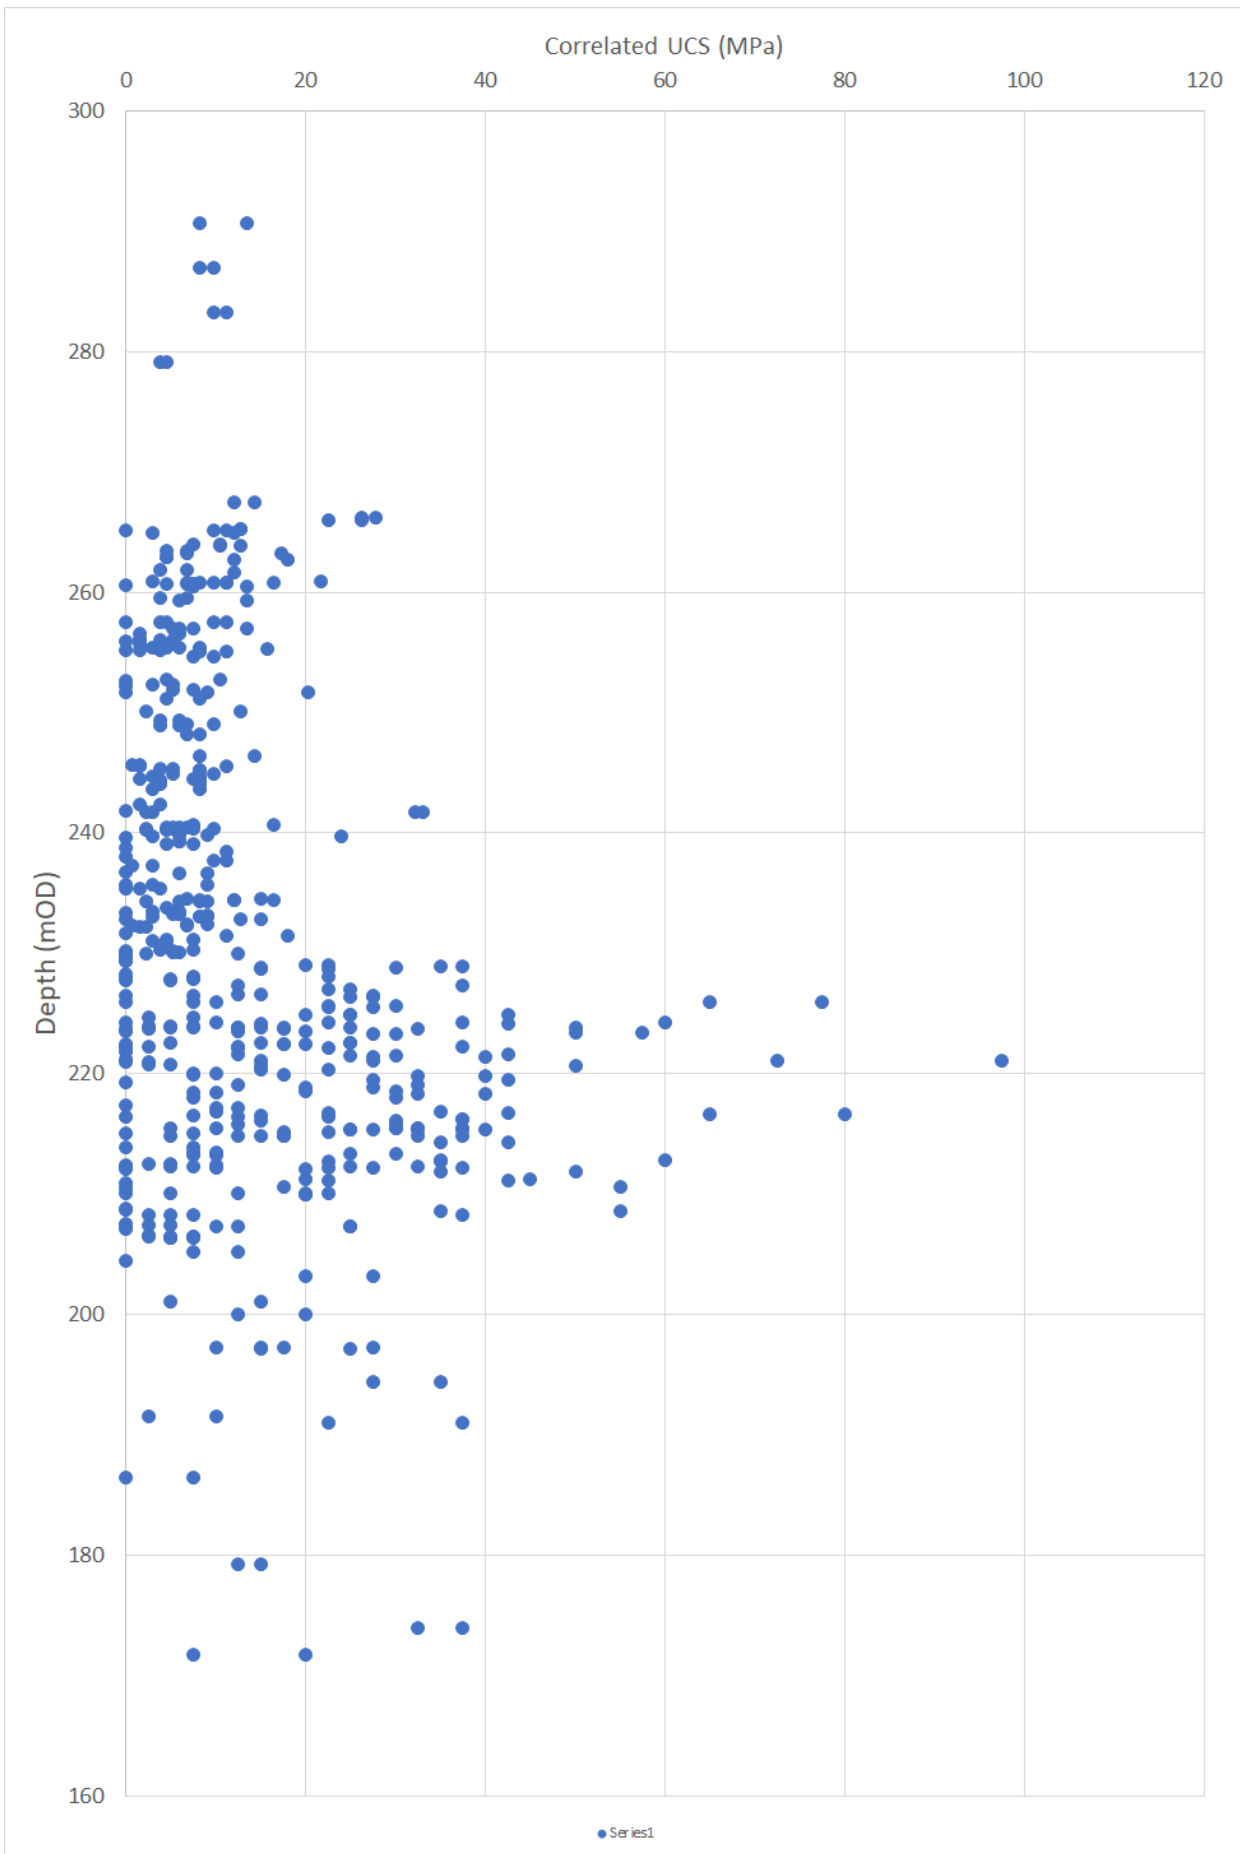
**A417 - MISSING LINK  
UCS FROM UCS/POINT LOAD  
CORRELATION  
INFERIOR OOLITE GROUP**

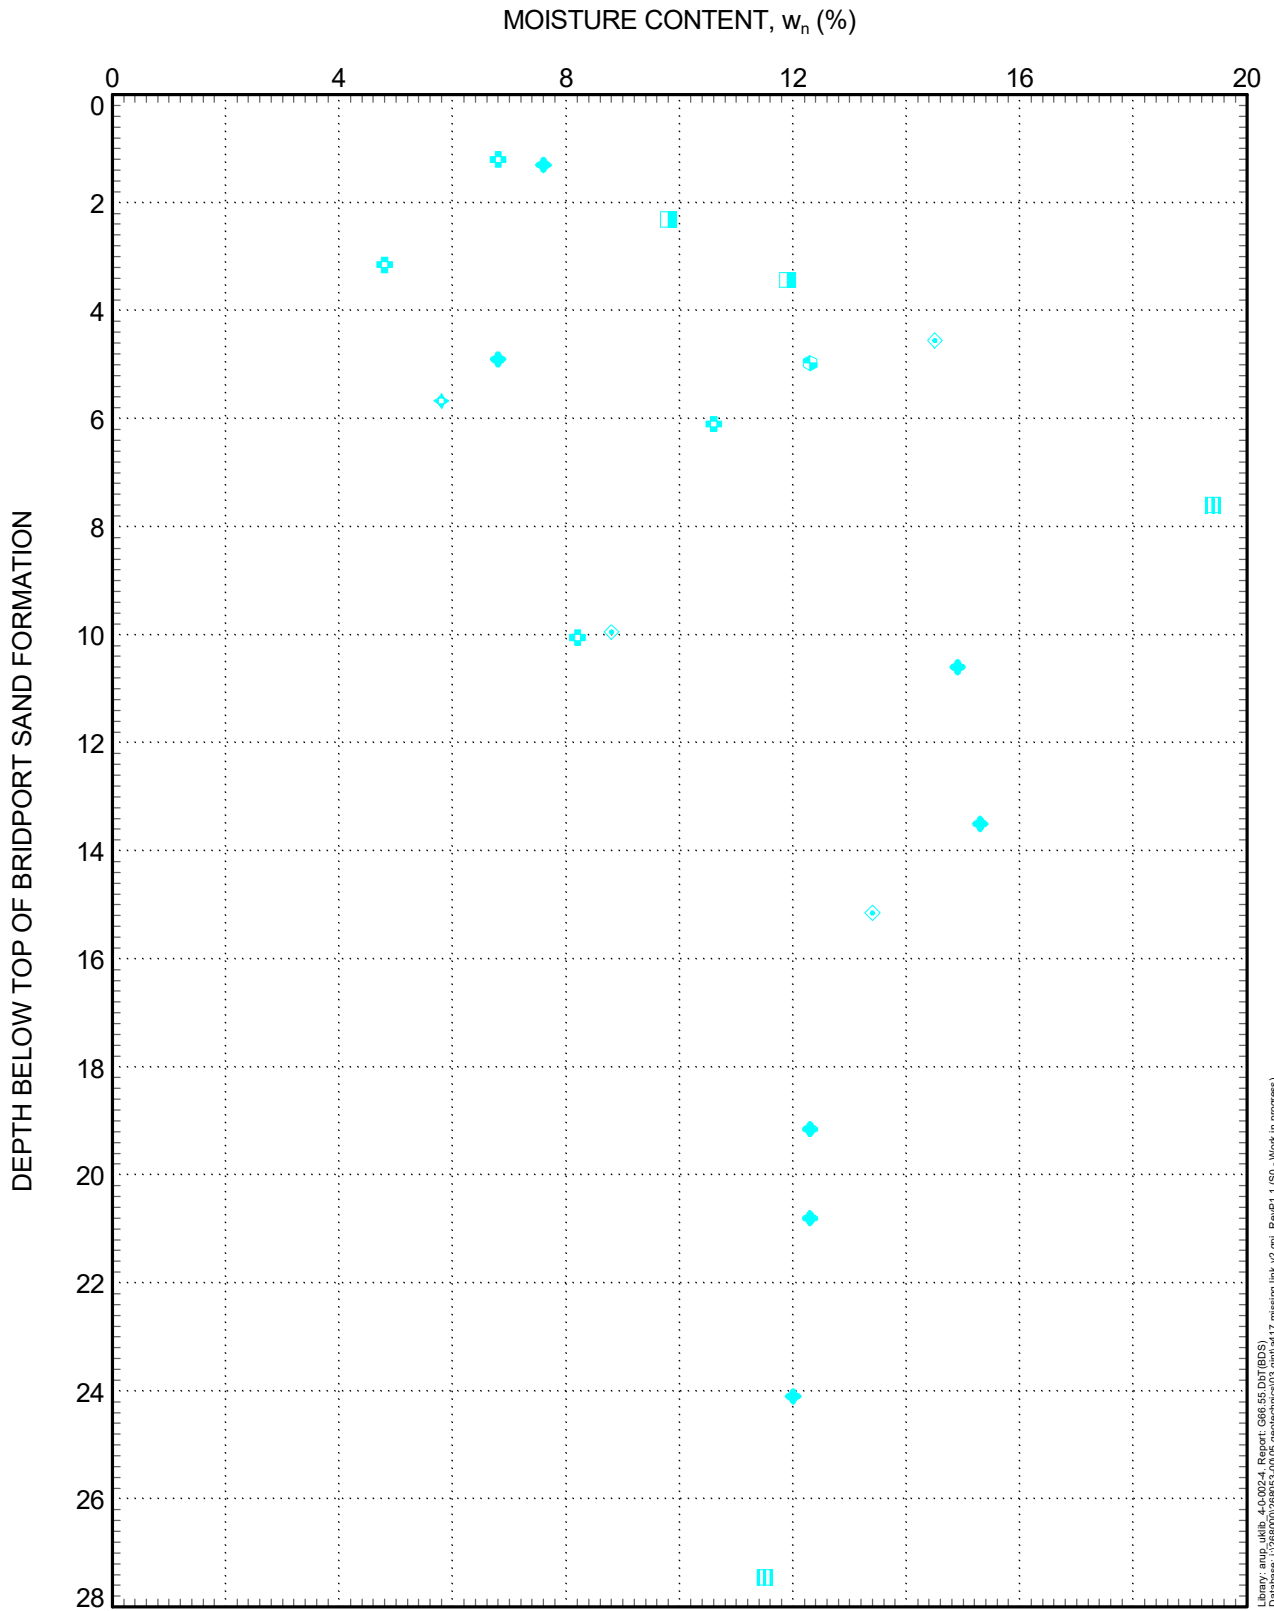
**A417 - MISSING LINK  
ROCK MOISTURE CONTENT  
BRIDPORT SAND FORMATION**

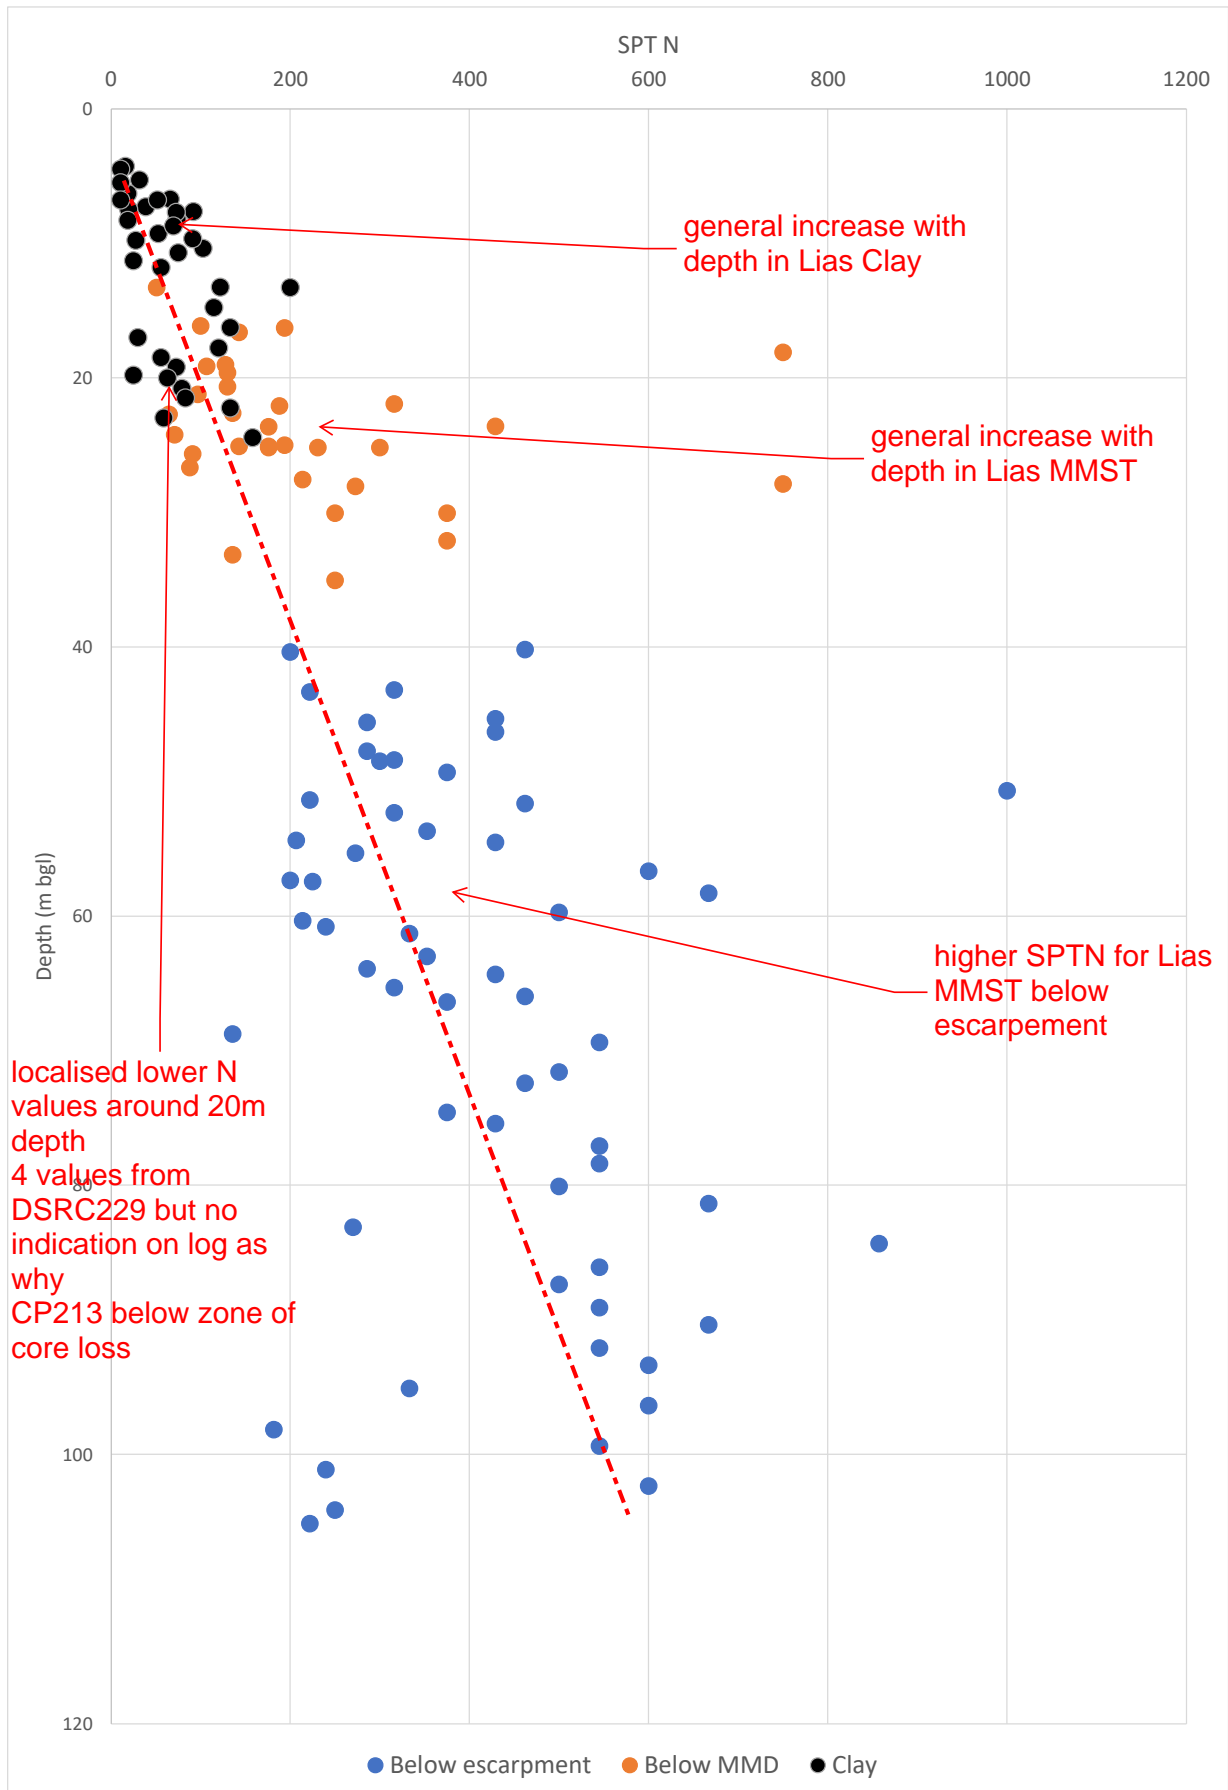
**A417 MISSING LINK  
STANDARD PENETRATION TEST  
WITH DEPTH  
LIAS GROUP**

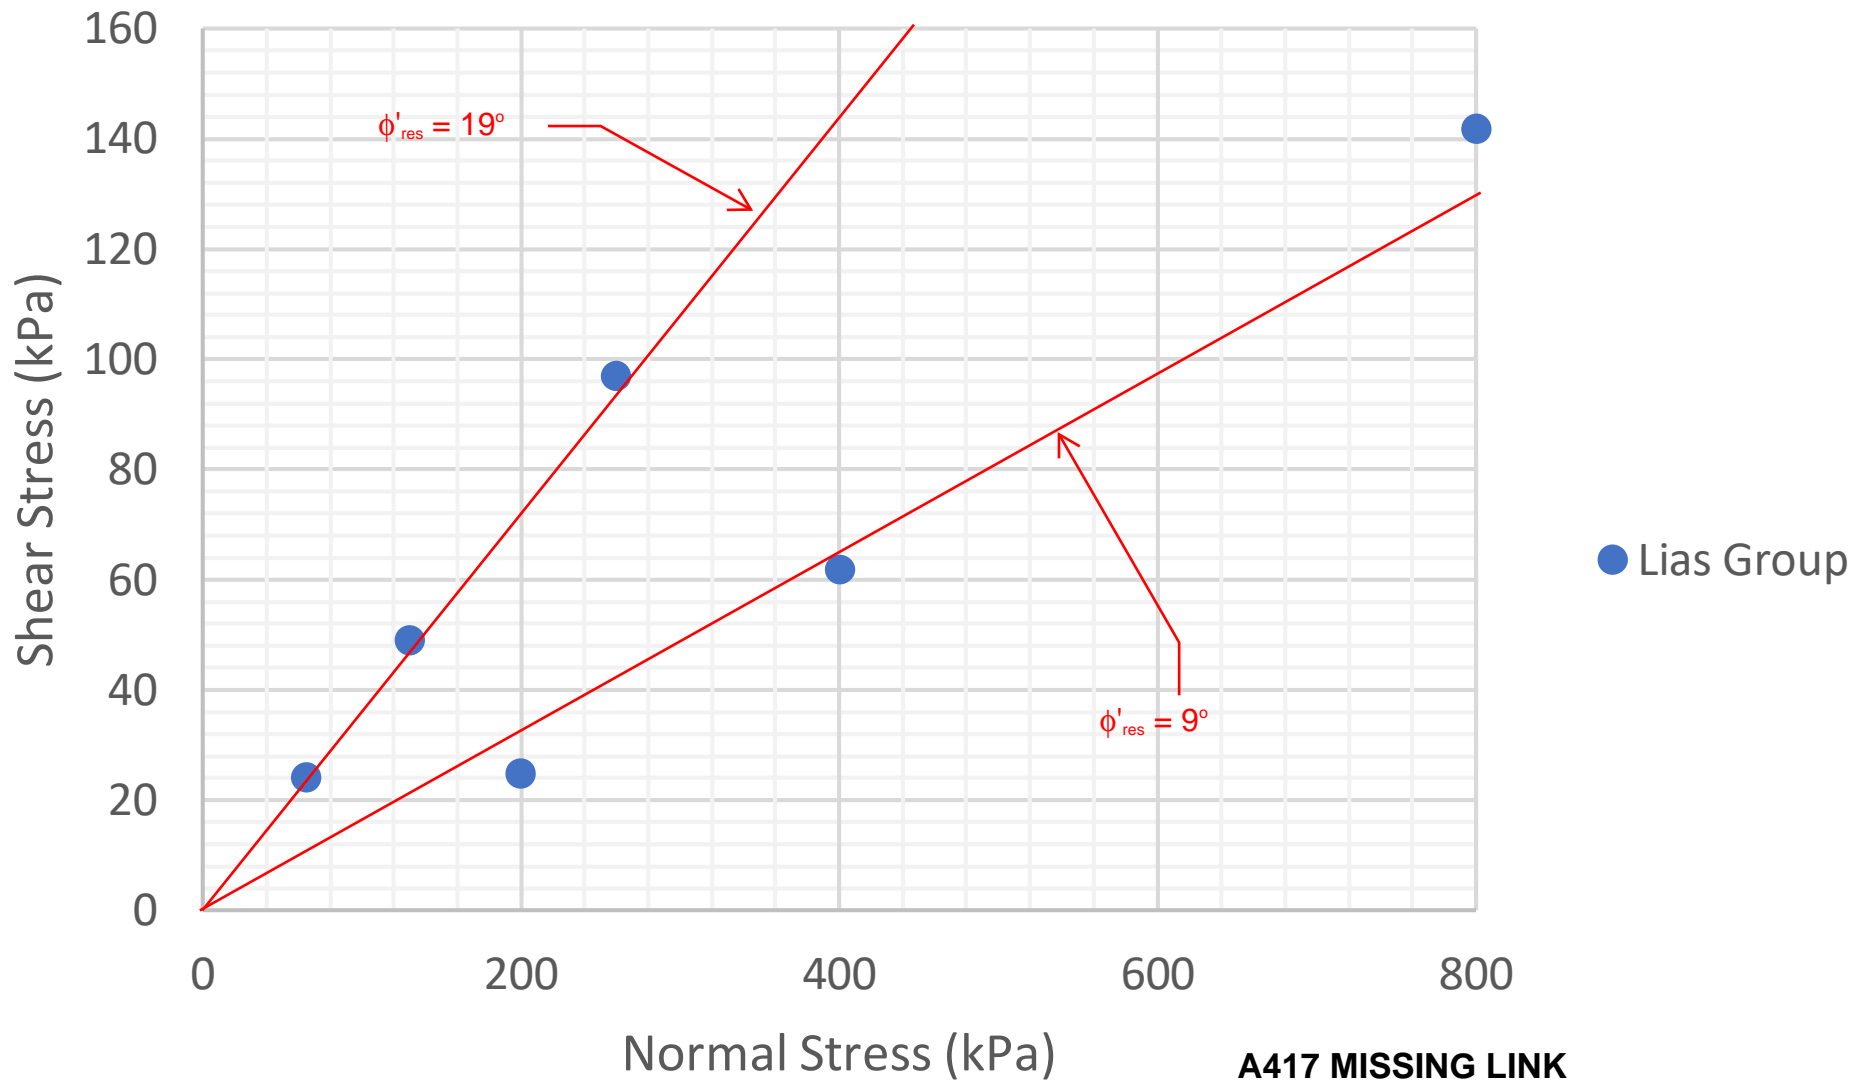
**A417 MISSING LINK  
RING SHEAR RESULTS  
LIAS GROUP**
