A417 Missing Link
TR010056

6.4 Environmental Statement
Appendix 9.3 Ground Investigation
Factual Report
Part 2 of 5

**REPORT ON THE
GEOPHYSICAL LOGGING
OF
SEVENTEEN BOREHOLES
AT
THE A417
BIRDLIP**

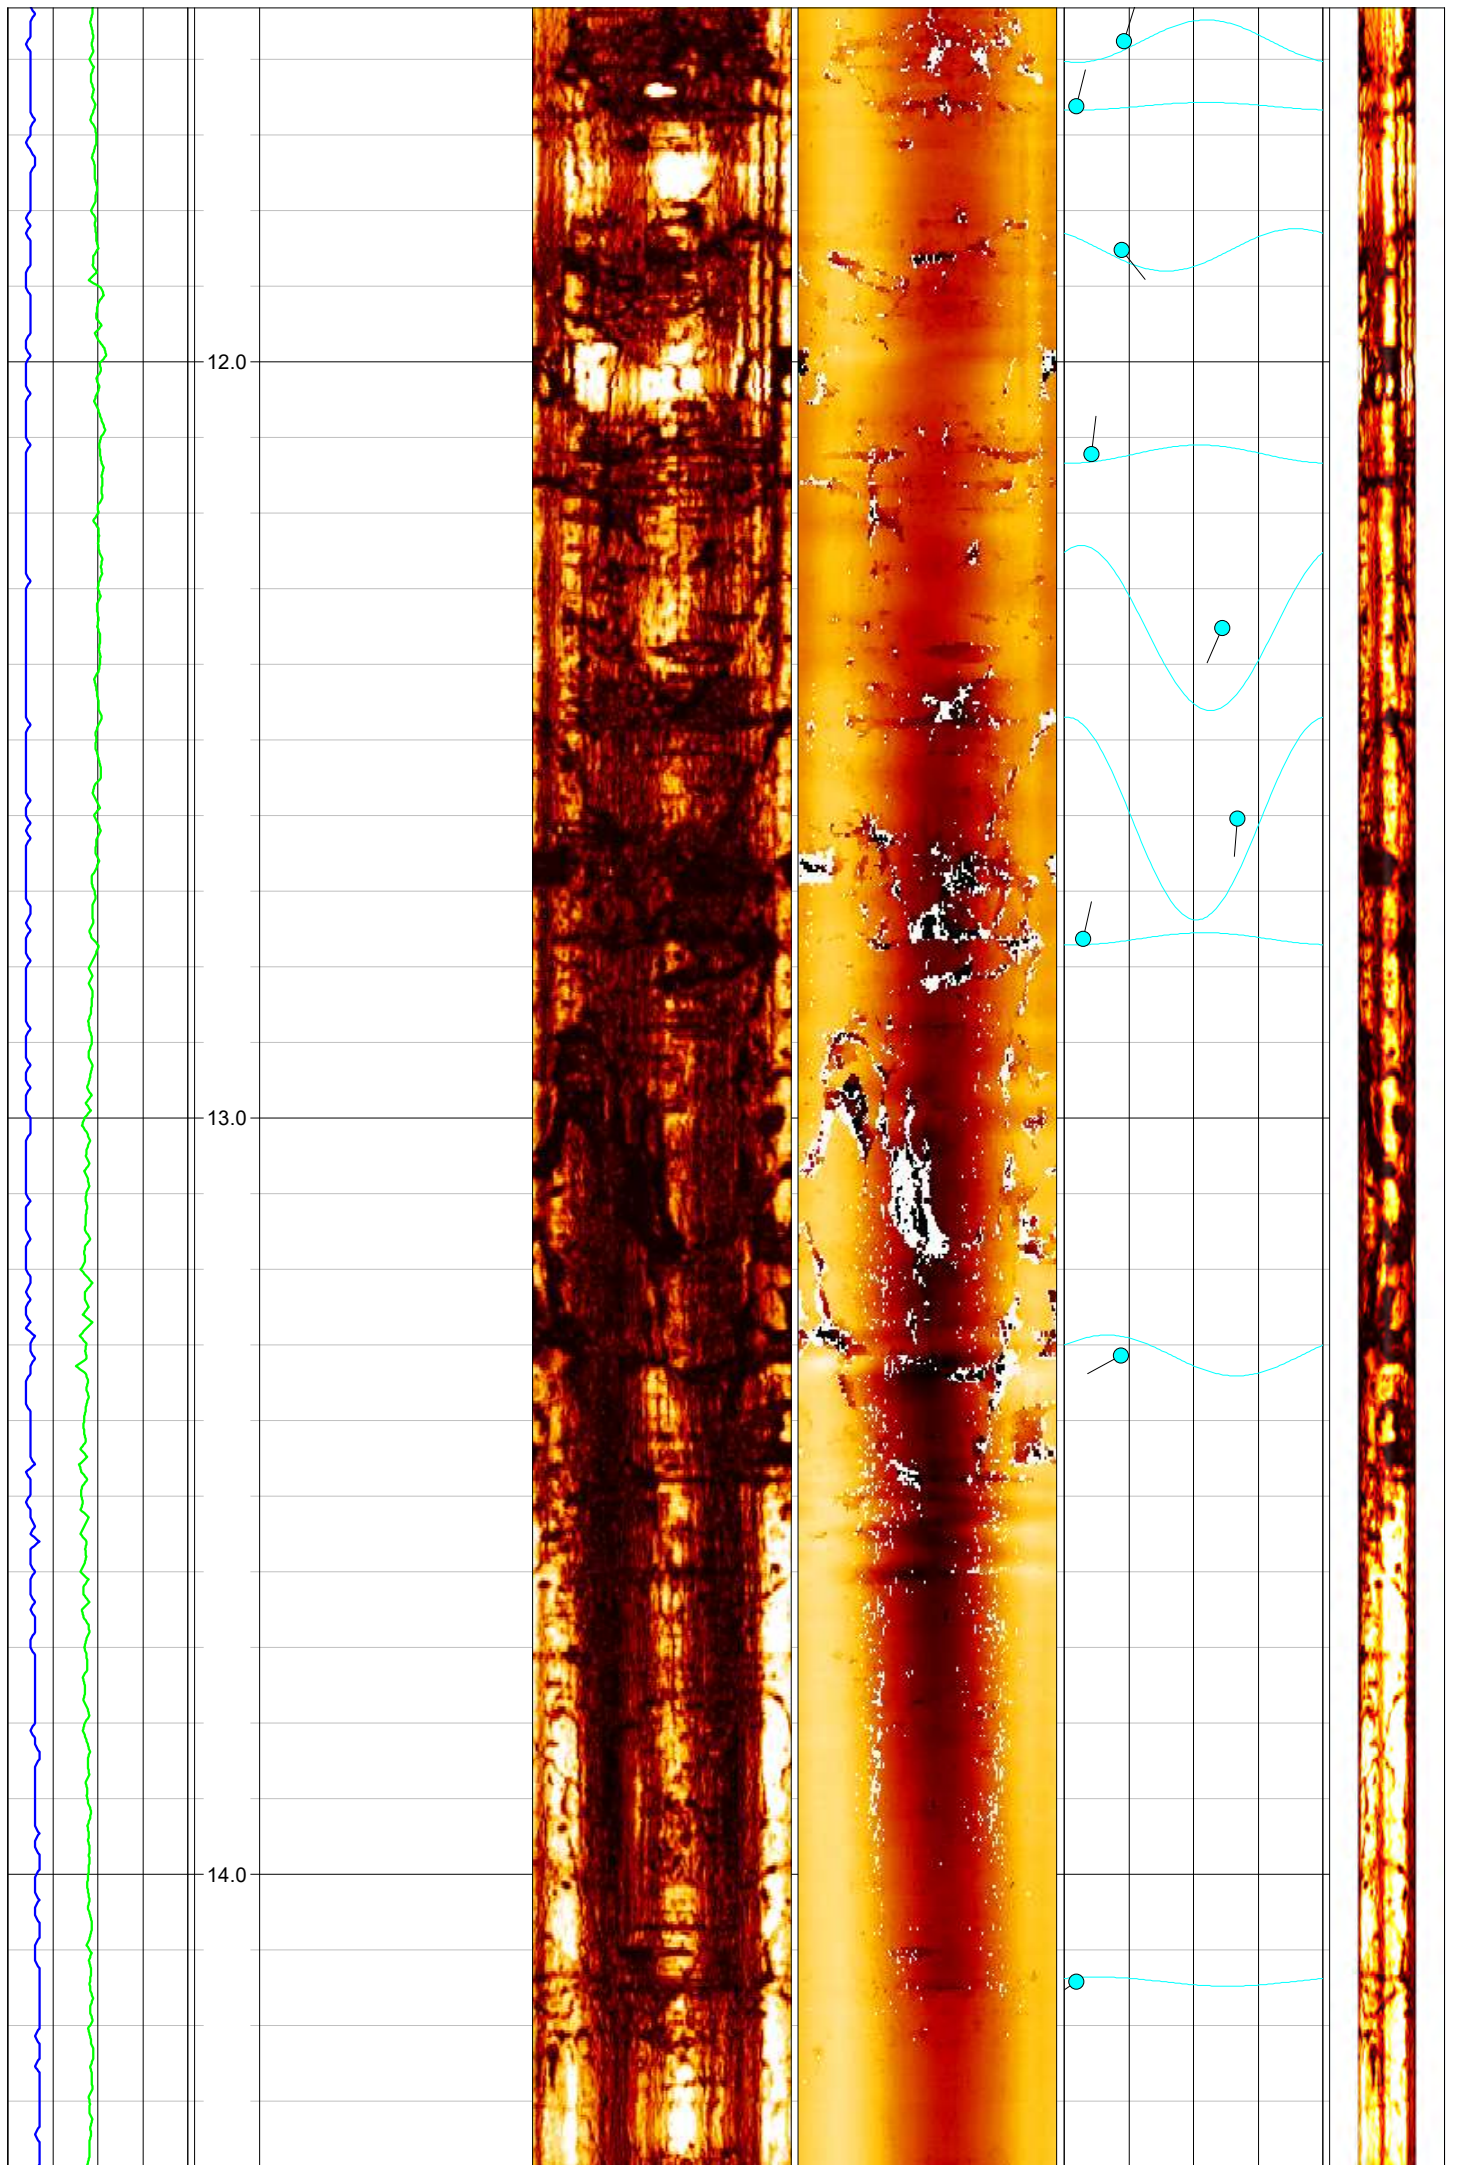
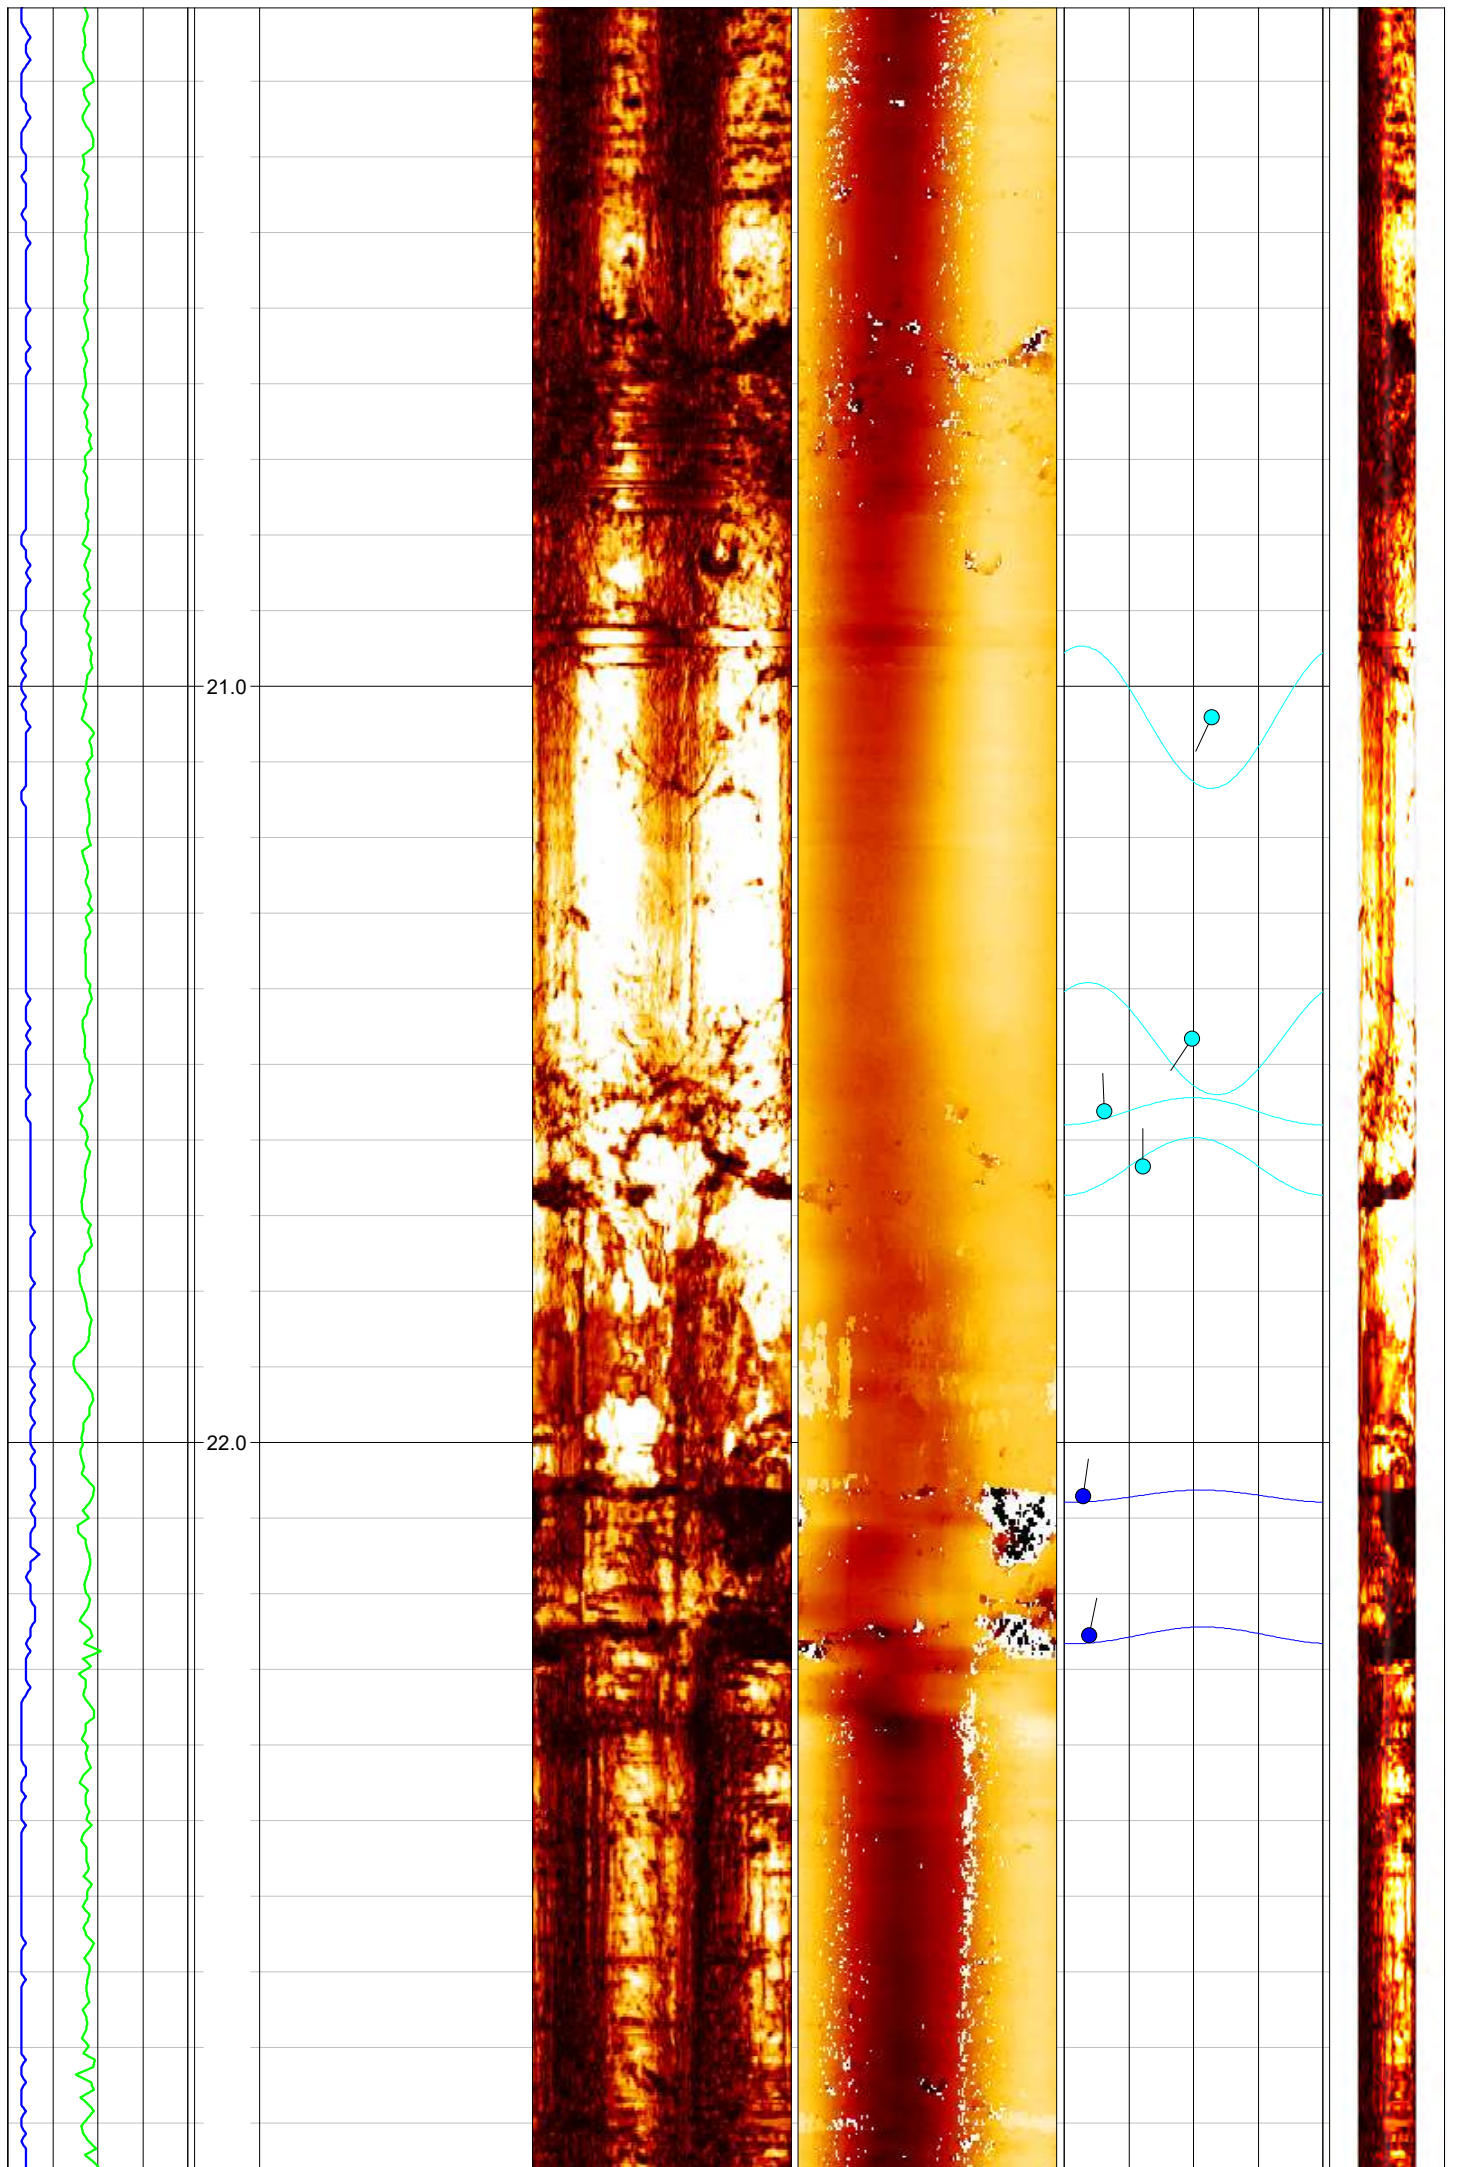
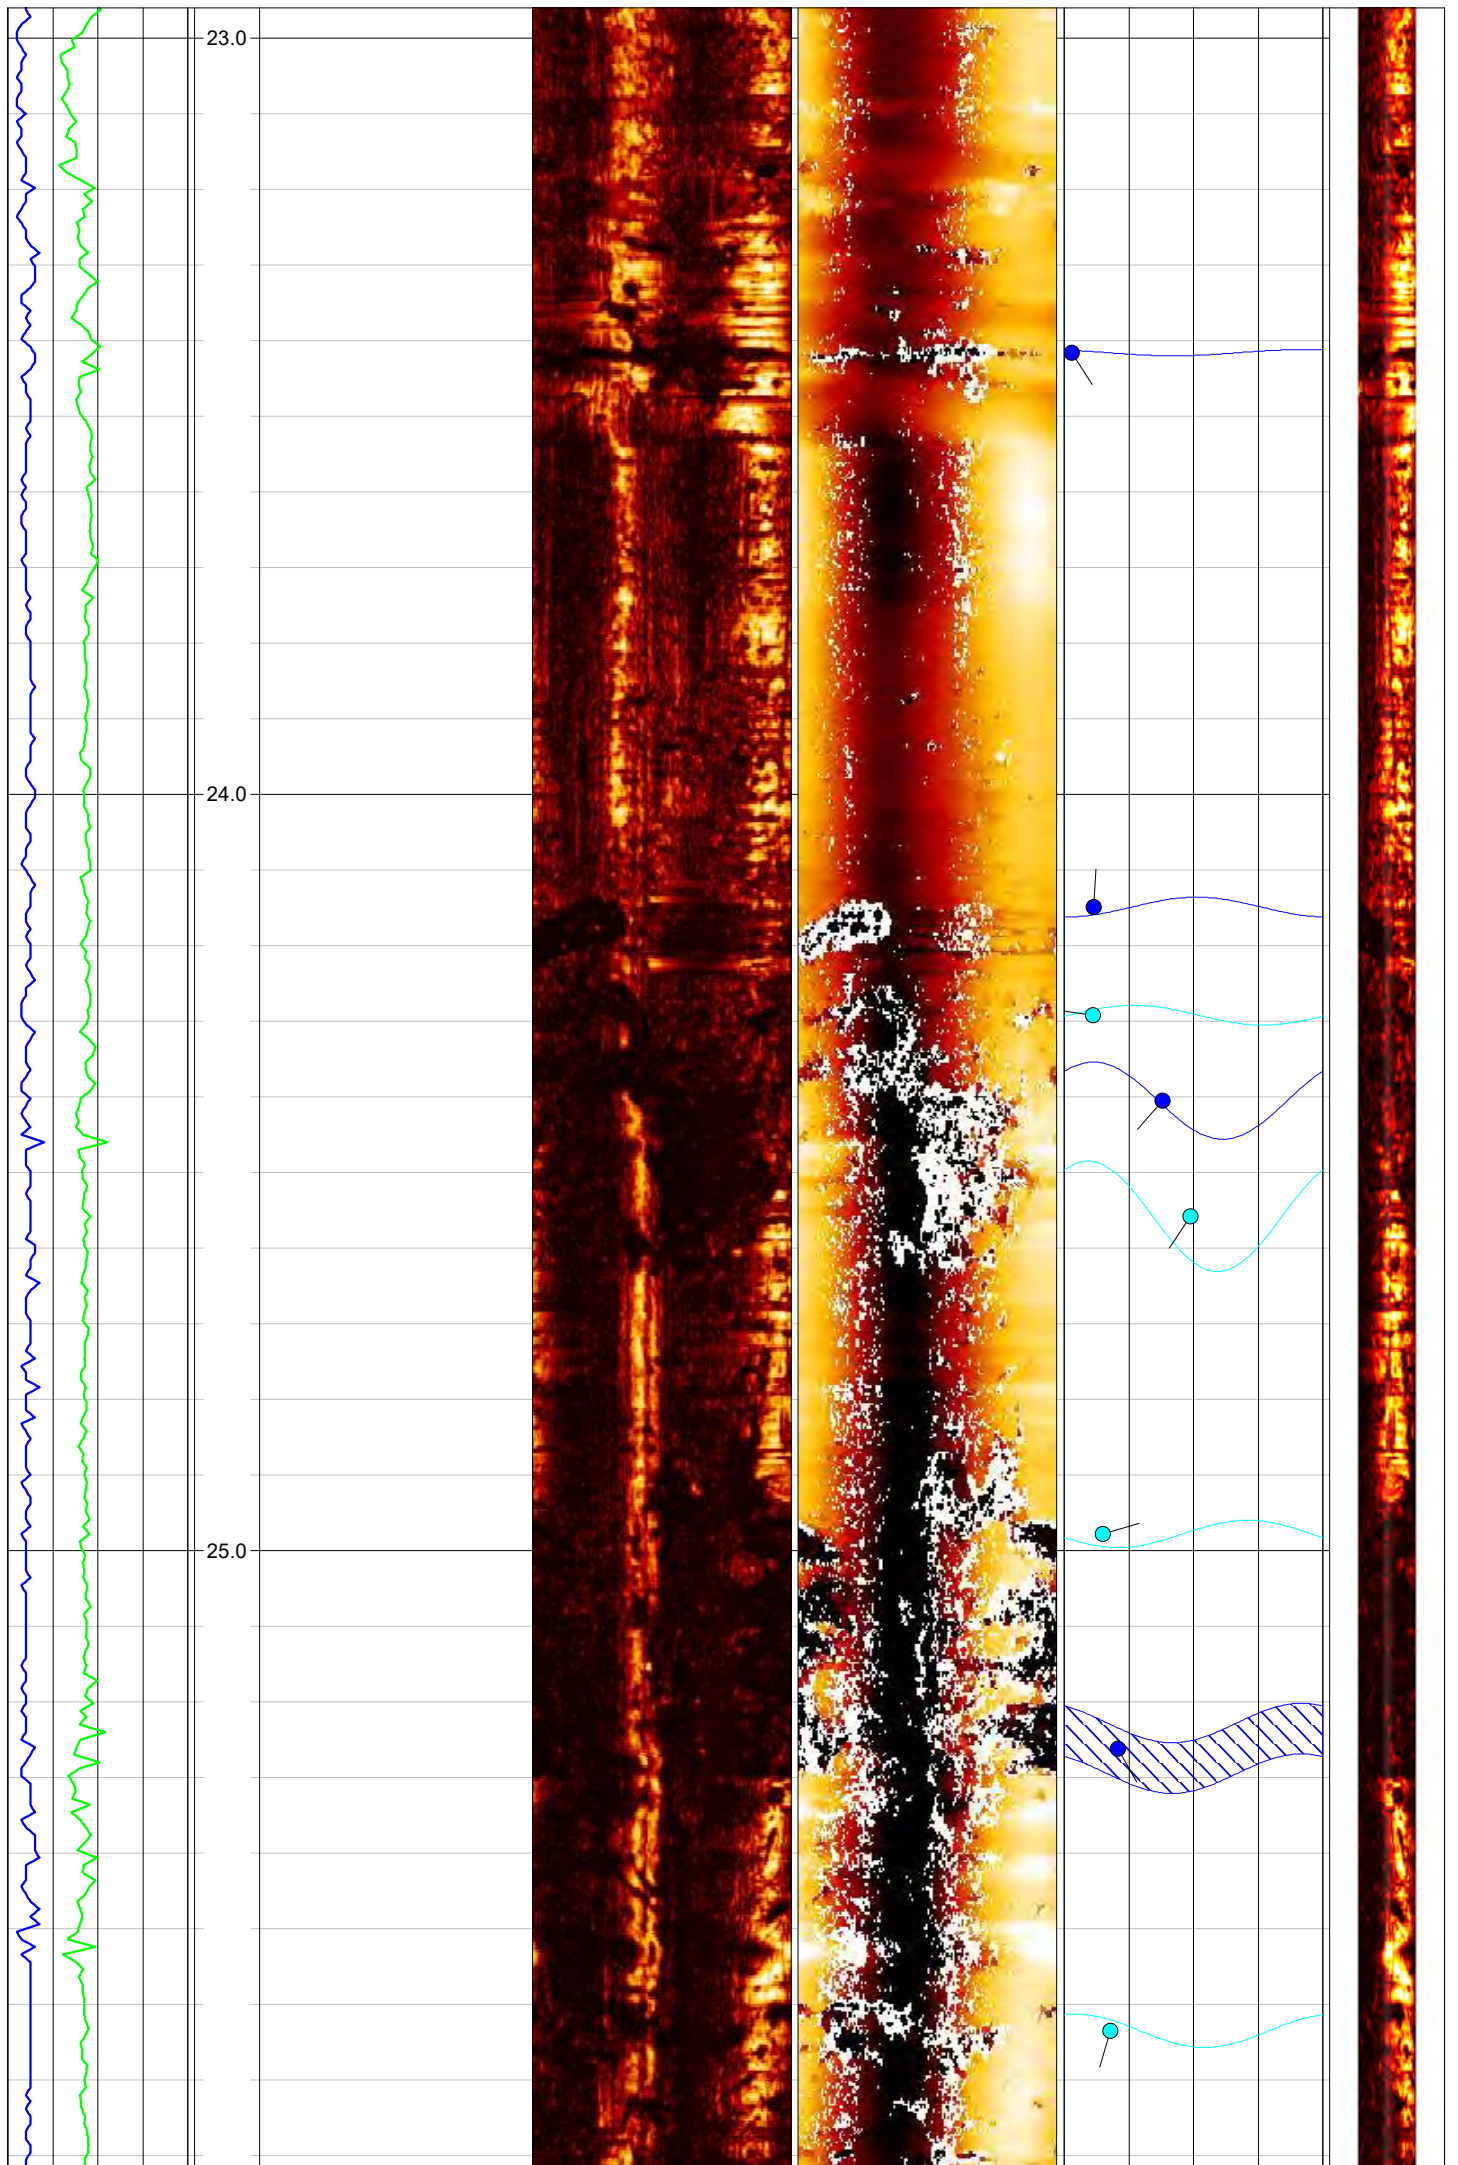
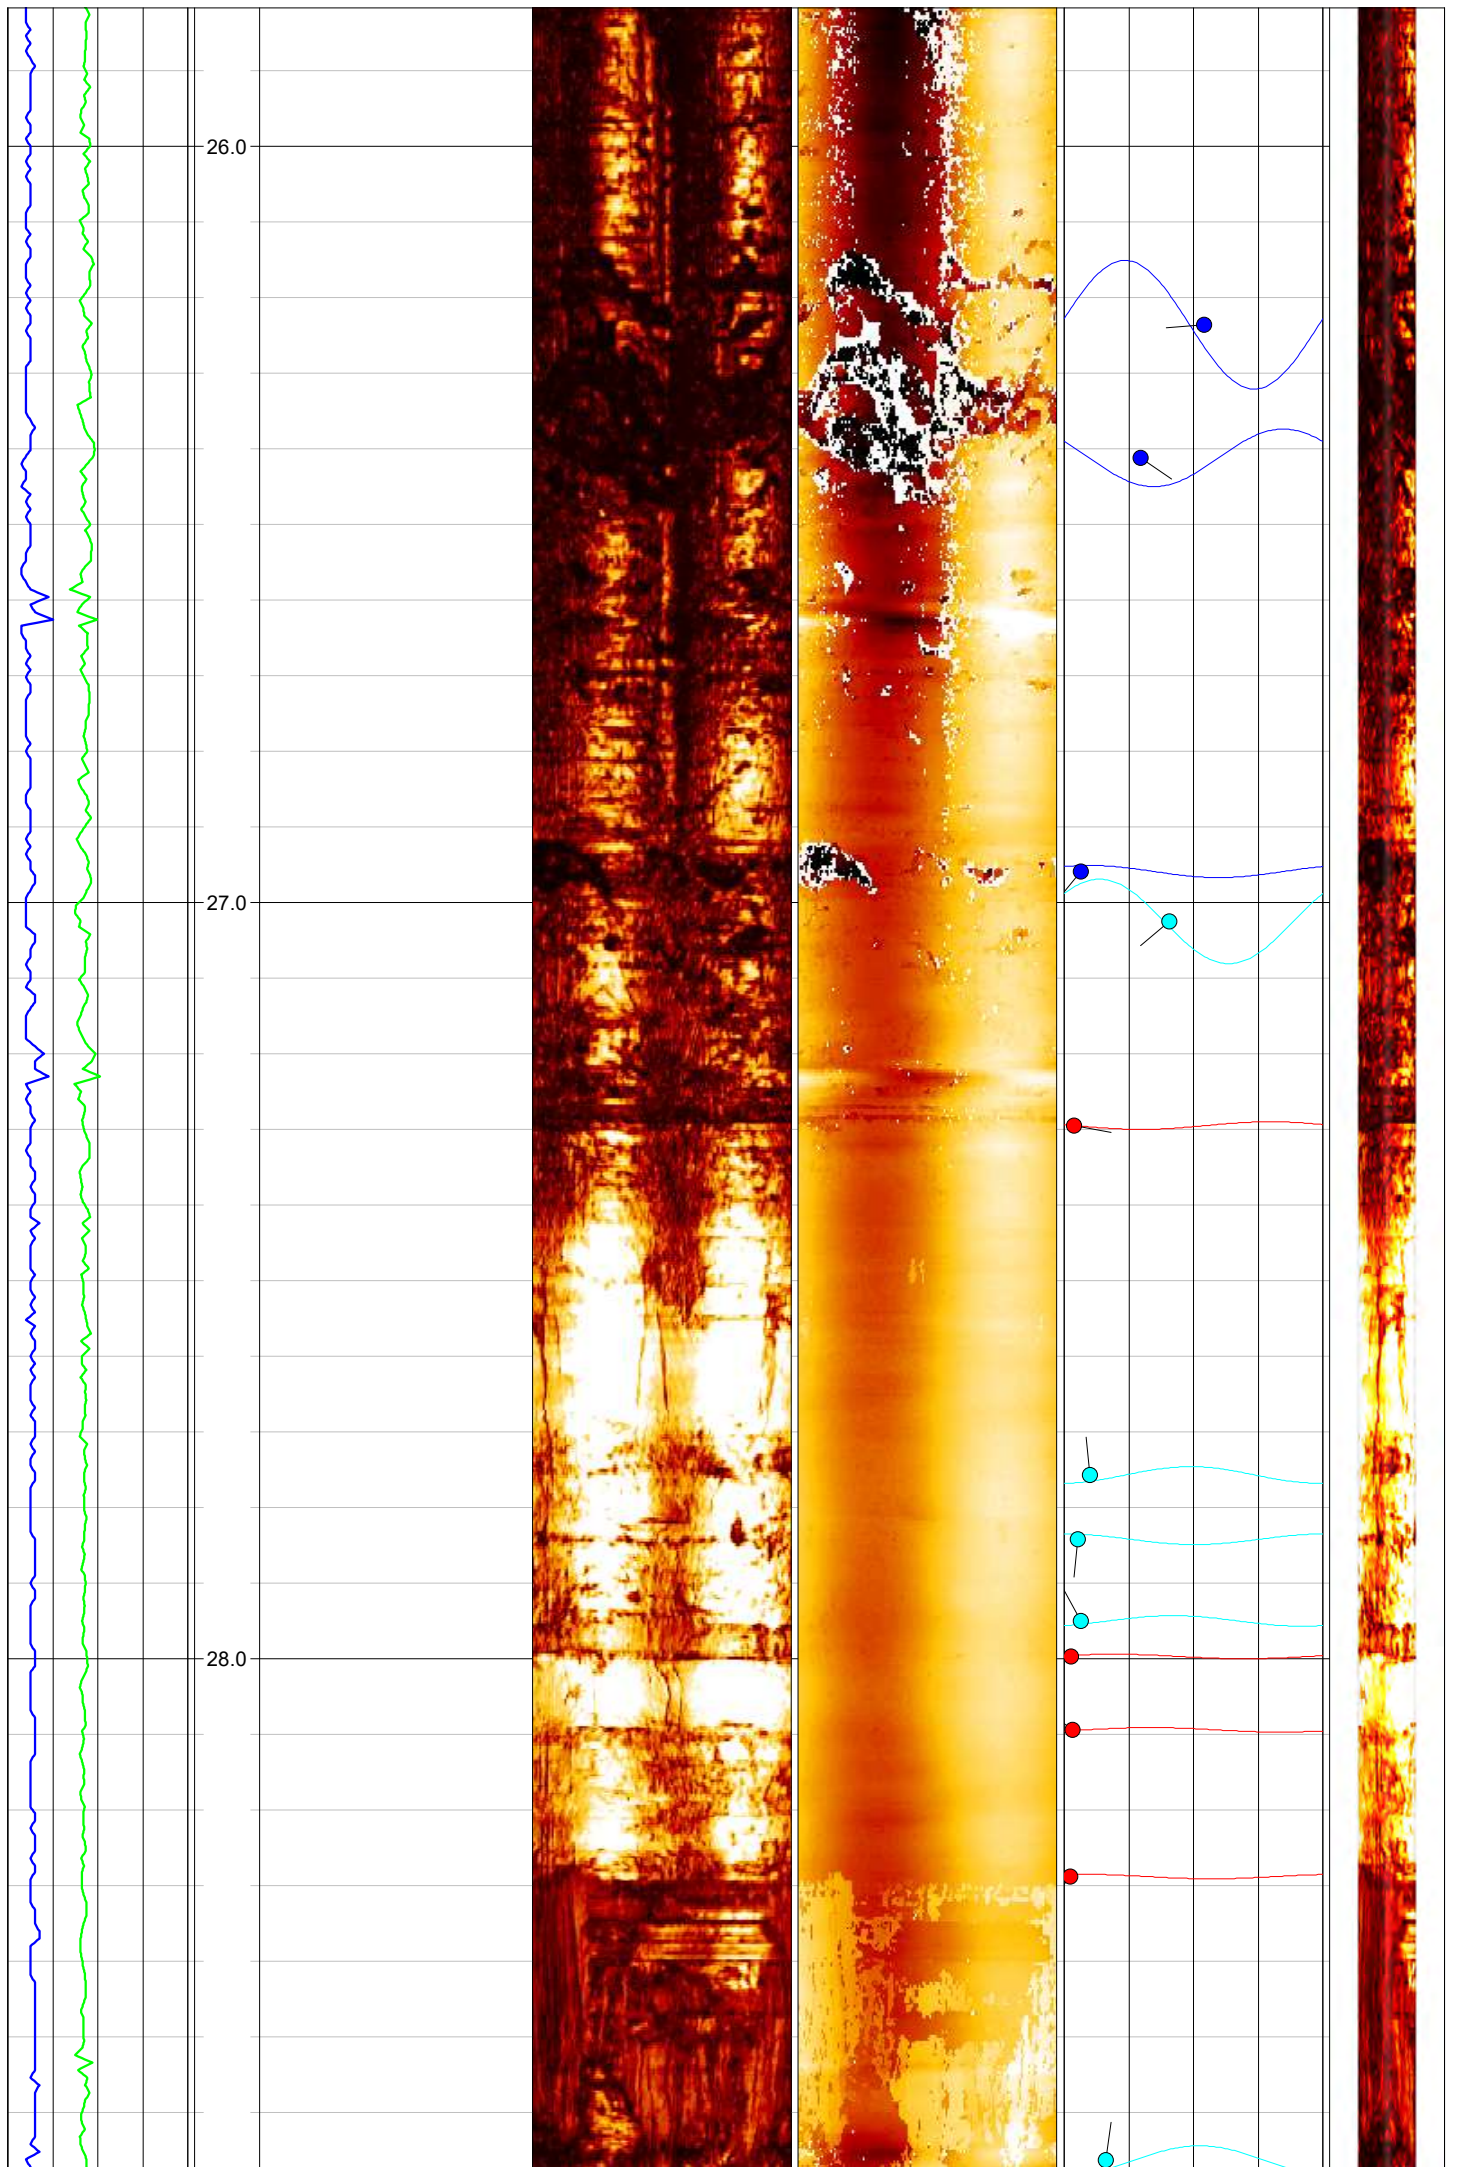
Borehole: **CP217**

Image

Drilled Depth: (m)	33.6	Date:	9th August 2019
Logged Depth: (m)	33.6	Recorded By:	Dave Hingley
Logging Datum:	Ground Level	Remarks: Logging completed immediately after drilling completed. Unable to run Optical Imager and flow logs. Water level dropping during logging.	
Logged Interval: (m)	10.3 - 33.6		
Fluid Level: (m)	~8.1

Bit: (mm)	From: (m)	To: (m)	Type	Size: (mm)	From: (m)	To: (m)
Geo	0.0	33.6	steel	geo	-0.7	10.3
