A417 Missing Link  
TR010056

6.4 Environmental Statement  
Appendix 11.2 Baseline Noise  
Survey Results

Volume 6

**6.4 Environmental Statement  
Appendix 11.2 Baseline Noise Survey Results**

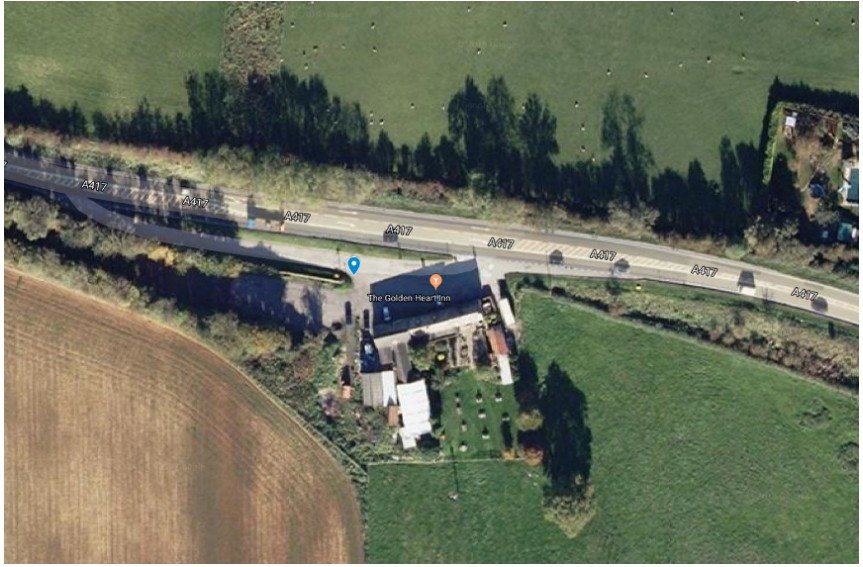
### 2.2 Baseline noise monitoring location S1

<p><b>Location description:</b> The Golden Heart Inn (near to A417 Cowley Junction)</p> <p><b>Measurement duration:</b> Tue 03/09/2019 10:09 to Tue 03/09/2019 12:24</p> <p><b>Weather conditions:</b> Wind direction: North Summary: Breeze with occasional gusts.</p> <p><b>Personnel:</b> Henry Cook</p>	<p><b>Environment and observations:</b> A417 dominant. Continuous traffic.</p>

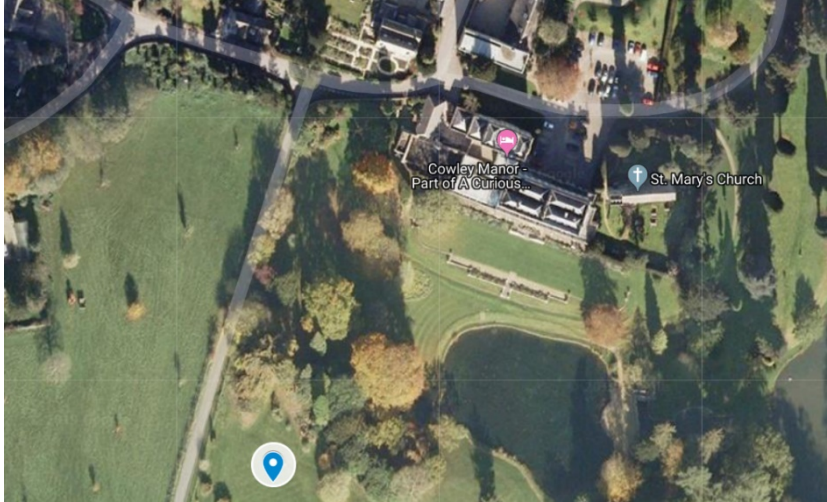
## 2.3 Baseline noise monitoring location S2

<p><b>Location description:</b> Cowley Village</p> <p><b>Measurement duration:</b> Wed 06/11/2019 12:49 to Wed 06/11/2019 15:31</p> <p><b>Weather conditions:</b> Wind direction: East Summary: Light breeze, 1.5m/s average wind speed. Light rain.</p> <p><b>Personnel:</b> Laura McLeod and Holly Cowperthwaite</p>	<p><b>Environment and observations:</b> A417 audible, generally dominant. Occasional noise from aircraft and activity from shooting ground.</p>

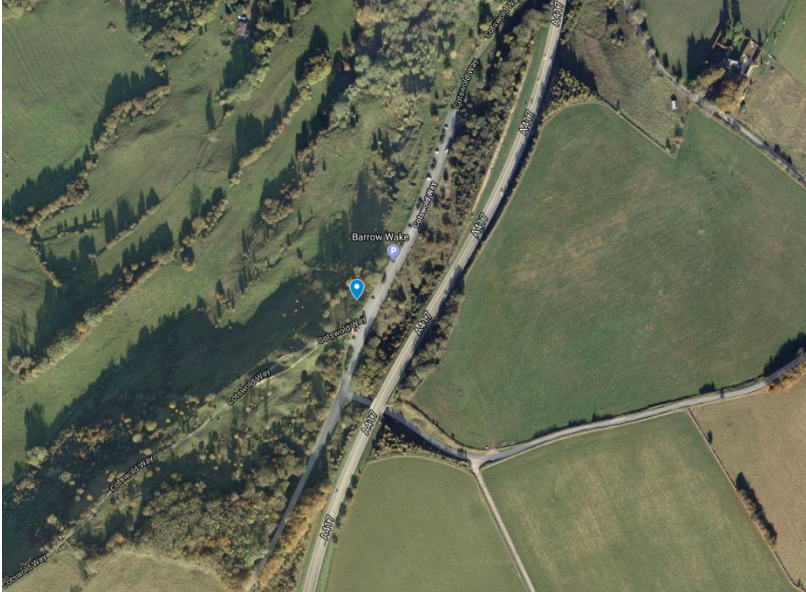
## 2.5 Baseline noise monitoring location S4

<p><b>Location description:</b> Barrow Wake Car Park</p> <p><b>Measurement duration:</b> Tue 03/09/2019 14:13 to Tue 03/09/2019 14:28</p> <p><b>Weather conditions:</b> Wind direction: Summary: Fairly strong wind periodically.</p> <p><b>Personnel:</b> Henry Cook</p>	<p><b>Environment and observations:</b> A417 very clearly audible, both nearby (SE) and from the further section of road to the W. Various cars entering and leaving the car park, driving over a cattle grid.</p>

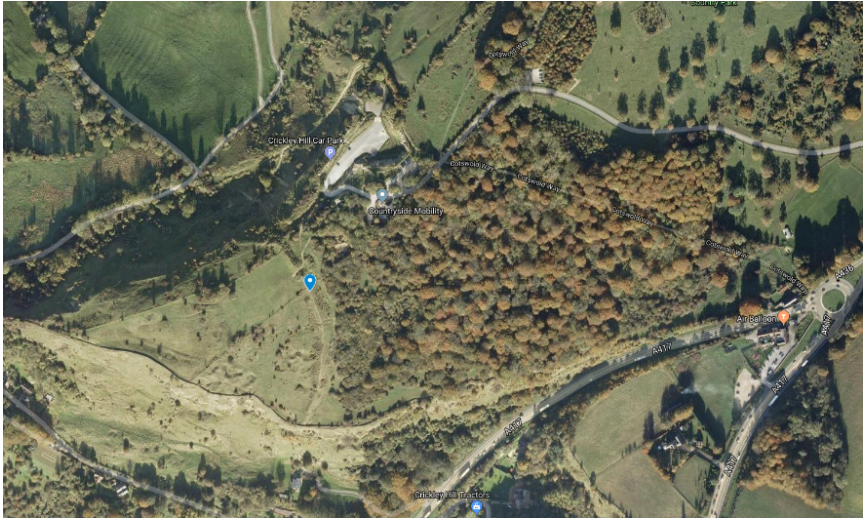
## 2.6 Baseline noise monitoring location S5

<p><b>Location description:</b> Near Crickly Hill Car Park – top of the hill</p> <p><b>Measurement duration:</b> Tue 03/09/2019 14:43 to Tue 03/09/2019 14:53</p> <p><b>Weather conditions:</b> Wind direction: North Summary: Fairly strong wind.</p> <p><b>Personnel:</b> Henry Cook</p>	<p><b>Environment and observations:</b> Noise climate dominated by A417.</p>

Measurements were aborted at this location due to wind conditions.

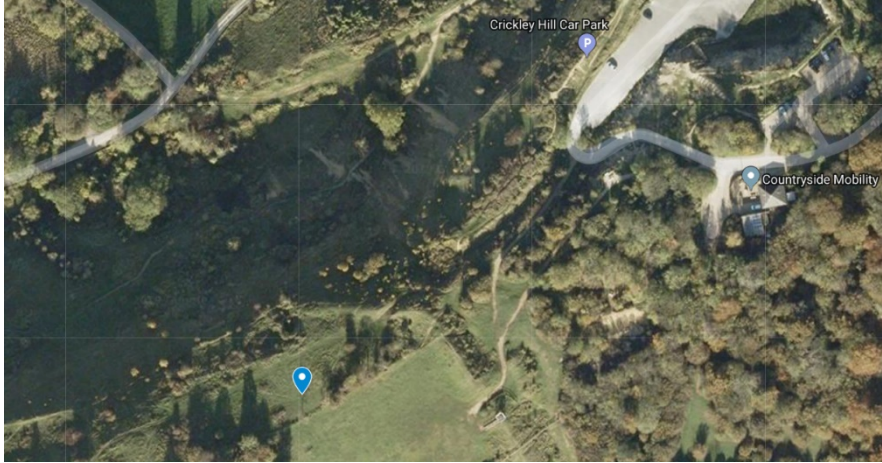
## 2.7 Baseline noise monitoring location S6

<p><b>Location description:</b> Crickley Hill Country Park</p> <p><b>Measurement duration:</b> Thurs 07/11/2019 10:27 to Thurs 07/11/2019 13:30</p> <p><b>Weather conditions:</b> Wind direction: East Very light wind at 1m/s with occasional gusts of up to 3.8m/s</p> <p><b>Personnel:</b> Laura McLeod and Holly Cowperthwaite</p>	<p><b>Environment and observations:</b> A417 dominant. Occasional aircraft and pedestrians passing.</p>

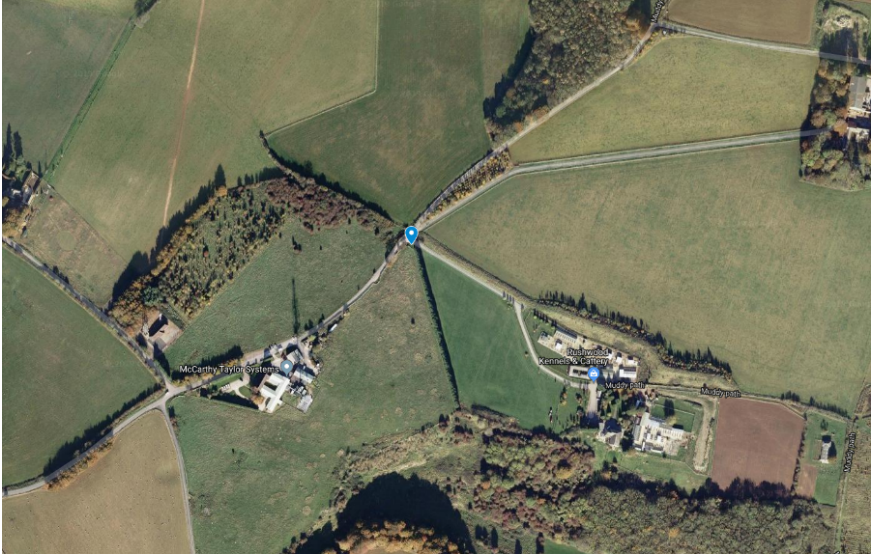
## 2.8 Baseline noise monitoring location S7

<p><b>Location description:</b> Entrance of Rushwood Kennels &amp; Cattery</p> <p><b>Measurement duration:</b> Tue 04/09/2019 10:17 to Tue 04/09/2019 12:47</p> <p><b>Weather conditions:</b> Wind direction: Variable Summary: Light breeze.</p> <p><b>Personnel:</b> Henry Cook</p>	<p><b>Environment and observations:</b> Leaves rustling, birds, A417 clearly audible in background. 30 vehicles passed by between 10:01 and end of measurement.</p>

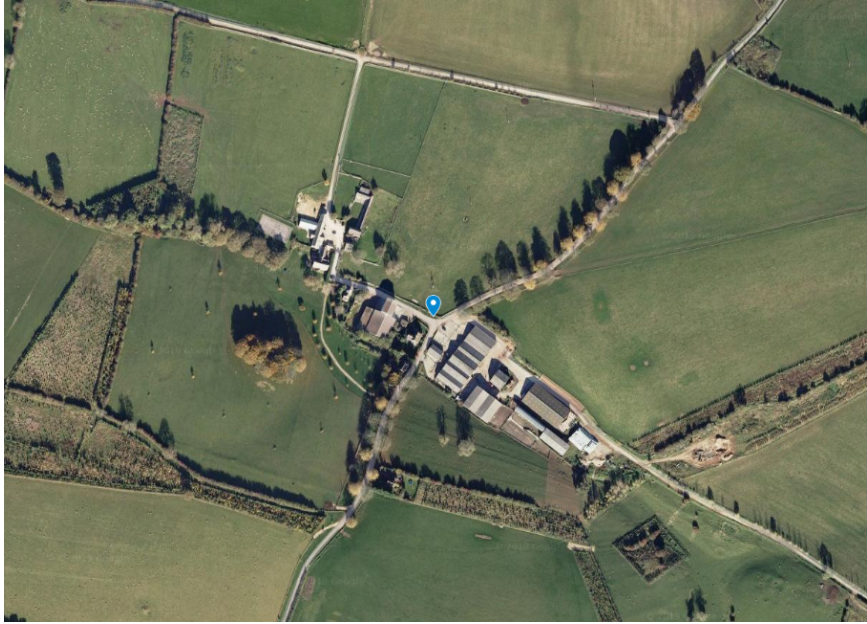
## 2.9 Baseline noise monitoring location S8

<p><b>Location description:</b> Stockwell (approx. middle of village)</p> <p><b>Measurement duration:</b> Tue 04/09/2019 14:00 to Tue 04/09/2019 16:15</p> <p><b>Weather conditions:</b> Wind direction: East Summary: light breeze, with gusts.</p> <p><b>Personnel:</b> Henry Cook</p>	<p><b>Environment and observations:</b> Opposite farmyard. Farmer was collecting hay, so coming back and forth in tractor with trailer. Various other noise events related to farm, passing cars, but mostly calm.</p>

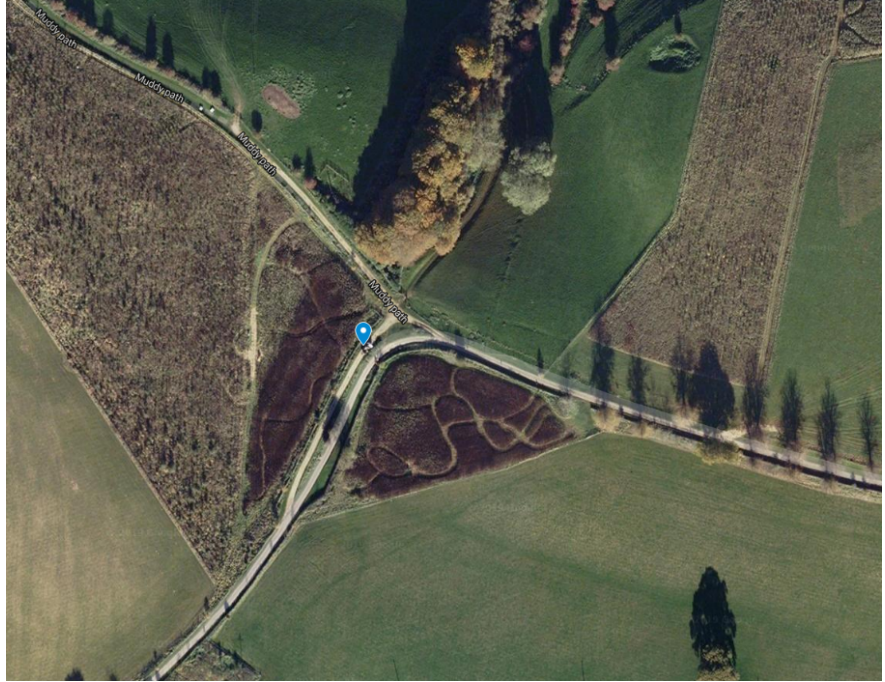
## 2.10 Baseline noise monitoring location S9

<p><b>Location description:</b> At corner of lane intersection with 'Muddy Path' PRow</p> <p><b>Measurement duration:</b> Tue 04/09/2019 14:25 to Tue 04/09/2019 16:44</p> <p><b>Weather conditions:</b> Wind direction: Northeast/east Summary: Light breeze with gusts.</p> <p><b>Personnel:</b> Henry Cook</p>	<p><b>Environment and observations:</b> Birds, leaves rustling, A417 clearly audible.</p>

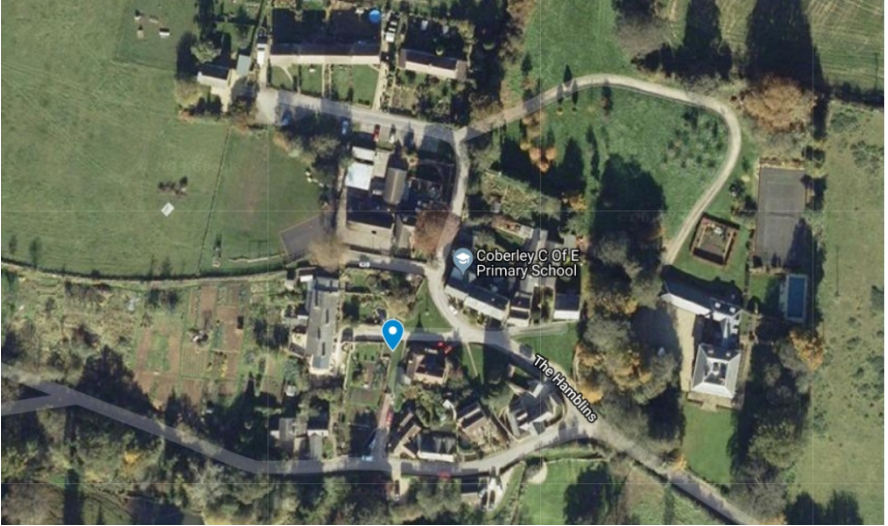
## 2.11 Baseline noise monitoring location S10

<p><b>Location description:</b> Coberley Village</p> <p><b>Measurement duration:</b> Wed 06/11/2019 13:34 to Wed 06/11/2019 13:51</p> <p><b>Weather conditions:</b> Wind direction: East Summary: Very light breeze, maximum wind speeds of 1m/s. Light drizzle.</p> <p><b>Personnel:</b> Laura McLeod and Holly Cowperthwaite</p>	<p><b>Environment and observations:</b> Road traffic noise audible, A417 dominant. Occasional noise from aircraft, pedestrians and birds.</p>

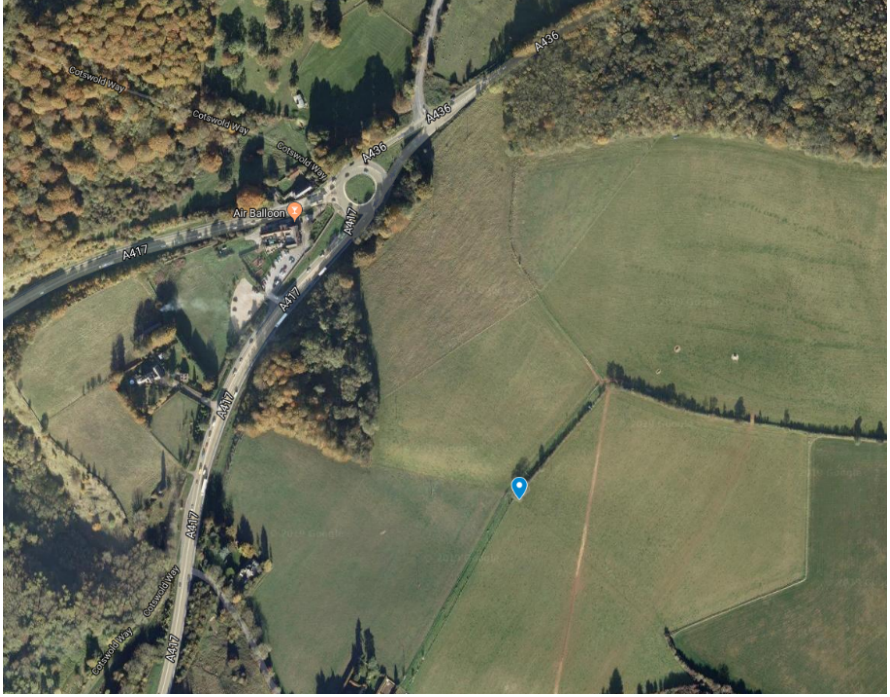
## 2.12 Baseline noise monitoring location S11

<p><b>Location description:</b> Gloucestershire Way, Cowley Footpath No.1 – PRoW</p> <p><b>Measurement duration:</b> Thu 05/09/19 10:43 to Thu 05/09/19 12:43</p> <p><b>Weather conditions:</b> Wind direction: Southeast Summary: Light breeze.</p> <p><b>Personnel:</b> Henry Cook</p>	<p><b>Environment and observations:</b> Tree/hedge rustling, A417 clearly audible, mostly dominant.</p>

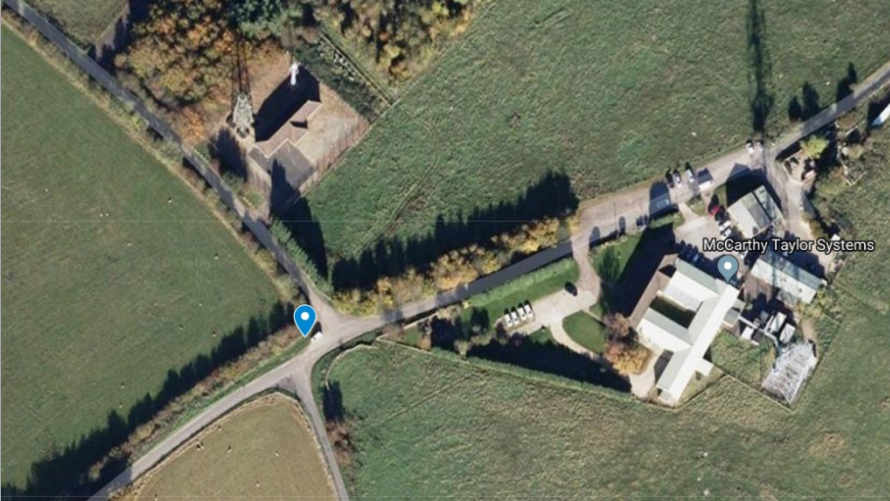
## 2.13 Baseline noise monitoring location S12

<p><b>Location description:</b></p> <p><b>Measurement duration:</b> Wed 06/11/2019 16:37 to Wed 06/11/2019 15:59</p> <p><b>Weather Conditions:</b> Wind direction: East Summary: Calm conditions with occasional gusts up to 0.8m/s.</p> <p><b>Personnel:</b> Laura McLeod and Holly Cowperthwaite</p>	<p><b>Environment and observations:</b> A417 dominant. Paused for traffic passbys on the Barn Junction.</p>

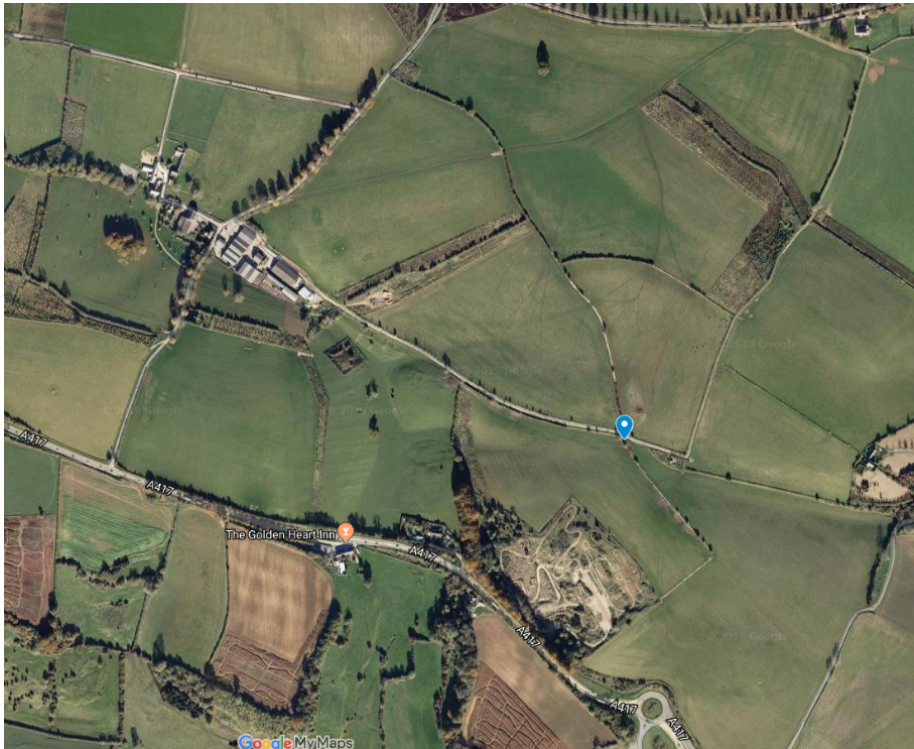
## 2.14 Baseline noise monitoring location S13

<p><b>Location description:</b> Cowley Footpath No.22 - ProW</p> <p><b>Measurement duration:</b> Thu 05/09/19 14:01 to Thu 05/09/19 17:01</p> <p><b>Weather Conditions:</b> Wind direction: East Summary: Fairly still. Occasional breeze.</p> <p><b>Personnel:</b> Henry Cook</p>	<p><b>Environment and observations:</b> A417 dominant.</p>
