# **A1 in Northumberland: Morpeth to Ellingham**

**Scheme Number: TR010041**

## **6.8 Environmental Statement – Appendix 9.5 Bat Report**

**Part B**

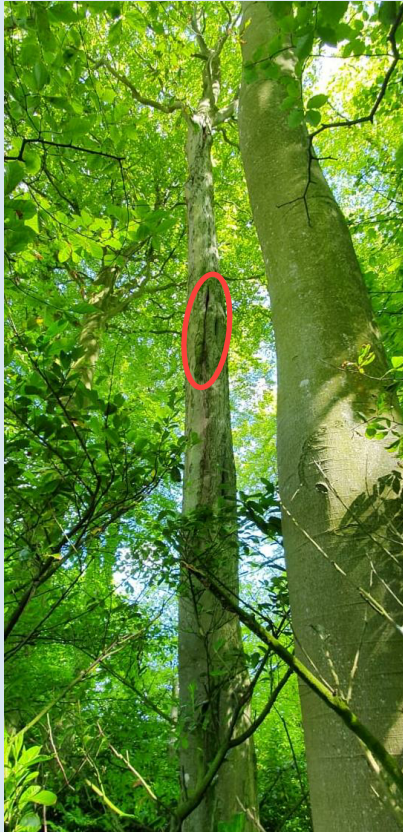
**Table 4-2 – Tree Roost Results**

ID	Description of Tree and Roost Location	Photographs of Tree
G02	Beech <i>Fagus sylvatica</i> tree located at NU 18588 16149. Large cavity on the main stem around 10 m high that leads to a large hollow that extends up within the tree. Noctule maternity roost present with over 80 bats roosting within (highlighted with red in photo).

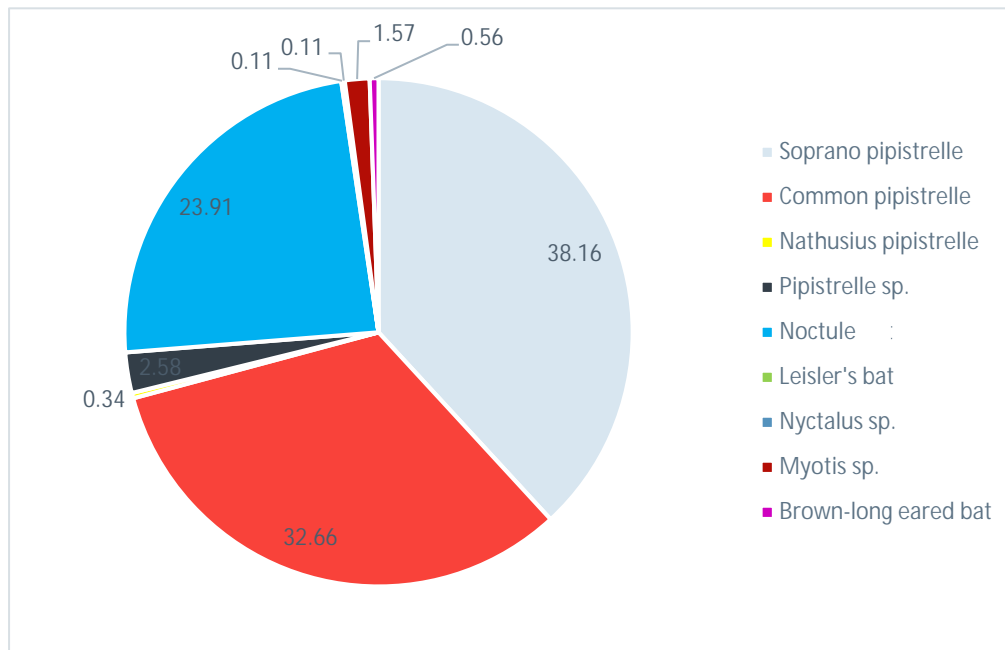
**Chart 4-1 – Percentage Breakdown of Bat Passes Recorded from Each Species during Bat Activity Transects Combined**

4.2.15. The most commonly recorded species across all transects was soprano pipistrelle, which constituted 38.16% of all bat passes recorded at PC locations. Common pipistrelle was the second most commonly recorded species, constituting of 32.66% of all bat passes recorded (**Chart 4-1**). Both soprano and common pipistrelle were recorded during each transect.

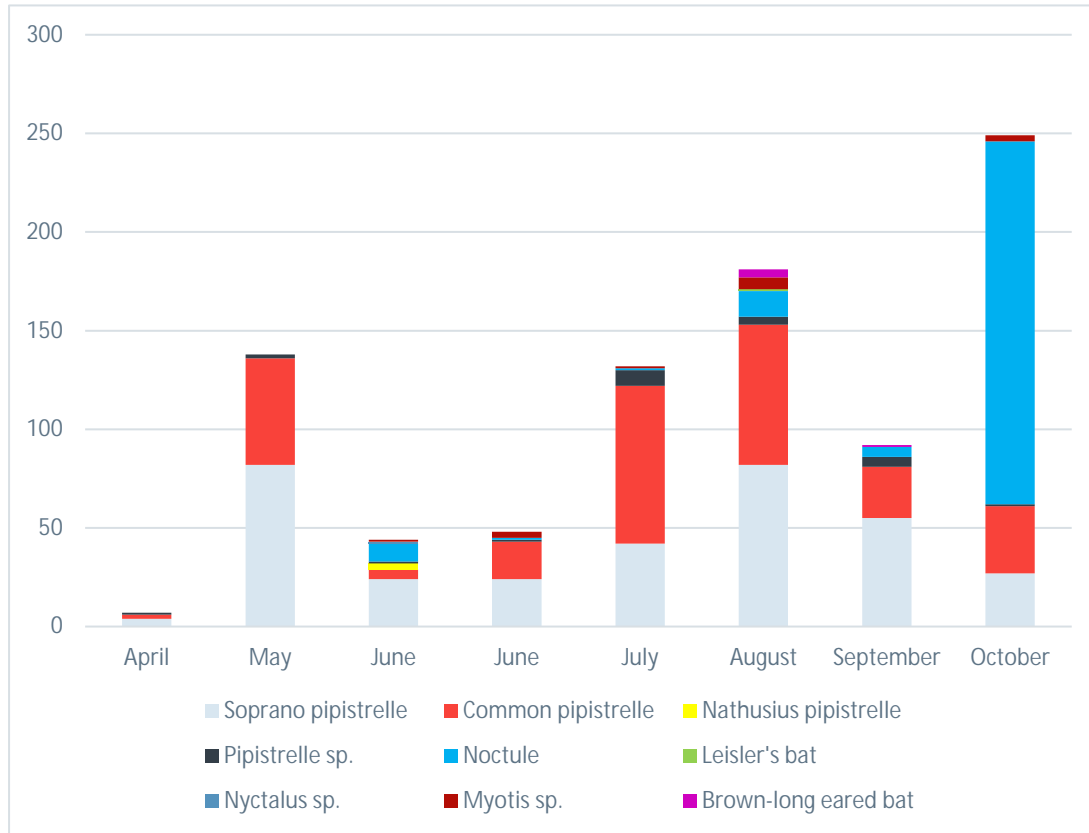
**Chart 4-2 – Seasonal Variations of Bat Activity Levels of each Species during the Combined Bat Activity Transects**

4.2.16. Bat activity levels were highest within the months of August 2018 and October 2018, and May 2019, with the lowest levels of bat activity being recorded in April 2019 (**Chart 4-2**). Bats were active throughout the active bat season with a range of bat species recorded commuting and foraging. The higher level of bat activity in October 2018 is attributable to a comparatively higher level of noctule activity recorded at PC 1 of Transect 1.

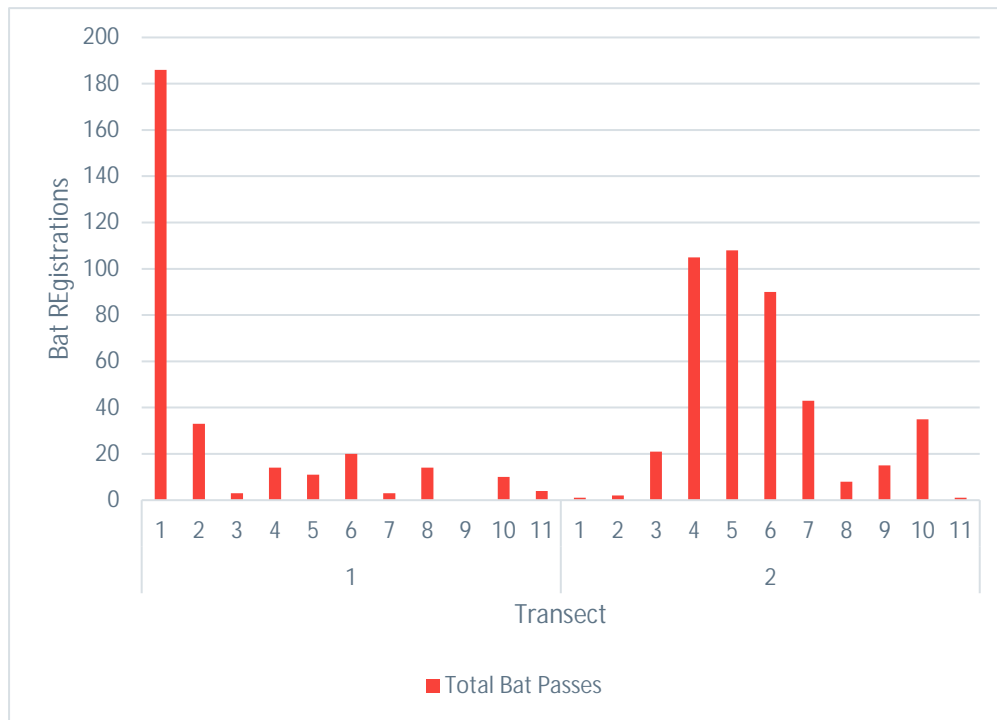
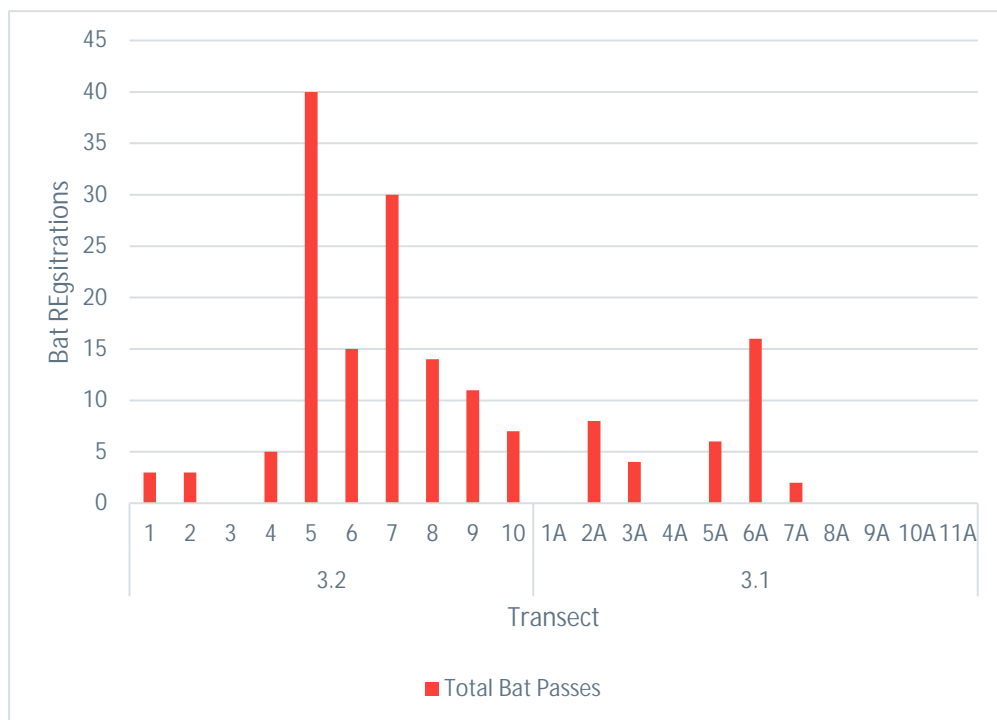
**Charts 4-3 – Bat Activity Level at each Point Count Location Separated by Transects**

4.2.17. Bat activity was highest at PC locations along edge habitat (e.g. woodland edge). Within Transect 1, the highest level of activity was recorded along woodland at the start of surveys at PC1 and PC2. Activity was then lower as linear hedgelines and fences were followed but the linear habitat was not as prominent as the tree lines in Transects 2, 3.1 and 3.2. Transect 2 has a clear increase in activity levels at PC locations closer to woodland edge habitat (PC 4, 5, 6, 7 and 10).

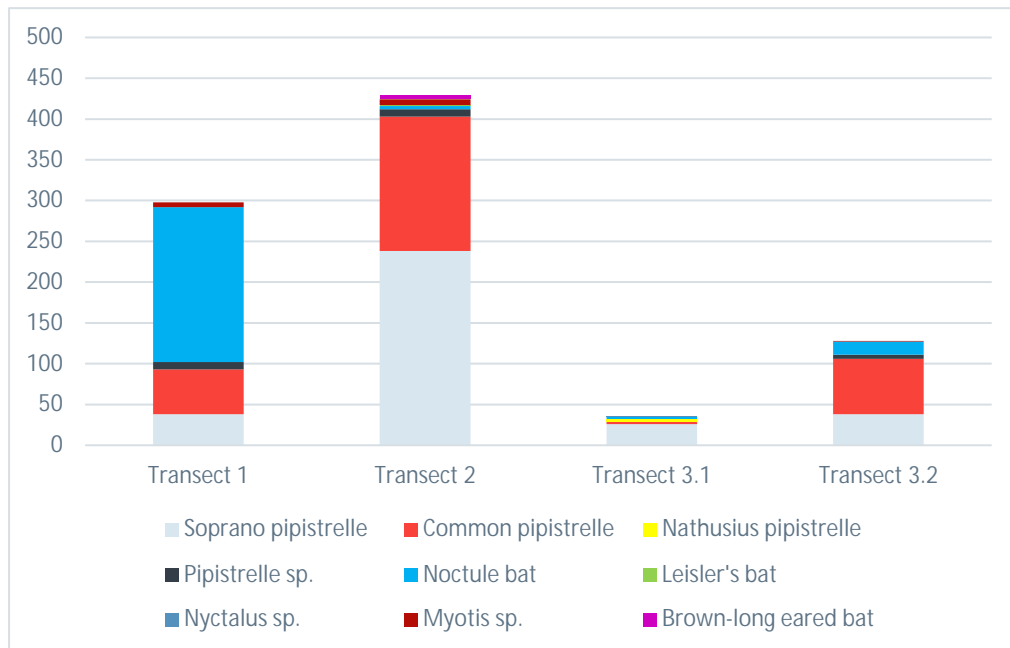
**Chart 4-4 – Bat Passes per Transect**

4.2.18. Bat activity levels were highest for Transect 2 out of the four transects; and lowest for Transects 3.1 and 3.2. Bat activity per transect are represented in **Chart 4-4**.

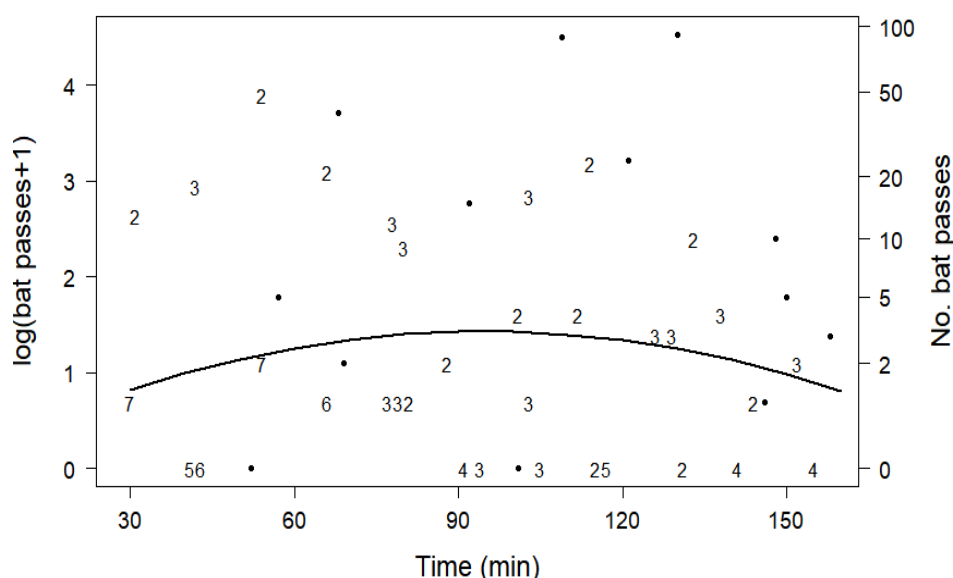
**Chart 4-8 – Effect of Distance from 0 – 1000m on Total Bat Activity with the Final GEE Model**

- 4.2.24. As described in Defra guidance (**Ref. 5**) this pattern of bat activity was observed both when walking away from the road (coefficient = 'Time (away)') (GEE, Wald  $x^2=11.1$ ,  $P<0.001$ ; **Table 4-7**) and towards the road (coefficient = 'Time (towards)') (GEE, Wald  $x^2=12.5$ ,  $P<0.001$ ; **Table 4-7**). The number of bat passes remained the same irrespective of changes in habitat grade (refer to habitat descriptions **Table 2-4**) and distance from the road, indicating the time relating to sunset / sunrise was the main factor in differences in activity levels.

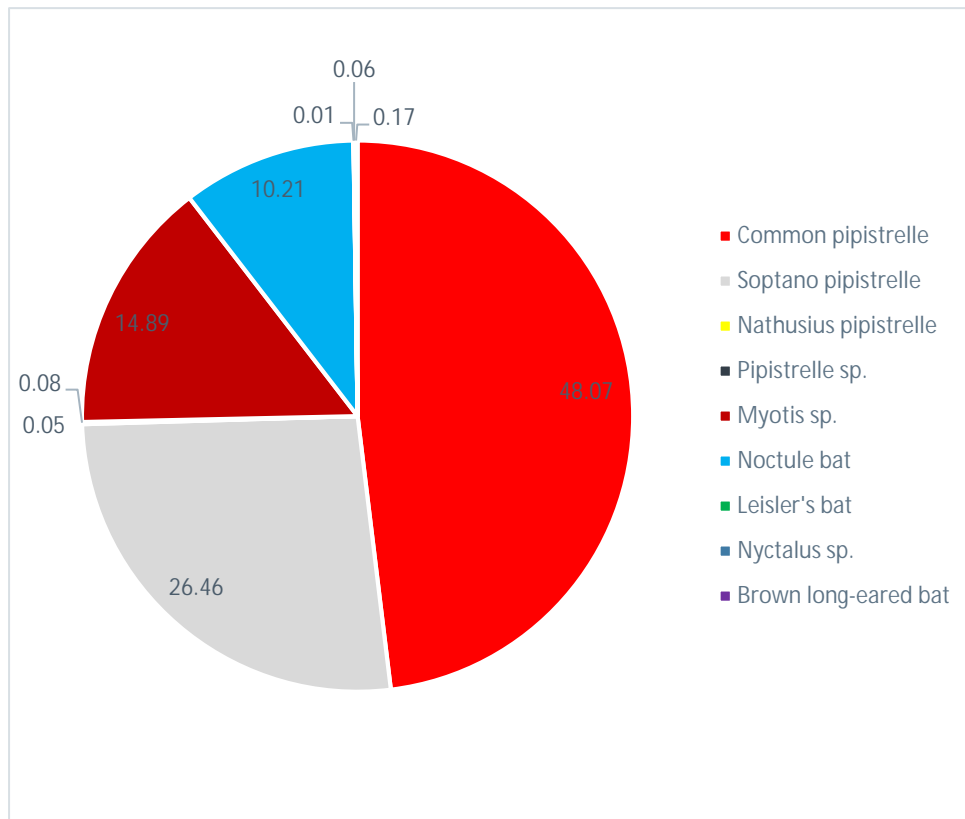
**Chart 4-5 – Total Bat Registrations by Species**

4.2.25. During the 2018 and 2019 automated detector surveys, bat calls were recorded from the following seven species / species groups: soprano pipistrelle, common pipistrelle, Nathusius' pipistrelle, noctule, Leisler's bat, brown long-eared bat and Myotis species (**Chart 4-5**). The most commonly recorded species was common pipistrelle, which constituted 48.07% of all bat registrations recorded. Soprano pipistrelle were the second most commonly recorded species, constituting of 26.46% of all bat registrations recorded (**Chart 4-5**). Both soprano and common pipistrelle were recorded at each static detector location.

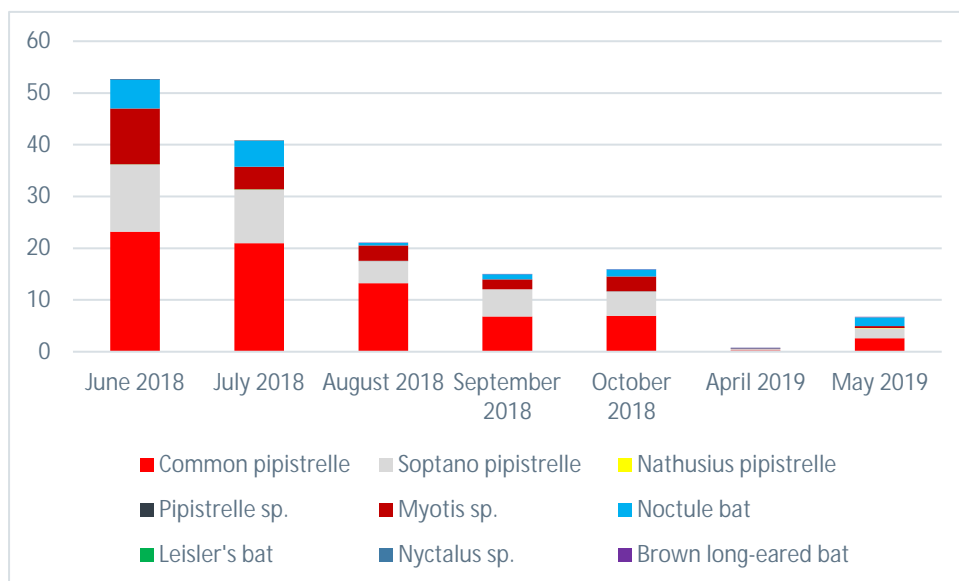
**Chart 4-6: Activity (pph) by Survey Month**

4.2.26. The peak levels of bat pph were recorded during June 2018 (peak activity season month), with the lowest levels of bat activity recorded in April 2019 (transitional period) (**Chart 4-6**).

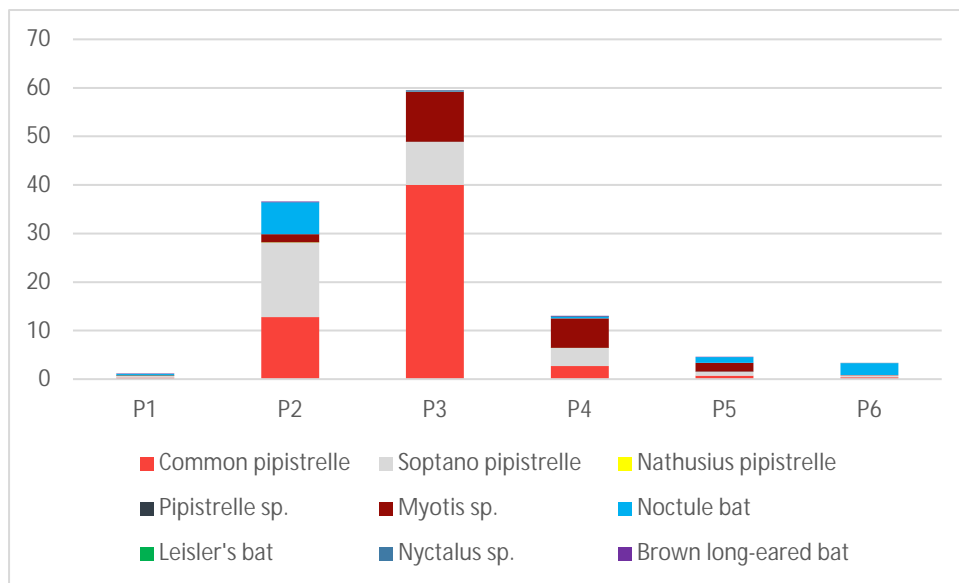
**Chart 4-7 Activity (pph) by Automated Detector Location**

4.2.27. The levels of bat activity varied between static detector locations, with static P3 (located at a crossing point in edge habitat) the most active static location with an average of 59.40 pph. The next detector with the next highest level of activity was static P2 (located between a woodland and two waterbodies) with an average of 36.57 bat pph (**Chart 4-7**). The lowest bat activity levels were recorded at P1 with only 1.11 bat pph (located in open habitat, set back from the A1 carriageway).

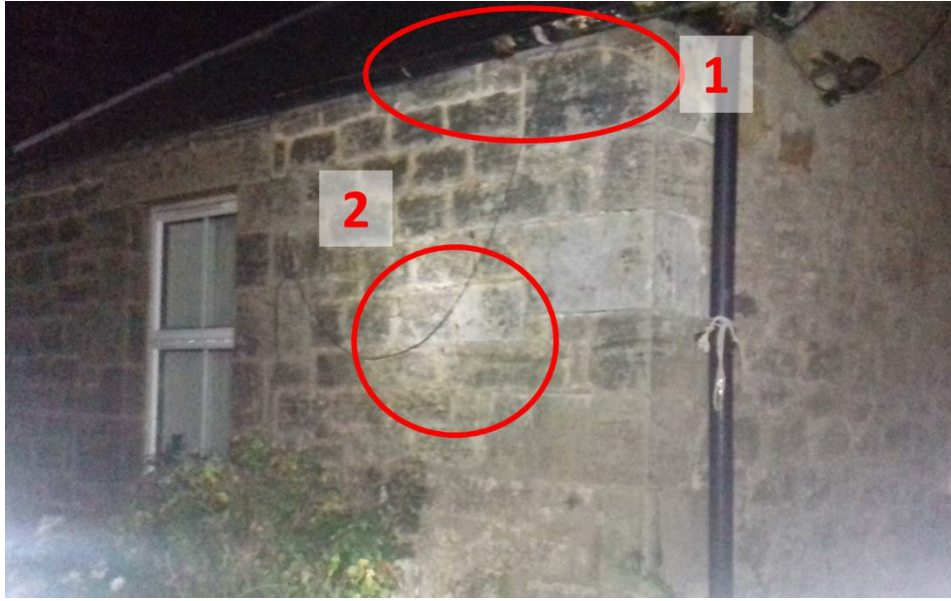
<p>B100B- well maintained, single-storey, stone dwelling with associated kennels and modern pre-fabricated garage. The dwelling had a slate roof. The surrounding land comprised grazed pasture and hedgerows.</p> <p>Small gaps under ridge tiles and beneath coping stones.</p> <p><b>Bat Roost Suitability = Low (2016 survey result)</b></p> <p><b>2018 reassessment = Moderate</b></p> <p><b>Hibernation suitability – Moderate</b></p>	<p>NU 17554 21051</p>	<p>No roost was recorded</p>
<p>B102B – A well-maintained, single-storey detached stone dwelling. The dwelling had a slate roof. Two stone extensions were located on the northern side with single-pitched, slate-covered roofs. The surrounding land featured farmland and hedgerows.</p> <p><b>Bat Roost Suitability = Low (2016 survey result)</b></p> <p><b>2018 reassessment = High</b></p> <p><b>Hibernation suitability – Moderate</b></p>	<p>NU 17787 20638</p>	<p><b>1:</b> Roost is located under the gutter towards the south-eastern corner on the south facing side of the structure.</p> <p><b>Roost classification:</b></p> <p>Common pipistrelle – Non-breeding, summer roost</p> <p>Max count = 2, Emergence, 22 August 2018</p> <p><b>2:</b> The roost is located in a crevasse within the buildings stone and mortar work, approximately 1.5m above the ground on south-eastern corner on the south facing facade of the structure</p> <p><b>Roost classification:</b></p> <p>Common pipistrelle – Non-breeding, Summer roost</p>

Description of Structure / Bat Roost Suitability / Hibernation Suitability	Grid Ref	Roost Description and Location
		<p>Max count = 5, Re-entering, 22 August 2018</p>

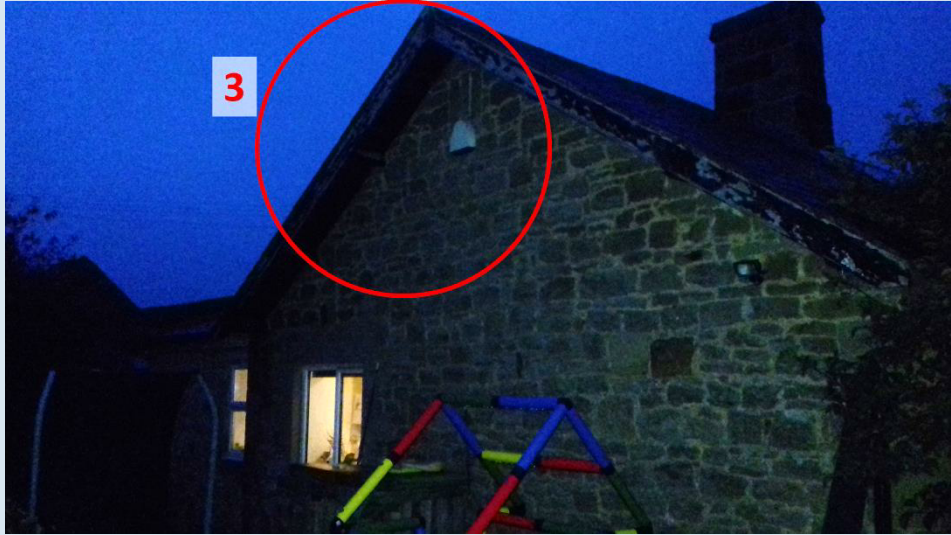
<p>3: The roost is located at the westerly gable end of the structure  <b>Roost classification:</b>                  Common/soprano pipistrelle – Non-breeding, summer roost                  Max Count = 5, re-entry, 31 July 2019</p>

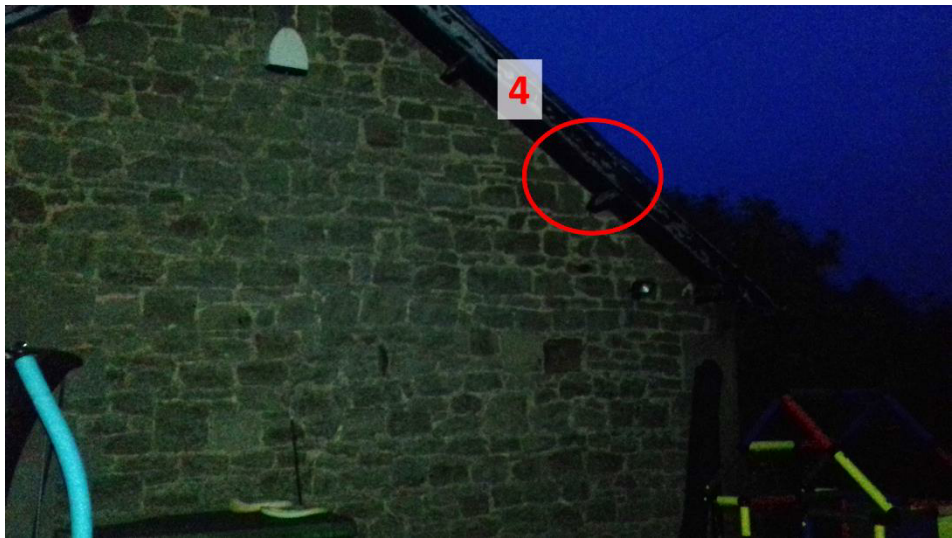
<p>4: The roost is located at the westerly gable end of the structure  <b>Roost classification:</b>                  Noctule – Non-breeding, summer roost                  Max Count = 1, emergence, 14 August 2019</p>

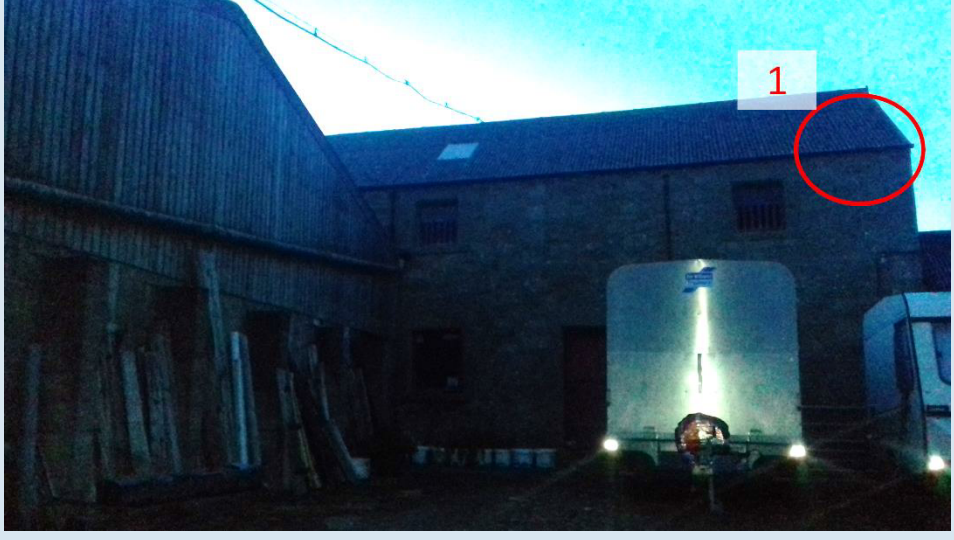
Description of Structure/ Bat Roost Suitability/Hibernation Suitability	Grid Ref	Roost Description and Location
B6A - Two-storey stone block construction with asbestos cement sheet roof. <b>Bat Roost Suitability = High (2019 Assessment)</b> <b>Hibernation suitability – Moderate</b>	NU 17728 20678	No roost was recorded
B6B - Single pitched extension off B6A/B6C. Stone block with asbestos cement roof. <b>Bat Roost Suitability = Low (2019 Assessment)</b> <b>Hibernation suitability – Moderate</b>	NU 17739 20685	No roost was recorded
B6C -Two-storey stone block construction with asbestos cement sheet roof. <b>Bat Roost Suitability = Confirmed from 2018 surveys</b> <b>Hibernation suitability – Moderate</b>	NU 17744 20682	<p>1: Possible roost located within south facing side of the structure, light levels prevented specific location identification</p> <p><b>Roost classification:</b>                      Possible Common pipistrelle – Non-breeding, summer roost                      Max count = 1, emergence, 21 July 2019 and 15 August 2019</p>

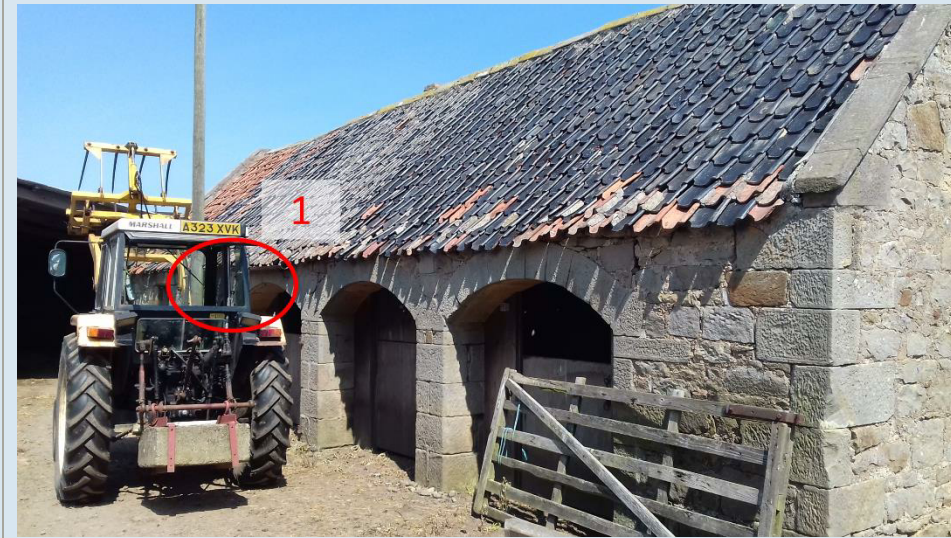
B6K - Stone block construction with a Clay pan tile roof in poor condition. <b>Bat Roost Suitability = Confirmed (2019 Assessment)</b> <b>Hibernation suitability – Moderate</b>	NU 17774 20666	<b>1:</b> Roost is in a crevasse within the buildings stone and mortar work on the west facing side of the buildings. The roost is approximately 2 m above the ground <b>Roost classification:</b> Common pipistrelle – Non-breeding, summer roost Max Count = 1, re-entering, 15 May 2019

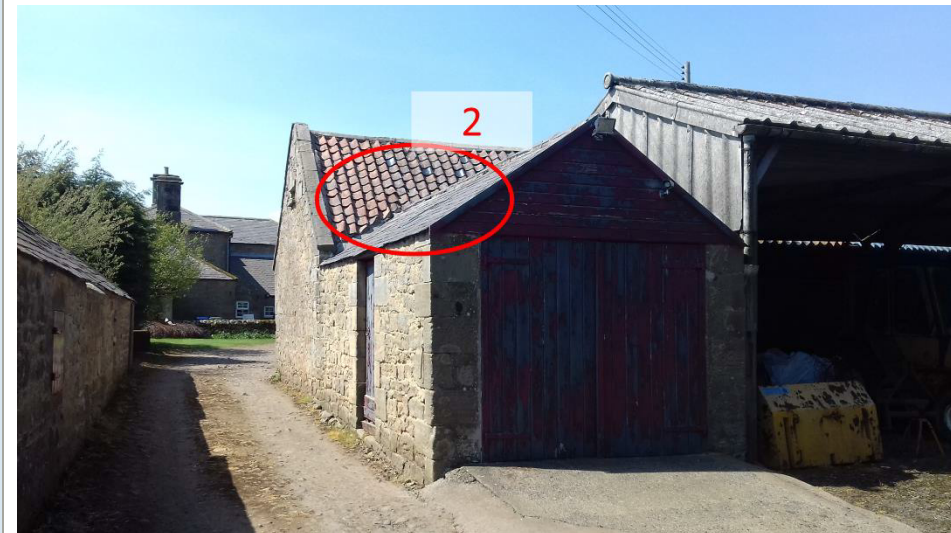
2: Roost location unspecified. Located on the south facing aspect of the structure

Common pipistrelle – Non-breeding, Summer roost

Max Count = 1, emergence, 15 August 2019

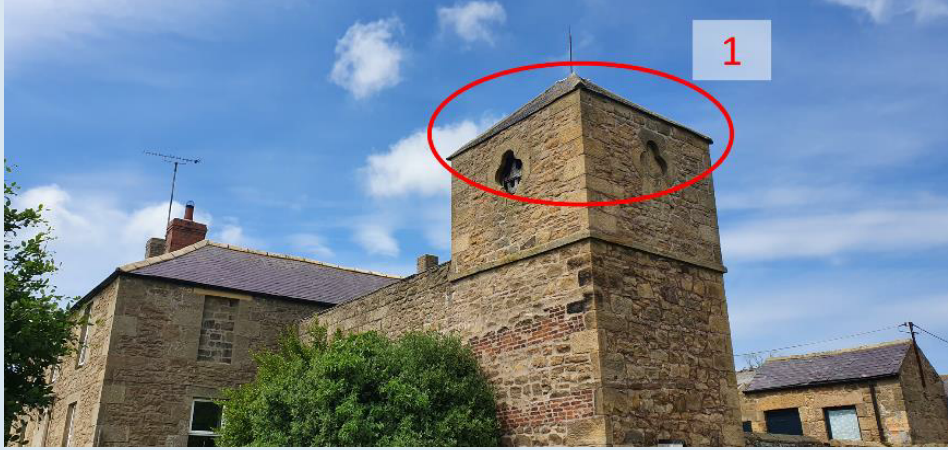
Description of Structure/ Bat Roost Suitability/Hibernation Suitability	Grid Ref	Roost Description and Location
<p>HF1 - Two storey residential, stone walled building with slate roof with dove cote attached.  <b>Bat Roost Suitability = High (2019 Assessment)</b>  <b>Hibernation suitability – Moderate</b></p>	<p>NU 18719 17266</p>	<p>1: Roost is located within the disused dove cote towards the westerly extent of the building  <b>Roost classification:</b>                      Common/soprano pipistrelle – Non-breeding, summer roost                      Max Count = 1, re-entry, 27 June 2019 and 28 June 2019</p>

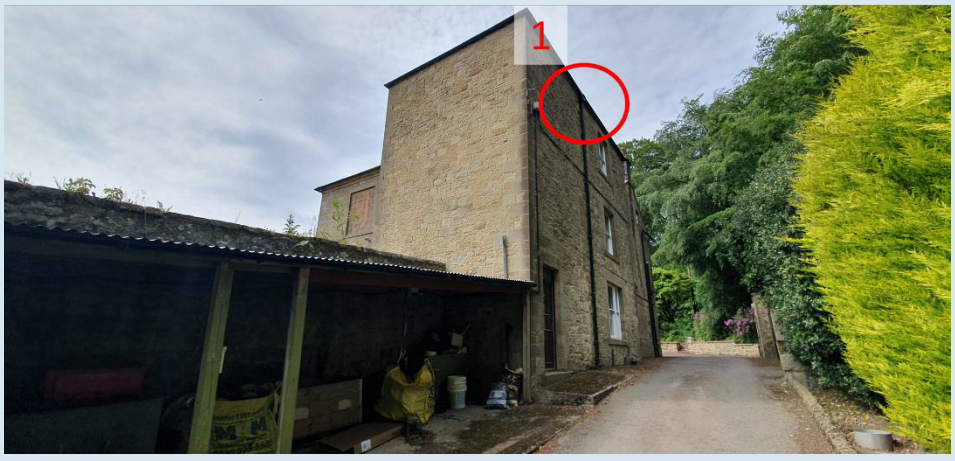
Description of Structure/ Bat Roost Suitability/Hibernation Suitability	Grid Ref	Roost Description and Location
<p>HH1 - Three storey stone building residential house with slate roof.</p> <p><b>Bat Roost Suitability = High (2019 Assessment)</b></p> <p><b>Hibernation suitability – Moderate</b></p>	<p>NU 18648 16155</p>	<p><b>1:</b> Roost is located under guttering on the north facing side of the structure</p> <p><b>Roost classification:</b> Soprano pipistrelle – Non-breeding, summer roost Max Count = 2, emergence, 15 July 2019</p> <p><b>Roost classification:</b> <i>Nyctalus</i> species – Non-breeding, summer roost Max count = 1, emergence, 15 July 2019</p>

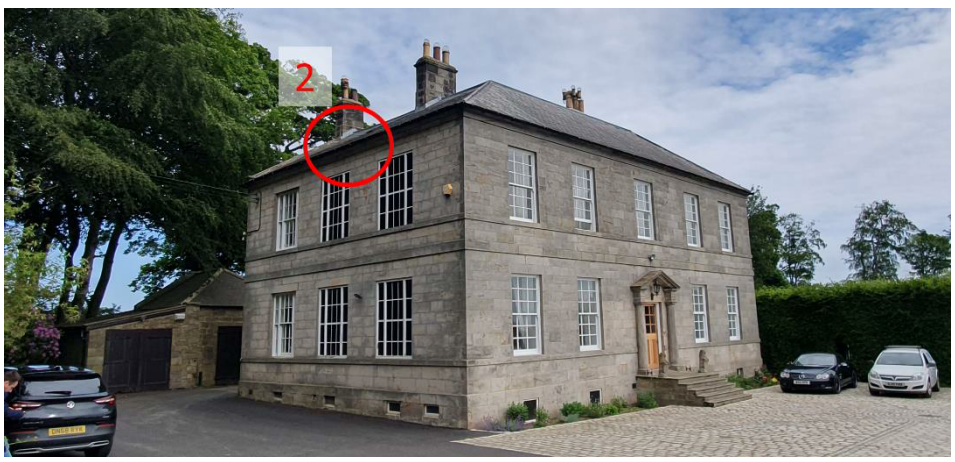
<p><b>2:</b> Roost is located under the lead flashing linking the base of the north-west chimney stack.</p> <p><b>Roost classification:</b> Soprano pipistrelle – Non-breeding, summer roost Max Count= 1, re-entry, 16 July 2019</p>

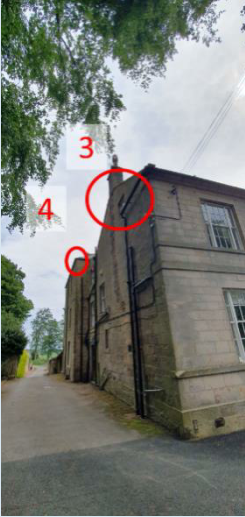
<p><b>3:</b> Roost located under edging tiles on the north facing gable end of the structure  <b>Roost classification:</b>                  Soprano pipistrelle – Non-breeding, summer roost                  Max Count= 1, re-entry, 16 July 2019</p> <p><b>4:</b> Roost located under the guttering of the north facing side of the structure  <b>Roost classification:</b>                  Soprano pipistrelle – Non-breeding, summer roost                  Max Count= 3, emergence, 29 July 2019</p>

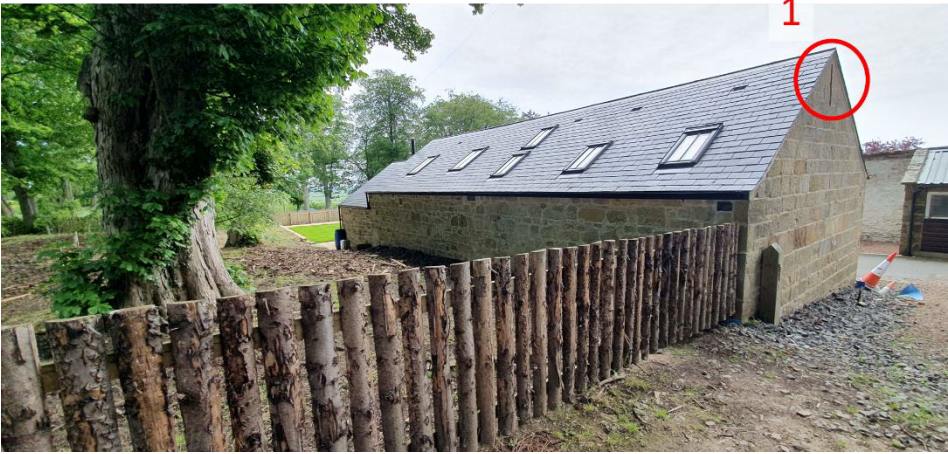
<p>HH2 - Stone and wooden outbuilding associated with the manor house.  <b>Bat Roost Suitability = High (2019 Assessment)</b>  <b>Hibernation suitability – Moderate</b></p>	<p>NU 18674                  16180</p>	<p><b>1:</b> Roost located within the structural open at the structure west facing gable end  <b>Roost classification:</b>                  Soprano pipistrelle – Non-breeding, summer roost                  Max Count= 1, re-entry, 31 July 2019</p>

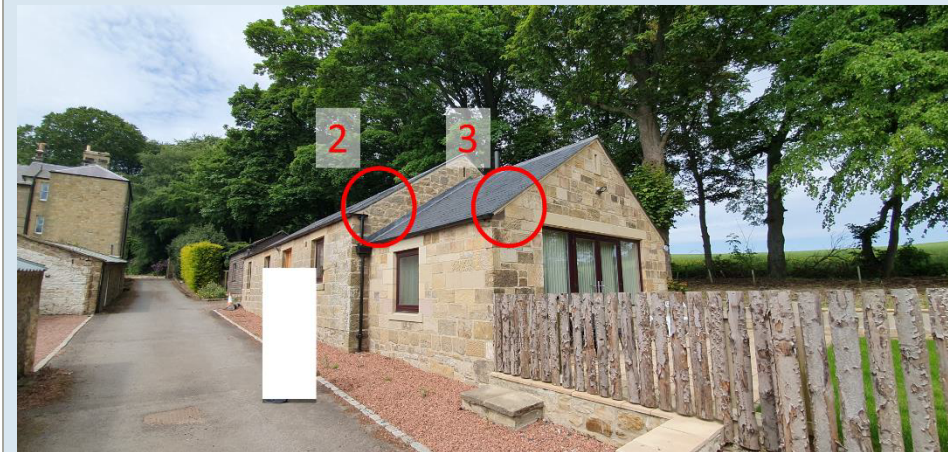
**2:** Roost located at the tiled roof edge toward the east of the structure

Soprano pipistrelle – Non-breeding, summer roost

Max Count = 1, re-entry, 31 July 2019

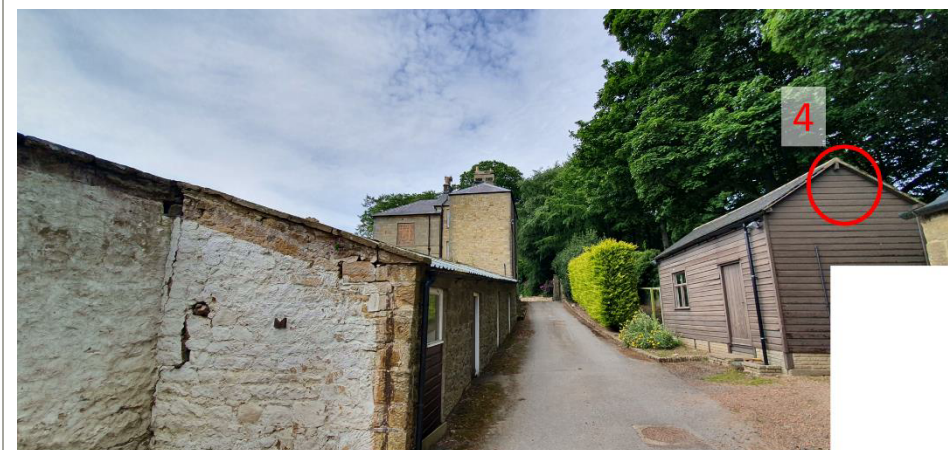
**4:** Roost located under the roof edge at the east facing gable of the wood panelled structure.

Soprano pipistrelle – Non-breeding, Summer roost

Max Count= 1, re-entry, 31 July 2019

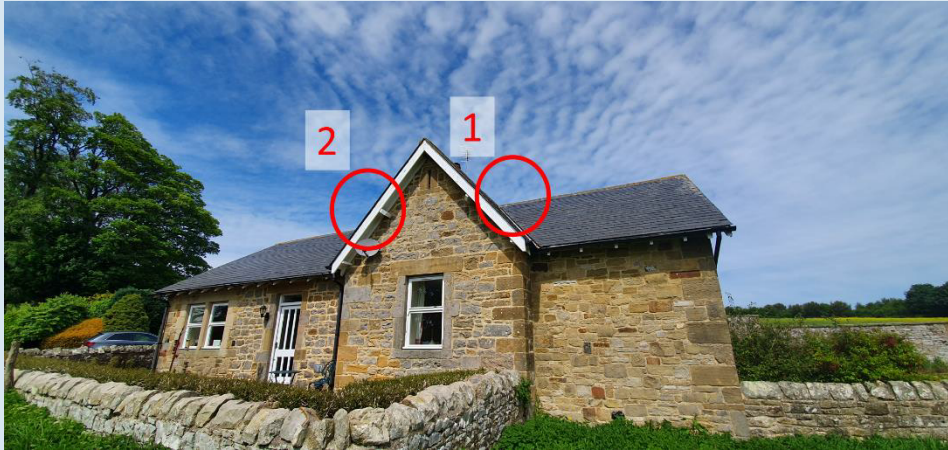
Description of Structure/ Bat Roost Suitability/Hibernation Suitability	Grid Ref	Roost Description and Location
HH3 - Residential single storey, stone wall and slate rooved structure. <b>Bat Roost Suitability = High (2019 Assessment)</b> <b>Hibernation suitability – Moderate</b>	NU 18778 16235	<p><b>1:</b> Roost located on the on the south facing wall of the structure.                      Roost classification:                      Common pipistrelle – Non-breeding, Summer roost                      Max Count = 2, emergence, 8 August 2019</p> <p><b>2:</b> Roost located on the on the south facing wall of the structure                      Roost classification:                      Soprano pipistrelle – Non-breeding, summer roost                      Max count = 1, emergence, 22 July 2019</p>

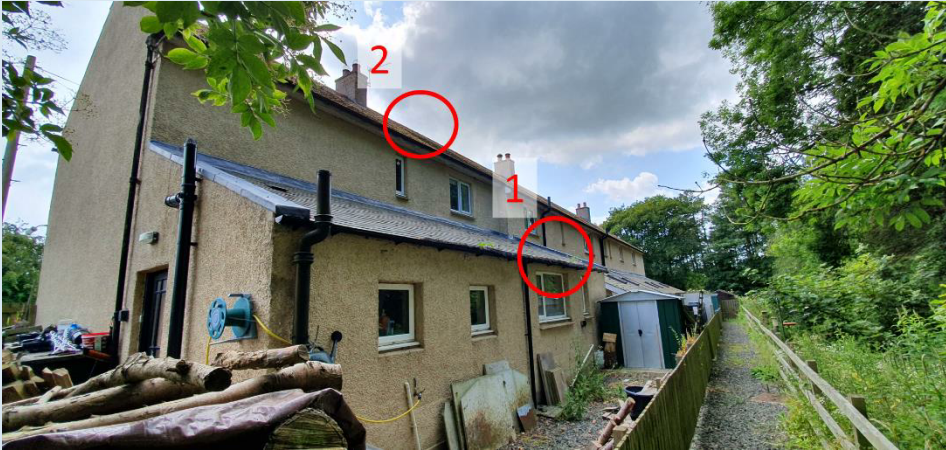
Description of Structure/ Bat Roost Suitability/Hibernation Suitability	Grid Ref	Roost Description and Location
SF1 - Two storied, newly built/refurbished structure with stone walls and slate tiled roof. Not with in Bat Survey Area	NU 19285 18980	No roost was recorded
SF2 - two storey residential structure with pebble dashed walls with tiled roof. <b>Bat Roost Suitability = High (2019 Assessment)</b> <b>Hibernation suitability – Moderate</b>	NU 19199 18903	No roost was recorded
SF3 - two storey residential terrace with pebble dashed walls with tiled roof. <b>Bat Roost Suitability = High (2019 Assessment)</b> <b>Hibernation suitability – Moderate</b>	NU 19174 18941	<p><b>1:</b> Roost was located under the gutter of a single-storey lean-to extension at the northeast aspect of the building  <b>Roost classification:</b>                      Common Pipistrelle – Non-breeding, summer roost                      Max count = 1, emergence, 22 July 2019</p> <p><b>2:</b> Roost was located under a ridge tile between the 2<sup>nd</sup> and third chimneys from the eastern end of the structure  <b>Roost classification:</b>                      Unspecified species, Possible common/soprano pipistrelle– Non-breeding, summer roost</p>

<p>Max Count = 1, re-entry, 07 August 2019</p>

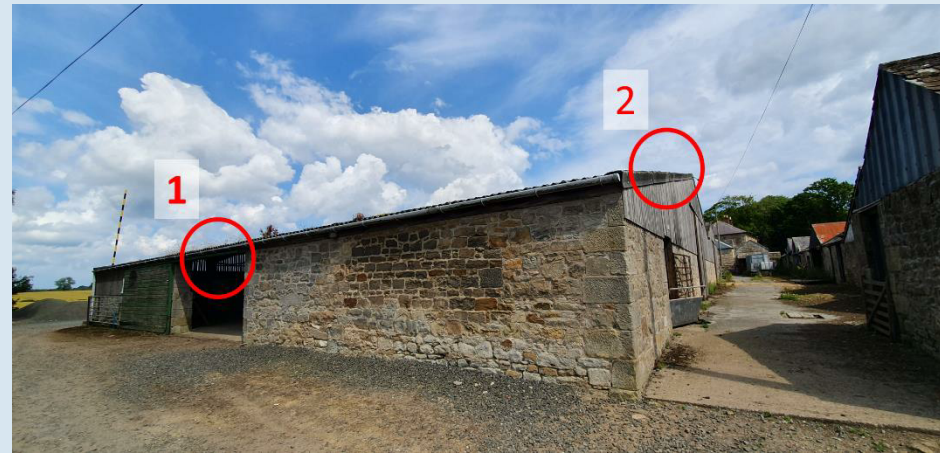
<p>SF4 - 11 single storey, stone barns with tiles rooves.  <b>Bat Roost Suitability = High (2019 Assessment)</b>  <b>Hibernation suitability – Moderate</b></p>	<p>NU 19242          18954</p>	<p>No roost was recorded</p>
<p>SF5 - Large open barn structure.  <b>Bat Roost Suitability = High (2019 Assessment)</b>  <b>Hibernation suitability – Moderate</b></p>	<p>NU 19228          18976</p>	<p>1: Roost was located within in the open barn structure, emergency was recorded form the opening in the west facing wall for the barn.  <b>Roost classification:</b>          Common Pipistrelle – Non-breeding, summer roost          Max count = 1, emergence, 23 August 2019</p> <p>2: Roost was located within in the open barn structure, emergency was recorded form the roof edge on the barns south facing gable end  <b>Roost classification:</b>          Common Pipistrelle – Non-breeding, summer roost          Max count = 1, emergence, 23 August 2019</p>

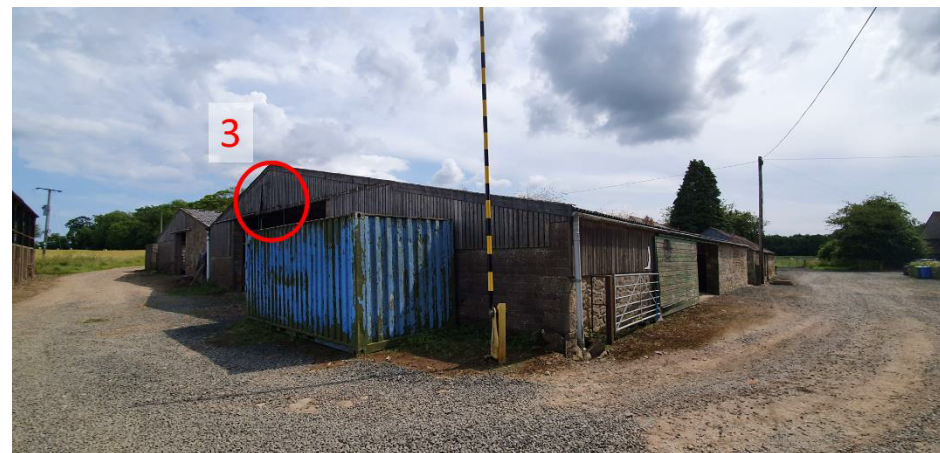
3: Roost was located within in the open barn structure, emergency was recorded form the opening in the north facing gable end of barn

Soprano pipistrelle– Non-breeding, summer roost

Max count = 1, re-entry, 23 July 2019
