# A1 in Northumberland: Morpeth to Ellingham

**Scheme Number: TR010059**

# 6.54 Updated Desk Study and Habitat Verification Survey Report

March 2024

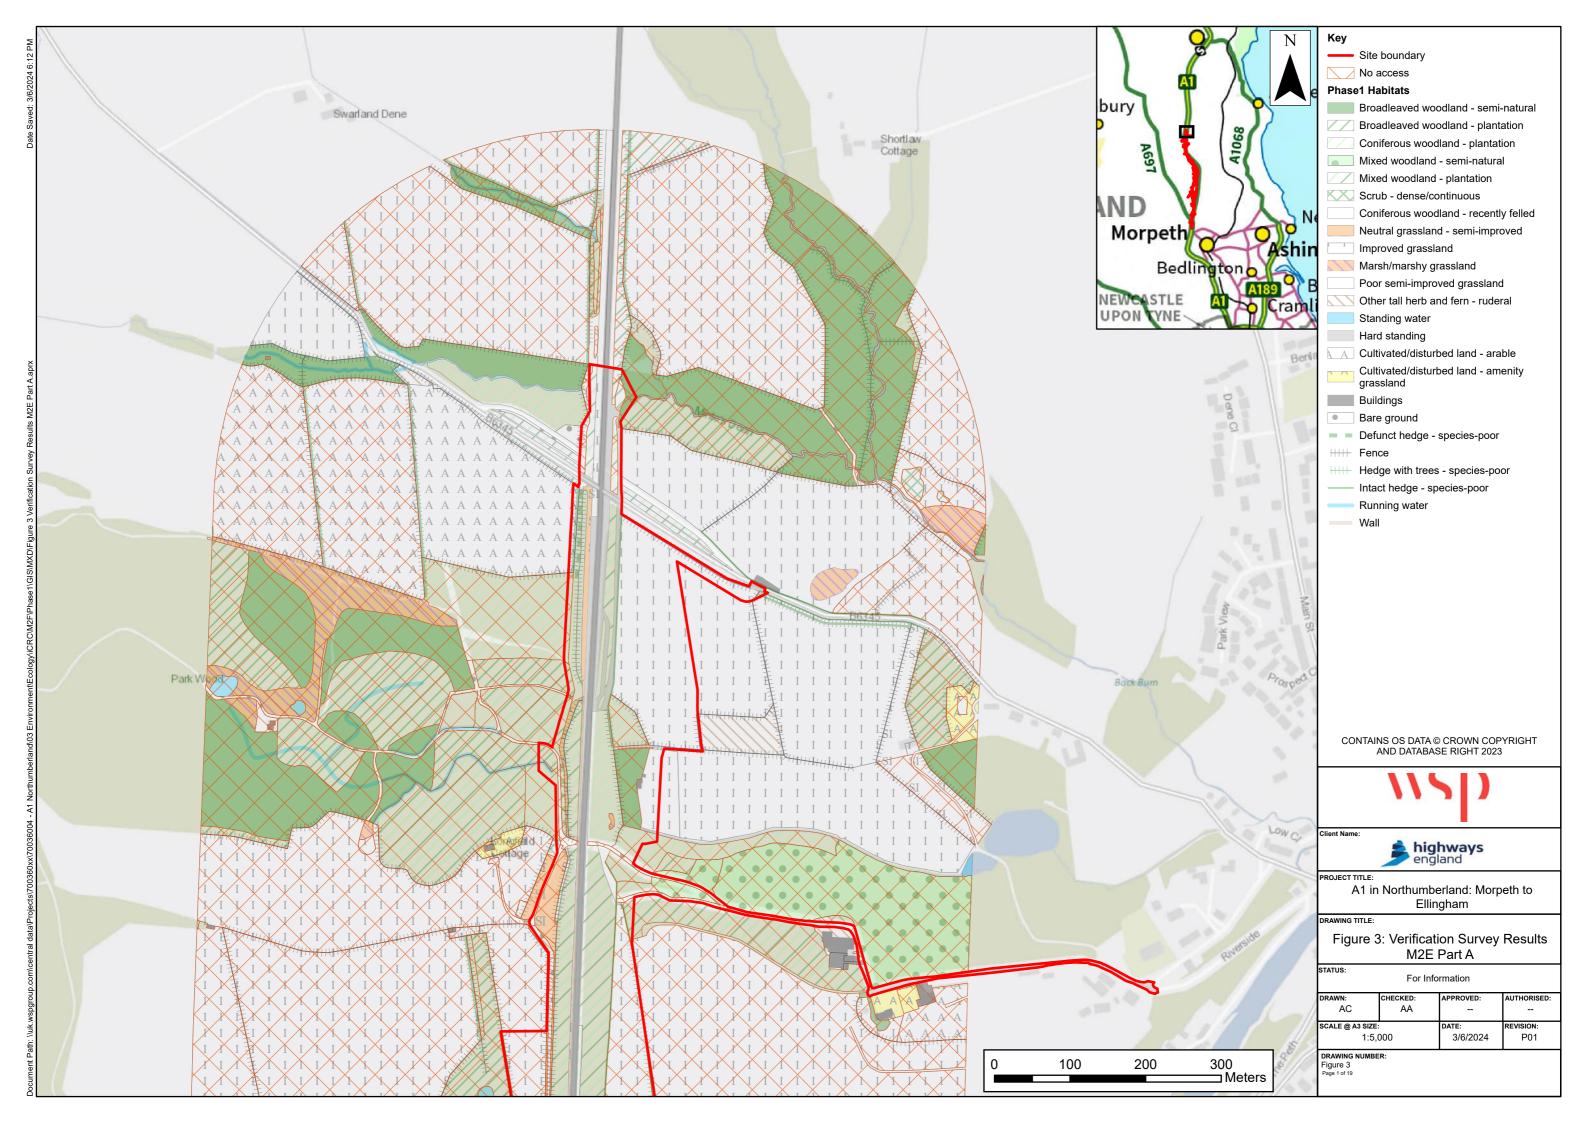
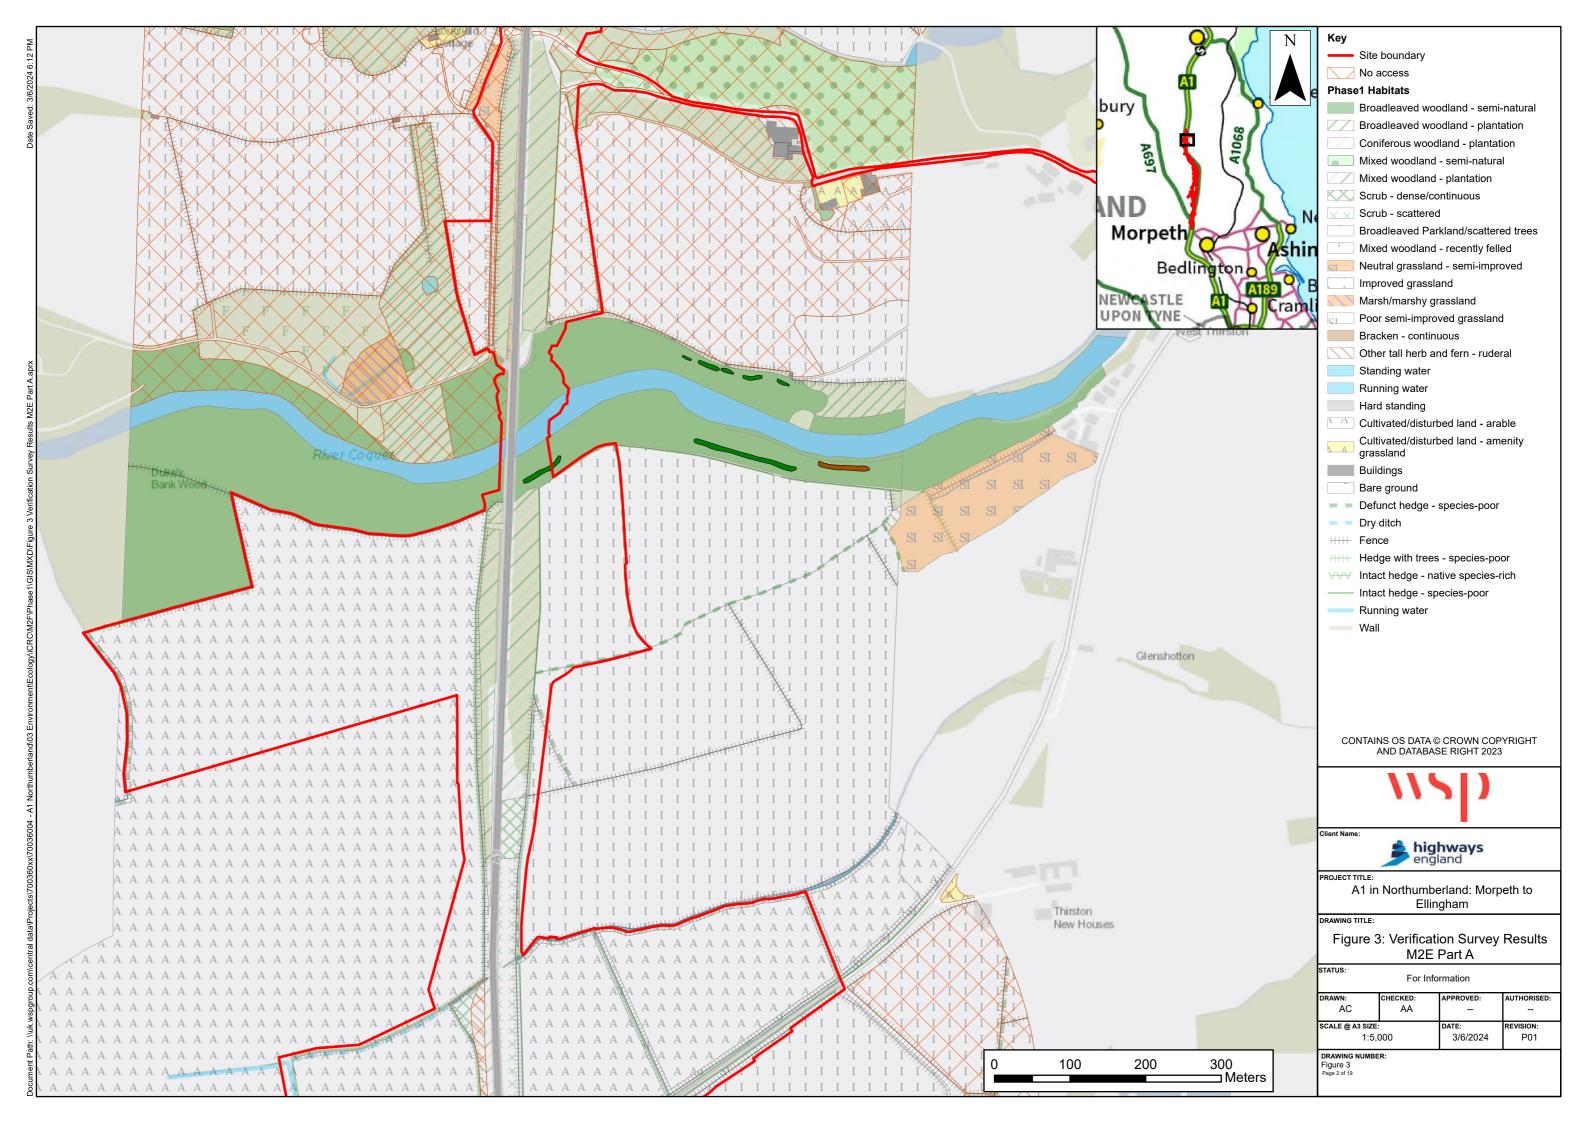
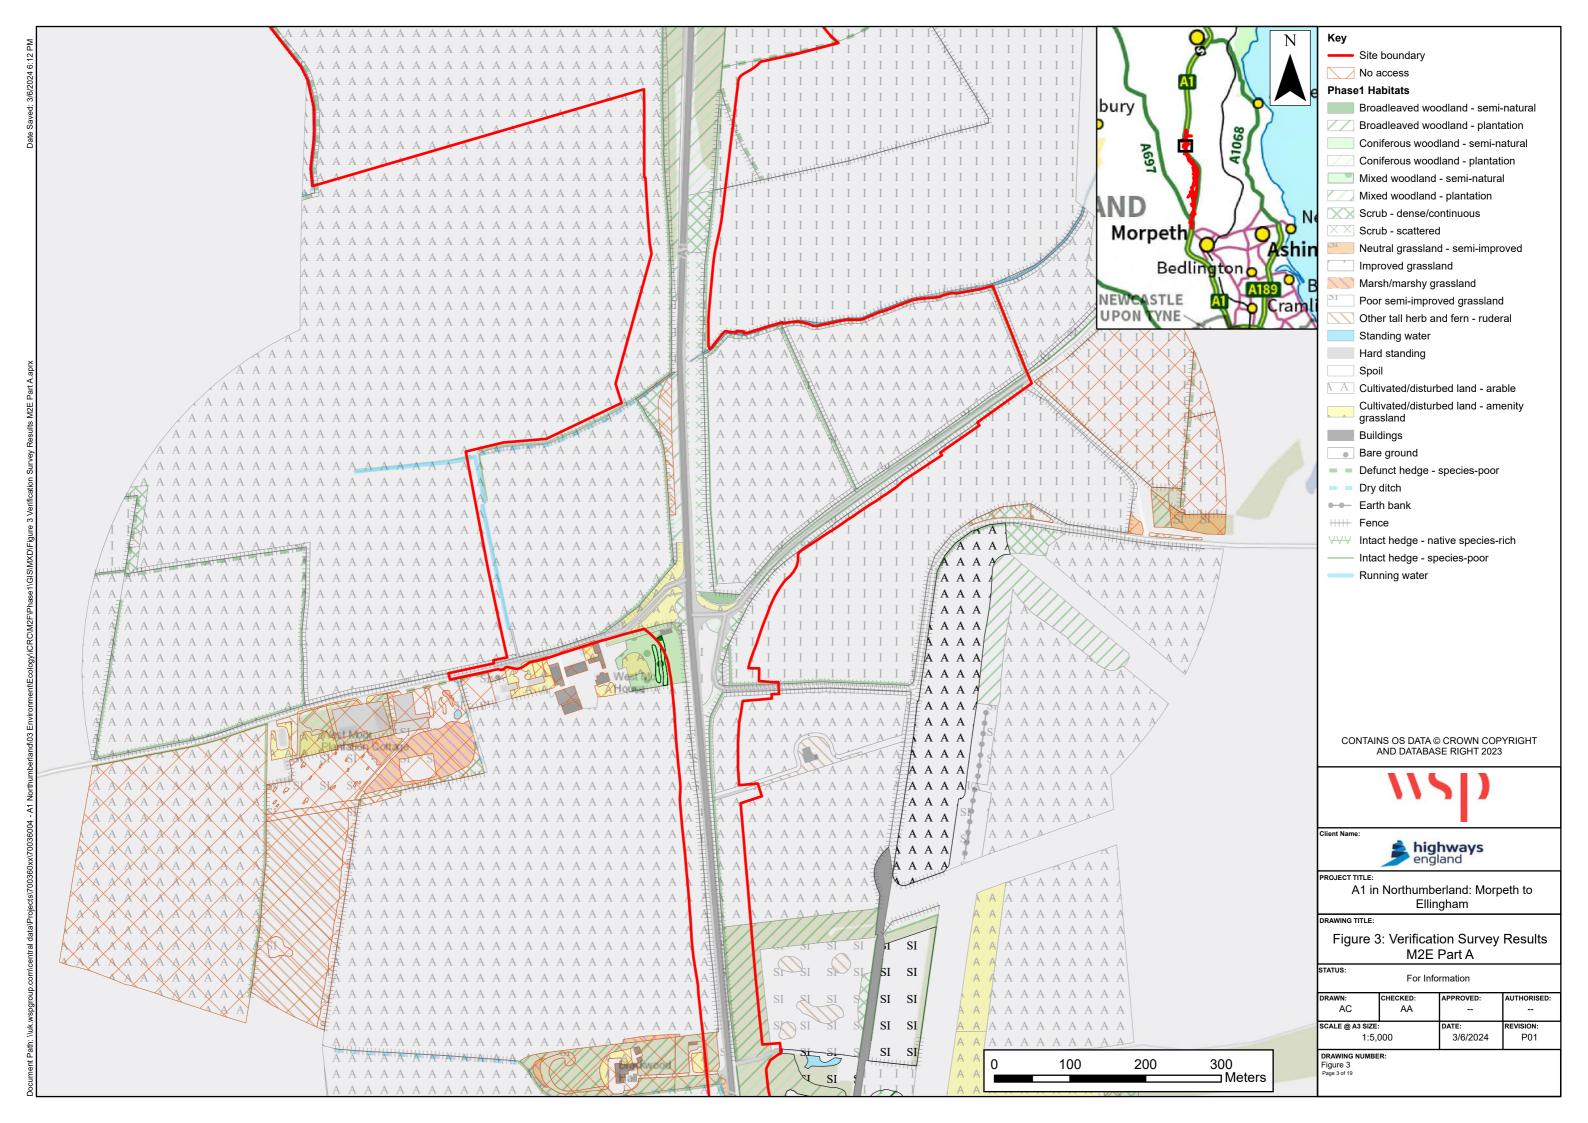
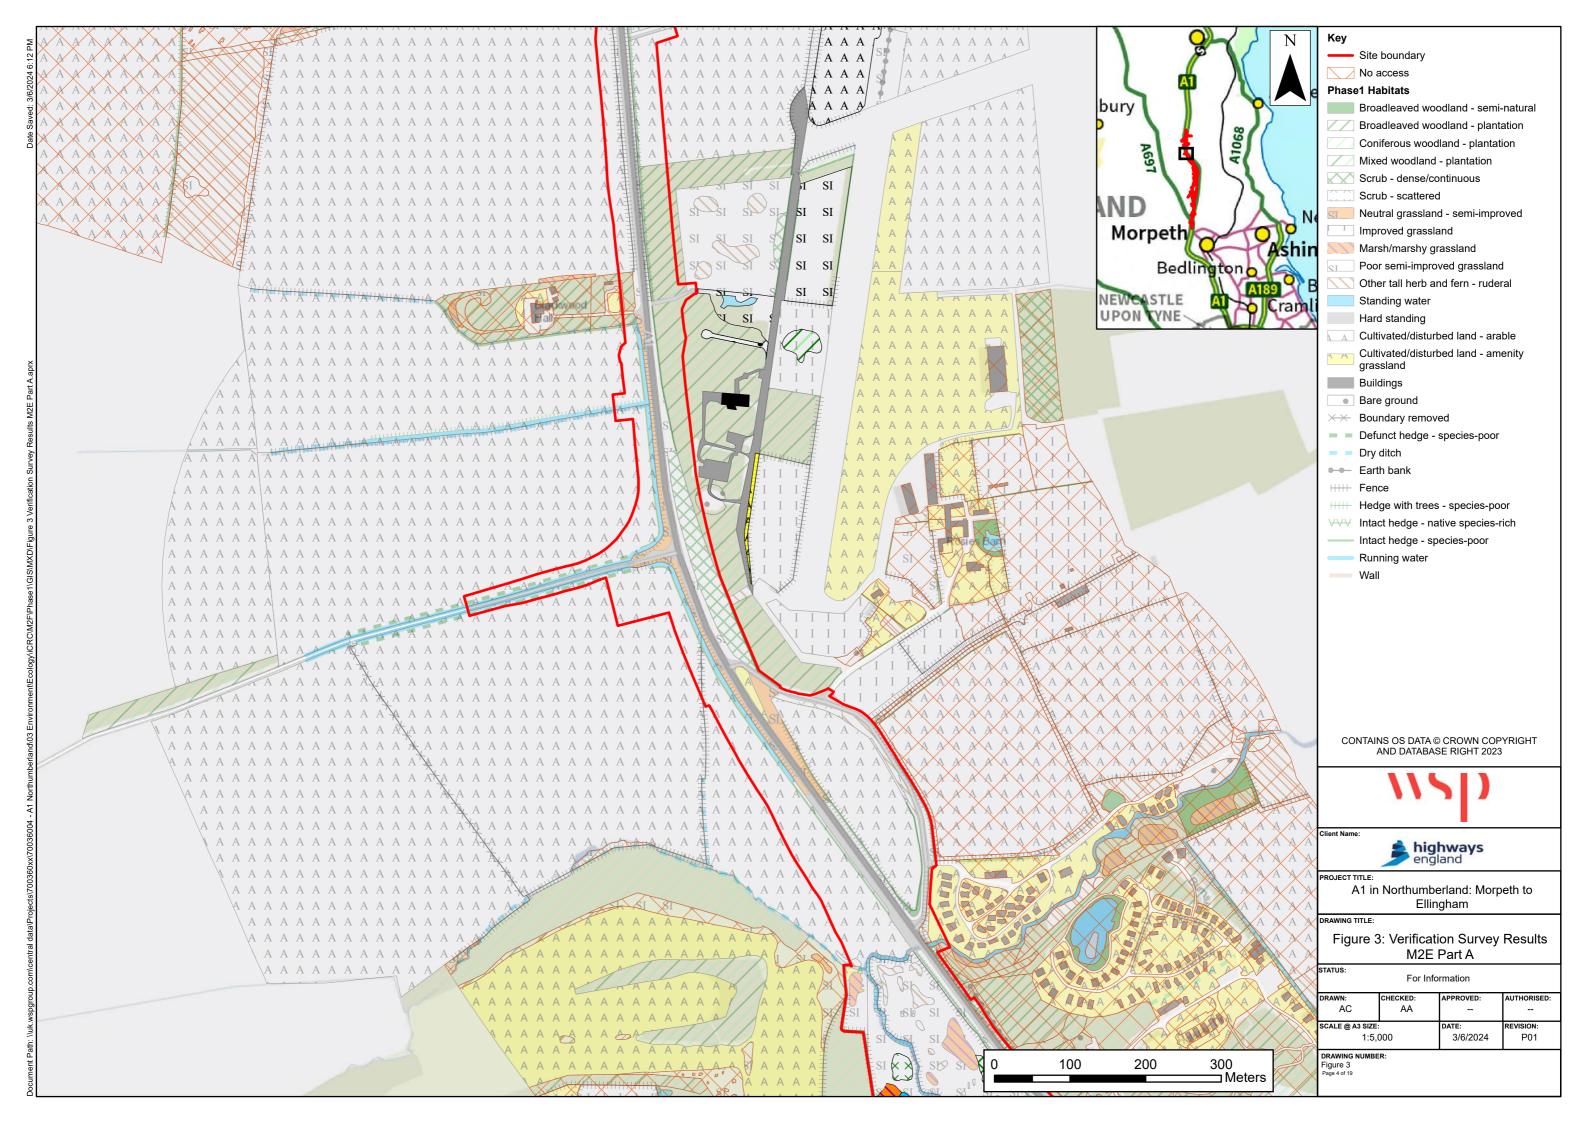
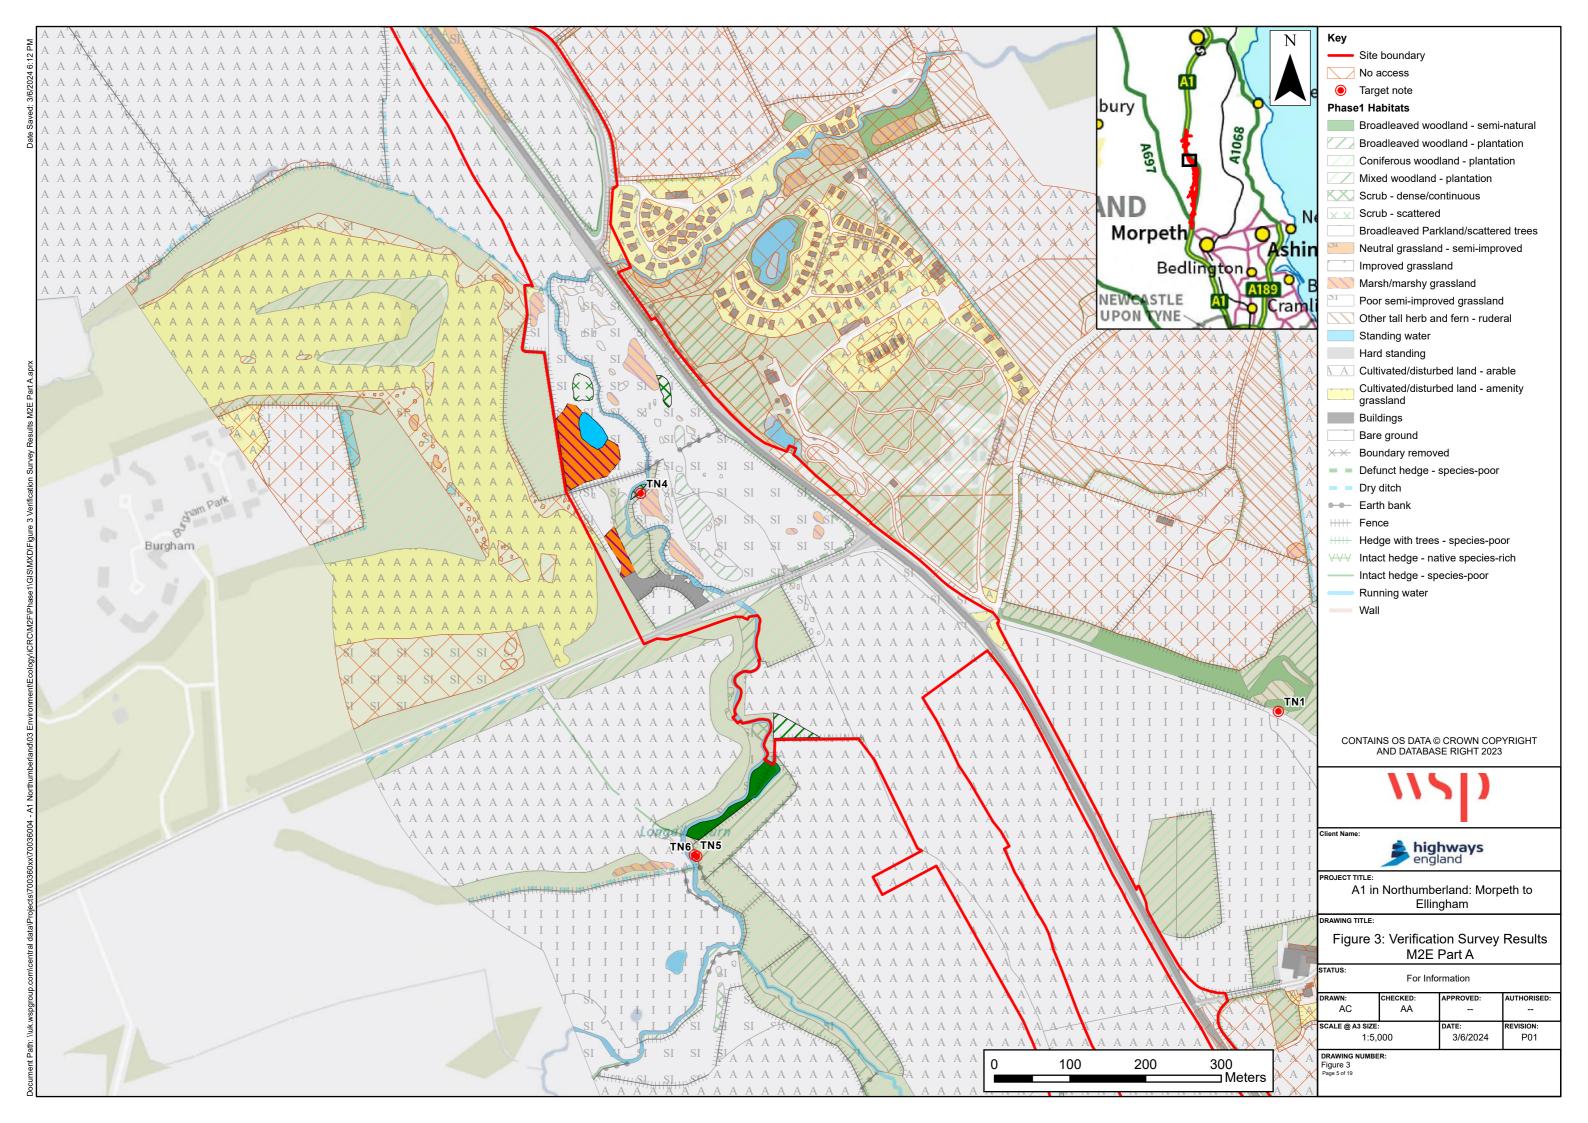
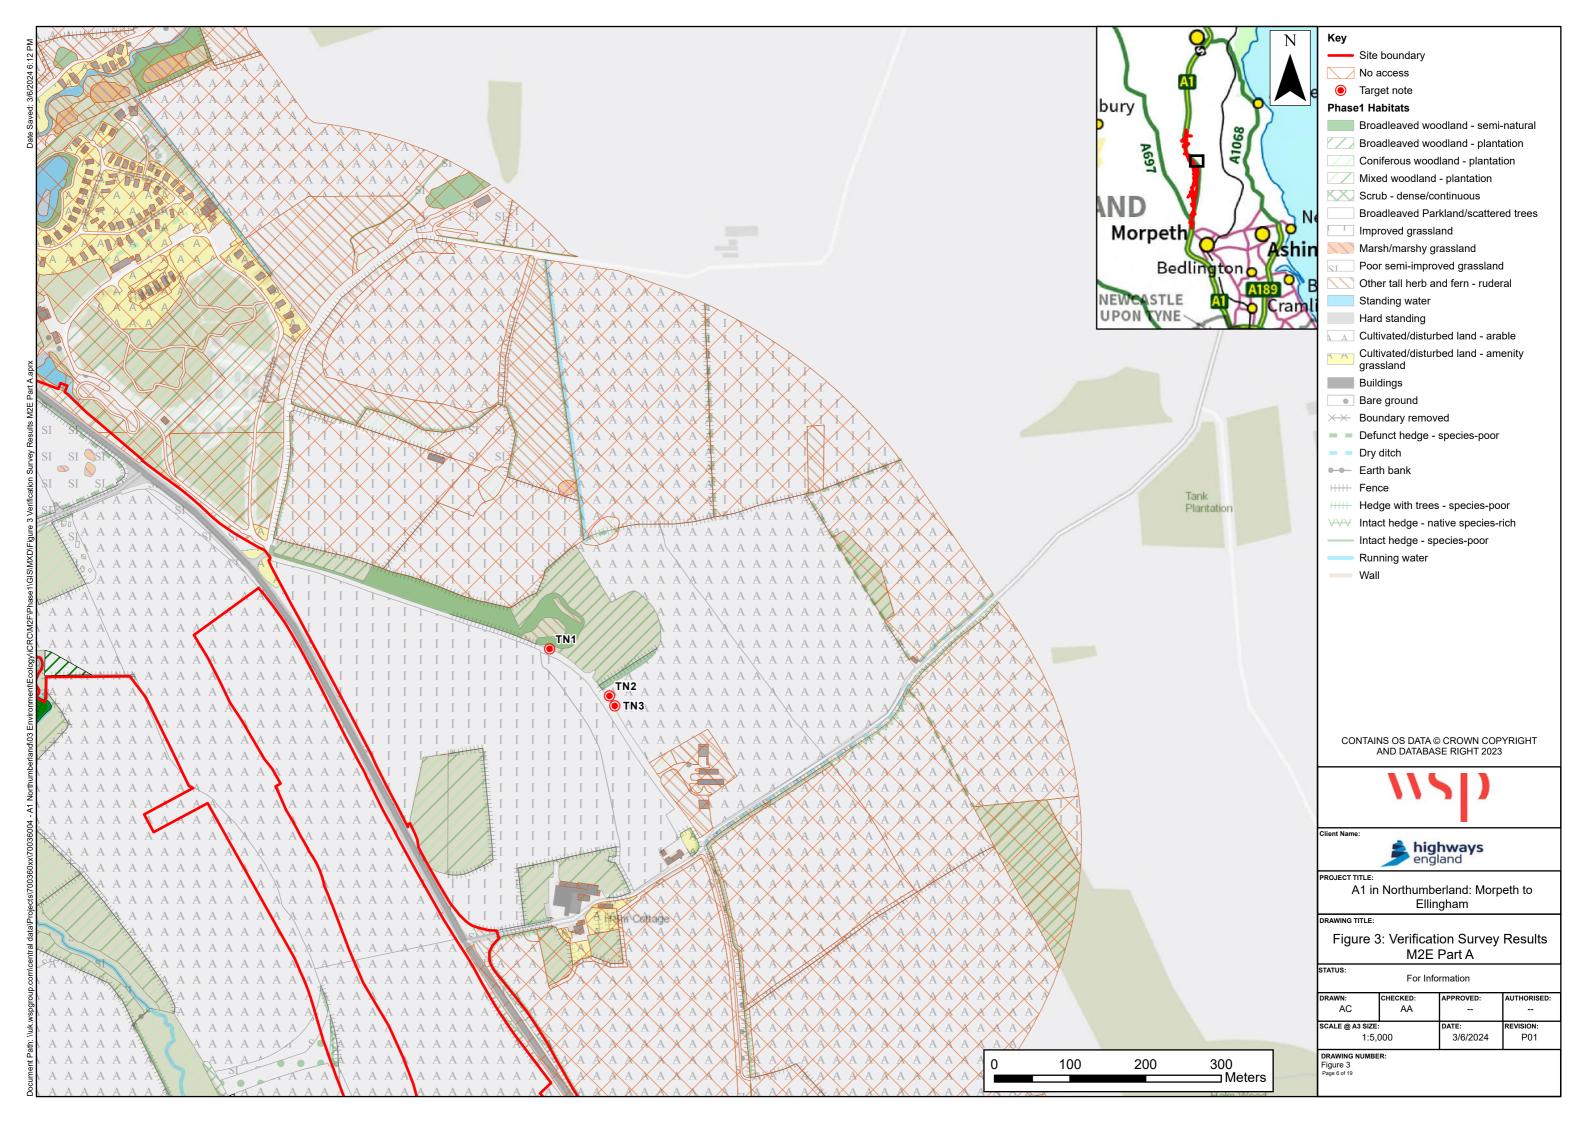
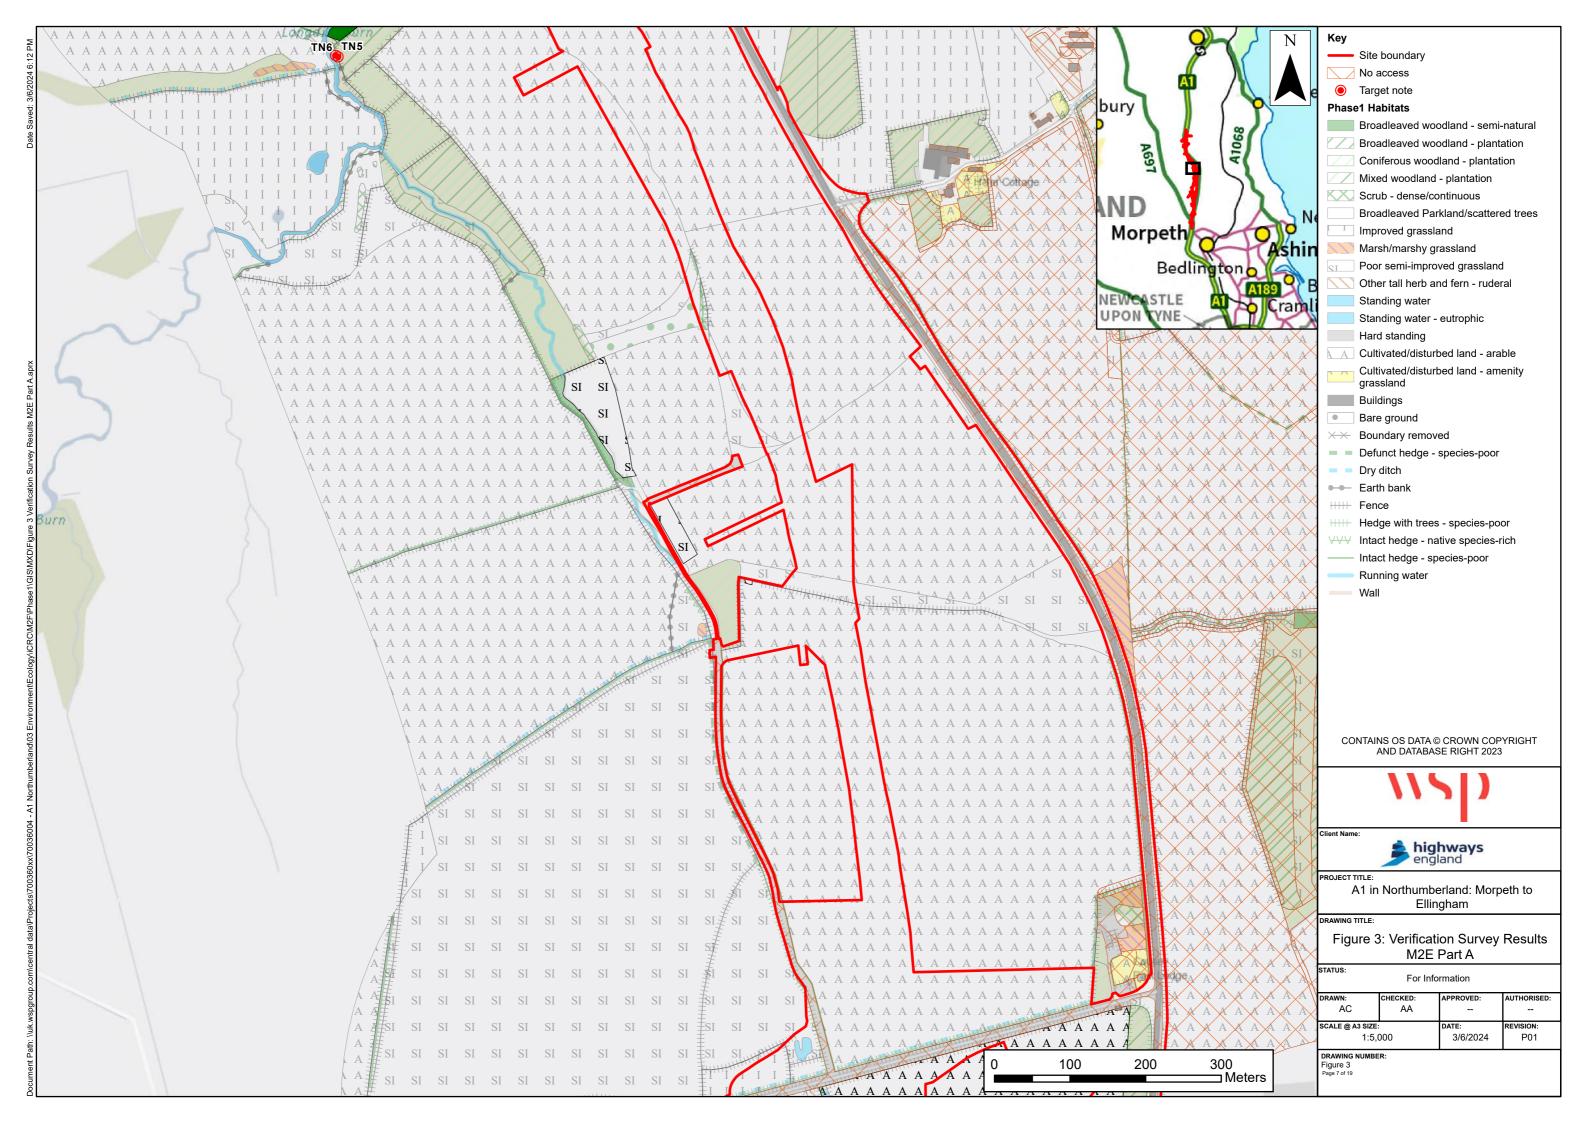
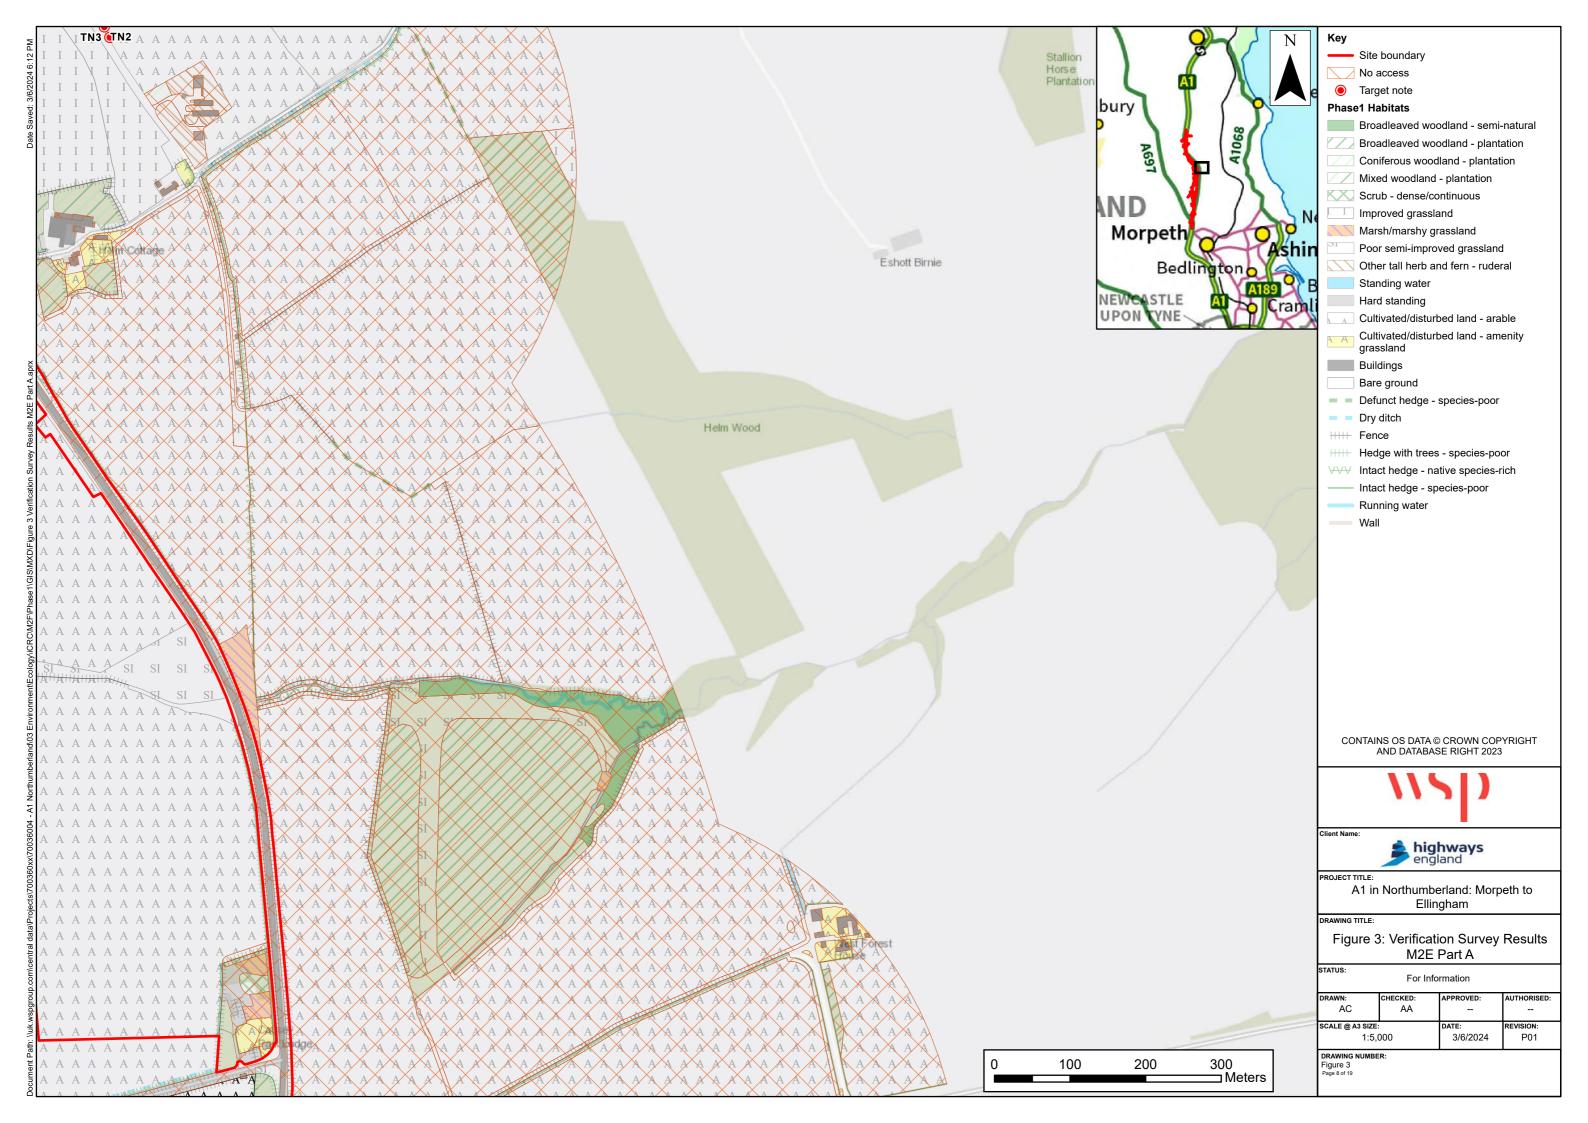
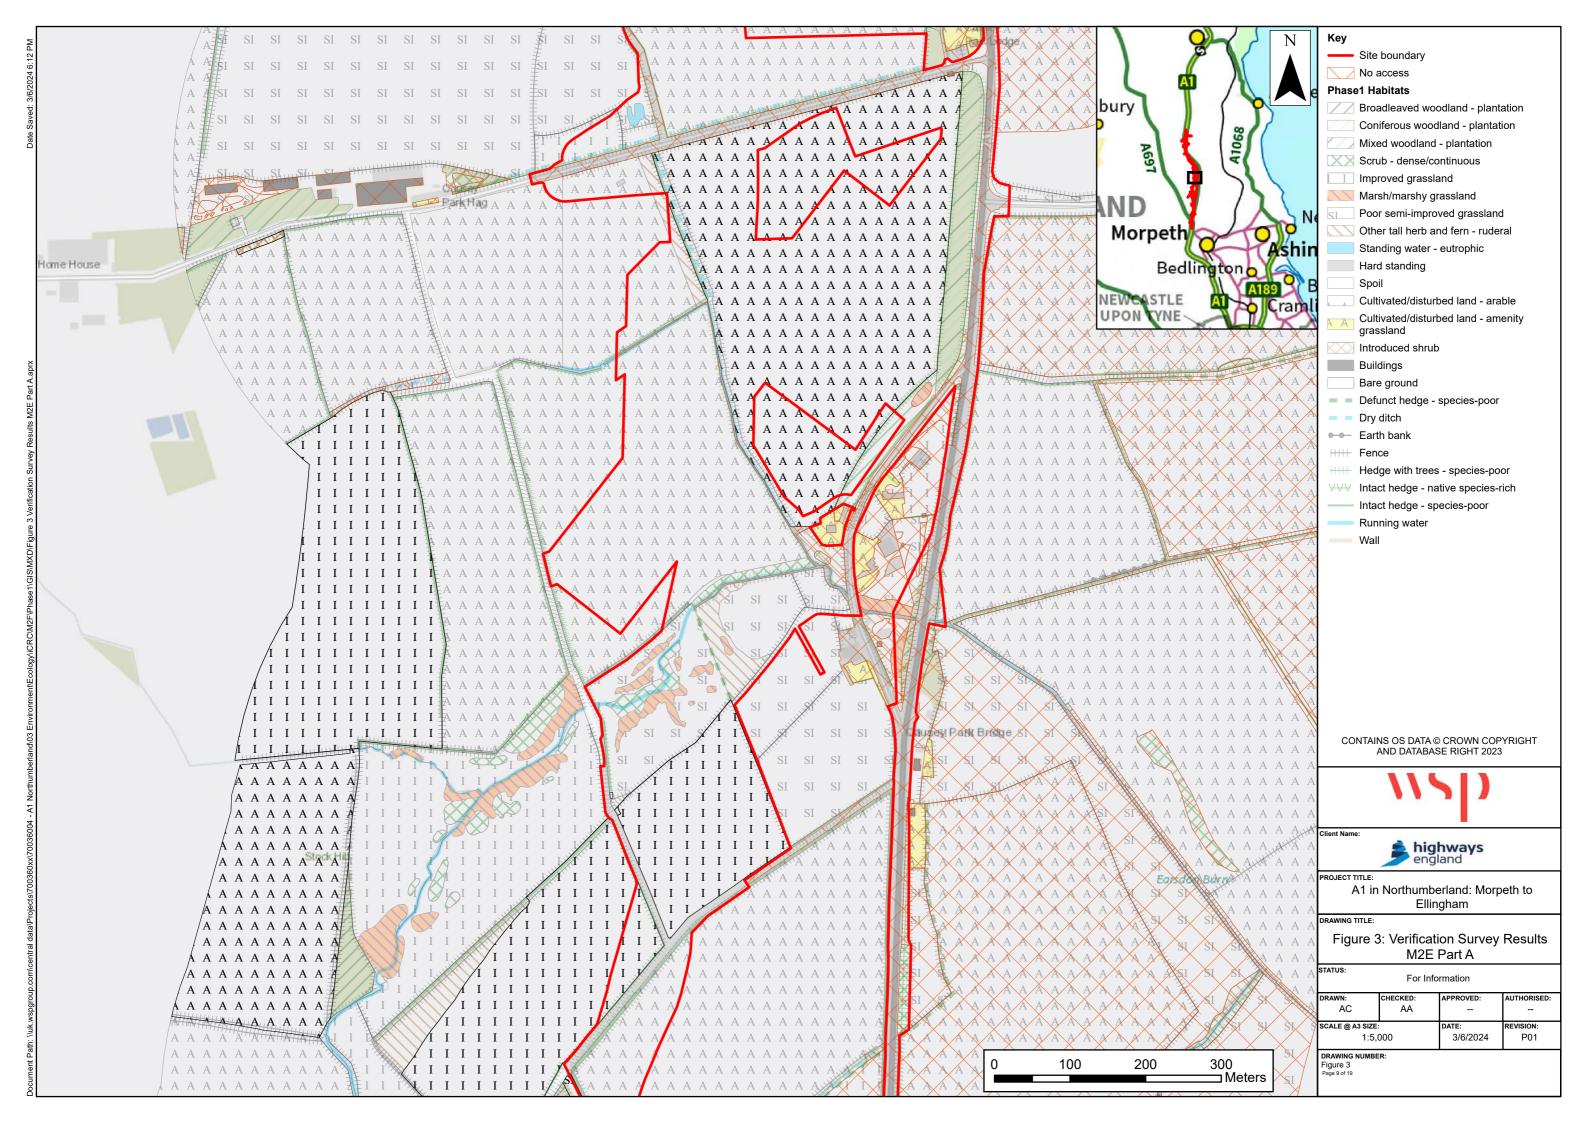
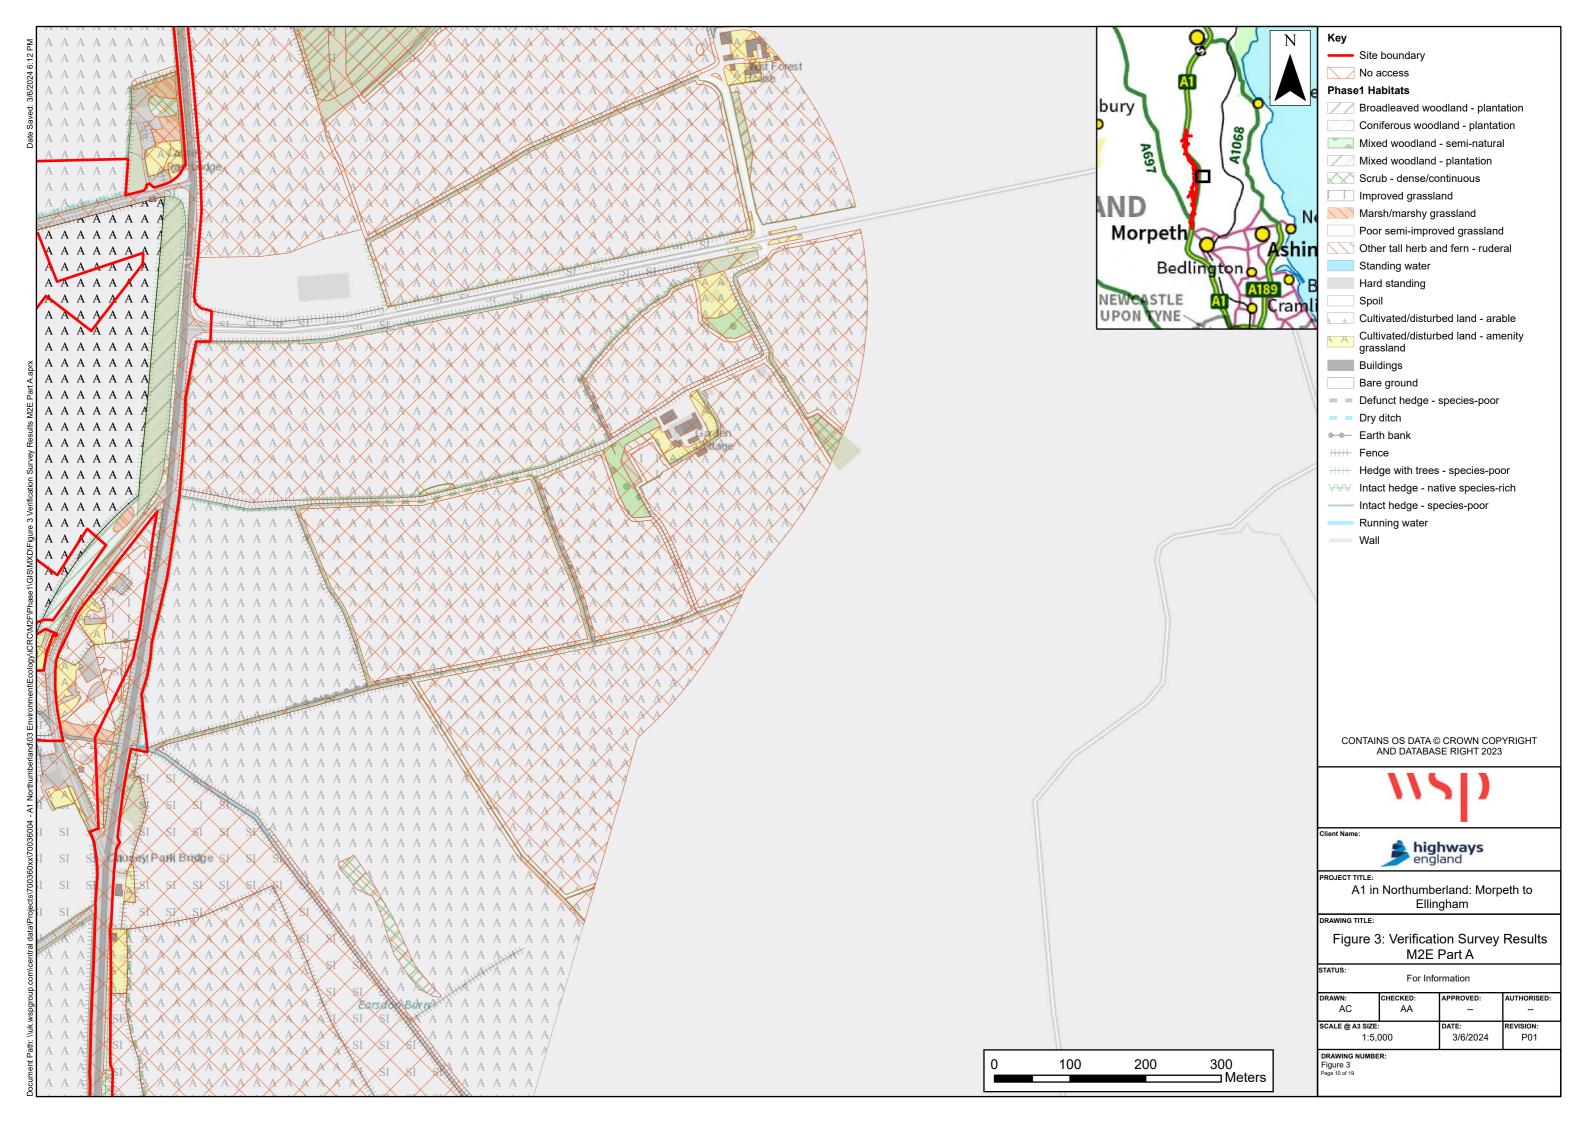
- 2.1.8. Habitats were recorded via digital tablet using Geographical Information System (GIS) software. Where required, target notes were made to capture information on specific features of ecological interest (e.g. a badger sett) or habitat features too small to be mapped. The findings of the verification walkover survey are presented on Figures 3 (Part A) and 4 (Part B).

- 3.3.3. The 2024 habitat verification survey identified habitats to be largely unchanged since the original baseline assessment, with the majority of the Order Limits continuing to represent agricultural land. There were areas of land use change where arable fields had changed use to improved grasslands used for grazing (or vice versa). However, the overall ecological value and importance of these habitats remains the same.

- 3.3.4. A few relatively small patches of semi-natural habitats (<0.1 ha) had naturally succeeded as a result of a lack of, or limited, management. For example, this included small areas of tall ruderal or grassland habitats that had succeeded to scrub, notably to the west of the A1 adjacent to Burgham Park Golf Course (centred around grid reference NZ 17856 97091). In addition, an area previously identified as poor semi-improved grassland had become marshy grassland around standing water also adjacent to the golf course. However, these</p>

- minor changes would not alter the overall impact assessment or significance of effect detailed within the Application (and as updated during the Examination).
- 3.3.5. Habitat changes as identified during the 2024 verification survey are shown in bold on **Figure 3**. Overall, the findings of the updated assessment do not change the importance classification of habitats within the Order Limits, the impact assessment or the significance of effect detailed in **Chapter 9**: **Biodiversity Part A [APP-048]**.
