A12 Chelmsford to A120 widening scheme

6.3 ENVIRONMENTAL STATEMENT APPENDIX 7.4 AERIAL INVESTIGATION AND MAPPING REPORT

Aerial Investigation and Mapping Report

Date: January 2021

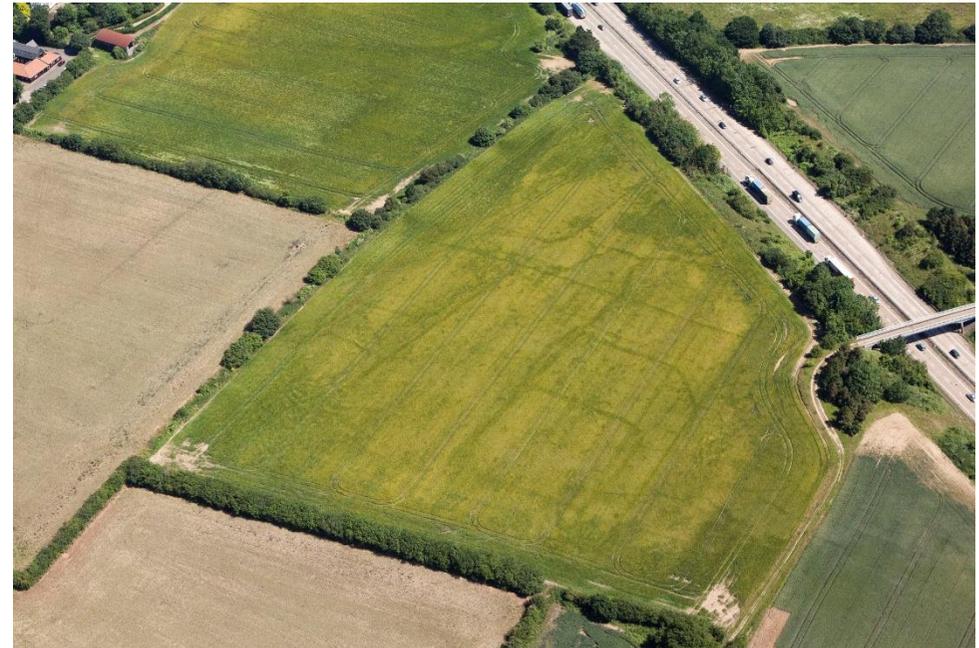
Plate 1 - Aerial Photograph of a possible enclosure (Site 16) (EX19/03/015 © Essex County Council)

All the photographic prints held within the HER were assessed in conjunction with the digital images (both oblique and verticals) held (Plate 1 is an example of a digital oblique image held within the HER and Plate 2 is an extract from the ECC vertical collection). The Essex County Council vertical collection is entirely digital, with scanned prints from 1960 to 1990 and digital ortho-rectified images from 2000, 2010 and 2014. The HER holds a limited number of prints from the Cambridge University Collection of Aerial Photographs (CUCAP) and these were assessed along with the other prints; however, the HER only holds approximately 18% of the prints that are actually within the CUCAP collection.

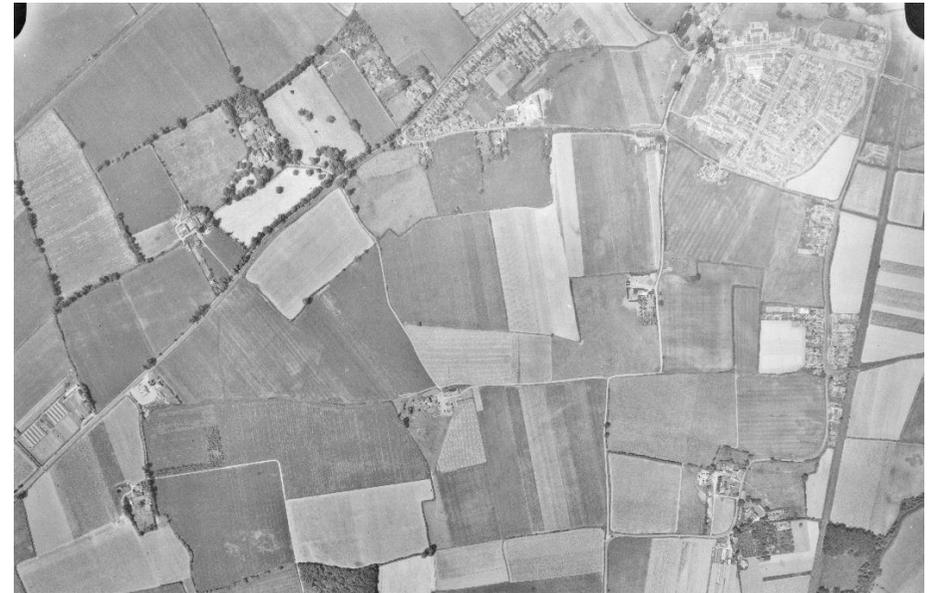
Plate 2 - Extract from a 1960 ECC vertical prior construction of the A12 (ESSEX/60/19/042 © Essex County Council)

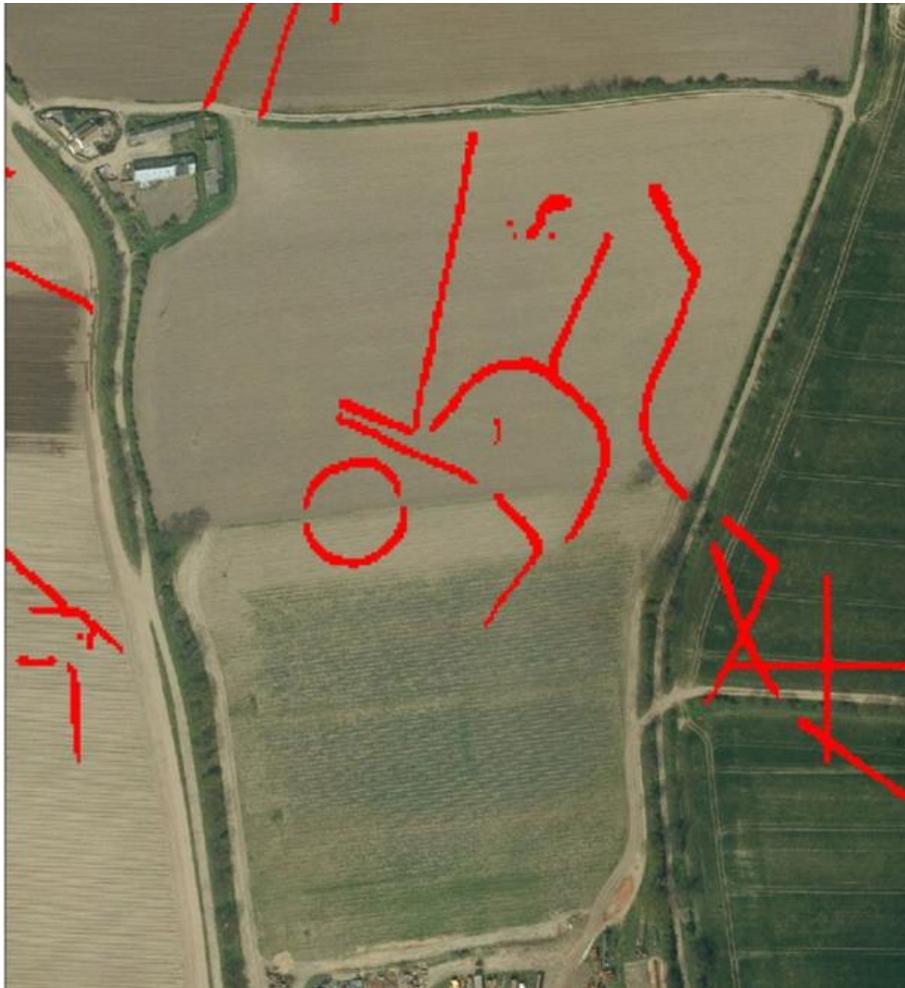
Plate 3 - The archaeological cropmarks identified during the NMP at Mill House Farm, Chadwell St. Mary

The original NMP emphasized the extensive number of below-ground archaeological features that could only be seen from the air. However, recent excavations have demonstrated that while archaeological cropmarks are crucial to the identification of sites, they rarely give a true indication of the number of archaeological features on a site. The archaeological cropmarks of a circular enclosure approximately 40m in diameter, some field boundaries and a possible incomplete sub-circular enclosure were identified and recorded during the Essex NMP at Mill House Farm, Chadwell St. Mary (Plate 3). However, Plate 4 shows the excavation plan following work carried out ahead of gravel extraction (Archaeological Solutions 2017). This excavation identified an extensive archaeological landscape comprising in excess of 1000 features.

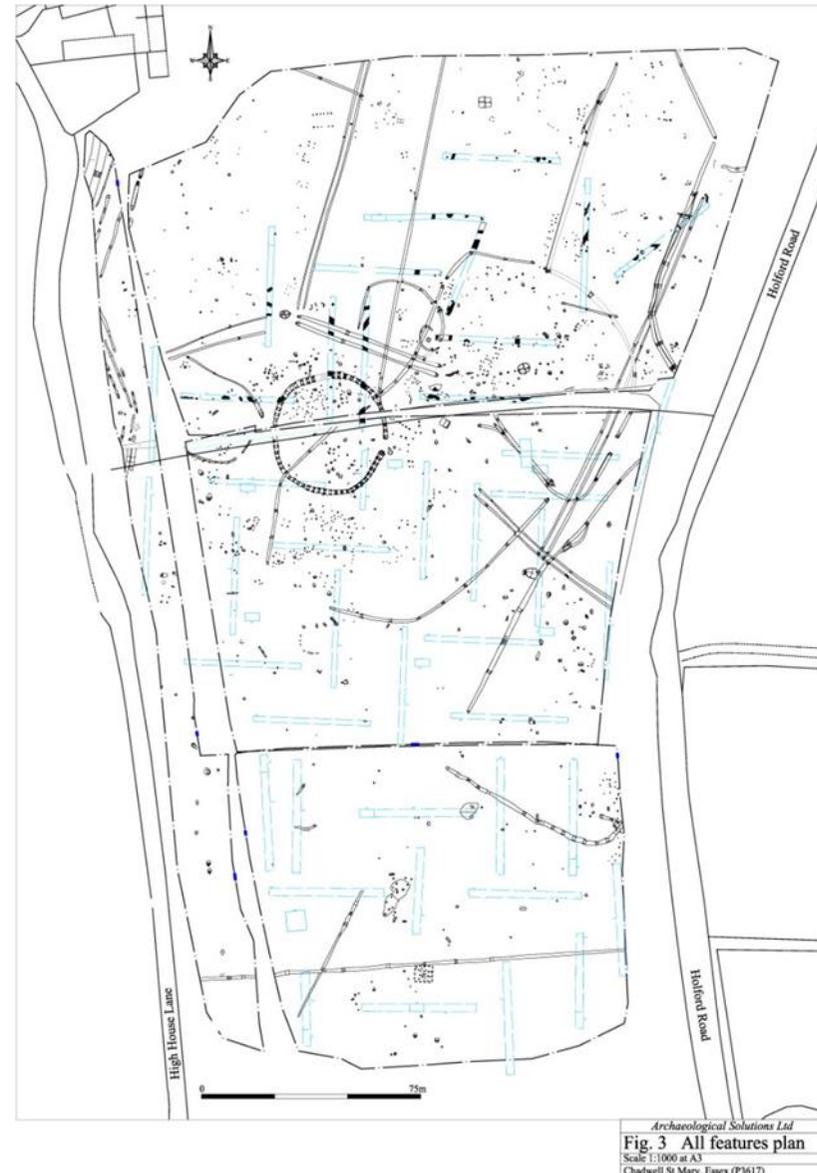
Plate 4 - Excavation plan of all features identified at Mill House Farm, Chadwell St. Mary (© Archaeological Solutions 2017, Figure 3)

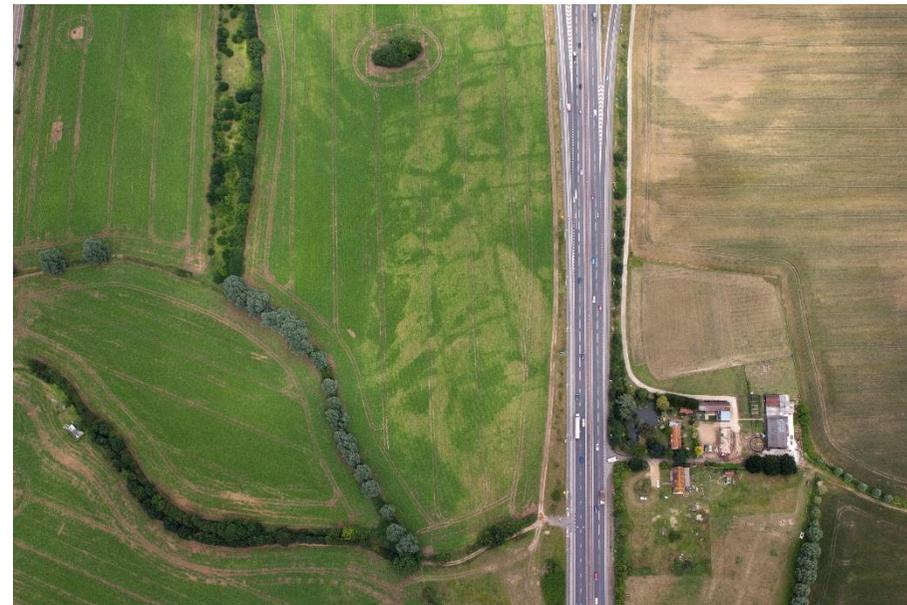
Plate 5 – Geological cropmarks masking archaeological features at Site 7 (EX17/04/107 © Essex County Council)

Several sites had both archaeological and geological cropmarks visible. Where the underlying geology created geological cropmarks, it is possible that further archaeological features have been masked. Plate 5 shows the widespread geological marks on Site 7, with extensive archaeological features present.

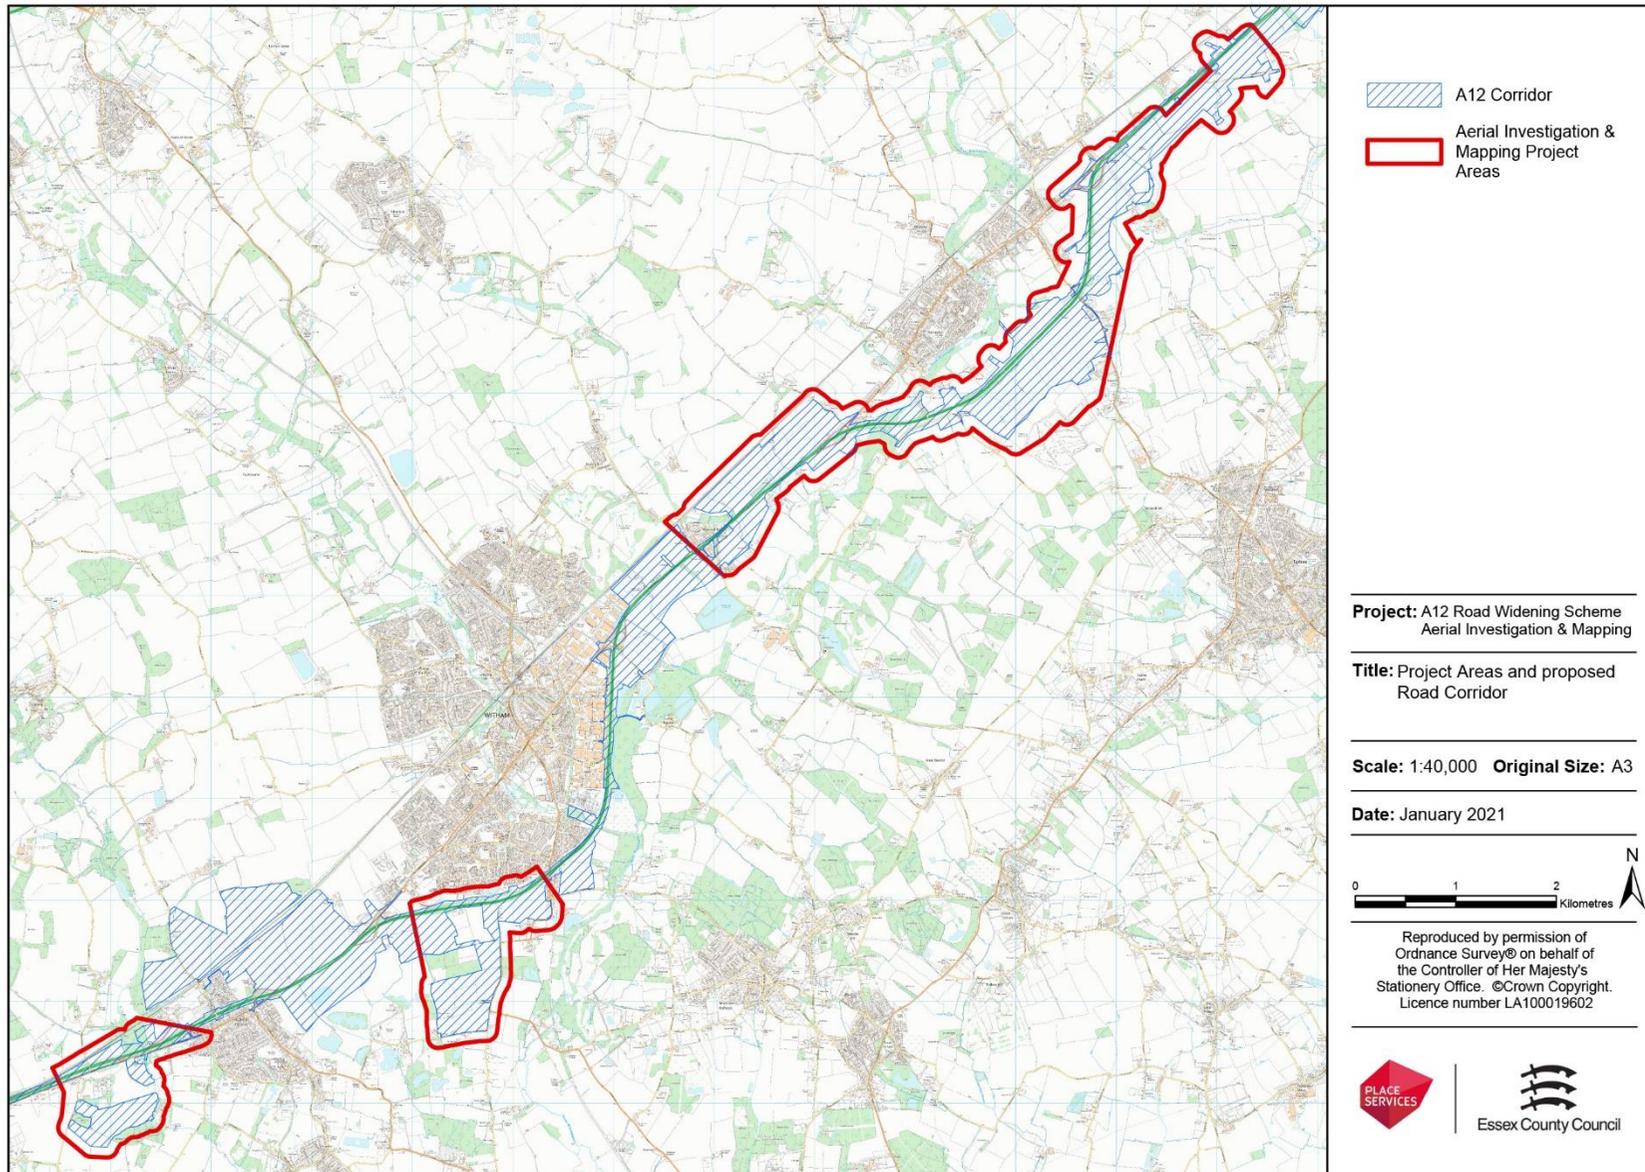
Figure 1 - Project areas and proposed road widening corridor

While the proposed road widening corridor runs between Boreham and Marks Tey the current AIM work has specifically targeted three areas. A GIS shape file of the specific road corridor was supplied by the client and areas were identified within this corridor that would benefit from additional AIM work. The study areas cover approximately 845 hectares including a small buffer of 100m (Figure 1). The majority of historic assets visible were within these areas and were recorded for this project, although several features were noted outside the study areas.

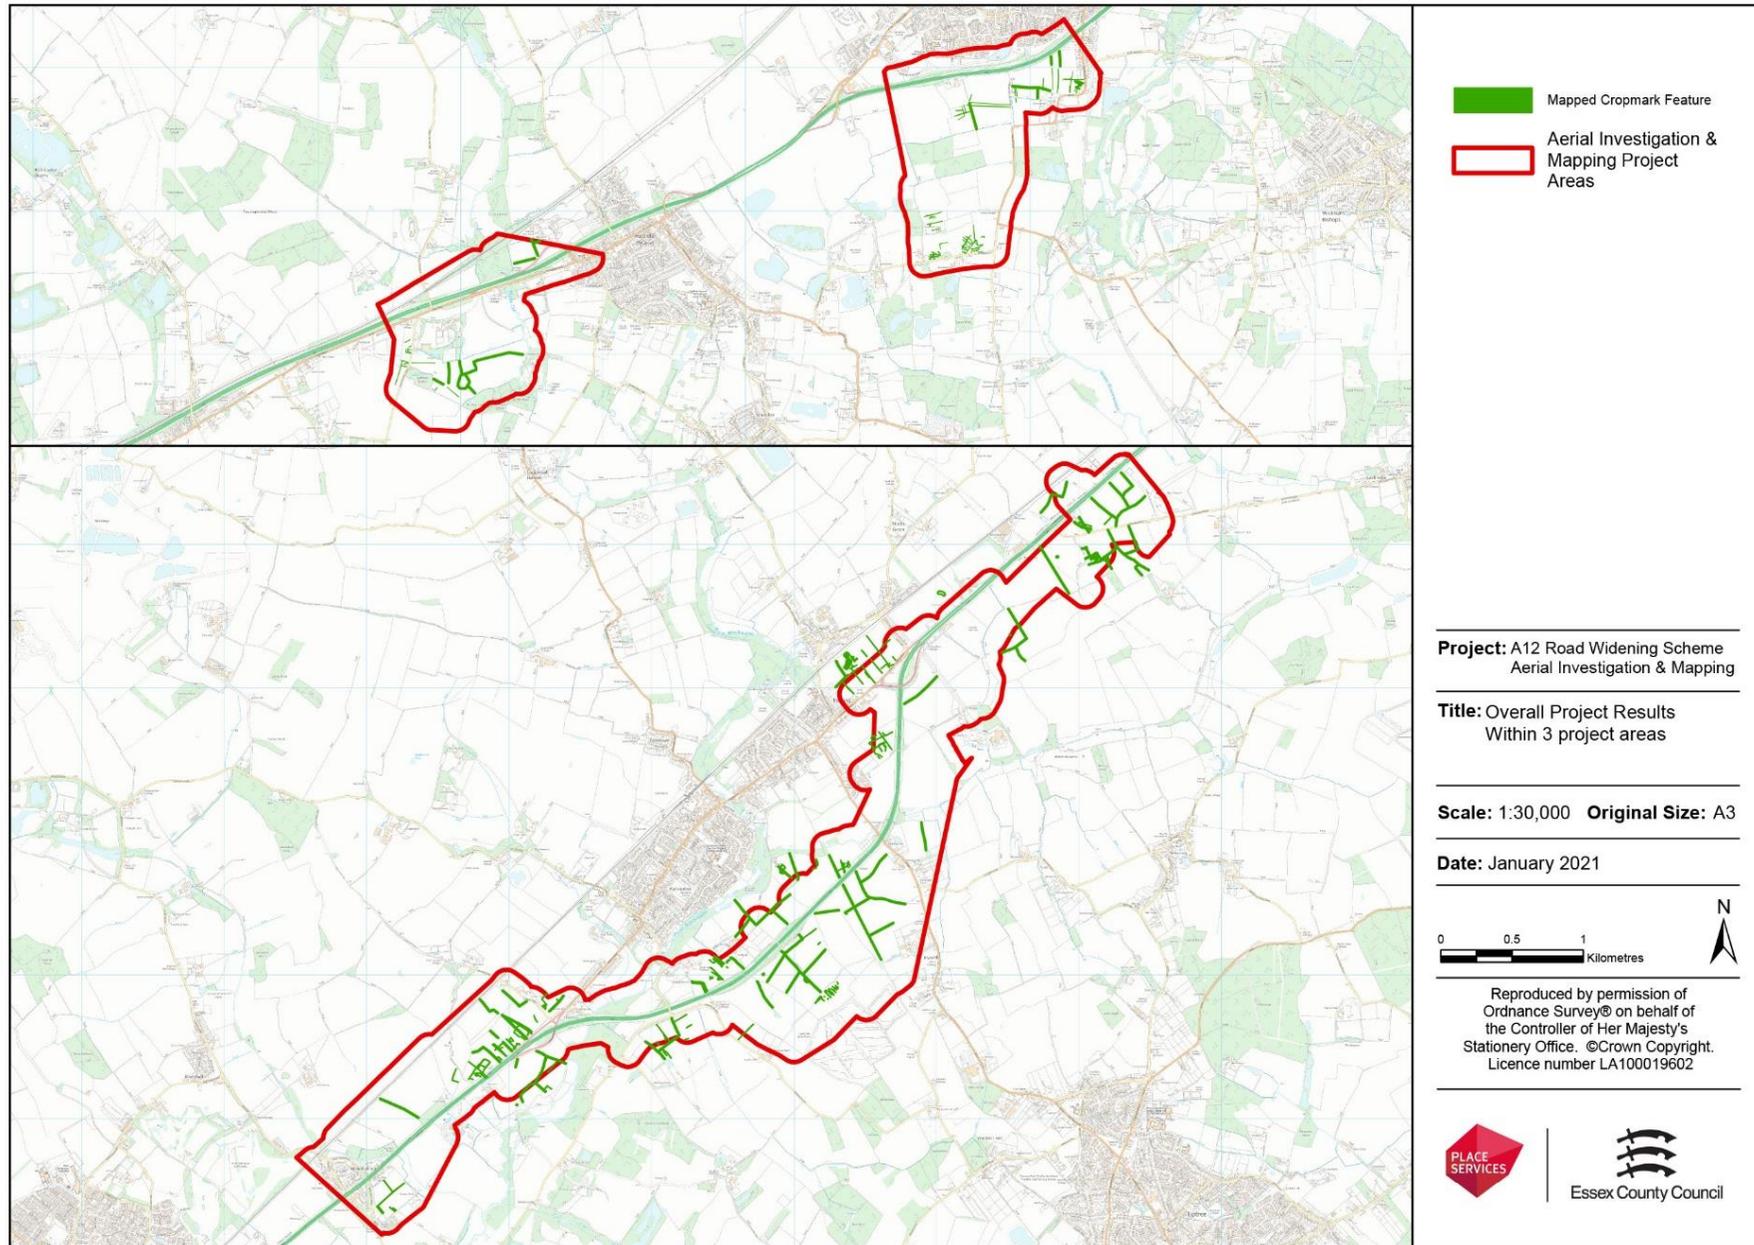
Figure 2 - All archaeological features mapped within the project areas

Archaeological features were recorded along the road corridor and an overall project results can be seen in Figure 2 . Below is a table of the results from this AIM work. Each site area has a summary description of the features recorded and where possible a suggested date and function. A guide to the archaeological potential and archaeological significance of each site has been given as Low, Medium, High or Very High. The location of each site can be seen in Figure 3. There were a few features that were recorded on the original NMP that were not recorded during this current project. This could be because access to the photographs was limited and they were not visible on the assessed images or because of the interpretation of the visible features. Where these previously mapped features are located within a digitally mapped site they have been noted below

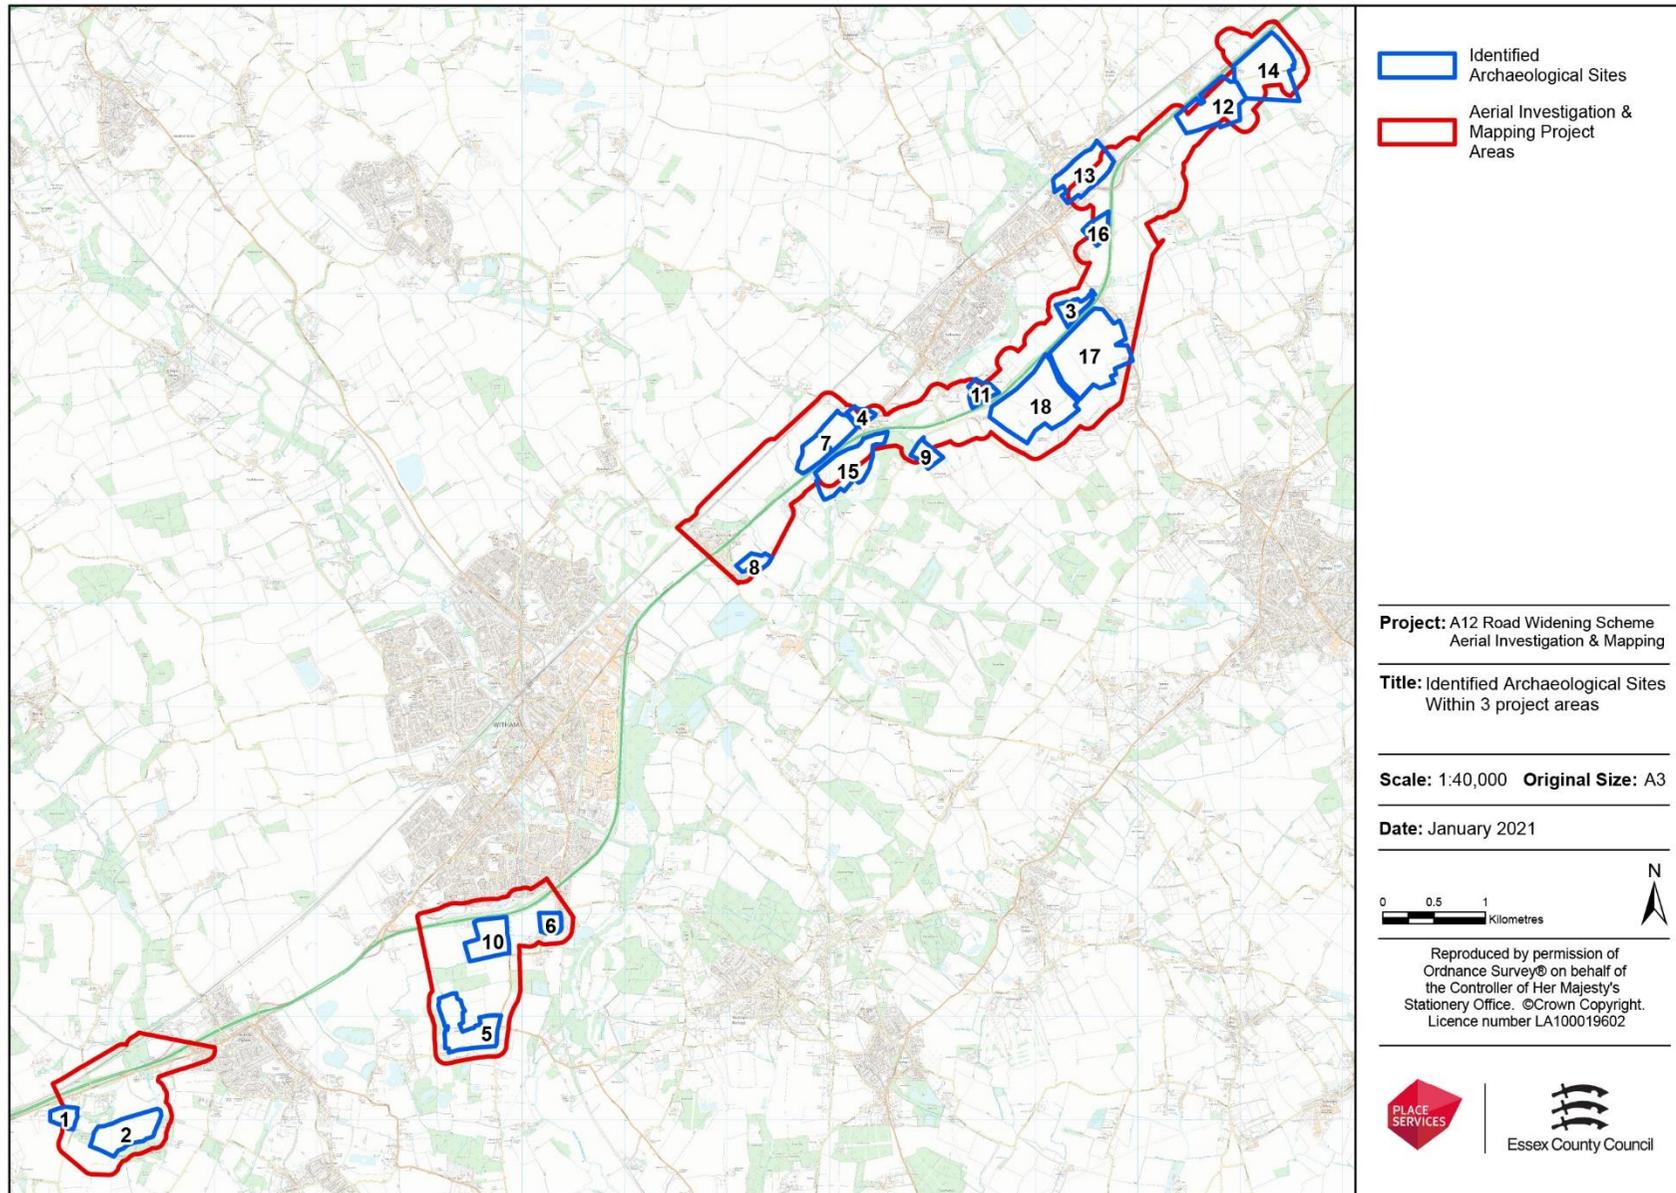
Figure 3 – Areas of identified archaeological features and Site Numbers

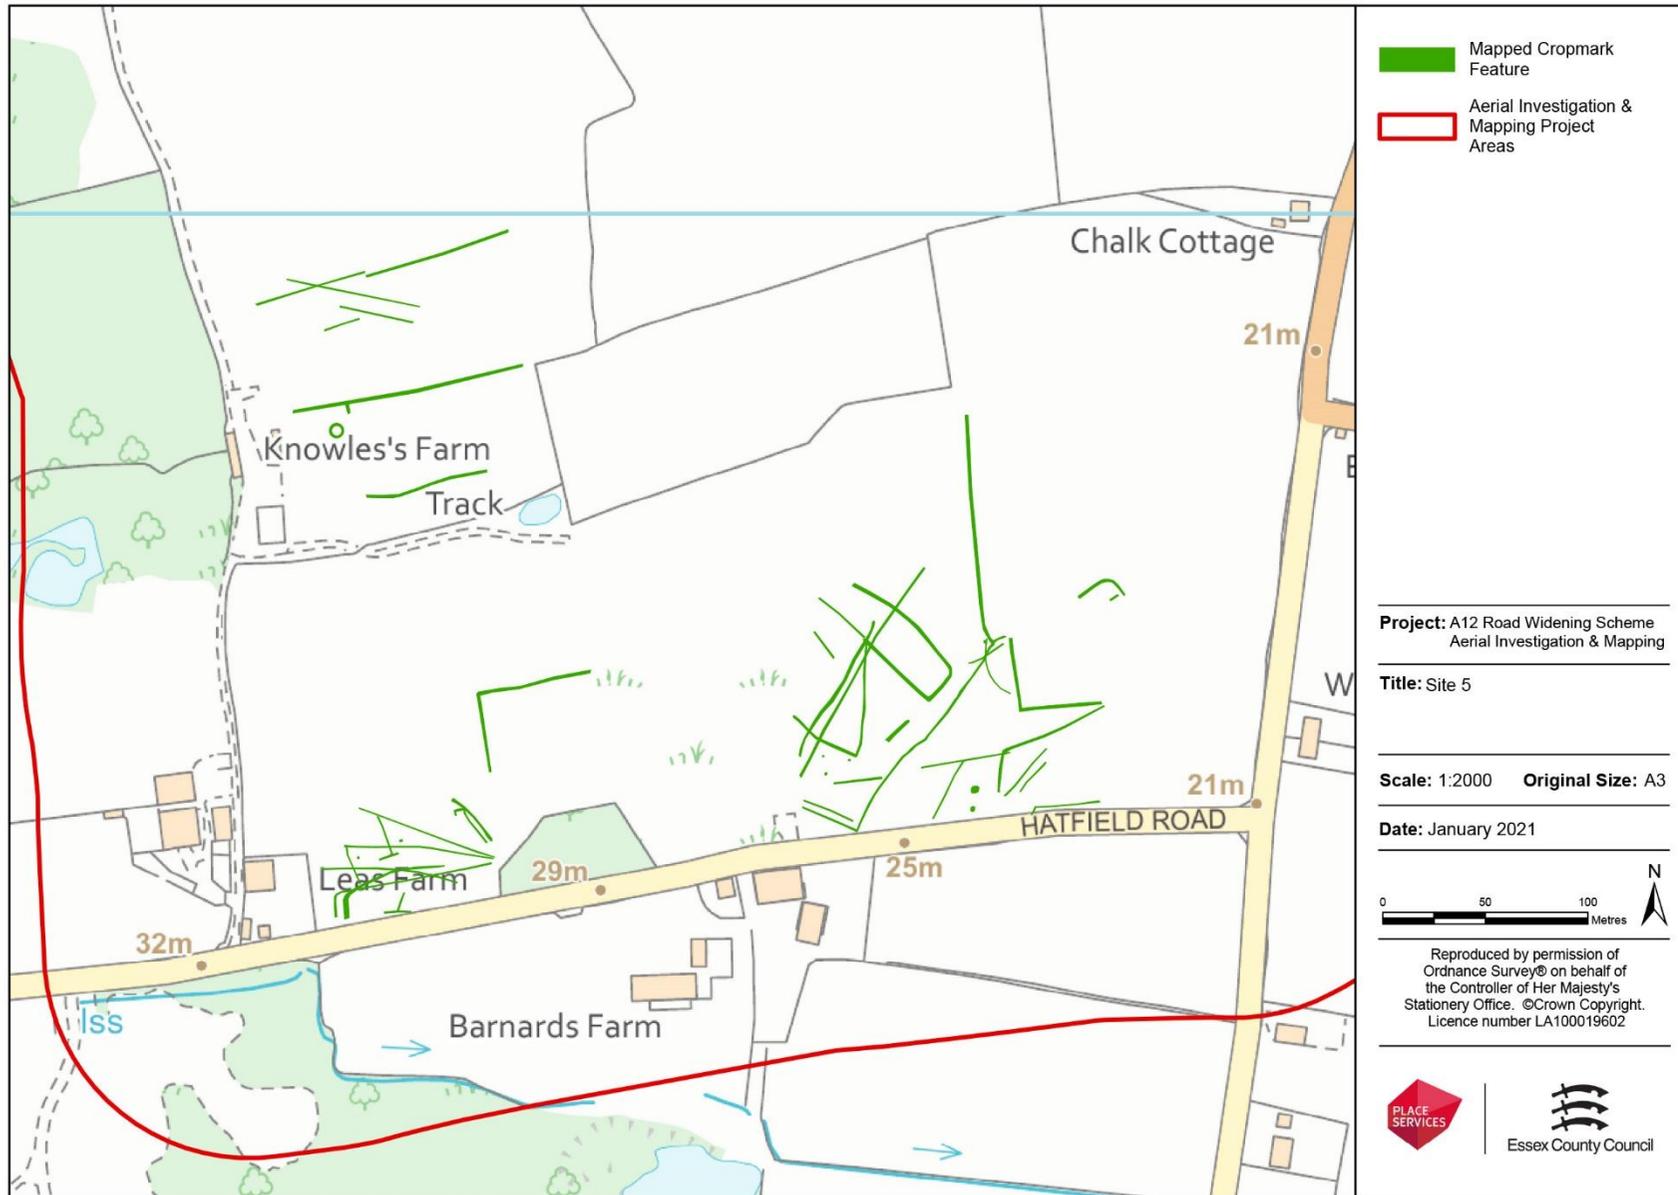
Figure 4 – Cropmarks of enclosure, pits and field boundaries (Site 5)

| Site Number | HER Number | Description of site and features mapped | Potential | Significance |
|---|---|---|---|---|
| 5 | 8401 | Extensive cropmarks of a large, but incomplete enclosure with internal divisions, with widespread pits, field boundaries and other linear features surrounding it. The enclosure could be of prehistoric date. The cropmarks continue to the west side of an area of disturbed land with a series of overlapping field boundaries and linear features. To the north of this further field boundaries (not visible on the first edition OS mapping) and a possible trackway. A small circular enclosure, possibly representing a round barrow was also mapped (Figure 4). There is the potential for additional features within this area, but the geological cropmarks are extensive and could be masking them. | High | High |

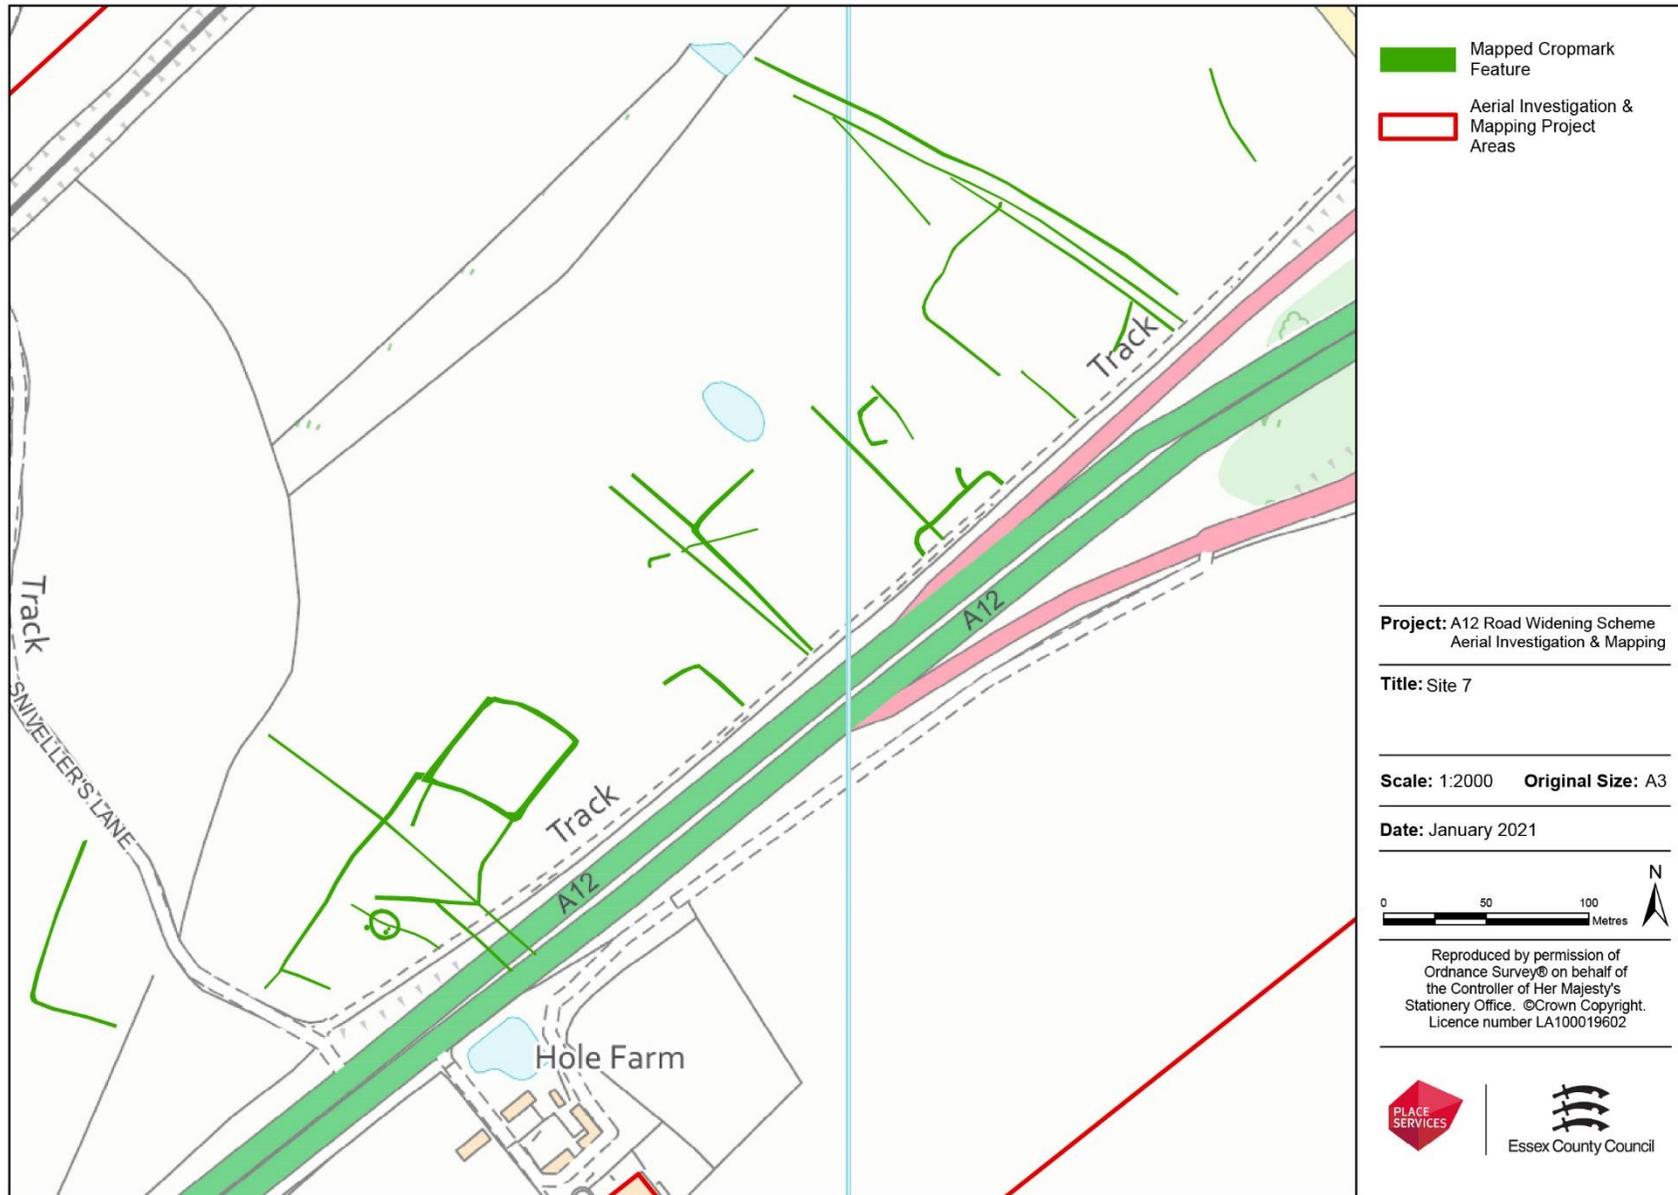
Figure 5 – Cropmarks of enclosure with annex, round barrow and field boundaries (Site 7)

| Site Number | HER Number | Description of site and features mapped | Potential | Significance |
|---|---|---|---|---|
| 7 | 8422, 16445 | <p>Extensive cropmarks of a square enclosure and incomplete annex of possible Roman date. A ring-ditch, with internal pits, that may represent a Bronze Age round barrow and a possible trackway (Figure 5). There are also widespread linear features which may represent a field system associated with the enclosure. Other cropmark features mapped could represent additional enclosures, although none are complete or as substantial as the features on the east side of the site. Additional field boundaries marked on the 1st Edition OS mapping have also been mapped. Geology across this site could be masking further archaeological features.</p> <p>The geophysical survey that was conducted along the boundary adjacent to the current A12 did record some of the archaeological features including the round barrow and some of the other boundaries visible on the aerial photographs.</p> | High | High |

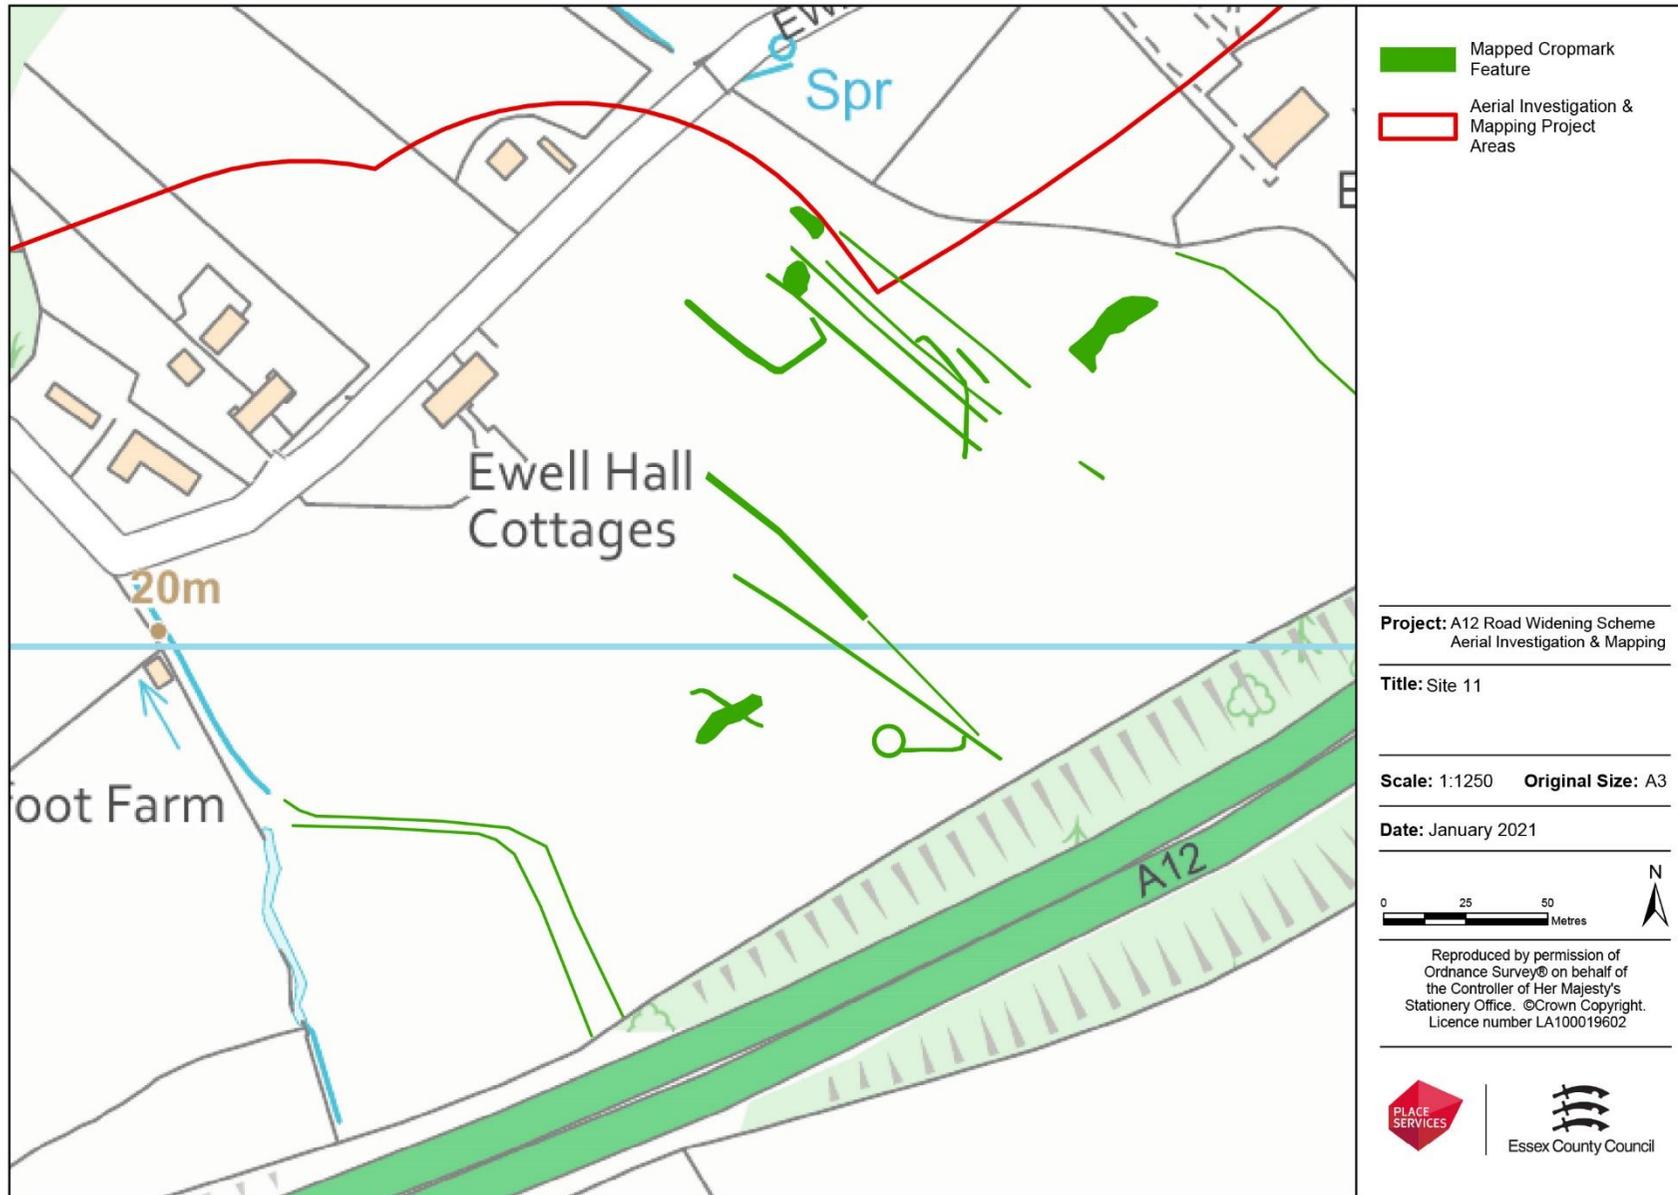
Figure 6 - Cropmarks of trackway, ring ditch, enclosure and field boundaries (Site 11)

| Site Number | HER Number | Description of site and features mapped | Potential | Significance |
|---|---|---|---|---|
| 11 | 8471 | <p>Cropmarks of a trackway, enclosure, field boundaries, a possible round barrow and extraction pits. The round barrow is only faintly visible on a single photograph and the northern part of the enclosure is masked by geology. The geological cropmarks across this site are quite extensive. The course of a former road marked on the 1st Edition OS map is also visible (Figure 6).</p> <p>This site was not covered by the geophysical survey</p> | Medium | Medium |

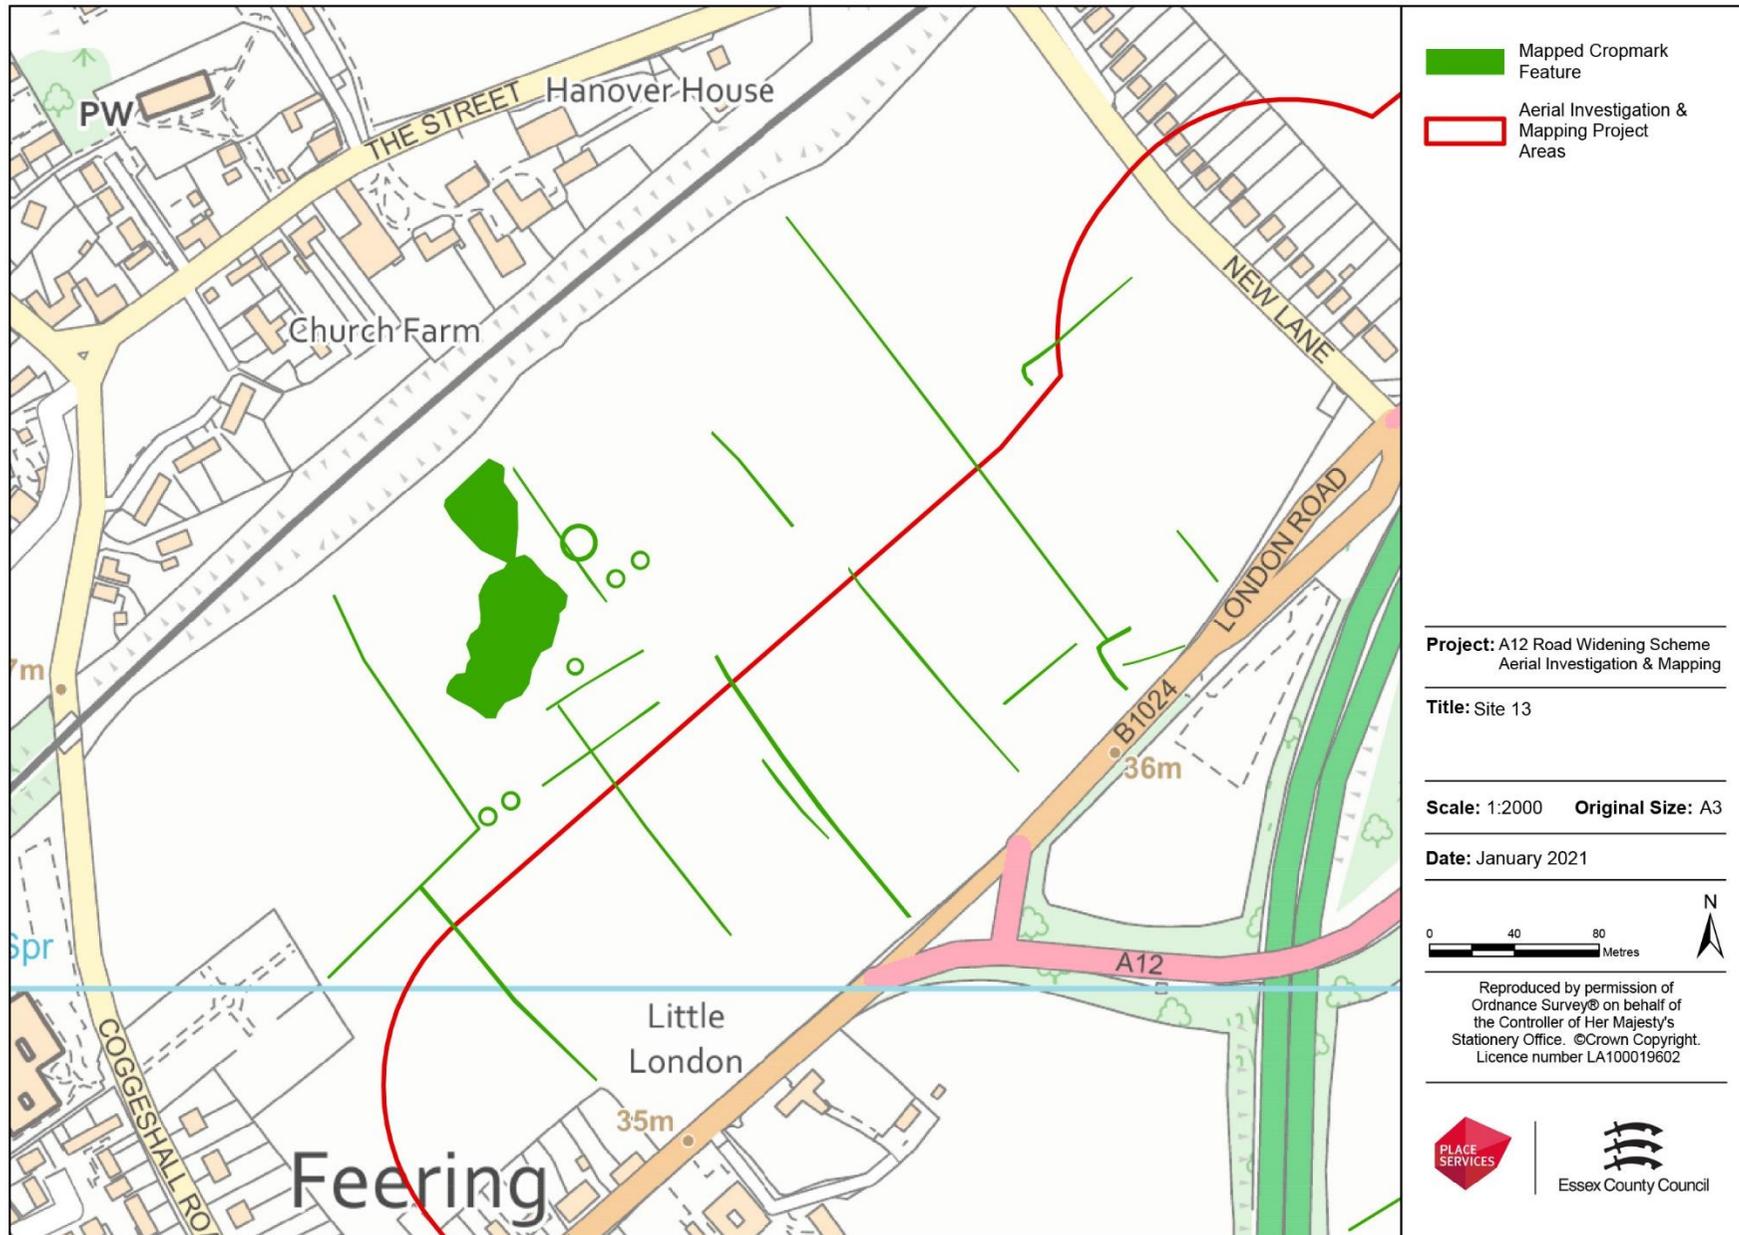
Figure 7 - Cropmarks of field boundaries, possible Bronze Age barrow cemetery and extraction pits (Site 13)

| Site Number | HER Number | Description of site and features mapped | Potential | Significance |
|---|---|---|---|---|
| 13 | 8806 | Cropmarks of a series of linear features and field boundaries. Further cropmarks of a possible Bronze Age barrow cemetery have been mapped to the north of this field, which is located just outside the project boundary. There are extensive geological cropmarks across this site which may be masking further archaeological marks (Figure 7) | Medium | Medium |

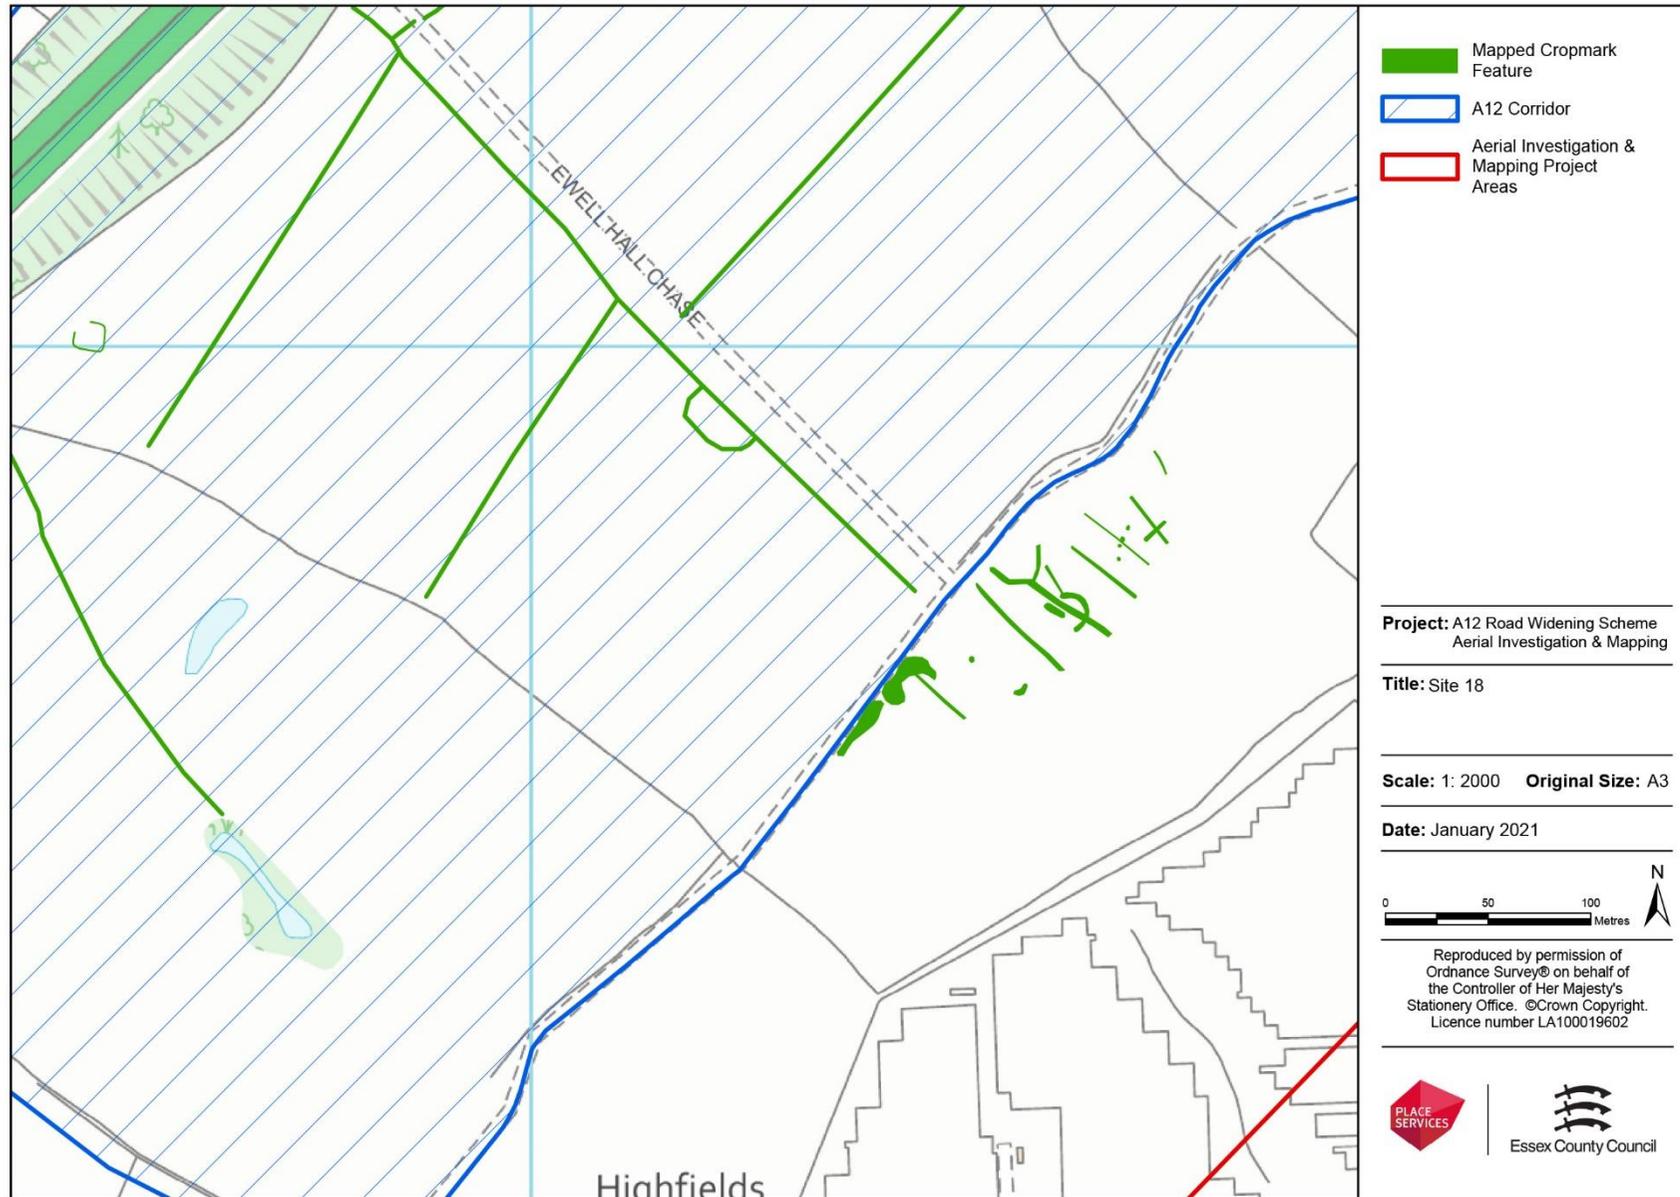
Figure 8 - Cropmarks of possible enclosure, linear features, pits and boundaries possibly associated with nearby Iron Age and Roman sites (Site 18)

| Site Number | HER Number | Description of site and features mapped | Potential | Significance |
|---|---|---|---|---|
| 18 | 8363, 8362, New | This site covers a large area and the features mapped adjacent to the A12 include a field system that is visible on the 1 st edition OS mapping of the 1880s. However, to the south of the site are a series of cropmarks of short linear features, pits and a possible incomplete curved enclosure these features could be associated with the Iron Age burial and Roman settlement site. While the cropmark features do not appear to go into the field to the north the geology may be masking features. There is also an isolated square enclosure (only visible on a single aerial photograph) located to the north-west of the main cropmark complex (Figure 8). | Medium | Medium |
