A12 Chelmsford to A120 widening scheme

6.3 ENVIRONMENTAL STATEMENT APPENDIX 7.4 AERIAL INVESTIGATION AND MAPPING REPORT

Aerial Investigation and Mapping Report

Date: January 2021

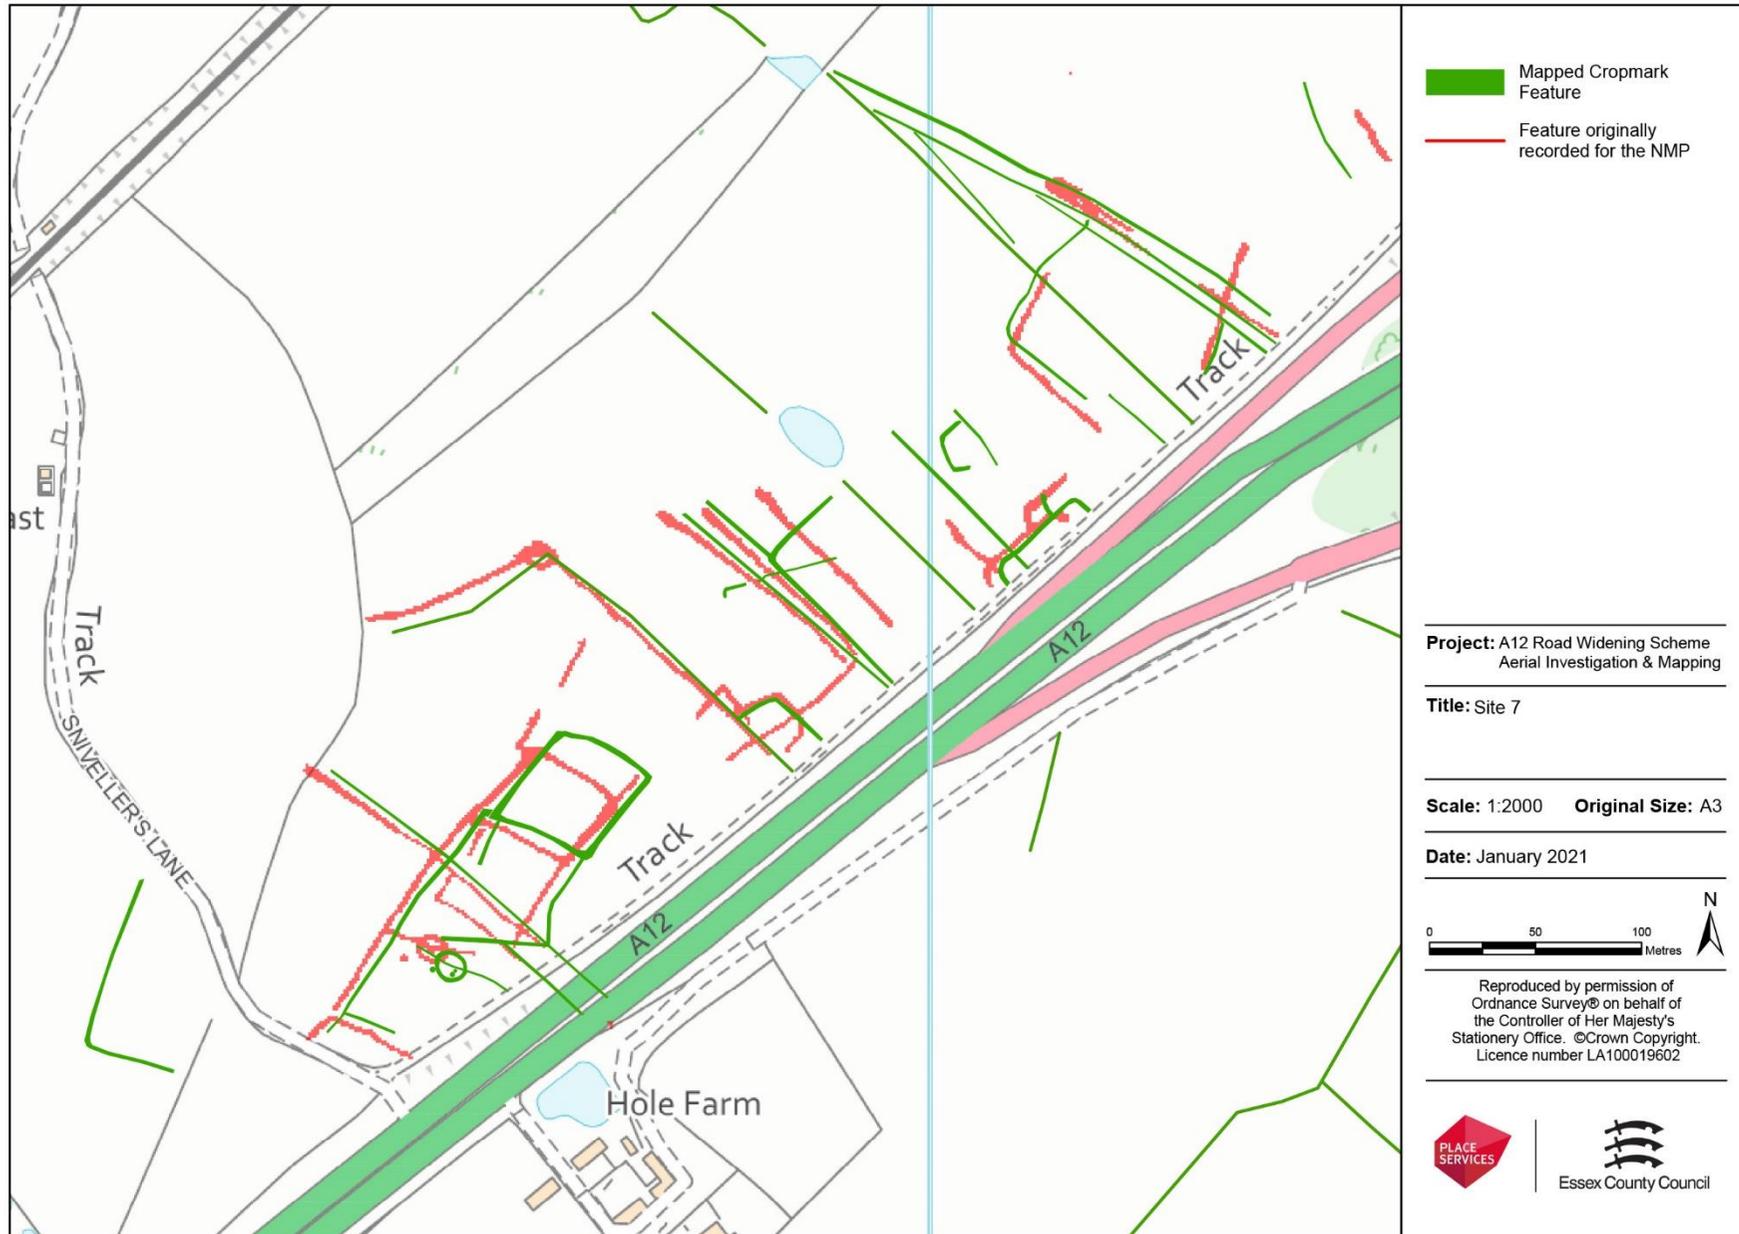
Figure 9 - Differences between digital mapping and original NMP mapping at Site 7

While every effort has been made to access the widest variety of photographic sources, there are some differences between the original NMP mapping and the digital mapping evidence. The original NMP mapping for Site 7 included some linear features that could not be seen on the available photography; however, this does not mean these features should be dismissed (Figure 9).
