**A66 Northern Trans-Pennine Project
TR010062**

**3.4 Environmental Statement
Appendix 6.18 Fish Habitat
Assessment and MorPh**

**3.4 ENVIRONMENTAL STATEMENT
APPENDIX 6.18 FISH HABITAT ASSESSMENT AND
MORPH**

Regulation Number:	Regulation 5(2)(a)
Planning Inspectorate Scheme Reference	TR010062
Application Document Reference	3.4
Author:	A66 Northern Trans-Pennine Project Team, National Highways

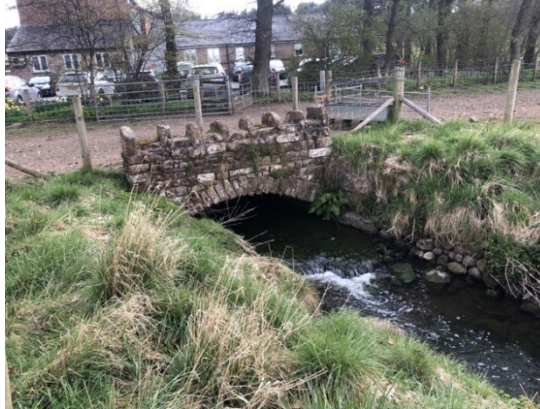
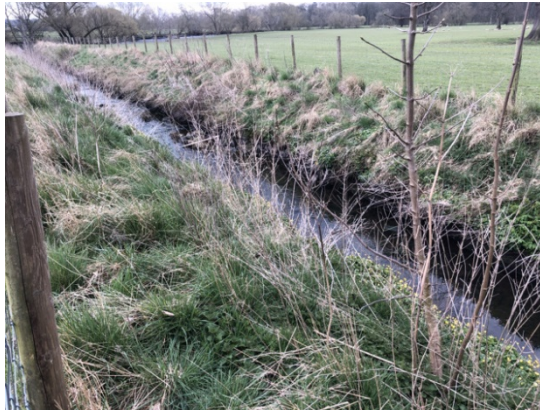
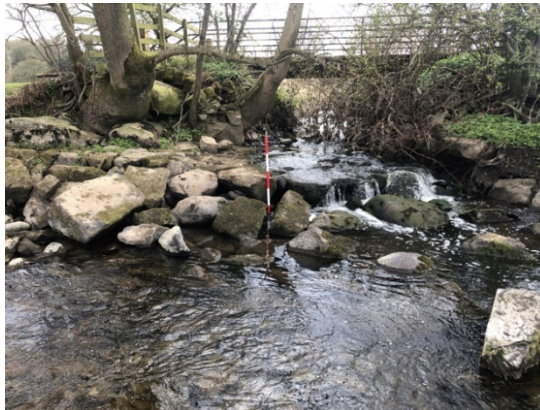
A

Plate 1: Thacka Beck (WCP_01) downstream of the existing A66. Cumbria Constabulary buildings culvert (A), trapezoidal channel (B), perched bed at confluence with River Eamont (C)

- 6.18.5.19 Downstream of the Cumbria Constabulary buildings, the river was deeply incised and was uniformly trapezoid in section (Plate 1, A). The channel width was 3.00m and the water depth was 0.15 to 0.20m and flowed through heavily grazed, improved grassland. The instream habitat was characterised by mixed juvenile and fry habitat with a predominately cobble substrate, with some gravel and sand present. Optimal spawning habitat was absent from this reach.

- 6.18.5.21 The entire of Thack Beck is considered to be disconnected from the River Eamont under low flow conditions as it is significantly perched at the confluence with the River Eamont, which restricts fish migration between the two rivers. It appears that the River Eamont has eroded to a lower level and the historic boulder bank protection has created a step (Plate 1, C). Under medium to high flows the two watercourse will be connected.

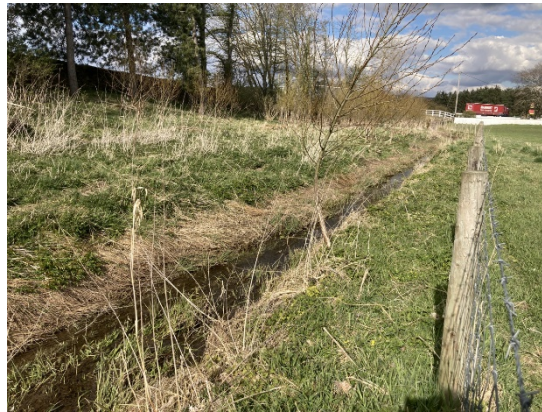
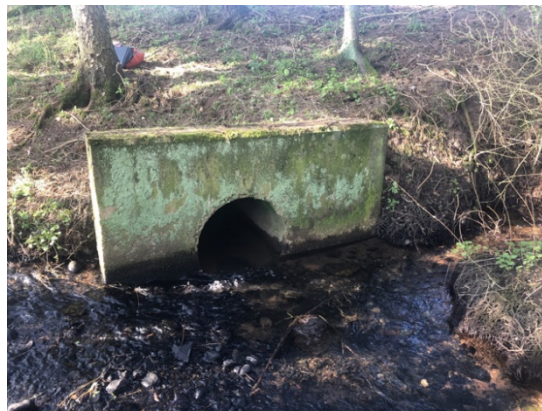
- 6.18.5.25 This tributary of Light Water is considered to be of limited value for fish due to being extensively culverted. A section of open channel originates from a small culvert (NGR: NY5462328901) south of the A66; the channel between here and the A66 is characterised by slow flowing shallow glide habitat, with a silt dominated substrate. The channel width is ~2m, with a wetted width of ~1.5m. The watercourse enters a culvert upstream of the A66 and remains culverted until its confluence with Light Water. The culvert is considered to be a barrier to fish migration.
- 6.18.5.26 Despite its modified nature, the MoRPh survey of Unnamed Tributary of Light Water 3.1 resulted in a river condition class of Fairly Good, due to the absence of hard engineered in-channel and riparian structures within the 50m survey reach.

Plate 2: Unnamed Tributary of Light Water 3.1 (WCP_02). Section of open channel upstream of the A66 (A) and the confluence with Light Water (B).

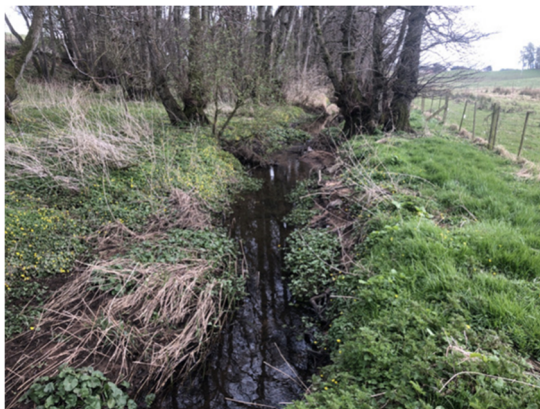
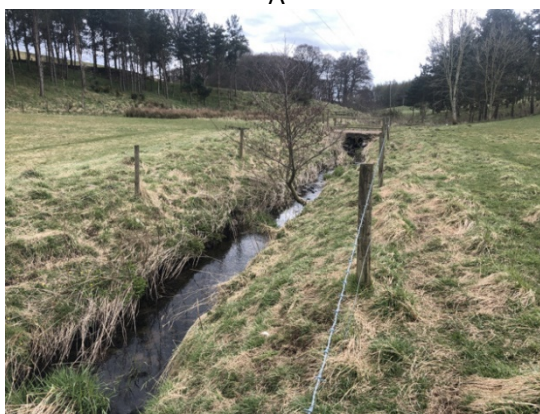
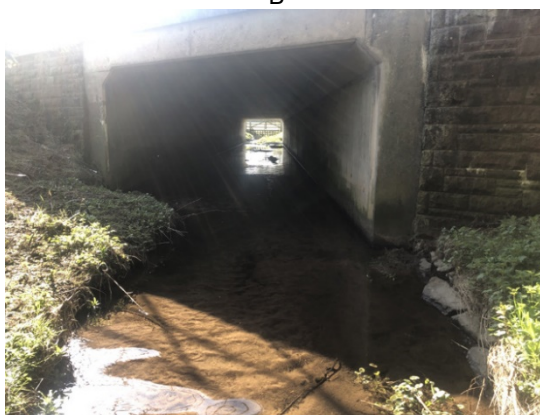
- 6.18.5.32 An undersized and failed culvert (NGR: NY5524129403) associated with a farm track was identified ~200m upstream of the River Eamont confluence. The culvert was blocked, creating a step under low flows; under high flows the velocity through the pipe could also restrict fish movement.

Plate 3: Light Water (WCP_03) upstream of the existing A66 crossing. 91E0 alluvial forest (A), straightened trapezoidal channel (B), existing A66 culvert looking upstream (C).

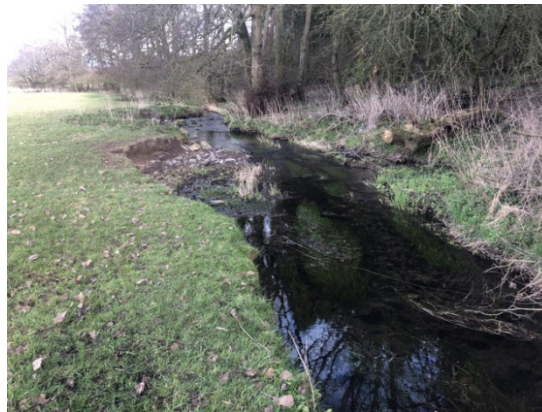
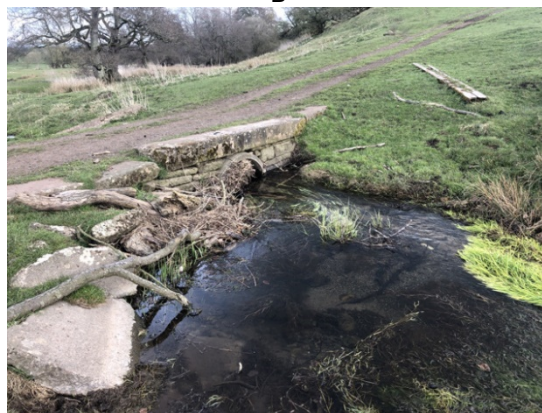
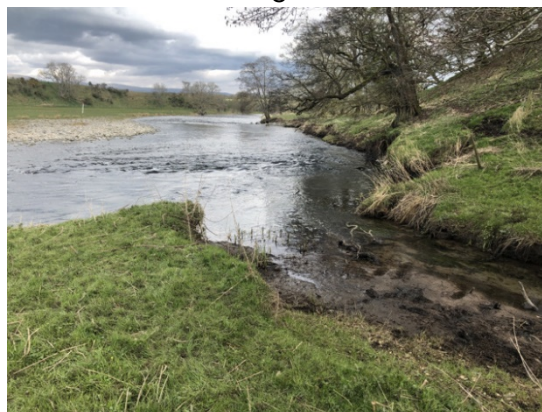
Plate 4: Light Water (WCP_03) downstream of the existing A66 crossing. Riffle / fry habitat downstream of the existing A66 (A), *Ranunculus* sp. beds / 3260 habitat (B), failed and undersized culvert (C) and confluence with River Eamont (D).

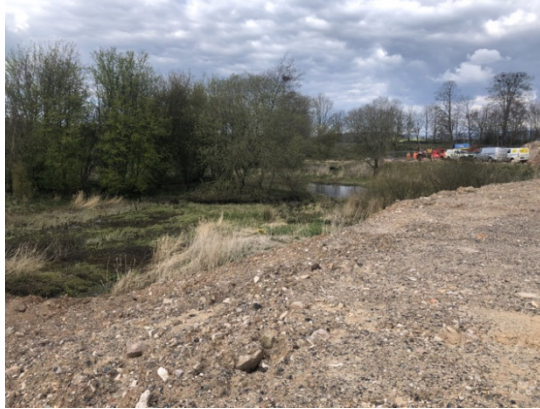
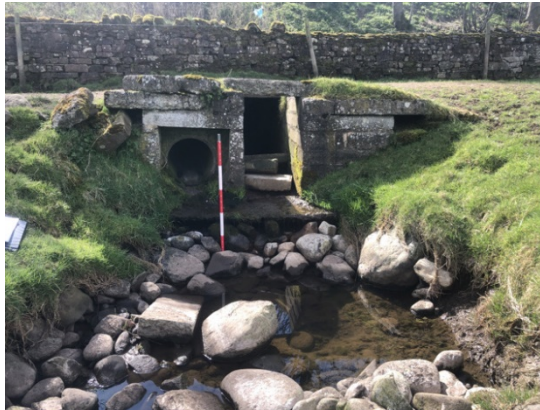
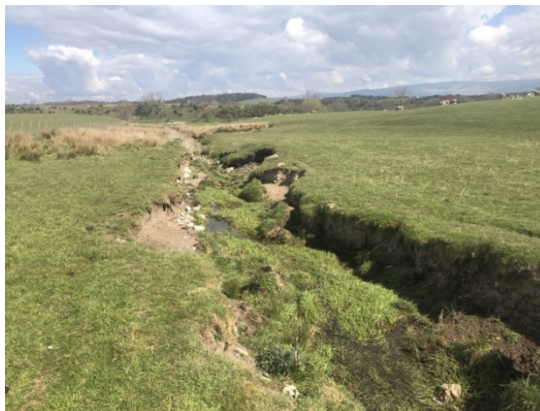
- 6.18.5.36 The watercourse is fed by the overflow of an online lake (NGR: NY5558428846) and no flow was observed through the A66 culvert on the day of the survey. Habitat upstream is considered disconnected to the River Eamont due to the A66 culvert structure and the overflow pipe from the lake which represent a complete barriers to fish movement.

- 6.18.5.37 Downstream of the A66, the watercourse flows through improved grassland. The instream habitat is degraded due to lack of flow with duckweeds (*Lemna* sp). colonising the stagnant pools. Riparian habitats were heavily poached, likely a result of intensive sheep-grazing.

Plate 5: Unnamed Tributary of River Eamont 3.3 (WCP_04). Online pond upstream of the existing A66 (A), immediately downstream of the A66 culvert (B), channel downstream of the A66 (C)

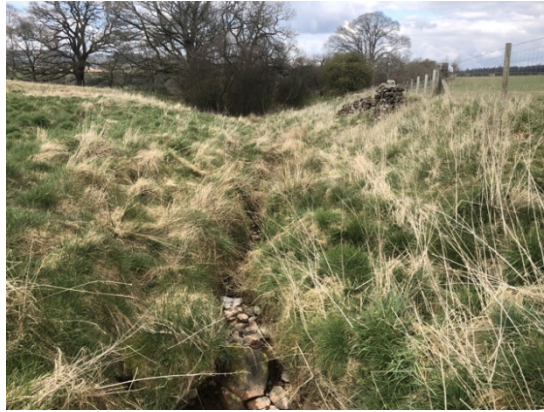
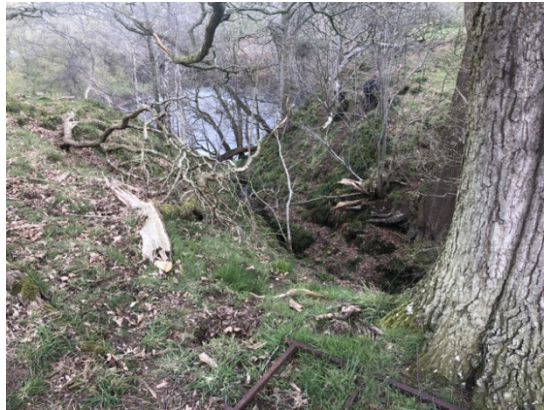
- 6.18.5.40 Unnamed Tributary of River Eamont 3.5 is a ditch. The upper section was dry when surveyed. The lower section was flowing (downstream of NRG: NY5629029149) with a silt dominated substrate, however, there is no connectivity with the River Eamont for fish, due to steep bedrock ravine and associated waterfall. This watercourse is therefore considered unsuitable habitat for fish.

Plate 6: Unnamed Tributary of River Eamont 3.5 (WCP_06). Ephemeral ditch (A) and bedrock ravine acting as a natural barrier to fish movement to and from the River Eamont (B)

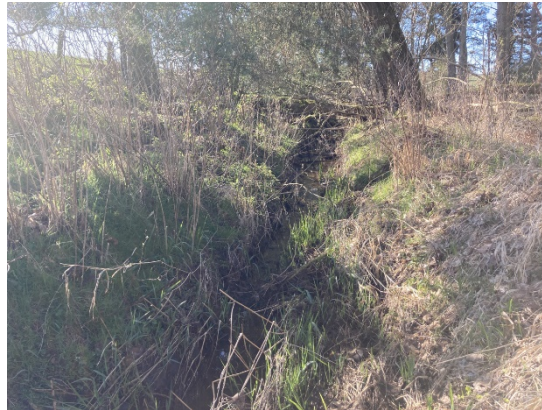
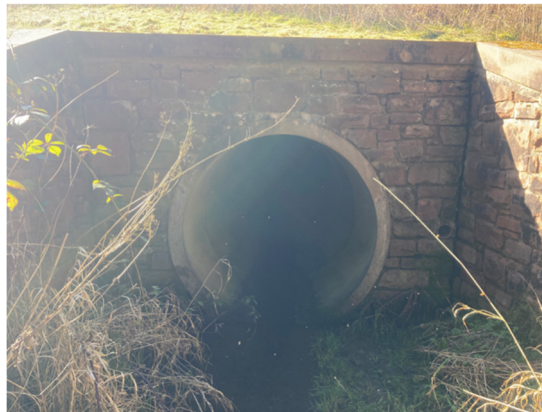
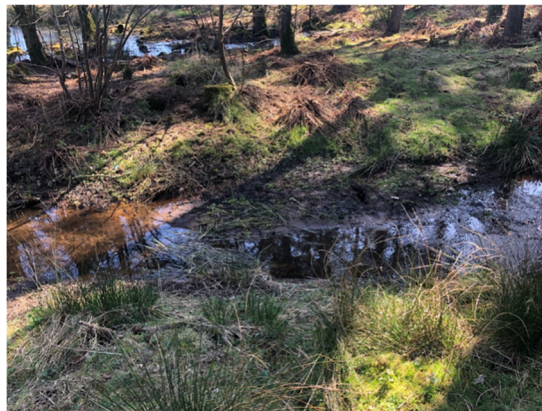
- 6.18.5.41 The surveyed area of Swine Gill is characterised by slow moving shallow glide with a silt dominated substrate. Upstream of the road, the watercourse appears to have been modified and is a perched ditch on the side of a slope adjacent to an area of standing water / wet woodland to the east.
- 6.18.5.42 The watercourse flows through a culvert under the A66 (NGR: NY5826228744) which is considered a barrier to fish migration. Whilst Swine Gill offers a potentially valuable aquatic habitat and is well connected to its floodplain, specifically an area of wet plantation woodland, the watercourse is considered unsuitable for fish of conservation value due to lack of flow and substrate other than sand and silt.
- 6.18.5.43 The MoRPh survey of Swine Gill resulted in a river condition class of Fairly Good.

Plate 7: Swine Gill (WCP_07). Ditch habitat upstream of the existing A66 (A), downstream of the A66 culvert looking upstream(B), silt dominated shallow glide habitat with adjacent wetted plantation woodland (C).

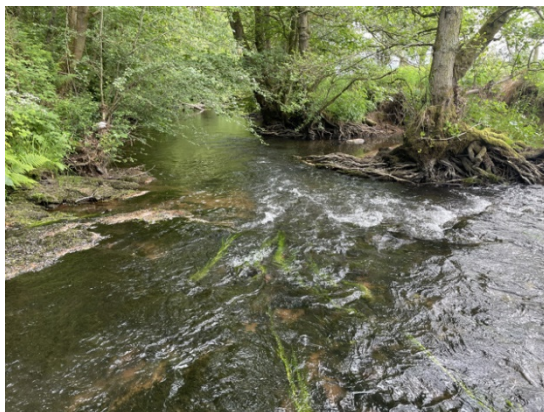
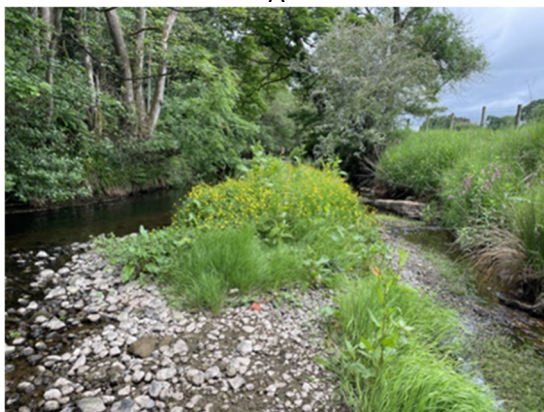
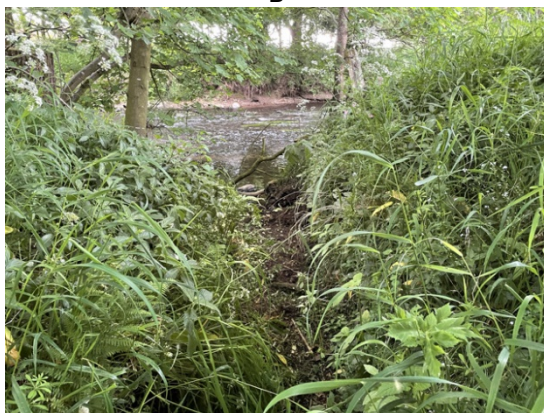
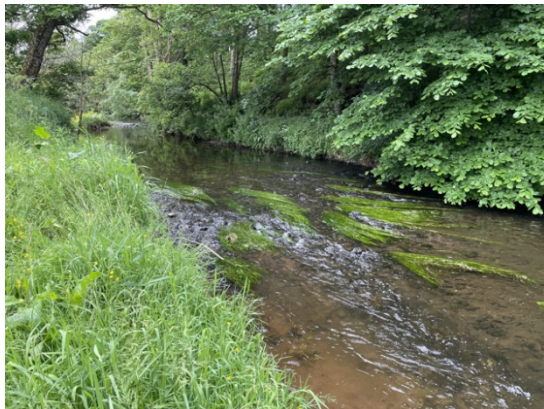
- 6.18.5.49 No barriers to fish migration or obvious bank protection was recorded in this stretch. Two piped discharges (NRG: NY6536924296 and NY6532424335), likely surface water drains were recorded, one of which was active (flowing with clear water).

- 6.18.5.50 The MoRPh survey of this section of Trout Beck (NGR: NY6575224120) resulted in a river condition class of Moderate.

Plate 8: Trout Beck (WCP_08_US_RED), Pool-pool sequence and marginal lamprey sp. habitat (A), vegetated bar (B), backwater refuge habitat (C), *Ranunculus* sp. beds and silted spawning (D)

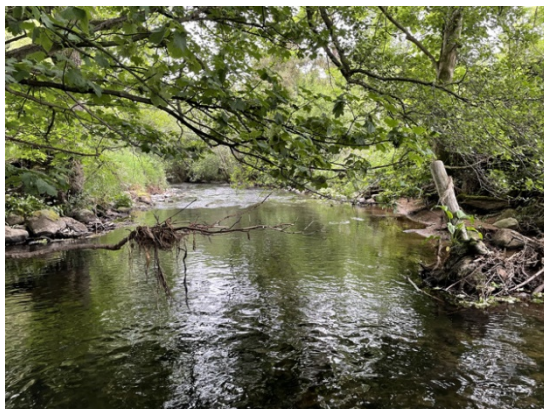
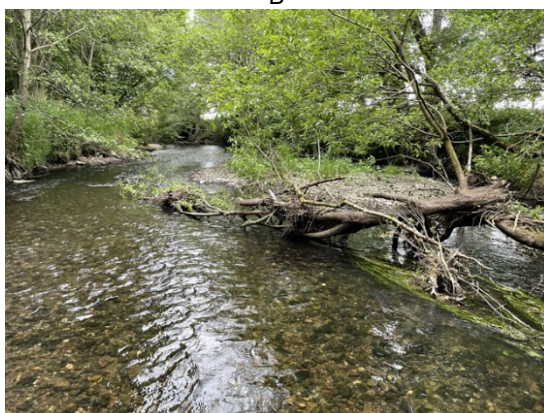
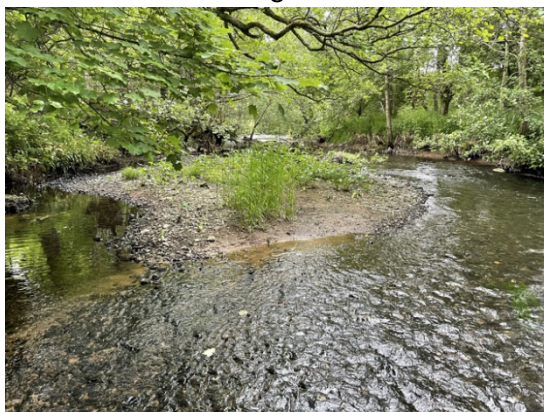
Plate 9: Trout Beck (WCP_08_US)

- 6.18.5.54 No definitive spawning redds were identified, but areas of clean gravel offering potential spawning opportunities for salmonid and lamprey sp. were commonplace.

- 6.18.5.55 No barriers to fish migration or discharges were recorded.
- 6.18.5.56 The MoRPh survey of this section of Trout Beck (NGR: NY6499024484) resulted in a river condition class of Fairly Good.

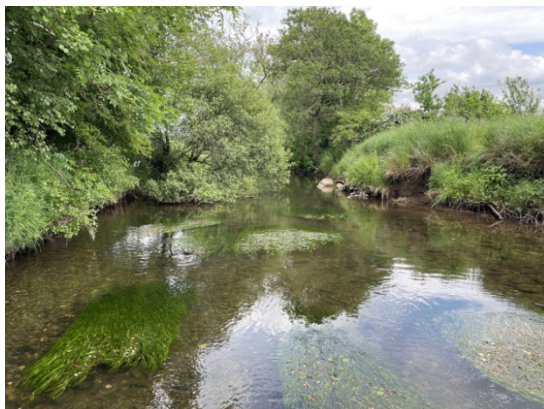
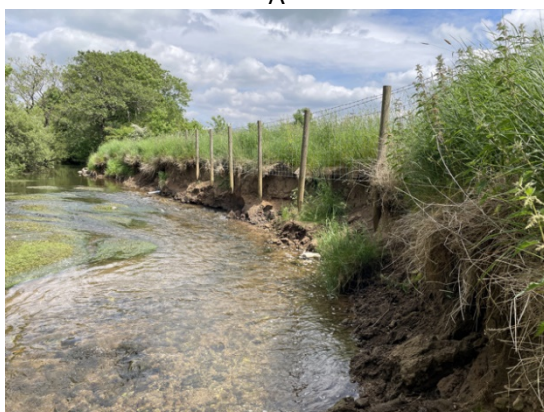
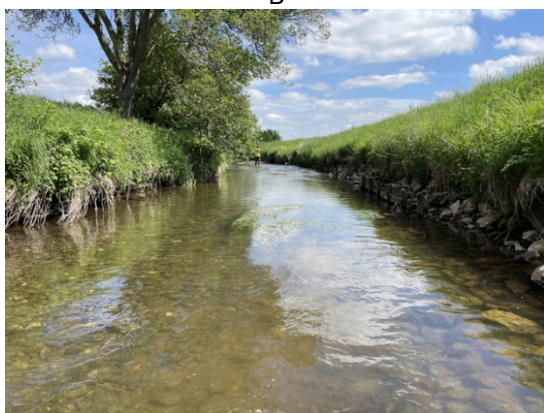
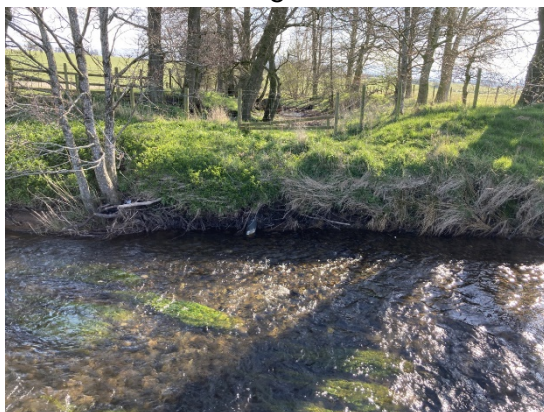
- 6.18.5.57 The river in this section is very similar in characteristics to that upstream, with a narrow riparian buffer and extensive bank erosion present through this section which has been historically straightened. Re-naturalisation of the channel is occurring; remains of some historical bank protection, consisting of wooden boards with cobble sized substrate behind, is failing in places delivering cobble sized substrate to the channel.

- 6.18.5.60 Three cut off meanders were recorded in the riparian zone through this section (at NGR: NY6453824596, NY6447324810 and NY6444924924). Unlike the meander feature noted upstream, these features are typically disconnected from the channel, which is deeply incised, and would only be charged in very high flow events.

Plate 10: Trout Beck (WCP_08_DS). *Ranunculus* sp. beds and clean gravels (A), extensive bank erosions (B), failed bank protection and silted gravel (C), perched remnant meander bend (D).

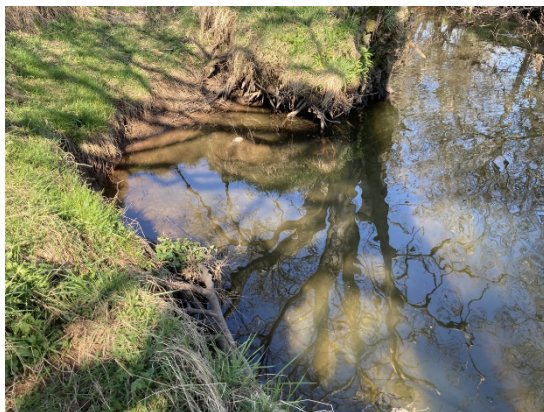
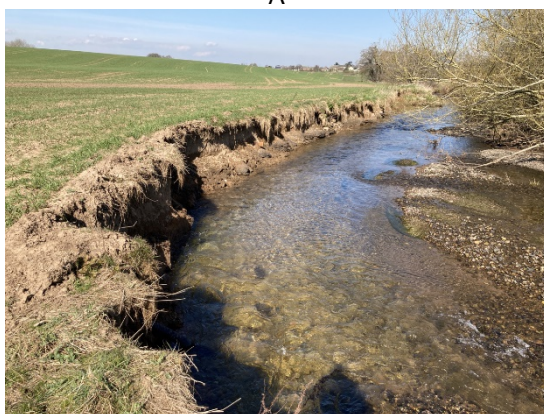
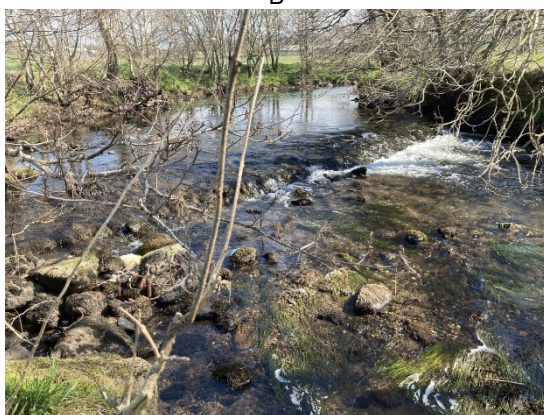
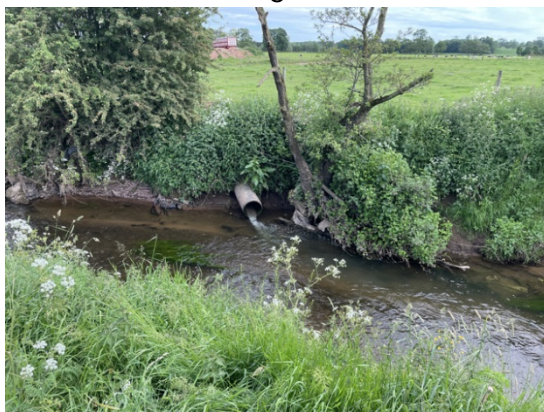
Plate 11: Trout Beck (WCP_08_ORANGE)

- 6.18.5.67 No barriers to fish migration were identified, although a minor step was observed at NGR: NY6391925440 where a weir appears to have been removed. A surface water drain or combined sewer overflow (NRG: NY6391125443) was recorded as was a farmyard discharge (NRG: NY6335025135), the latter that was associated with the dairy farm located downstream of the existing A66 crossing, was actively discharging a white liquid to Trout Beck immediately upstream of the confluence with the River Eden.

- 6.18.5.68 The MoRPh survey of this section of Trout Beck (NGR: NY6347825210) resulted in a river condition class of Fairly Poor.
- 6.18.5.69 Despite the pressures noted, based on habitat assessment, the entire of Trout Beck was considered likely to support fish of conservation value. This was confirmed during fish surveys (electric fishing and eDNA) which across all sites recorded the presence of bullhead, brown trout, eel, minnow, river/brook lamprey ammocoetes, river/brook lamprey transformers, salmon, stone loach and three-spined stickleback. Full analysis of the fish surveys are outlined in Appendix 6.19: Fish (Application Document 3.4).

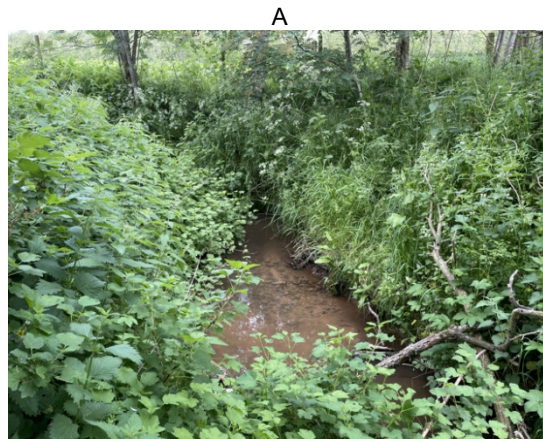
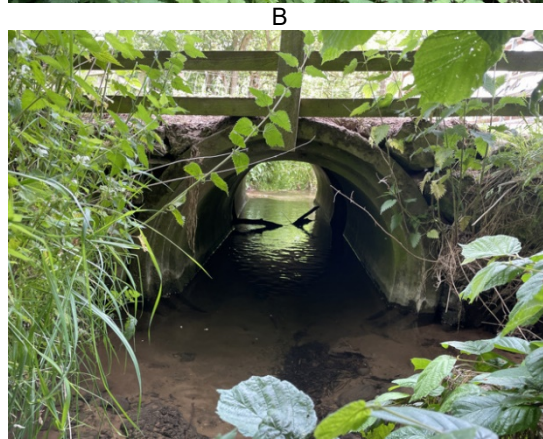
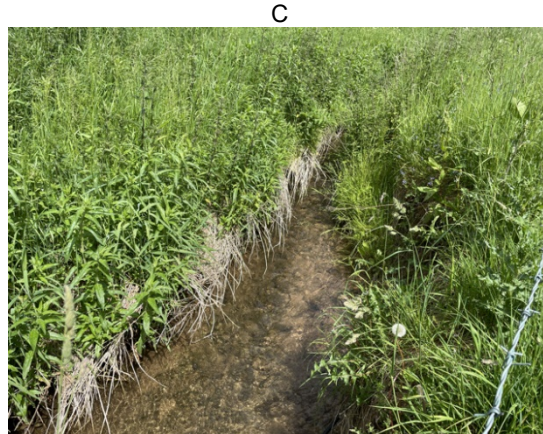
D
Plate 12: Keld Sike (WCP_08_KS)

- 6.18.5.71 No barriers to fish migration were identified, although two culverts (pre-cast concrete pipes) were noted at NRG: NY6516024562 and NY6538924605. Both culverts were considered passable for all species under all flow conditions.

- 6.18.5.73 No definitive spawning redds were identified, but gravel substrate dominated in many areas, offering potential spawning opportunities for salmonid and lamprey sp. migrating from Trout Beck during higher flows. In addition, the watercourse likely acts as an important nursery zone and refuge area during period of high flows.

- 6.18.5.74 The MoRPh survey Keld Sike (NRG: NY6539024664) resulted in a river condition class of Moderate.

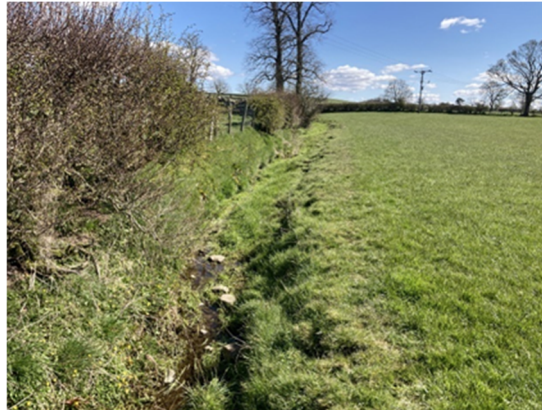
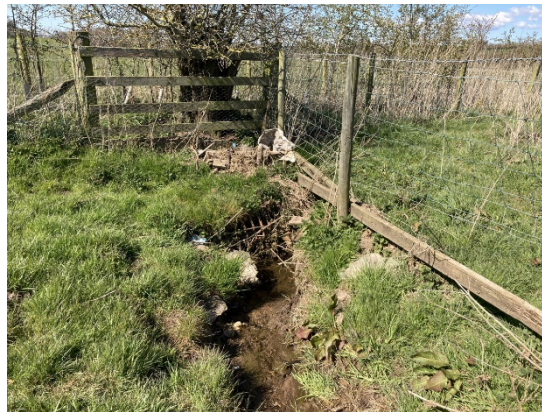
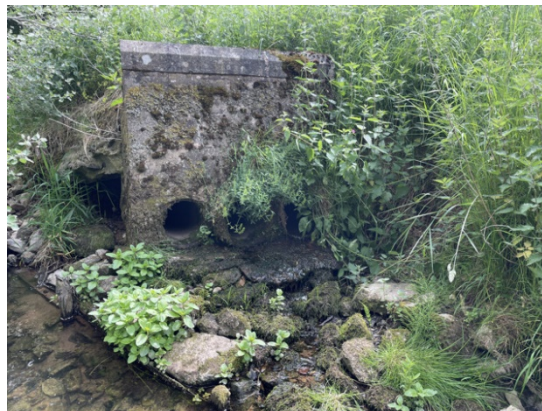
6.18.5.75 Unnamed Tributary of Trout Beck 4.5 is a ditch. The ditch enters a culvert at NGR: NY6501424207 and remains culverted until its confluence with Trout Beck (NGR: NY6489424414). Little or no flow was entering Trout Beck on the day of the survey. The culvert is considered to be a barrier to fish migration and the ditch is considered unsuitable habitat for fish.

Plate 13: Unnamed Tributary of Trout Beck 4.5 (WCP_09 & WCP09). Ditch habitat, likely ephemeral (A), culvert entrance upstream of Trout Beck (B), confluence with Trout beck (C)

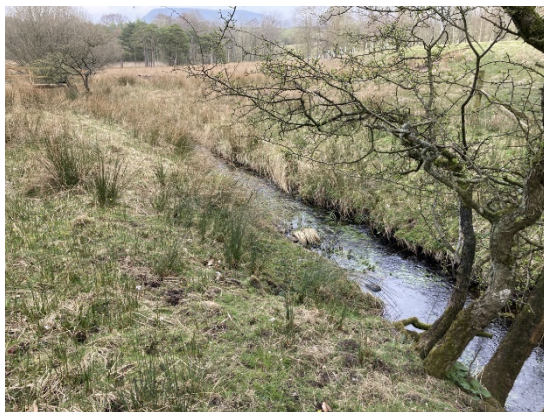
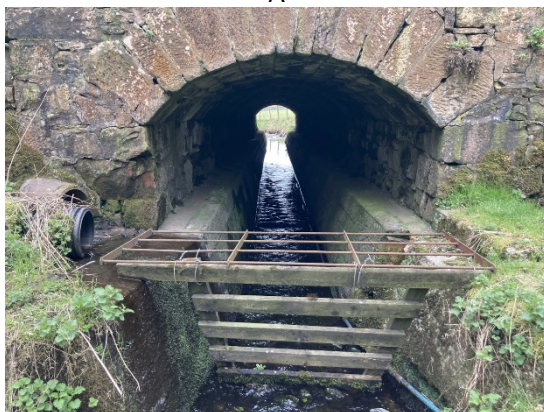
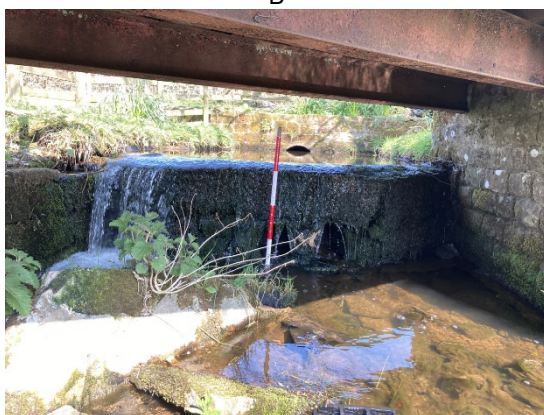
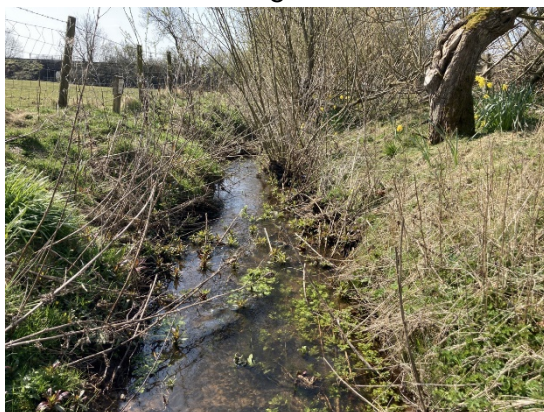
sediment trap associated with a works access track. The weir was assessed as likely to be impassable by all species in normal flow conditions.

Plate 14: Unnamed Tributary of Mire Sike 6.12 (WCP_11). Upstream of existing A66 culvert (A), existing A66 culvert (B), barrier to fish migration at access road (C), channel downstream of A66 and access road.

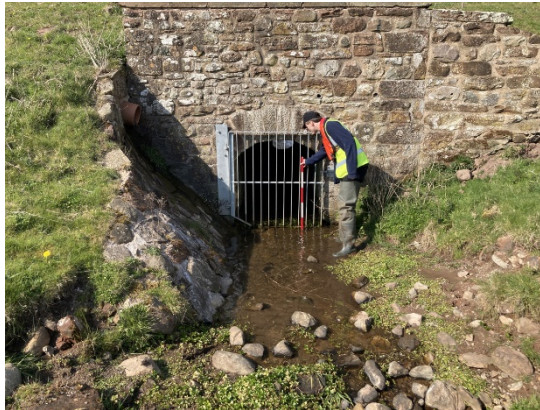
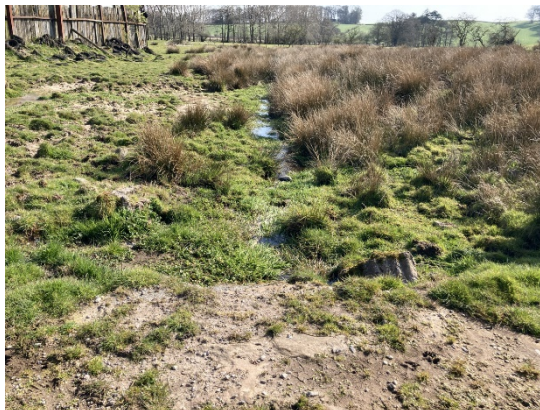
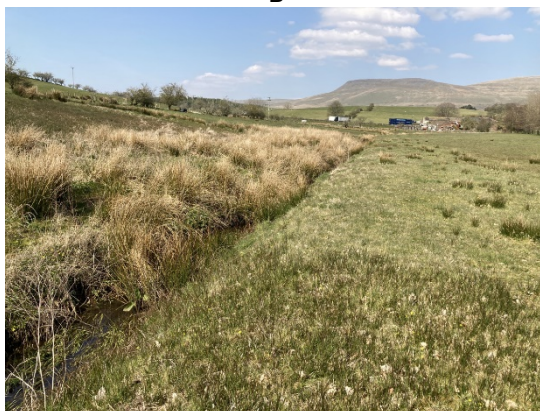
- 6.18.5.80 Unnamed Tributary of Cringle Beck 6.1 is a ditch / wetland features with no defined channel in some sections. There is no connectivity between the ditch and Cringle Beck, which flows into an area of boggy land upstream of the disused railway line (NGR: NY7431316280). The ditch is considered unsuitable habitat for fish.
- 6.18.5.81 A MoRPh survey was not conducted at this site.

Plate 15: Unnamed Tributary of Cringle Beck 6.1 (WCP_12).

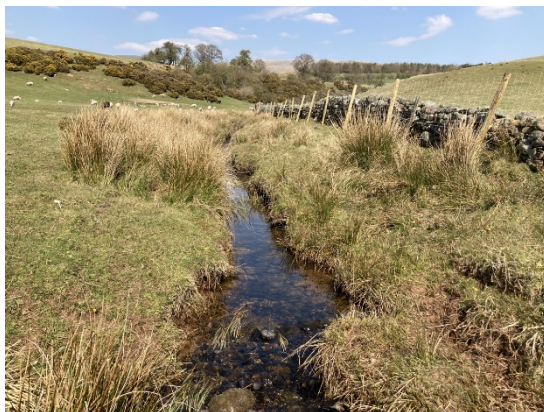
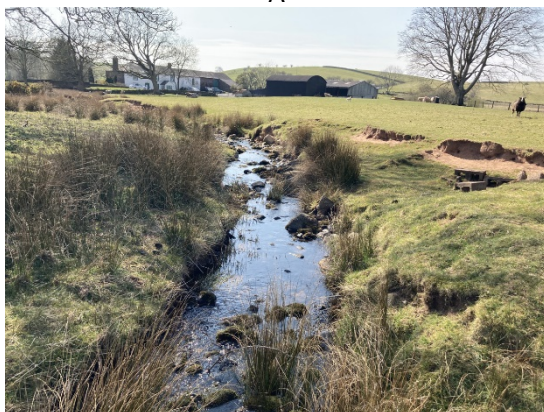
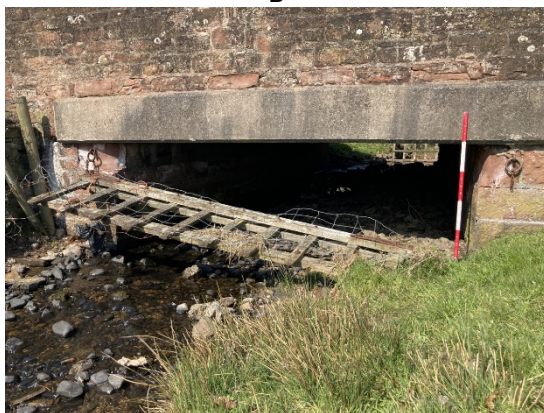
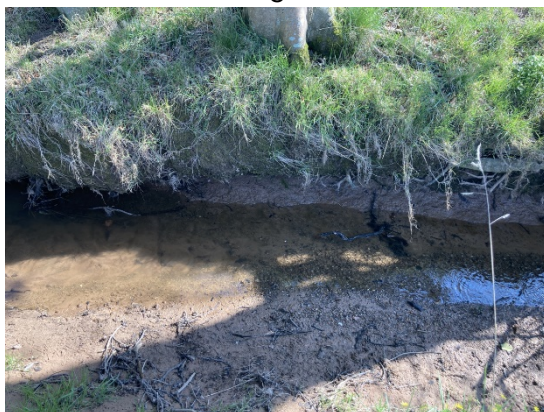
- substrate requirements of fry and parr stage salmonid species. Obvious areas of juvenile lamprey habitat was absent.
- 6.18.5.83 The existing A66 culvert (NGR: NY7453216607) is considered passable for all fish species under normal flow conditions and has a natural cobble-dominated substrate.

- 6.18.5.84 Downstream of the road the watercourse is characterised by fry habitat with a coarse gravel dominated substrate. Significant sand deposits were noted in the section immediately upstream of the disused railway line.

Plate 16: Cringle Beck (WCP_13). Optimal juvenile salmonid habitat upstream of the A66 (A & B), existing A66 culvert considered passable for all species (C), fry habitat with significant sand deposition upstream of the disused railway (D)

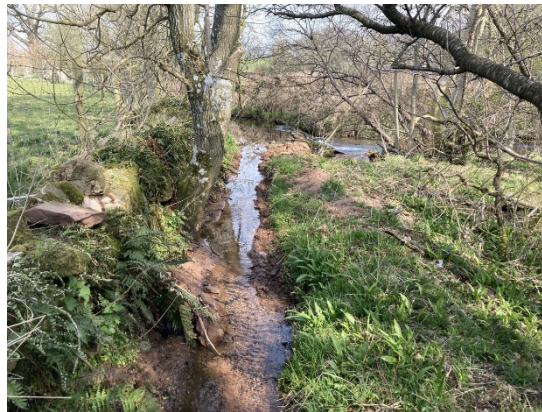
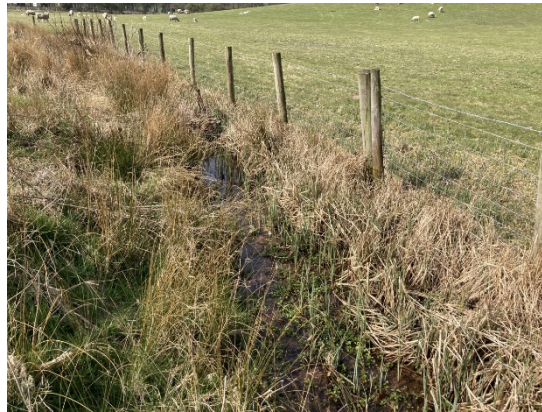
- 6.18.5.87 The Moor Beck offtake diverts water from a weir (NY7494816241) on Moor Beck. The channel is understood to feed a pond used for fire water at the MOD barracks. The channel is ditch-like, choked with terrestrial vegetation and ephemeral (the ditch was dry during a site visit in January 2022). The substrate was entirely sand near the weir and silt further downstream.
- 6.18.5.88 There appears to be no connectivity for fish between Crooks Beck and the offtake channel / barracks pond (NGR: NY7496715843) and the ditch is considered unsuitable habitat for notable fish.
- 6.18.5.89 A MoRPh survey was not conducted at this site.

Plate 17: Moor Beck (Offtake) (WCP_14). Diversion / offtake at weir on Moor Beck (A), ditch habitat (B).

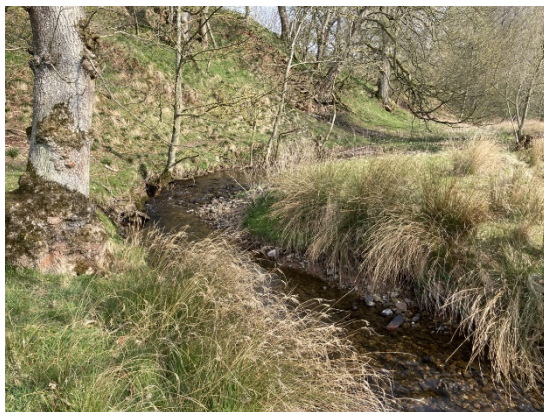
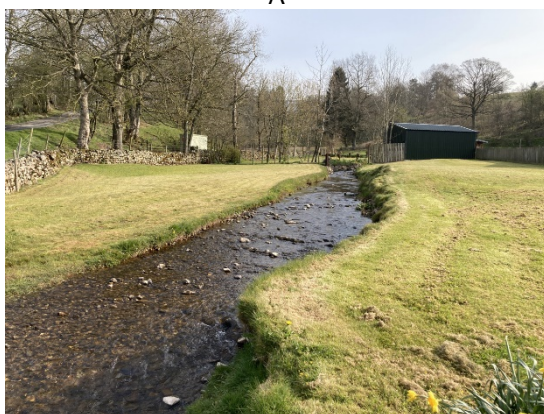
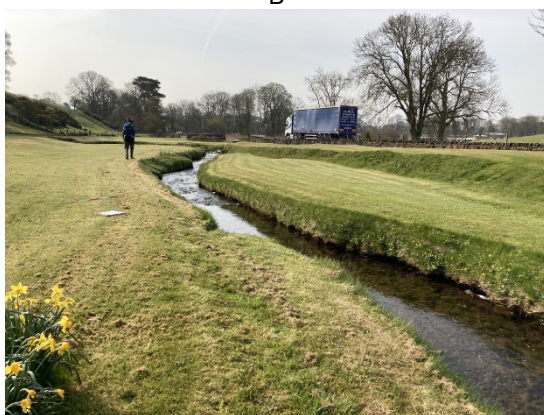
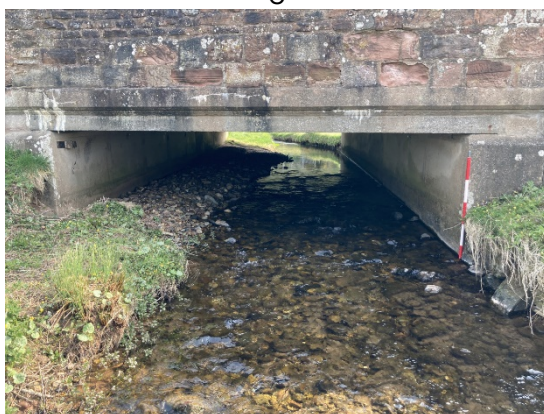
Plate 18: Moor Beck (WCP_15) upstream of the existing A66 crossing.

- 6.18.5.91 A potential barrier to fish migration under low flow conditions was recorded at NGR: NY7496316416 and the banks of the river had been reinforced in places to prevent bank erosion.

- 6.18.5.93 The existing A66 culvert (NGR: NY7493916292) is considered passable for all fish species under normal flow conditions and has a natural cobble-dominated substrate.

- 6.18.5.99 Despite the quality of instream habitat, the MoRPh survey of Moor Beck (NGR: NY7505116073) resulted in a river condition class of only Moderate, driven by the lack of riparian vegetation structure.

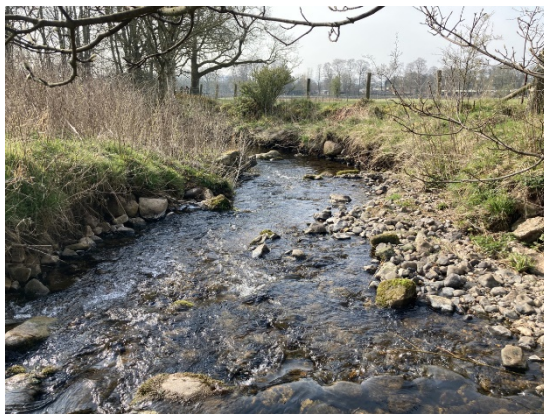
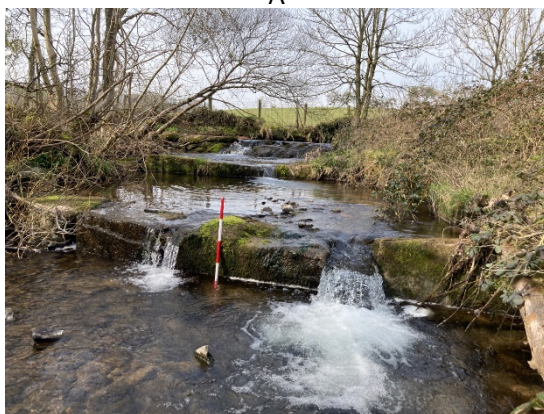
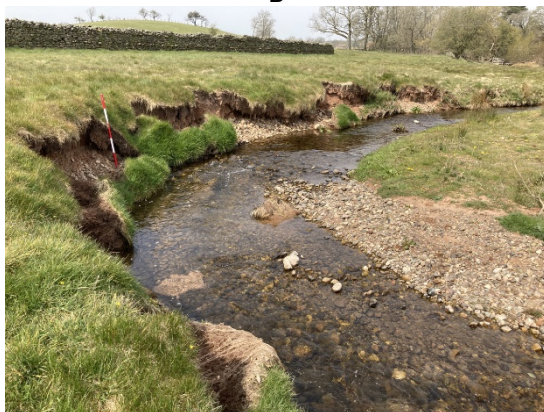
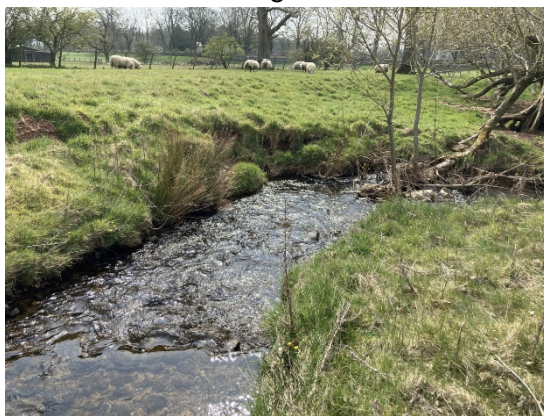
Plate 19: Moor Beck (WCP_15). Downstream of A66 and upstream of weir (A), offtake weir with fish passage improvements (B), sinuous and dynamic channel (C) mixed juvenile habitat (D).

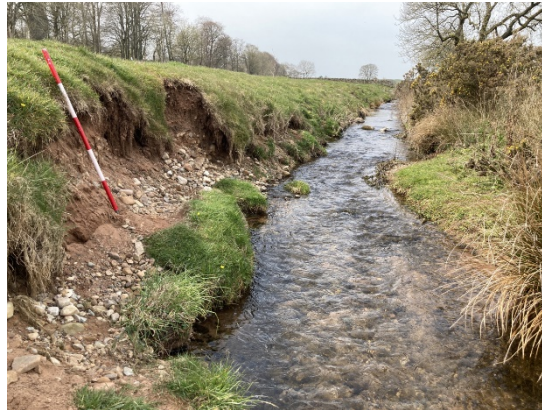
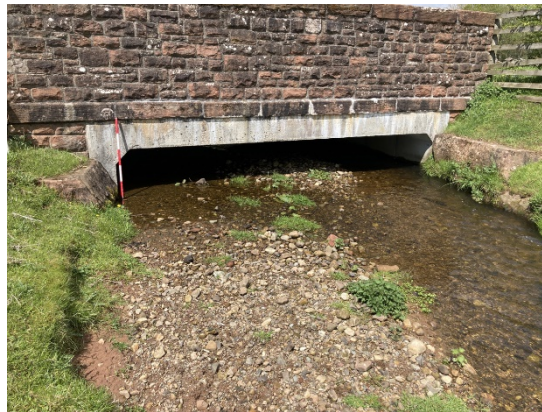
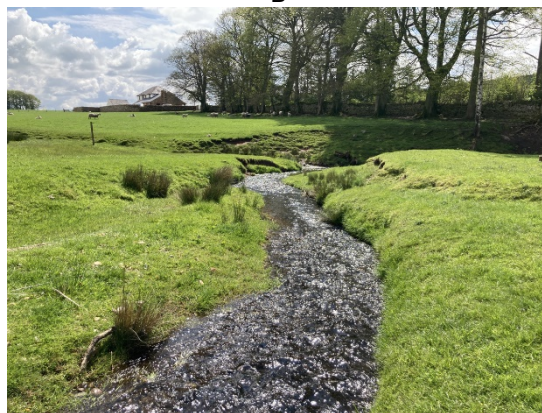
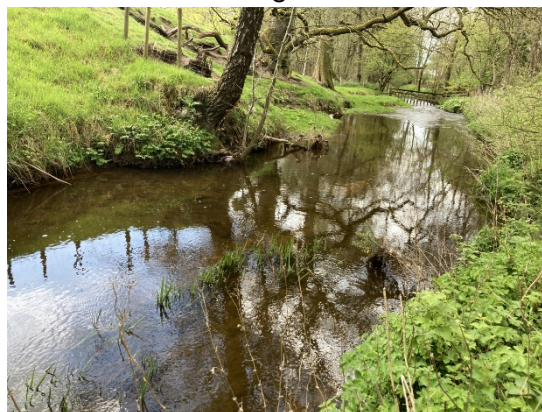
- 6.18.5.103 The MoRPh survey of this section of Moor Beck (NGR: NY7517815896) resulted in a river condition class of Moderate.
- 6.18.5.104 Moor Beck and Eastfield Sike converge to form Crooks Beck upstream of the disused railway culvert at NGR: NY7528615765. The river is deeper in this section and characterised by parr habitat interspersed with glides and pools. The riparian woodland downstream of the disused railway (NGR: NY7524315737) conforms to the Annex I habitat: 91E0 Alluvial forests with *Alnus glutinosa* and *Fraxinus excelsior*. A full description of the floral assemblage of all rivers surveyed is provided in ES Appendix 6.20: Aquatic Macrophyte and River Corridor Survey (Application Document 3.4).

Plate 20: Moor Beck (WCP_16). Eroding bank in straightened section of Moor Beck (A), culvert on Warcop access road (B), sinuous section of Moor Beck upstream of the Eastfield Sike confluence (C), Crooks Beck downstream of disused railway (D)

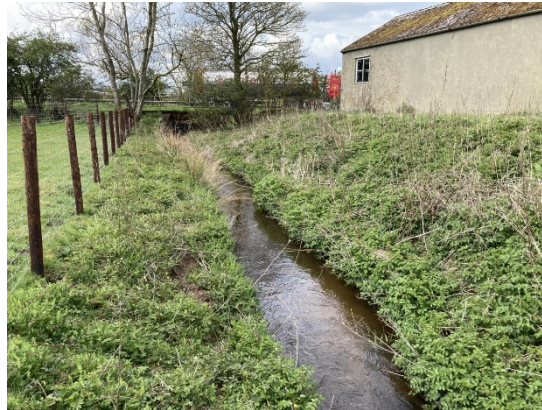
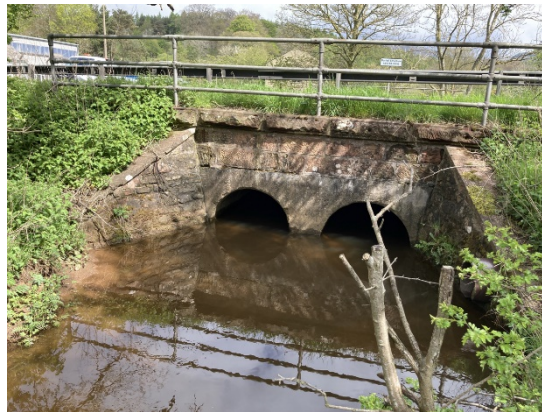
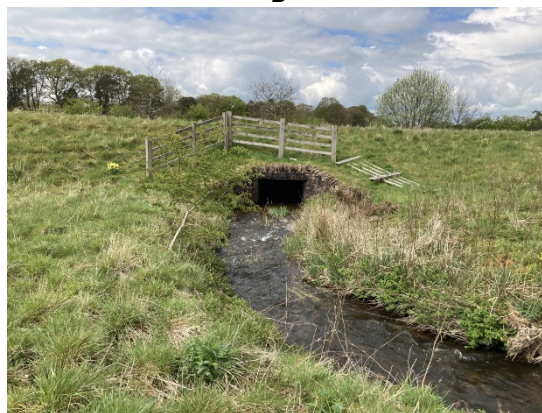
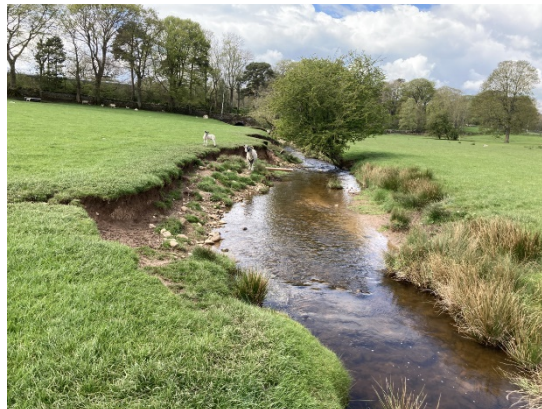
- 6.18.5.105 The upper section of the surveyed reach (Eastfield Sike upstream of the existing A66) was characterised by mixed juvenile habitat with a coarse gravel-dominated substrate, interspersed with area of shallow glide. The channel has been modified by a series of culverts associated with two MOD tracks (north of the existing A66), the existing A66, and the tank turning area (south of the existing A66); these culverts were all considered to be passable for all fish species under normal flow conditions.

Plate 21: Eastfield Sike (WCP_17). Modified section upstream of existing A66 (A), existing A66 culvert (B), mixed juvenile habitat between the A66 and tank turning area (C) heavily poached reach upstream of Moor Beck confluence

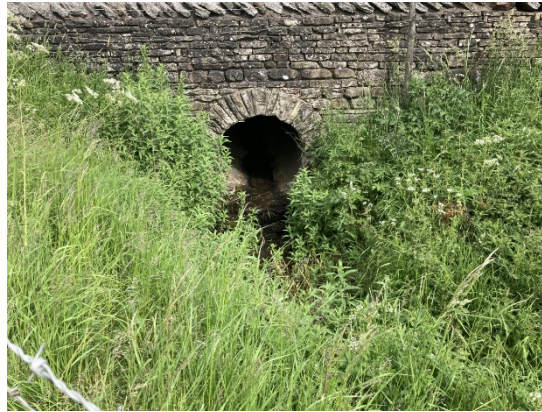
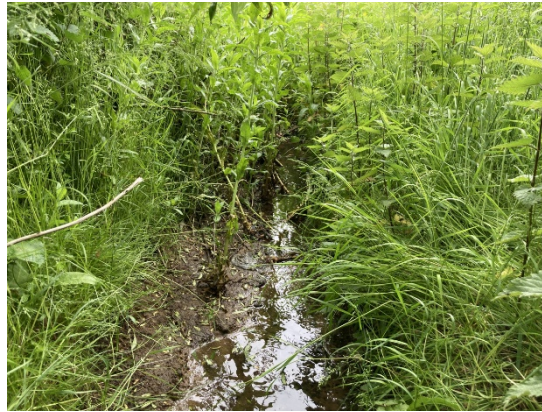
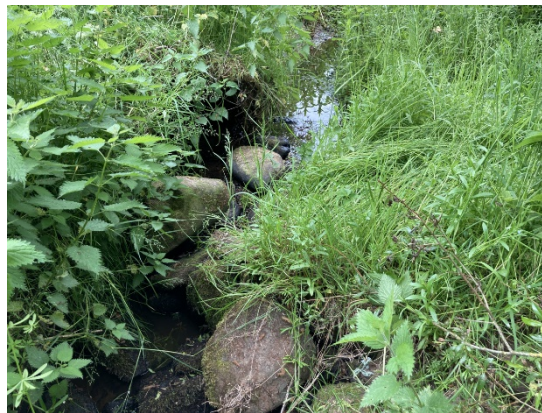
- 6.18.5.114 The MoRPh survey of Unnamed Tributary of Lowgill Beck 6.1 resulted in a river condition class of Fairly Poor.

Plate 22: Unnamed Tributary of Lowgill Beck 6.1 (WCP_18). Existing A66 culvert (A), vegetated silt dominated habitat (B), presence of in channel boulders (C).

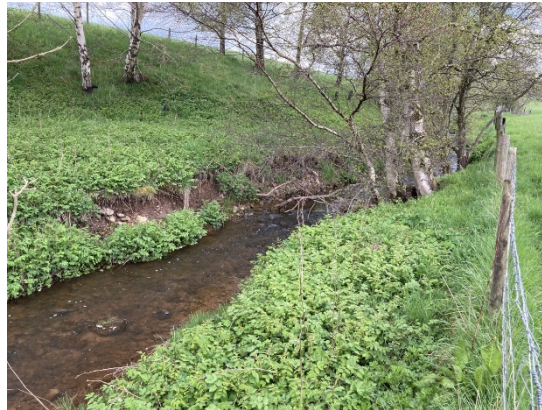
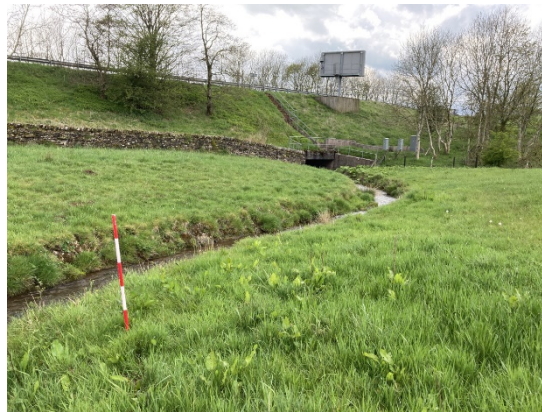
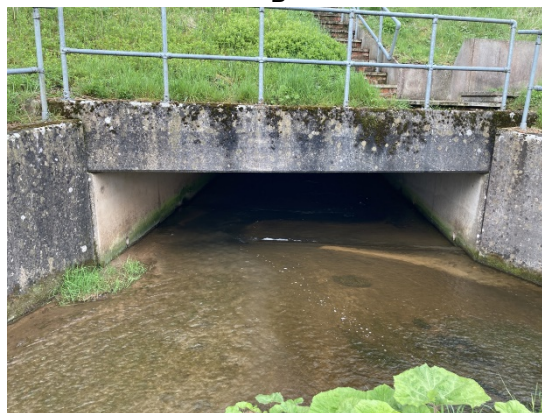
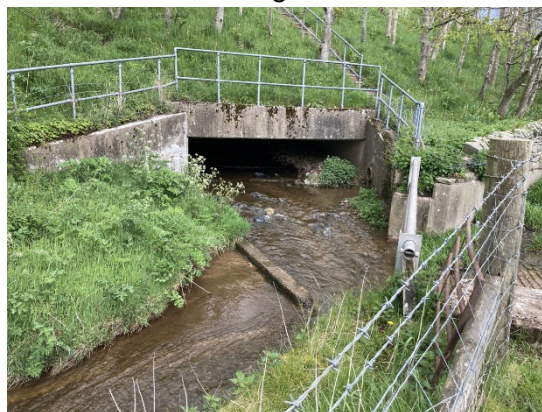
- 6.18.5.116 Baffles within the existing A66 culvert and a baulk/groyne (Plate 23, D) at the downstream end of the culvert (to focus flow and create depth for approaching fish), were recorded. It is unclear whether these features, aimed at facilitating improved fish passage, were installed when the culvert was built or have been retrofitted. The interventions appeared to be successful in creating suitable depth and storing natural bed material within the culvert and downstream. The water depth over the concrete bed at the upstream end of the culvert was very shallow (<2cm depth) and is considered to be a barrier for all fish species with the exception of eel under normal low flow conditions. It should be noted that there had been some recent rainfall on the day of the survey and river levels were slightly elevated, yet depths were still considered insufficient for fish to migrate (Plate 23, C).

Plate 23: Lowgill Beck/ Woodend Sike/ Yosgill Sike (WCP_19). Woodend Sike (A), Yosgill Sike (B), very shallow water associated with artificial substrate at Woodend-Yosgill confluence (C), baulk/groyne to focus flow downstream of the existing A66 culvert (D)

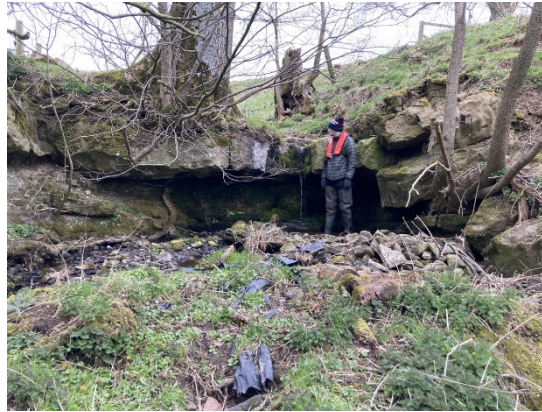
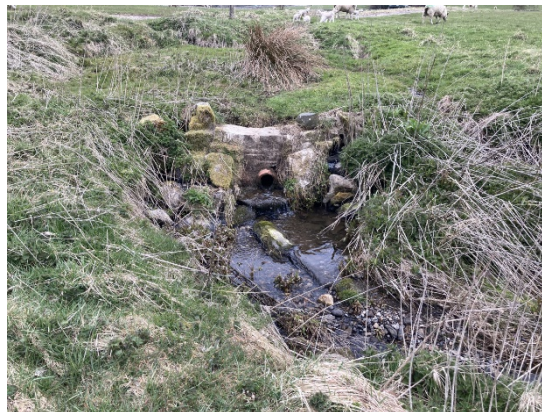
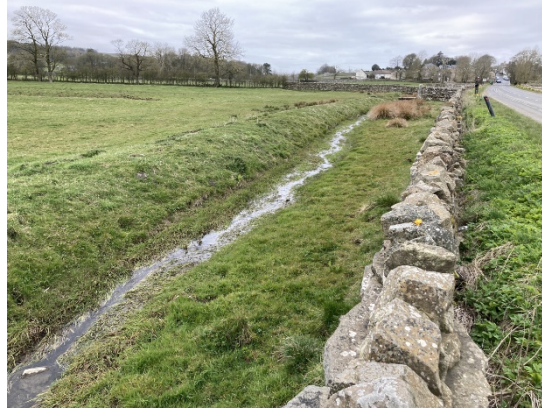
- 6.18.5.120 Unnamed Tributary of River Greta 7.3 is considered to be of limited value for fish in the wider Greta catchment due a natural waterfall approximately 50m upstream (NGR: NZ0016113199) of the River Greta that is considered a barrier for all species. The watercourse has also be extensively culverted, most notably for a 500m section spanning the existing A66.
- 6.18.5.121 A MoRPh survey was not conducted at this site as the proposed alignment is within an area of land where the watercourse is entirely already culverted.

Plate 24: Unnamed Tributary of River Greta 7.3 Natural barrier to fish migration ~50m upstream of the Greta confluence (A), culvert barrier highlighting modified nature of watercourse (B), section adjacent to B-road (C).
