**A66 Northern Trans-Pennine Project
TR010062**

**3.4 Environmental Statement
Appendix 6.18 Fish Habitat
Assessment and MorPh**

**3.4 ENVIRONMENTAL STATEMENT
APPENDIX 6.18 FISH HABITAT ASSESSMENT AND
MORPH**

Regulation Number:	Regulation 5(2)(a)
Planning Inspectorate Scheme Reference	TR010062
Application Document Reference	3.4
Author:	A66 Northern Trans-Pennine Project Team, National Highways

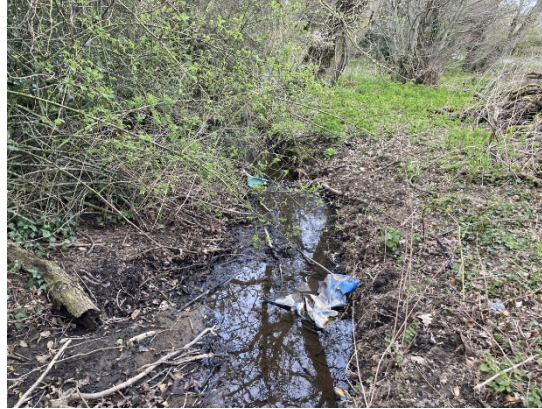
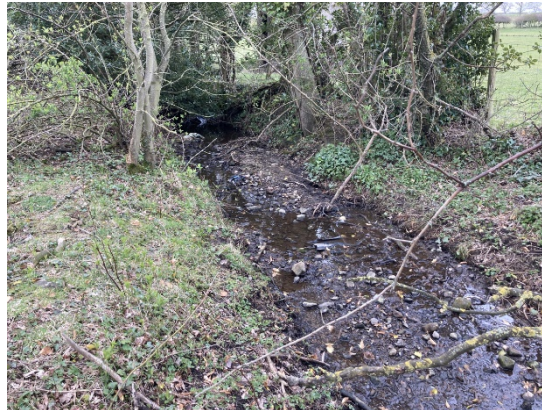
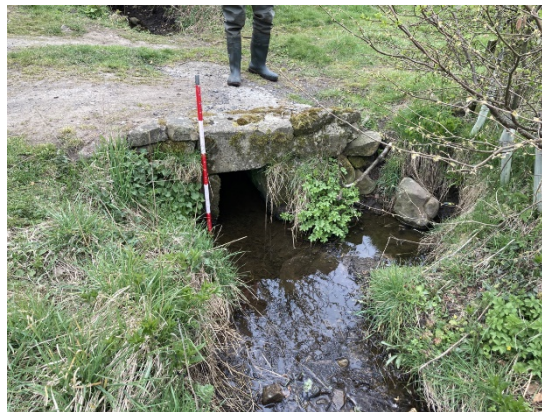
6.18.5.123 The MoRPh survey of Unnamed Tributary of Tutta Beck 8.1 resulted in a river condition class of Moderate.

Plate 25: Unnamed Tributary of Tutta Beck 8.1 (WCP_23). (A), (B), (C).

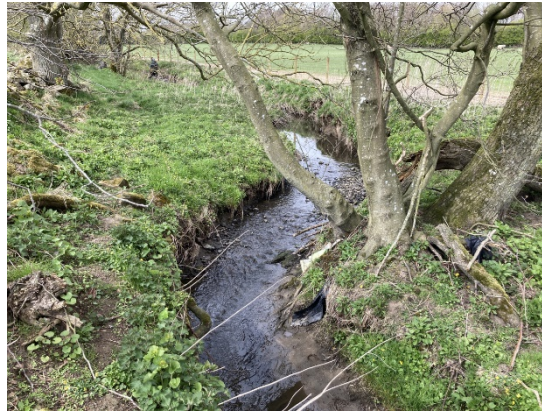
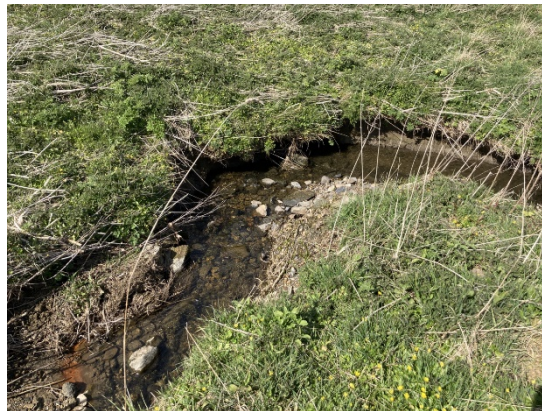
salmonid species was recorded, as were marginal areas of optimal and suboptimal juvenile lamprey habitat. The habitat variability was associated with result of active bank erosion and bar deposition in the sinuous channel.

- 6.18.5.125 No barriers to fish migration were recorded. No spawning redds were identified, but areas of clean gravel offering potential spawning opportunities for salmonid and lamprey sp. were commonplace.
- 6.18.5.126 Based on habitat assessment, Tutta Beck was considered to have the potential to support fish of conservation value. This was confirmed during fish surveys (electric fishing and eDNA) which recorded the presence of brown trout (electric fishing only) and eel (eDNA only), as outlined in Appendix 6.19: Fish (Application Document 3.4).
- 6.18.5.127 The MoRPh survey of Tutta Beck resulted in a river condition class of Moderate.

Plate 26: Tutta Beck (WCP_24). Sinuous channel with erosion and deposition created varied habitat and subsyared (A), culvert barrier highlighting modified nature of watercourse (B), section adjacent to B-road (C).

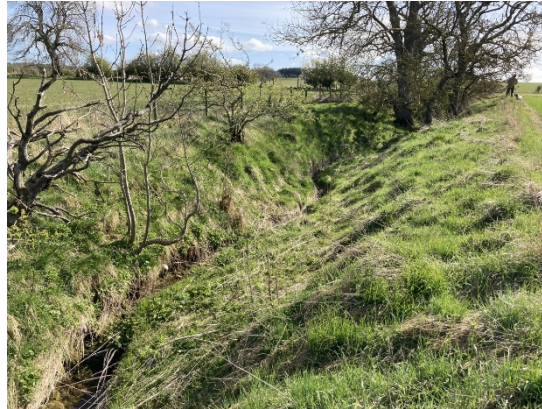
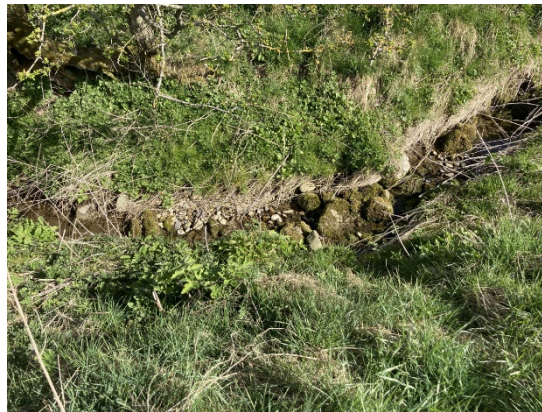
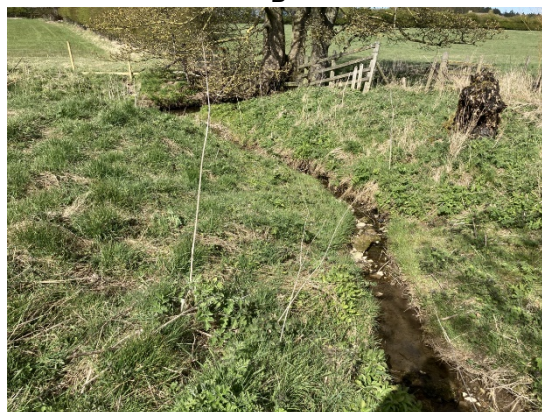
the watercourse was considered unlikely to support fish of conservation value.

Plate 27: Unnamed Tributary of River Greta 7.3 Natural barrier to fish migration ~50m upstream of the Greta confluence (A), culvert barrier highlighting modified nature of watercourse (B), section adjacent to B-road (C).

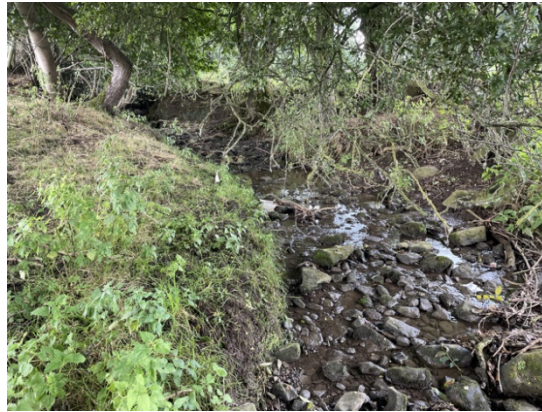
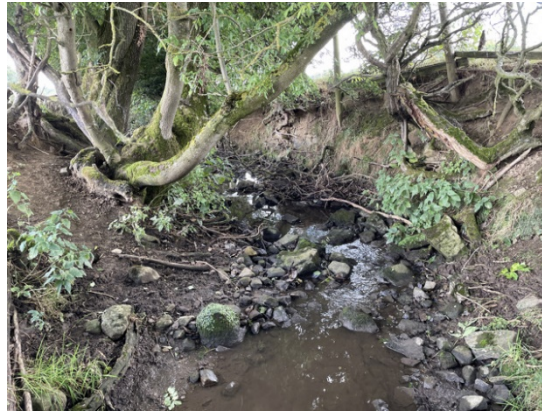
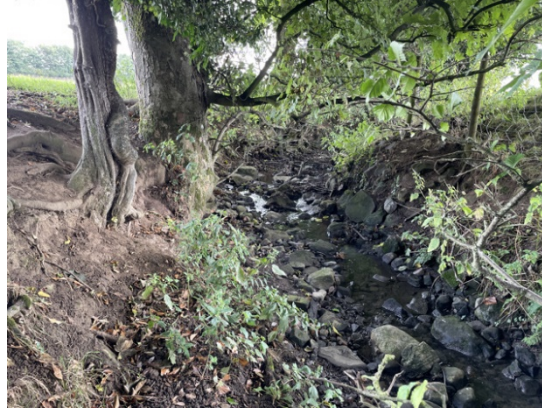
Plate 28: Punder Gill. Shallow fry habitat with a cobble and boulder-dominated substrate (A, B and C).

6.18.5.132 Based on habitat assessment, Punder Gill was considered to have the potential to support fish of conservation value. However, fish surveys (electric fishing and eDNA) confirmed the absence of all species, as outlined in ES Appendix 6.19: Fish (Application Document 3.4). The electric fish survey returned a nil catch and no fish DNA was recorded from the water sample collected.

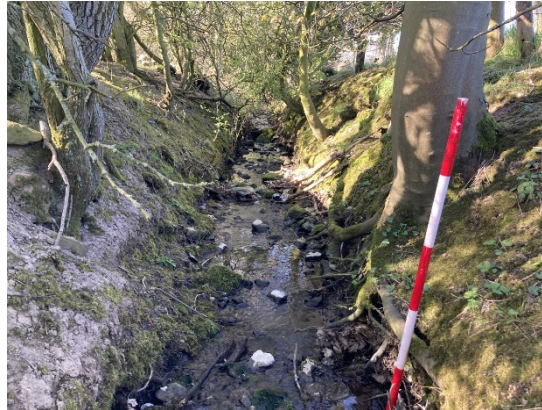
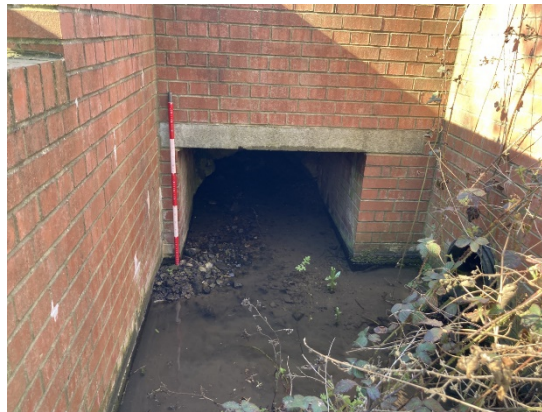
Plate 29: Unnamed Tributary of Holme Beck 9.6 (WCP_28). (A), (B), (C).

- 6.18.5.135 Based on habitat assessment, the watercourse was considered unlikely to support fish of conservation value, this was confirmed by the absence of fish DNA in the water sample collected, as outlined in Appendix 6.19: Fish (Application Document 3.4).
- 6.18.5.136 A MoRPh survey was not conducted at this site due to the fact that the site was dry when the MoRPH survey was attempted.

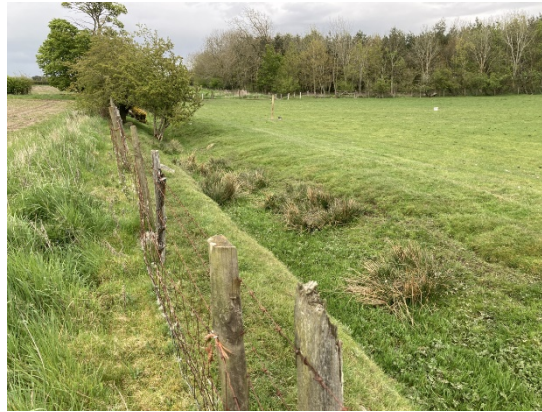
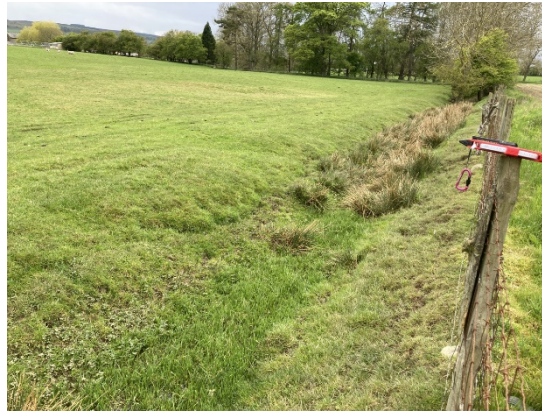
Plate 30: Unnamed Tributary of Holme Beck 9.3 (WCP_29). (A), (B), (C).

- 6.18.5.137 Unnamed Tributary of Holme Beck 9.3 was an ephemeral ditch and was considered unsuitable habitat for fish.
- 6.18.5.138 A MoRPh survey was not conducted at this site.

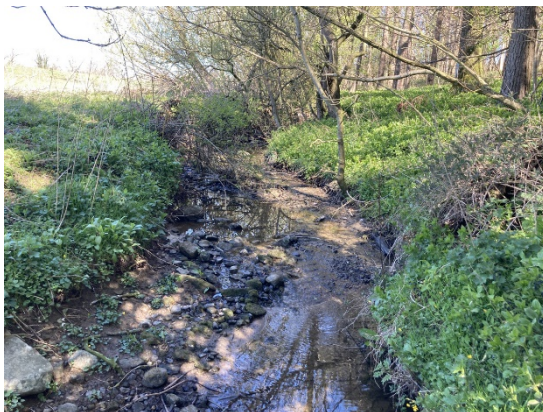
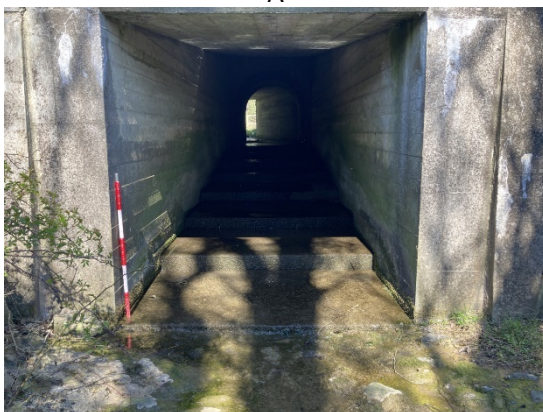
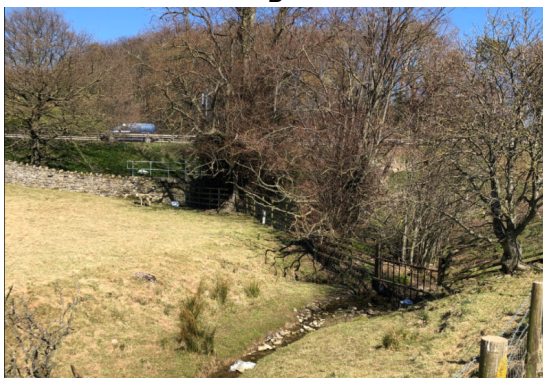
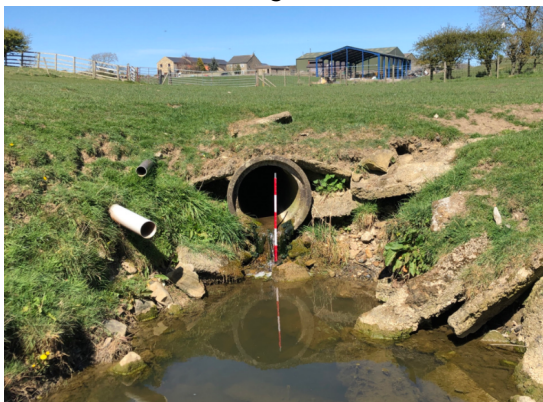
Plate 31: Mains Gill (WCP_30). (A), (B), (C).

- 6.18.5.139 Mains Gill upstream of the A66 was characterised by fry habitat with a gravel-dominated substrate, interspersed with sections of shallow glide. This reach is considered disconnected to the wide catchment as a result of the existing A66 stepped culvert (Plate 31, B), which was considered a barrier to mitigation for all fish species, with the potential exception of eel.

- 6.18.5.140 Downstream of the existing A66 the channel was open before entering a pipe culvert (~300m in length) adjacent to Mains Gill farm shop. At the downstream end of the culvert the pipe is perched and is considered to be a barrier to migration for all species of fish (Plate 31, C).

- 6.18.5.142 The MoRPh survey of Mains Gill resulted in a river condition class of Moderate.

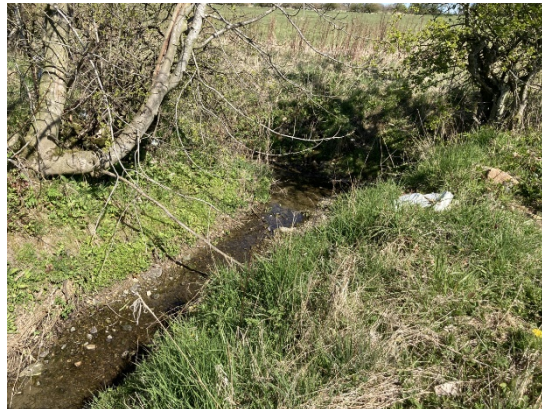
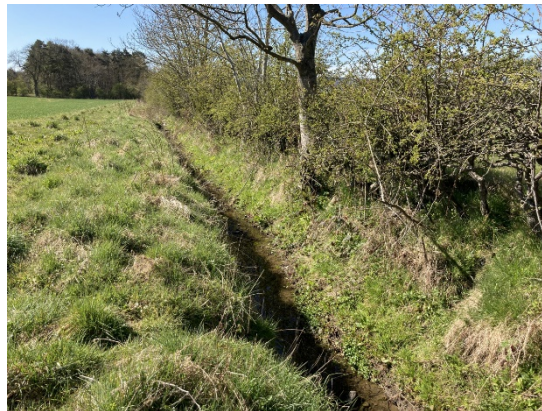
Plate 32: Unnamed Tributary of Mains Gill 9.1 (WCP_31). Straightened watercourse with gravel substrate (A and B).

- 6.18.5.143 Unnamed Tributary of Mains Gill 9.1 was characterised by shallow fry habitat with a fine gravel-dominated substrate. The watercourse appears to have been historically straightened. Based on habitat assessment, the watercourse was considered unlikely to support fish of conservation value. Main Gills, which is downstream of this site was dry when the electric fishing survey was undertaken. Full details of the fish surveys are outlined in Appendix 6.19: Fish (Application Document 3.4).
- 6.18.5.144 No MoRPh survey was conducted at this site as condition was derived from adjacent site (WCP_30).

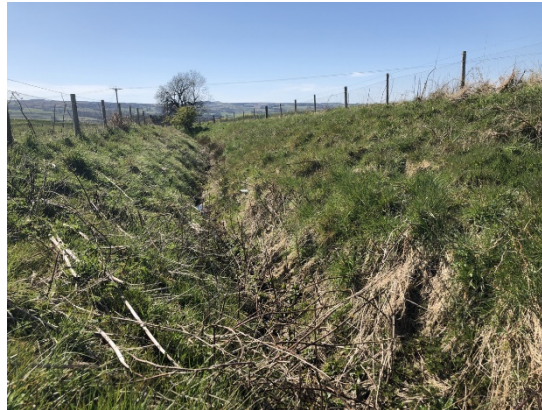
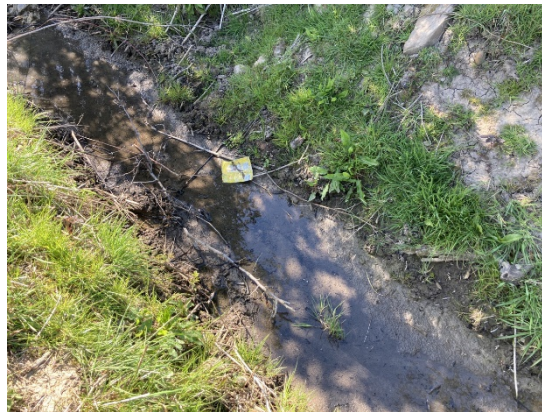
Plate 33: Unnamed Tributary of Holme Beck 9.8 (WCP_32). Channel choked with vegetation (A), silt-dominated substrate (B).

- 6.18.5.145 Unnamed Tributary of Holme Beck 9.8 was an ephemeral ditch with a silt-dominated substrate. The channel was choked with terrestrial vegetation and was considered unsuitable habitat for fish.

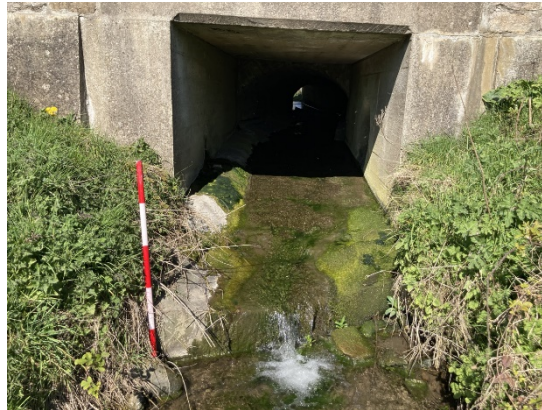
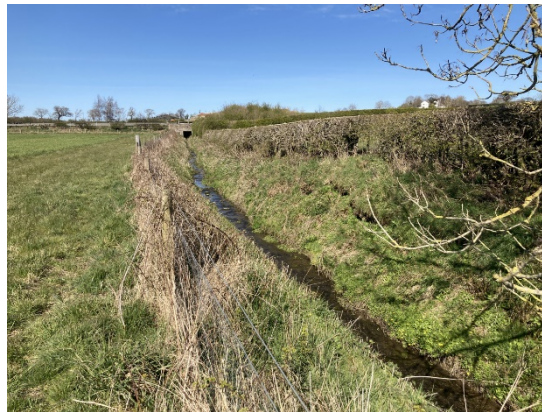
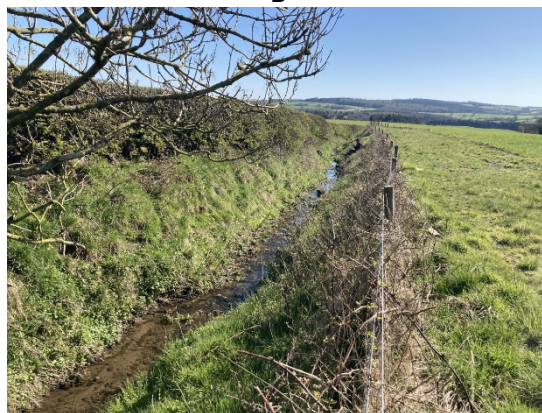
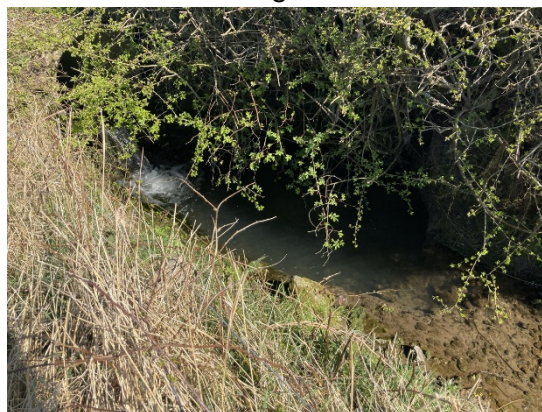
- 6.18.5.147 Based on habitat assessment, Unnamed Tributary of Holme Beck 9.2 was considered to have the potential to support fish of conservation value. Surveys (electric fishing and eDNA) from downstream of the perched pipe culvert confirmed the presence bullhead; the electric fish survey returned a nil catch, but bullhead DNA was returned from the water sample collected.

- 6.18.5.148 Despite its modified nature, the MoRPh survey of Unnamed Tributary of Holme Beck 9.2 resulted in a river condition class of Moderate.

Plate 34: Unnamed Tributary of Holme Beck 9.2 (WCP_33 and WCP_34). Existing A66 culvert (A), incised channel (B and C), perched pipe culvert considered a barrier to migration for all fish species (C).
