**A66 Northern Trans-Pennine Project
TR010062**

**3.4 Environmental Statement
Appendix 12.1 Baseline Noise Survey
Results**

**3.4 ENVIRONMENTAL STATEMENT
APPENDIX 12.1 BASELINE NOISE SURVEY RESULTS**

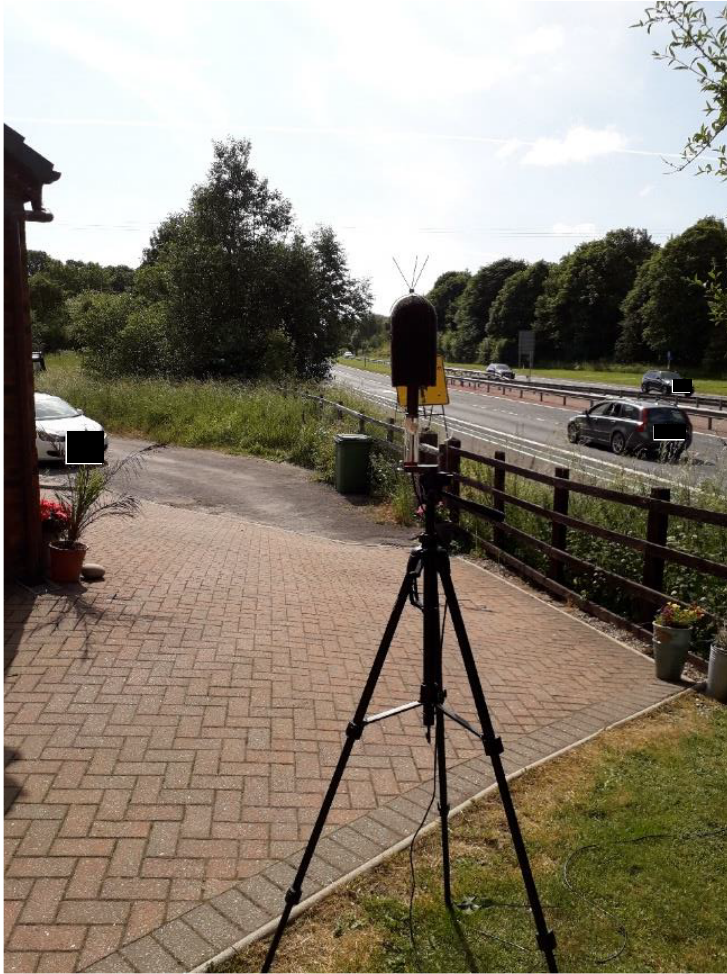
- 12.1.3.1 Monitoring equipment was set up on 30th June 2021 and was left unattended in a façade position for a period of 24 hours as per Plate 1: Noise monitoring equipment at 4 Eamont Terrace

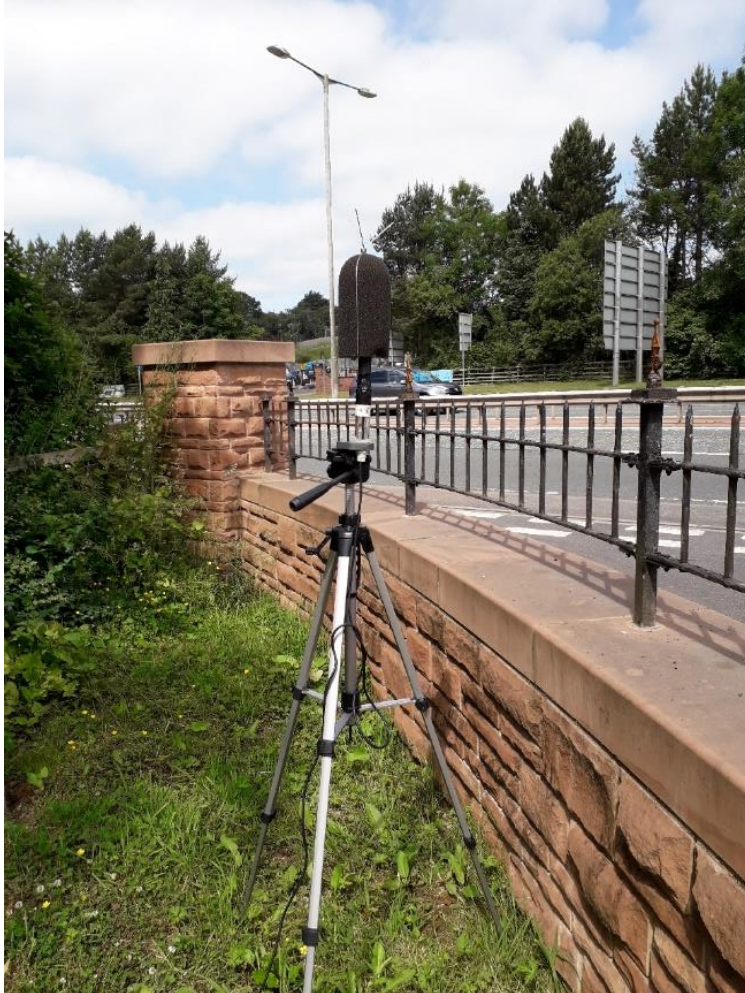
Plate 3: Noise monitoring equipment at Skirsgill Lodge

- 12.1.3.6 Monitoring equipment was set up on 30th June 2021 and a 3-hour noise measurement was undertaken. The equipment was set up in a free field position as per Plate 3: Noise monitoring equipment at Skirsgill Lodge.

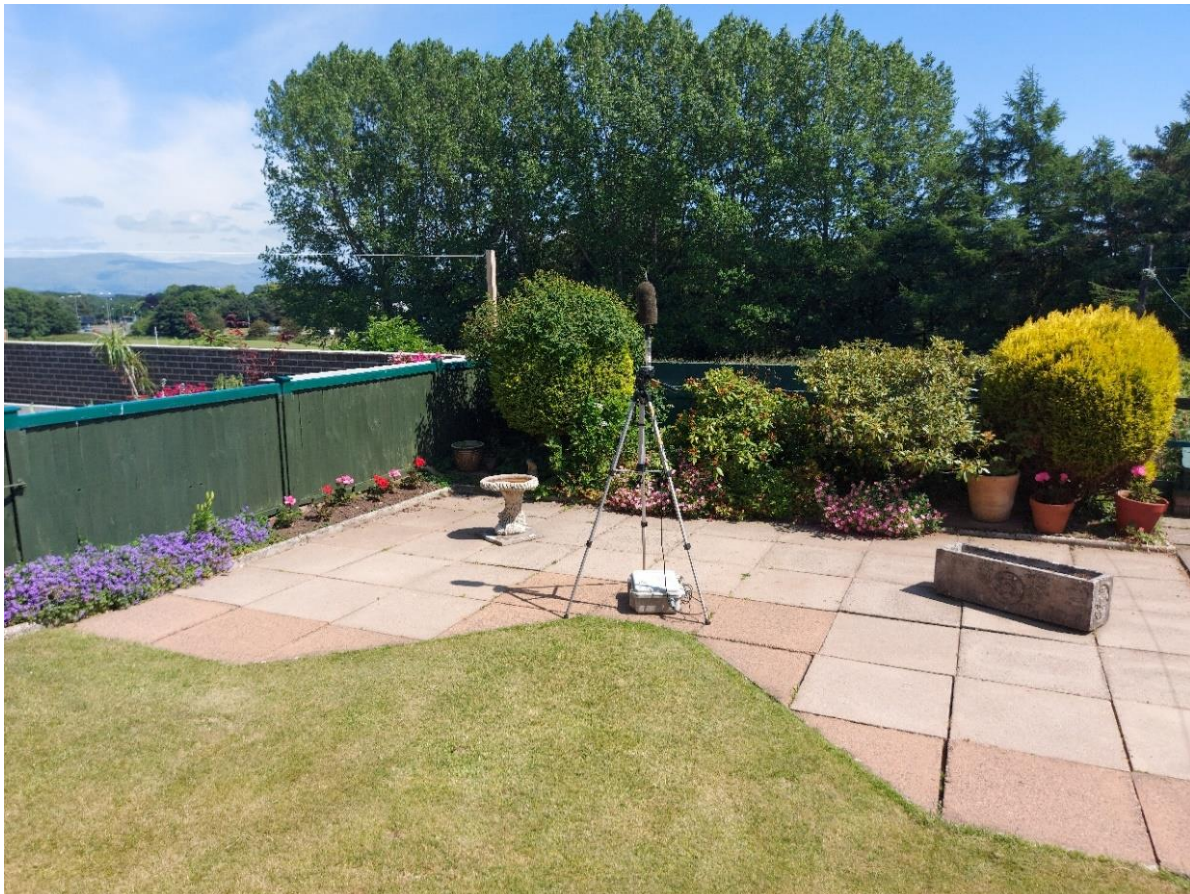
Plate 4: Noise monitoring equipment at 35 Clifford Road

12.1.3.11 Monitoring equipment was set up on 30th June 2021 and was left unattended for a period of 24 hours. The equipment was set up in a free field position as per Plate 4: Noise monitoring equipment at 35 Clifford Road.

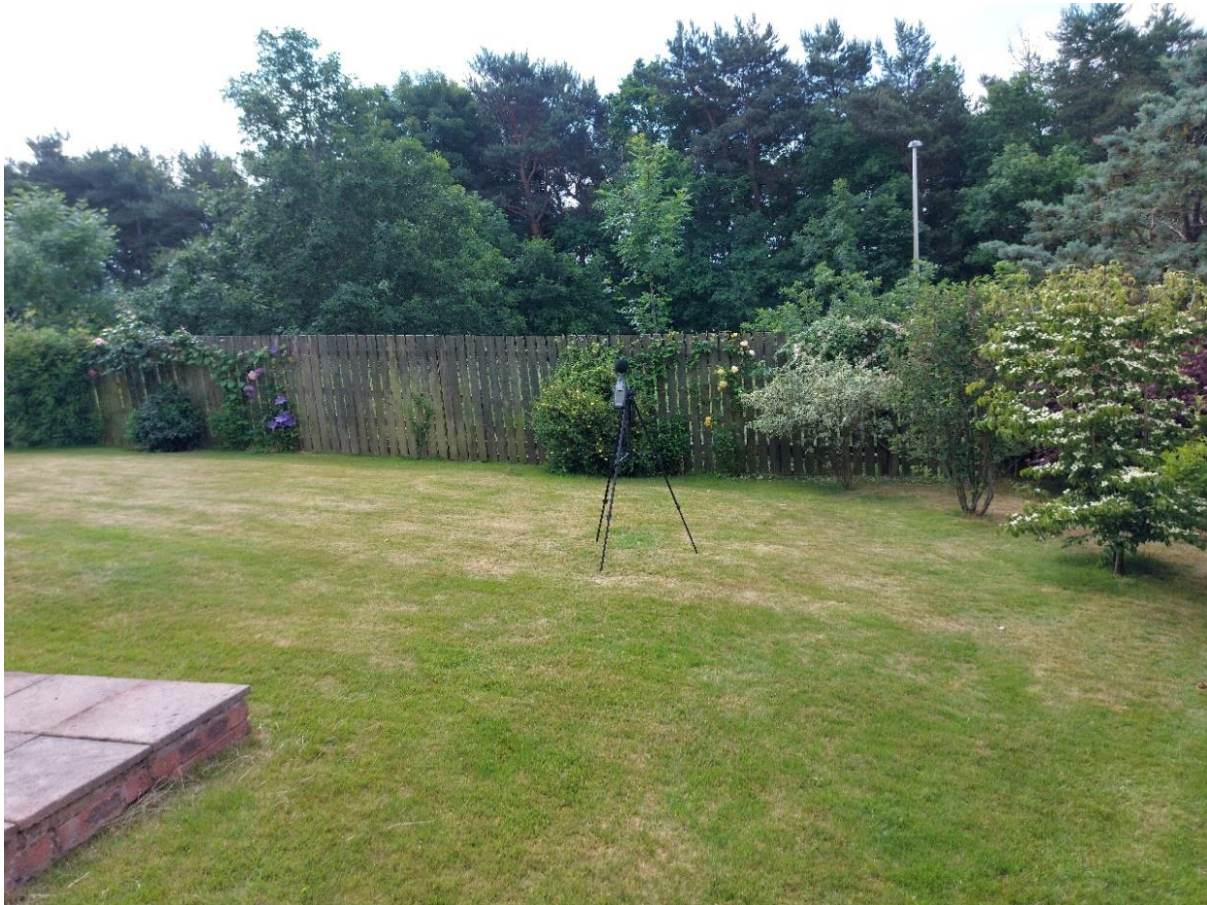
Plate 6: Noise monitoring equipment at 11 Carlton Hall Gardens

12.1.3.16 Monitoring equipment was set up on 30th June 2021 and a 3-hour noise measurement was undertaken. The equipment was set up in a free field position as per Plate 6: Noise monitoring equipment at 11 Carlton Hall Gardens.

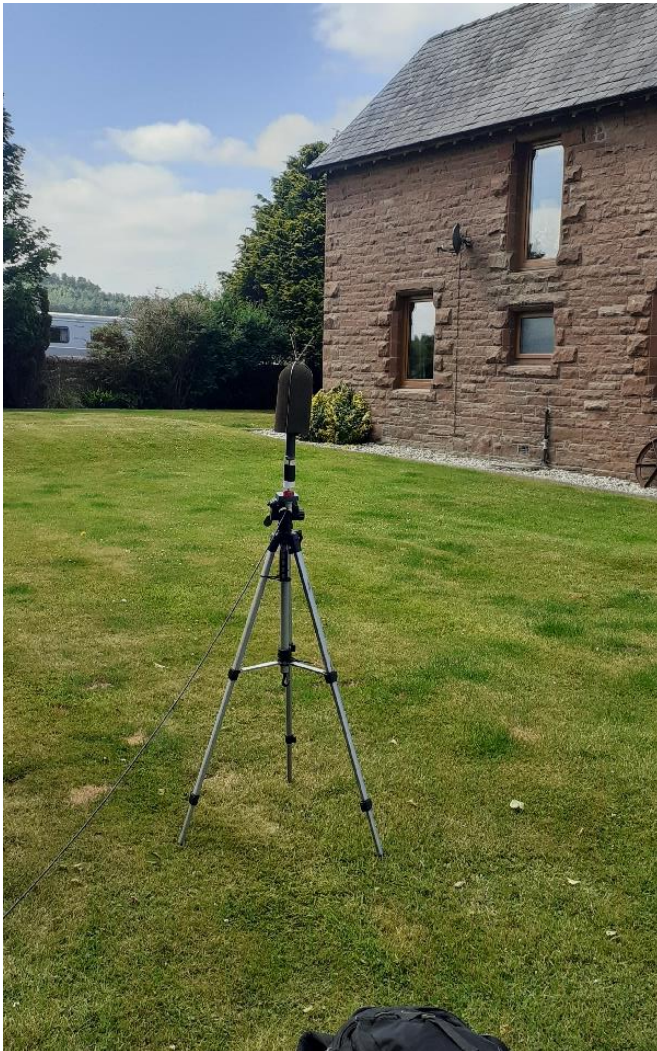
Plate 7: Noise monitoring equipment at School House

12.1.3.21 Monitoring equipment was set up on 30th June 2021 and was left unattended for a period of 24 hours. The equipment was set up in a free field position as per Plate 7: Noise monitoring equipment at School House.

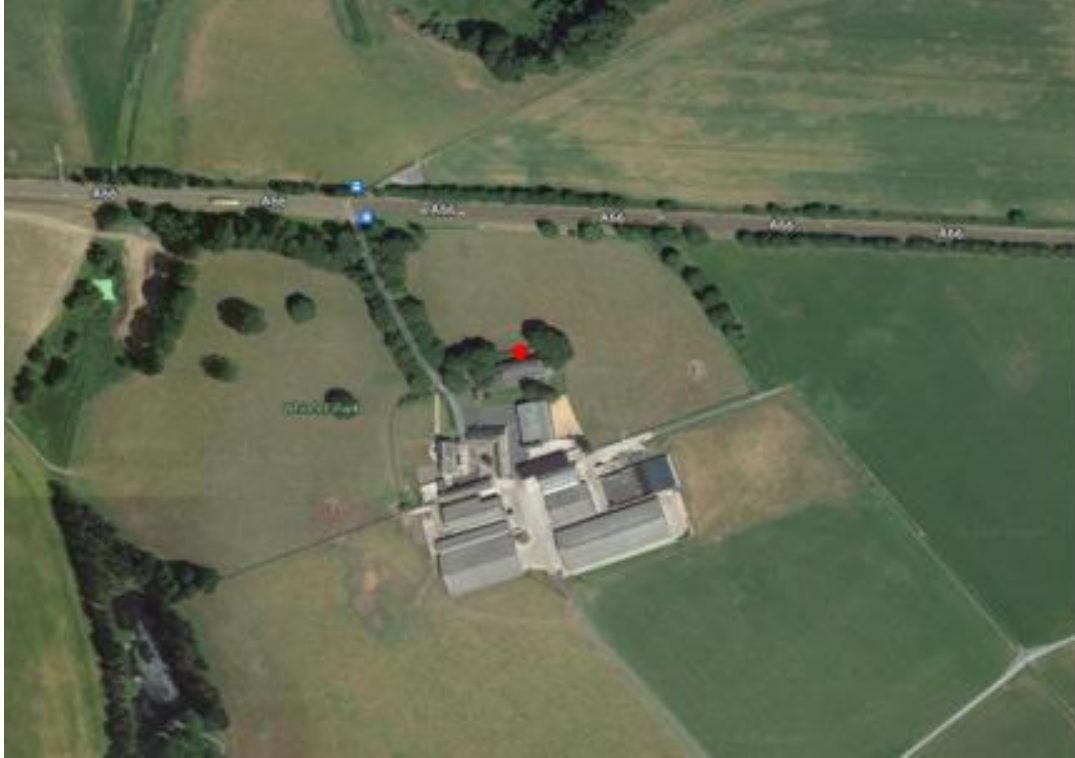
Plate 9: Location of monitoring equipment at Whinfell Cottages

12.1.3.26 Monitoring equipment was set up on 29th June 2021 and a 3-hour CRTN noise measurement was undertaken. The equipment was set up in a free field position, however, due to technical difficulties, no site photos are available. The location of the equipment is shown below in Plate 9: Location of monitoring equipment at Whinfell Cottages.

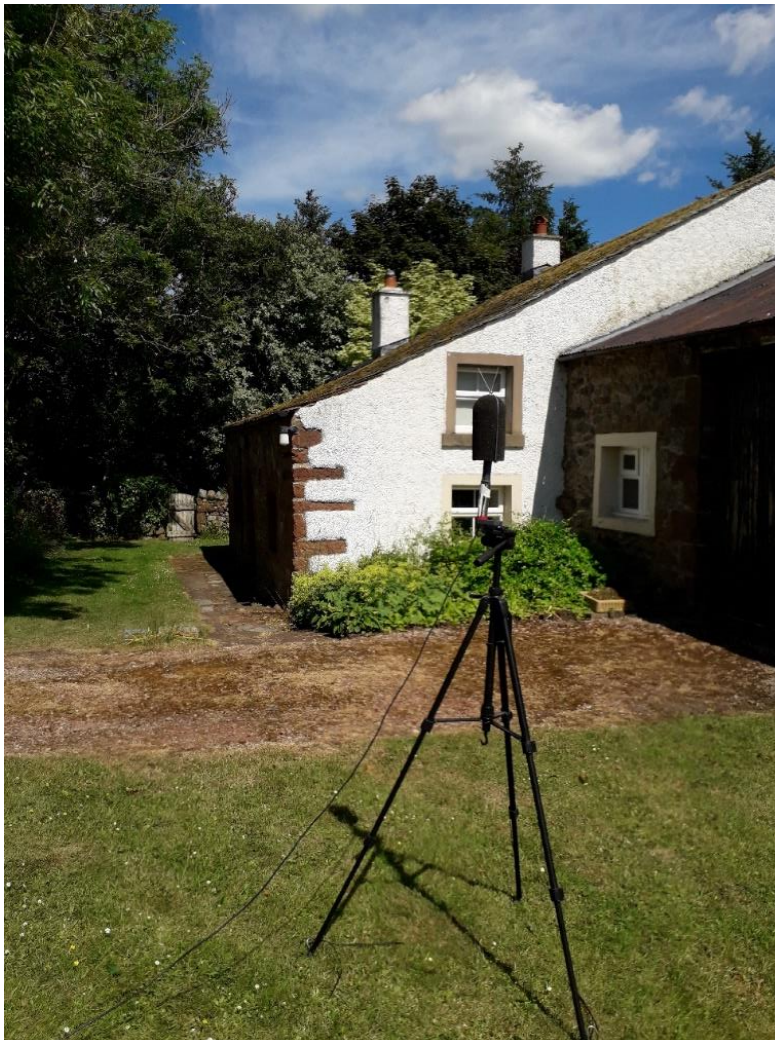
Plate 10: Noise monitoring equipment at Castrigg Lane

12.1.3.31 Monitoring equipment was set up on 29th June 2021 and was left unattended for a period of 24 hours. The equipment was set up in a free field position as per Plate 10: Noise monitoring equipment at Castrigg Lane.

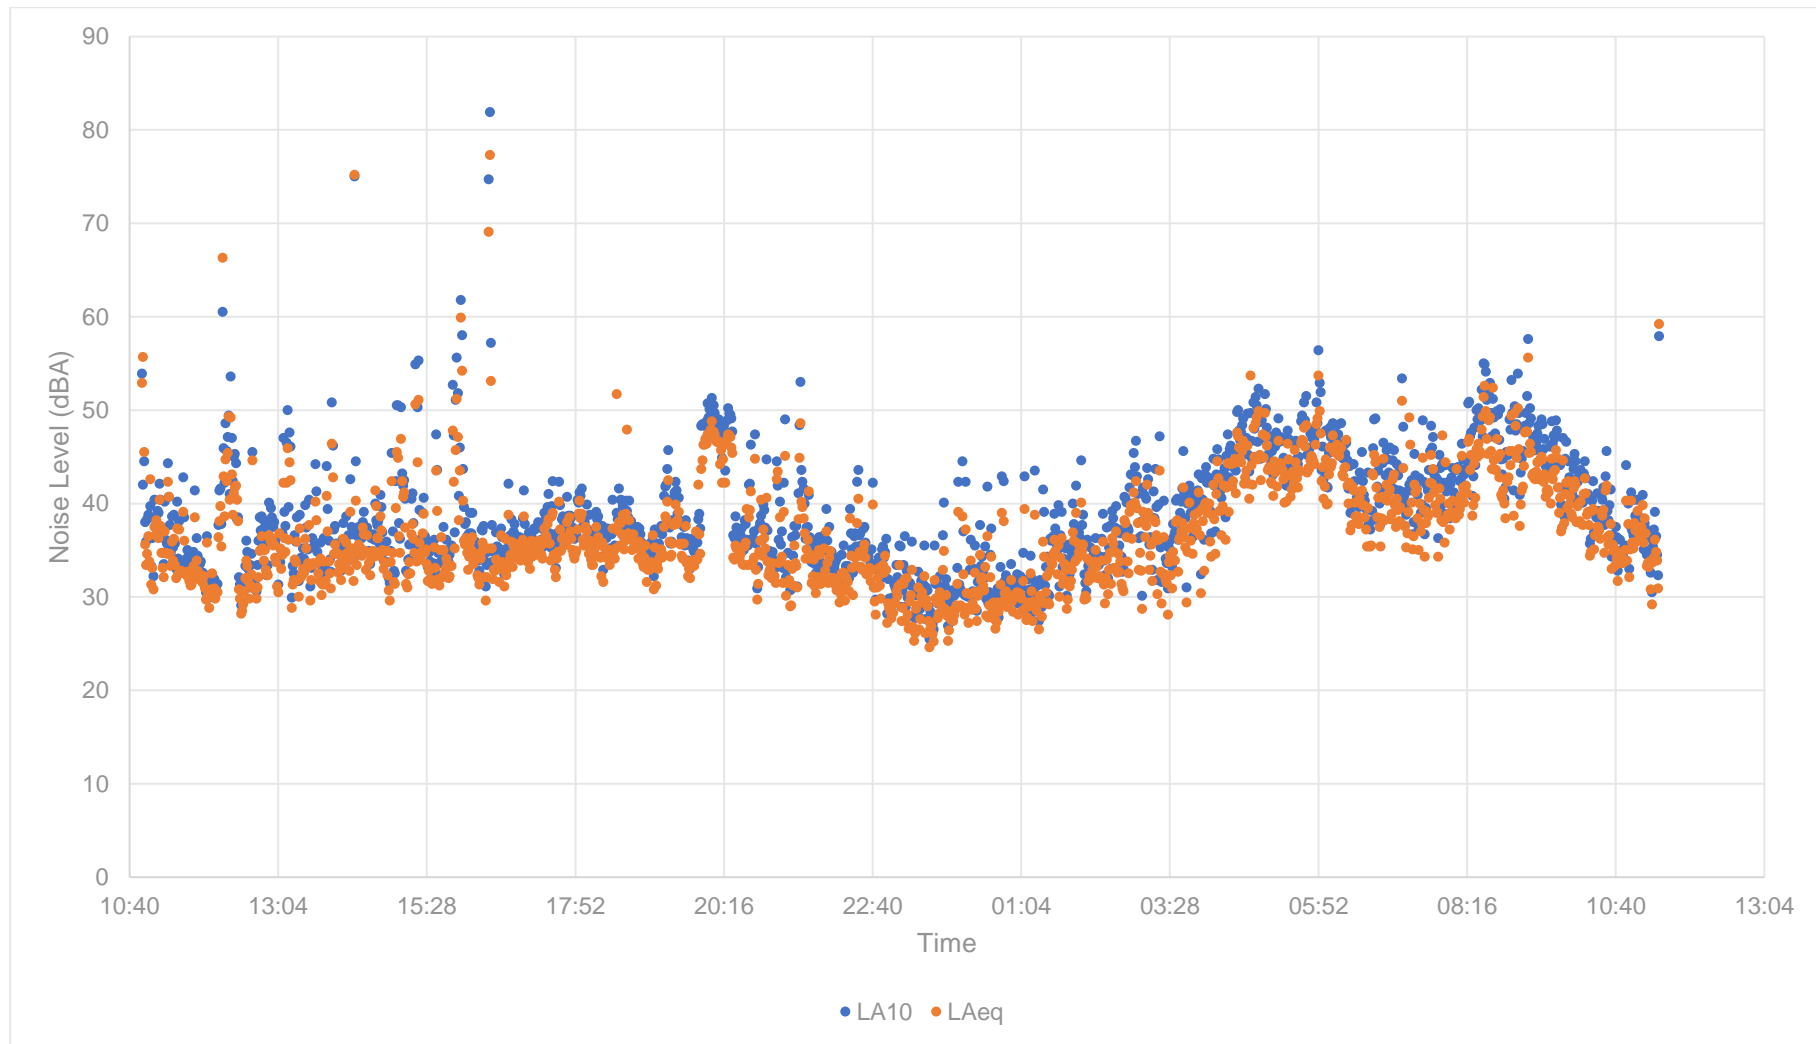
Plate 13: Measured levels at 48 Sanderson Croft

12.1.3.38 The main noise sources were noted to be road traffic noise from the local road network, birds and voices from residents in their gardens. Occasional aircraft and distant industrial noise was also noted during equipment set up.

12.1.3.40 Noise levels recorded throughout the monitoring period are shown in Plate 13: Measured levels at 48 Sanderson Croft.

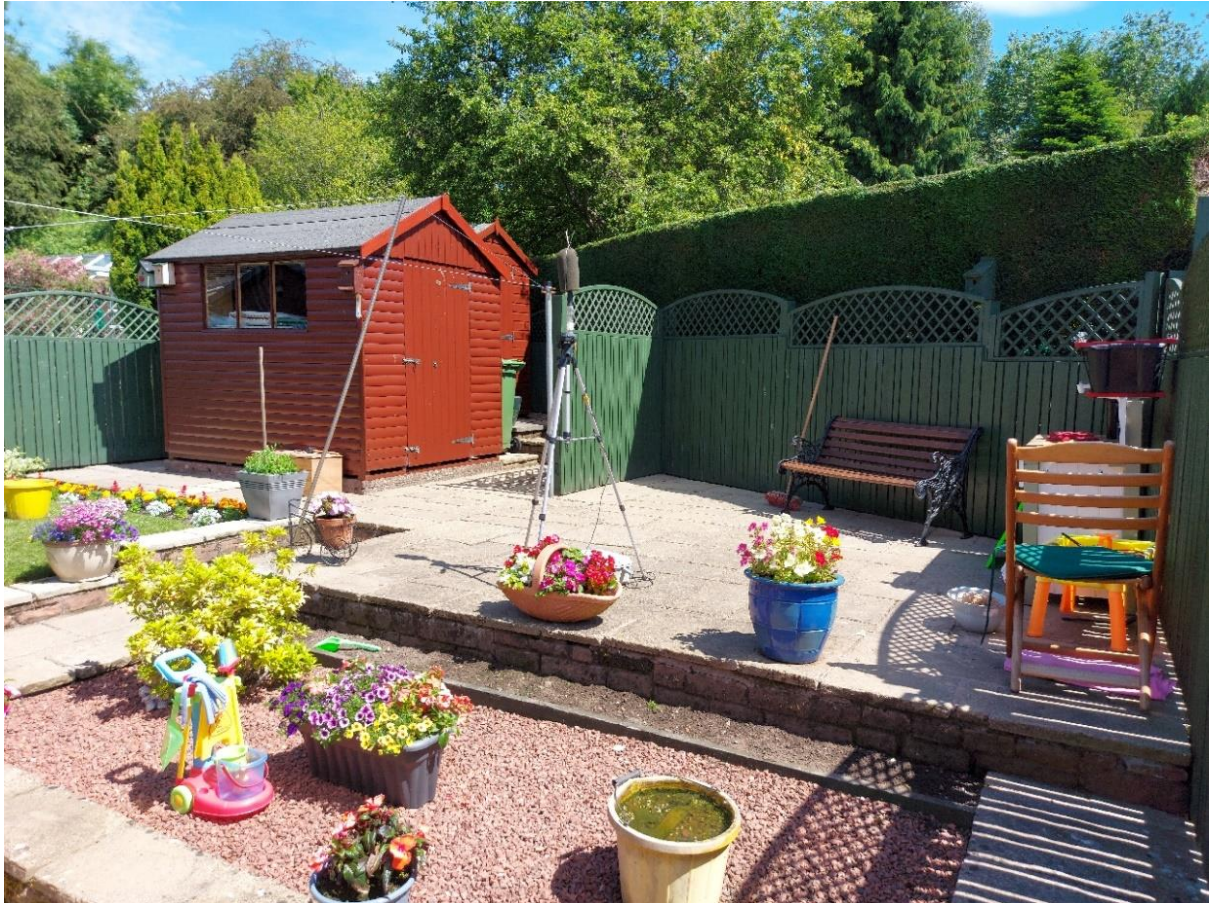
Plate 14: Noise monitoring equipment at 12 Long Marten Road

12.1.3.41 Monitoring equipment was set up on 29th June 2021 and was left unattended for a period of 24 hours. The equipment was set up in a free field position as per Plate 14: Noise monitoring equipment at 12 Long Marten Road.

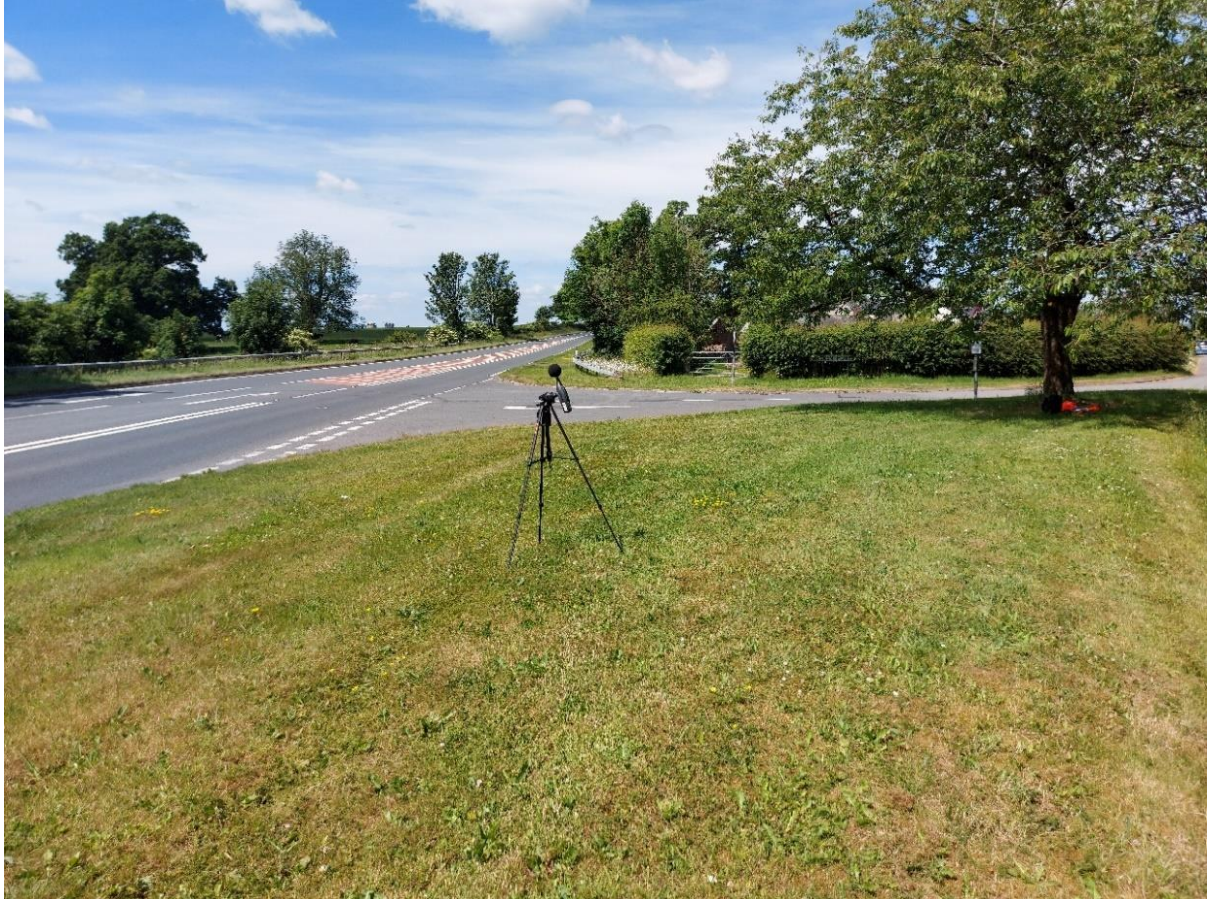
Plate 16: Noise monitoring equipment at Crackenthorpe Junction

12.1.3.46 Monitoring equipment was set up on 29th June 2021 and a 3-hour noise measurement was undertaken. The equipment was set up in a free field position as per

12.1.3.47 Plate 16: Noise monitoring equipment at Crackenthorpe Junction.

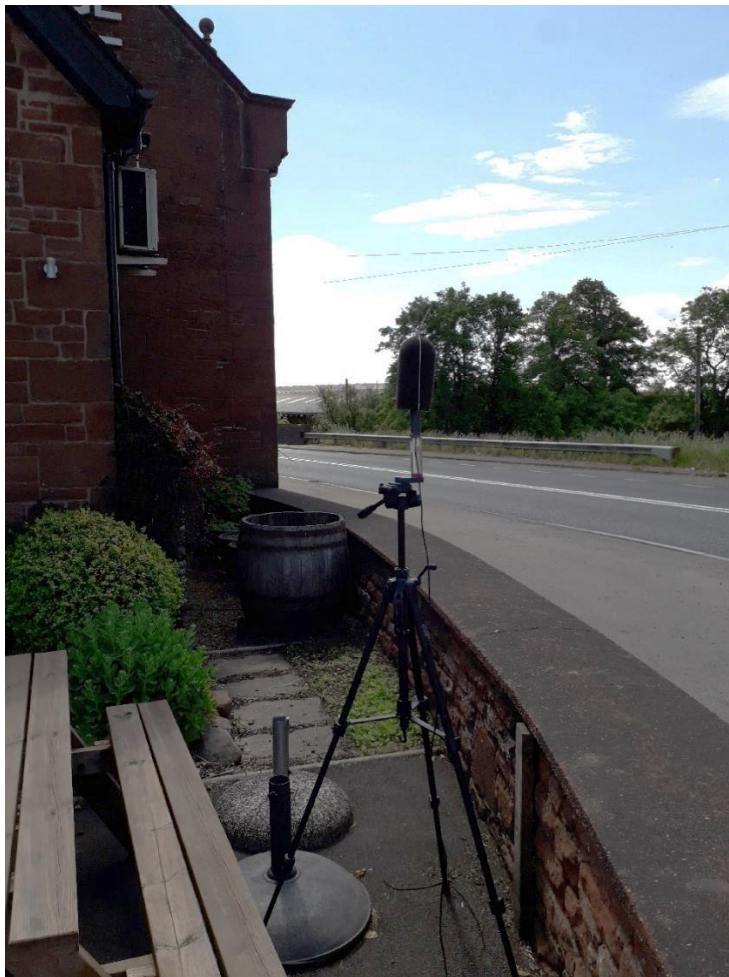
Plate 17: Noise monitoring equipment at Bridge Hotel

12.1.3.52 Monitoring equipment was set up on 29th June 2021 and a 3-hour noise measurement was undertaken. The equipment was set up in a free field position as per Plate 17: Noise monitoring equipment at Bridge Hotel.

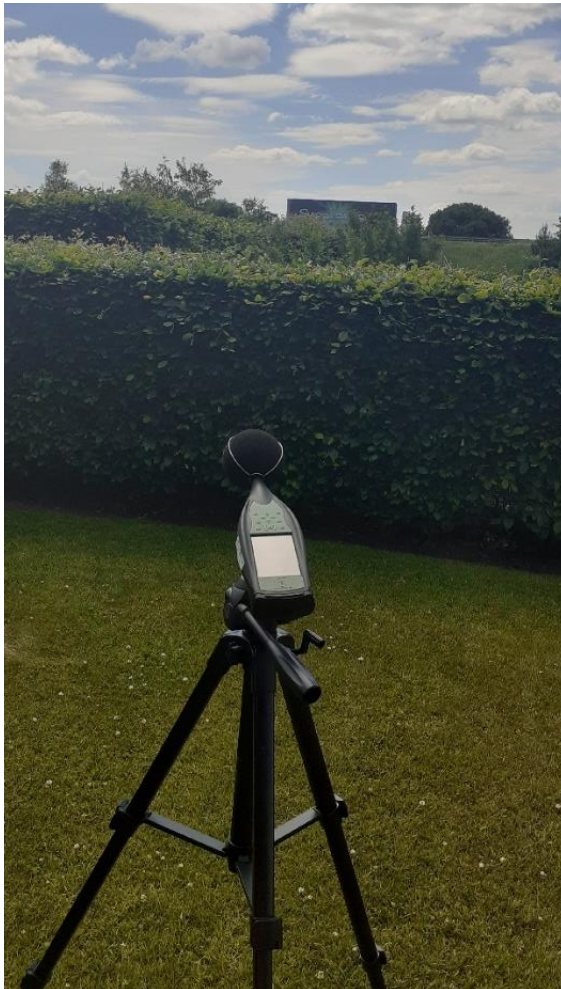
Plate 18: Noise monitoring equipment at Comrie Lea

12.1.3.57 Monitoring equipment was set up on 29th June 2021 and a 3-hour noise measurement was undertaken. The equipment was set up in a free field position as per Plate 18: Noise monitoring equipment at Comrie Lea.

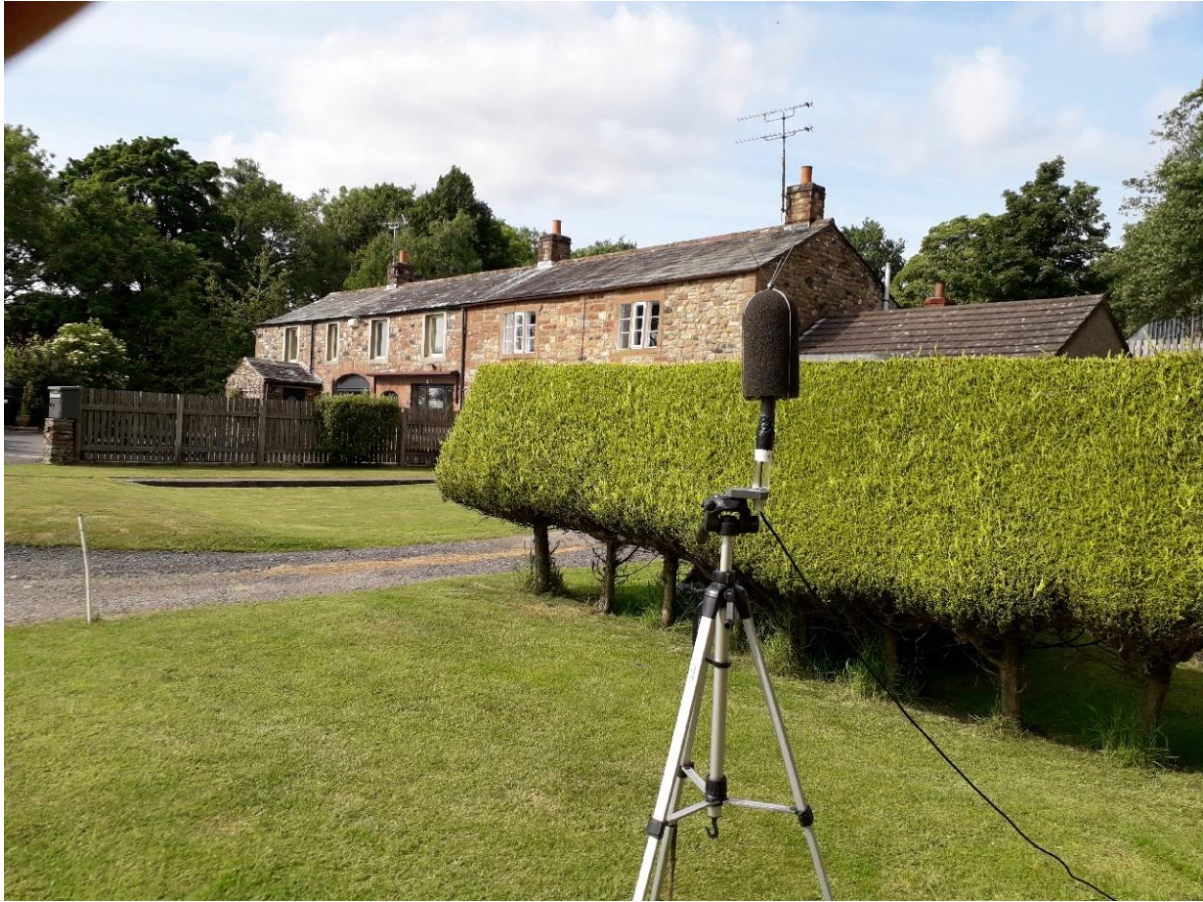
Plate 19: Noise monitoring equipment at Walkmill

12.1.3.62 Monitoring equipment was set up on 30th June 2021 and was left unattended for a period of 24 hours. The equipment was set up in a free field position as per Plate 19: Noise monitoring equipment at Walkmill.

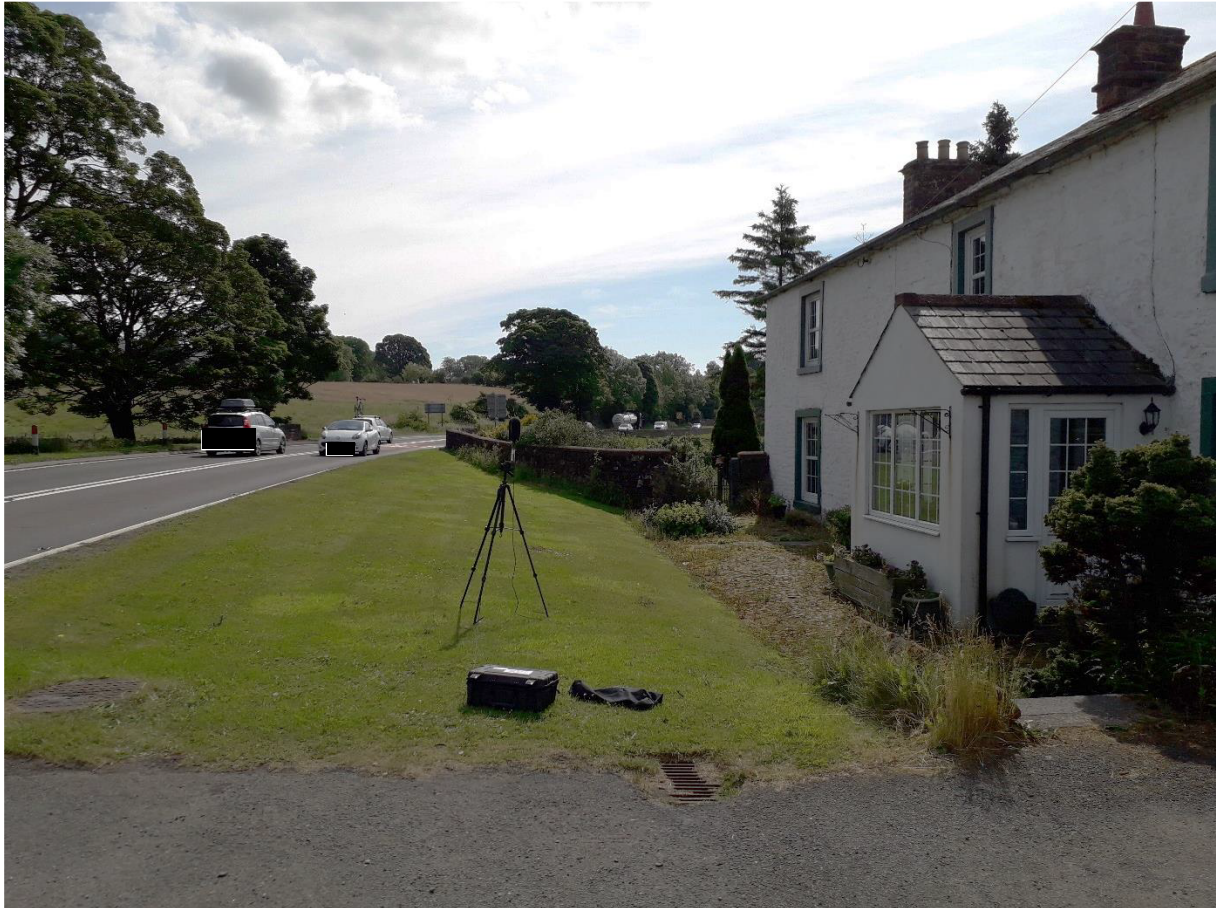
Plate 21: Noise monitoring equipment at Wheatsheaf Farm

12.1.3.67 Monitoring equipment was set up on 28th June 2021 and a 3-hour noise measurement was undertaken. The equipment was set up in a free field position as per Plate 21: Noise monitoring equipment at Wheatsheaf Farm.

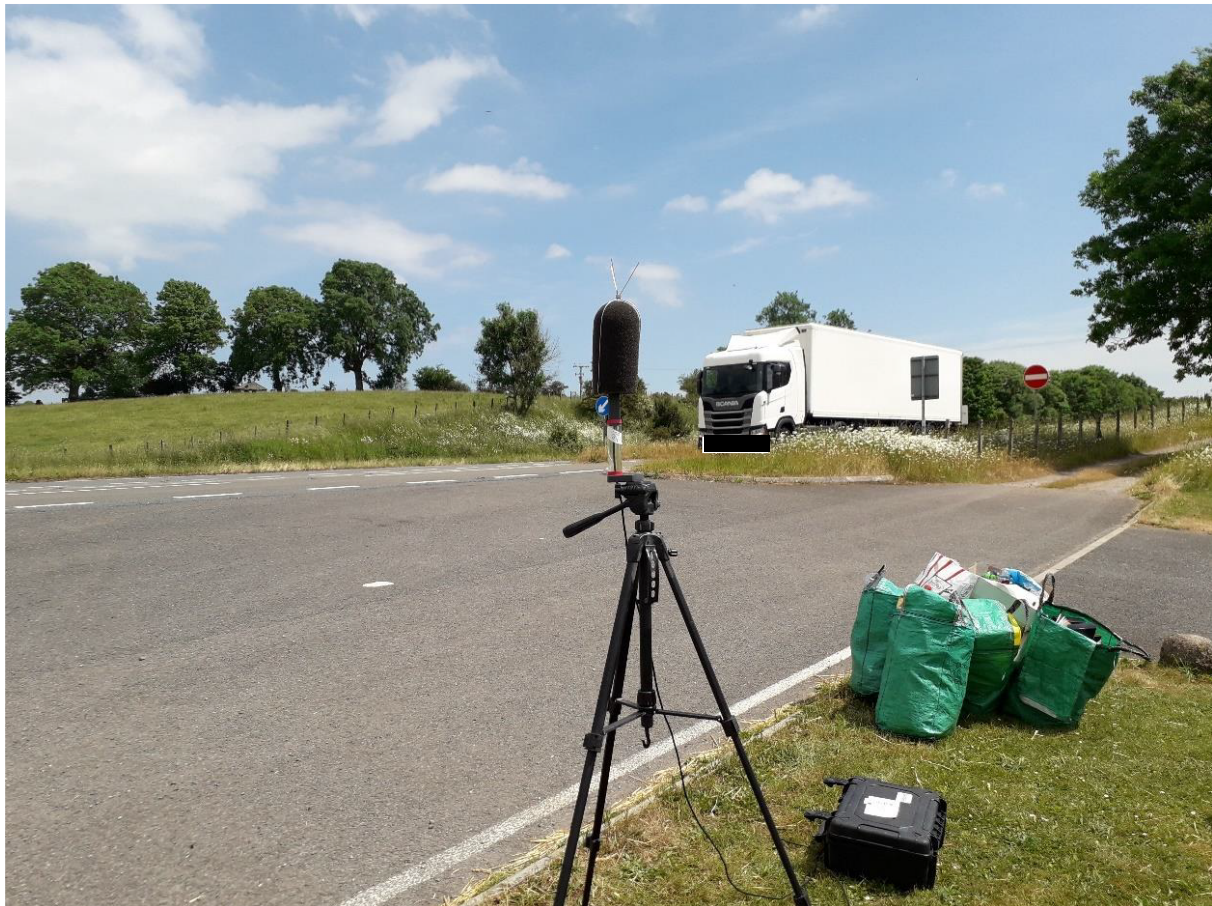
Plate 22: Noise monitoring equipment at Near Croft off A66

12.1.3.72 Monitoring equipment was set up on 28th June 2021 and a 3-hour CRTN noise measurement was undertaken. The equipment was set up in a free field position as per Plate 22: Noise monitoring equipment at Near Croft off A66.

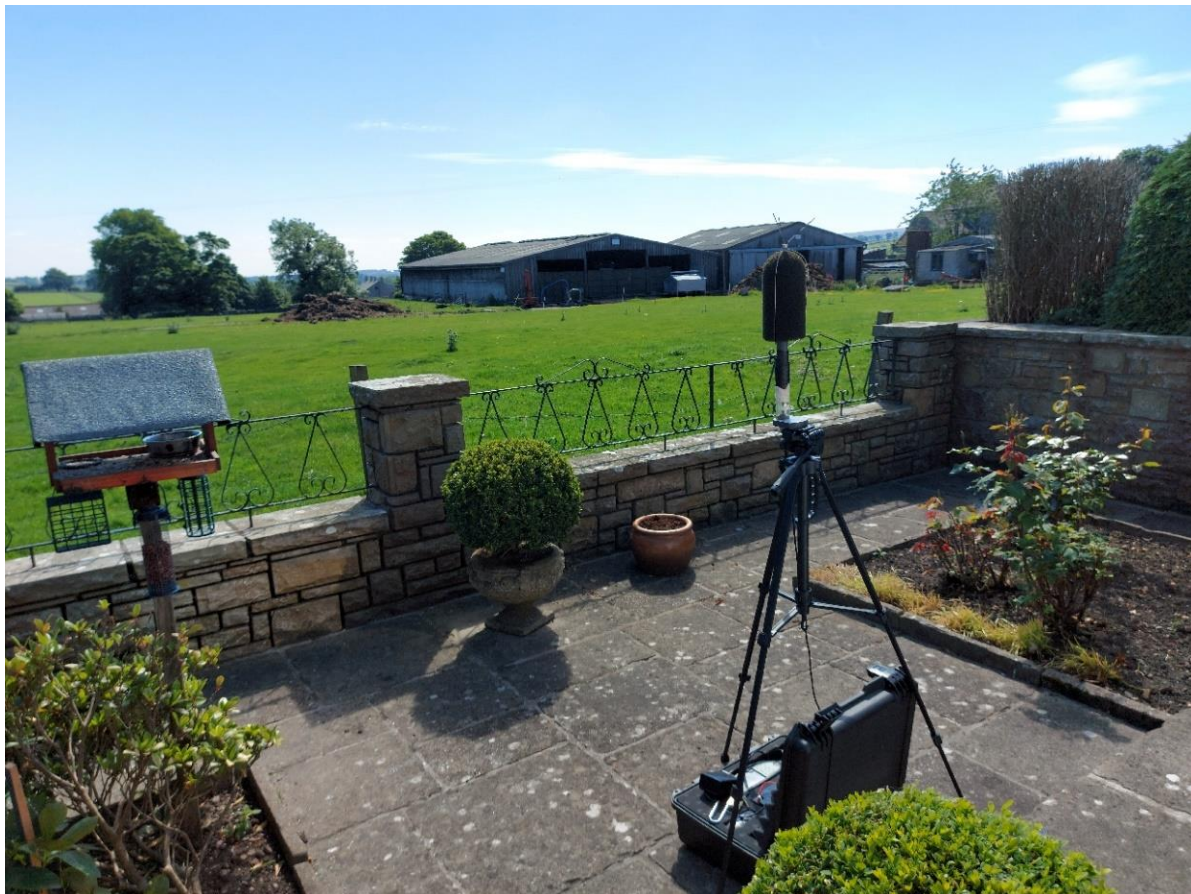
Plate 23: Noise monitoring equipment at Kilmond View

12.1.3.77 Monitoring equipment was set up on 1st July 2021 and was left unattended for a period of 24 hours. The equipment was set up in a free field position as per Plate 23: Noise monitoring equipment at Kilmond View.

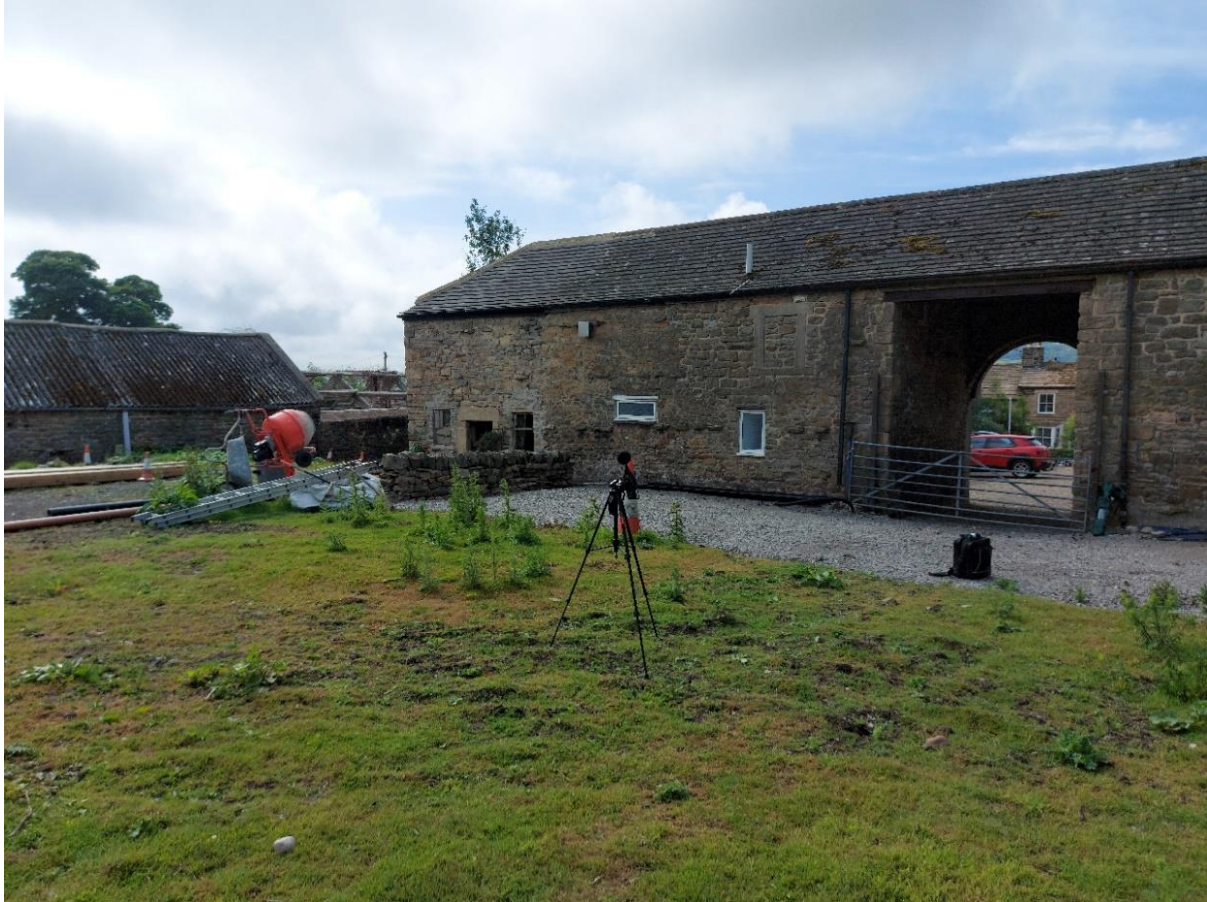
Plate 25: Noise monitoring equipment at Unicorn View

12.1.3.82 Monitoring equipment was set up on 28th June 2021 and a 3-hour noise measurement was undertaken. The equipment was set up in a free field position as per Plate 25: Noise monitoring equipment at Unicorn View.

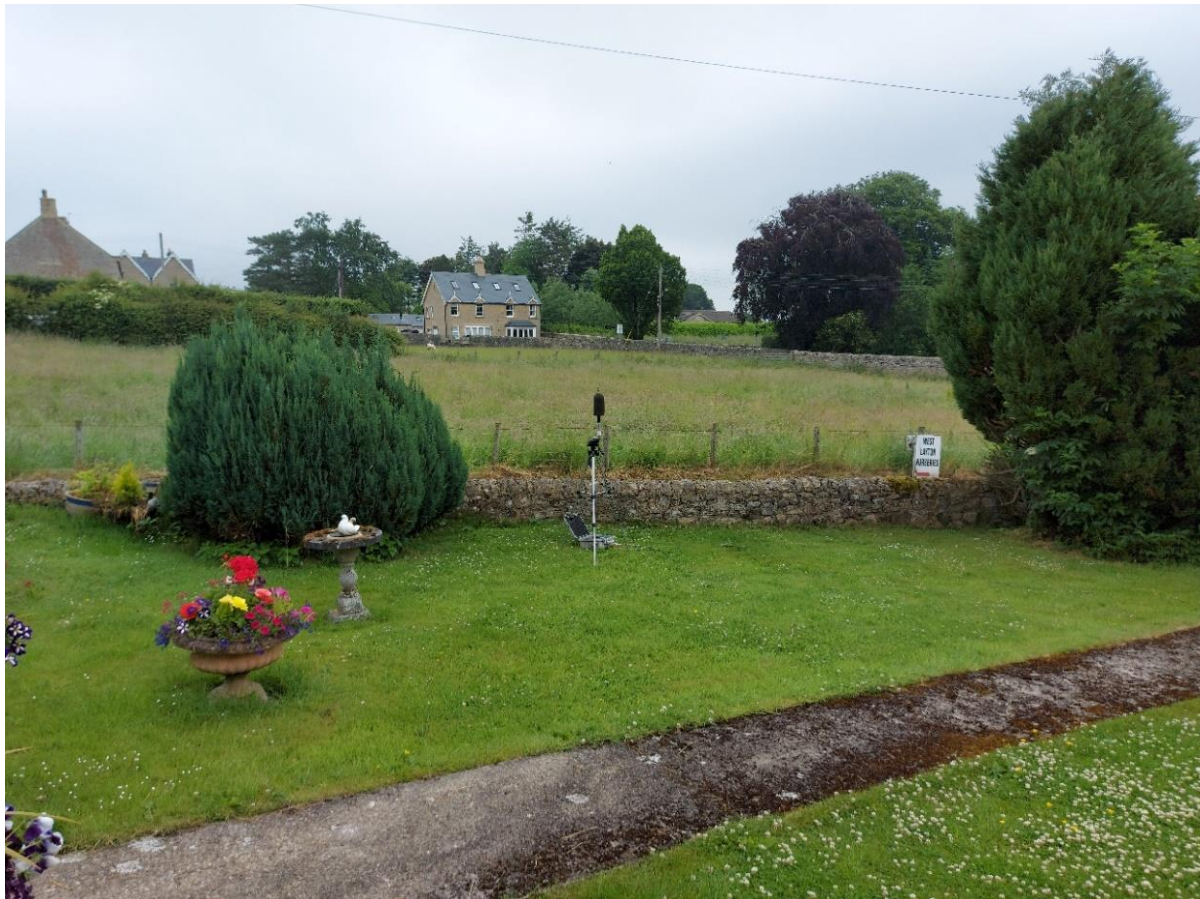
Plate 26: Noise monitoring equipment at the Laurels

12.1.3.87 Monitoring equipment was set up on 28th July 2021 and was left unattended for a period of 24 hours. The equipment was set up in a free field position as per Plate 26: Noise monitoring equipment at the Laurels.

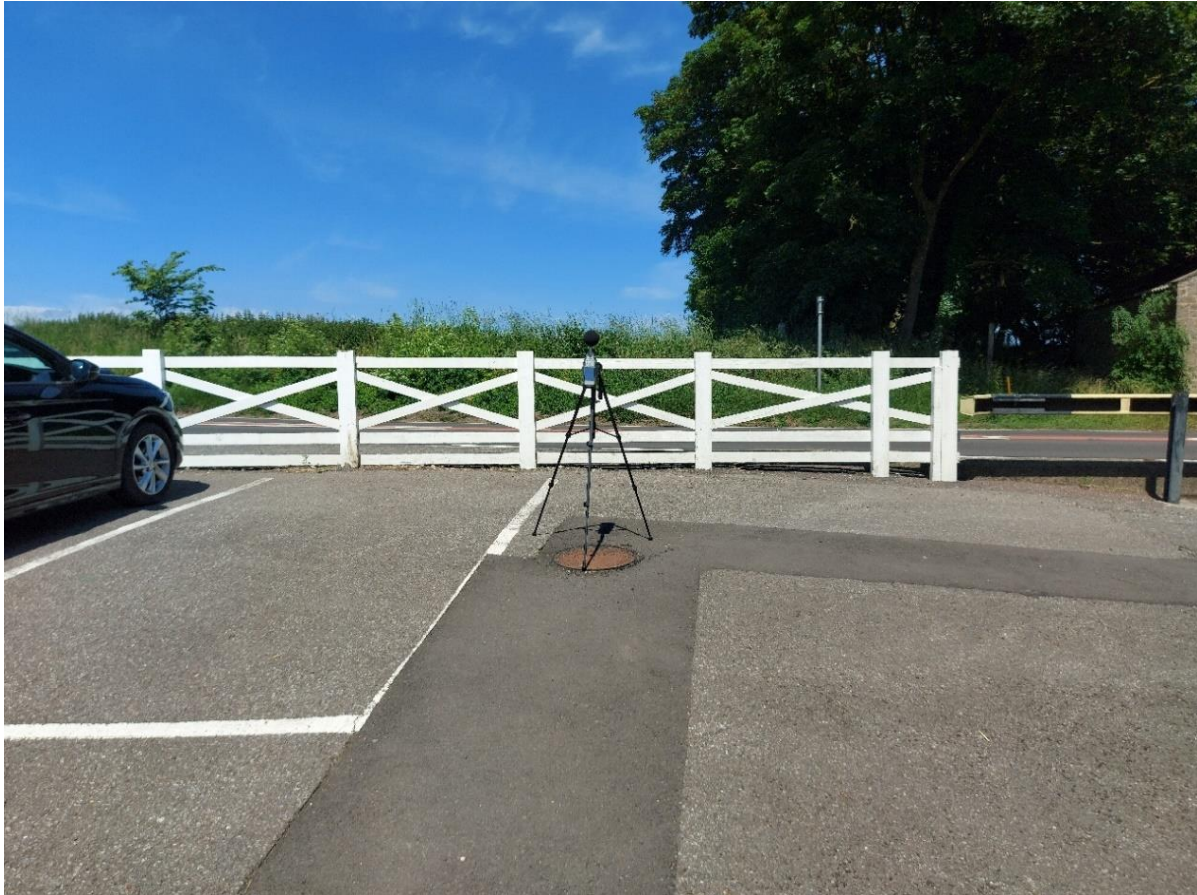
Plate 28: Noise monitoring equipment at Foxhall Inn

12.1.3.92 Monitoring equipment was set up on 28th June 2021 and a 3-hour noise measurement was undertaken. The equipment was set up in a free field position as per Plate 28: Noise monitoring equipment at Foxhall Inn.

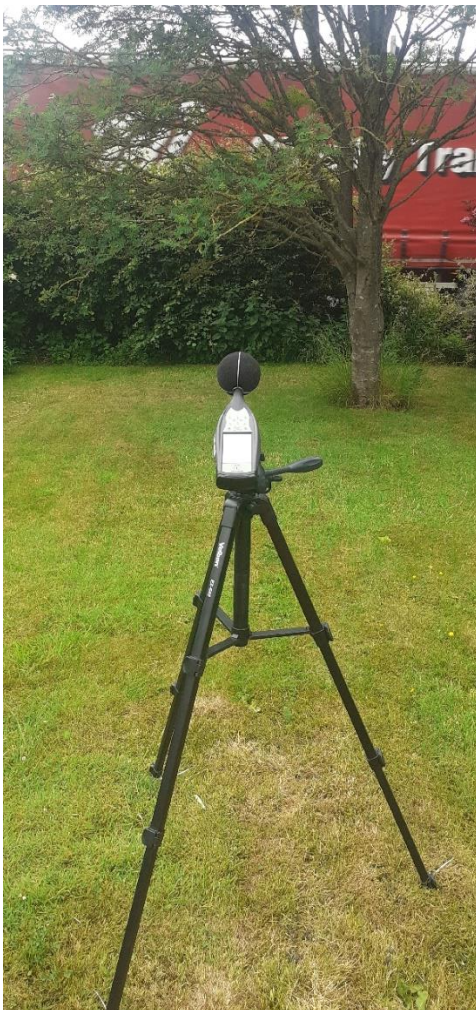
Plate 29: Noise monitoring equipment at Foxhall Farm

12.1.3.97 Monitoring equipment was set up on 28th July 2021 and a 3-hour noise measurement was undertaken. The equipment was set up in a free field position as per Plate 29: Noise monitoring equipment at Foxhall Farm.
