**A66 Northern Trans-Pennine Project
TR010062**

**3.4 Environmental Statement
Appendix 14.9 Detailed
Geomorphological Modelling**

**3.4 ENVIRONMENTAL STATEMENT
APPENDIX 14.9 DETAILED GEOMORPHOLOGICAL
MODELLING**

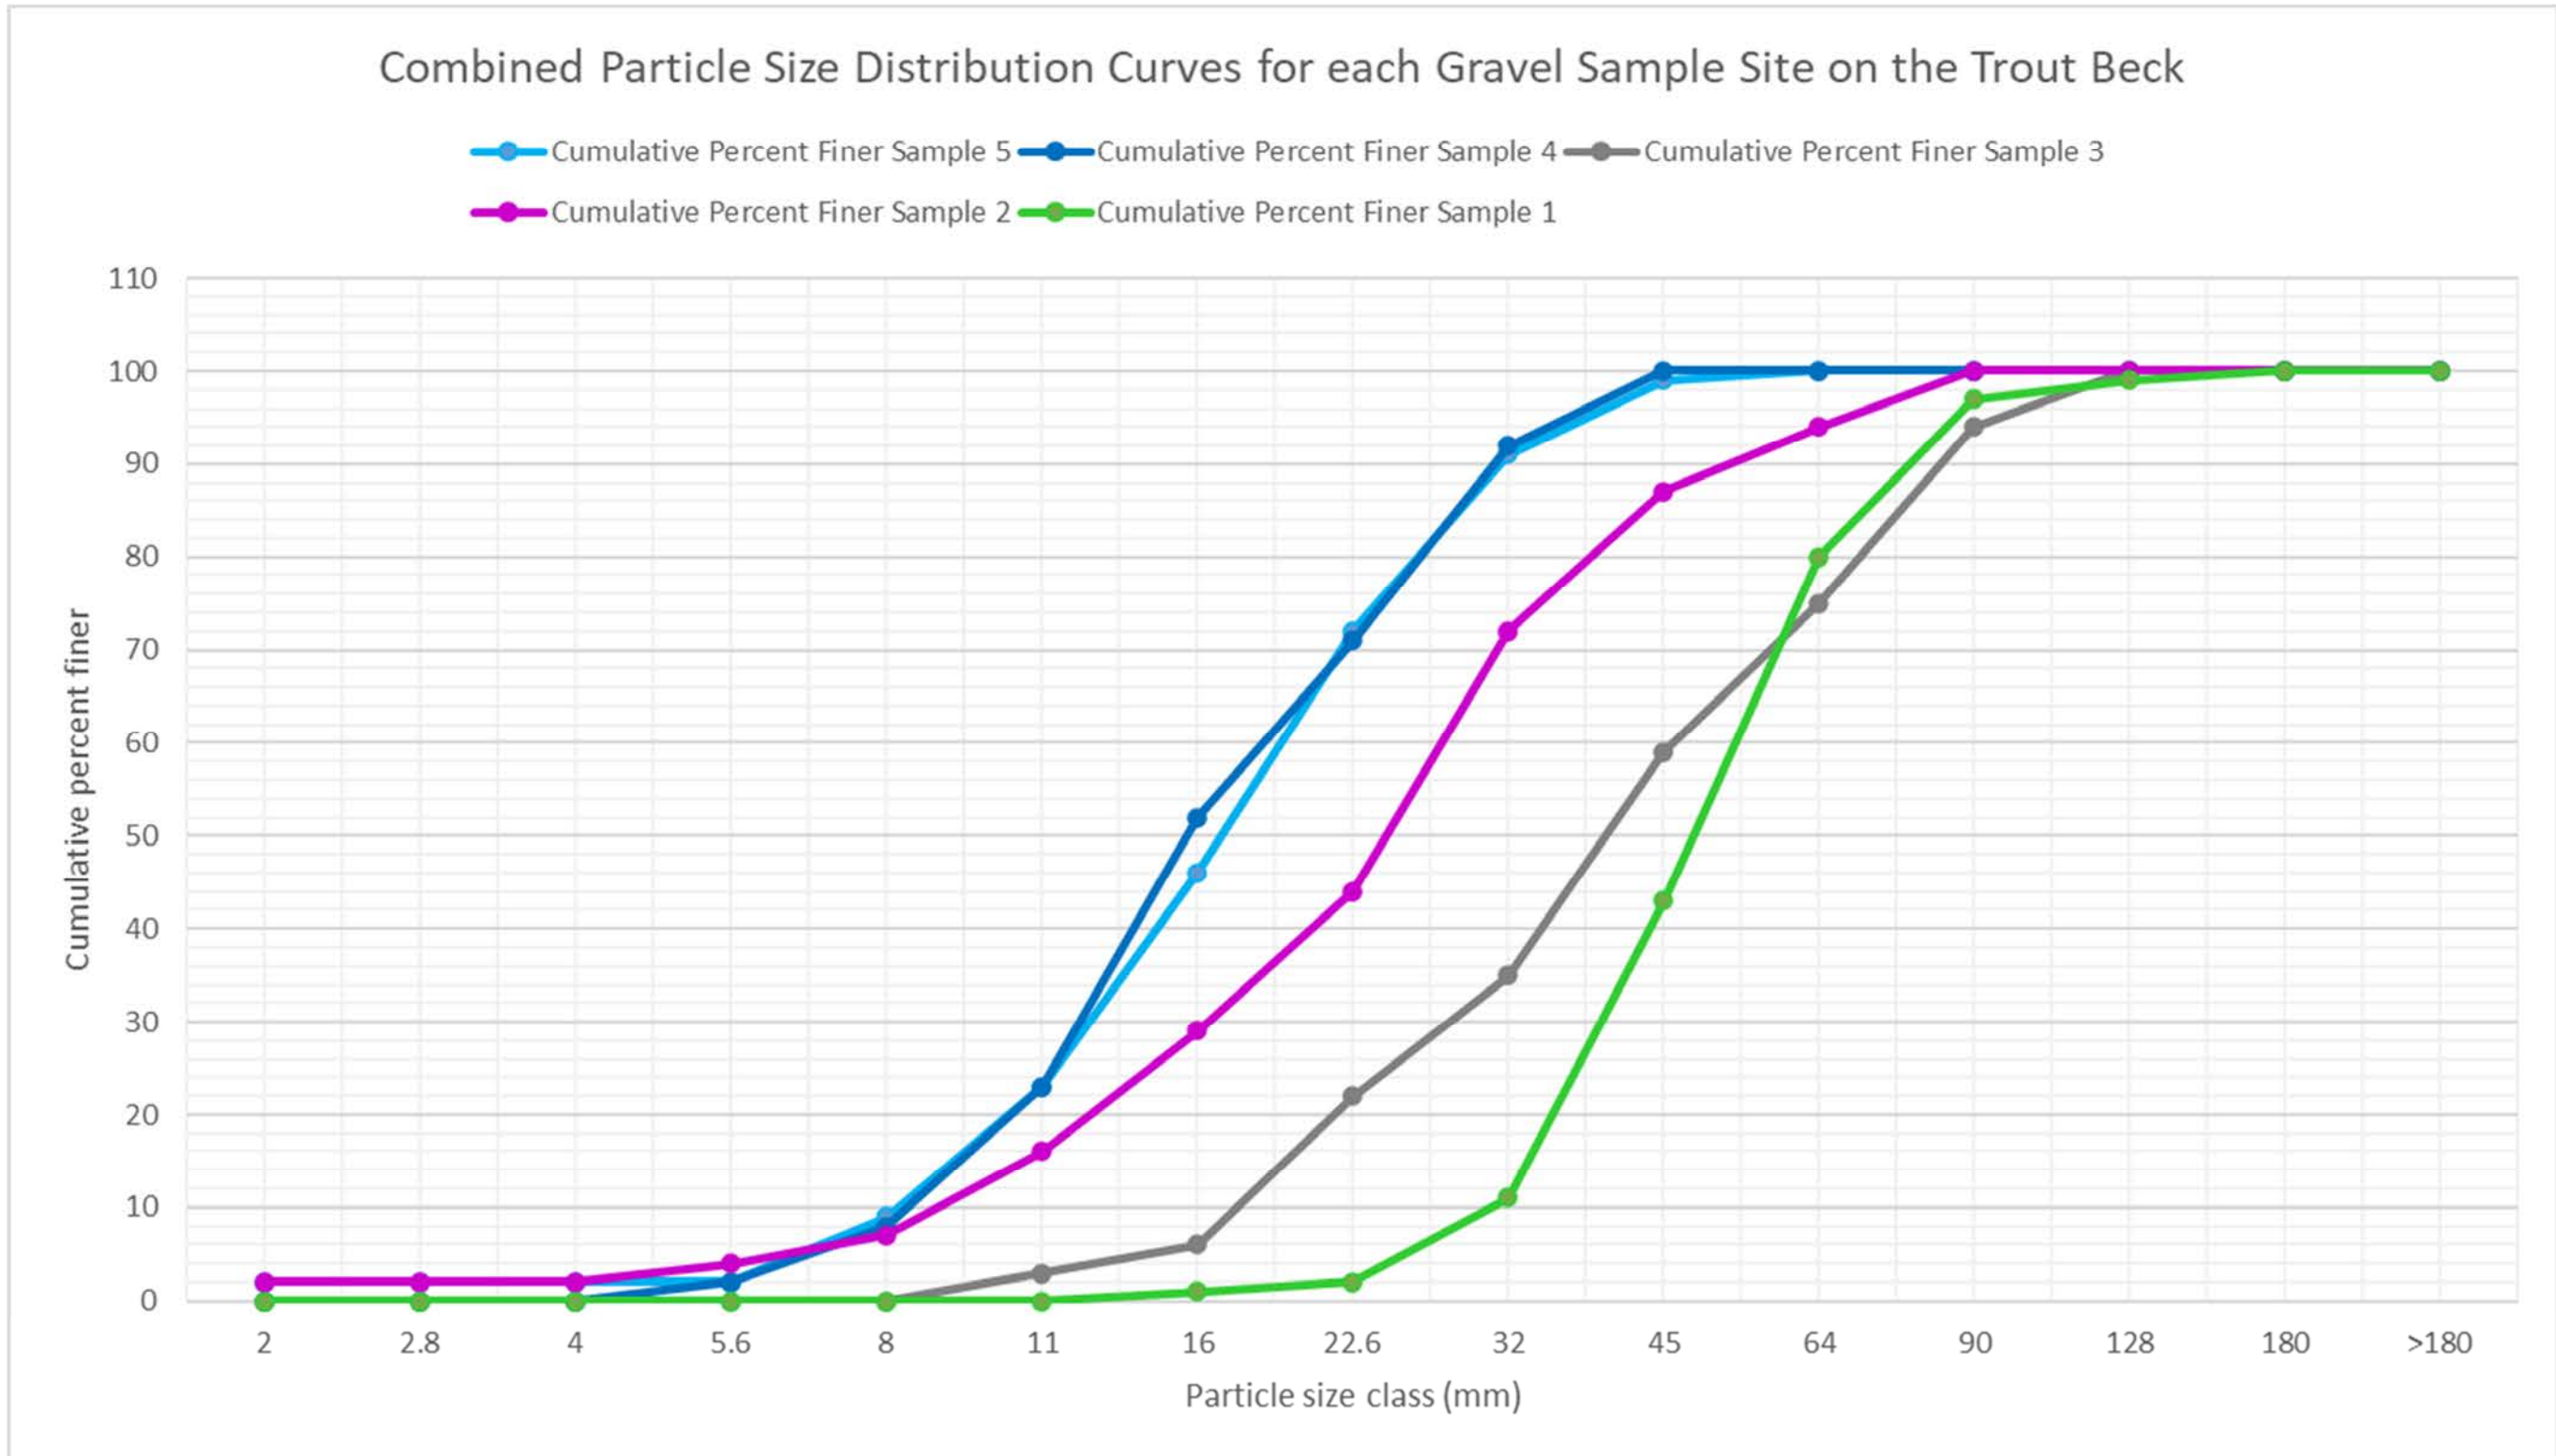
Plate 51: Combined Particle Size Distribution curves for each gravel sampling site on Trout Beck

particle size distribution, with 90% of the samples measuring <90mm and <64mm respectively (Table 3: D10, D50 and D90 particle size distribution values for each gravel bar sampling site on Trout Beck). In comparison the particle size distribution at Sample Locations 4 and 5 are finer, with 90% of the samples measuring <32mm at both locations (Table 3: D10, D50 and D90 particle size distribution values for each gravel bar sampling site on Trout Beck). As observed in Plate 51: Combined Particle Size Distribution curves for each gravel sampling site on Trout Beck, the particle size distribution at Sample Location 3 is somewhat coarser than Sample Location 2, with 90% of the samples measuring <90mm.

affect channel planform change in the future and could pose a threat to the scheme at Trout Beck located directly downstream of Sample Location 4 (Plate 51: Combined Particle Size Distribution curves for each gravel sampling site on Trout Beck).

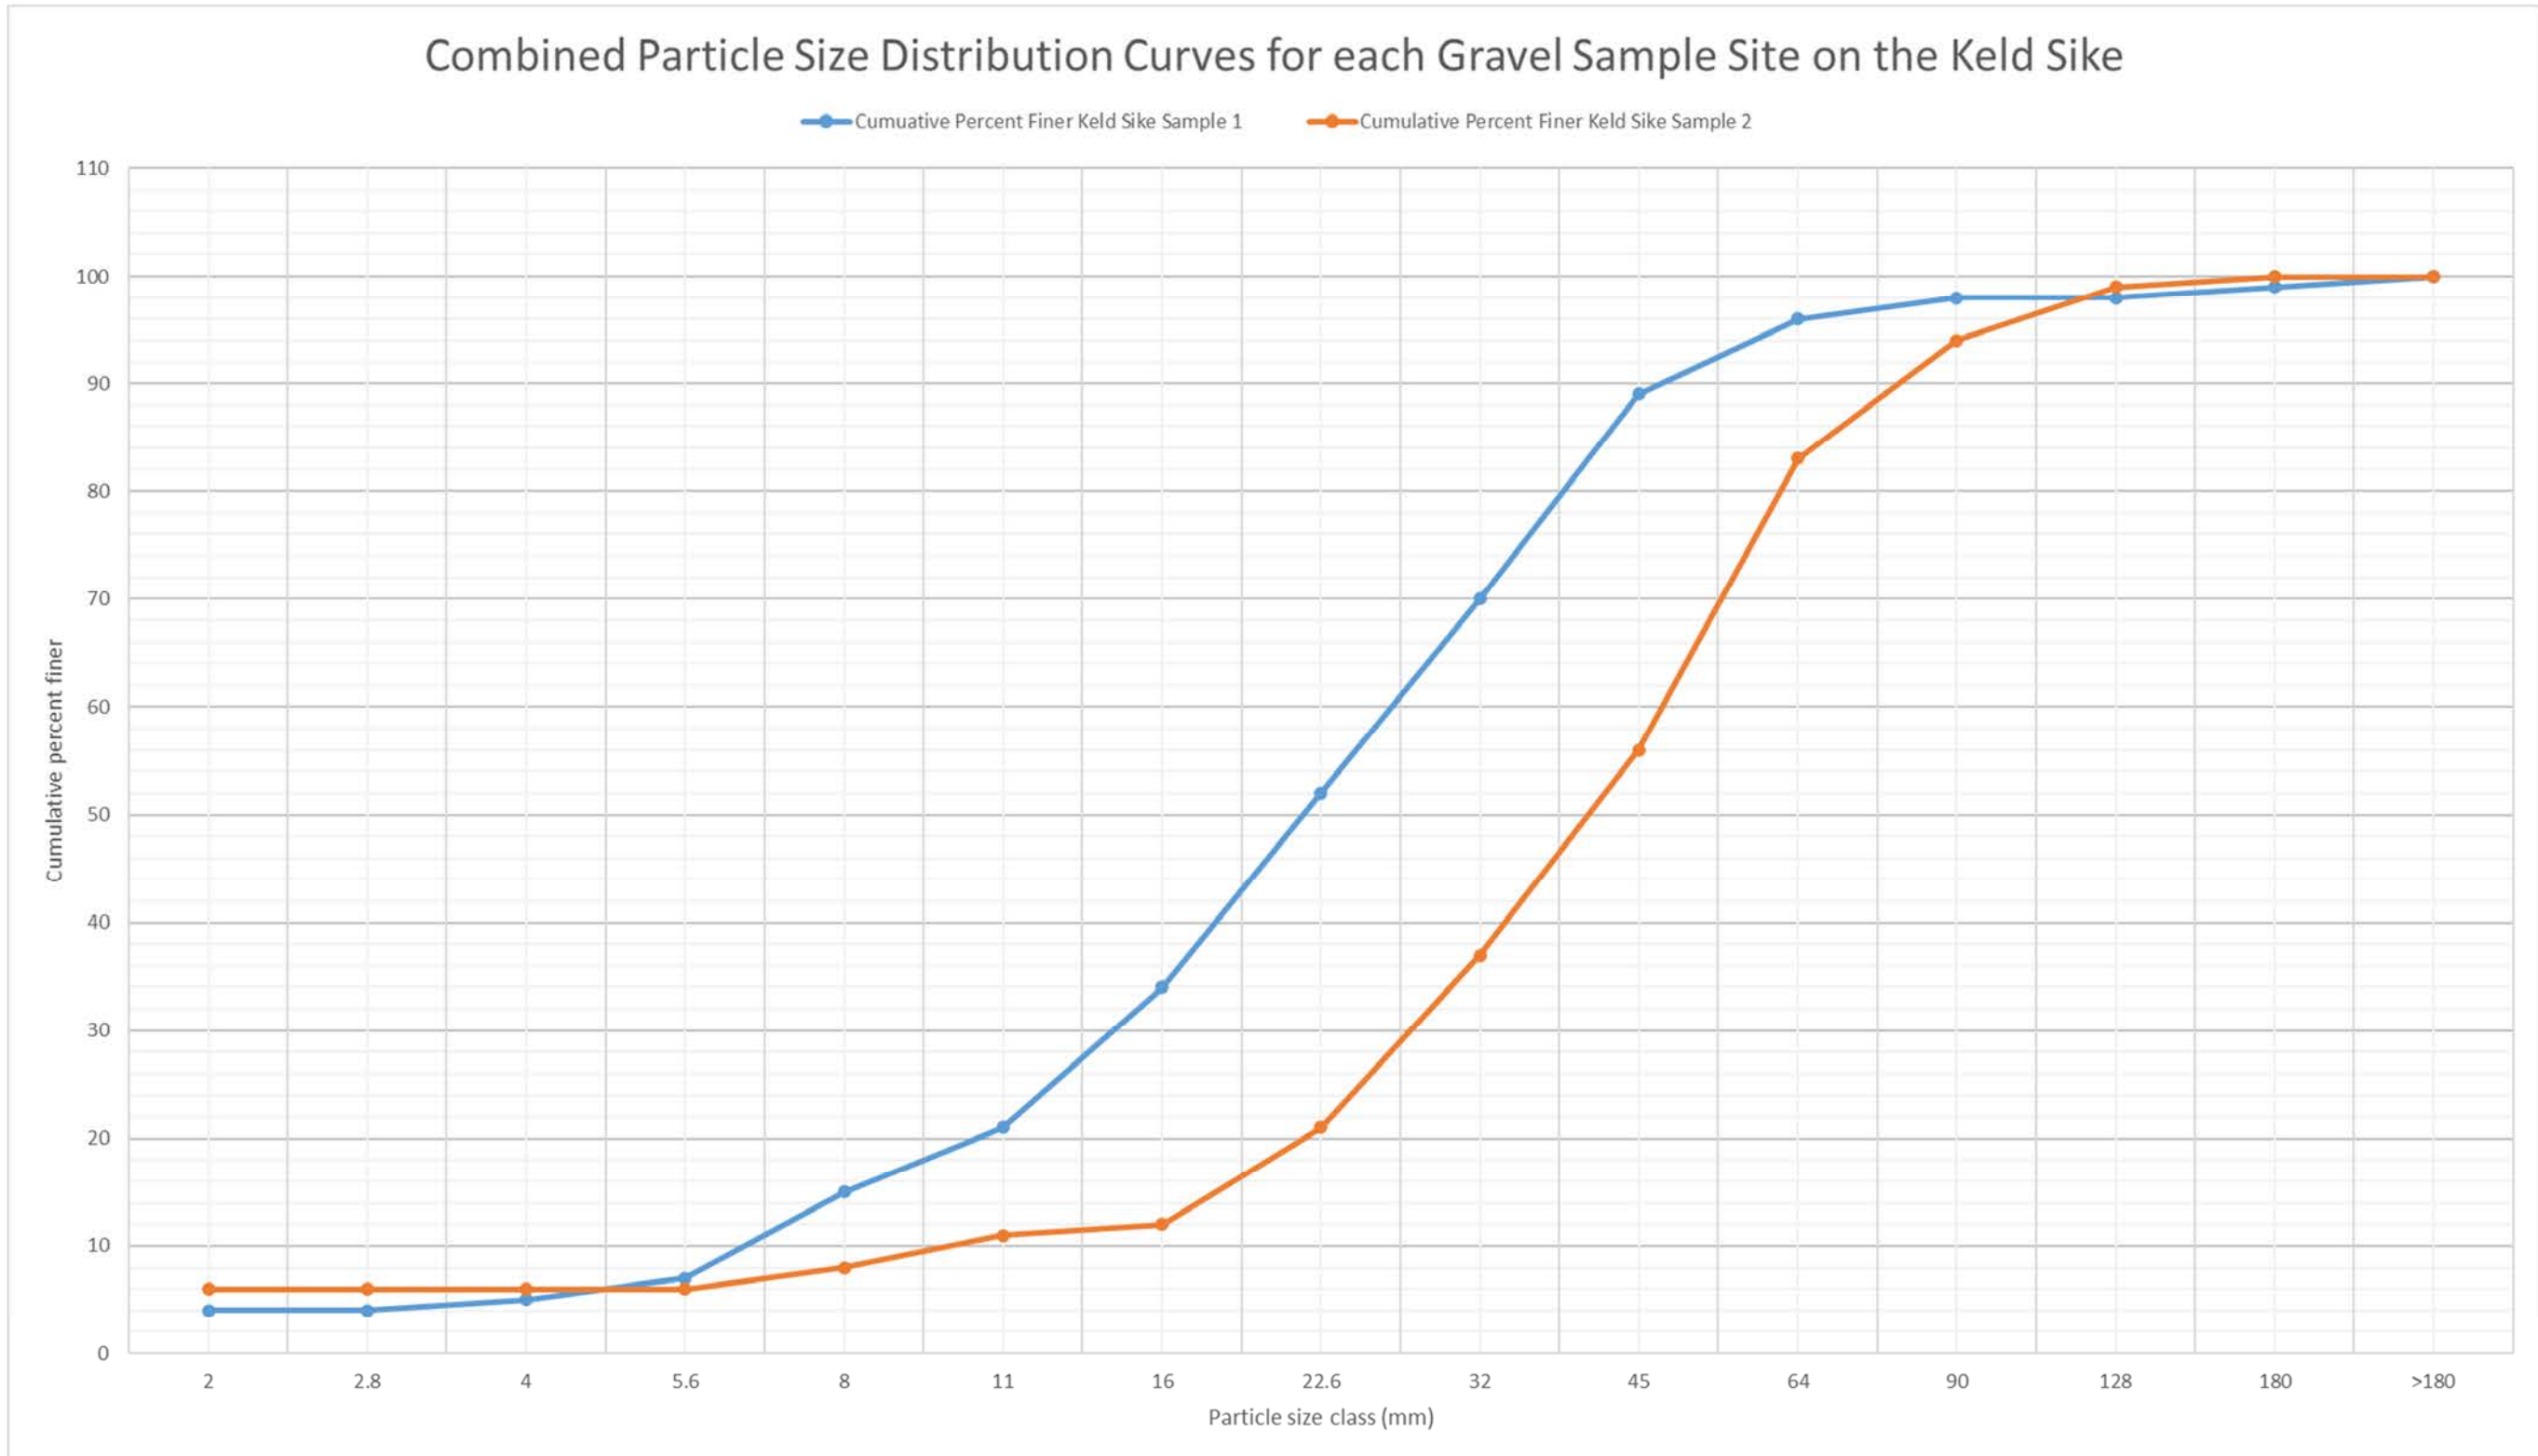
Plate 52: Combined Particle Size Distribution curves for each gravel sampling site on Keld Sike

- 14.9.2.113 The similar morphological conditions identified at Sample Locations 1 and 2 ensure that the composition and range of sediment sizes at gravel bars are broadly similar, ranging from Very Coarse Gravel to Medium Gravel.

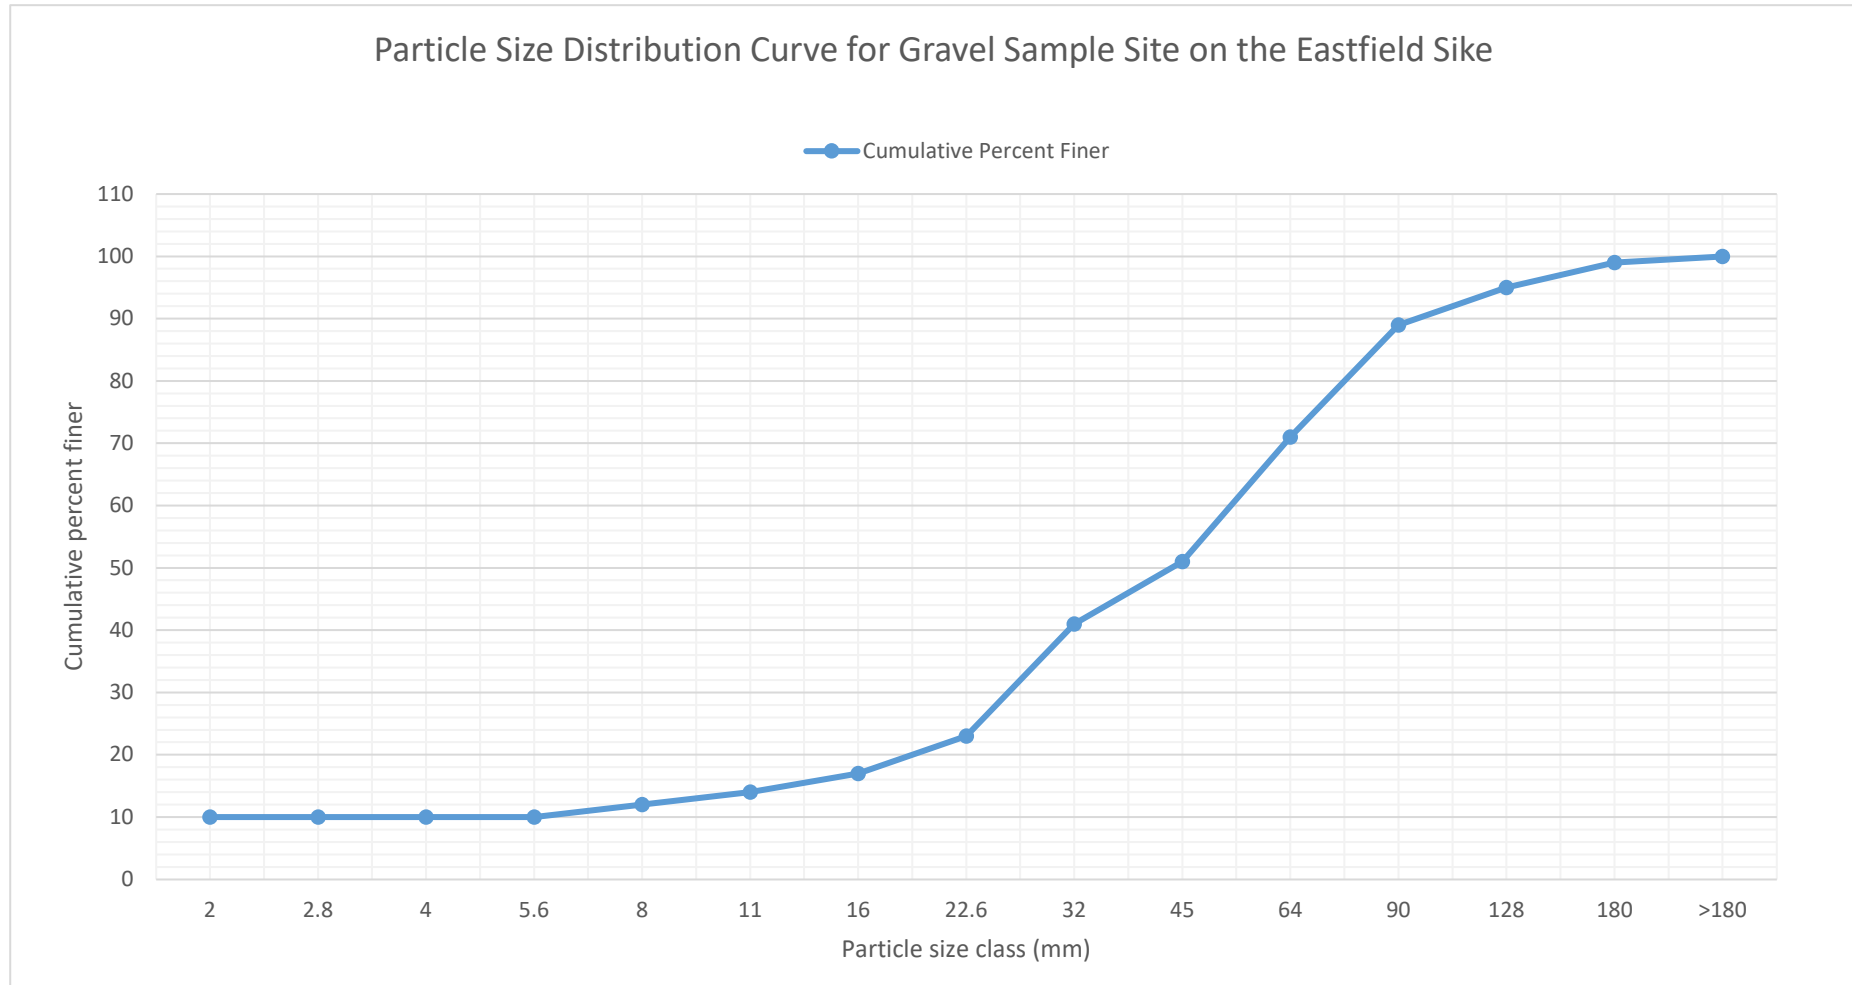
Plate 76: Particle size distribution curve for the gravel sampling site on Eastfield Sike

Description	Size (mm)
Coarse Sand	0.5 to 2.0
Gravel	2.0 to 16.0
Pebbles	16.0 to 64.0
Cobbles	64.0 to 256.0
Boulders	> 256
