A66 Northern Trans-Pennine Project TR010062

7.25 Tree Loss and Compensation Planting Report

7.25 TREE LOSS AND COMPENSATION PLANTING REPORT

Planning Inspectorate Scheme	TR010062
Reference	
Application Document Reference	7.25
Author:	A66 Northern Trans-Pennine Project Team,
	National Highways

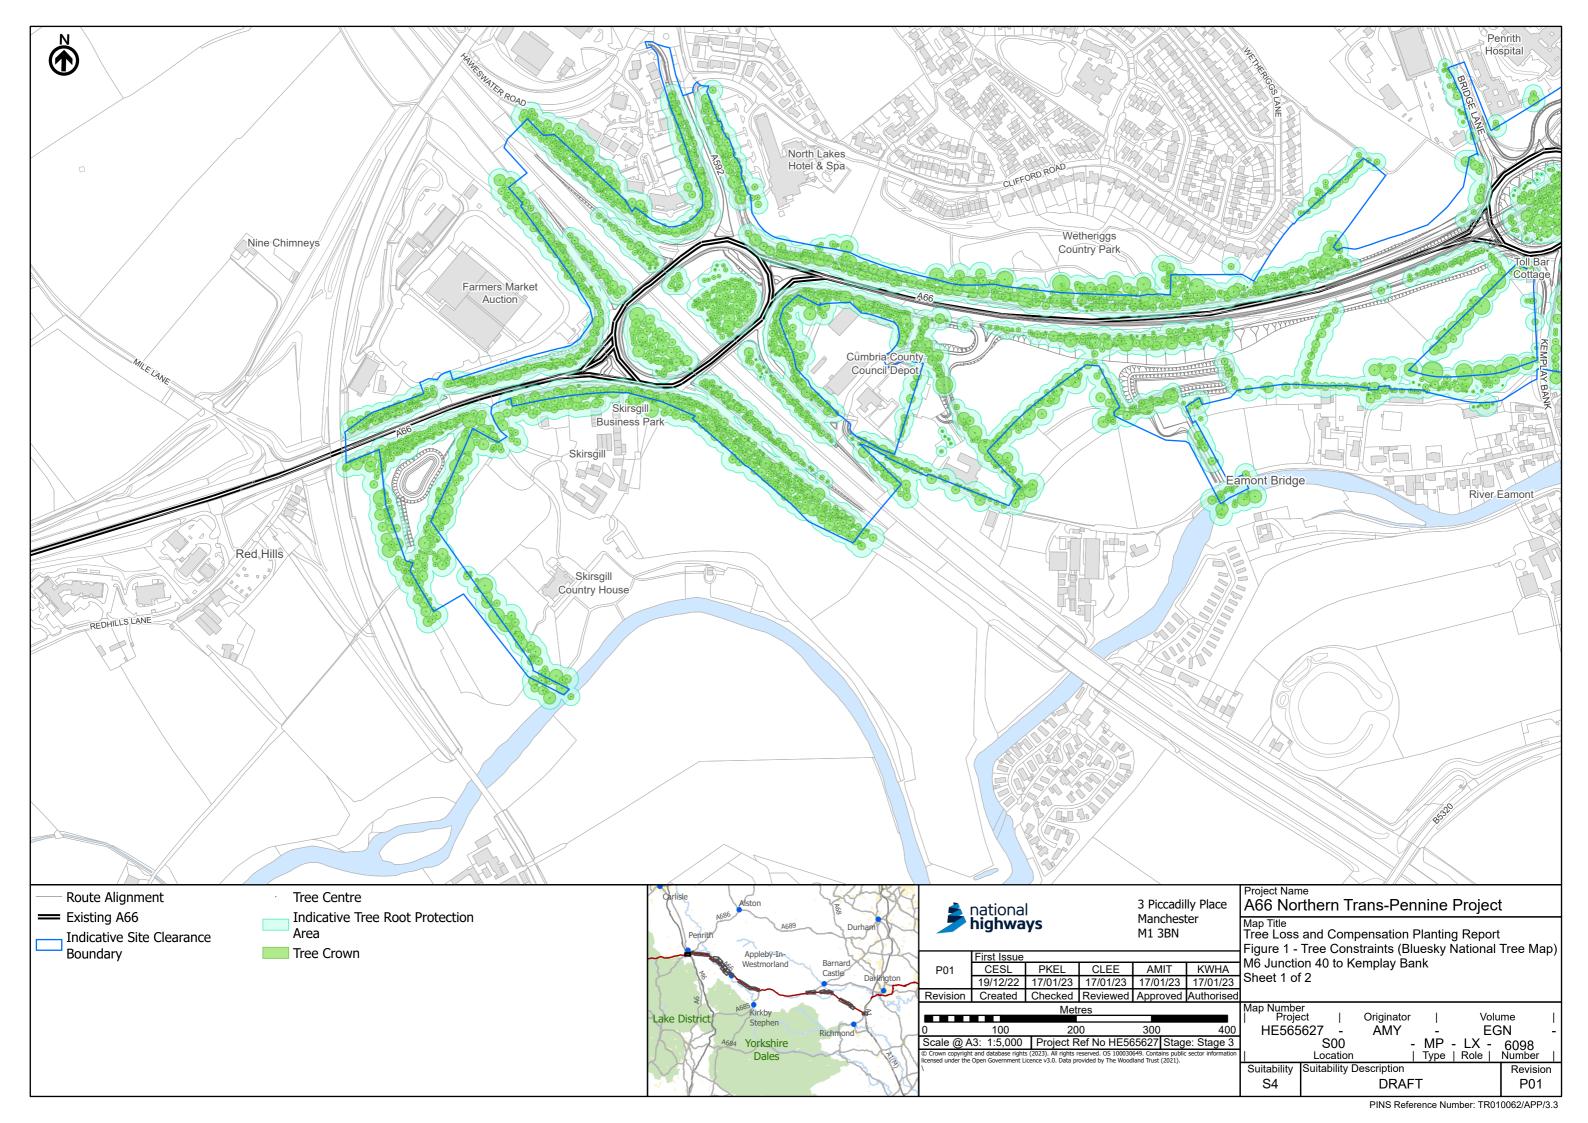
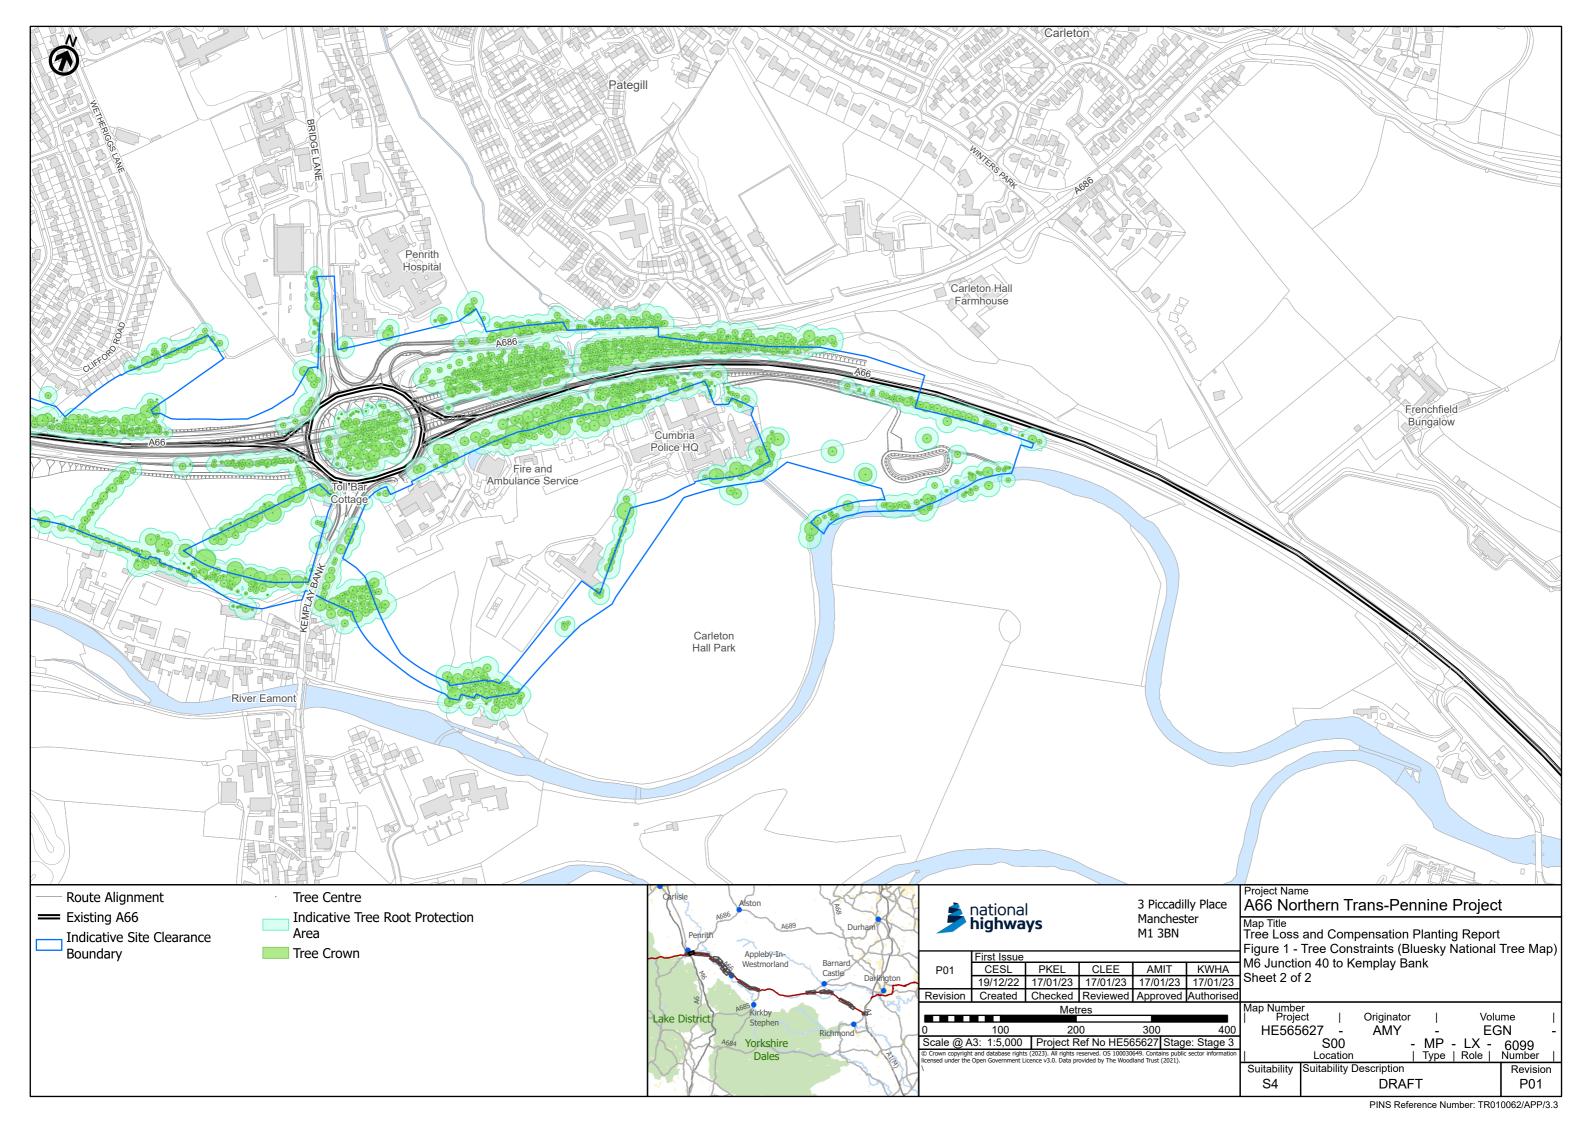
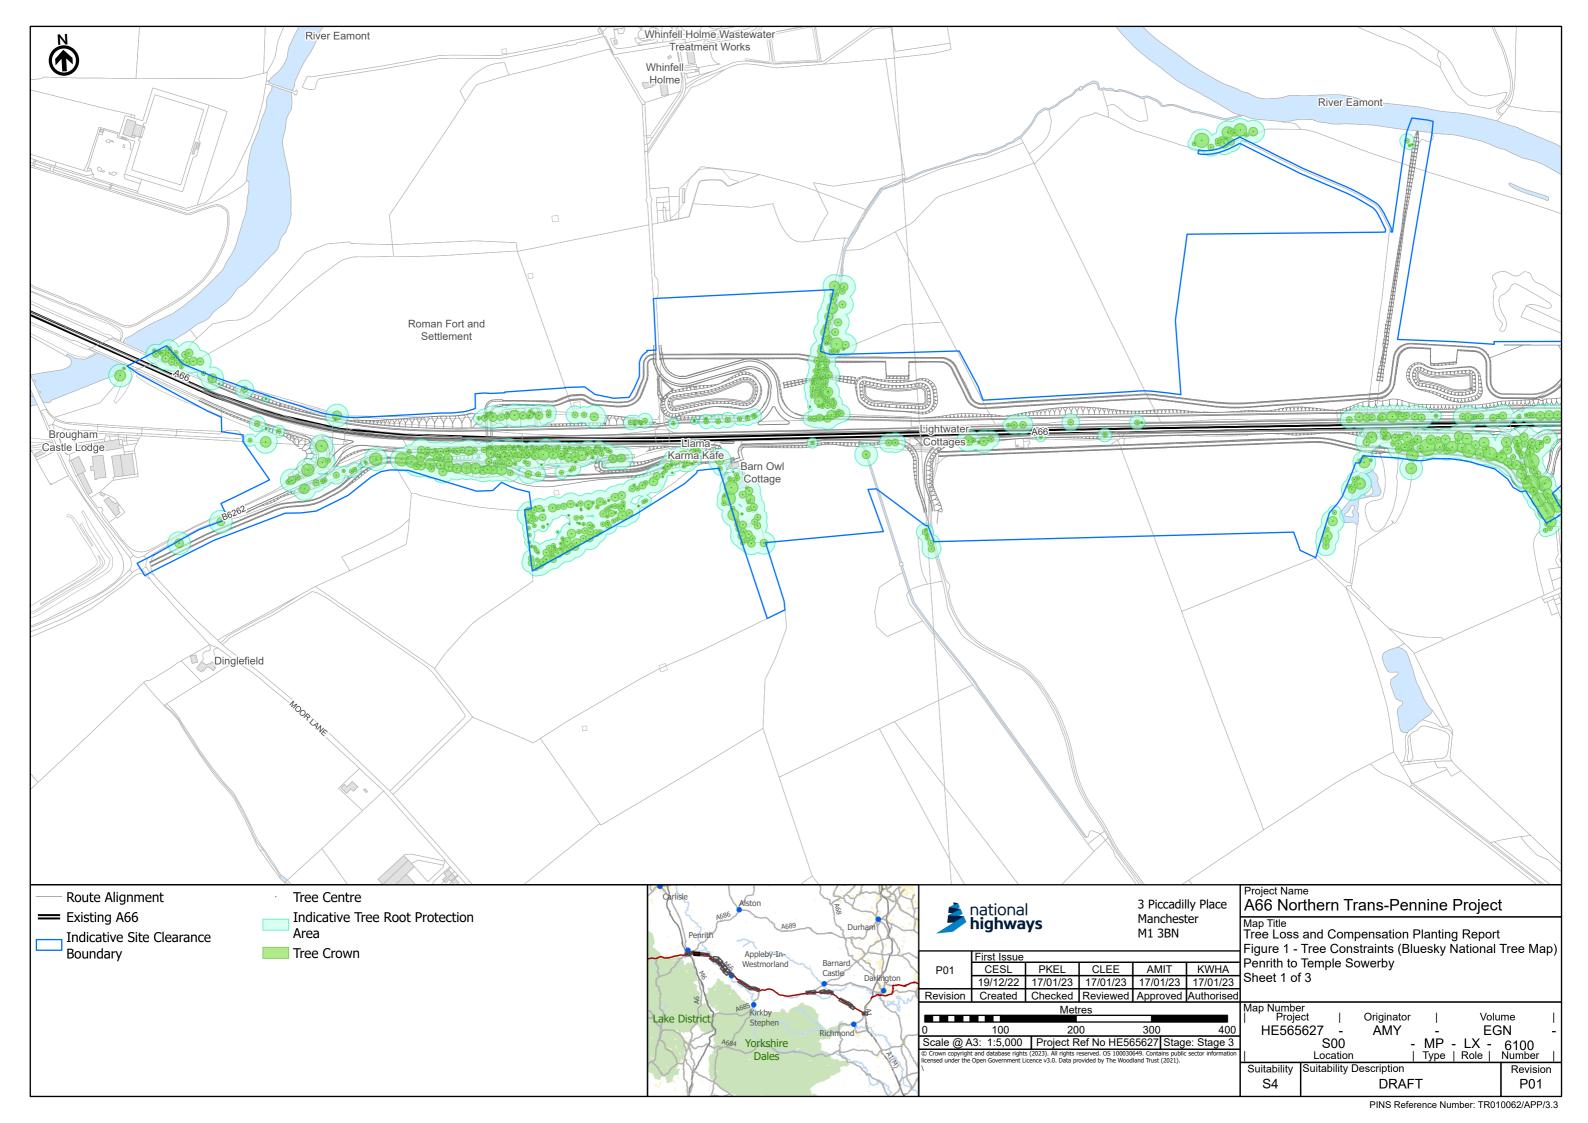
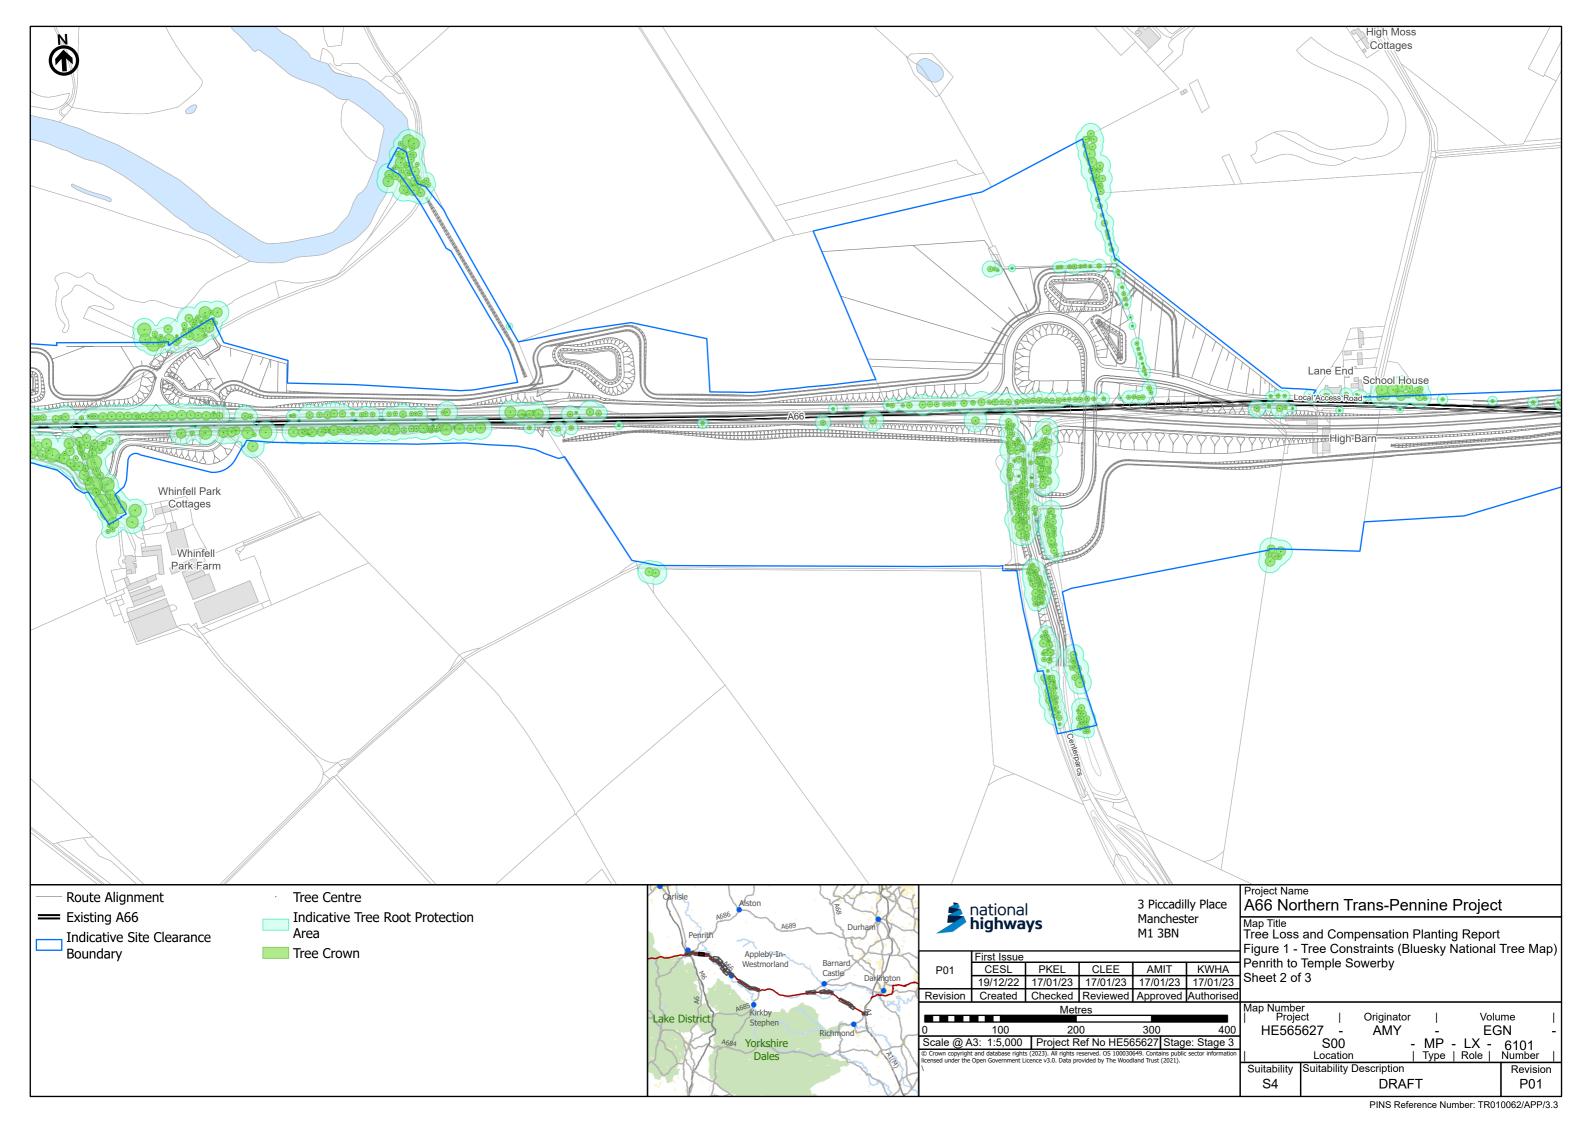
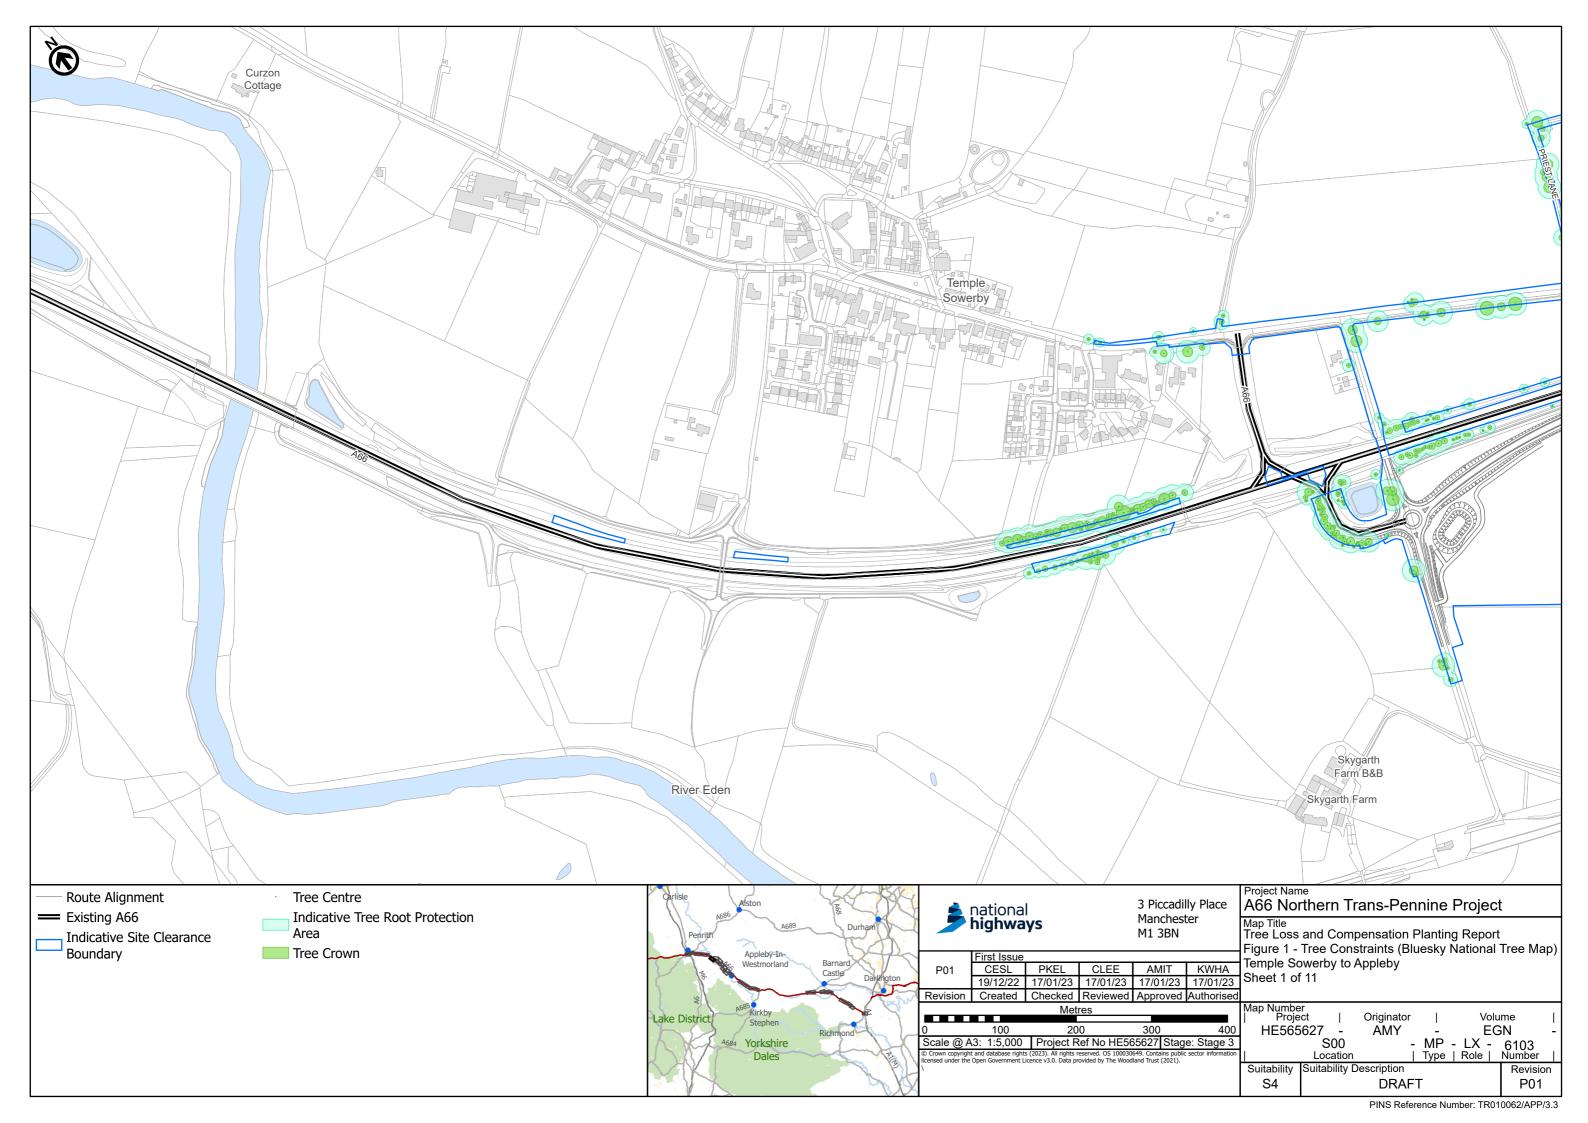
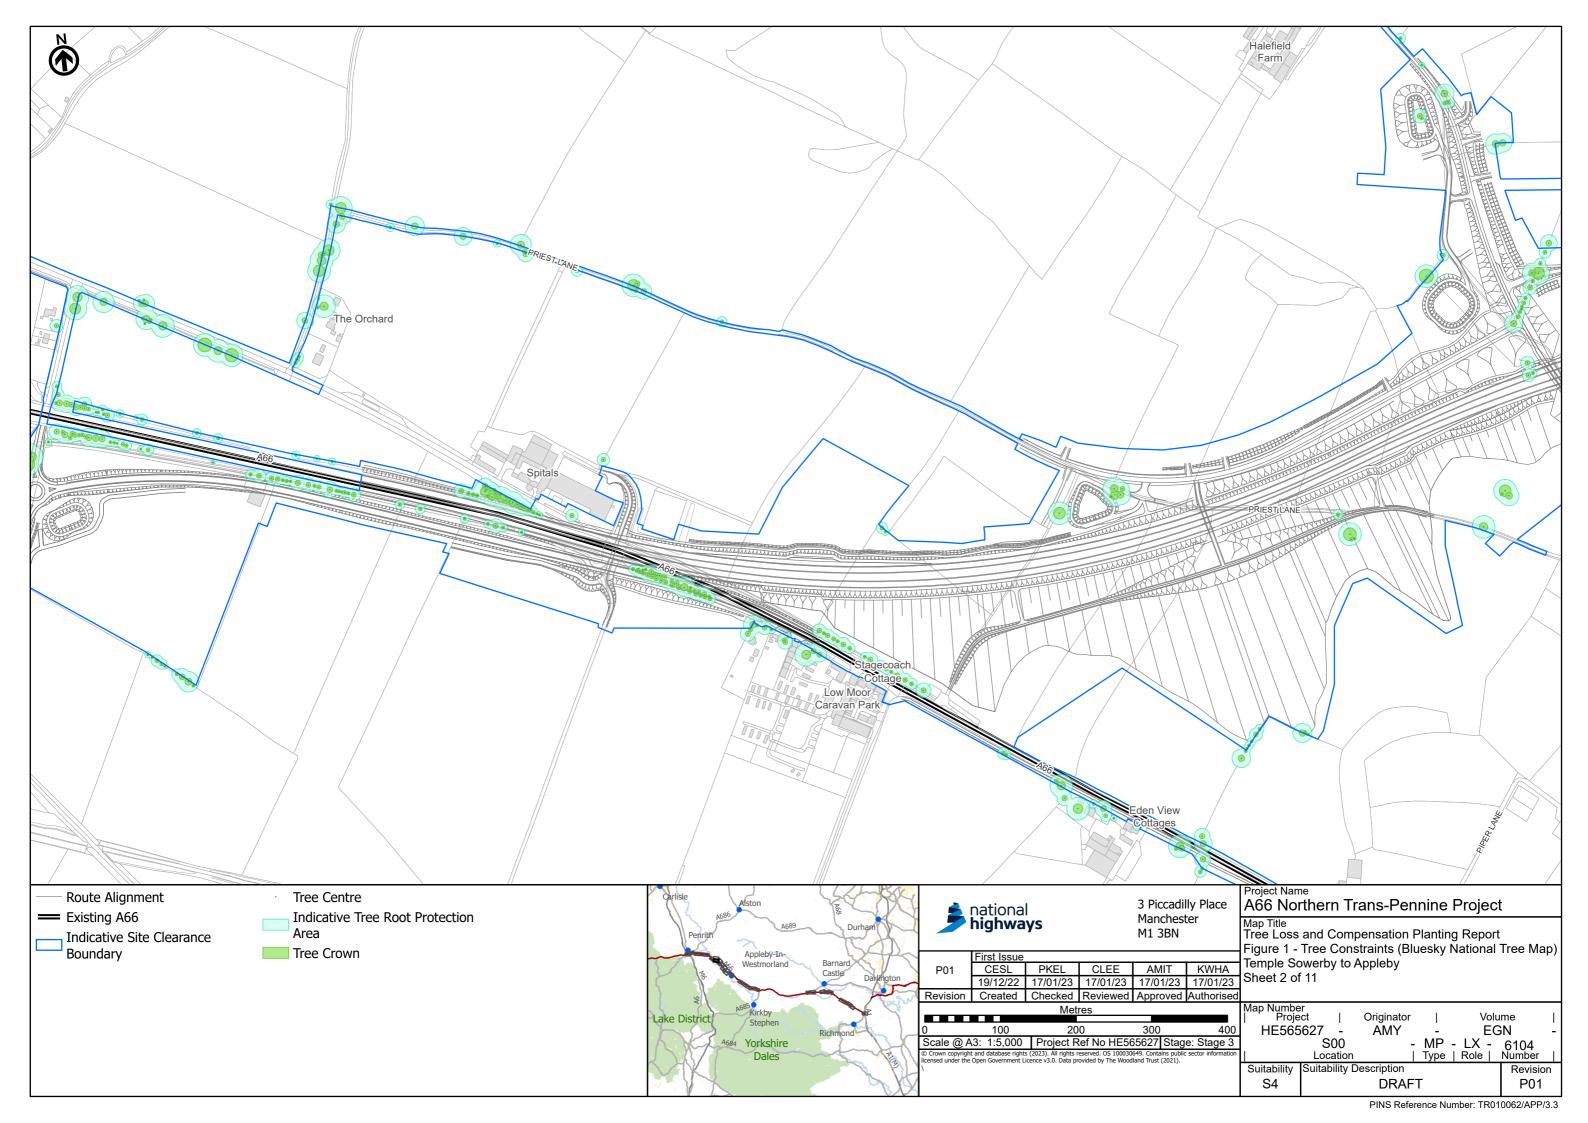
Appendix 1: Figure 1 – Tree Constraints

2.1.4 Individual trees have been identified using the most recent NTM dataset available at the time of writing this report. The root protection area (RPA) has been illustrated by an offset from each individual tree crown as shown in Figure 1 of this report, Tree Constraints Plan. The RPA has been calculated by multiplying the radius of the crown three times and to a maximum of 15m (in accordance with British Standard BS5837:2012 – 'Trees in relation to design, demolition, and construction – Recommendations'). Where the RPAs intersect with the Indicative Site Clearance Boundary those trees have been identified as being lost. Refer to Figure 1 Tree Constraints Plan which shows the trees identified and their indicative root protection areas.

2.1.5 The approximate position of the trees which are potentially impacted by the Project and assumed as being lost are indicated in Figure 1 Tree Constraints Plan, including those that intersect with the 2m offset from the Indicative Site Clearance Boundary. This plan is not to scale and

represents the approximate physical parameters of the trees using the NTM dataset.

- 2.3.2 Data gathered from the NTM, presented in Table 4-1 and illustrated in Figure 1 has been used to identify the impacts that the Project will have on individual trees.

- 4.1.1 The findings of this assessment are presented in Tables 4-1, 4-2 and 4-3 below:
- 4.1.2 Table 4-1 should be read in conjunction with Figure 1 Tree Constraints Plan.

- 4.1.3 The information presented in Table 4-1 illustrates the number of trees located within the Indicative Site Clearance Boundary using the NTM dataset, refer to Figure 1 of this report (Tree Constraints Plan).

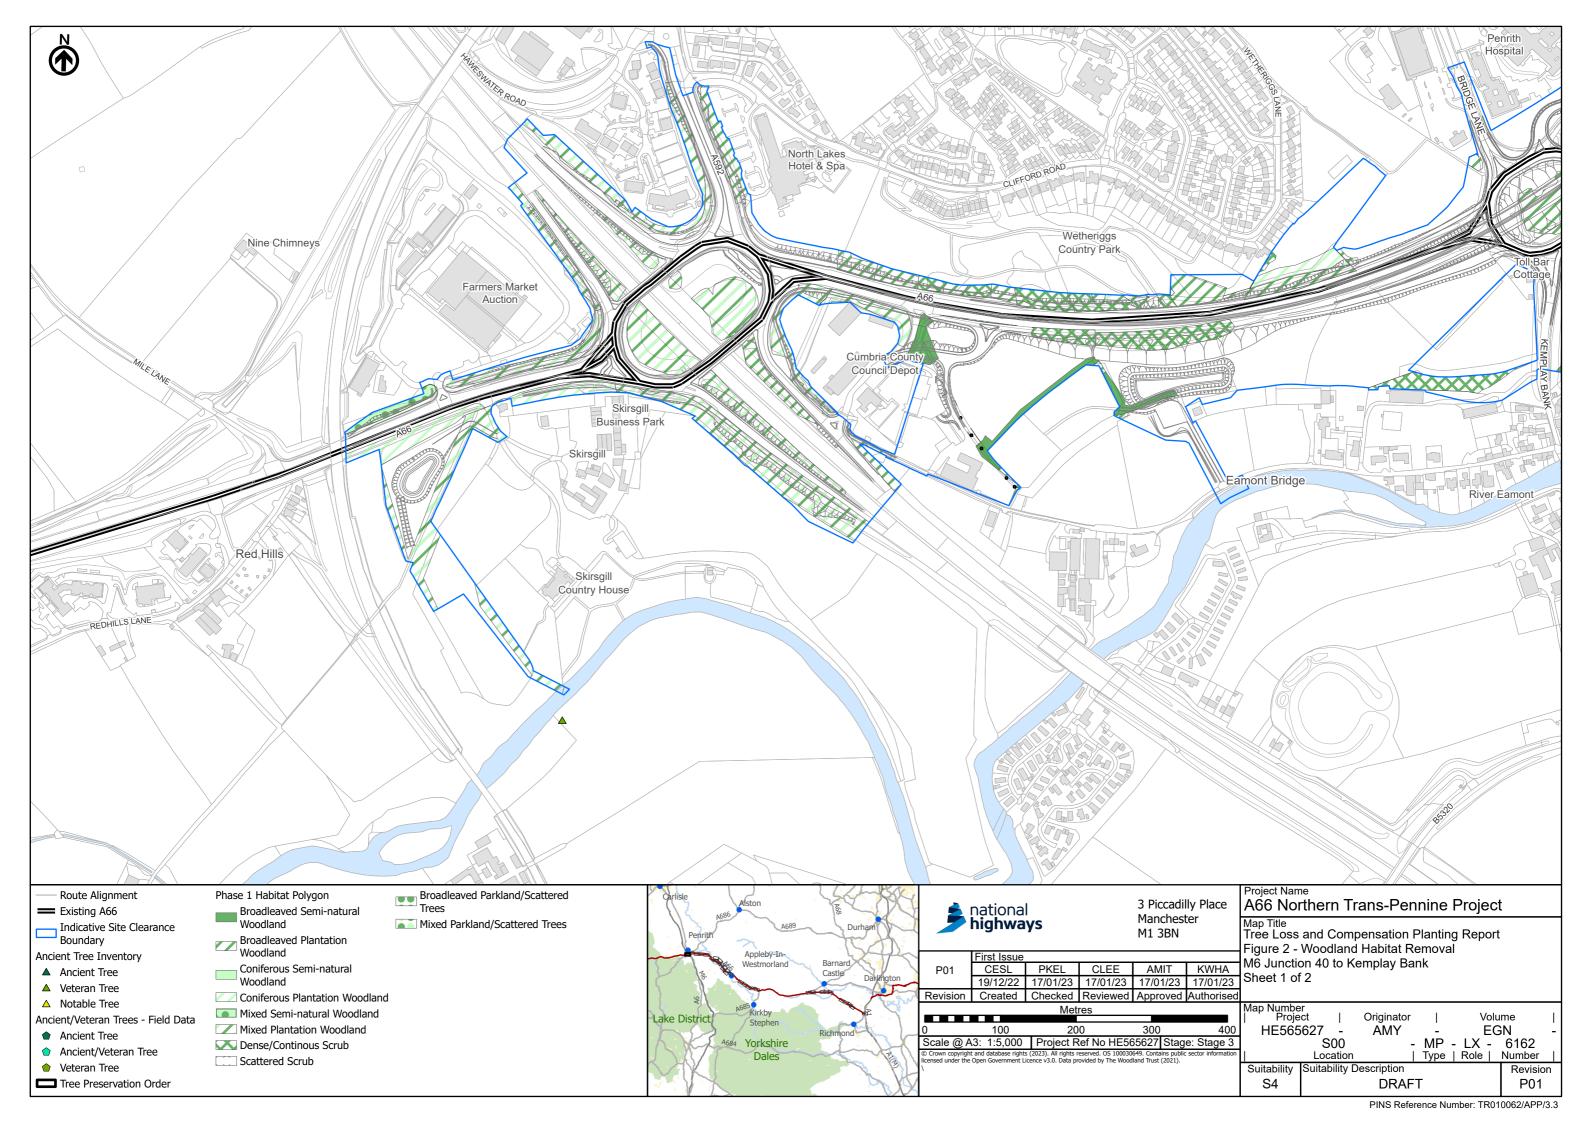
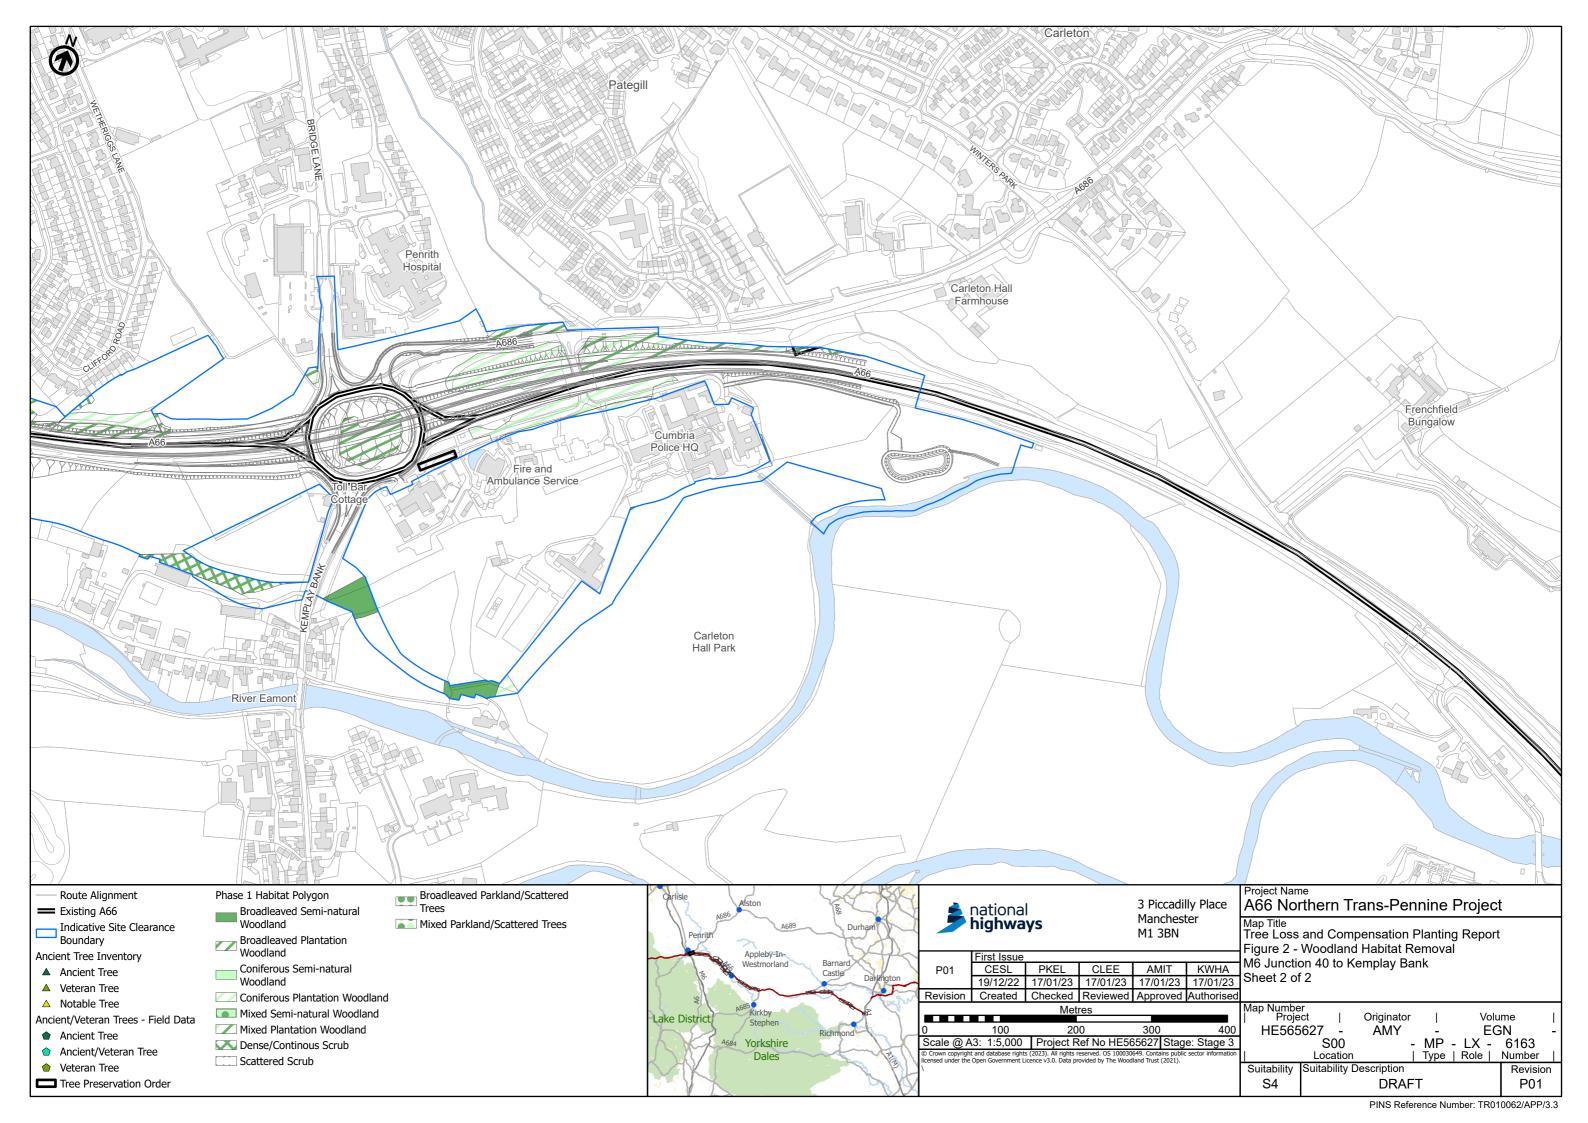
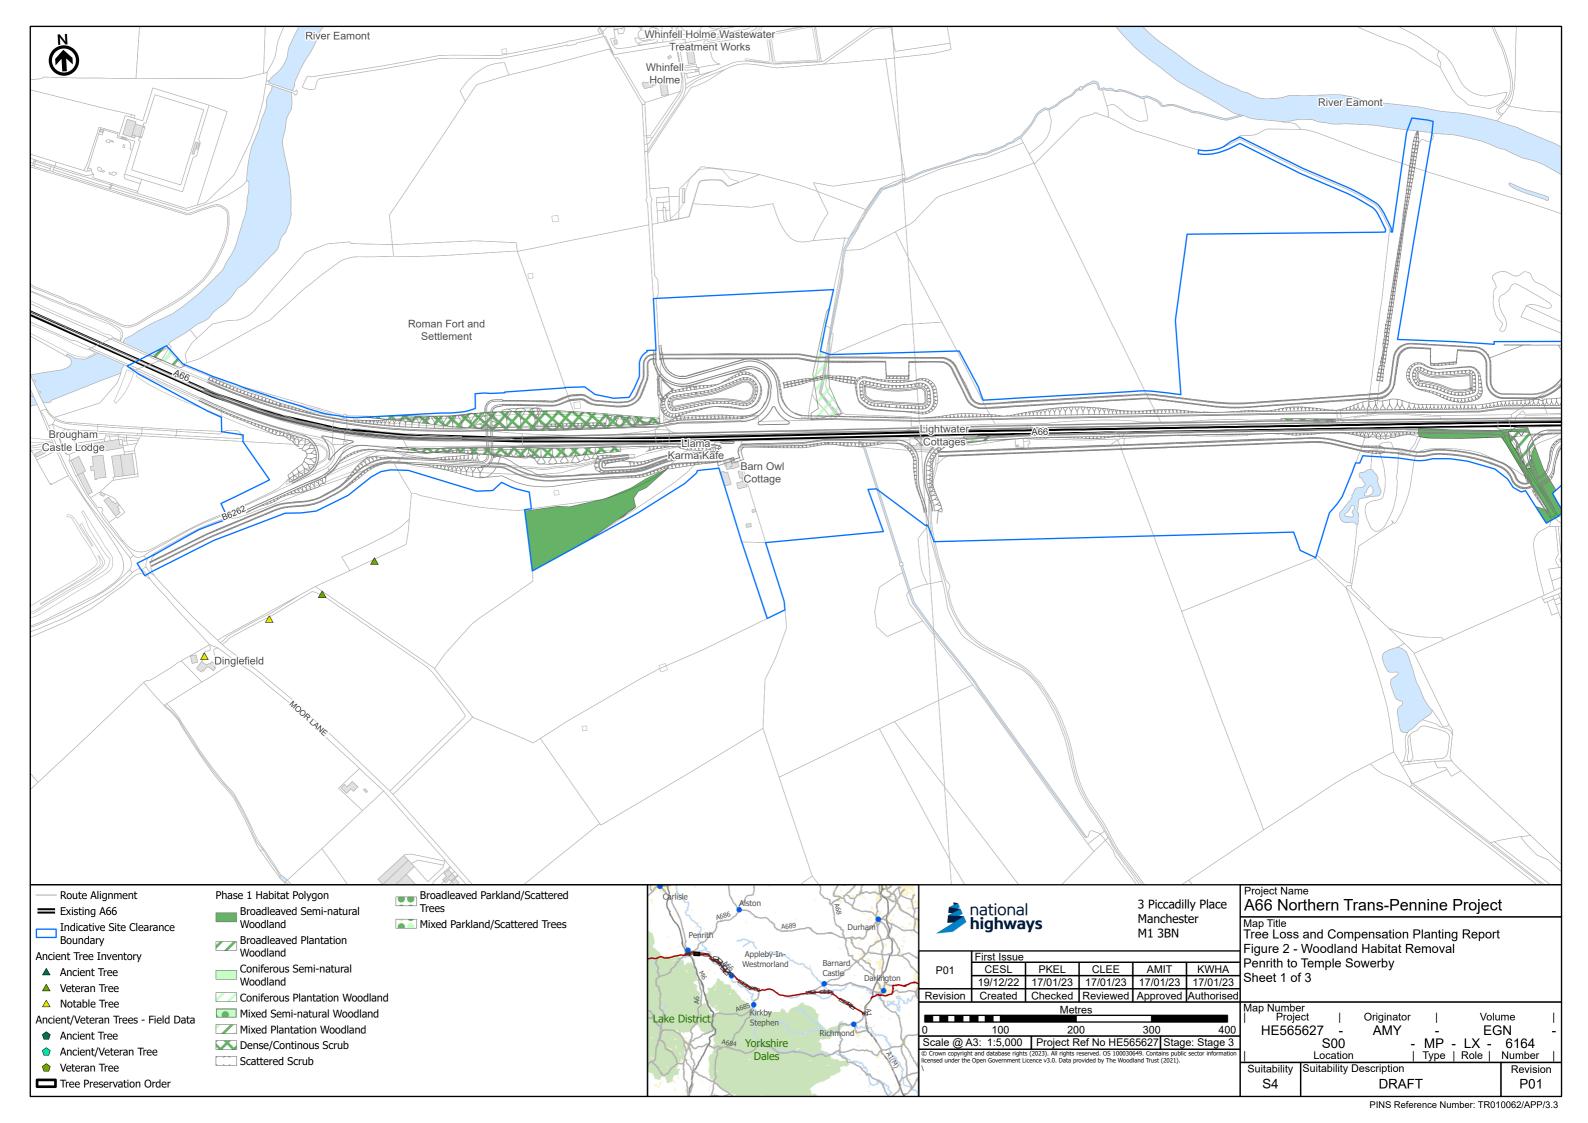
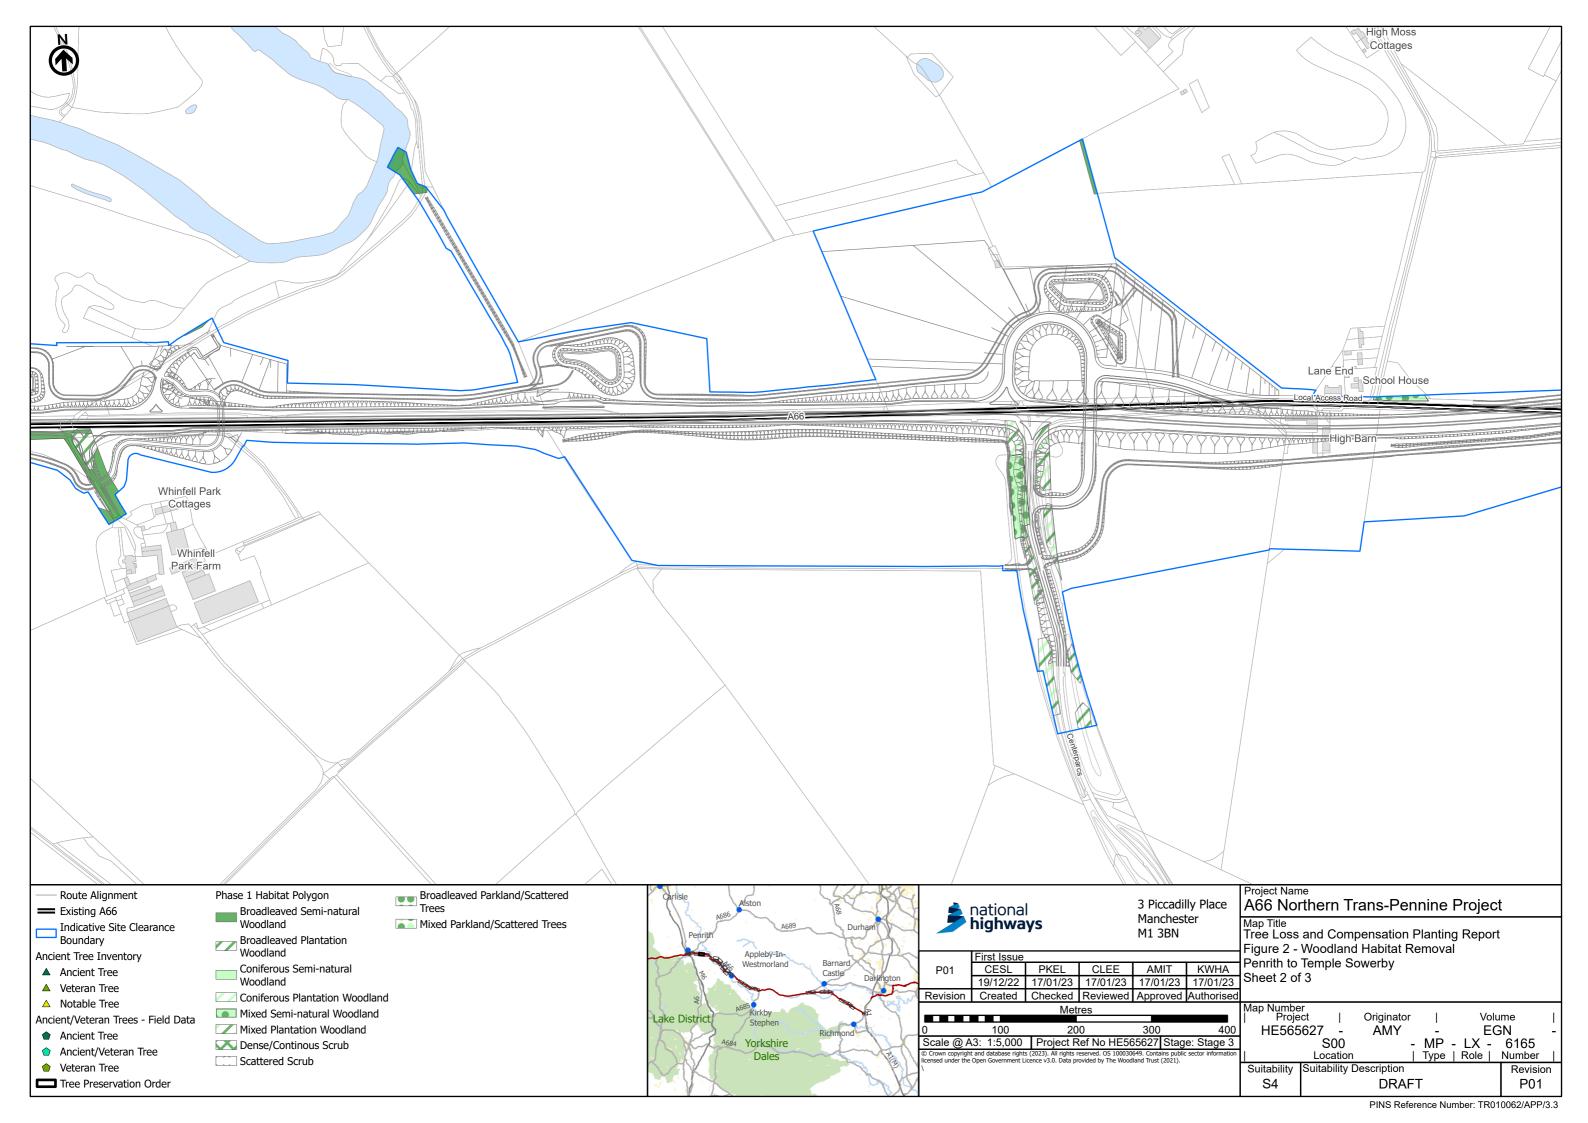
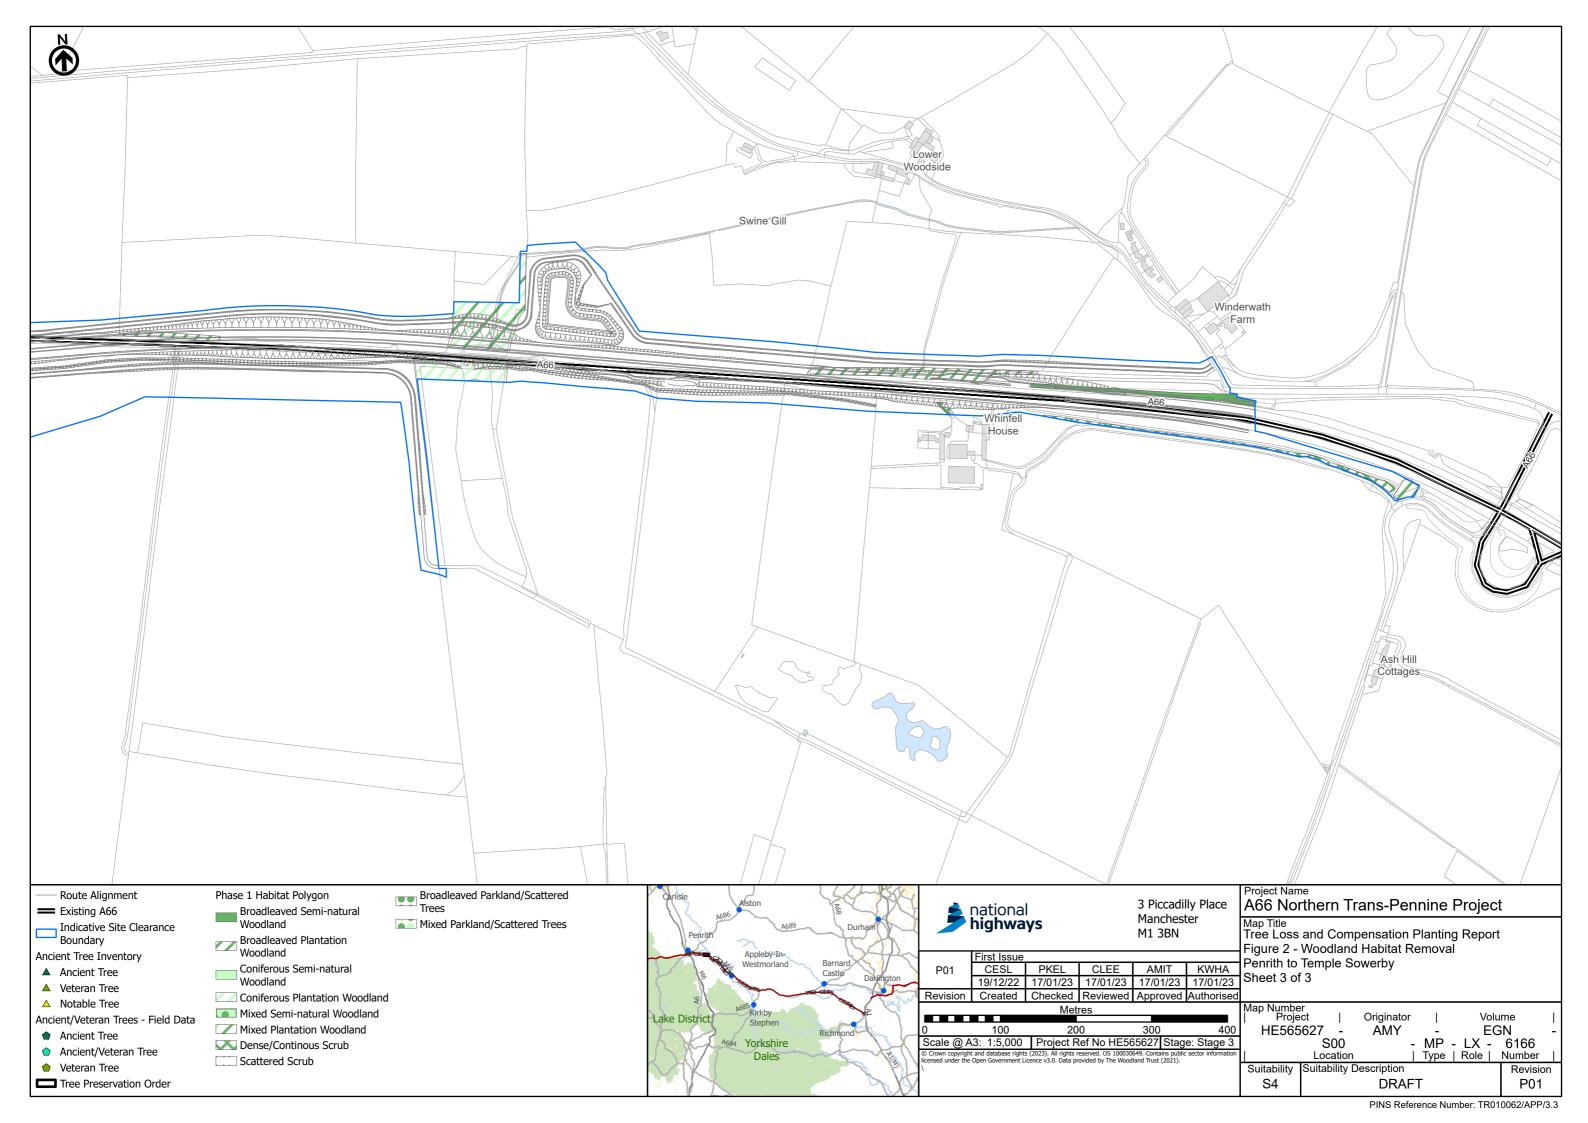
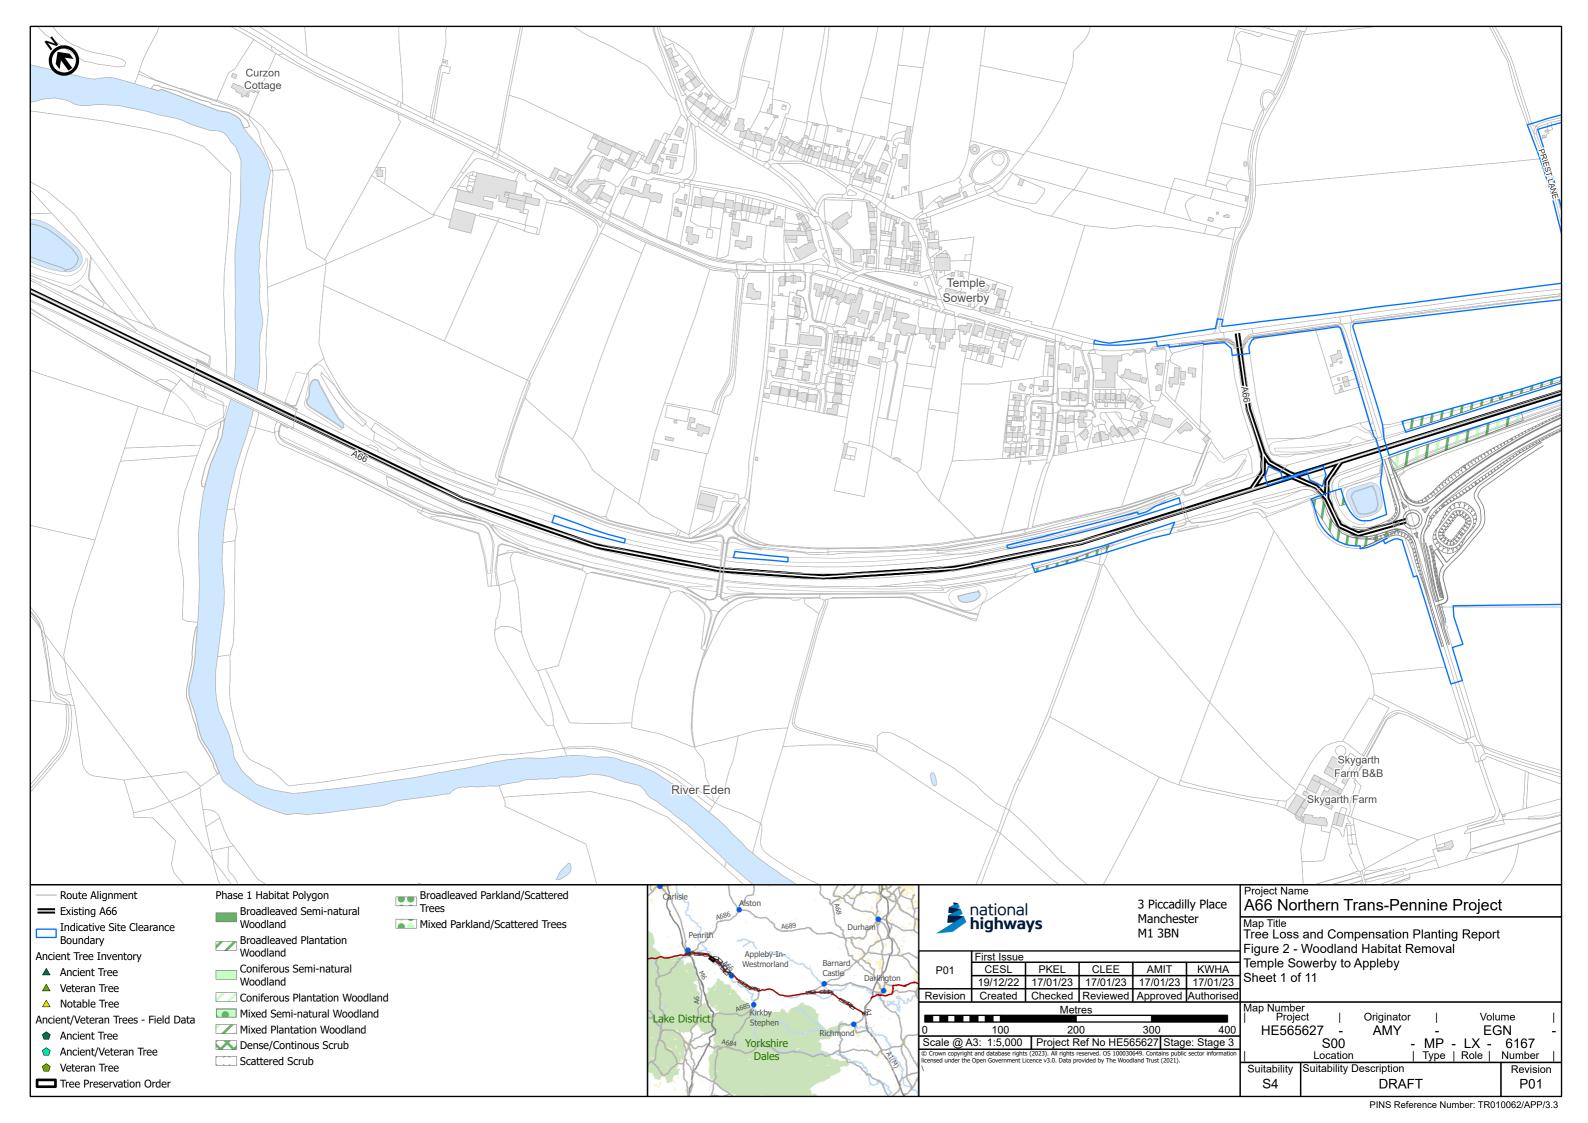
Appendix 2: Figure 2 – Woodland Habitat Removal

- 2.2.1 Areas of woodland were identified by aerial photography and subsequently ratified by site survey (Phase 1 Habitat survey Document Reference 3.4 / APP-156). The types of woodland and species mix have been noted in Table 6.20 of ES Chapter 6: Biodiversity (Document Reference 3.2 / APP-049). This survey data is copied across and presented in Figure 2 of this report which illustrates the woodland habitat removal.

- 2.3.3 Data gathered from site surveys, presented in Table 4-2 and illustrated in Figure 2 has been used to identify the impacts the Project will have on woodland habitats and the area of tree losses.

- 3.1.2 This report does not constitute an ecological assessment of the trees and the Project. A separate Phase 1 habitat survey has been carried out and a report produced in Chapter 6 Biodiversity within the ES (Document Reference 3.2 / APP-049), the findings from this survey have been illustrated on Figure 2 of this report (Woodland Habitat Removal) and have informed this supplementary assessment.

4.2.1 Table 4-2 should be read in conjunction with Figure 2 Woodland Habitat Removal.
