A66 Northern Trans-Pennine Project TR010062

7.25 Tree Loss and Compensation Planting Report

7.25 TREE LOSS AND COMPENSATION PLANTING REPORT

Planning Inspectorate Scheme	TR010062
Reference	
Application Document Reference	7.25
Author:	A66 Northern Trans-Pennine Project Team,
	National Highways

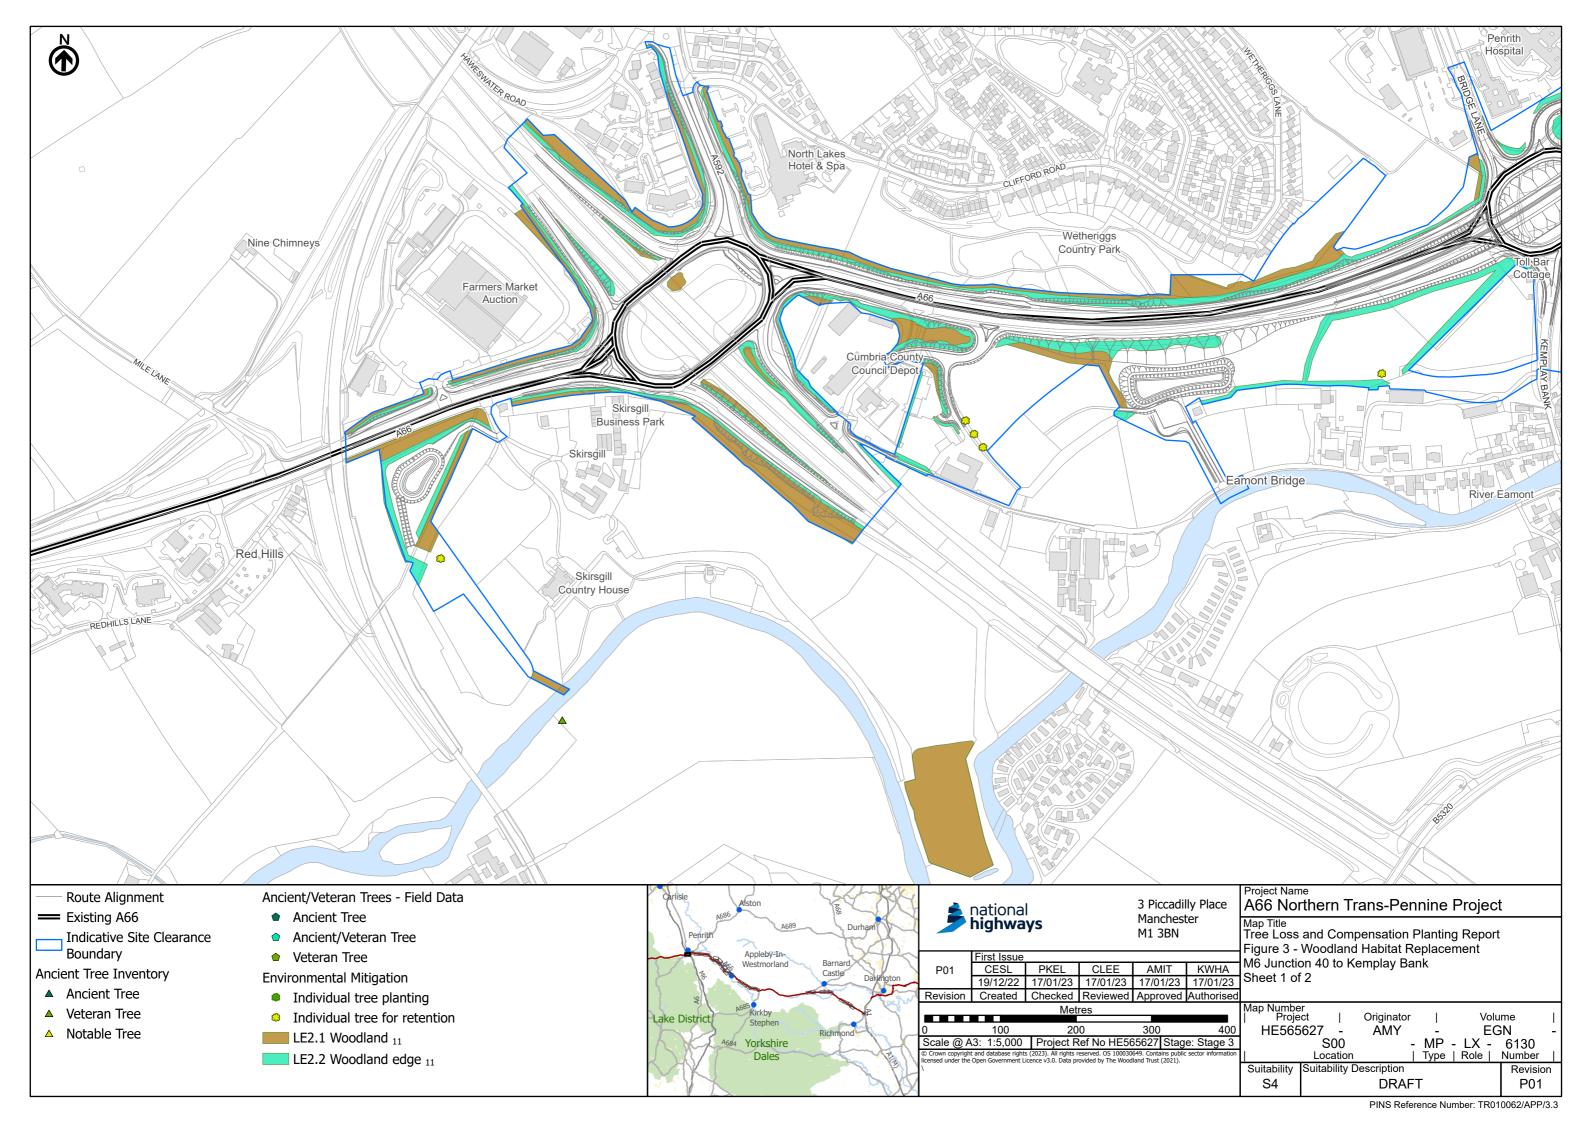
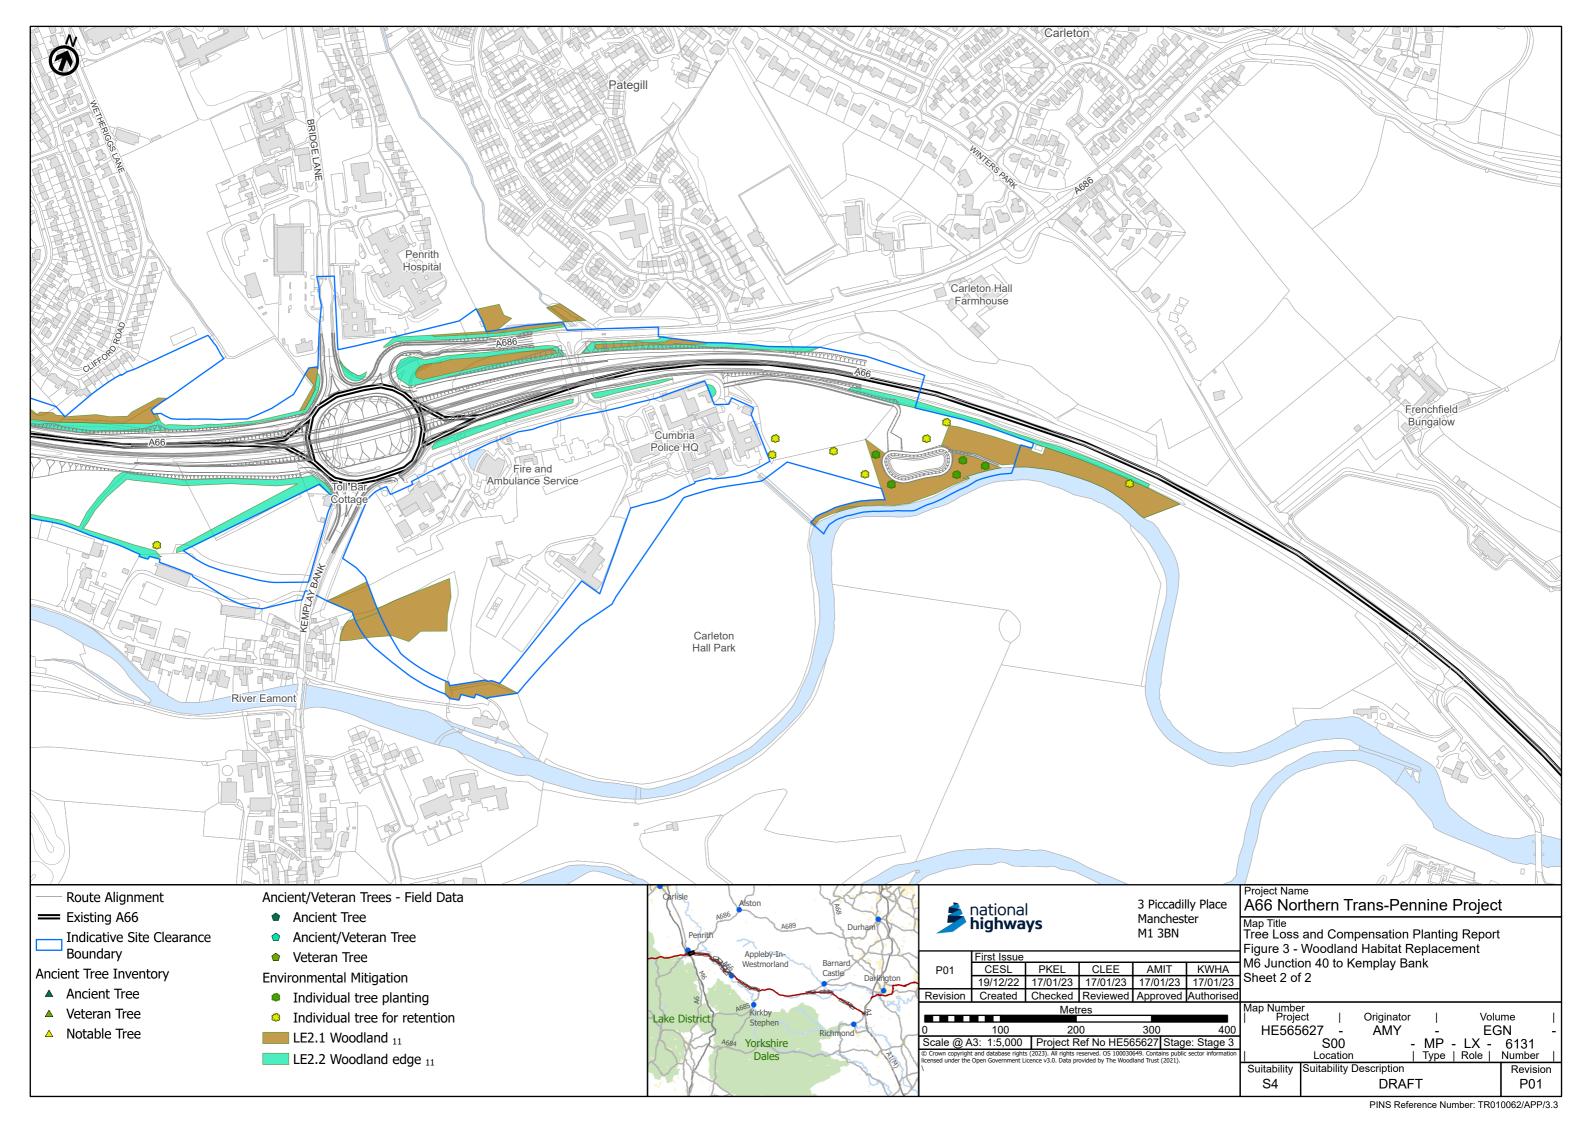
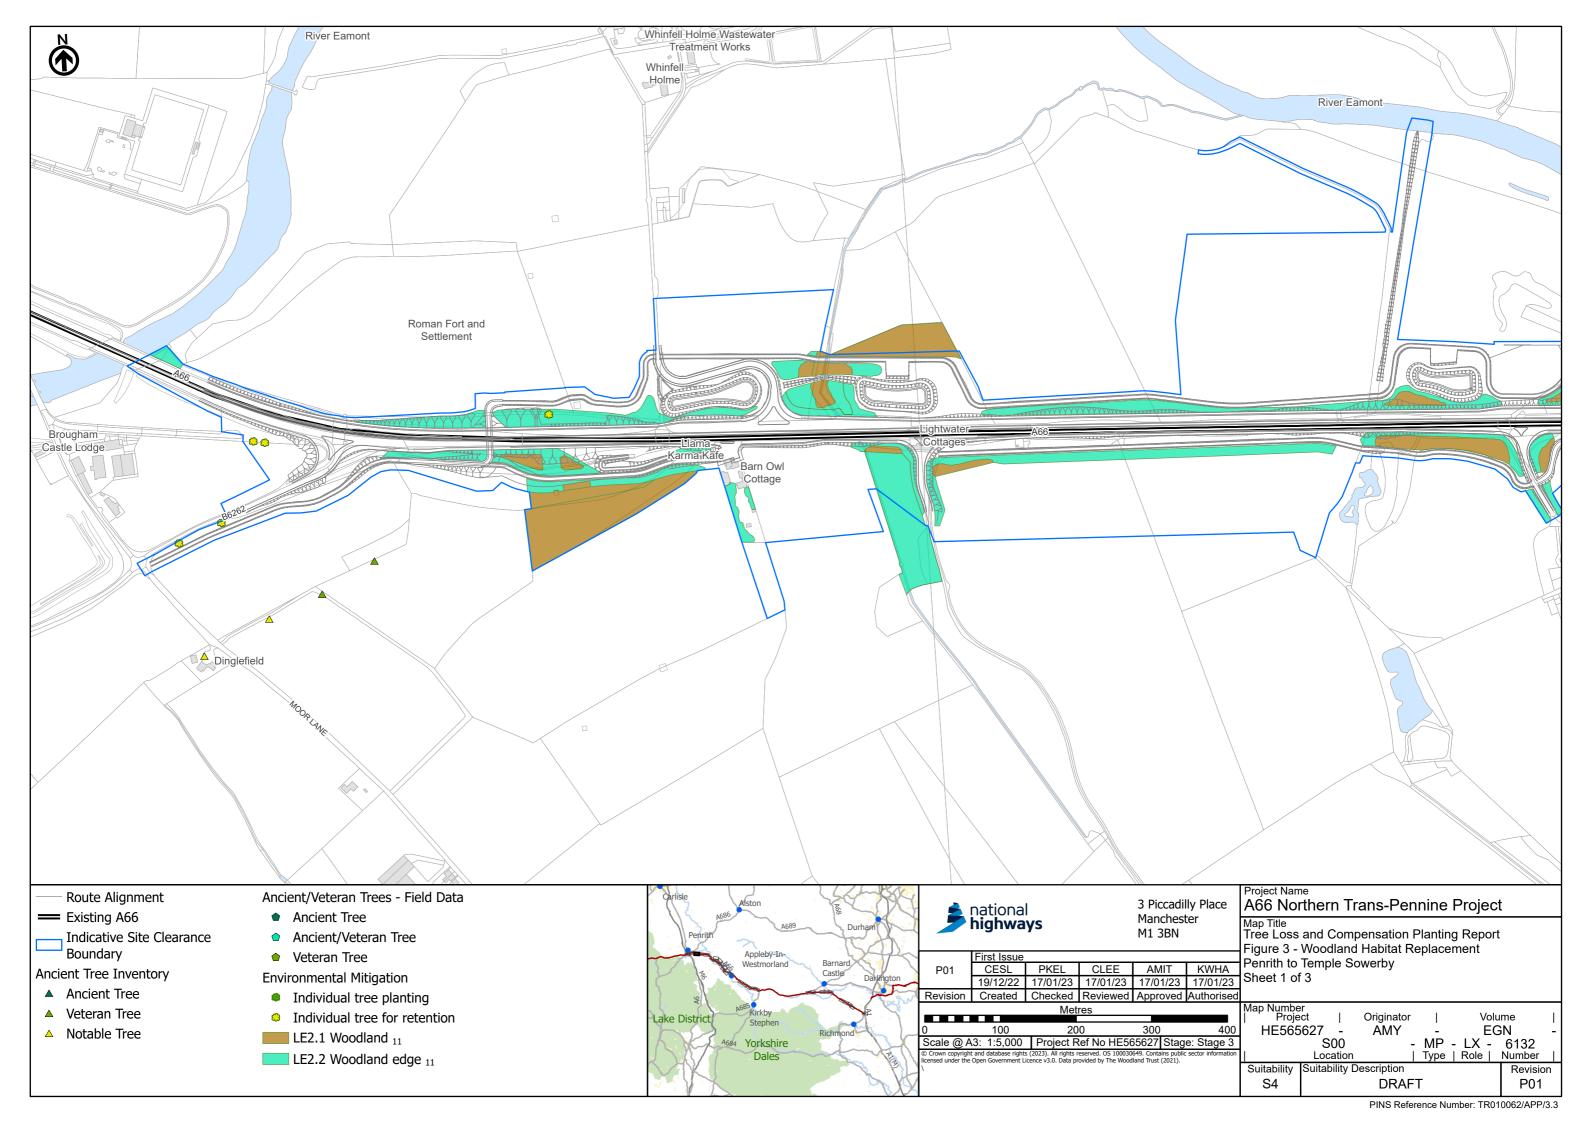
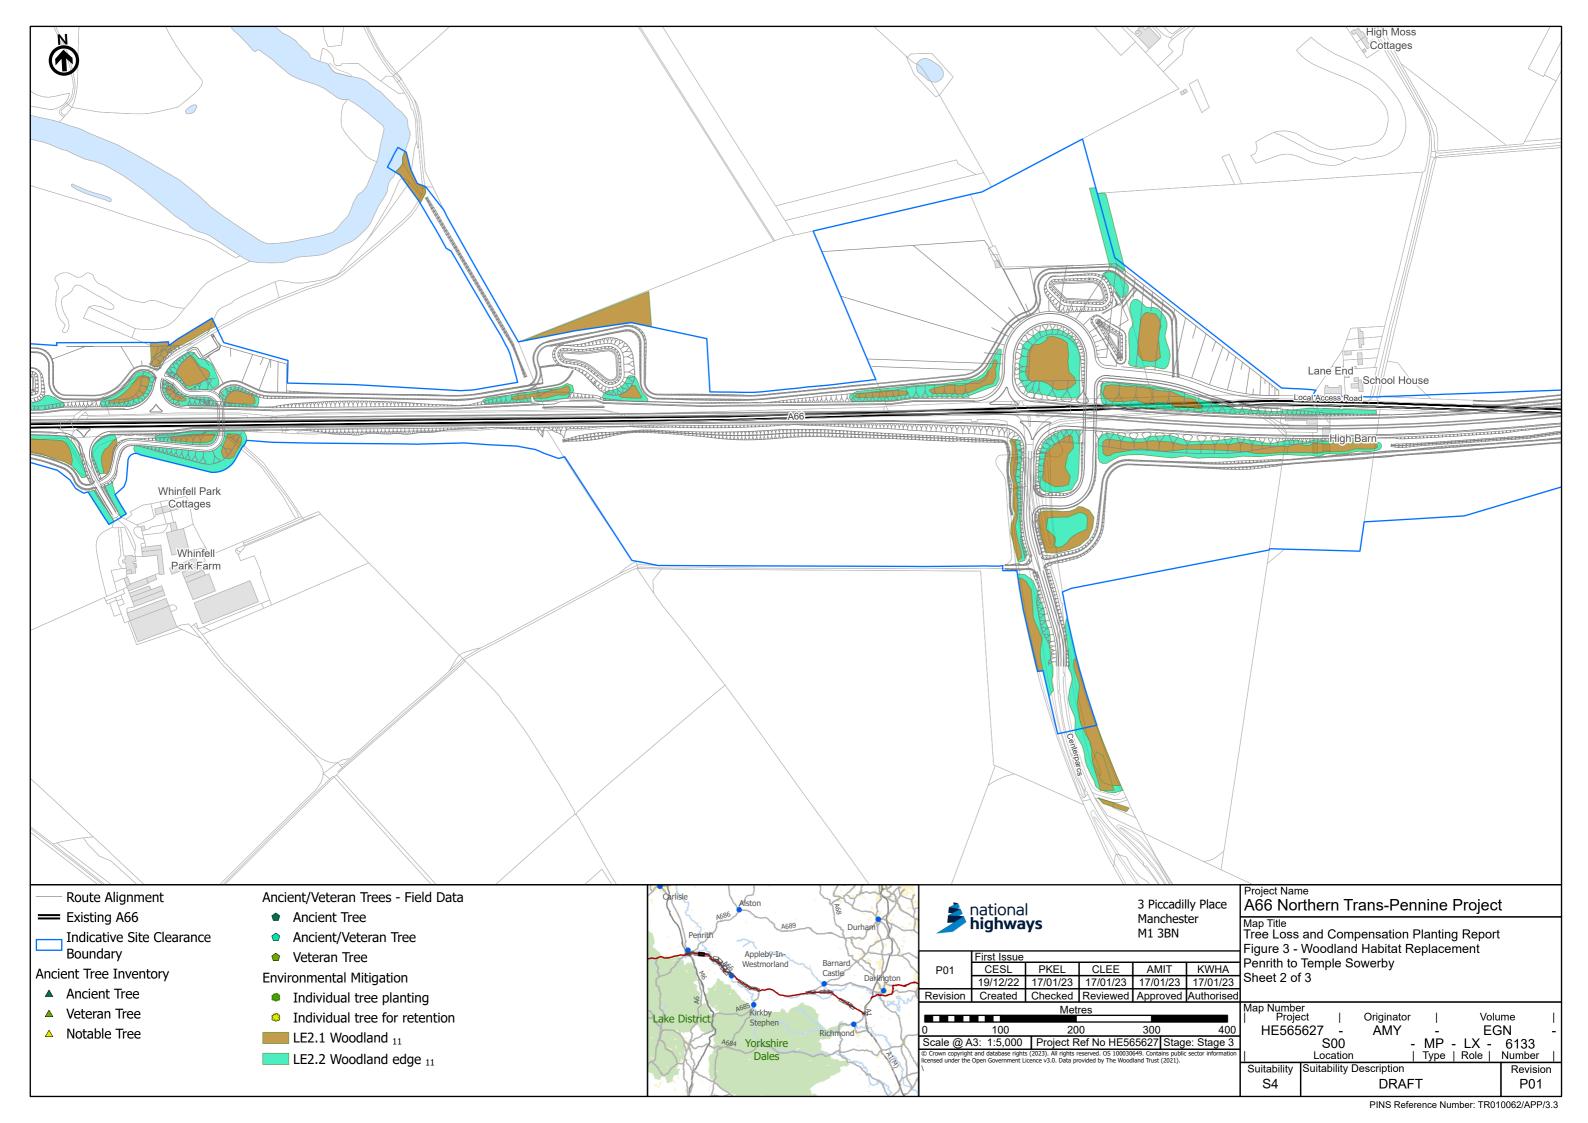
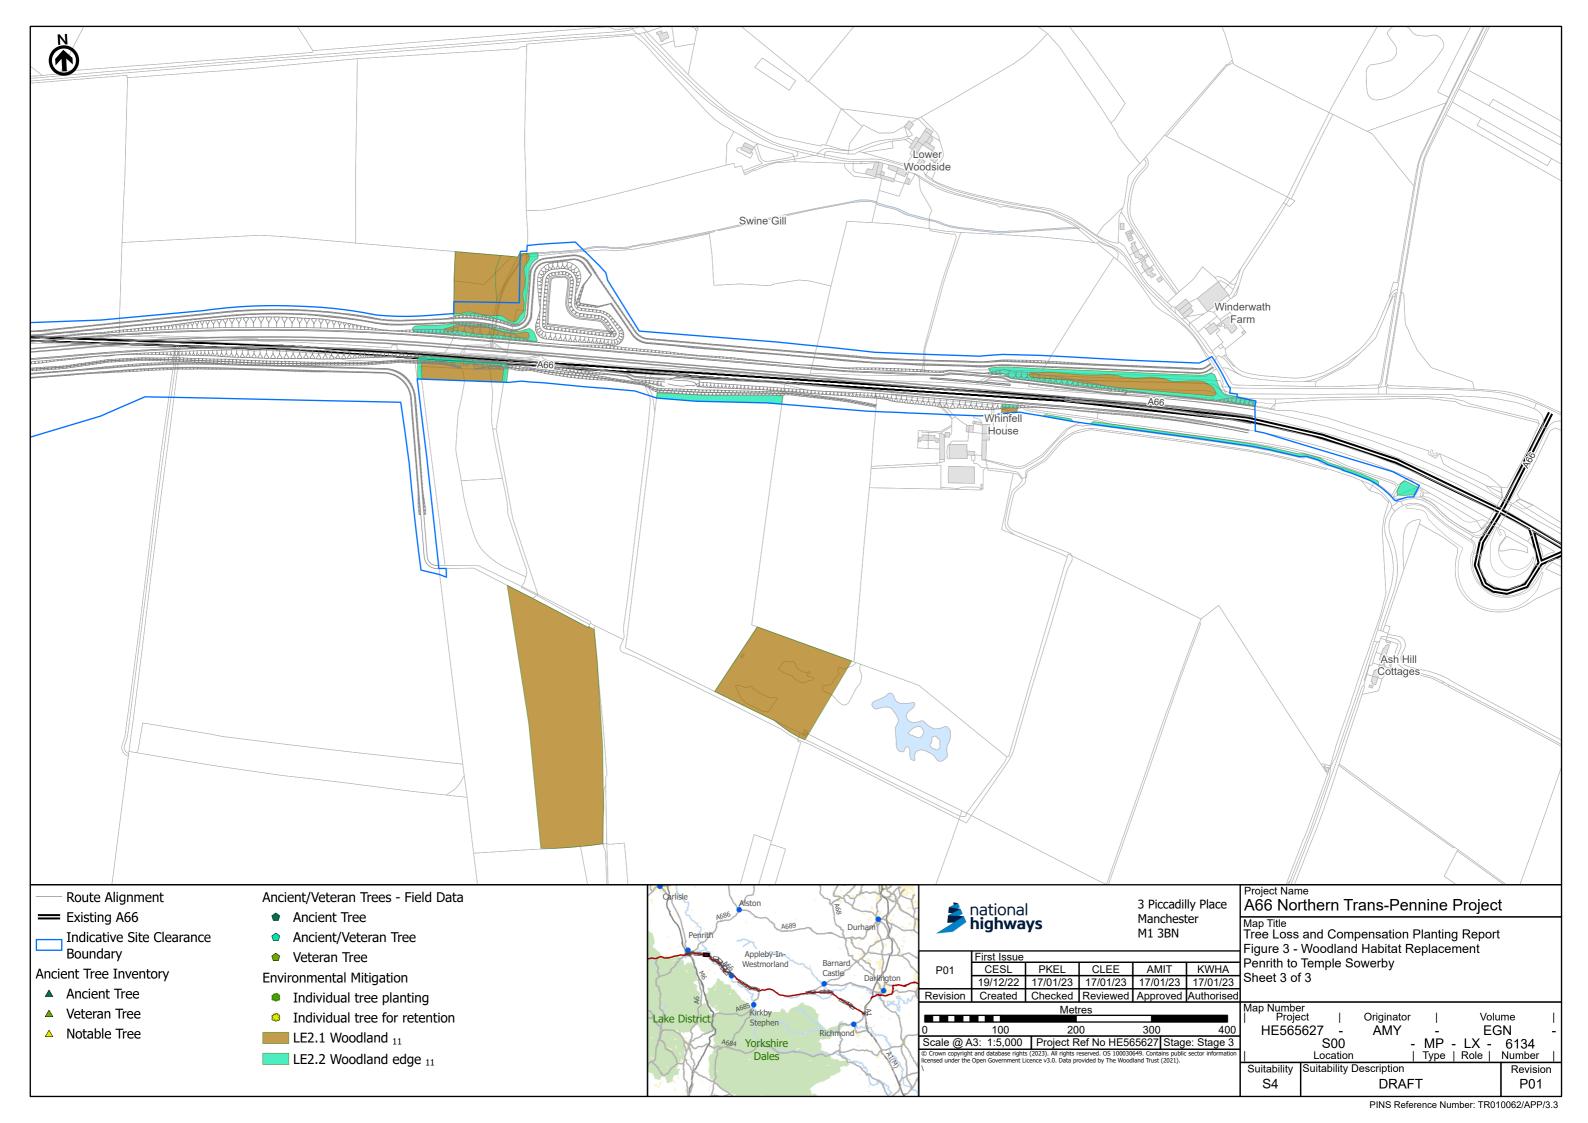
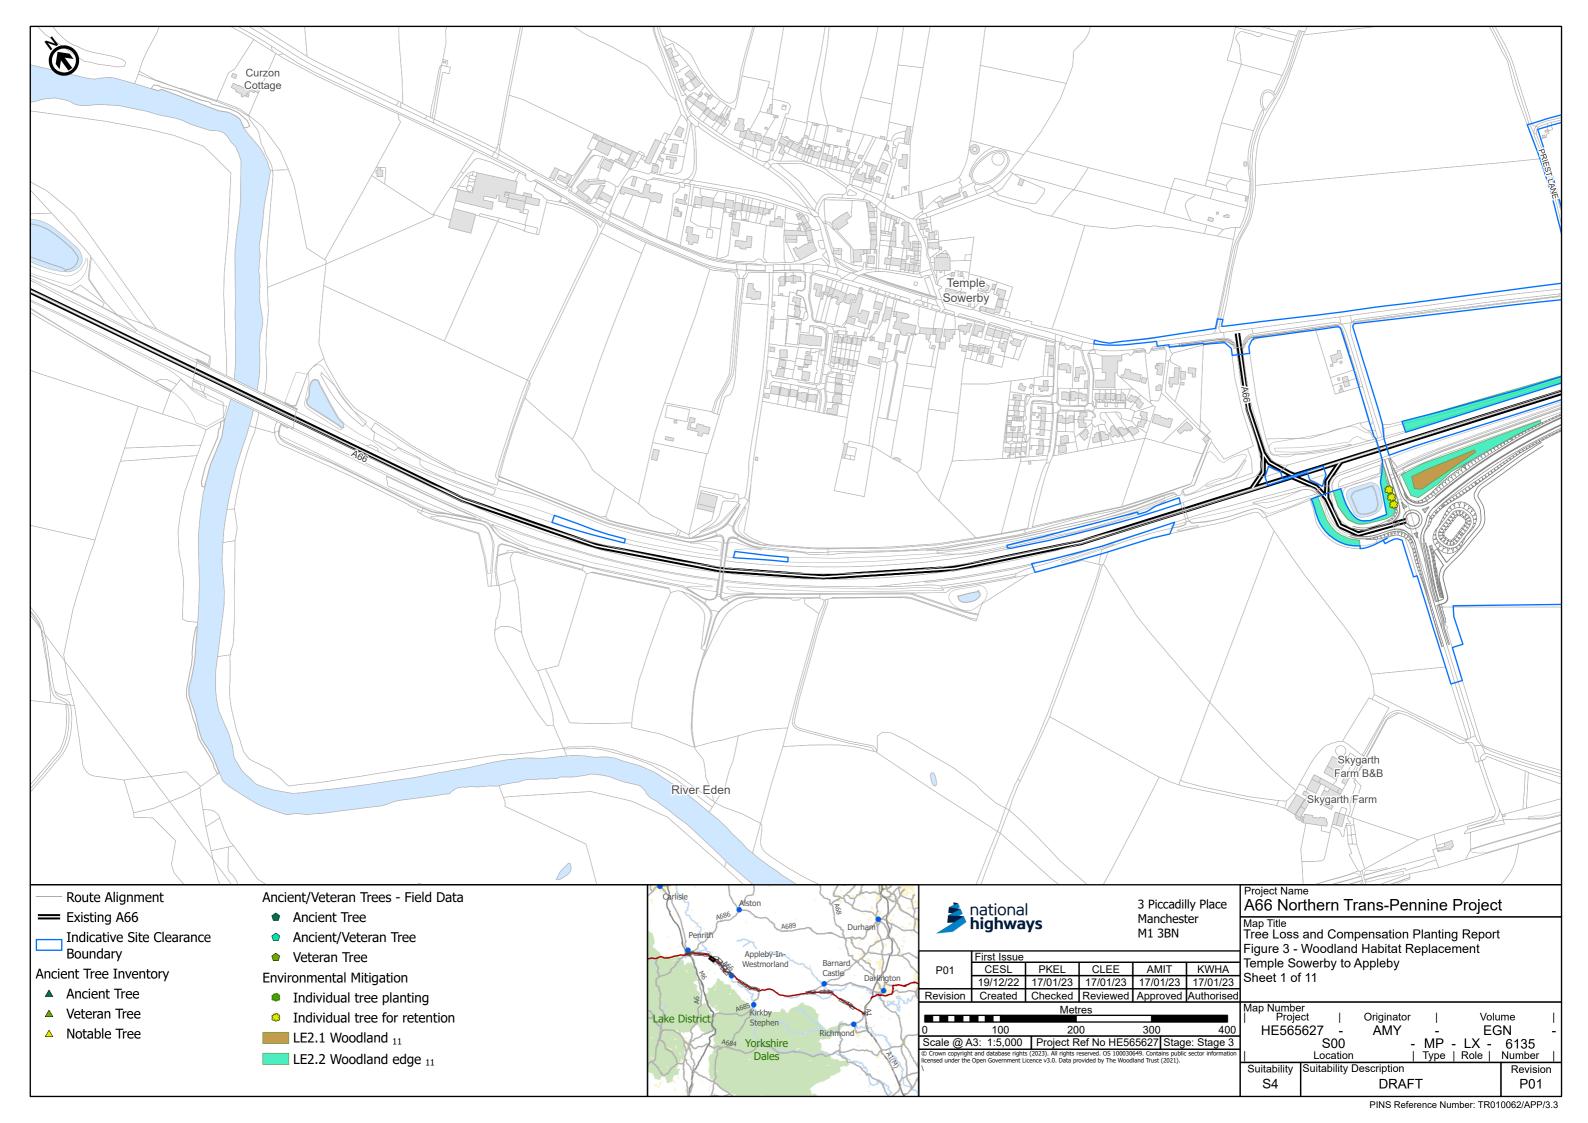
Appendix 3: Figure 3 – Woodland Habitat Replacement

2.2.3 Compensation planting areas have been identified with the landscape element code noted, species mixes and density can be found within the Landscape and Ecology Management Plan (LEMP) (Document Reference 2.7 / APP-021). An average planting density of 1.5 metre centres (approximately 1 plant every two square metres) has been applied within the LEMP, giving a resulting total of trees to be planted. Refer to Figure 3 of this report which maps the approximate location of woodland habitat replacement.

- 2.3.4 Data gathered from the Mitigation Maps and densities set out in the LEMP presented in Table 4-3 and illustrated in Figure 3 has been used to identify

4.3.1 Table 4-3 should be read in conjunction with Figure 3 Woodland Habitat Replacement.

4.3.2 The information presented in Table 4-3 illustrates the areas of environmental mitigation that include tree planting within the Order Limits, refer to Figure 3 of this report (Woodland Habitat Replacement) which illustrates the approximate location of woodland mitigation areas.
