M5 Junction 10 Improvements Scheme

Environmental Statement Appendix 7.3 Bat Survey

TR010063 – APP 6.15

Appendix 7.3 Bat Survey – Part 1 of 2

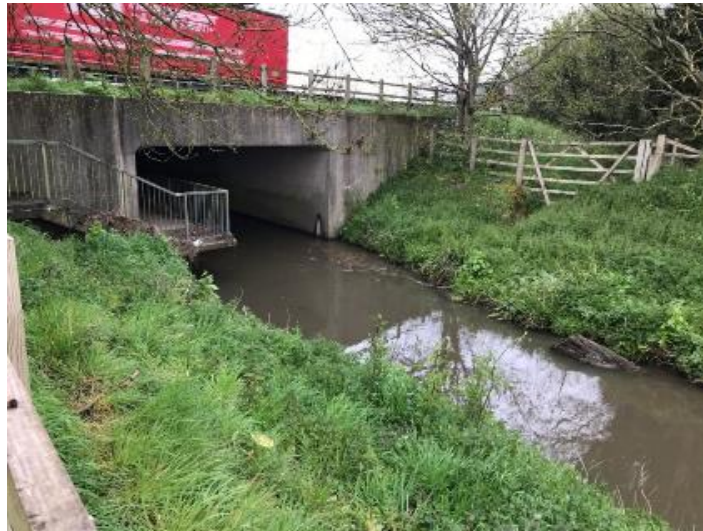
Figure 2-3 – Bat Trapping Location 2, River Chelt M5 Culvert

- 2.3.122 The M5 culvert over the River Chelt – accessed from the east of the culvert. Two harp traps were placed next to each other at this location in May 2021, with the objective of trapping bats when passing through the culvert. No mist nets were used at this location.

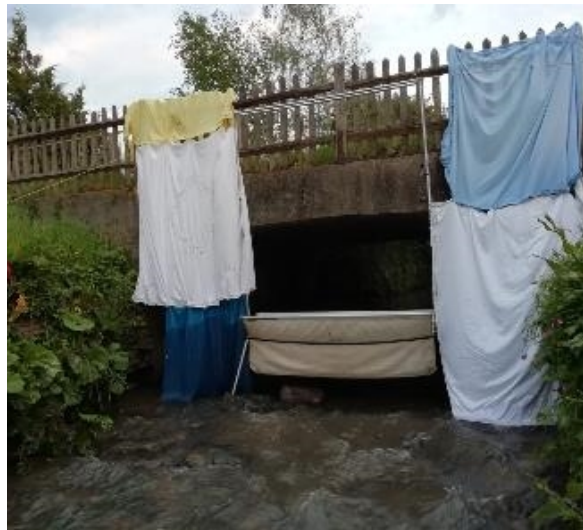
Figure 2-4 – Bat Trapping Location 3, River Chelt M5 Culvert

- 2.3.123 The Withybridge Lane bridge over the River Chelt. A single harp trap was placed at this location in May 2021 and fabric was hung either side of the harp trap to prevent bats flying around the harp trap, with the objective of trapping bats when passing through the culvert. No mist nets were used at this location.

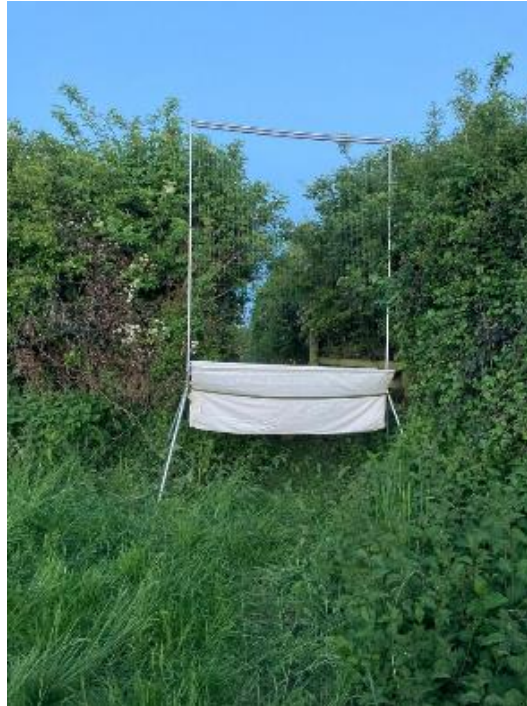
Figure 2-5 – Bat Trapping Location 5, Footpath Through Hedgerows where the Harp Trap was Located

- 2.3.125 A tree line running parallel to the A4019, 150 m to the south (along CP3). Mist nets and harp traps were used in this location (and the field to the south) in May 2021 adjacent to hedgerows and in gaps in the hedgerow where footpaths crossed.

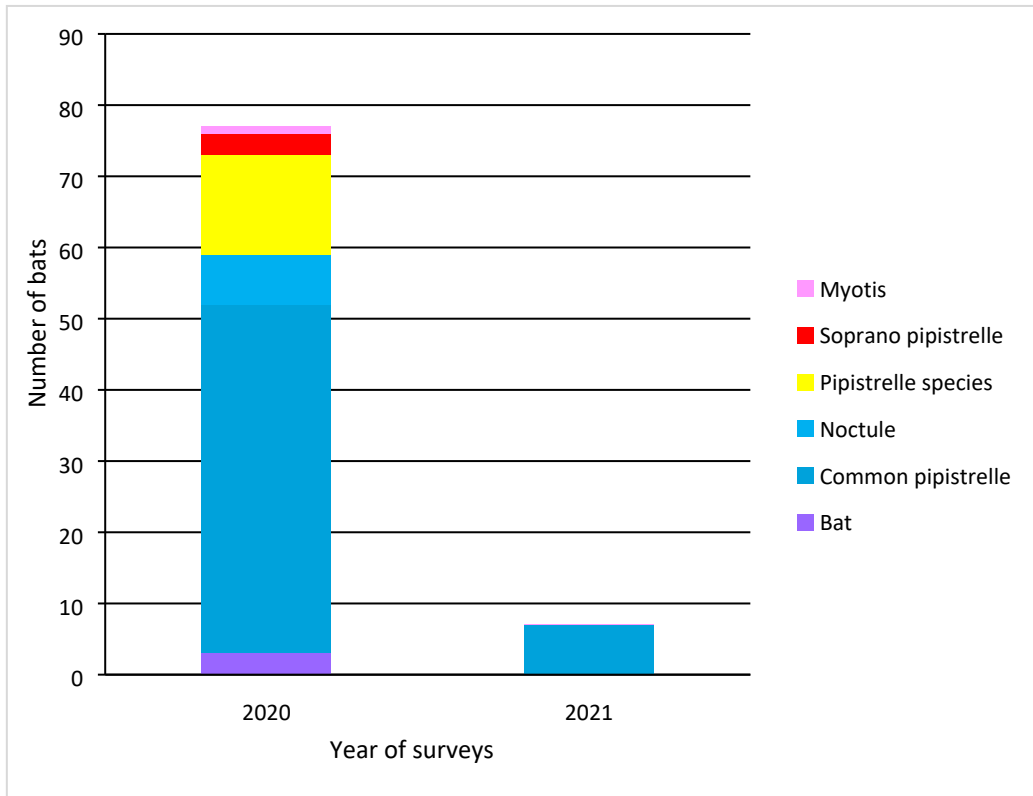
Figure 3-15 – Graph comparing 2020 to 2021 data for CP4

- 3.4.29 More bats were recorded crossing at an unsafe height in 2020, with a total of 77 over the six surveys, compared to only 7 bat passes in 2021, see Figure 3-15.
- 3.4.30 Of those bats that crossed at a safe height in 2021 99% were common pipistrelle passes.

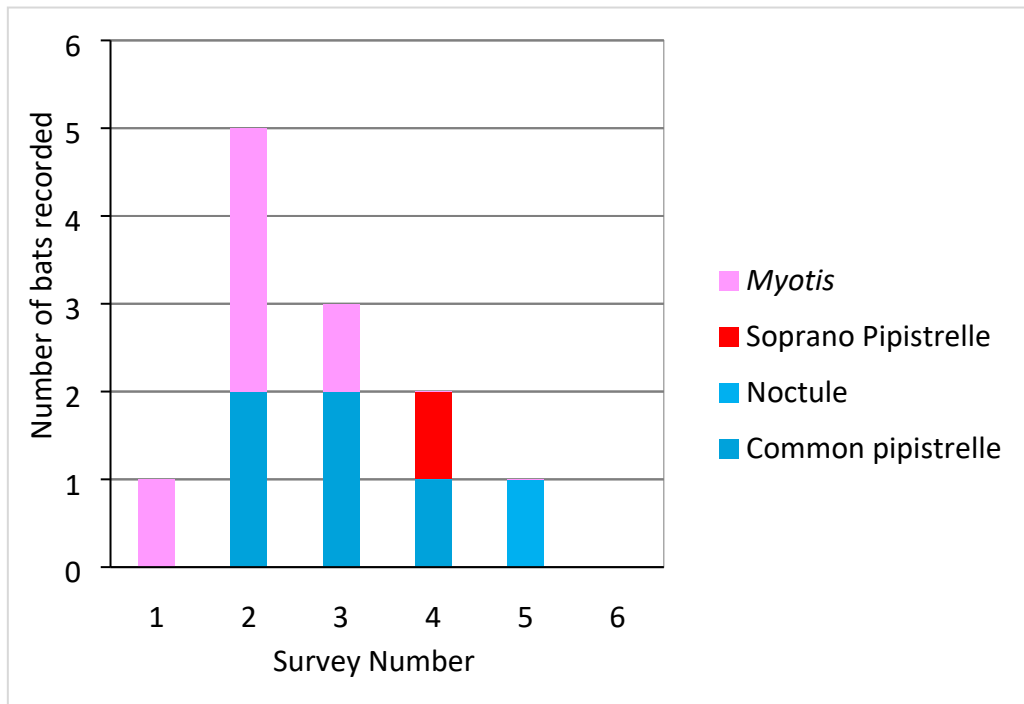
Figure 3-19 – Graph to Show CP8 Survey Data 2021

3.4.38 CP8 was considered to be a confirmed crossing point, as it met the criteria set out in Table 2-5, achieving a Crossing Point Score of 14 points over the initial two surveys. Over the six surveys common pipistrelle, soprano pipistrelle, *Myotis* species and noctule bat passes were recorded, totalling four bat species recorded crossing the road at this location, see Figure 3-19.

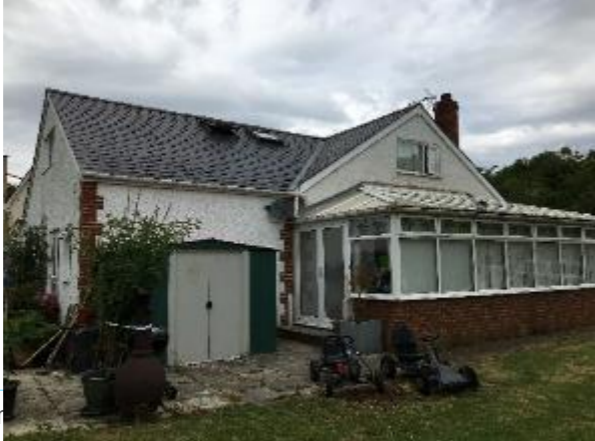
13/09/2021	19:12 to 20:57 (sunset = 19:27)	BU_1030	EMT 2 x 4	Air temp: 18 down to 17 (°C), no rain, cloud cover 7/6, wind speed 1
Comments: Roost survey results: Surveyors on the south side of the house saw one unknown species (not echolocating) emerge from the soffit gap at the back of the building (19:50).				
Survey 3 – No access				
Photos/ diagrams:

Roost Characterisation: Com (with limitations)

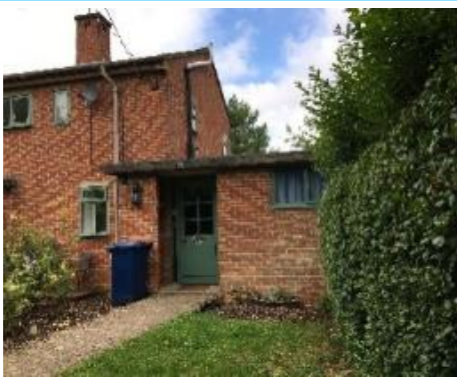
Comments: Roost survey results: One common pipistrelle bat at 19:52 landing and returning for about three minutes, displaying roosting behaviour; however, like last survey they didn't appear to return to the roost or emerge. Additionally, at 19:51 three common pipistrelle bats were swarming the southern end of the building. No emergence recorded.				
Photos/ diagrams:

Roost Characterisation: Common pipistrelle – day / mating roost; and Soprano pipistrelle – mating roost

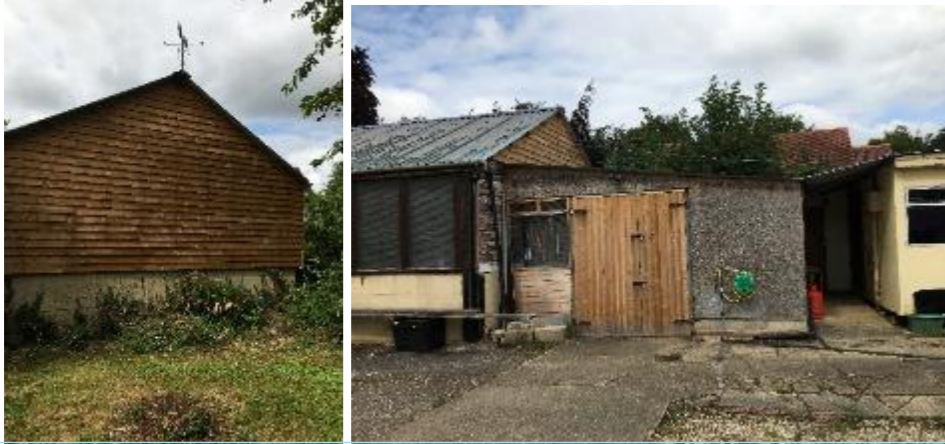
21/09/2021	18:50 to 21:05 (sunset = 19:05)	BU_1039	Walkabout x 4 and one IR camera (Canon XA11) and IR lamp (technical issue with IR lamp, meant that camera had to be used without additional IR lighting from 20:00. Camera has in-built IR.)	Air temp: 16 to 13 (°C), no rain, cloud cover 0, wind speed 0
Comments: Roost survey results: Possible emergence from south west gable of a non-echolocating bat seen at 19:27. However, building thoroughly observed at end of survey with no obvious potential roosting features.				
10/05/2022	20:32 to 22:47 (sunset = 20:47)	BU_1039	Walkabout x 4	Air temp: 13 to 12 (°C), no rain, cloud cover 8, wind speed 0
Comments: Roost survey results: No emergences.				
Photos/ diagrams:

Roost Characterisation: Common pipistrelle – day roost

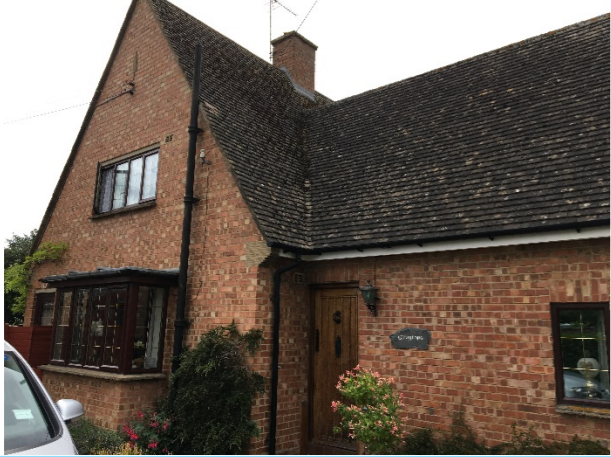
Comments: , Limitations: None				
Roost survey results: No roosting observed.				
Survey 3 – not completed				
Photos/ diagrams:

Roost characterisation: Soprano pipistrelle – day roost

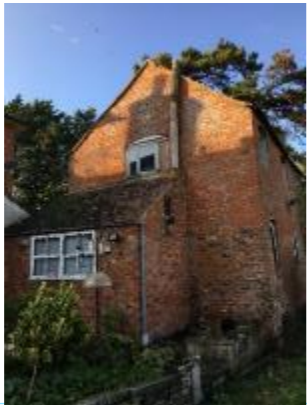
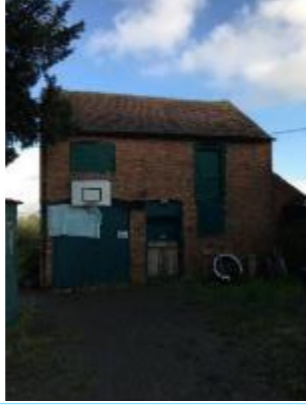
Table 4-8 – Survey Results BU_370

Date of Survey	Start and End Times and Time of Sunset	Structure Reference	Equipment Used (include make of bat detectors and logging equipment)	Weather (include start and end temps, precipitation, Beaufort wind scale etc)
24/10/2019	PBRA (external only)	BU_370	N/A	No rain, cloud cover 5, wind speed 0, sunny spells, cool
Comments:				
Visual inspection Several timber doors and windows present on western elevation. During the PBRA the tenant made an un-verified comment about seeing a bat leave the structure. No evidence of bats was recorded by the surveyors.				
Access refused for hibernation survey				
Survey 3 – access refused				
Survey 3 – access refused				
Survey 3 – access refused				
Photos/ diagrams: <div style="display: flex; justify-content: space-around; align-items: center;">

</div>				
Roost characterisation: Bat – unknown roost (assumed, with limitations)

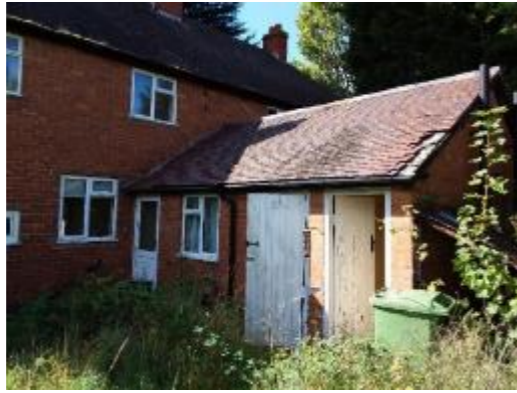
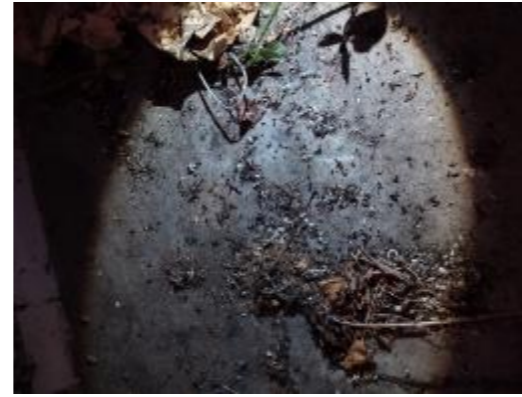
Table 4-11 – Survey Results BU_507

28/04/2022	20:13 to 22:28 (sunset = 20:28)	BU_507	Walkabout x 2	Air temp: 10 down to 6 (°C), no rain, cloud cover 2/1, wind speed 1/0
<p>Comments:</p> <p>Roost survey results: Recorded a re-entry to the porch on the east elevation (pipistrelle (assumed to be soprano pipistrelle at 21:22, 54 minutes after sunset) in the same location a re-entry confirmed on the 2021 re-entry survey.</p>

Roost characterisation: Soprano pipistrelle – day roost; and Lesser horseshoe – day/ feeding roost

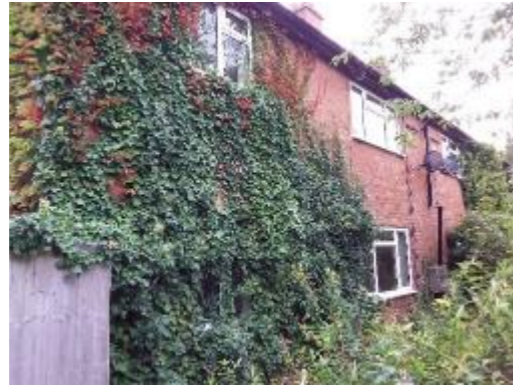
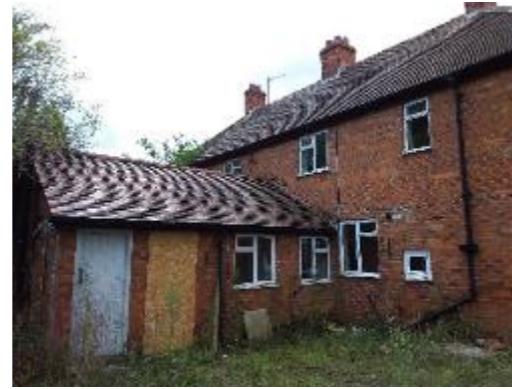
Table 4-12 – Survey Results BU_610

<p>Comments:</p> <p>Roost survey results: No emergences observed. Bats not inside the outdoor room.</p>				
03/08/2021	20:41 to 22:54 (sunset = 21:54)	BU_610/ BU_611	SM4/ Duet and EMT 2	Air temp: 19 down to 17 (°C), no rain, cloud cover 6/ 7, wind speed 0
<p>Comments:</p> <p>Roost survey results: One common pipistrelle emergence from the north side of roof (21:31).</p>

Roost characterisation: Common pipistrelle – day roost; and Noctule – day roost

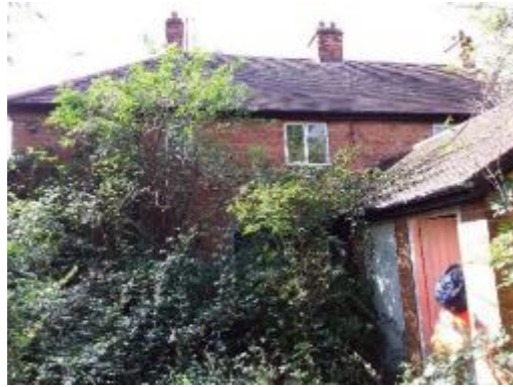
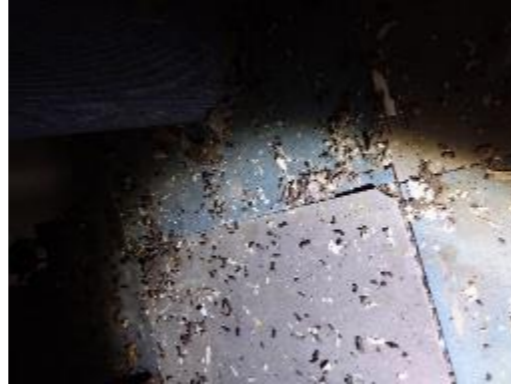
Table 4-13 – Survey Results BU_611

Comments: Roost survey results: No bats emerged from BU_611.

Roost characterisation: Lesser horseshoe – day/ feeding roost

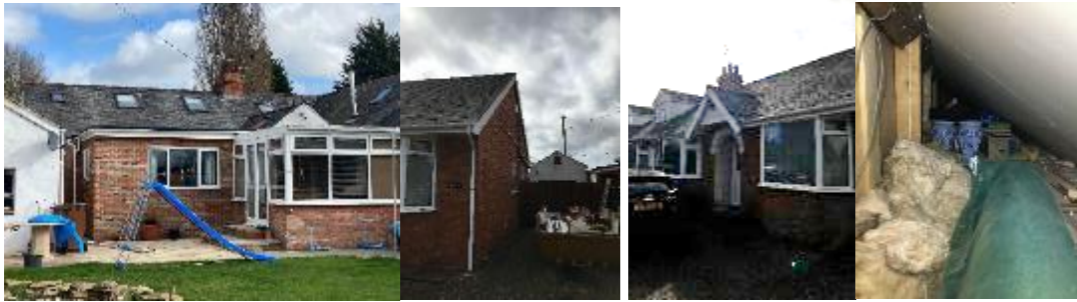
Table 4-14 – Survey Results BU_614

Date of Survey	Start and End Times and Time of Sunset	Structure Reference	Equipment Used (include make of bat detectors and logging equipment)	Weather (include start and end temps, precipitation, Beaufort wind scale etc)
09/03/2022	PBRA	BU_614	N/A	Air temp: 20°C, no rain, cloud cover 8, wind speed 2
<p>Comments:</p> <p>Visual inspection results: Features were identified under the ridge tiles to the rear of the property. On the front of the property gaps were identified between the roof tiles and barge board on the porch dormer, and slipped side on the dormer roof. There is a gap in the plastic soffit box above the security light on the porch dormer. Attic is converted with attic space restricted only to the eaves. Eaves on the front and back (north and south) of the property. Each is approximately 1 m wide, 1 m high and 8 m long (length of the house). Access is possible through crawl space doors.</p> <p>The northern crawl space was boarded across the rafters along its length. Insulation blocks and plasterboard was covering the roof trusses along the entire length of the house. There were no obvious gaps, and no droppings of any kind were found. The southern crawl space - no bat droppings were identified.</p>

No hibernation survey completed				
26/04/2022	20:10 to 22:25 (sunset = 20:25)	BU_614	Walkabout x 2	Air temp: 10 to 9 (°C), no rain, cloud cover 8/5 wind speed 1/1
<p>Comments: Limitations: Survey was carried out a few days before the start of the official bat survey season (May to September); however, weather conditions were suitable, so not considered to be a significant limitation</p> <p>Roost survey results: A single soprano pipistrelle bat emerged at 20:41 (16 minutes after sunset) from underneath a roof tile on the western gable end and flew north.</p>				
Survey 2 – No survey completed				
Survey 3 – No survey completed				
<p>Photos/ diagrams:</p>

<p>Roost characterisation: Soprano pipistrelle – day roost</p>

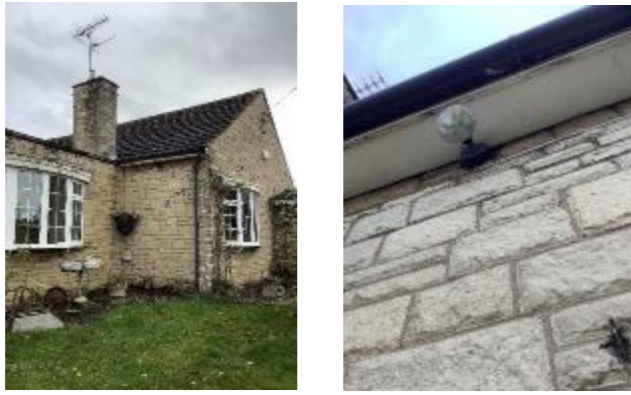
Table 4-15 – Survey Results BU_653

Comments: Roost survey results: No bats emerged. Photos/ diagrams:

Roost characterisation: Common pipistrelle – day roost; or Soprano pipistrelle – day roost

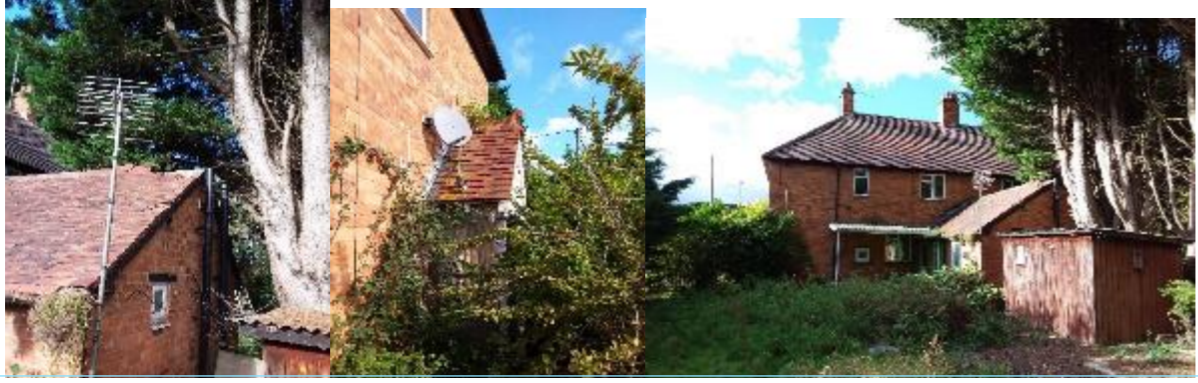
Table 4-16 – Survey Results BU_694

Comments: Roost survey results: At 22:02 a <i>Myotis</i> bat was recorded entering the outhouse doorway of BU_709 and emerging a six minutes later from the same doorway. Photos/ diagrams:

Roost characterisation: Lesser horseshoe – day / night roosts; and brown long-eared – day roost

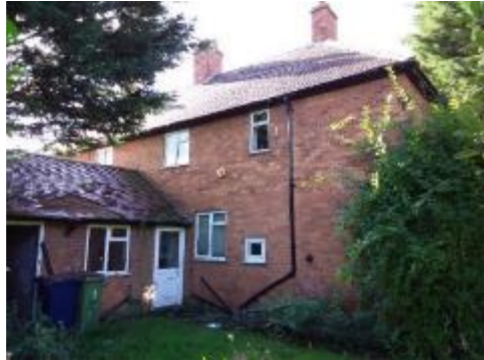
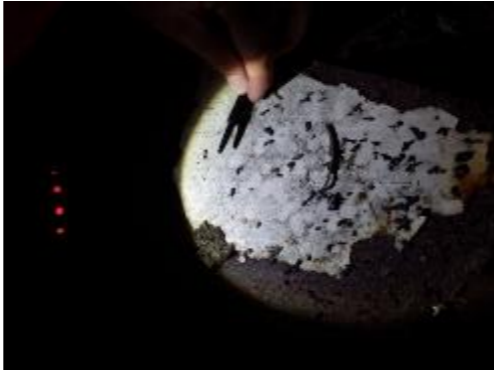
Table 4-17 – Survey Results BU_709

Comments: Roost survey results: At 22:02 a <i>Myotis</i> bat was recorded entering the outhouse doorway of BU_709 and emerging a six minutes later from the same doorway. It was determined not to be roosting in this location.				
Photos/ diagrams: <div style="display: flex; justify-content: space-around; align-items: center;">

</div>				
Roost characterisation: Lesser horseshoe – day / feeding roost

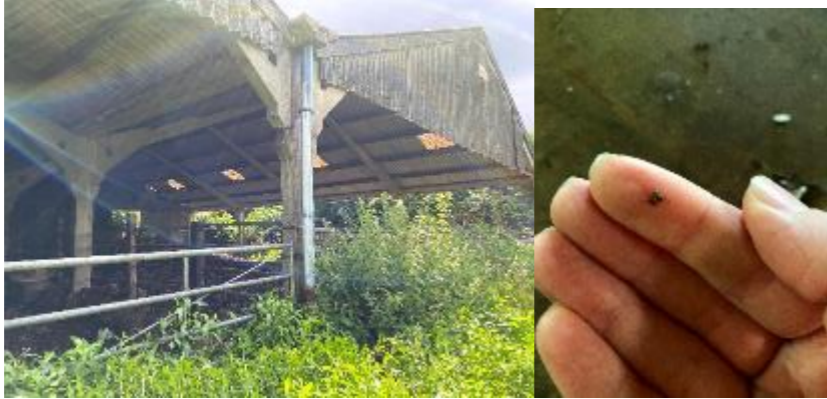
Table 4-18 – Survey Results BU_723

Comments: Limitation: Delayed start for three surveyors due to traffic delaying surveyor with kit, limited visibility from start. Roost survey results: One confirmed emergence by common pipistrelle from inside building from unknown location (19:44).				
Photos/ diagrams:

Roost characterisation: Common pipistrelle – day roost; and <i>Myotis</i> (assumed to be Natterer's) – day roost

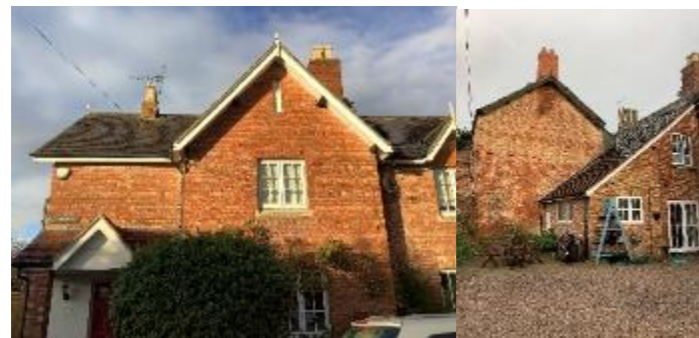
Table 4-19 – Survey Results BU_735

Hibernation survey – no access				
11/05/2021	20:30 to 22:32 (sunset = 20:49)	BU_735	Walkabout x 3 and EMT 2	Air temp: 12 down to 11 (°C), rain 1, cloud cover 8, wind speed 2/3
Comments: Roost survey results: A brown long eared was recorded flying near neighbours building to the west BU_661 (possible emergence, 21:34).				
26/07/2021	20:54 to 23:09 (sunset = 21:09)	BU_735	SM4/ Duet x 4 and FLIR T540	Air temp: 23 down to 21 (°C), no rain, cloud cover 3/8, wind speed 0/2
Comments: Roost survey results: One common pipistrelle emergence seen at 21:54 (45 minutes after sunset) from the house to the west (BU_638).				
23/09/2021	04:55 to 07:10 (sunrise = 06:55)	BU_735	EMT 2 x 3 and FLIR T540	Air temp: 14 down to 13 (°C), rain 0, cloud cover 2/1, wind speed 2/3
Comments: Roost survey results: One common pipistrelle re-entered to the cracked brick to the right of 1 st floor window at 06:21. A further common pipistrelle was recorded at 06:01 circling above behind house then assumed to re-enter a roost. Finally a third common pipistrelle bat was seen at 06:08 circling above house near chimney <u>on adjacent property (BU_638)</u> . It was assumed that it re-entered on adjacent property in between roof pitches.

Roost characterisation: Common pipistrelle – day roost

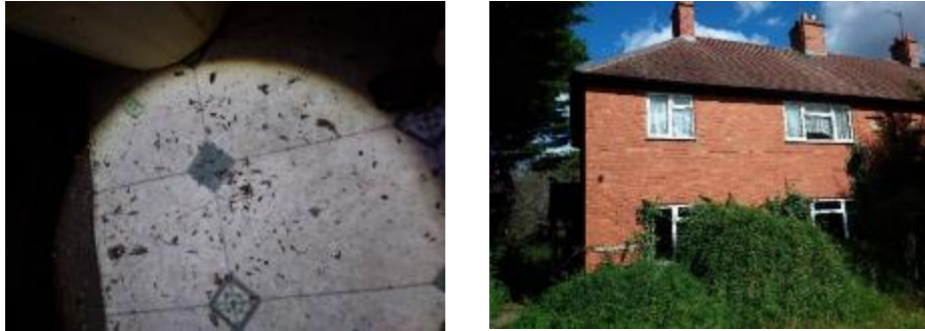
Table 4-20 – Survey Results BU_819

Hibernation survey not carried out as internal access could not be arranged by the landowner during the correct time period				
08/07/2021	21:14 to 23:29 (sunset = 21:29)	BU_819	EMT 2 x 2	Air temp: 16/ 15 (°C), no rain, cloud cover 8/ 3, wind speed 1
Comments Roost survey results: No bats emerged.				
22/07/2021	03:16 to 05:31 (sunrise = 05:16)	BU_819	EMT 2 and Batlogger M2	Air temp: 16/ 15 (°C), no rain, cloud cover 8/ 3, wind speed 1
Comments: Roost survey results: No bats emerged.				
09/08/2021	20:29 to 22:44 (sunset = 20:44)	BU_819	EMT 2 x 2 and thermal camera	Air temp: 16/ 15 (°C), no rain, cloud cover 8/ 3, wind speed 1
Comments: Roost survey results: Two common pipistrelle emerged at 21:12 (28 minutes after sunset). Photos/ diagrams:

Roost characterisation: Lesser horseshoe - transitional roost; and Common pipistrelle – day roost

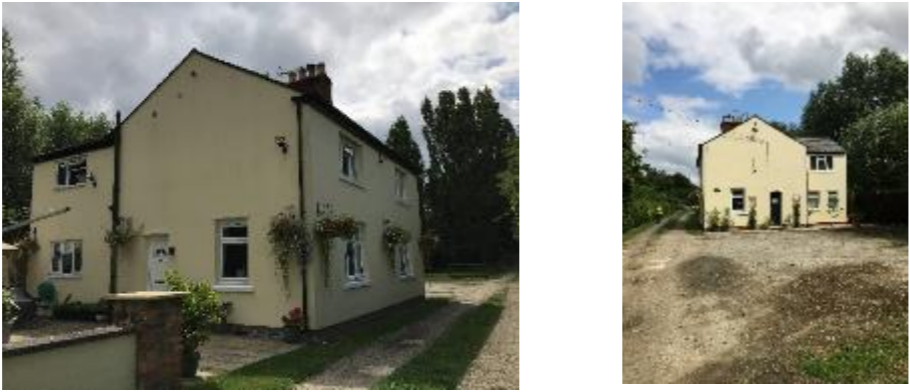
Comments: Roost survey results: One soprano pipistrelle was recorded circling the car park before roosting within the structure at 05:36 (32 minutes before sunrise).				
07/07/2021	21:12 to 23:22 (sunset = 21:27)	BU_963	EM Touch and Walkabout	Air temp: 18 (°C), no rain, cloud cover 6, wind speed 1
Comments: Roost survey results: No bats observed emerging by any surveyor.				
Photos/ diagrams:

Roost characterisation: Soprano pipistrelle – day roost

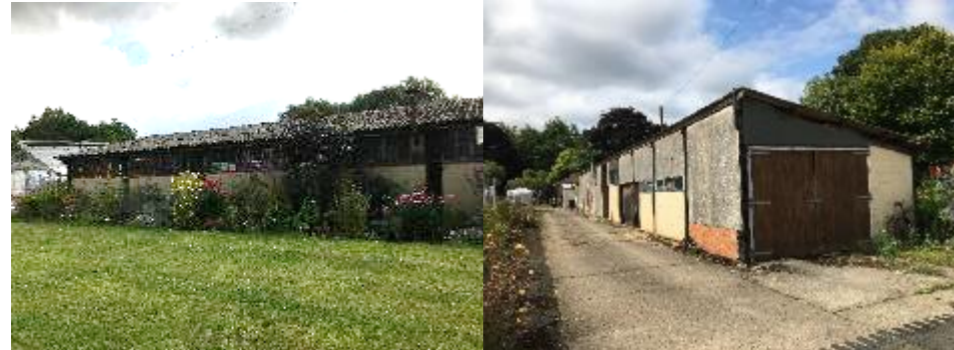
Table 4-23 – Survey Results BU_972

29/09/2021	18:36 to 20:51 (sunset = 18:51)	BU_972	Walkabout x 2, Batlogger M2 x 1	Air temp: 14 down to 9 (°C), no rain, cloud cover 2/3, wind speed 0/1
Comments: Roost survey results: Common pipistrelle bat emerged from the south east corner of the building at 19:14, from the wooden post on the corner of the building by the top of the garage door.				
10/05/2022	20:33 to 22:48 (sunset = 20:48)	BU_972	Batlogger M2 x 3	Air temp: 14 down to 12 (°C), no rain, cloud cover 8, wind speed 4/1
Comments: Roost survey results: No bat emergences				
Photos/ diagrams:

Roost characterisation: Common pipistrelle – day roost

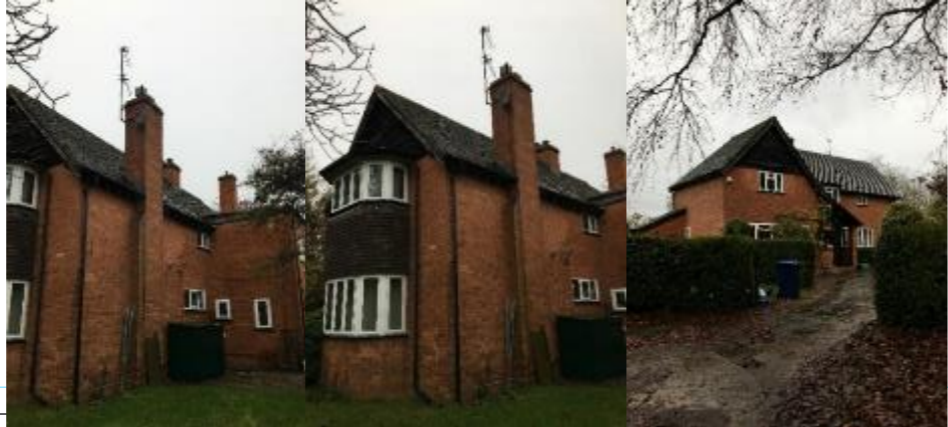
07/07/2021	21:12 to 23:27 (sunset = 21:27)	BU_981	Walkabout x 4	Air temp: 19 (°C) no rain, cloud cover 7, wind speed 1
Comments: Roost survey results: Common pipistrelle emerged at 21:42 (15 minutes after sunset). A non-echo-locating bat emerged from the wooden cladding at 21:51 (24 minutes after sunset), this was seen by two surveyors, with no bat calls recorded.				
Survey 3 – access refused				
Photos/ diagrams:

Roost characterisation: Common pipistrelle

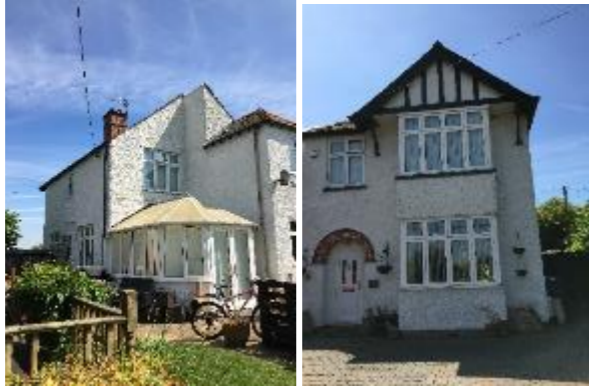
31/8/2021	19:43 to 21:58 (sunset = 19:58)	BU_987	EMT 2 and Samsung tablets x 4 plus one infra-red Canon XA15 and two x Eerel 140 LED Infra-red lamps	Air temp: 16 (°C), no rain, cloud cover 3, wind speed 2
Comments: Roost survey results: Two emergences recorded from the same feature (from very top of the roof where it looks-like loose lead flashing is present), of soprano pipistrelle (20:09 and 20:12, 12 and 15 minutes after sunset).				
Survey 3 – no access				
Photos/ diagrams:

Roost characterisation: Soprano pipistrelle – maternity / day roost (assumed, with limitations)

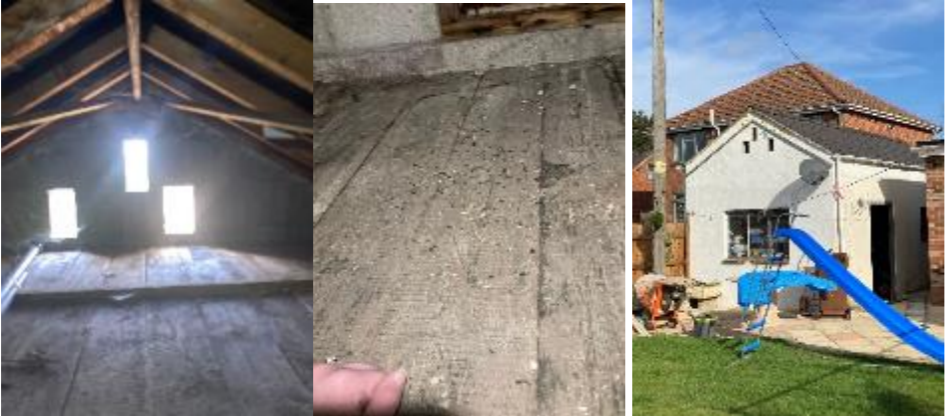
Table 4-27 – Survey Results BU_11

Date of Survey	Start and End Times and Time of Sunset	Structure Reference	Equipment Used (include make of bat detectors and logging equipment)	Weather (include start and end temps, precipitation, Beaufort wind scale etc)
09/03/2022	PBRA (internal survey on the same date)	BU_11	N/A	Air temp: 20°C, no rain, cloud cover 8, wind speed 2
<p>Comments:</p> <p>Visual inspection results: At the eaves of the roof there were gaps along the east and west aspect approx. 10 cm wide where the boarding does not meet the roof. Access is possible via the southern gable end where three bricks were missing each approximately 10 cm x 20 cm in size. At the northern gable end approximately 70 lesser horseshoe droppings were identified, later confirmed from eDNA analysis. The roof was lined with felt with no obvious gaps or tears. There are some minor gaps under the ridge tiles.</p> <p>DNA: date collected 16/02/2022 – Lesser horseshoe</p>

Roost characterisation: Lesser horseshoe – day roost

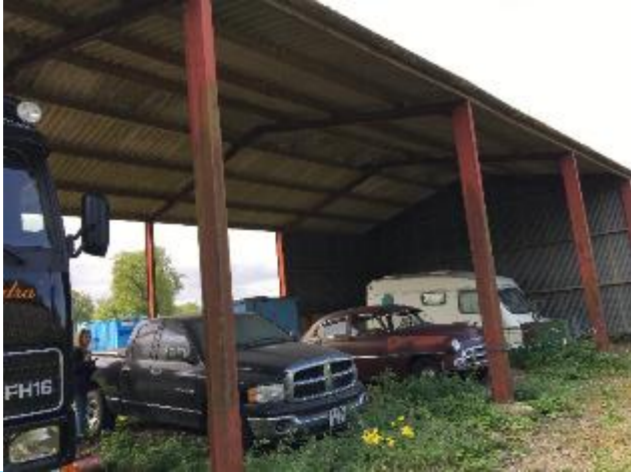
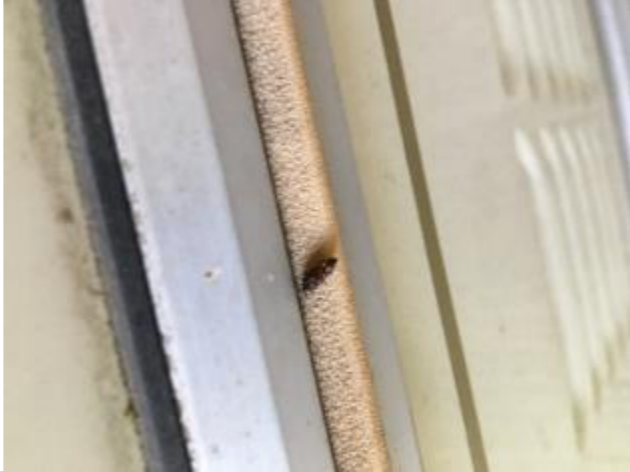
Table 4-28 – Survey Results BU_357

Date of Survey	Start and End Times and Time of Sunset	Structure Reference	Equipment Used (include make of bat detectors and logging equipment)	Weather (include start and end temps, precipitation, Beaufort wind scale etc)
22/08/2019	PBRA	BU_357	N/A	Air temp: 19 (°C), very light rain, cloud cover 8, wind speed 1
Comments: Visual inspection: Bat dropping indicative of pipistrelle droppings were recorded throughout the barn (no DNA analysis has been carried out).				
No hibernation suitability				
05/08/2020	20:35 to 22:20 (sunset = 20:50)	BU_357	Walkabout x 2	Air temp: 19 down to 17 (°C), no rain, cloud cover 7/ 2, wind speed 2
Comments: Roost survey results: No emergences were recorded.				
30/09/2020	19:36 to 21:21 (sunset = 19:51)	BU_357	Walkabout x 2	Air temp: 17 down to 16 (°C), no rain, cloud cover 7, wind speed 2
Comments: Roost survey results: No emergences were recorded.				
Survey 3 – Access refused

</div>				
Roost characterisation: Unknown species – Night/ feeding roost

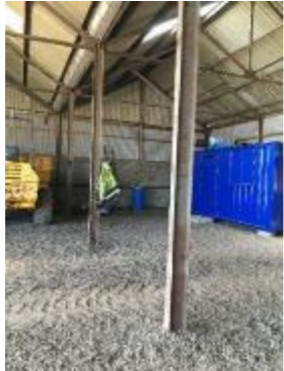
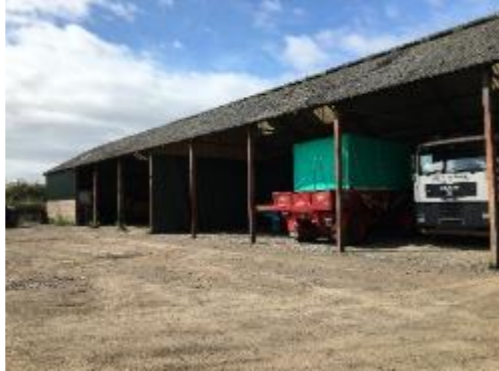
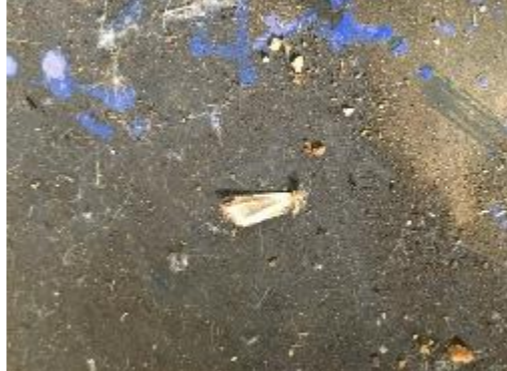
Table 4-29 – Survey Results BU_364

Comments: Roost survey results: No bats seen to emerge.				
03/08/2020	20:38 to 22:23 (sunset = 20:53)	BU_364	Walkabout x 4	Air temp: 20 down to 16 (°C), no rain, cloud cover 6, wind speed 0
Comments: Roost survey results: No bats seen to emerge.				
Survey 3 – Access refused				
Photos/ diagrams: <div style="display: flex; justify-content: space-around; align-items: flex-start;">

</div>				
Roost characterisation: Soprano pipistrelle – Night/ feeding roost

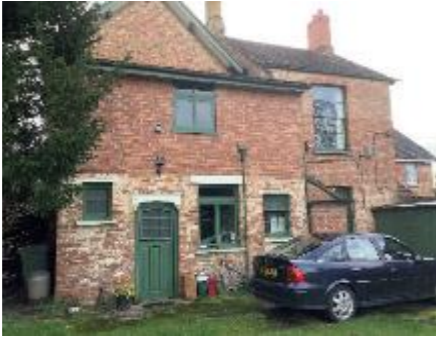
Table 4-30 – Survey Results BU_638

17/05/2021	20:34 to 22:19 (sunset = 20:49)	BU_638	EMT 2 and Samsung Tablet	Air temp: 14 down to 13 (°C), no rain, cloud cover 1, wind speed 0
Comments: Roost survey results: No roosting activity noted.				
08/07/2021	21:22 to 23:27	BU_638	SM4/ Duet x 4 and one thermal camera	Air temp: 14 down to 13 (°C), no rain, cloud cover 1, wind speed 0
Comments: Roost survey results: One common pipistrelle emerged from the northern elevation of the structure (21:58). A second common pipistrelle is likely to have emerged from the eastern side (22:16).				
12/08/2021	04:05 to 06:01 (sunrise = 05:46)	BU_638	EMT 2 x 4	Air temp: 14 down to 13 (°C), no rain, cloud cover 1, wind speed 0
Comments: Roost survey results: No bats emerged.				
23/09/2021	04:55 to 07:10 (sunrise = 06:55)	BU_735	EMT 2 x 3 and FLIR T540	Air temp: 14 down to 13 (°C), rain 0, cloud cover 2/1, wind speed 2/3
Comments: Roost survey results: A common pipistrelle bat was seen at 06:08 circling above house near chimney on BU_638, when surveying BU_735. It was assumed that it re-entered on adjacent property in between roof pitches (BU_735).

</div>				
Roost characterisation: Common pipistrelle – day roost / hibernation roost

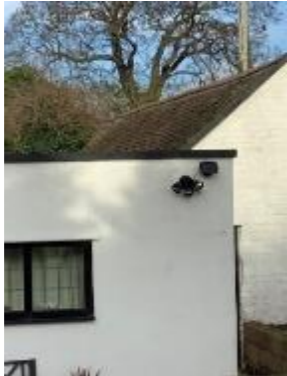
Table 4-31 – Survey Results BU_661

13/09/2021	19:12 to 21:27 (sunset = 19:27)	BU_661	EM touch 2 Pro x 2 and Canon camera	Air temp: 19 down to 17 (°C), no rain, cloud cover 8, wind speed 0
Comments: Limitations: No access to the back garden so view restricted to southern gable and very restricted view along the roof line. Roost survey results: No emergences.				
11/05/2021	20:30 to 22:32 (sunset = 20:49)	BU_735 (adjacent property)	Walkabout x 3 and EMT 2	Air temp: 12 down to 11 (°C), rain 1, cloud cover 8, wind speed 2/3
Comments: Roost survey results: A brown long eared was recorded flying near neighbours building to the west BU_661 (possible emergence, 21:34).				
16/06/2021	21:15 to 23:00 (sunset = 21:30)	BU_705 (adjacent property)	Walkabout x 4 and EMT 2	Air temp: 22 down to 24 (°C), rain 0 / 2, cloud cover 7 / 8, wind speed 1
Comments: Limitations: On and off drizzle throughout the survey – more consistent towards the end. DT's detector did not record. IR camera put away at 22:16 to avoid water damage. Roost survey results: Single pipistrelle bat seen emerging from neighbours shed (21:47), which back onto the garden – bat foraging around garden for a while until it disappeared.

Roost characterisation: Common pipistrelle – day roost; and brown long-eared – day roost

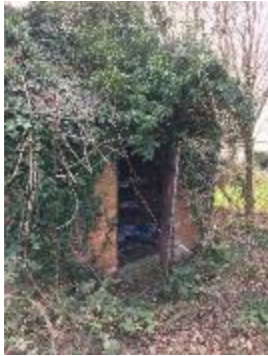
Table 4-32 – Survey Results BU_668

Date of Survey	Start and End Times and Time of Sunset	Structure Reference	Equipment Used (include make of bat detectors and logging equipment)	Weather (include start and end temps, precipitation, Beaufort wind scale etc)
09/03/2022	PBRA	BU_668	N/A	Air temp: 10 (°C), rain 2, cloud cover 7, wind speed 1
Comments: Limitations: Unable to fully inspect inside due to dirt and ivy. Visual inspection: Scattered bat droppings recorded in the structure. DNA: date collected 09/03/2022 – Lesser horseshoe				
Hibernation survey required – not completed				
10/05/2022	20:32 to 22:47 (sunset = 20:47)	BU_686	Walkabout x 4 and Canon camera and infra-red lighting	Air temp: 15 down to 12 (°C), no rain, cloud cover 8, wind speed 2 / 1
Comments: Limitations: One elevation was completely covered with ivy. All other elevations had some level of ivy obscuring the view. Roost survey results: Common pipistrelle bat was seen to emerge from the roof on the northern elevation, top left from the open door where the roof is covered in vegetation at 21:11 (24 minutes after sunset)), then fly north. A lesser horseshoe bat was seen to emerge (21:14) from the open door on the northern elevation, then flay along the building Lesser horseshoe bat emerged from the doorway and flew at a height of 1.5m along the side of the structure, following the hedgerow away, heading south.

Roost characterisation: Lesser horseshoe – day roost; and common pipistrelle – day roost

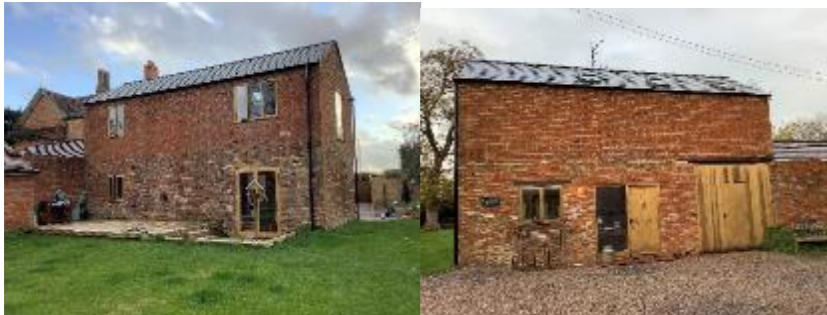
Table 4-33 – Survey Results BU_705

Comments: Limitations: Could only see three sides of the property on the re-entry survey				
Roost survey results: While surveying BU_646, a common pipistrelle entered and roosted in the south east corner of the shed BU_705 (was labelled as BU_646 incorrectly at the time).				
7/09/2021	19:28 to 21:13 (sunset = 19:43)	BU_705	EMT 2 x 2 and IR Canon XA15 and x2 140 LED lamps	Air temp: 27 down to 23 (°C), rain 0, cloud cover 1, wind speed 2
Comments:				
Roost survey results: No bat emergences.				
Survey 3 – not completed				
Photos/ diagrams:

Roost characterisation: Common pipistrelle – day roost

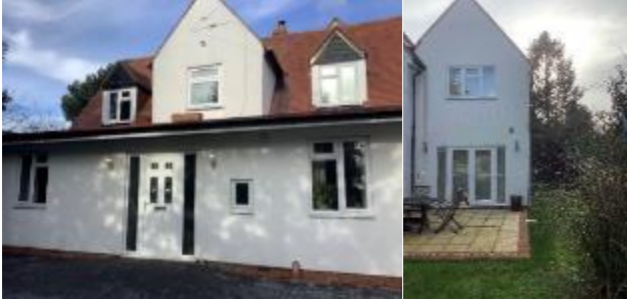
Table 4-34 – Survey Results BU_737

Comments: Roost survey results: At 20:34/35 a common pipistrelle bat was recorded emerging east, from south eastern window.				
09/09/2021	19:23 to 21:38 (sunset = 19:38)	BU_737	EMT 2, Walkabout x 2 and Batlogger M x 1 and Canon XA11 camera x 2	Air temp: 19 down to 17 (°C), rain 1/0, cloud cover 8, wind speed 1
Comments: light rain between 19:23-19:33 only, remainder of survey sunny and dry				
Roost survey results: Two emergences of common pipistrelle from the west dormer (20:00 and 20:06/07), the same location as on the 12/07/2021. They appeared from left side of dormer from behind wooden barge board (video file 55 at 03:30 minutes).				
Photos/ diagrams:

Roost characterisation: Common pipistrelle – day / transitional roost

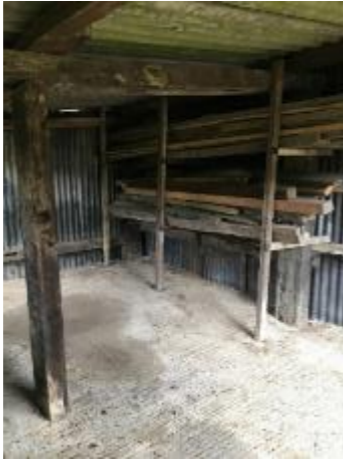
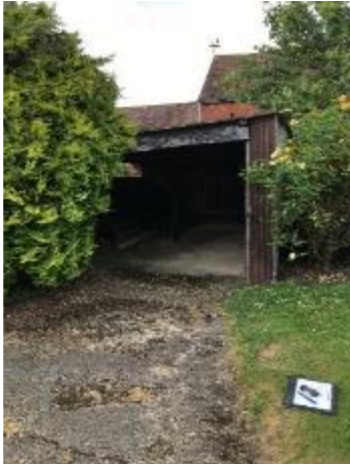
Table 4-35 – Survey Results BU_747

Date of Survey	Start and End Times and Time of Sunset	Structure Reference	Equipment Used (include make of bat detectors and logging equipment)	Weather (include start and end temps, precipitation, Beaufort wind scale etc)
18/07/2019	PBRA (external only)	BU_747	N/A	Air temp: 19 (°C), no rain, cloud cover 6, wind speed 1
Comments: Visual inspection. Shed with timber frame, flat corrugated asbestos roof and walls; one wall is partially brick; concrete floor. Approximately four small sized droppings on stored wood. No DNA analysis completed No hibernation suitability				
05/09/2019	19:32 to 21:17 (sunset = 19:47)	BU_747	EMT 2 and Walkabout	Air temp: 12.4 down to 11 (°C), no rain, cloud cover 0, wind speed 0/ 1
Comments: Roost survey results: One lesser horseshoe bat at 20:16 emerged (29 minutes after sunset). Survey 2 – access refused Survey 3 – access refused				
Photos/ diagrams: <div style="display: flex; justify-content: space-around; align-items: center;">

Roost characterisation: Lesser horseshoe – transitional / day roost

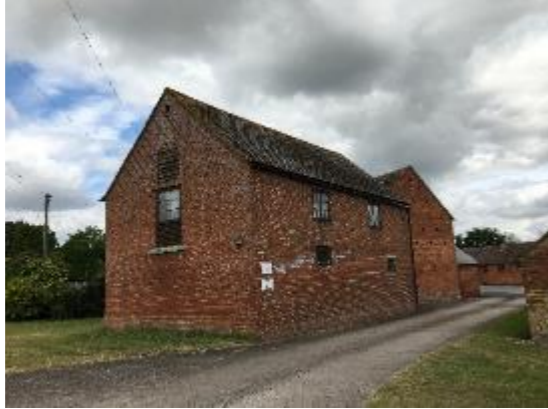
09/09/2020	19:20 to 21:05 (sunset = 19:36)	BU_751	Scout and EMT 2	Air temp: 18 down to 16 (°C), no rain, cloud cover 3, wind speed 2
Comments: Roost survey results: Likely brown long-eared bat emerged at 19:58 (22 minutes after sunset) from wooden slats on gable end. Emerged and flew west (no recorded noise).				
Survey 3 – access refused				
Photos/ diagrams: <div style="display: flex; align-items: center;">

</div>				
Roost characterisation: Common pipistrelle – day roost; and brown long-eared – day roost

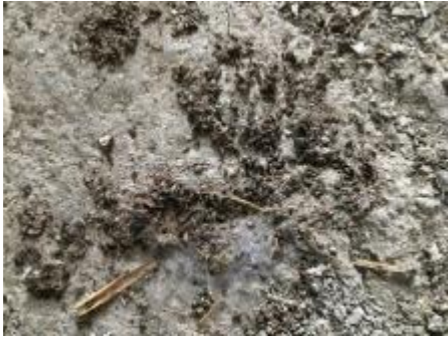
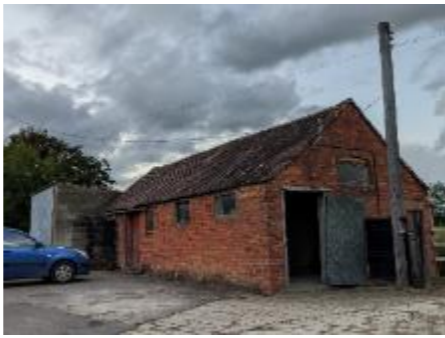
Table 4-37 – Survey Results BU_752

24/09/2020	18:48 to 20:31 (sunset = 19:03)	BU_752	Batlogger M, EMT 2, Walkabout and Scout	Air temp: 11 down to 10 (°C), no rain (0) to 3 (moderate rain) by the end of the survey, cloud cover 4 up to 7, wind speed 1
Comments: Limitations: Some rain during the survey, not considered to be a significant limitation Roost survey results: Common pipistrelle foraging and noctule passes (seen foraging on previous surveys). No emergences.				
28/05/2021	Advanced licence bat survey techniques (radio tracking)	BU_752 (assumed with significant limitations)	Radio tracking	N/A
Comments: Bat 2 was a Natterer's (female adult in breeding condition) and was only recorded to roost during the day within Butler's Court farm buildings between the M5 and Withybridge Lane. Due to the inaccuracy ⁹⁰ of radio tracking the exact location of this bat's roost(s) is unknown; however, it is assumed that on at least one occasion the bat was roosting in BU_752 (grid reference 390212.5, 224854.8) based on the triangulated radio tracking position on the 28/05/2021.

</div>				
Roost characterisation: Natterer's –maternity / day / night roost; brown long-eared – day roost; and Lesser horseshoe – day roost

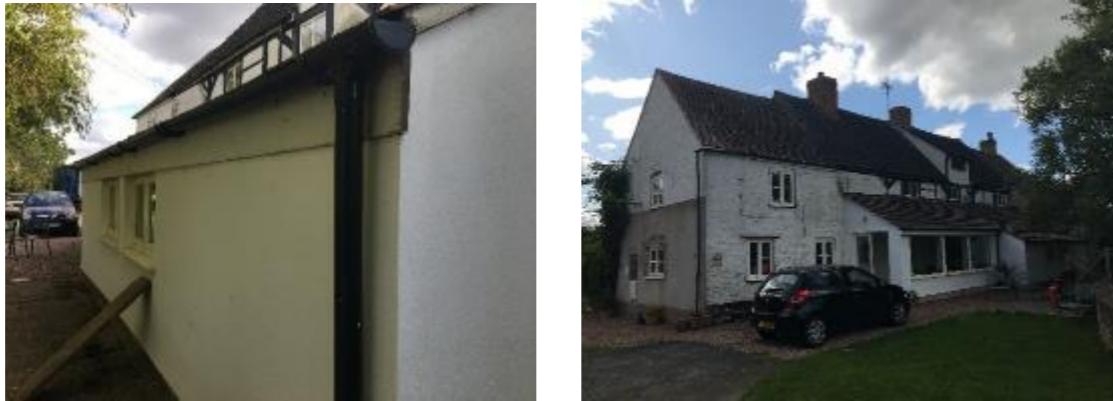
Comments: Roost survey results: At 21:25 a single soprano pipistrelle was seen by the lead surveyor to have emerged; however, the exact location was not recorded.				
Survey 3 – access refused				
Photos / diagrams:

Roost characterisation: Soprano pipistrelle – day roost

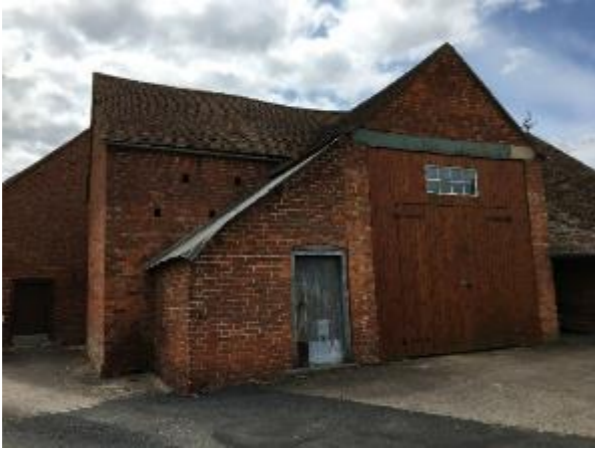
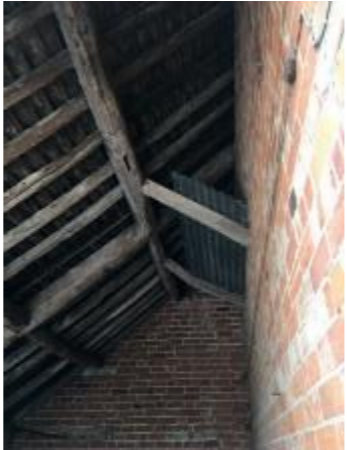
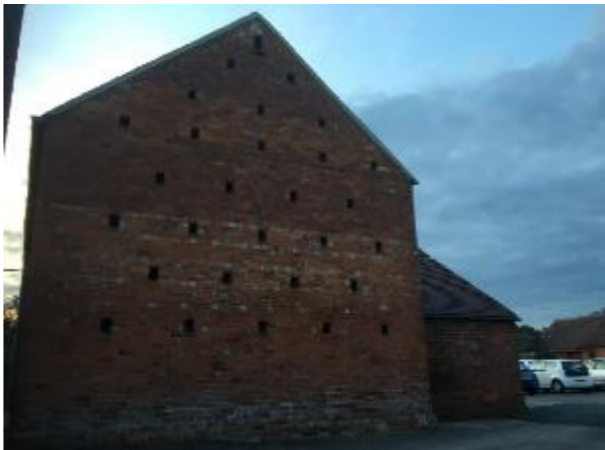
Table 4-39 – Survey Results BU_757

29/09/2020	18:35 to 20:50 (sunset = 18:50)	BU_757	EMT 2, Scout x 2 and Batlogger M2	Air temp: 14 down to 13 (°C), no rain, cloud cover 2/ 4, wind speed 1
Comments: Roost survey results: Four emergences recorded from the gaps in the brick wall. Eight re-entries also recorded into the same spaces. A couple of times the bats emerged then re-entered immediately. There was a lot of activity after it was dark as well so potentially more emergences/ re-entries as they were flying around this area of the structure continuously, but it had got too dark to be sure. There was a lot of foraging activity in front of the structure and commuting bats from south-north. Mainly common pipistrelles recorded but also a <i>Myotis</i> and noctule. One lesser horseshoe and one brown long-eared was recorded. Common pipistrelle emerged at 19:26 (36 minutes after sunset), then a bat re-entered at 19:27. Common pipistrelle entered the brickwork from south,-re-entry into gap on left side at 19:28 (38 minutes after sunset). Common pipistrelle entered third row from the top left side. Common pipistrelle emergence, flew north from right side. Common pipistrelle entered from north to top, right of structure. Common pipistrelle entered middle, 3 rd row down.

29/07/2019	20:43 to 22:33 (sunset = 21:03)	BU_751 (additional info while surveying here)	Walkabout and EMT 2	Air temp: 18.3 down to 16.5 (°C), no rain, cloud cover 4, wind speed 3
Comments: Roost survey results: While surveying BU_751 on the 29/07/2019, a possible re-entry into BU_757 close to the ridge tiles was seen.				
Survey 3 – access refused				
Photos/ diagrams: <div style="display: flex; justify-content: space-around; align-items: center;">

</div>				
Roost characterisation: Common pipistrelle –mating roost; brown long-eared – day roost; and lesser horseshoe – day roost

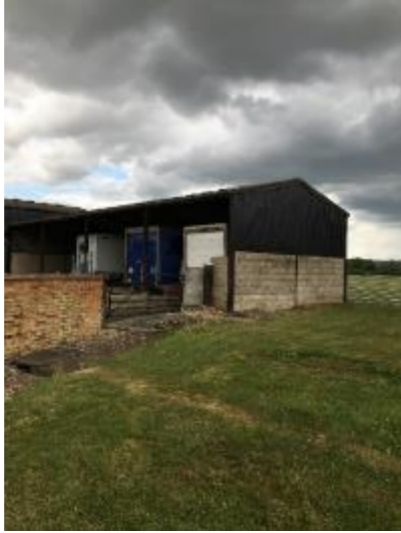
Table 4-40 – Survey Results BU_761

Date of Survey	Start and End Times and Time of Sunset	Structure Reference	Equipment Used (include make of bat detectors and logging equipment)	Weather (include start and end temps, precipitation, Beaufort wind scale etc)
18/07/2019	PBRA	BU_761	N/A	Air temp: 19 (°C), no rain, cloud cover 6, wind speed 1
Comments: Visual inspection. Open-fronted, dutch style barn with breeze block walls and corrugated asbestos sheets on roof; metal clad walls. Metal frame. Dropping found on caravan inside shed (no DNA analysis carried out).				
No Hibernation suitability				
29/09/2020	18:34 to 20:49 (sunset = 18:49)	BU_761	Walkabout x 2	Air temp: 16 down to 15 (°C), a light drizzle at 19:05, cloud cover 3/ 7, wind speed 0/ 1
Comments: Roost survey results: Social calls by common pipistrelle throughout survey. Frequent <i>Myotis</i> passes recorded. At 19:39 and 19:42 (50 and 53 minutes after sunset) <i>Myotis</i> (from call analysis assessed to be Natterer's) bats were recorded emerging from the barn. At 19:43 and subsequently at 19:46 <i>Myotis</i> bats were recorded re-entering the roost at the same location. At 20:26 and 20:35 <i>Myotis</i> (from call analysis assessed to be Natterer's) bats were recorded emerging, assumed likely to be the same as the bats that previously entered i.e. maximum count of two <i>Myotis</i> (assessed to be Natterer's). A brown long-eared bat was recorded within the barn at 20:49 (2 hours after sunset) assumed to be using the barn.

Roost characterisation: Brown long-eared bat – night/ feeding roost; and <i>Myotis</i> (assumed to be Natterer's) – transitional roost.

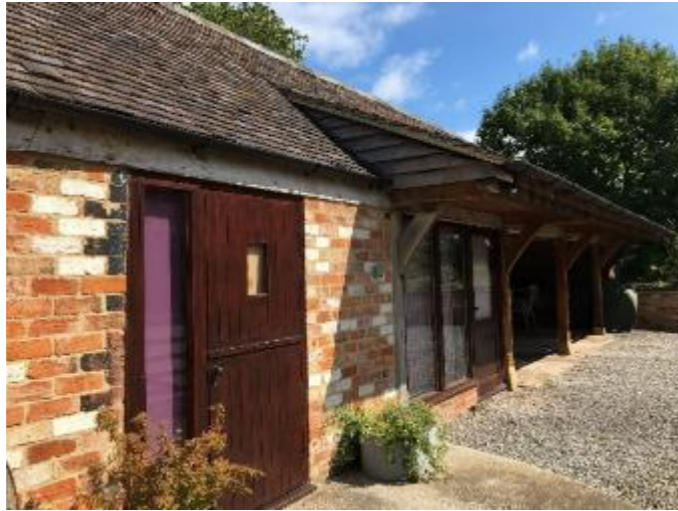
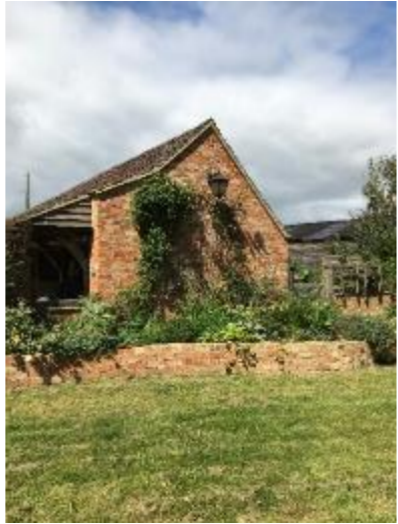
Table 4-41 – Survey Results BU_762

Access refused for hibernation survey				
06/09/2019	04:58 to 06:43 (sunrise = 06:28)	BU_762	Walkabout and EMT 2 x 3	Air temp: 13.1 up to 13.6 (°C), no rain, cloud cover 100%, wind speed 1/ 2
Comments: Roost survey results: Very little bat activity, all but one bat (soprano pipistrelle) were common pipistrelles and one brown long-eared bat, recorded foraging and commuting. A common pipistrelle was seen at 06:17 (26 minutes before sunrise) that was assumed to return to the roost in BU_771.				
17/09/2020	19:02 to 20:47 (sunset = 19:17)	BU_762	Walkabout x 4	Air temp: 21.3 down to 18.1 (°C), no rain, cloud cover 0, wind speed 1
Comments: Roost survey results: At 19:35 a common pipistrelle bat was seen to emerge from the southern elevation although the exact location was unknown. A further common pipistrelle emerged from under the apex ridge tile and headed south at 19:40 (23 minutes after sunset). Other bats included soprano pipistrelle and <i>Myotis</i> .

</div>				
Roost characterisation: Common pipistrelle – mating / transitional roost
