M5 Junction 10 Improvements Scheme

Environmental Statement Appendix 7.3 Bat Survey

TR010063 – APP 6.15

Appendix 7.3 Bat Survey – Part 1 of 2

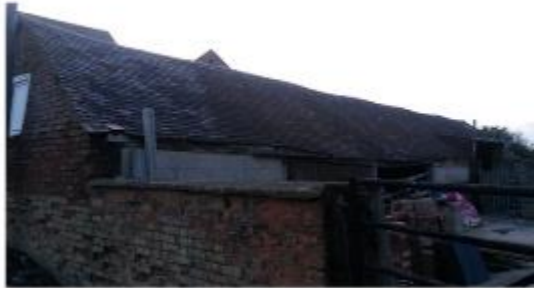
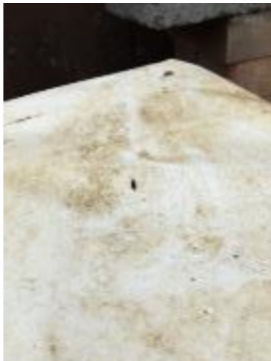
Table 4-42 – Survey Results BU_763

Comments: Roost survey results: Regular activity by <i>Myotis</i> probably Natterers bat as well as foraging activity by common and soprano pipistrelle. No emergence seen but difficult structure to see emergence once light levels dropped.				
09/09/2020	19:20 to 21:05 (sunset = 19:36)	BU_763	Annabat Scout and EMT 2	Air temp: 18 down to 16 (°C), no rain, cloud cover 2/ 3, wind speed 2
Comments: Roost survey results: A roosting pipistrelle species (no sound file to confirm species) under northern apex of the structure (labelled as BU_849 on the notes but is actually BU_763) at 19:20 (15 minutes before sunset). A further roosting pipistrelle species (no sound file to confirm species) emerged at 20:01 (25 minutes after sunset) emerged from the same location. At 20:10 (34 minutes after sunset) a common pipistrelle bat emerged from BU_763. At 20:22 and 20:25 (46 and 49 minutes after sunset) <i>Myotis</i> were seen to emerge (two in total one briefly re-entering).

29/09/2020	18:34 to 20:49 (sunset = 18:49)	BU_761 (incidental sighting)	Walkabout x 2	Air temp: 16 down to 15 (°C), no rain, cloud cover between 3 and 7, wind speed 0/1
Comments: Roost survey results: While surveyors were surveying BU_761 they saw a likely emergence from adjacent structure (BU_763), of a common pipistrelle.				
Survey 3 – access refused				
Photos / diagrams: <div style="display: flex; justify-content: space-around; align-items: center;">

</div>				
Roost characterisation: Common pipistrelle – mating / transitional roost; and <i>Myotis</i> (assumed to be Natterer's) – transitional roost

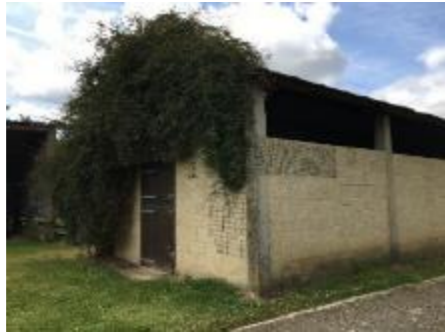
15/09/2020	19:07 to 20:52 (sunset = 19:22)	BU_765	EMT 2 and Scout	Air temp: 23/ 22 (°C), no rain, cloud cover 3/ 5, wind speed 0
Comments: Roost survey results: No bats were recorded emerging from the structure. Bats recorded during the survey included noctule, common pipistrelle, <i>Myotis</i> and soprano pipistrelle.				
Survey 3 – access refused				
Photos/ diagrams:

Roost characterisation: Unknown species (potentially brown long-eared or pipistrelle) – day roost

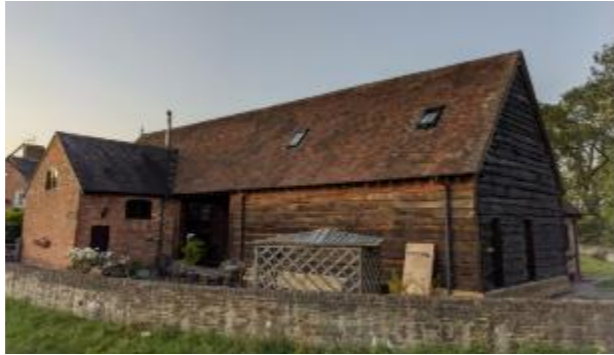
14/09/2020	19:09 to 20:55 (sunset = 19:24)	BU_771	Scout x 2 and EMT 2 x 2	Air temp: 22 (°C), no rain, wind speed 0, cloud cover 0
Comments: Roost survey results: Few noctule passes and constant common pipistrelle and some soprano pipistrelle foraging behind the barn, some social calls were also recorded. One common pipistrelle emerged from the lower, left gable end at 19:52 (28 minutes after sunset) and flew north.				
Survey 3 – access refused				
Photos/ diagrams:

Roost characterisation: Common pipistrelle – transitional roost

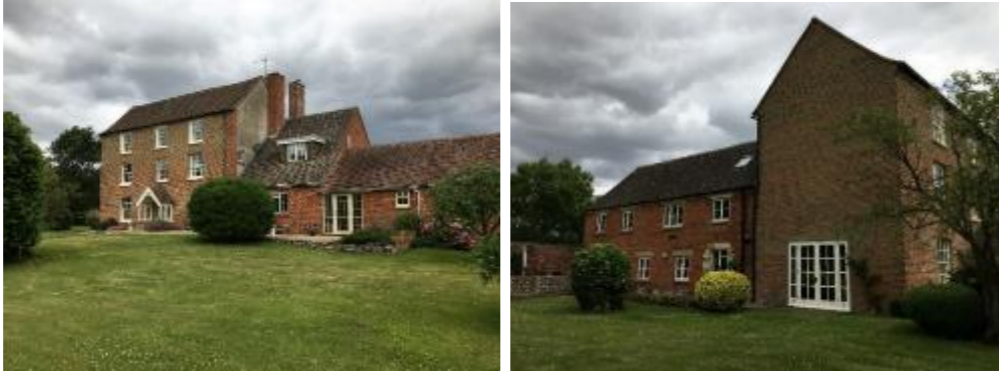
Table 4-46 – Survey Results BU_850

Date of Survey	Start and End Times and Time of Sunset	Structure Reference	Equipment Used (include make of bat detectors and logging equipment)	Weather (include start and end temps, precipitation, Beaufort wind scale etc)
18/07/2019	N/A PBRA (external only)	BU_850	N/A	Air temp: 19 (°C), no rain, cloud cover 6, wind speed 1
Comments: Visual inspection: Three storey residential structure with a series of extensions. On the northern elevation a two-storey extension with gabled roof and church style windows with stone surrounds (maybe formerly a chapel). On the eastern elevation of the main house a two-storey extension is attached with a dormer window on the southern side, attached to the east of this a single storey extension containing garages which is listed as a separate structure (BU_855). Main house is cross-gabled; three brick chimneys; plain clay tiles; stone ridge; lead flashing; dormer window covered with lead. Some new PVC windows. Timber beams on wall plate with joint holes. A brick wall is attached to the northern most extension. Stone wall (attached to house) has gaps between brickwork. No internal access.

Access refused for hibernation survey				
05/09/2019	19:32 to 21:17 (sunset = 19:47)	BU_850	EMT 2 and Walkabout	Air temp: 12.4 down to 11 (°C), no rain, cloud cover 0, wind speed 0/ 1
Comments: Roost survey results: Lots of common pipistrelle foraging and commuting with occasional <i>Myotis</i> passes. Regular bat activity throughout survey by <i>Myotis</i> (likely Natterer's), common pipistrelle and few passes from brown long-eared and soprano pipistrelle. One common pipistrelle emergence from gable end at 20:00 (13 minutes after sunset).				
Survey 2 – access refused				
Survey 3 – access refused				
Photos/ diagrams:

Roost characterisation: Common pipistrelle – day roost

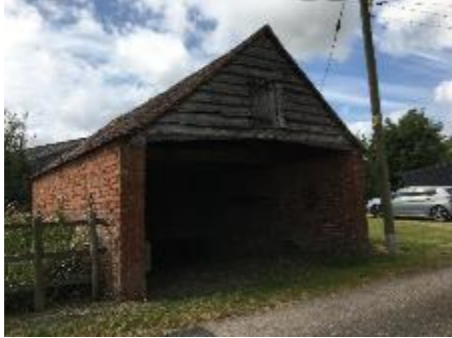
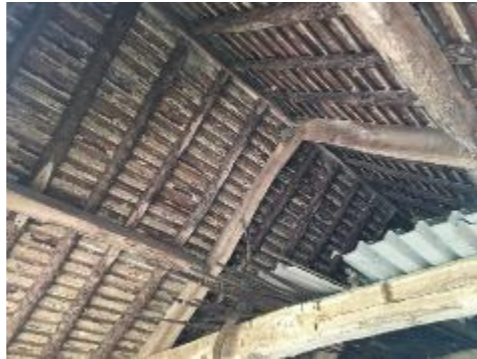
Table 4-47 – Survey Results BU_853

Comments: Roost survey results: Calls from <i>Nyctalus</i> spp, common pipistrelle soprano pipistrelle, <i>Myotis</i> and brown long-eared. At 22:33 (59 minutes after sunset) a <i>Myotis</i> (Likely to be Natterer's from sound analysis) emerged from a lifted roof tile. At 22:46 (1 hr 14 minutes after sunset) a brown long-eared bat was seen to emerge from the barn. Finally, 22:50 (1 hr 22 min after sunset) a further <i>Myotis</i> (likely to be Natterer's from sound analysis) bat was seen to emerge from the open front of the shed.				
29/07/2019	20:43 to 22:33 (sunset = 21:03)	BU_853	EMT 2 x 2	Air temp: 18 down to 16.5 (°C), no rain, cloud cover 4-6, wind speed 0-3
Comments: Roost survey results: Foraging bats recorded include common pipistrelle and noctule. No bats were recorded to emerge from the structure.				
Survey 3 – access refused				
Photos/ diagrams: <div style="display: flex; justify-content: space-around;">

Roost characterisation: <i>Myotis</i> (assumed to be Natterer's) – Day roost; and Brown long-eared – Day roost

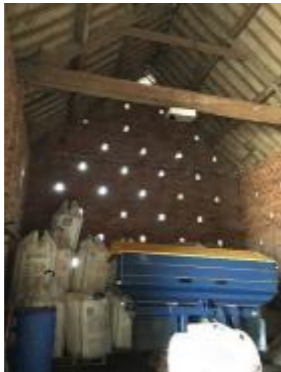
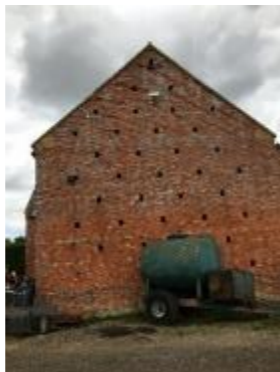
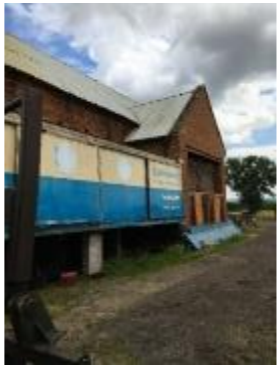
DNA: date collected 18/07/2019 – Natterer's bat, brown long-eared and common pipistrelle				
Access refused for hibernation survey				
24/06/2019	21:18 to 23:31 (sunset = 21:31)	BU_854	Walkabout x 5	Air temp: 22 to 24 (°C), no rain, cloud cover 7, wind speed 0
Comments: Roost survey results: Species heard includes: Nyctaloid, common pipistrelle, <i>Myotis</i> , brown long-eared, and soprano pipistrelle calls, later in the survey. Internal roosting locations not known. 21:45 (14 minutes after sunset) a common pipistrelle was observed emerging out of the main barn. A further bat (not recorded on the detector, although it's assumed it was a common pipistrelle) emerged from the top of the roof entrance and flew into the barn. Between 21:56 and 22:01 an assumed seven (maximum three bats were seen at one time) further common pipistrelles emerged from the structure, likely to be light sampling/ foraging under cover. Additionally, two <i>Myotis</i> (assumed to be Natterer's based on DNA dropping analysis) bats emerged at 22:13 and 22:19 from the barn.

30/07/2019	03:58 to 05:43 (sunrise = 05:28)	BU_854	EMT 2 x 3 and Walkabout	Air temp: 16.2 down to 15.6 (°C), no rain, cloud cover 0, wind speed 2
Comments: Roost survey results: Very little bat activity from <i>Myotis</i> and common pipistrelle and soprano pipistrelle and brown long-eared bats. At 04:51 (37 minutes before sunrise) a common pipistrelle was recorded likely to be re-entering the roost to the open front, east orientation of BU_854.				
26/05/2021	20:56 to 23:11 (sunset = 21:11)	BU_854	EMT 2 x4	Air temp: 15 down to 9 (°C), no rain, cloud cover 3/2, wind speed 5/2
Comments: Limitations: Security lights on the southern end of the structure cast a glare and shadows. The sound of the river flowing overwhelmed any possibility of audibly detecting bats by ear unless they were very close.				
Roost survey results: Relatively quiet survey. No signs of emerging bats, despite noting some feeding debris (butterfly wings) inside the barn on the northern internal wall. IR camera was facing the northern aspect on this survey. Only a couple of pips were in the space around the farmyard and structure, generally foraging back and forth towards the end of the survey.

</div>				
Roost characterisation: Common pipistrelle – maternity roost; Natterer's – day roost; and Brown long-eared – day roost

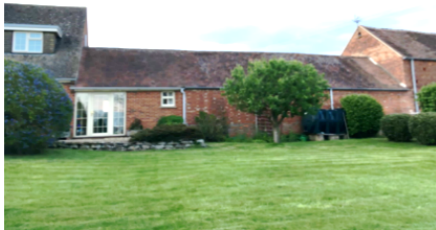
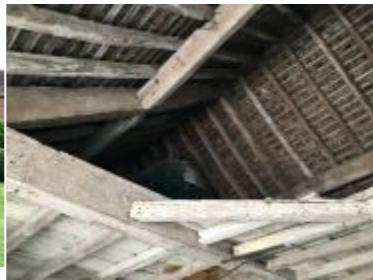
Access refused for hibernation survey				
05/09/2019	19:32 to 21:17 (sunset = 19:47)	BU_855	EMT 2 and Walkabout	Air temp: 12.4 down to 11 (°C), no rain, cloud cover 0, wind speed 0/ 1
Comments: Roost survey results: Lots of common pipistrelle foraging and commuting with occasional <i>Myotis</i> passes. Regular bat activity throughout survey by <i>Myotis</i> (likely Natterer's) , common pipistrelle and few passes from brown long-eared and soprano pipistrelle. No emergences from this structure.				
27/05/2021	21:00 to 23:15 (sunset = 21:15)	BU_855	Batlogger M2 and EMT 2 x 3	Air temp: 18 down to 11 (°C), no rain, cloud cover 5-10, wind speed 2/ 1
Comments: Roost survey results: Mostly common pipistrelles with occasional soprano pipistrelle were observed, brown long eared also seen commuting and foraging around the structure, as well as <i>Myotis</i> bat calls. At 21:19 and 21:37 (4 and 22 minutes after sunset) common pipistrelle bats were seen to emerge, dropping out of the garage and flying north east and another flying east over the house.

</div>				
Roost characterisation: Common pipistrelle – day roost

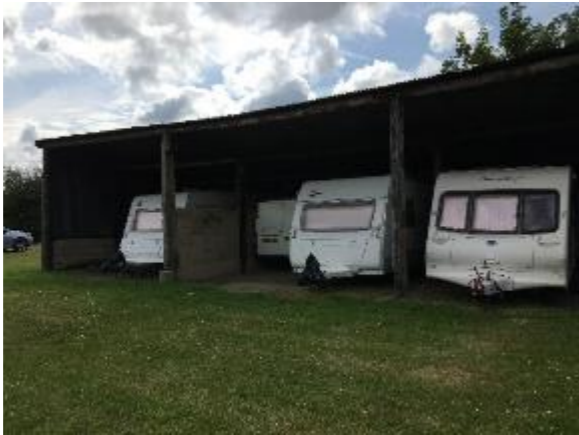
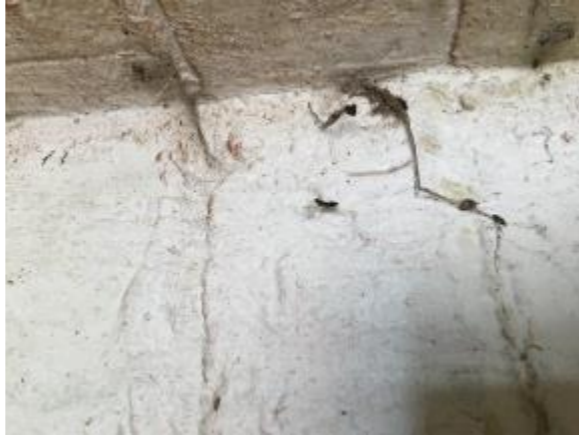
Table 4-50 – Survey Results BU_857

15/09/2020	19:07 to 20:52 (sunset = 19:22)	BU_857	Batlogger & Scout	Air temp: 23 down to 22 (°C), no rain, cloud cover 3/ 5, wind speed 0
Comments: Roost survey results: No emergences recorded. Bat recording included noctule, common and soprano pipistrelle and brief passes from lesser horseshoe, <i>Myotis</i> and brown long-eared.				
Survey 3 – access refused				
Photos/ diagrams: <div style="display: flex; justify-content: space-around; align-items: flex-start;">

</div>				
Roost characterisation: Common pipistrelle – Night / feeding roost; Natterer’s – Night / feeding roost; and Whiskered – Night / feeding roost

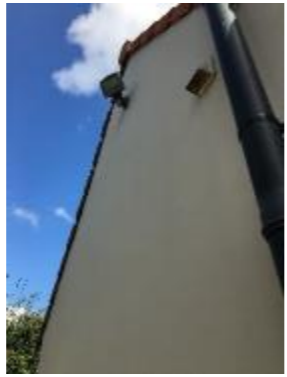
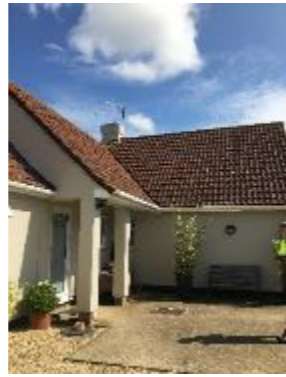
Table 4-51 – Survey Results BU_862

Date of Survey	Start and End Times and Time of Sunset	Structure Reference	Equipment Used (include make of bat detectors and logging equipment)	Weather (include start and end temps, precipitation, Beaufort wind scale etc)
21/08/2019	N/A PBRA (external only)	BU_862	N/A	Air temp: 18 (°C), no rain, cloud cover 4, wind speed 0
Comments: Visual inspection Residential structure (incl. barn conversions) A few gaps in roof tiles, but fairly tight. Soffit box has one small gap, no droppings.				
02/03/2021 – 25/03/2021	Hibernation static deployment	BU_862	Swift and EasyLog USB – Lascar temperature and humidity data logger	Between -0.5 and 27 (°C)
Comments: Deployed internally by landowner Hibernation results: No bat activity was recorded				
20/07/2020	20:59 to 22:44 (sunset = 21:14)	BU_862	Walkabout x 4	Air temp: 19 down to 17 (°C), no rain, cloud cover 1/ 7, wind speed 1
Comments: Roost survey results: At 21:32 two bats (not echolocating) emerged from under the ridge. One further bat emerged from this location and heading north at 22:06 (52 minutes after sunset), determined to be a common pipistrelle bat. On this basis all three bats have been presumed to be common pipistrelle. At 21:57 (43 minutes after sunset) a re-entry and possible emergence of another common pipistrelle coming from a different gable wall was detected. At 21:45 and 21:54 (29 and 38 minutes after sunset) two common pipistrelle bats in total emerged from a ridge tile at gable end.

21/09/2020	18:53 to 20:38 (sunset = 19:08)	BU_862	Scout, Walkabout, Batlogger M2 and EMT 2	Air temp: 22 down to 19 (°C), no rain, cloud cover 1/ 3, wind speed 1
Comments: Roost survey results: Regular bat calls from common pipistrelle with occasional noctule and <i>Myotis</i> . No bats emerged.				
03/08/2021	20:26 to 22:56 (sunset = 20:56)	BU_862	SM4/ Duet	Air temp: 18 down to 16 (°C), light drizzle then dry, cloud cover 8/ 6, wind speed 0
Comments: Roost survey results: Limited activity, occasional foraging. No emergences.				
Photos/ diagrams: <div style="display: flex; justify-content: space-around; align-items: center;">

</div>				
Roost characterisation: Common pipistrelle – day roost

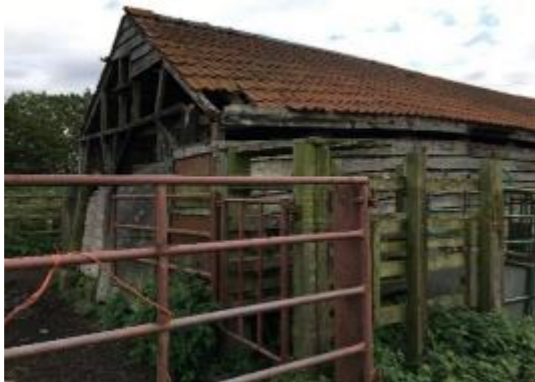
Table 4-52 – Survey Results BU_990

13/08/2019	04:20 to 06:05 (sunrise = 05:50)	BU_990	EMT 2 x 2	Air temp: 11.1 down to 8.8 (°C), no rain, cloud cover 0, wind speed 0
Comments: Roost survey results: Very little bat activity from common pipistrelle's and noctules and one <i>Myotis</i> . One common pipistrelle bat re-entered BU_992, not this structure.				
29/07/2020	20:47 to 22:32 (sunrise = 21:02)	BU_990	Walkabout x 2	No data
Comments: Roost survey results: One common pipistrelle bat was seen to emerge at 21:19 from the northern gable that is vegetated with elder or the south easter elevation (the exact location was unknown). Other bats recorded regularly during the survey were <i>Myotis</i> , common pipistrelle and noctule.				
Photos/ diagrams:

Roost characterisation: Common pipistrelle – day roost

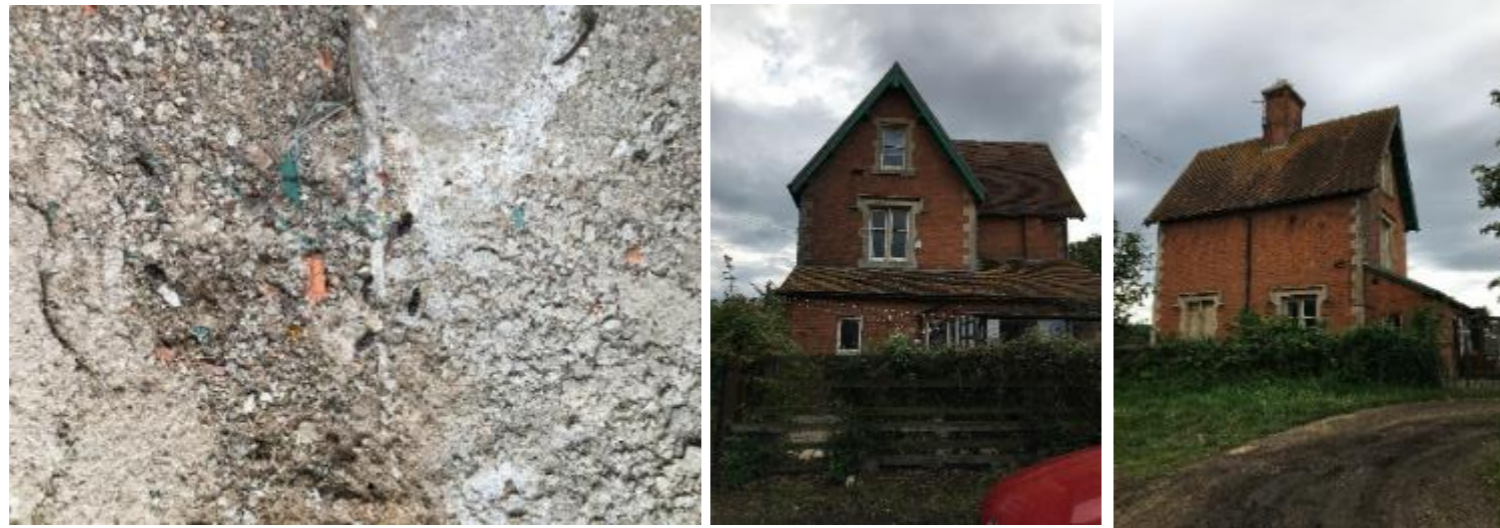
Table 4-53 – Survey Results BU_992

14/07/2020	21:04 to 22:51 (sunset = 21:21)	BU_992	Walkabout x 4	Air temp: 17 down to 16 (°C), no rain, cloud cover 8, wind speed 1
Comments: Roost survey results: At 21:34 (21:13 minutes after sunset) a common pipistrelle bat exited from the gable wall. At 21:35 (14 minutes after sunset) a common pipistrelle bat was seen foraging and then re-entering the same location. At 21:42 (21 minutes after sunset) a common pipistrelle bat was seen to exit from the same location. Bats recorded during the survey include serotine, noctule, <i>Myotis</i> , common and soprano pipistrelle and Leisler's. A total of 2 x common pipistrelle bats emerged.

Roost characterisation: Common pipistrelle – day roost; and Whiskered – transitional roost

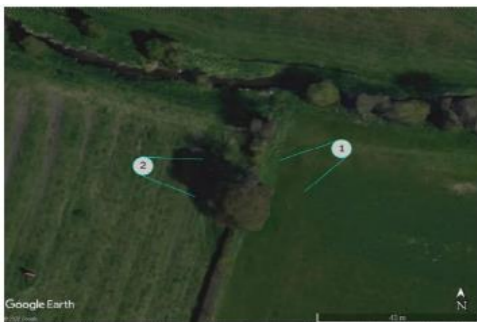
19/08/2020	18:43 to 20:50 (sunset 18:58)	86	2 x bat detectors and IR camera	Weather: temp 15, wind 3, rain 0 and cloud cover 7
Comments: Roost survey results: No emergence observed				
02/09/2020	19:30 to 21:23 (sunset 19:52)	86	2 x bat detectors and IR camera	Weather: temp 17, wind 2, rain 0 and cloud cover 3
Comments: Roost survey results: No emergence observed ALBST recorded a Natterer's male likely roosting in this tree on the 30/05/2021 for one night				
Photos:

Roost characterisation: Natterer's – day roost (assumed, with limitations)

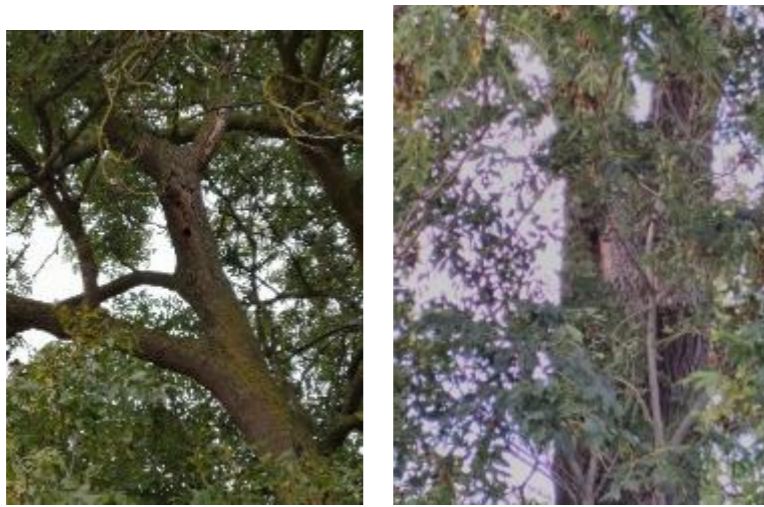
Table 4-55 – Survey Results Tree 576

19/08/2020	Aerial tree climbing	576	Endoscope	Air temp: 16°C, wind 3, cloud cover 8, rain 4
Comments:				
Roost survey results: The woodpecker hole facing south has snapped out leaving only the south east facing feature. The south east facing feature had a single noctule bat present with droppings observed at the base.				
01/09/2020	Aerial tree climbing	576	Endoscope	Air temp: 14°C, wind 1, cloud cover 0 and rain 0
Comments:				
Roost survey results: The south-east facing feature had a single noctule bat present.				
Photos:

Roost characterisation: Noctule day roost

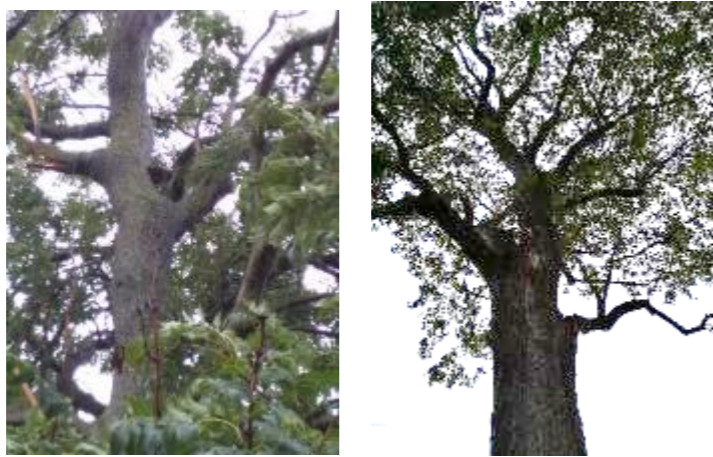
Table 4-56 – Survey Results Tree 578

28/07/2020	Aerial tree climbing	578	Endoscope	Air temp: 19°C, wind 2, cloud cover 2, rain 0.
Comments: Roost survey results: Two woodpecker holes were inspected, one north facing approximately 10m high extending upward 8cm, back and down approximately 40 cm and was found to be dry and dusty. A second woodpecker hole 8m and south facing was found to have numerous feathers and nesting materials present, extending downwards by 40 cm.				
19/08/2020	Aerial tree climbing	578	Endoscope	Air temp: 16°C, wind 3, cloud cover 8, rain 4
Comments: Roost survey results: The woodpecker hole facing north at 10m high at the base of a dead limb was found to have a single noctule bat present.				
01/09/2020	Aerial tree climbing	578	Endoscope	Air temp: 14°C, wind 1, cloud cover 0 and rain 0
Comments: Roost survey results: The woodpecker hole facing north at 10m high at the base of a dead limb was found to have a small number (assumed three) noctules present.

Roost characterisation: Noctule – day roost

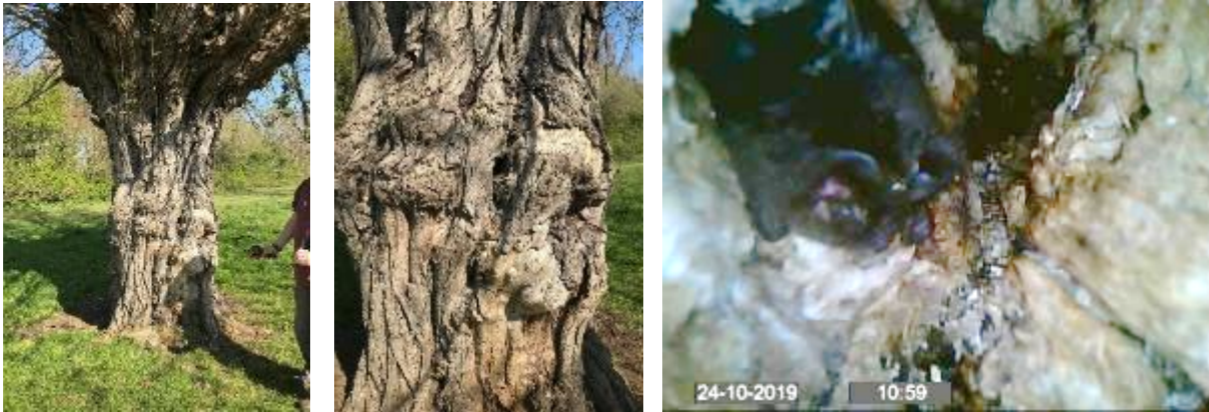
Table 4-57 – Survey Results Tree 496

24/07/2020	Ground and aerial assessment	496	Endoscope	Air temp. 4 °C, wind 2, cloud 7, rain 1
Comments: Roost survey results: The south west facing lifting bark extends upwards approximately 15 cm and was very dusty with cobwebs. The south east facing wound was heavily cobwebbed and dust inside.				
19/08/2020	Ground and aerial assessment	496	Endoscope	Air temp. 16 °C, wind 3, cloud 8, rain 4
Comments: Roost survey results: The south west facing lifting bark extends upwards approximately 15 cm and was very dust with cobwebs. The south east facing wound was heavily cobwebbed and dust inside.				
01/09/2020	Ground and aerial assessment	496	Endoscope	Not provided
Comments: Roost survey results: The south west facing lifting bark extends upwards approximately 15 cm and was very dust with cobwebs. The south east facing wound was heavily cobwebbed and dust inside. A further lifting bark feature was inspected east facing which was dry smooth and partially dusty.

</div>				
Photos: Roost characterisation: Barbastelle – transitional roost

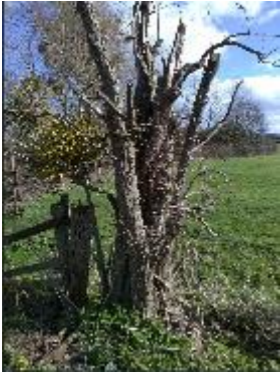
Date of Survey	Start and End Times and Time of Sunset	Tree Reference	Equipment Used (include make of bat detectors and logging equipment)	Weather (include start and end temps, precipitation, Beaufort wind scale etc)
05/06/2019	GLTA	Tree 101	Torch and endoscope	Air temp. 11°C, wind 4, cloud 7, rain 1
Comments: Visual inspection: Hawthorn, tree is 3m tall with a 28cm diameter at breast height. Hawthorn is mostly dead, several splits, loose bark, small cavities. All very superficial, limited shelter & exposed.				
02/03/2020	Hibernation tree climb	Tree 101	Torch and endoscope	Weather: temp 6, wind 2, rain 0 and cloud cover 1 Cold and sunny with light breeze
Comments: Results: No bats observed				
30/05/2021	Advanced licence bat survey techniques (radio tracking)	Tree 101 (assumed with significant limitations)	Radio tracking	N/A
Comments: Natterer's bat tagged and radio tracked over a seven night period. On the 3 rd night (30/05/2021) the male Natterer's bat was recorded to be roosting for the day (day roost) at the grid reference SO 90898 24548. Due to the inaccuracy ⁹⁵ of radio tracking the exact location of this bat roost is unknown. As Tree 101 is a tree located within 20 m of this grid reference, as a precautionary basis it is assumed that Tree 101 is a Natterer's day roost.

<p>Photo:</p>				
Roost characterisation: Natterer's – day roost

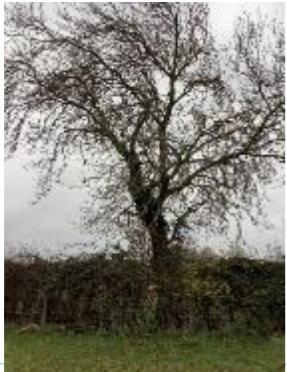
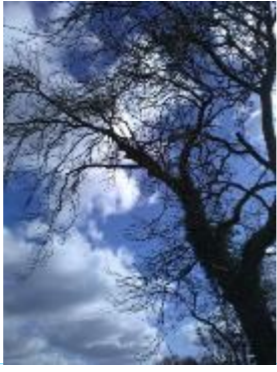
Comments: Roost survey results: A single woodpecker hole west facing at 7 m was identified and inspected. One feeding hole and two holes were present within the branch connecting into a larger cavity assessed to be too exposed to be suitable to roosting bats.				
05/05/2022	Roost tree climb survey	627	Endoscope	Air temp: 19 °C, wind 1, cloud cover 2, rain 0
Comments: Limitations: Unable to fully inspect recommend activity surveys for this tree going forwards. Roost survey results: No bats observed				
Roost Survey 2 – not completed (needs to be an emergence survey)				
Roost Survey 3 – not completed (needs to be an emergence survey)				
Photos: <div style="display: flex; justify-content: space-around; align-items: center;">

</div>				
Roost characterisation: Noctule – day roost

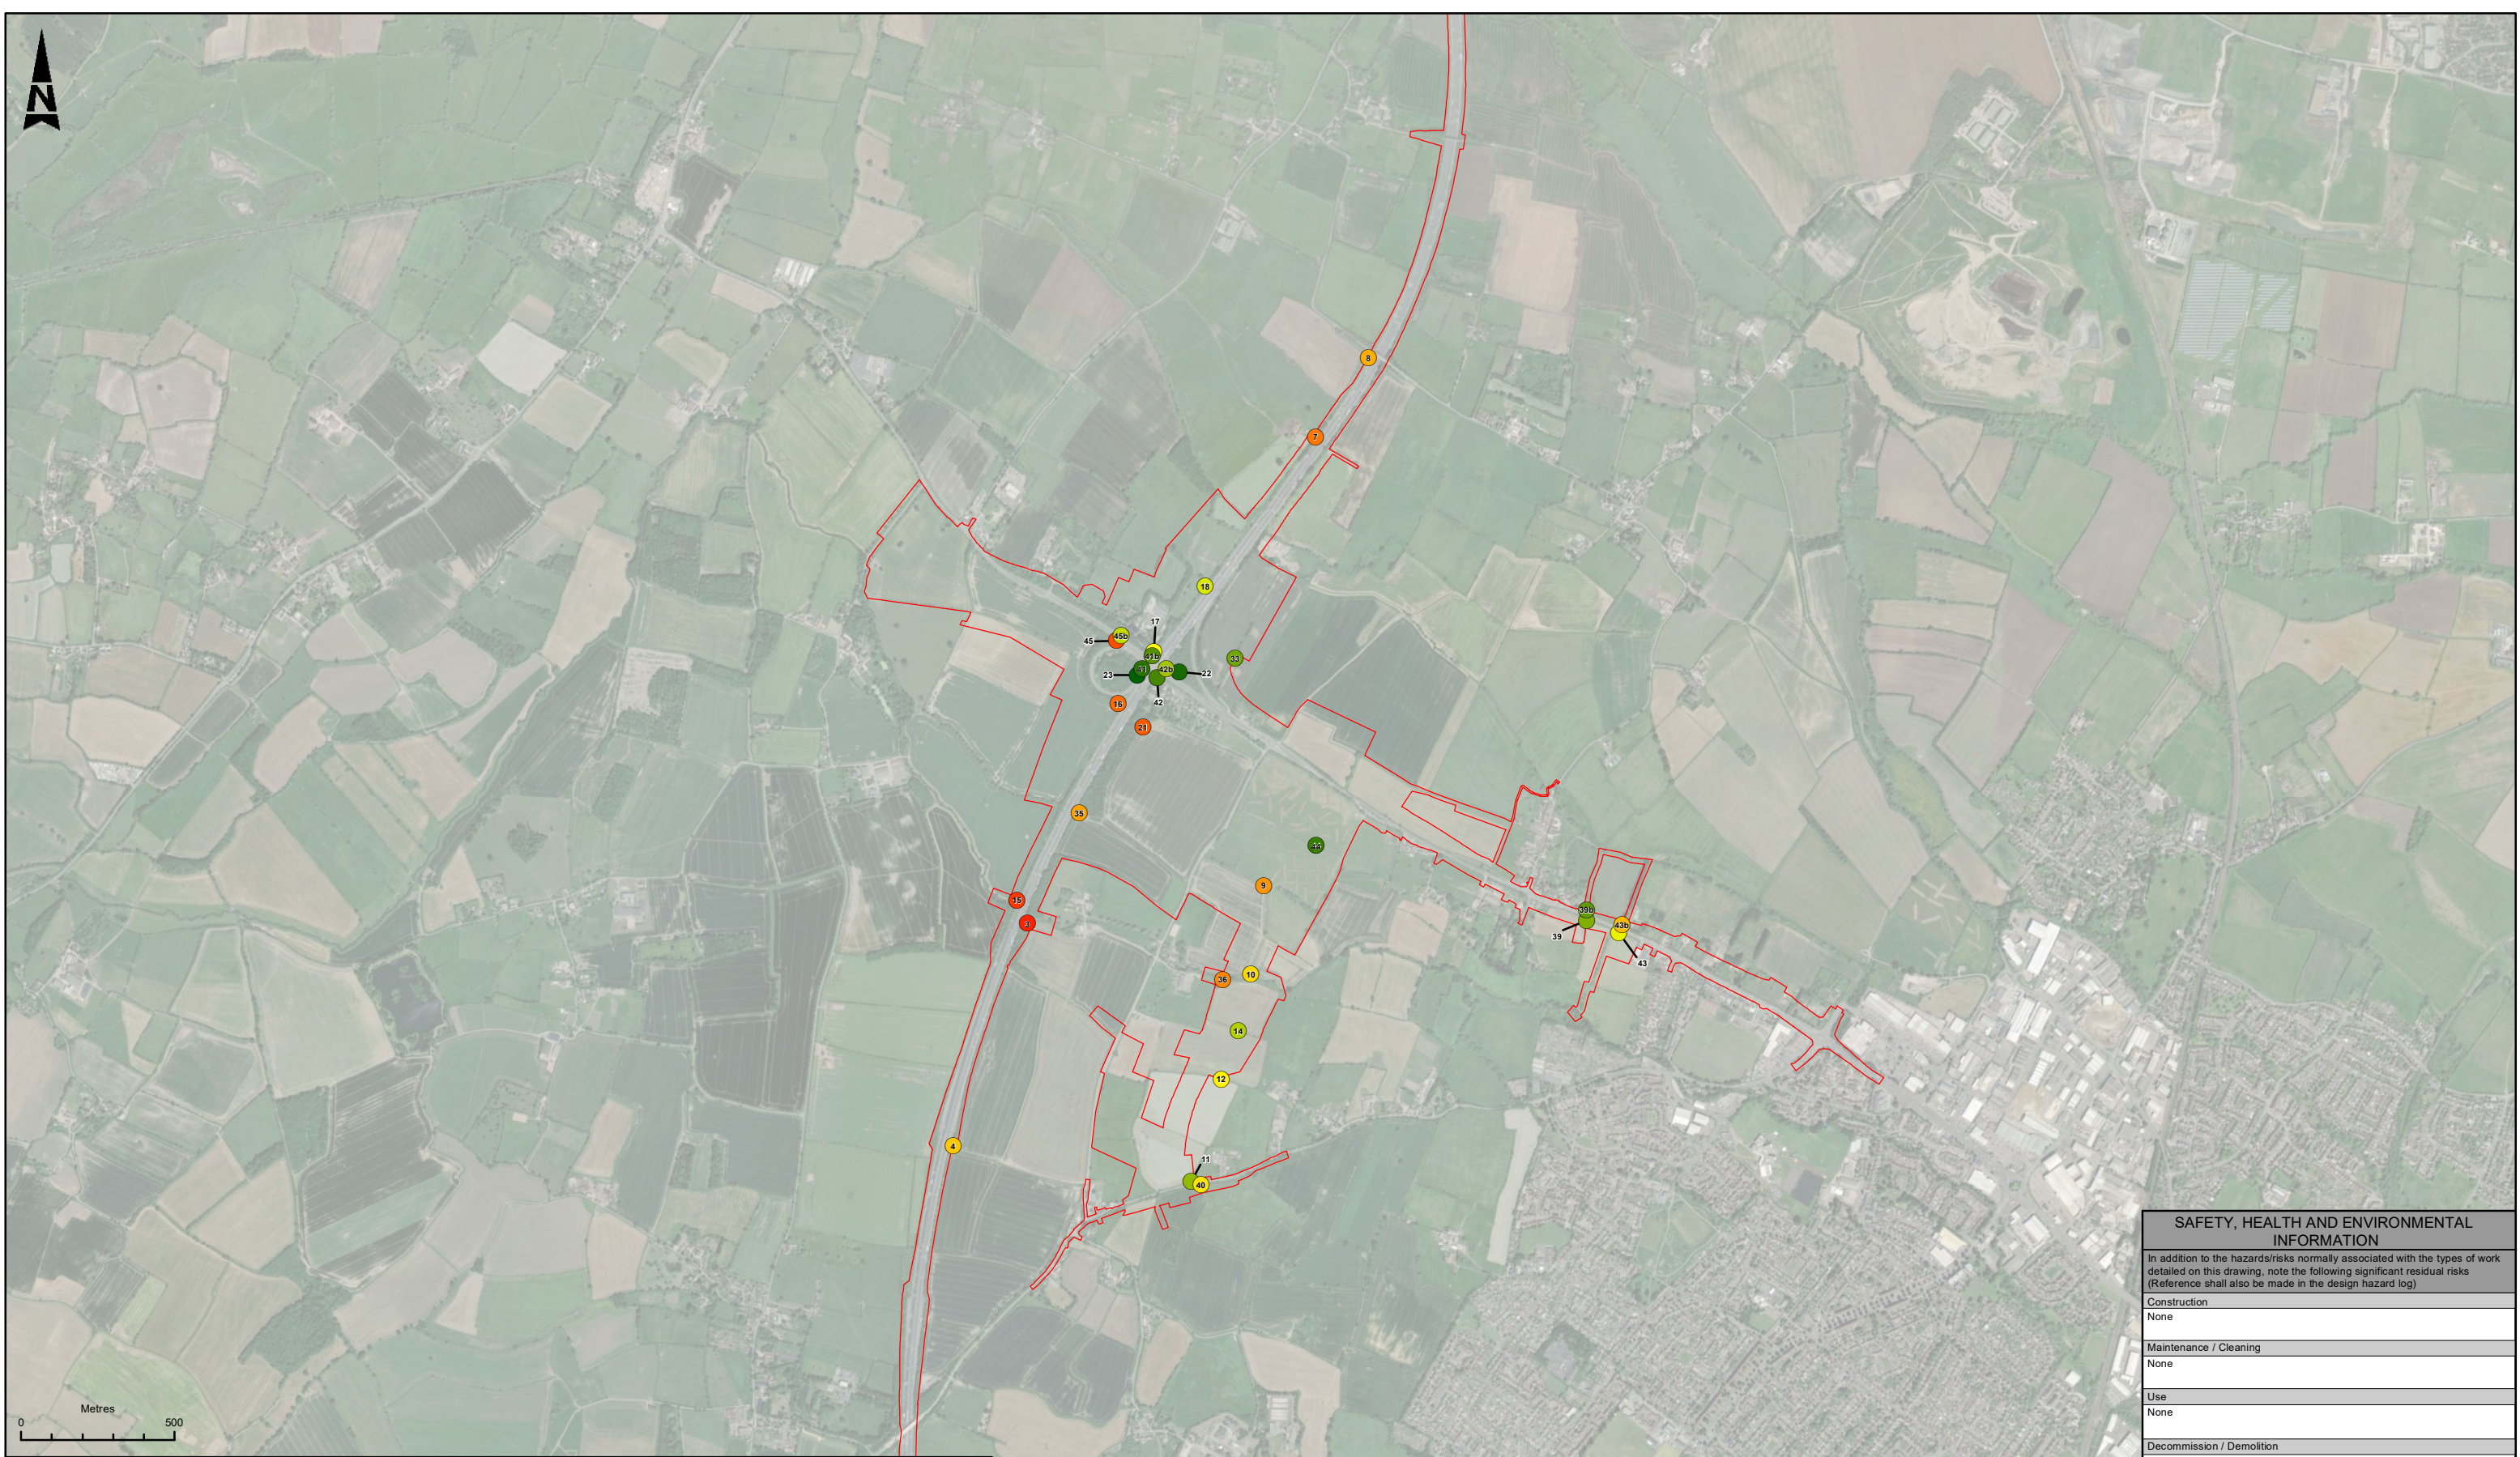
LOCATION OF BAT SPECIES POINTS IS INDICATIVE
