# M5 Junction 10 Improvements Scheme

## Environmental Statement Appendix 7.12 Aquatic ecology survey TR010063 – APP 6.15

#### 6.15 Environmental Statement:

#### Appendix 7.12 Aquatic ecology survey

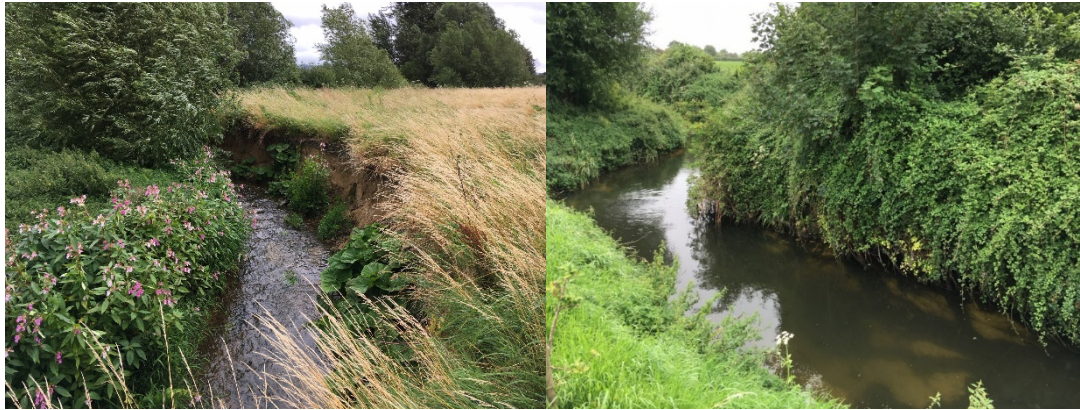
Photo 1: River Chelt upstream of M5 crossing (SO 90816 24584) (left)  
Photo 2: River Chelt downstream of M5 crossing (SO 89914 24887) (right)

The River Condition Assessment determined that this reach surveyed on the River Chelt has a River Condition Score of 0.6, which equates to a river Condition Class of 'Moderate'. The overall condition score is driven by lack of features present that would increase values for positive indicator scores across the bank-top, bank-face and within the channel. There does not appear to be an indicator value that is driving the overall condition score, however, particularly positive values were recorded for 'C3 – Bank Face Natural Bank Profile Extent' (3), 'C4 – Bank Face Natural Bank Profile Richness' (3) and 'D4 – Channel Margin Physical Feature Extent' (3). The most negative indicator values were recorded for 'B4 – Bank Top NNIPS Cover' (-3) and 'B5 – Bank Top Managed Ground Cover' (-3).

The River Condition Assessment determined that this reach on the River Chelt has a River Condition Score of -0.54, which equates to a River Condition Class of 'Fairly Poor'. The overall condition score is driven by lack of features present that would increase values for positive indicator scores across the bank-top, bank-face and within the channel. There does not appear to be an indicator value that is driving the overall condition score, however, particularly positive values were recorded for 'E4 – Channel bed Natural Features Extent' (3) only. The most negative indicator values were recorded for 'B5 – Bank Top Managed Ground Cover' (-4), 'C7 – Bank Face Artificial Bank Profile Extent' (-4), 'C9 – Bank Face Reinforcement Material Severity' (-4) and 'E10 – Channel Bed Artificial Features Severity' (-4).

The River Condition Assessment determined that this reach on the River Chelt has a River Condition Score of -0.28, which equates to a River Condition Class of 'Fairly Poor'. The overall condition score is driven by lack of features present that would increase values for positive indicator scores across the bank-top, bank-face and within the channel. There does not appear to be an indicator value that is driving the overall condition score, however, particularly positive values were recorded for 'D3 – Channel Margin Physical Feature Extent' (3) and 'E3 – Channel Bed Hydraulic Features Richness' (3). The most negative indicator values were recorded for 'B4 – Bank Top NNIPS Cover' (-3) and 'B5 – Bank Top Managed Ground Cover' (-3) and 'D5 – Channel Margin Artificial Features' (-3).

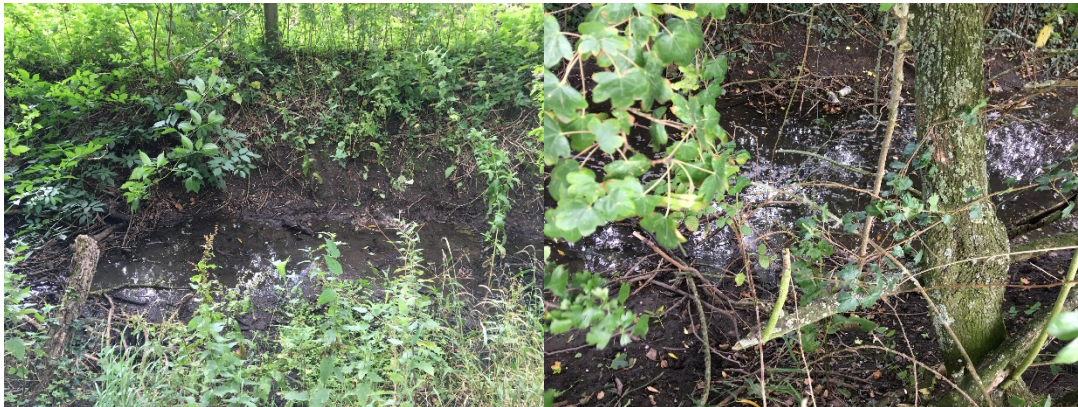
Photo 3 and Photo 4: Downstream of the M5 (SO 90579 26345 and SO 90650 26140)

The River Condition Assessment determined that the reach surveyed on the Leigh Brook has an Overall Condition Score of 0.43, which equates to a River Condition Class of 'Fairly Poor'. There does not appear to be an indicator value that is driven the overall condition score, however, particularly positive values were recorded for 'C3 – Bank Face Natural Bank Profile Extent' (2), 'C4 – Bank Face Natural Bank Profile Richness' (2) and 'E6 – Channel Bed Material Richness' (2). The most negative recorded is 'B5 – Bank Top Managed Ground Cover' (-2).

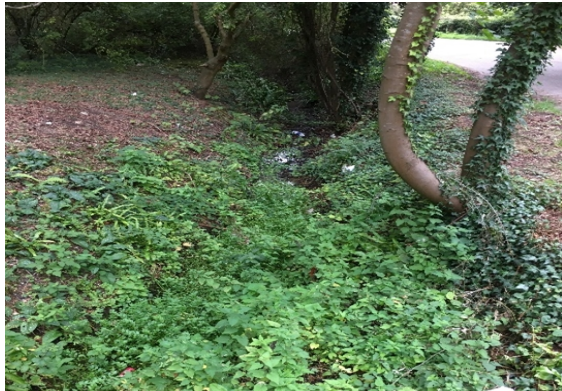
Photo 5: Drain 8 (SO 90279 25796)

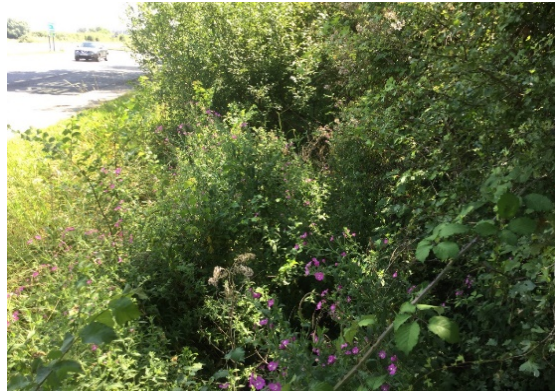
Photo 6: Drain 10 (SO 90773 25383)

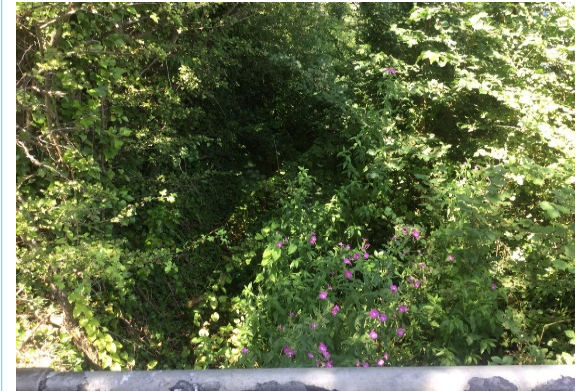
Photo 7: Drain 10 (SO 90773 25383)

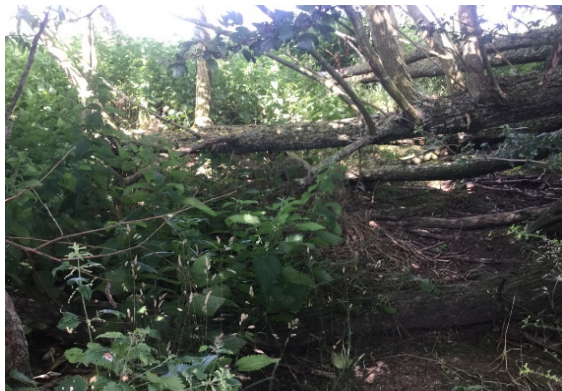
Photo 8: Drain 12 (SO 90817 24898)

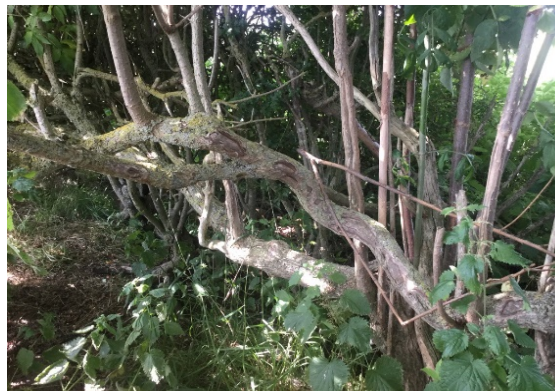
Photo 9: Drain 12 (SO 90817 24898)

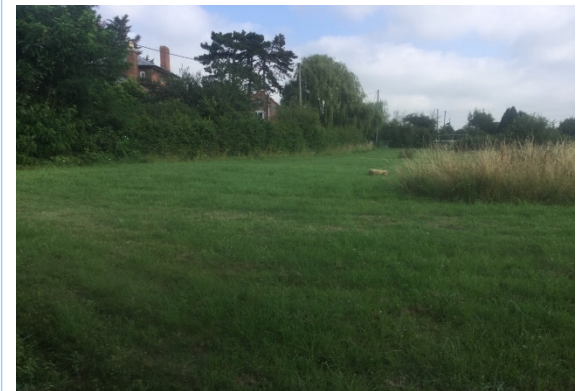
Photo 10: view looking north towards Drain 14 and the B4634 (SO 90284 23728)

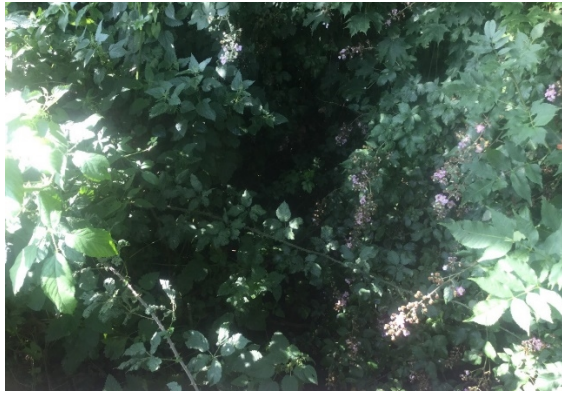
Photo 9: Drain 15 (SO 90407 23646)

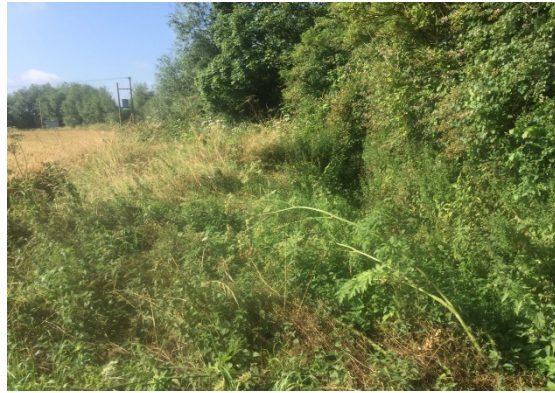
Photo 10: Drain 15 along field boundary  
(SO 90416 23664)

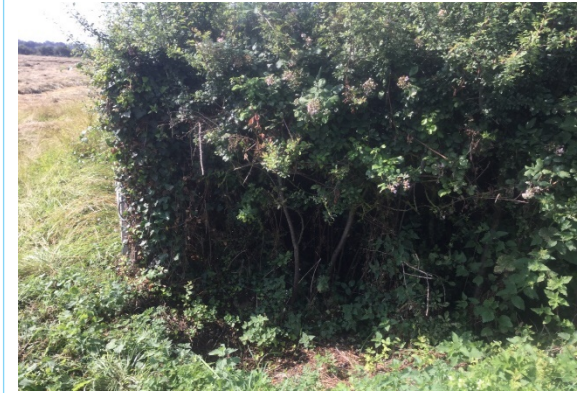
Photo 11: Drain 16 at confluence with Drain 20.  
Drain 16 is culverted under a farm access track at  
this location, but runs parallel to the Old Gloucester  
Road B4634 acting as road drainage  
(SO 90620 23925)

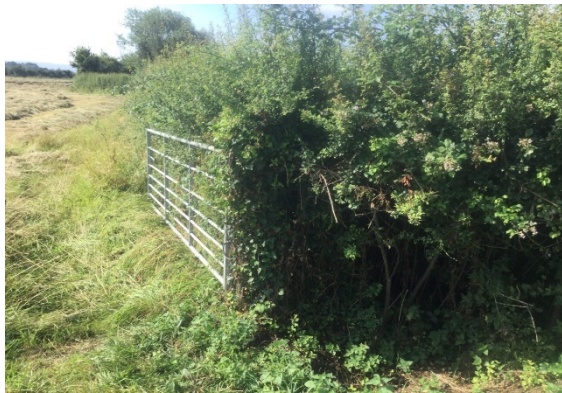
Photo 12: Looking south towards Drain 20 from the  
Old Gloucester Road B4634 and Drian 16  
(SO 90620 23925)

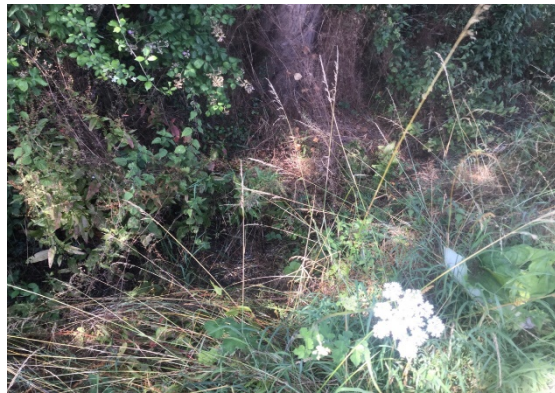
Photo 13: MW3 looking cross stream  
(SO 89964 25217)

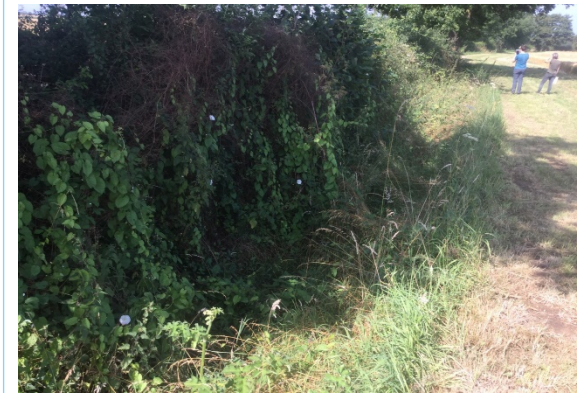
Photo 14: MW3 looking downstream  
(SO 90089 25184)
