M5 Junction 10 Improvements Scheme

Environmental Statement Appendix 7.3 Bat Survey - Part 1 of 2 TR010063 – APP 6.15

March 2024

Appendix 7.3 Bat Survey - Part 1 of 2

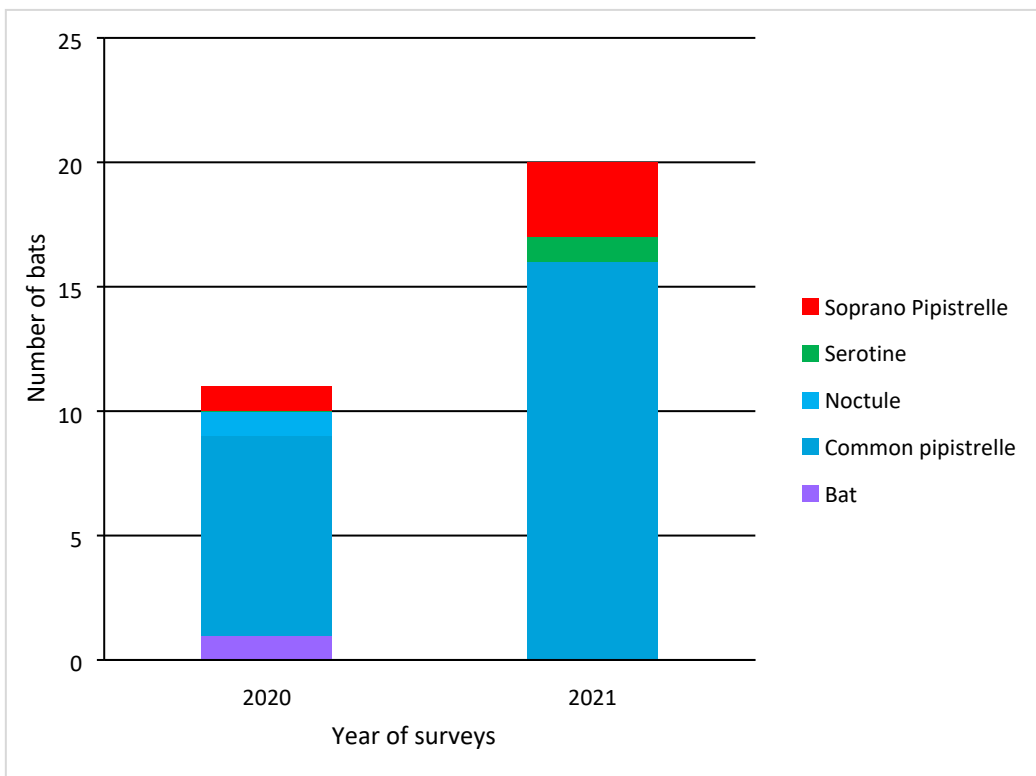
Figure 3-12 – Graph comparing 2020 to 2021 data for CP3

- 3.4.20 More bats were recorded crossing Feature B in 2021 (20 bat passes), with only 11 bat passes recorded in 2020, an increase of 80% in 2021. In 2020, the bats crossing Feature B included noctule; however, this species was not recorded in 2021. A single serotine was recorded on Survey 5 in 2021; however, this species was not recorded in 2020 (see Figure 3-12).
- 3.4.21 Based on the significant limitations with this survey location (see Appendix D), it is possible that this crossing point is used more frequently by bats than the data suggest. Therefore, on a precautionary basis, this location is considered to be a confirmed crossing point.

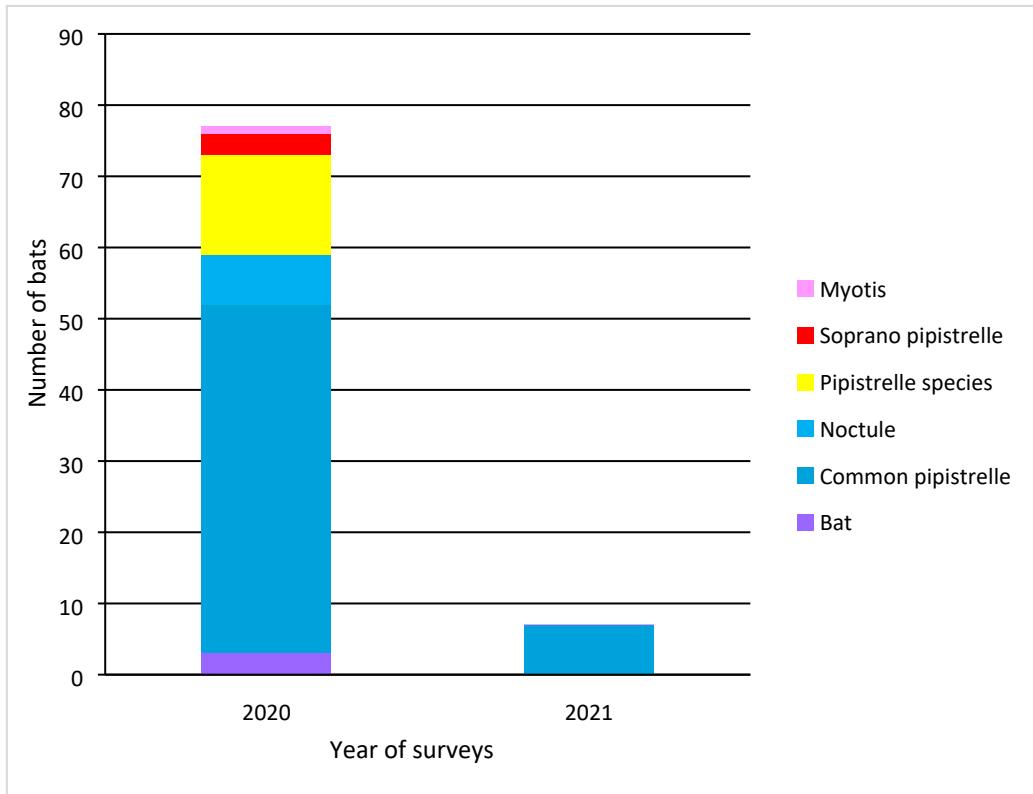
Figure 3-15 – Graph comparing 2020 to 2021 data for CP4

3.4.30 Of those bats that crossed at a safe height in 2021 99% were common pipistrelle passes.

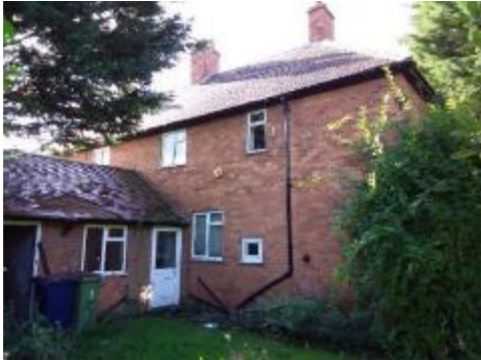
Comments: Roost survey results: At 22:02 a <i>Myotis</i> bat was recorded entering the outhouse doorway of BU_709 and emerging a six minutes later from the same doorway. It was determined not to be roosting in this location.				
Photos/ diagrams: <div style="display: flex; justify-content: space-around; align-items: center;">

</div>				
Roost characterisation: Lesser horseshoe – day / feeding roost

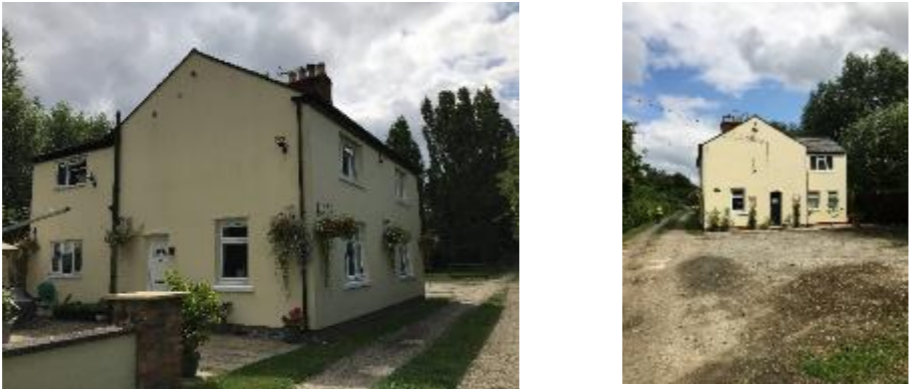
Comments: Roost survey results: One soprano pipistrelle was recorded circling the car park before roosting within the structure at 05:36 (32 minutes before sunrise).				
07/07/2021	21:12 to 23:22 (sunset = 21:27)	BU_963	EM Touch and Walkabout	Air temp: 18 (°C), no rain, cloud cover 6, wind speed 1
Comments: Roost survey results: No bats observed emerging by any surveyor.				
Photos/ diagrams:

Roost characterisation: Soprano pipistrelle – day roost
