M5 Junction 10 Improvements Scheme

Environmental Statement Appendix 8.2 WFD Compliance Assessment TR010063 – APP 6.15

Volume 6
June 2024

Appendix 8.2 WFD Compliance Assessment

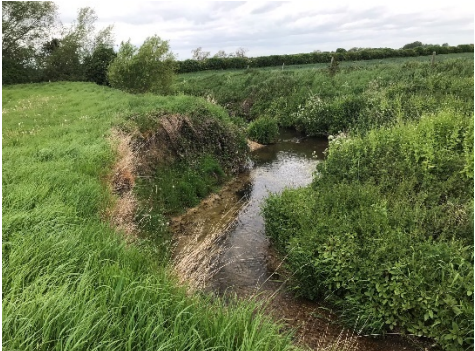
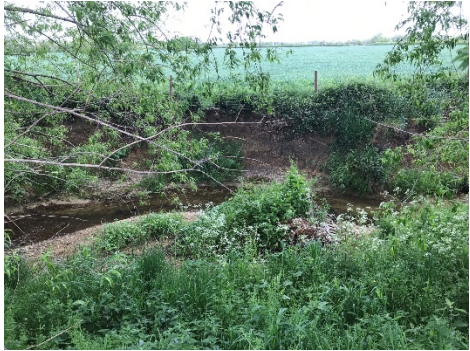
Table 4-3 - Water body photographs Chelt – source to M5

<p>Photo 1 (2022): Downstream view approximately 80m upstream from the Link Road River Chelt Bridge showing active bank erosion on the left bank.</p>	<p>Photo 2 (2022): View of right bank at site of the of the River Chelt Link Road Bridge. Bank erosion and in channel sediments shown with a large wood in channel.</p>

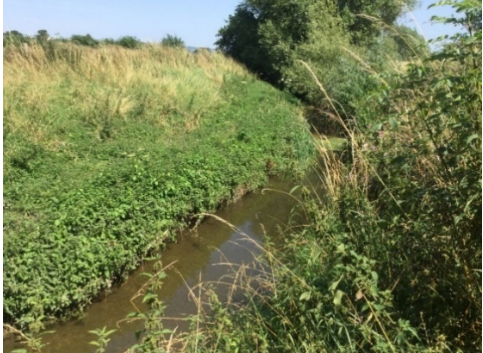
<p>Photo 3 (2019): View of site of for the Link Road River Chelt Bridge. An artificial embankment was present on both banks, alongside a straightened and over deepened channel. Some isolated trees provide shade.</p>	<p>Photo 4 (2019): View downstream from Link Road River Chelt Bridge. The flow was dynamic, with varying depth across the channel. Some deposits were vegetated with stream water crowfoot.</p>

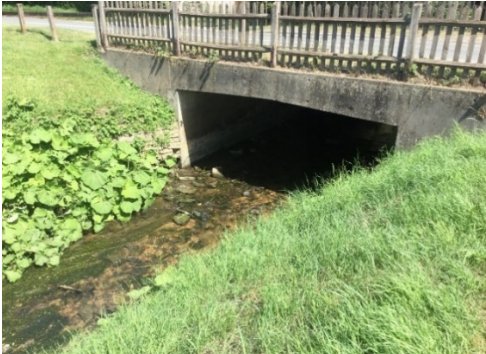
<p>Photo 5 (2019): A weir marks the upstream extent of a 80 m long channelised section, approximately 200 m downstream from the Link Road River Chelt Bridge, outside of the Order limits.</p>	<p>Photo 6 (2019): The existing bridge on Withybridge Lane marks the downstream extent of the channelised section. Small fish (assumed to be stickleback or fry of a larger species) were observed within a shaded section of channel upstream of this bridge.</p>

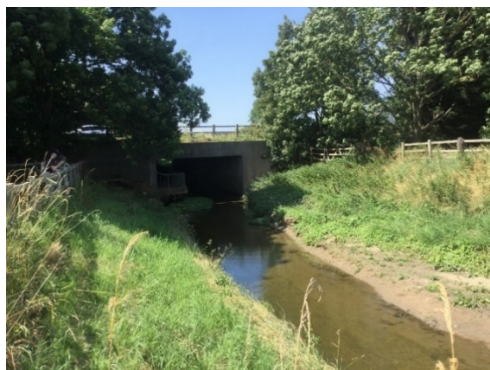
Photo 7 (2019): View of River Chelt Culvert inlet, with deposition collecting on the right bank. An artificial embankment was also present along this stretch.

5.3.4. At the existing River Chelt Culvert location, mitigation measures will result in a 100 m stretch of the River Chelt increasing from a Fairly Poor to a Moderate Condition.

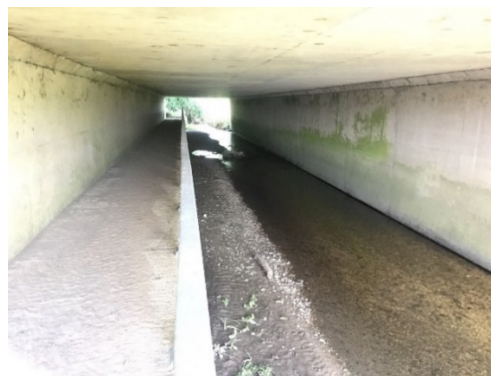
Photo 8 (2019): View through the River Chelt Culvert showing fine sediment deposition. Trash and vegetation which were assumed to be flood deposits observed on the concrete walkway indicates flows have been much higher within this reach.

- 4.1.41. The RHS returned a habitat modification score of 3605 which indicates the reach is severely modified. Within the surveyed reach (centred on the River Chelt Culvert) the habitat modification score was driven by bank and bed resectioning, embankments and the presence of the River Chelt Culvert.
- 4.1.42. Downstream of the River Chelt Culvert (WCID10_MRS_J10_DS) – one 50 m MoRPh survey was conducted, which has a river condition of 'Fairly Poor', constrained by the brick reinforcement on both banks of the River Chelt associated with the pedantised footbridge that crosses the River Chelt, the presence of a large outfall (assumed to be from sewage treatment works in the area) and its associated concrete channel bed reinforcement.

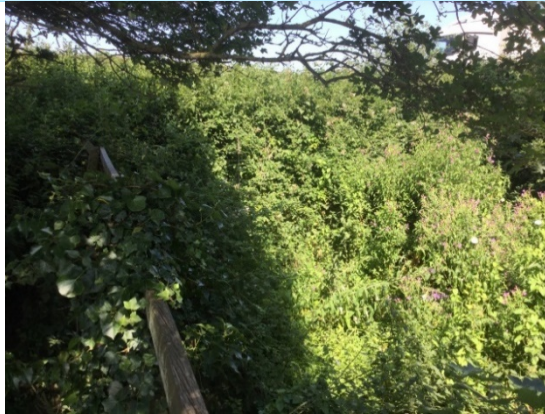
Table 4-5 - Water body photographs Leigh Bk – source to conf. R. Chelt

<p>Photo 11 (2019): Small Drainage ditch with culvert under access track. Channel is overgrown with vegetation and historically straightened. No obvious valley in this location.</p>	<p>Photo 12 (2019): View of hedge lined drainage ditch along an arable field boundary with approximately 5m agricultural field buffer along the bank. Dense vegetation was present on both banks and isolated trees on the left provided 80% shade. No perceivable flow at the time of survey.</p>

Photo 13 (2019): Leigh Brook Culvert could not be seen upstream of the Leigh Brook Culvert due to overgrown vegetation. No perceptible flow at this location at the time of survey.

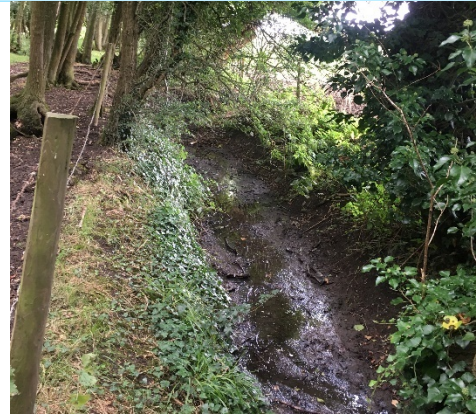
Photo 14 (2019): The channel was heavily shaded by dense scrub and woodland downstream of the Leigh Brook Culvert. The earth banks were shallow sloping and sparsely vegetated, and no vegetation was recorded within the channel. The channel was almost dry with some pools of standing water. Cattel poaching was recorded. (Image taken by ecology team: September 2019).

- 4.1.54. Downstream of the Leigh Brook Culvert – one 50 m MoRPh survey was conducted on the Leigh Brook (Survey Code: WCID02_MRS, SO 90731 26052 - SO 90699 26074). The Leigh Brook at this location had a river condition of ‘Fairly Poor’, where riparian land-use, the presence of the Leigh Brook Culvert and lack of marginal/in-channel features constrained condition. The remaining length of the Leigh Brook within the Order limits could not be surveyed due to access constraints. As such, a river condition of ‘Fairly Poor’ has been applied due to the similarities in habitat characteristics recorded in the MoRPh survey.

5.3.11. The BNG assessment has been completed and demonstrates that the mitigation measures implemented along the approximate 100 m stretch of the Leigh Brook, downstream of the Leigh Brook culvert will improve the condition from Fairly Poor to Moderate.

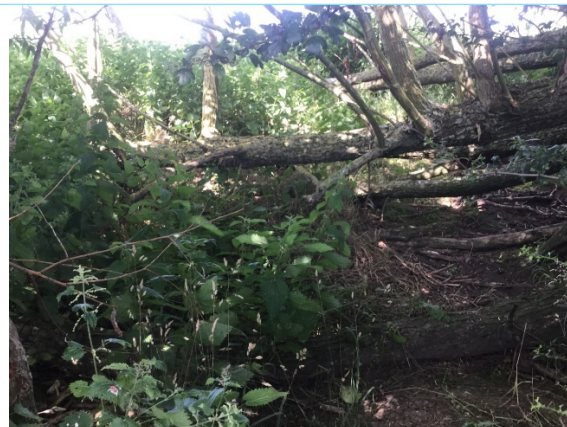
Photo 16 (2019): Drain 12 upstream of Withybridge Lane. There was no flow within the

<p>Balsam was present. This watercourse flowed alongside the A409 and is straightened throughout.</p>	<p>channel and large woody features were present, blocking the channel.</p>
