# M60/M62/M66 Simister Island Interchange

TR010064

## APPENDIX 8.9 RIPARIAN MAMMAL SURVEY REPORT

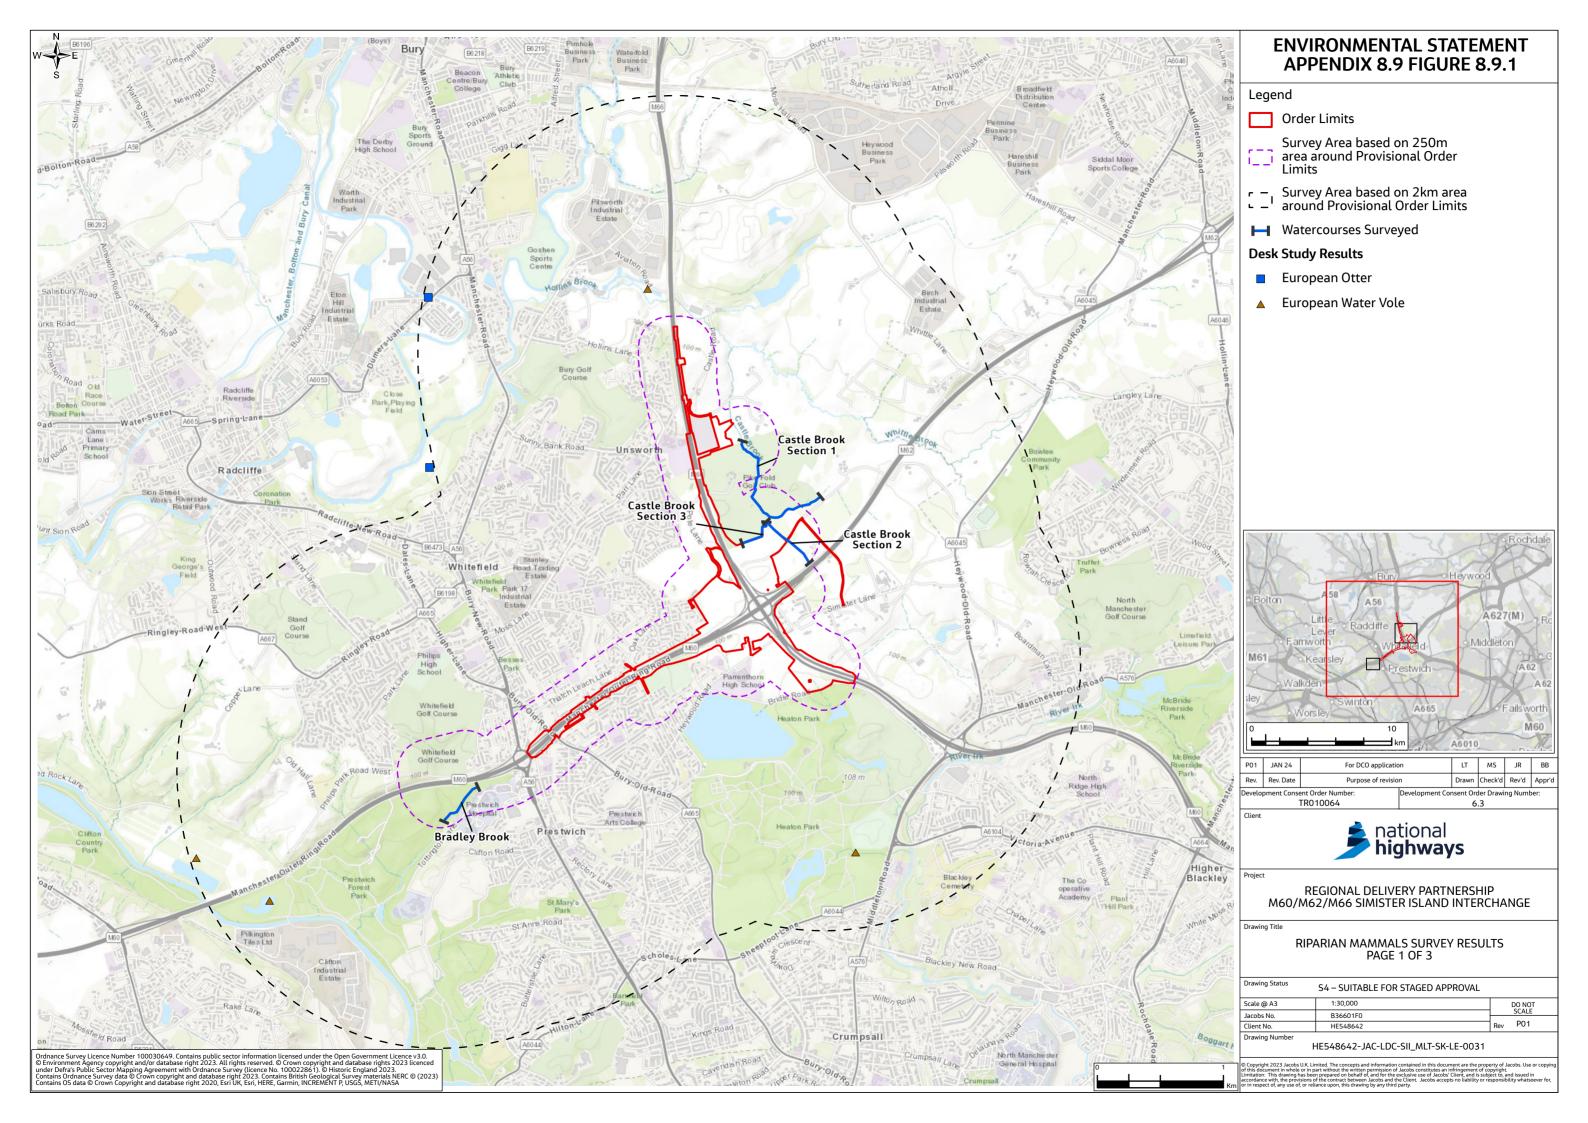
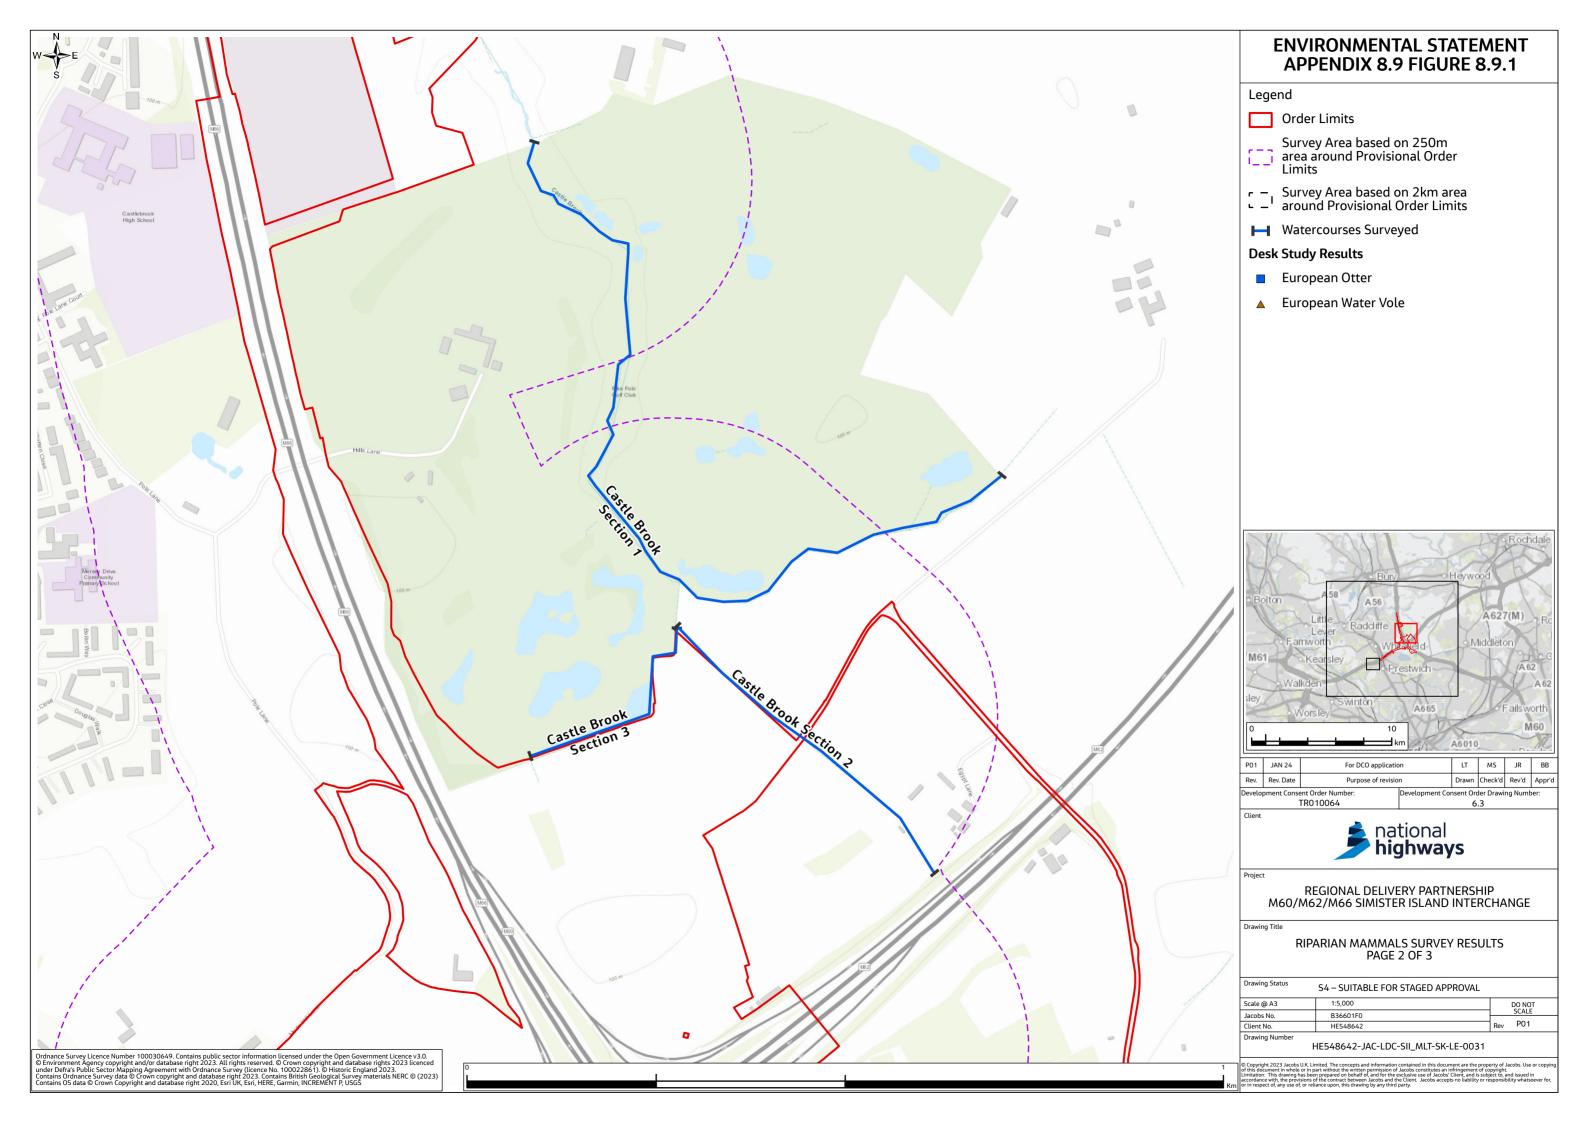
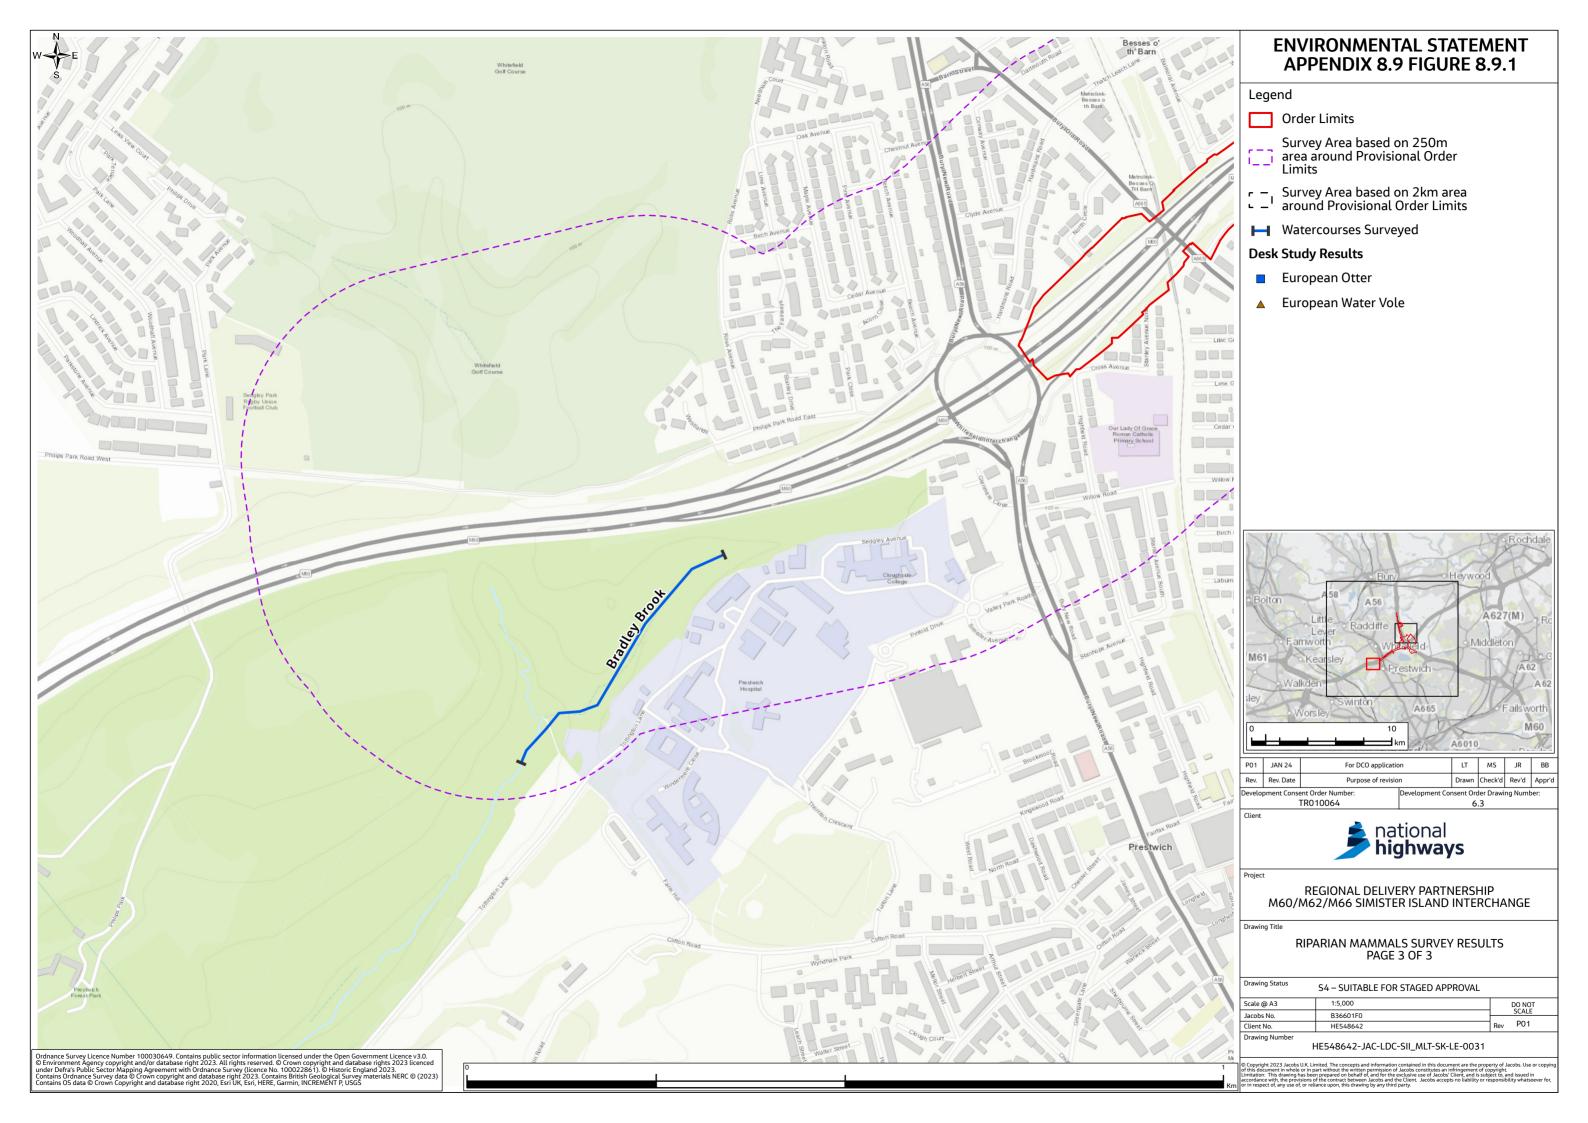
- 1.1.1 This report sets out the results of desk-based study and riparian mammal field surveys undertaken as part of the M60/M62/M66 Simister Island Interchange (the 'Scheme'). The aim is to establish an ecological baseline for the native otter *Lutra lutra* and water vole *Arvicola amphibius* and the non-native invasive American mink *Neovison vison* to provide supporting information for Chapter 8: Biodiversity of the Environmental Statement (TR010064/APP/6.1).
- 1.1.2 This report is supported by Figure 8.9.1: Riparian Mammals Survey Results in Annex B.

- 3.1.1 No statutory or non-statutory designated sites were identified as being designated due to their otter or water vole populations or were identified as supporting either species.
- 3.1.2 Two records of otter were returned in the desk study. These are listed in Table 3.1 and shown in Figure 8.9.1 in Annex B of this report. The records indicate the continued presence of otter in the River Irwell which is located on the outer north western edges of the study area. None of the River Irwell tributaries coincide with the survey area.

3.1.3 Four records of water vole were returned in the desk study, the most recent of which was from 2009 (see Table 3.2 and Figure 8.9.1 in Annex B of this report). The records are all at distance from the Order Limits, in waterbodies not directly linked to ones surveyed and potentially impacted by the Scheme.

3.2.1 Both watercourses had observable man-made influences and extensive coverage of invasive species in parts. Full detailed descriptions of the watercourses can be found in Table 3.3 with photographs in Annex A of this report. The different sections of Castle Brook are identified in Figure 8.9.1 in Annex B of this report.
