# **A46 Newark Bypass**

## **6.3 Environmental Statement**

### **Appendix 8.3 Bat Technical Report**

**APPENDIX 8.3 BAT TECHNICAL REPORT**

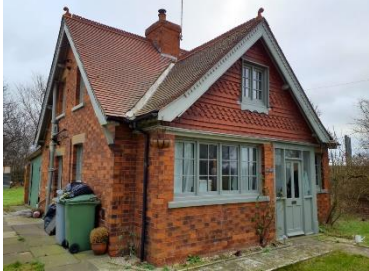
Feature number	Structure	Description of building	Assessment of Bat Roosting Suitability and Evidence of Bats	Photograph
F003	Residential home	Brick walled single storey residential home. Gap under fascia on north end gives access to roof void. Roof unlikely to provide suitable void for hibernation due to temperature fluctuations associated with heating this residential building. Several small openings within the mortar of the ridge tiles at gable ends. Multiple small gaps under lifted tiles at both gable ends	No evidence of bats observed. Moderate suitability for roosting bats.

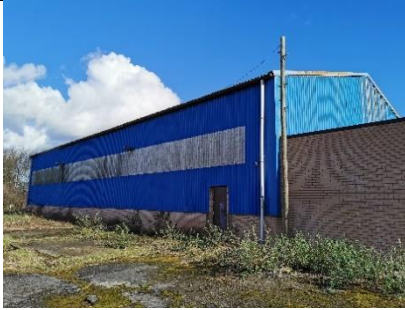
Feature number	Structure	Description of building	Assessment of Bat Roosting Suitability and Evidence of Bats	Photograph
F062	Disused warehouse depot	Single storey brick building with corrugated, shallow pitched metal roof. Boarded up doors and windows - occasional gaps around edges could provide access for bats. Gaps under edge of metal roofing on west side and north end could also provide access for bats. No internal access for survey due to the presence of asbestos.	No evidence of bats observed. Moderate suitability for roosting bats.

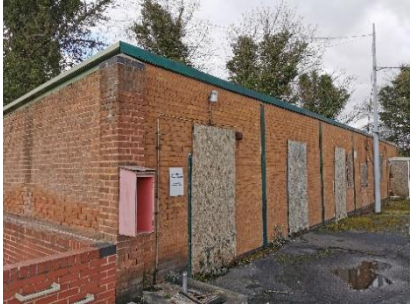
F063	Disused warehouse depot	Single storey brick warehouse building with pitched corrugated asbestos sheet roof. Boarded up doors and windows with small gaps at edges. Gaps under sheet at gable ends and at apex of western gable. No access for internal survey due to the presence of asbestos.	No evidence of bats observed. Moderate suitability for roosting bats.

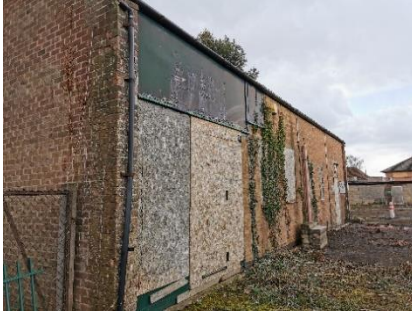
Feature number	Structure	Description of building	Assessment of Bat Roosting Suitability and Evidence of Bats	Photograph
F064	Disused warehouse depot	Single storey brick building with pitched metal sheet roof and boarded up windows and doors. Frequent potential access points on south side between roof sheets and insulation. Gaps in brickwork. Gaps at edges of boards. No access for internal survey due to the presence of asbestos.	No evidence of bats observed. Moderate suitability for roosting bats.

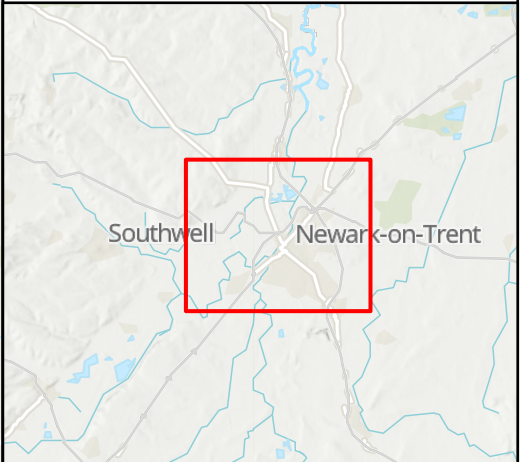
- KEY TO SYMBOLS**
- Order Limits
  - Order Limits 250m buffer
  - ▲ Tree - confirmed bat roost
  - Building - confirmed bat roost

C01	08/12/23	DCO APPLICATION	JB	BC	HF
REV.	DATE	AMENDMENT DETAILS	ORIG	CHKD	APPD
CLIENT					
PURPOSE OF ISSUE					
DCO APPLICATION					
DEVELOPMENT CONSENT ORDER NUMBER					
TR010065					
PROJECT TITLE					
A46 NEWARK BYPASS					
DRAWING TITLE					
Appendix G3 Confirmed Bat Roost Locations					
ORIGINAL SIZE		SCALE			
A3		1:30,000			
DRAWING NUMBER			ORIGINATOR		VOLUME
HE551478			SKAG		EBD
CONWI_CONW			DR LE		00065
LOCATION			TYPE		ROLE
PROJECT REF NO.					HE551478
REVISION					C01

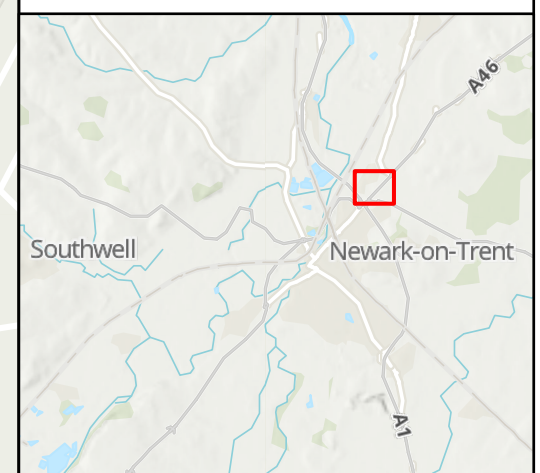
- Order Limits
- Listening point
- Transect number**
- BT01
- Bat distribution**
- Higher density
- Lower density

C01	08/12/23	DCO APPLICATION	JB	BC	HF
REV.	DATE	AMENDMENT DETAILS	ORIG	CHKD	APP'D
CLIENT					
PURPOSE OF ISSUE					
DCO APPLICATION					
DEVELOPMENT CONSENT ORDER NUMBER					
TR010065					
PROJECT TITLE					
A46 NEWARK BYPASS					
DRAWING TITLE					
Appendix I Bat Activity Transect Survey Heat Map BT01 Sheet: 1 of 6					
ORIGINAL SIZE		SCALE			
A3		1:4,000			
DRAWING NUMBER			ORIGINATOR		PROJECT REF NO.
HE551478			SKAG EBD		HE551478
CONWI_CONW			DR LE		REVISION
			00098		C01
LOCATION			TYPE		NUMBER

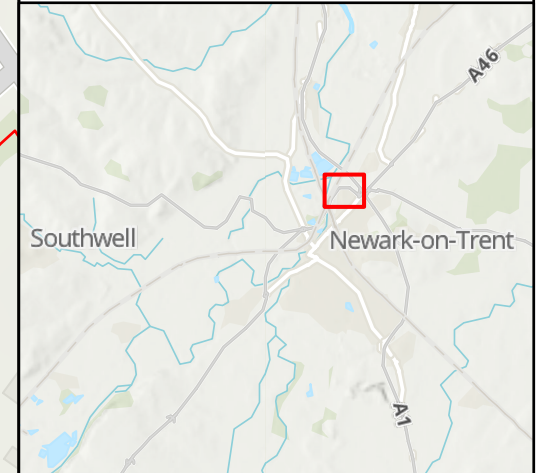
- Order Limits
- Listening point
- Transect number**
- BT02
- Bat distribution**
- Higher density
- Lower density

C01	08/12/23	DCO APPLICATION	JB	BC	HF
REV.	DATE	AMENDMENT DETAILS	ORIG	CHKD	APPD
CLIENT					
PURPOSE OF ISSUE					
DCO APPLICATION					
DEVELOPMENT CONSENT ORDER NUMBER					
TR010065					
PROJECT TITLE					
A46 NEWARK BYPASS					
DRAWING TITLE					
Appendix I Bat Activity Transect Survey Heat Map BT02 Sheet: 2 of 6					
ORIGINAL SIZE		SCALE			
A3		1:4,000			
DRAWING NUMBER			ORIGINATOR		PROJECT REF NO.
HE551478			SKAG EBD		HE551478
CONWI_CONW			DR LE		REVISION
			00099		C01
LOCATION			TYPE		NUMBER

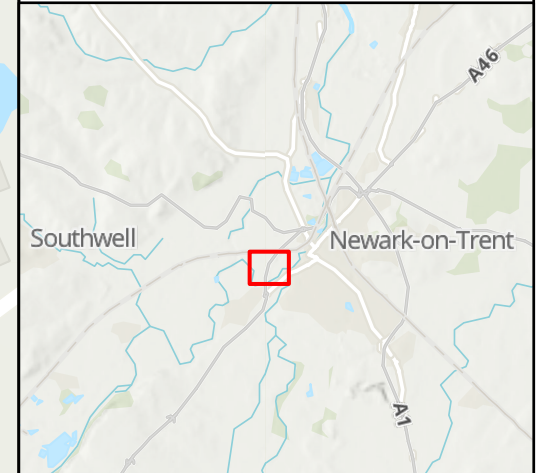
- Order Limits
- Listening point
- Transect number**
- BT03
- Bat distribution**
- Higher density
- Lower density

REV.	08/12/23	DCO APPLICATION	JB	BC	HF
	DATE	AMENDMENT DETAILS	ORIG	CHKD	APP'D
CLIENT					
PURPOSE OF ISSUE					
DCO APPLICATION					
DEVELOPMENT CONSENT ORDER NUMBER					
TR010065					
PROJECT TITLE					
A46 NEWARK BYPASS					
DRAWING TITLE					
Appendix I Bat Activity Transect Survey Heat Map BT03 Sheet: 3 of 6					
ORIGINAL SIZE			SCALE		
A3			1:4,000

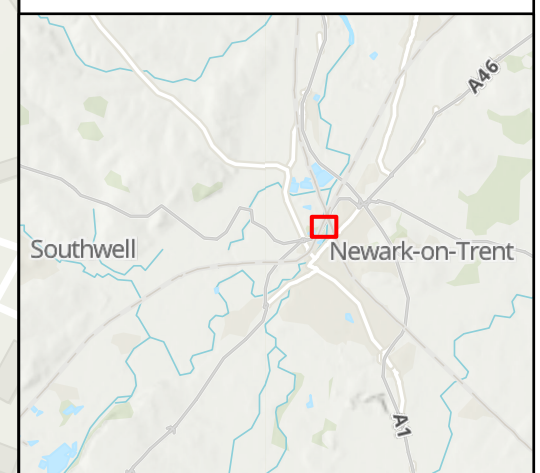
- Order Limits
- Listening point
- Transect number**  
 BT04
- Bat distribution**  
 Higher density  
 Lower density

C01	08/12/23	DCO APPLICATION	JB	BC	HF
REV.	DATE	AMENDMENT DETAILS	ORIG	CHKD	APP'D
CLIENT					
PURPOSE OF ISSUE					
DCO APPLICATION					
DEVELOPMENT CONSENT ORDER NUMBER					
TR010065					
PROJECT TITLE					
A46 NEWARK BYPASS					
DRAWING TITLE					
Appendix I					
Bat Activity Transect Survey Heat Map					
BT04					
Sheet: 4 of 6					
ORIGINAL SIZE		SCALE			
A3		1:2,500			
DRAWING NUMBER			ORIGINATOR		VOLUME
HE551478			SKAG		EBD
CONWI_CONW			DR LE		00101
LOCATION			TYPE		ROLE
PROJECT REF NO.					HE551478
REVISION					C01

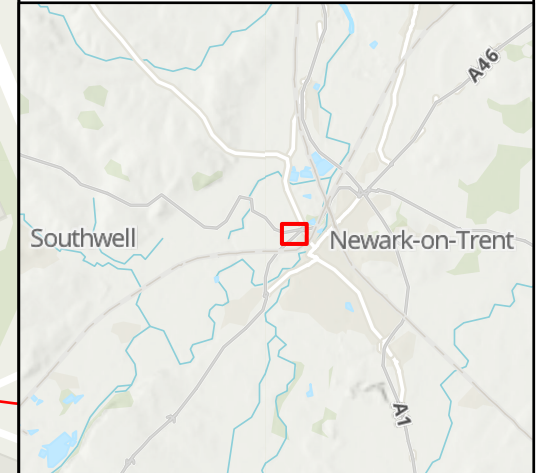
- Order Limits
- Listening point
- Transect number**
- BT05a
- Bat distribution**
- Higher density
- Lower density

C01	08/12/23	DCO APPLICATION	JB	BC	HF
REV.	DATE	AMENDMENT DETAILS	ORIG	CHKD	APPD
CLIENT					
PURPOSE OF ISSUE					
DCO APPLICATION					
DEVELOPMENT CONSENT ORDER NUMBER					
TR010065					
PROJECT TITLE					
A46 NEWARK BYPASS					
DRAWING TITLE					
Appendix I Bat Activity Transect Survey Heat Map BT05a Sheet: 5 of 6					
ORIGINAL SIZE			SCALE		
A3			1:2,500		
DRAWING NUMBER		ORIGINATOR	VOLUME	PROJECT REF NO.	
HE PIN		SKAG	EBD	HE551478	
CONWI_CONW		DR	LE	00102	REVISION
LOCATION		TYPE	ROLE	NUMBER	C01
