A46 Newark Bypass

TR010065/APP/6.3

6.3 Environmental Statement Appendix 6.1 Cultural Heritage Desk Based Assessment

ENVIRONMENTAL STATEMENT APPENDIX 6.1 CULTURAL HERITAGE DESK BASED ASSESSMENT

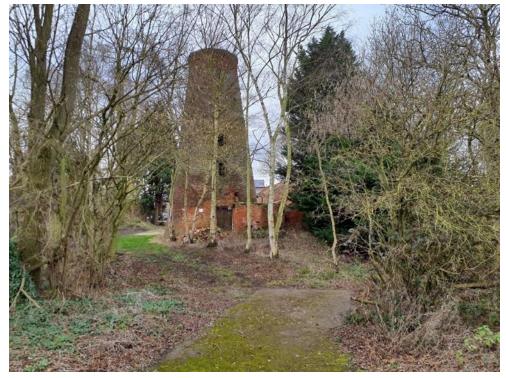
Photo 4-7: Grade II listed Farndon Windmill (MM139)

- 4.9.4 Fields north of the River Trent were walked with no discernible new heritage features identified (see Plate 4.6). South of the River Trent the grade II listed Farndon Windmill (MM139) was visited and the proximity to the Scheme noted.

- 4.9.7 The walkover on the 7 February 2023 visited sites across the Scheme including the grade II listed Farndon Windmill (MM139), designated and non-designated assets around Cattle Market Roundabout, Concrete Footbridge Across River Trent (MM038), Winthorpe Conservation Area (MM432) and The Church of St Michaels at Averham (MM019).
- 4.9.8 During the visit to Farndon Windmill (MM139), the proximity of the existing road was noted, with road and traffic noise encroaching significantly into its setting (see Photo 4-7). The windmill likely bears a relationship with historic buildings set out in a linear formation to the rear and which also form part of its setting. These may be considered as curtilage listed.
- 4.9.9 The visit to Cattle Market roundabout included an inspection of the ditch and tree line separating the scheduled Civil War redoubt 550m
