London Luton Airport Expansion

Volume 5 Environmental Statement and Related Documents
**5.02 Appendix 17.1 Preliminary Risk Assessment of Land
Contamination - Part A**

**5.02 ENVIRONMENTAL STATEMENT APPENDIX 17.1 PRELIMINARY
RISK ASSESSMENT OF LAND CONTAMINATION - PART A**

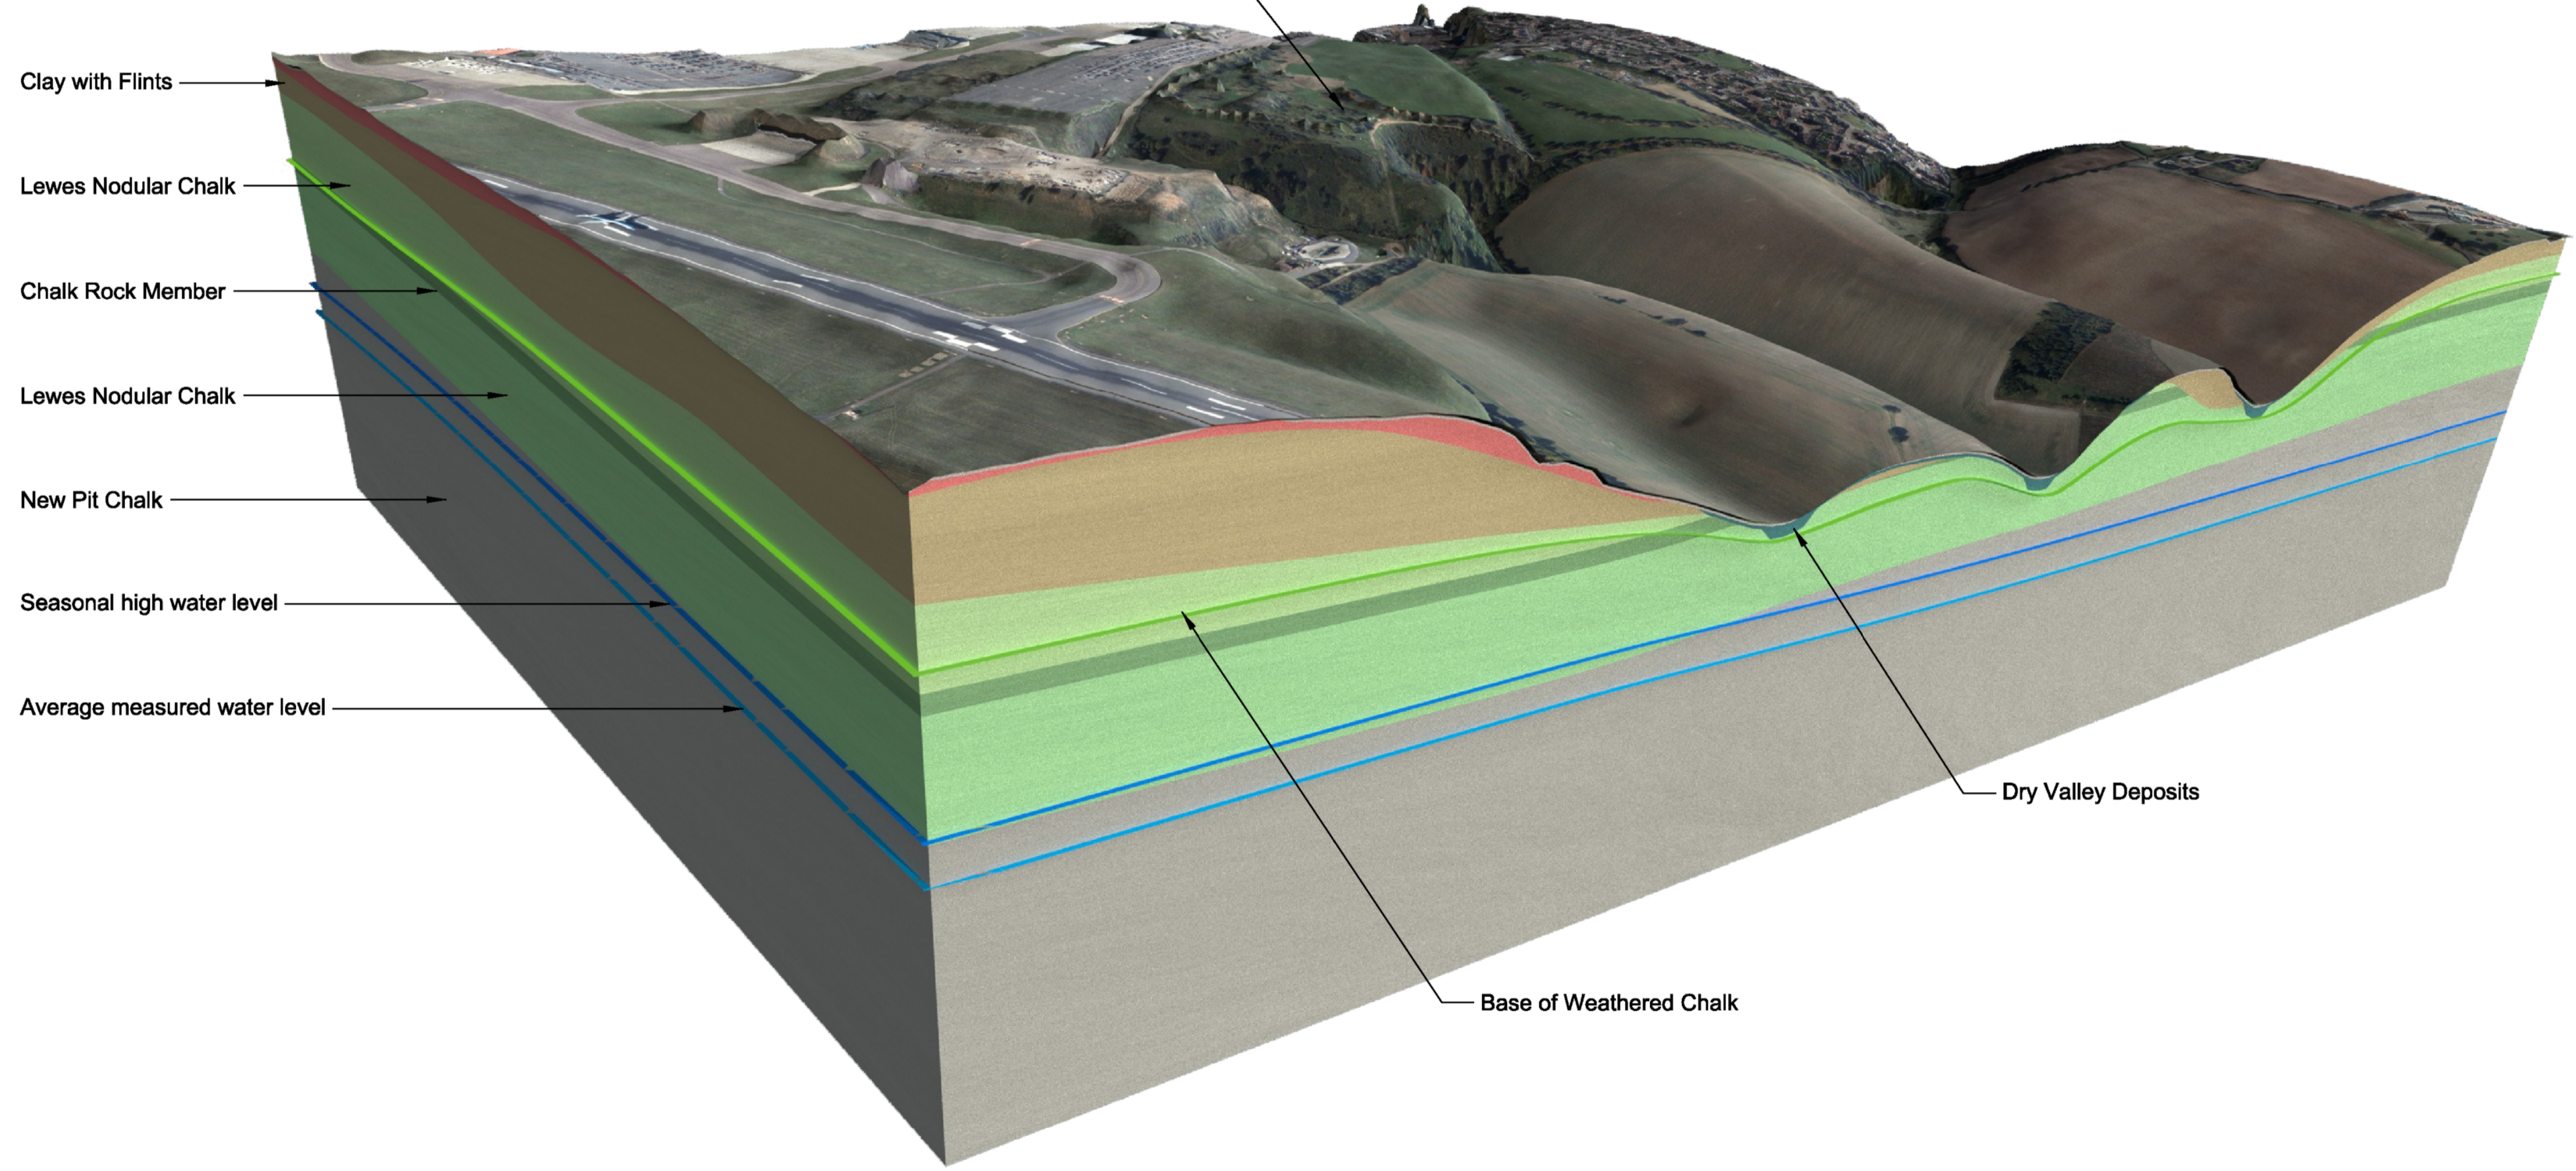
Top Left Section Cut

Below Centre Section Cut
