Gatwick Airport Northern Runway Project

Environmental Statement

Appendix 10.9.1: Preliminary Risk Assessment

Book 5

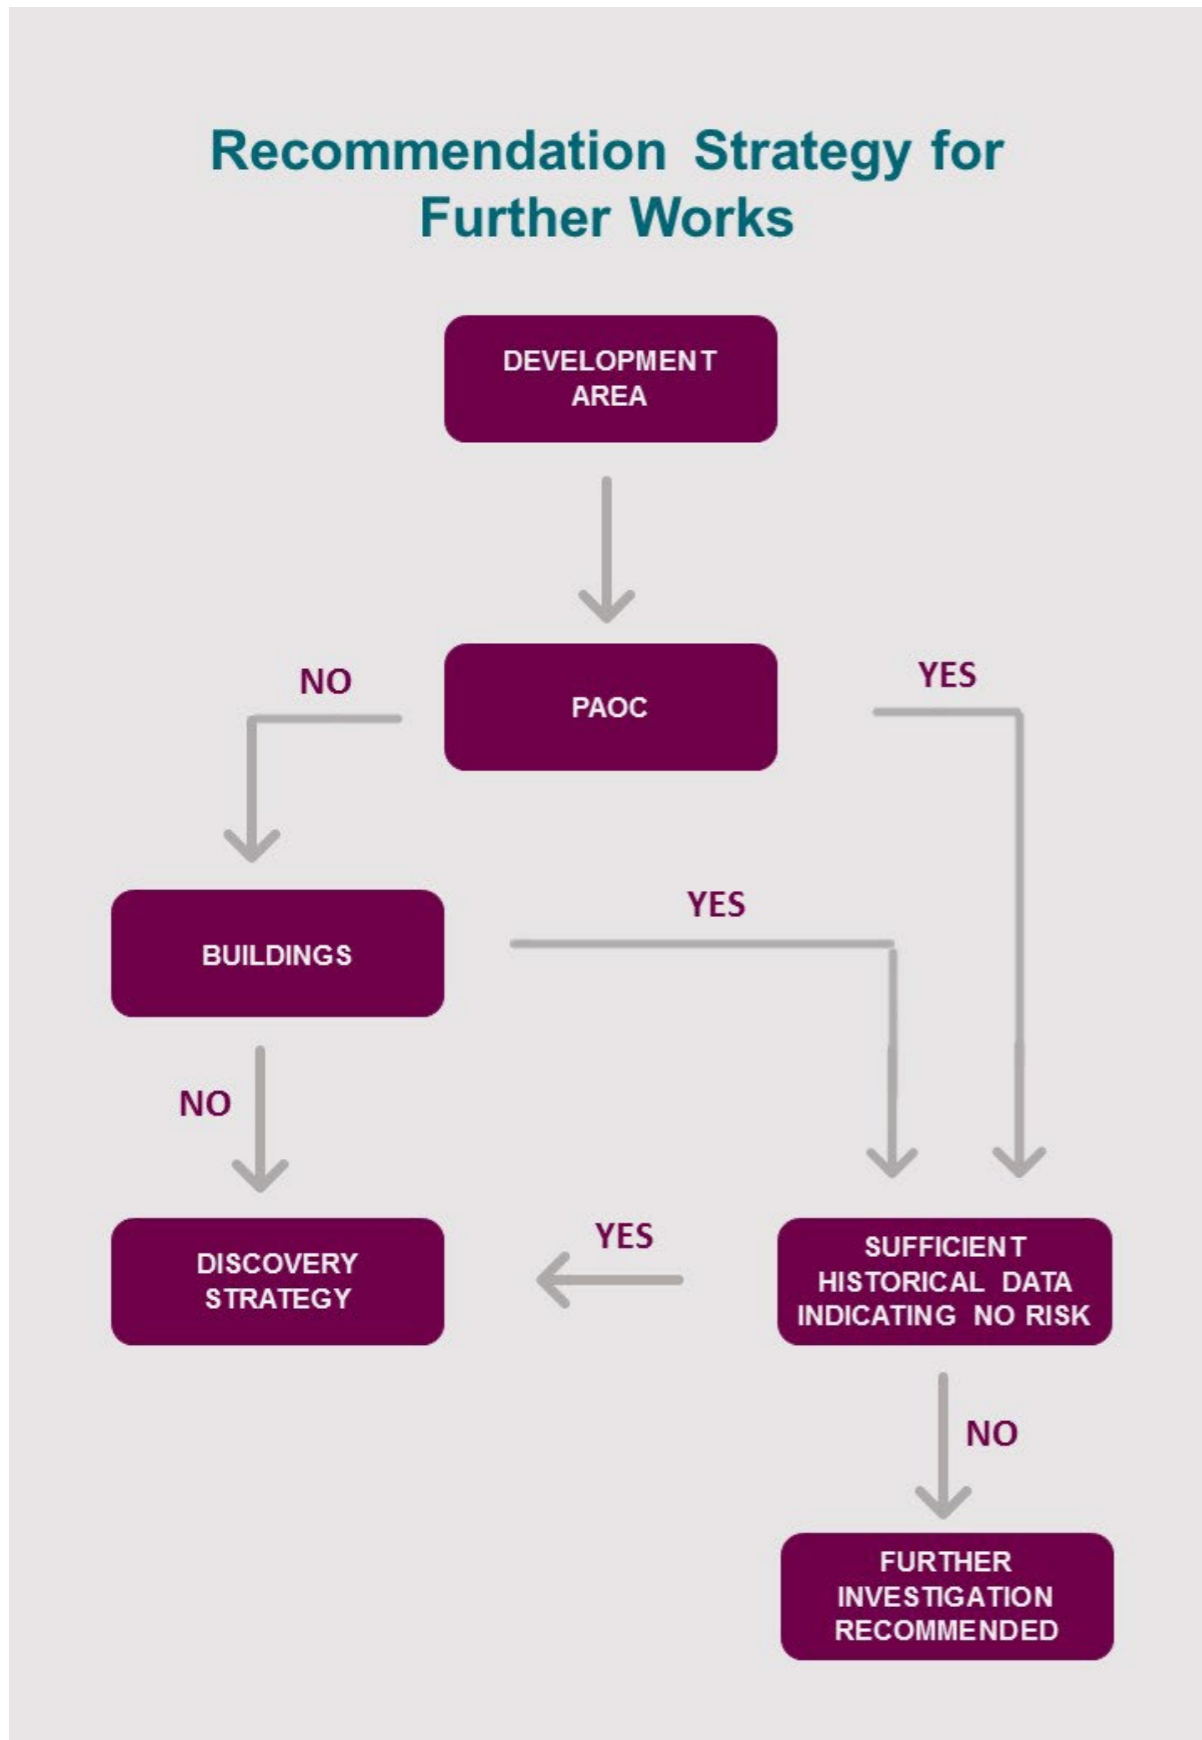
Annex 7

Strategy for Further Works

- pre-existing site investigation data, where available.
- 5.1.4 A flowchart detailing the recommendation strategy for further works is provided in Annex 6 together with a table detailing recommendations for each development area.
