# Gatwick Airport Northern Runway Project

Environmental Statement

Appendix 9.9.2: Biodiversity Net Gain Statement – Tracked Version

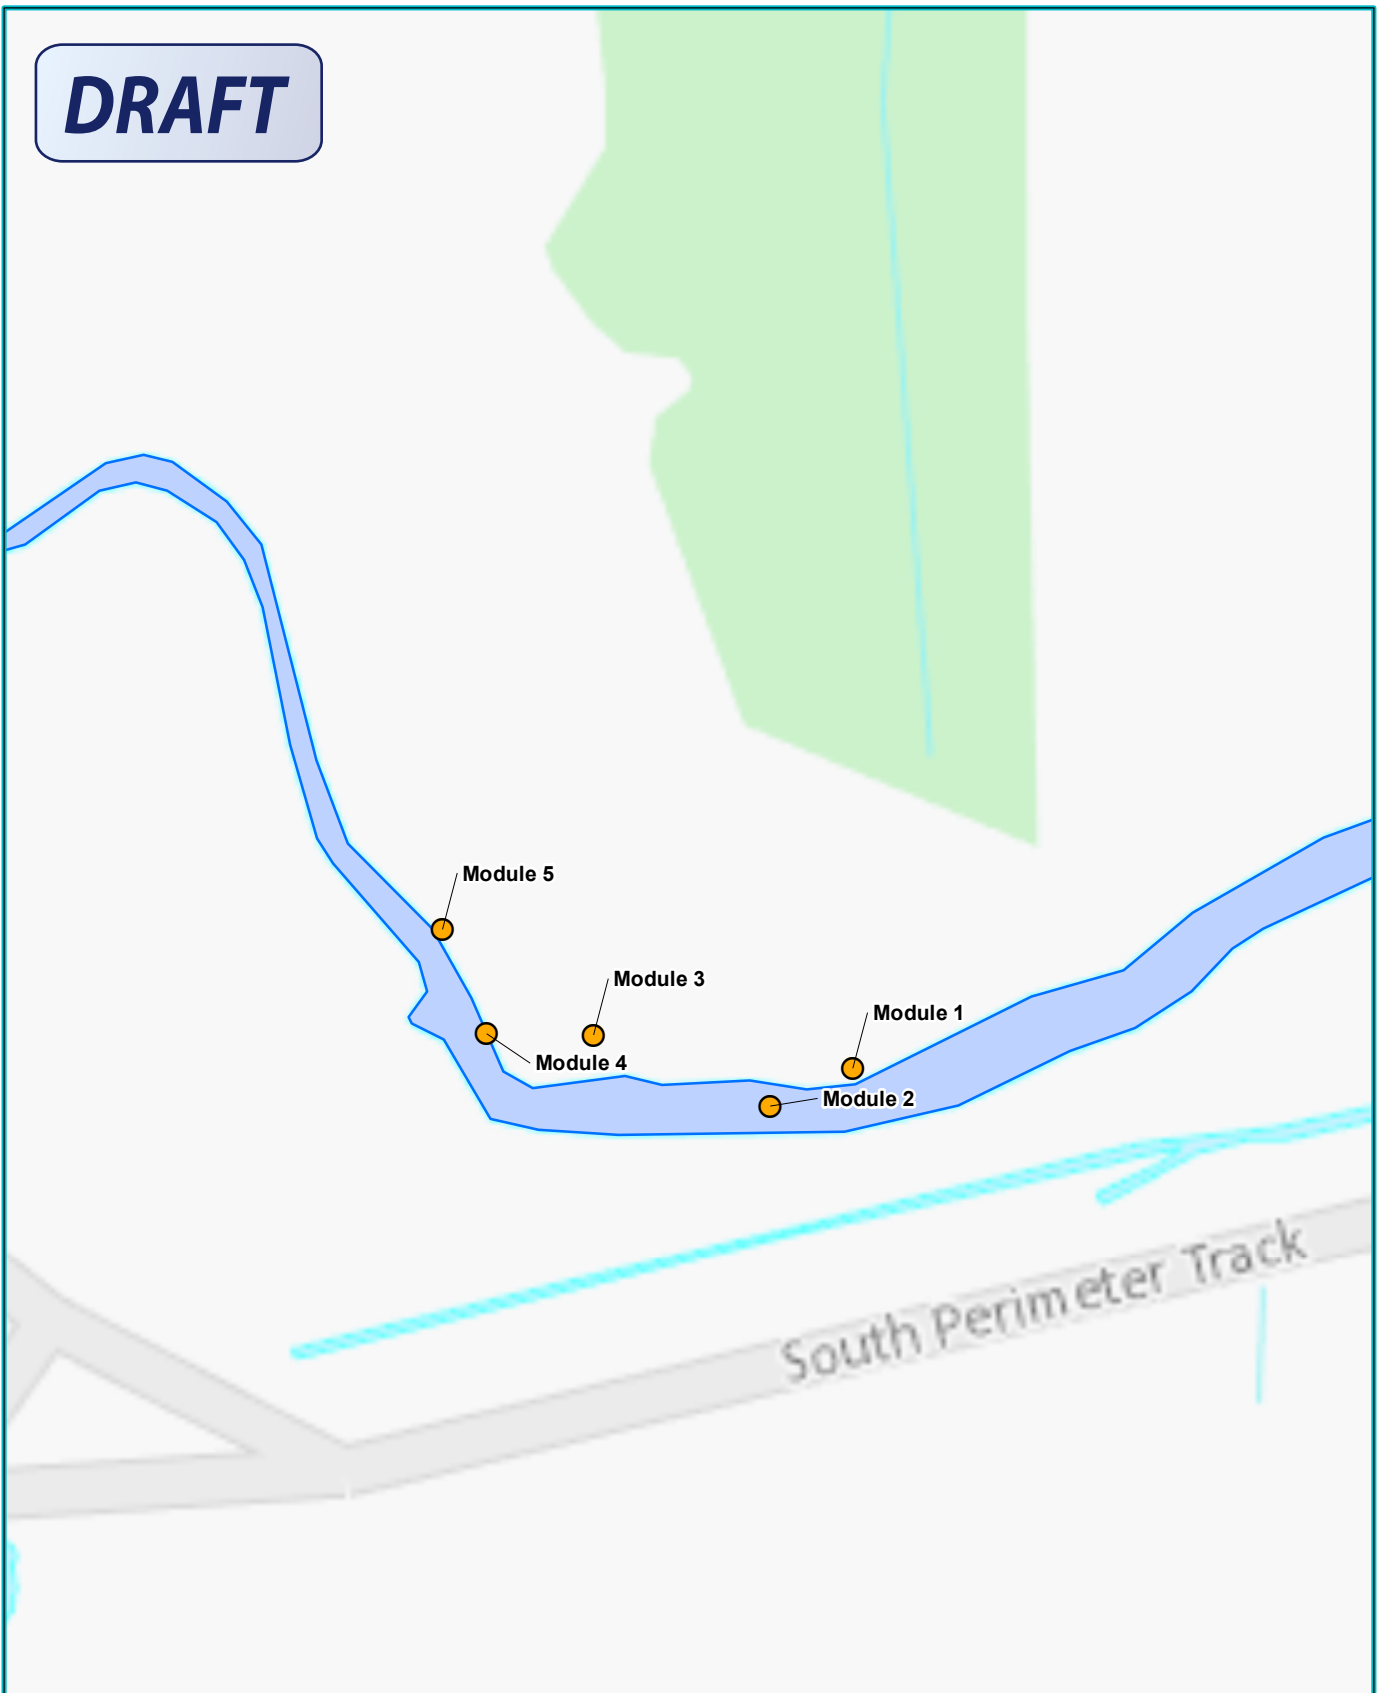
Client	RPS Consulting Services Ltd.		Drawing Ref	RPS001-022/401995/1		
Figure Number	2a		Scale at A4	1:1,000		
Figure Title	River Condition Assessment (River Mole)		Drawn	SC	Checked	AS
			Date	25/01/2023	Date	25/01/2023

**4.3.2** The preliminary RCA score was **0.62** (Table 6). As per Table 3 this gives a final river condition score for a Type H River of **Moderate**. The lower threshold for Fairly Good condition for Type H is 1.6.
