# Gatwick Airport Northern Runway Project

Appendix 5.3.2: Code of Construction Practice Annex 6 – Outline Arboricultural and Vegetation

Method Statement Part 3 - Tracked Version

Application Document Ref: 5.3

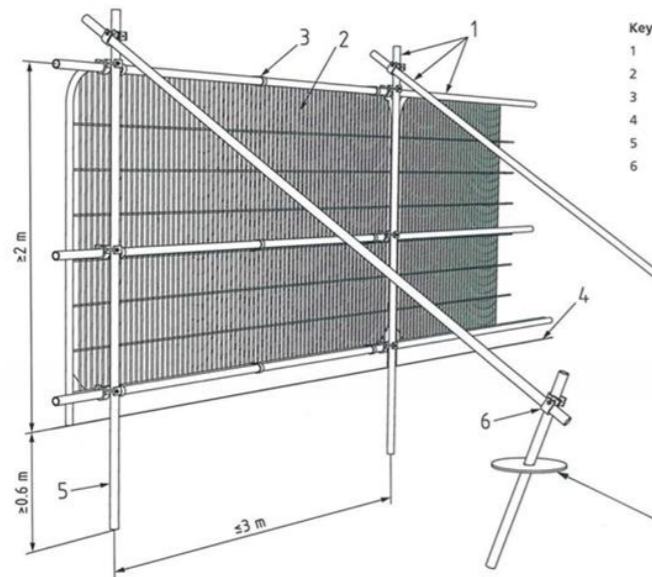
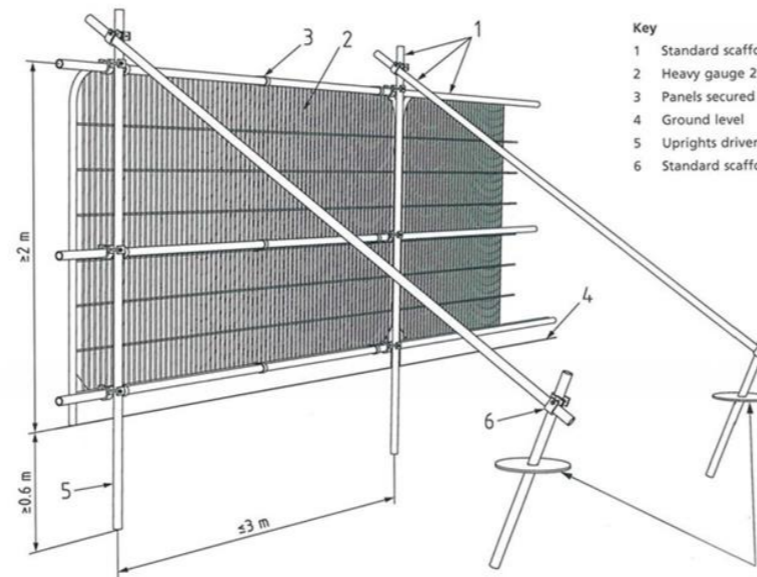
Figure 2 Default specification for protective barrier

- Key
- 1 Standard scaffold poles
  - 2 Heavy gauge 2 m tall galvanized tube and welded mesh infill panels
  - 3 Panels secured to uprights and cross-members with wire ties
  - 4 Ground level
  - 5 Uprights driven into the ground until secure (minimum depth 0.6 m)
  - 6 Standard scaffold clamps

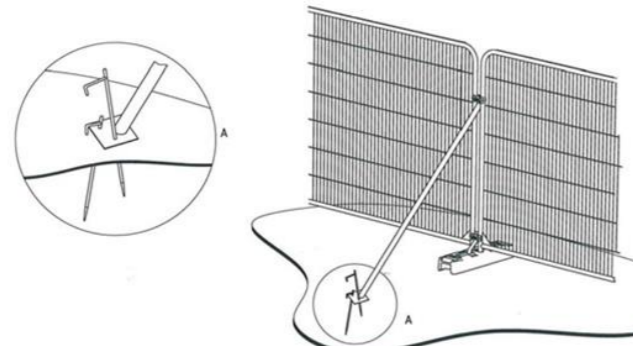
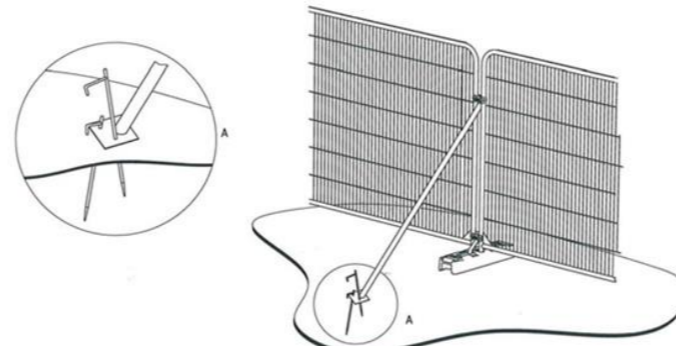
Figure 3 Examples of above-ground stabilizing systems

a) Stabilizer strut with base plate secured with ground pins

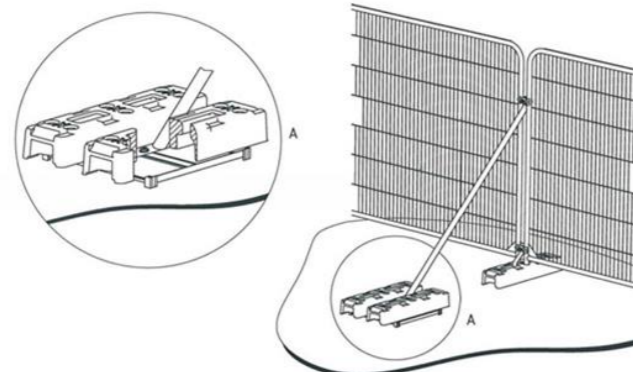
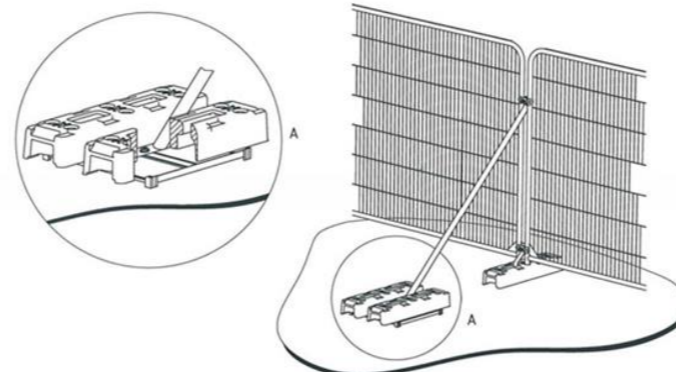
b) Stabilizer strut mounted on block tray

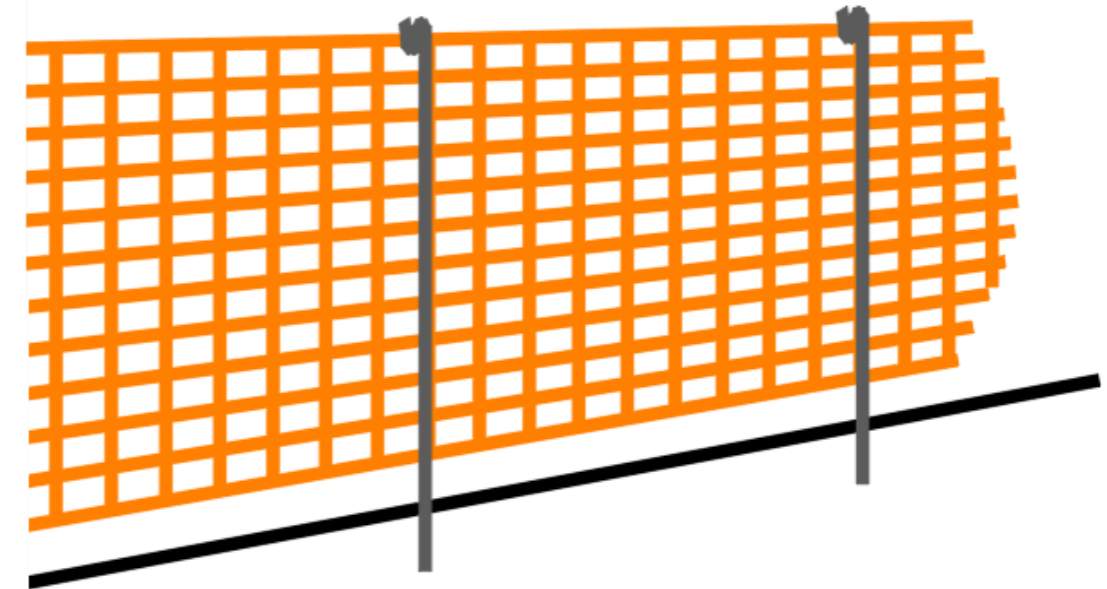
**VISUAL TREE PROTECTION BARRIER**  
Secondary tree protection barrier  
(Not to scale)

For trees and vegetation not immediately adjacent to construction works.  
 Heavy duty hi-vis barrier mesh  
 Mesh fitted to metal poles, timber stakes or railway pins driven into the ground  
 at regular intervals
