Gatwick Airport Northern Runway Project
Supporting Ecology Technical Notes

Book 10

Application Document Ref: 10.33

Table of Contents

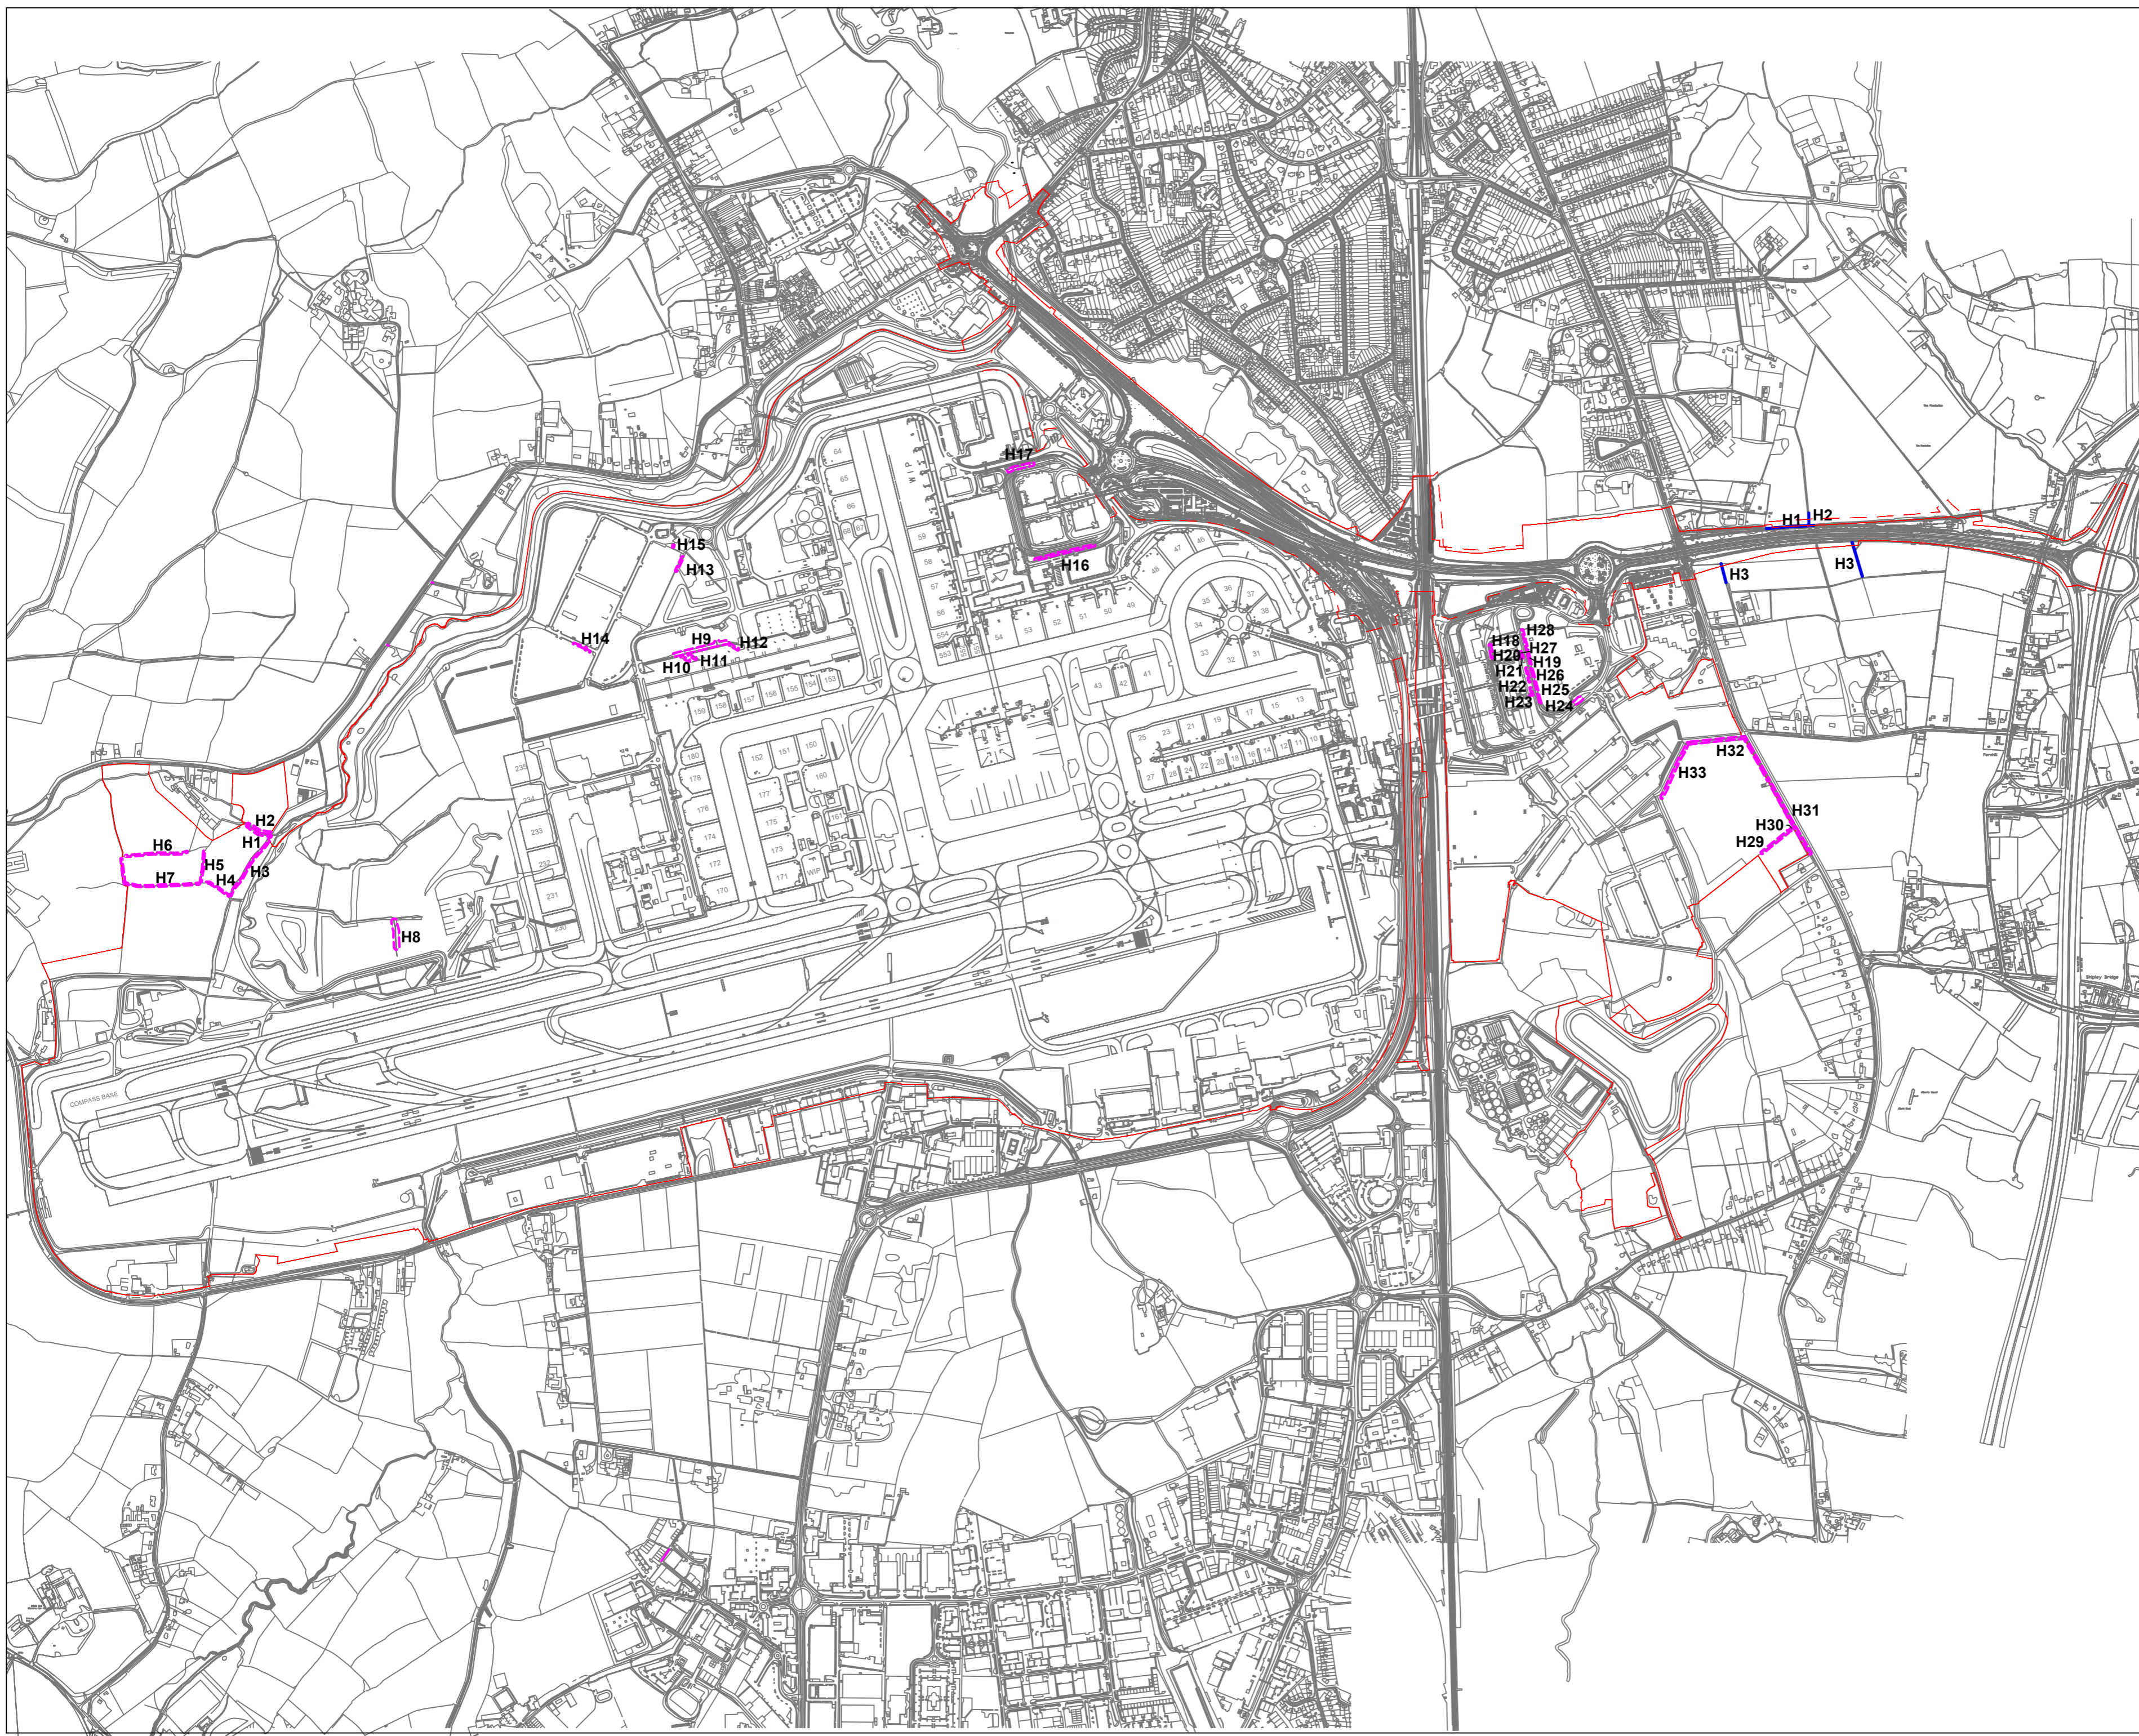
Figure 1: Hedges Overview

- 2.1.3 A total of 33 hedgerows were recorded on site (the results are contained in Table 2.1 and Figure 1), all of which are species poor (four or less woody species) with many dominated by non-native species. A ditch feature was identified along half or more of the length of 7 hedgerows (out of the 33 recorded hedgerows), being the only additional feature present. No other additional features were identified to meet the criteria of more than three or four features to qualify as an Important Hedgerow.

- 2.1.4 As demonstrated by Table 2.1, no hedgerows were identified to meet the above criteria in terms of the number of species or features.
- 2.1.5 Therefore, as set out in section 3.3 of **ES Appendix 9.6.2 Ecology Survey Report** [[APP-125](#)], no Important Hedgerows were recorded on the Project site during any of the surveys.

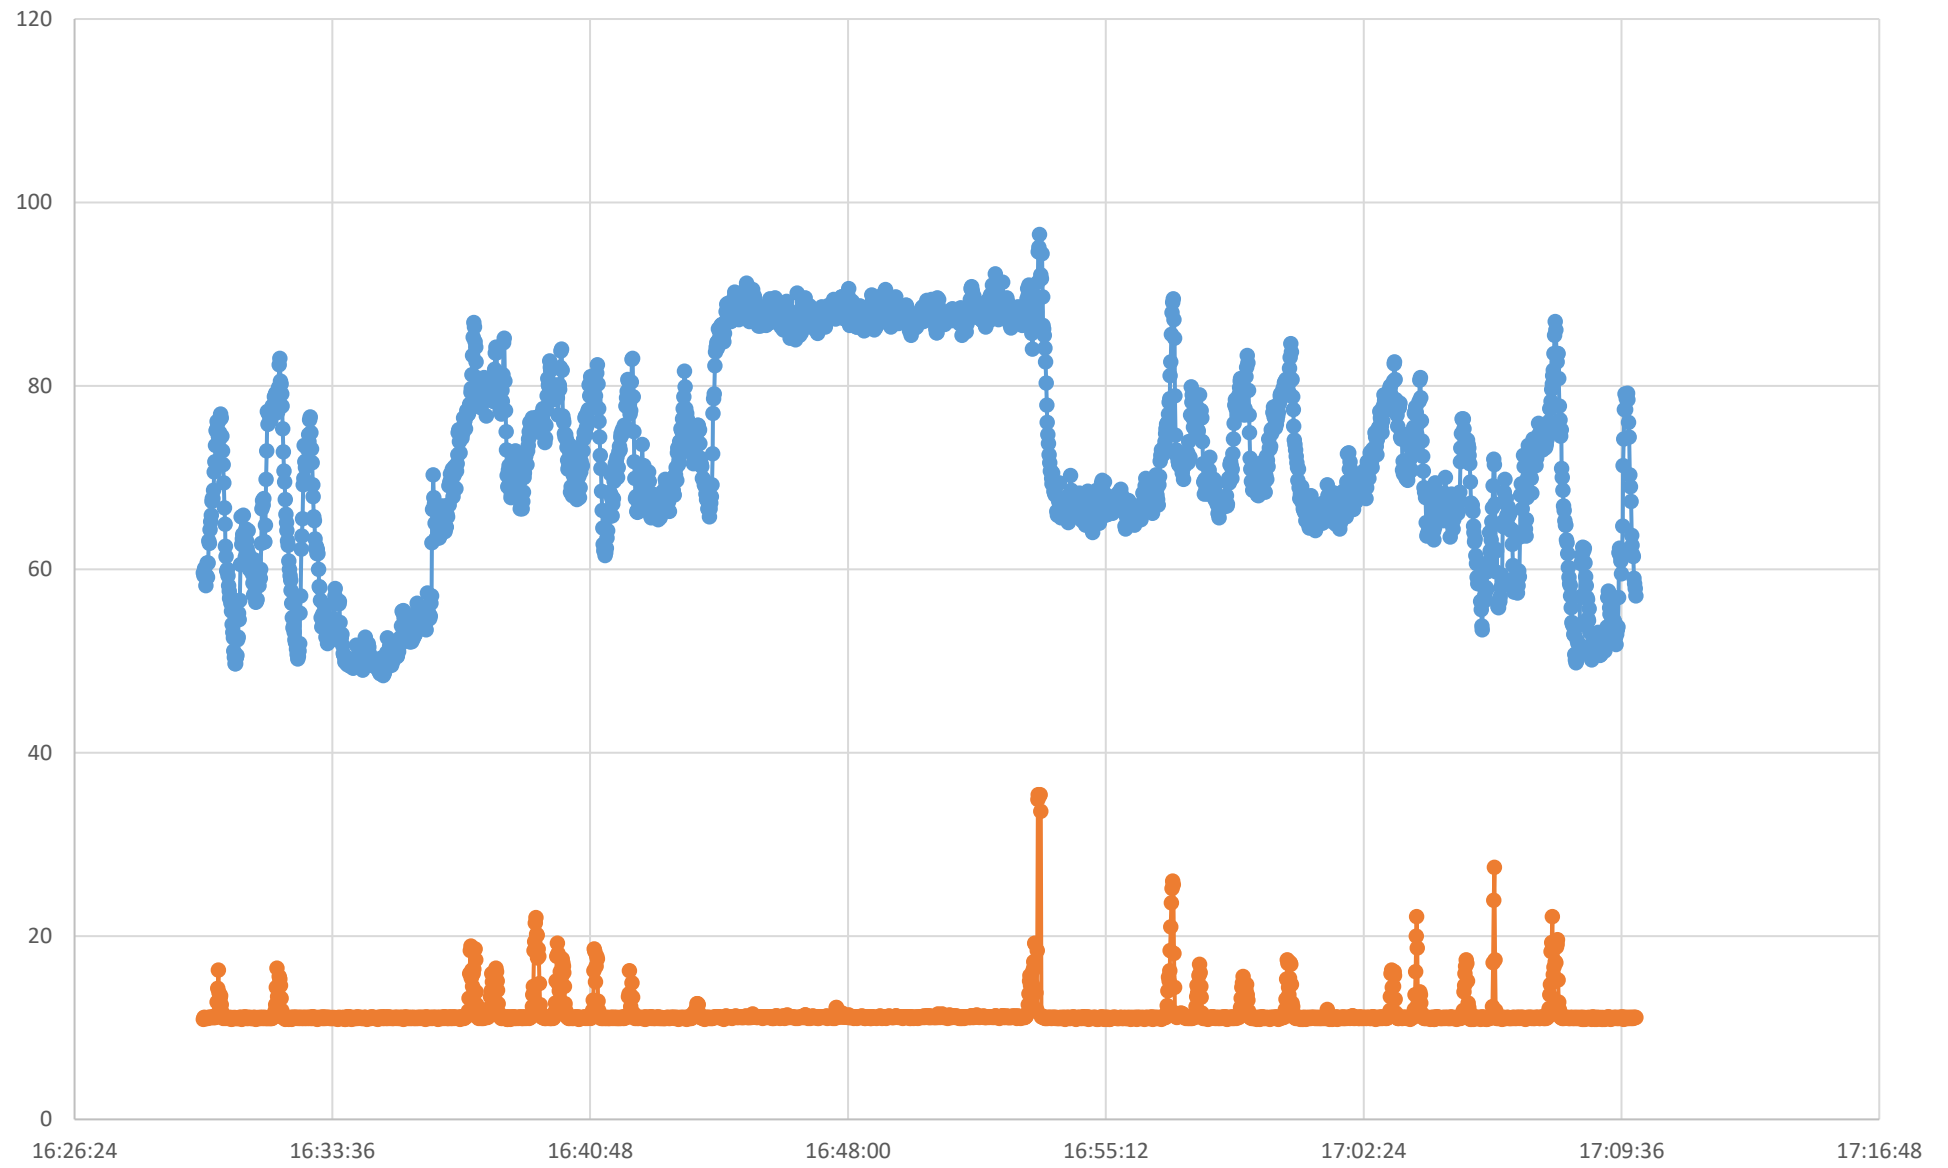
Figure 2: Measurements of an engine testing run for a B777 aircraft

information on the sort of noise levels experienced close to a large jet engine operating above 'flight idle' thrust settings. This shows the overall weighted L_{Aeq} sound pressure level in blue and the unweighted sound pressure level (L_{eq}) in the 20 kHz third-octave band in orange. It should be noted that when the jet engines are operating above 'flight idle' thrust settings, this can be generally considered representative of a greater power (and noise) output than would be required for the aircraft to maintain a steady altitude.

Ground Run Test at 150 m - Boeing 777-236ER

3.1.5 In terms of the noise output within the echolocation frequencies, there is actually very little noise output from aircraft engines within these ranges (that typically start from 20 KHz upward as noted at paragraph 3.1.3). A graph showing some measurements of an engine testing run for a B777 aircraft is provided at Figure 2. This is used as a proxy for aircraft noise more broadly as it provides

- 3.1.6 It is clear that in the middle of the graph (Figure 2) there is a section where the overall level sits around 90 dB L_{Aeq} for around 10 minutes and jumps up to a peak of 96 dB immediately before dropping down to around 70 dB. This 10-min section represents a period where the engine was run at a fairly constant high-power throttle setting above 'flight idle' before a change (reduction) in the throttle setting. There is a peak in the 20 kHz data of around 35 dB which corresponds to the peak of 96 dB in the overall L_{Aeq} data occurring when there is a change in the throttle setting. For frequencies above 20 kHz, the noise output of the jet engines is likely to be lower than this.

- 3.1.7 There are a few other lesser peaks in the 20 kHz data which also coincide with changes in throttle settings. This indicates that the steady output of the engine under a constant throttle setting produces next to nothing in the 20 kHz band but you could potentially get a peak of up to around 35 dB for a change in a high throttle setting. This peak is also measured at 150m and at the distances the woodlands are located from the airport, levels this low would have attenuated well below the level of any other background noise.
