Gatwick Airport Northern Runway Project

Environmental Statement

Appendix 8.10.1 – Tree Survey Report and Arboricultural Impact Assessment – Part 1 – Tracked Version

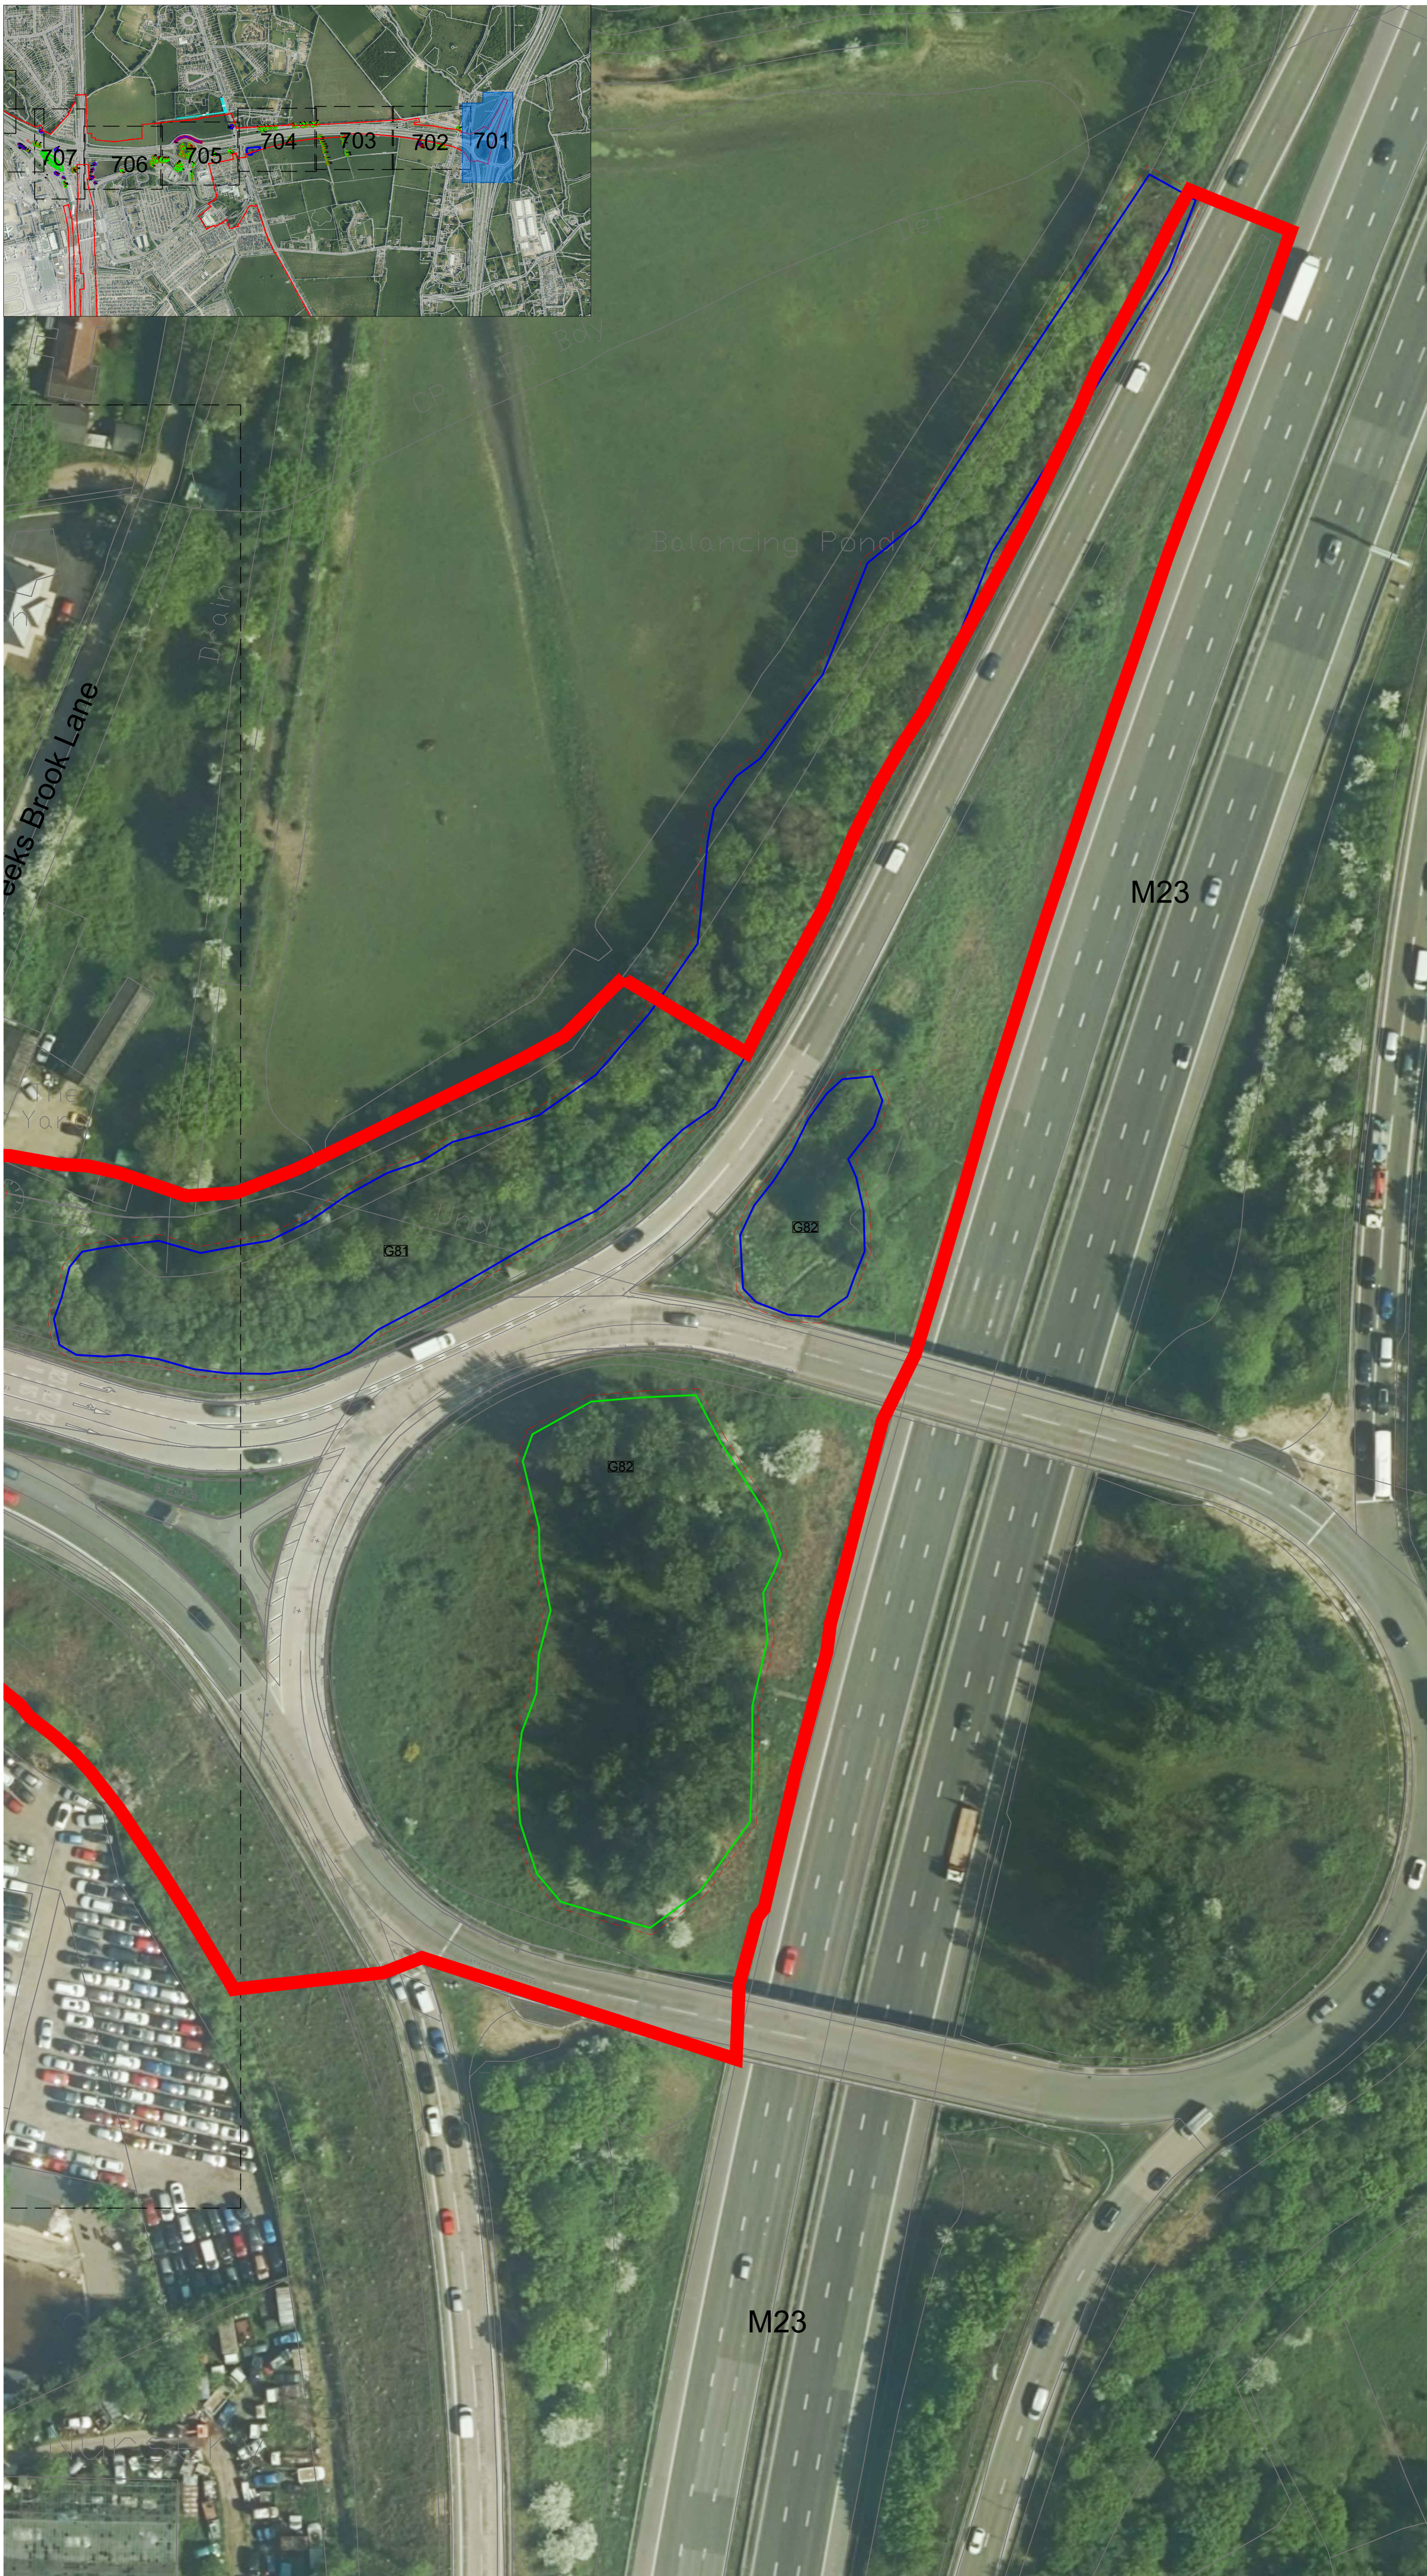
DRAWING TITLE
**M23 & A23 Tree Survey Plans
Appendix 8.10.1
Sheet 1 of 15**

- Refer to ES Appendix 8.10.1: Tree Survey Report and Arboricultural Impact Assessment for further details.
- Survey based on a visual inspection from the ground and is not intended as a full arboricultural inspection.
- Plan produced in accordance with recommendations set out in BS 5837:2012 - 'Trees in Relation to design, demolition and construction'.

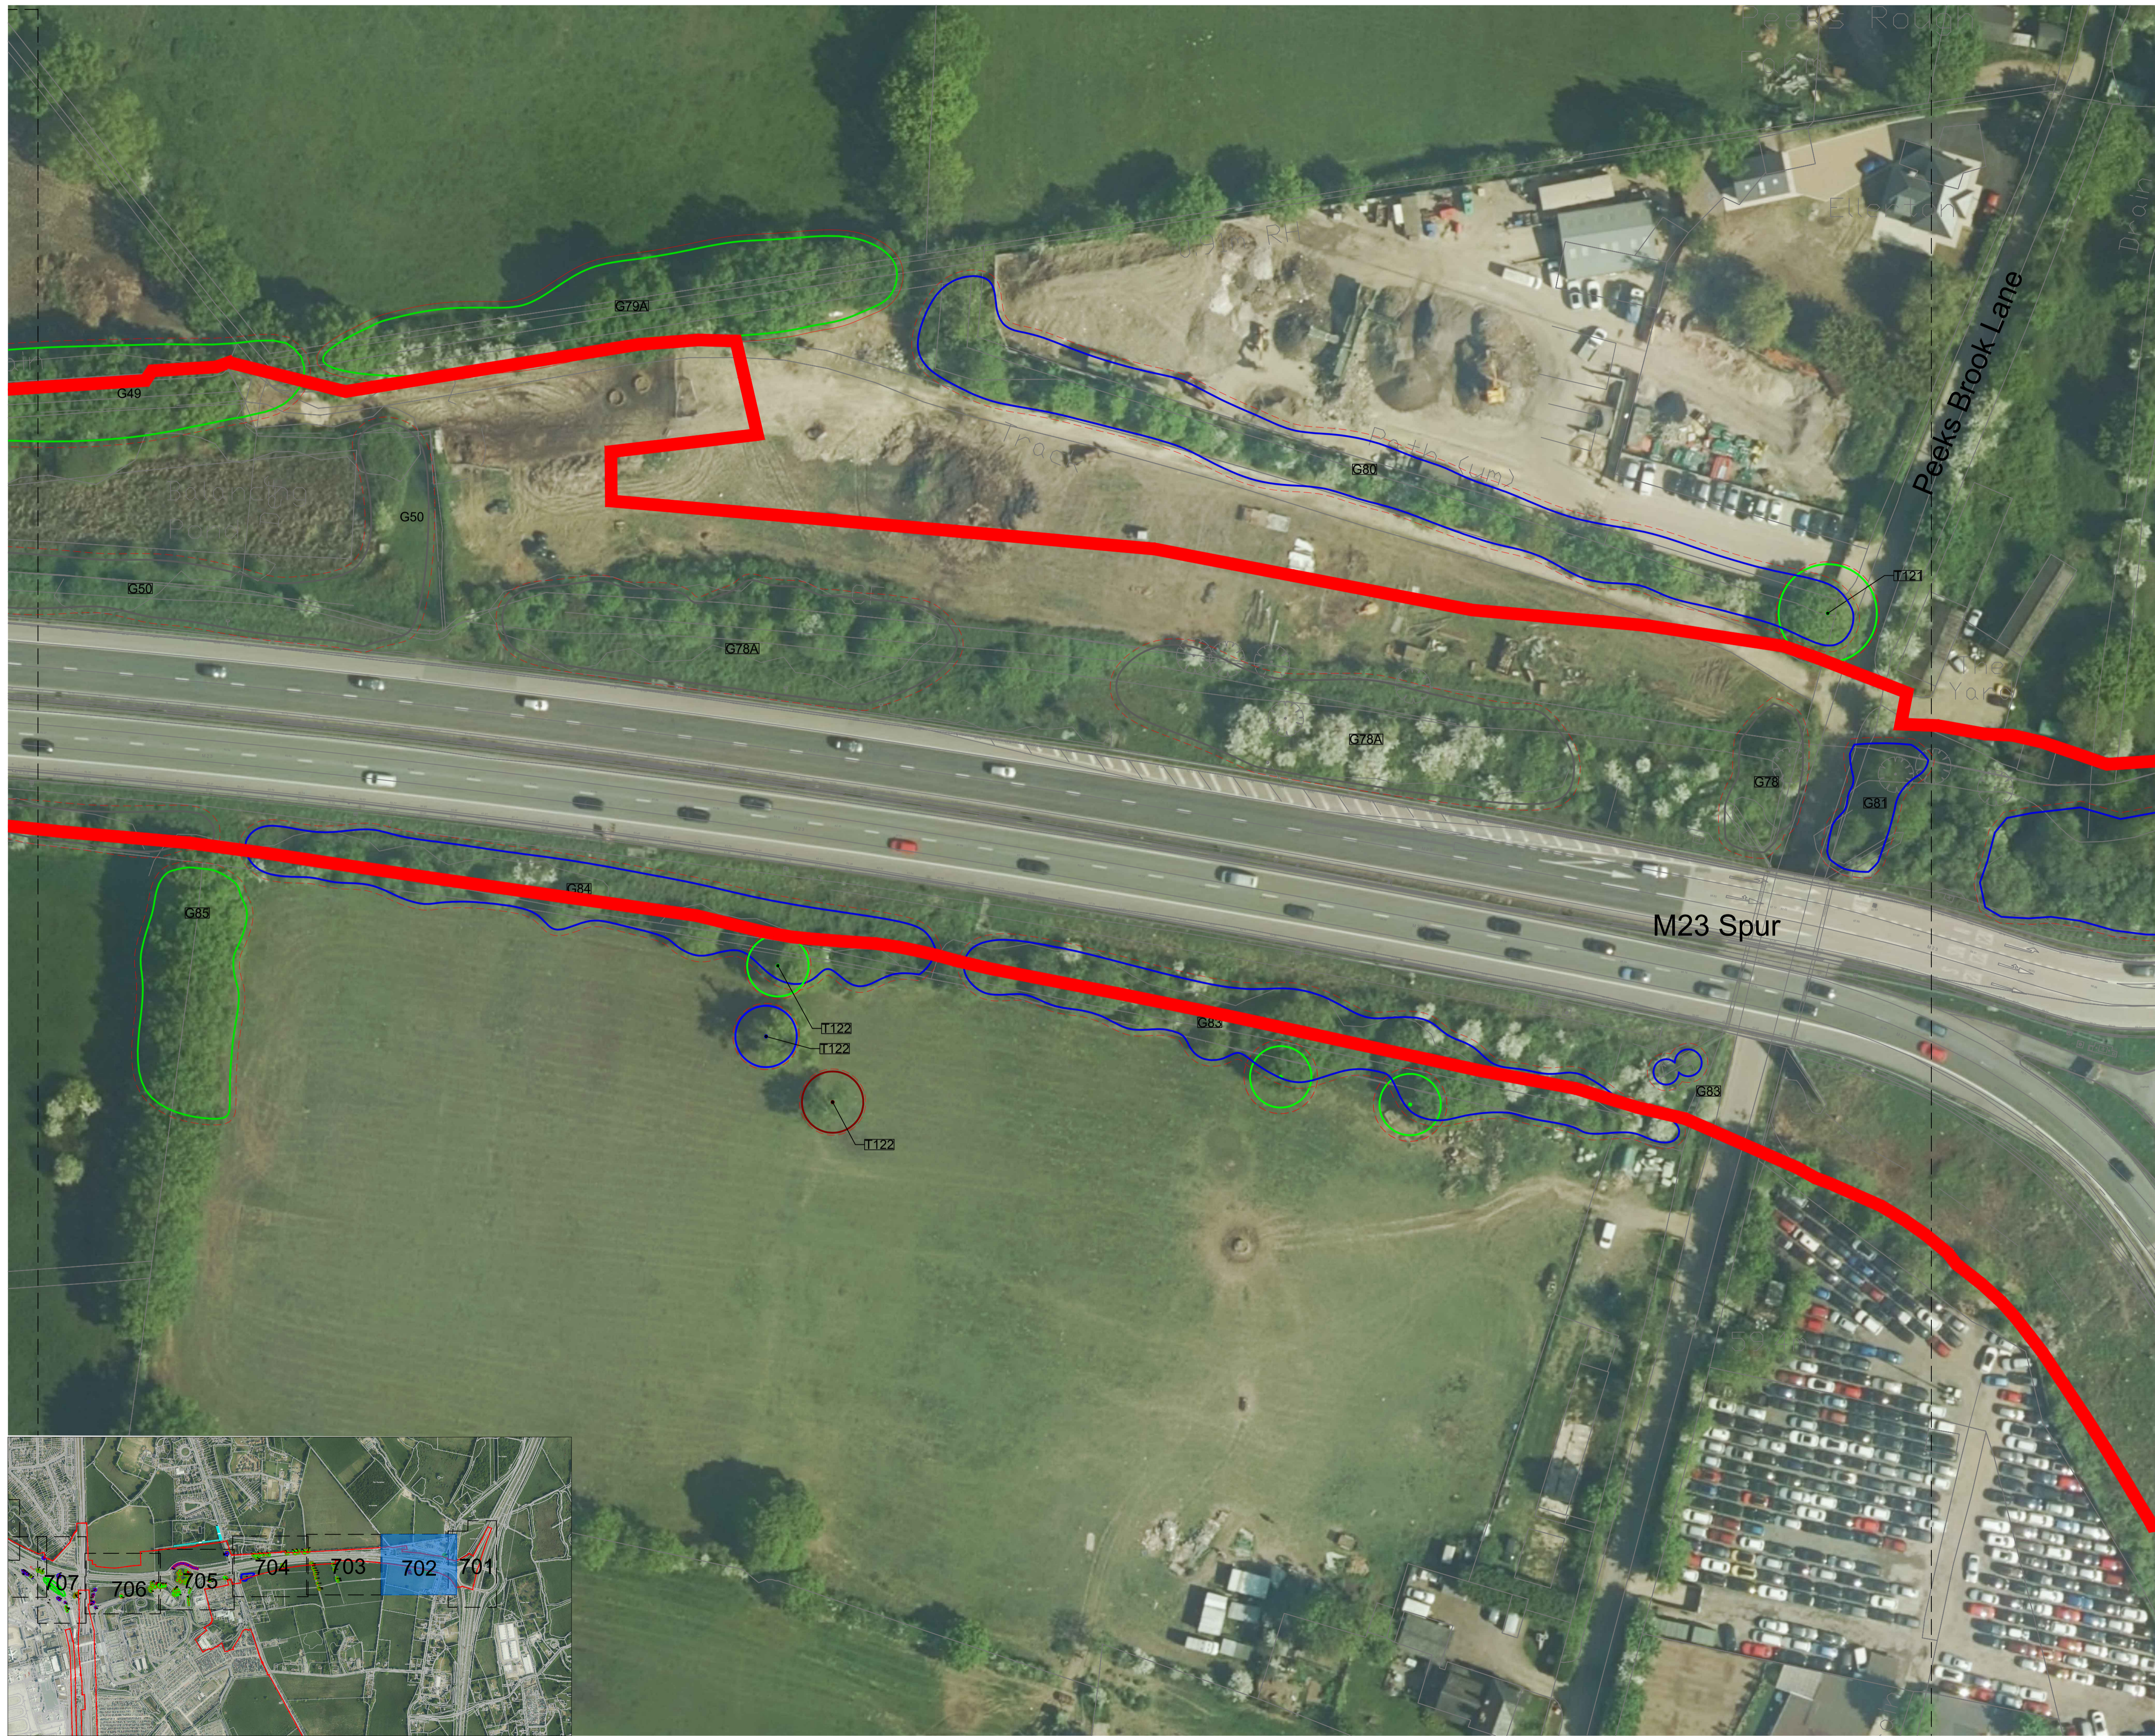
DRAWING TITLE
M23 & A23 Tree Survey Plans
Appendix 8.10.1
Sheet 2 of 15

- Refer to ES Appendix 8.10.1: Tree Survey Report and Arboricultural Impact Assessment for further details.
- Survey based on a visual inspection from the ground and is not intended as a full arboricultural inspection.

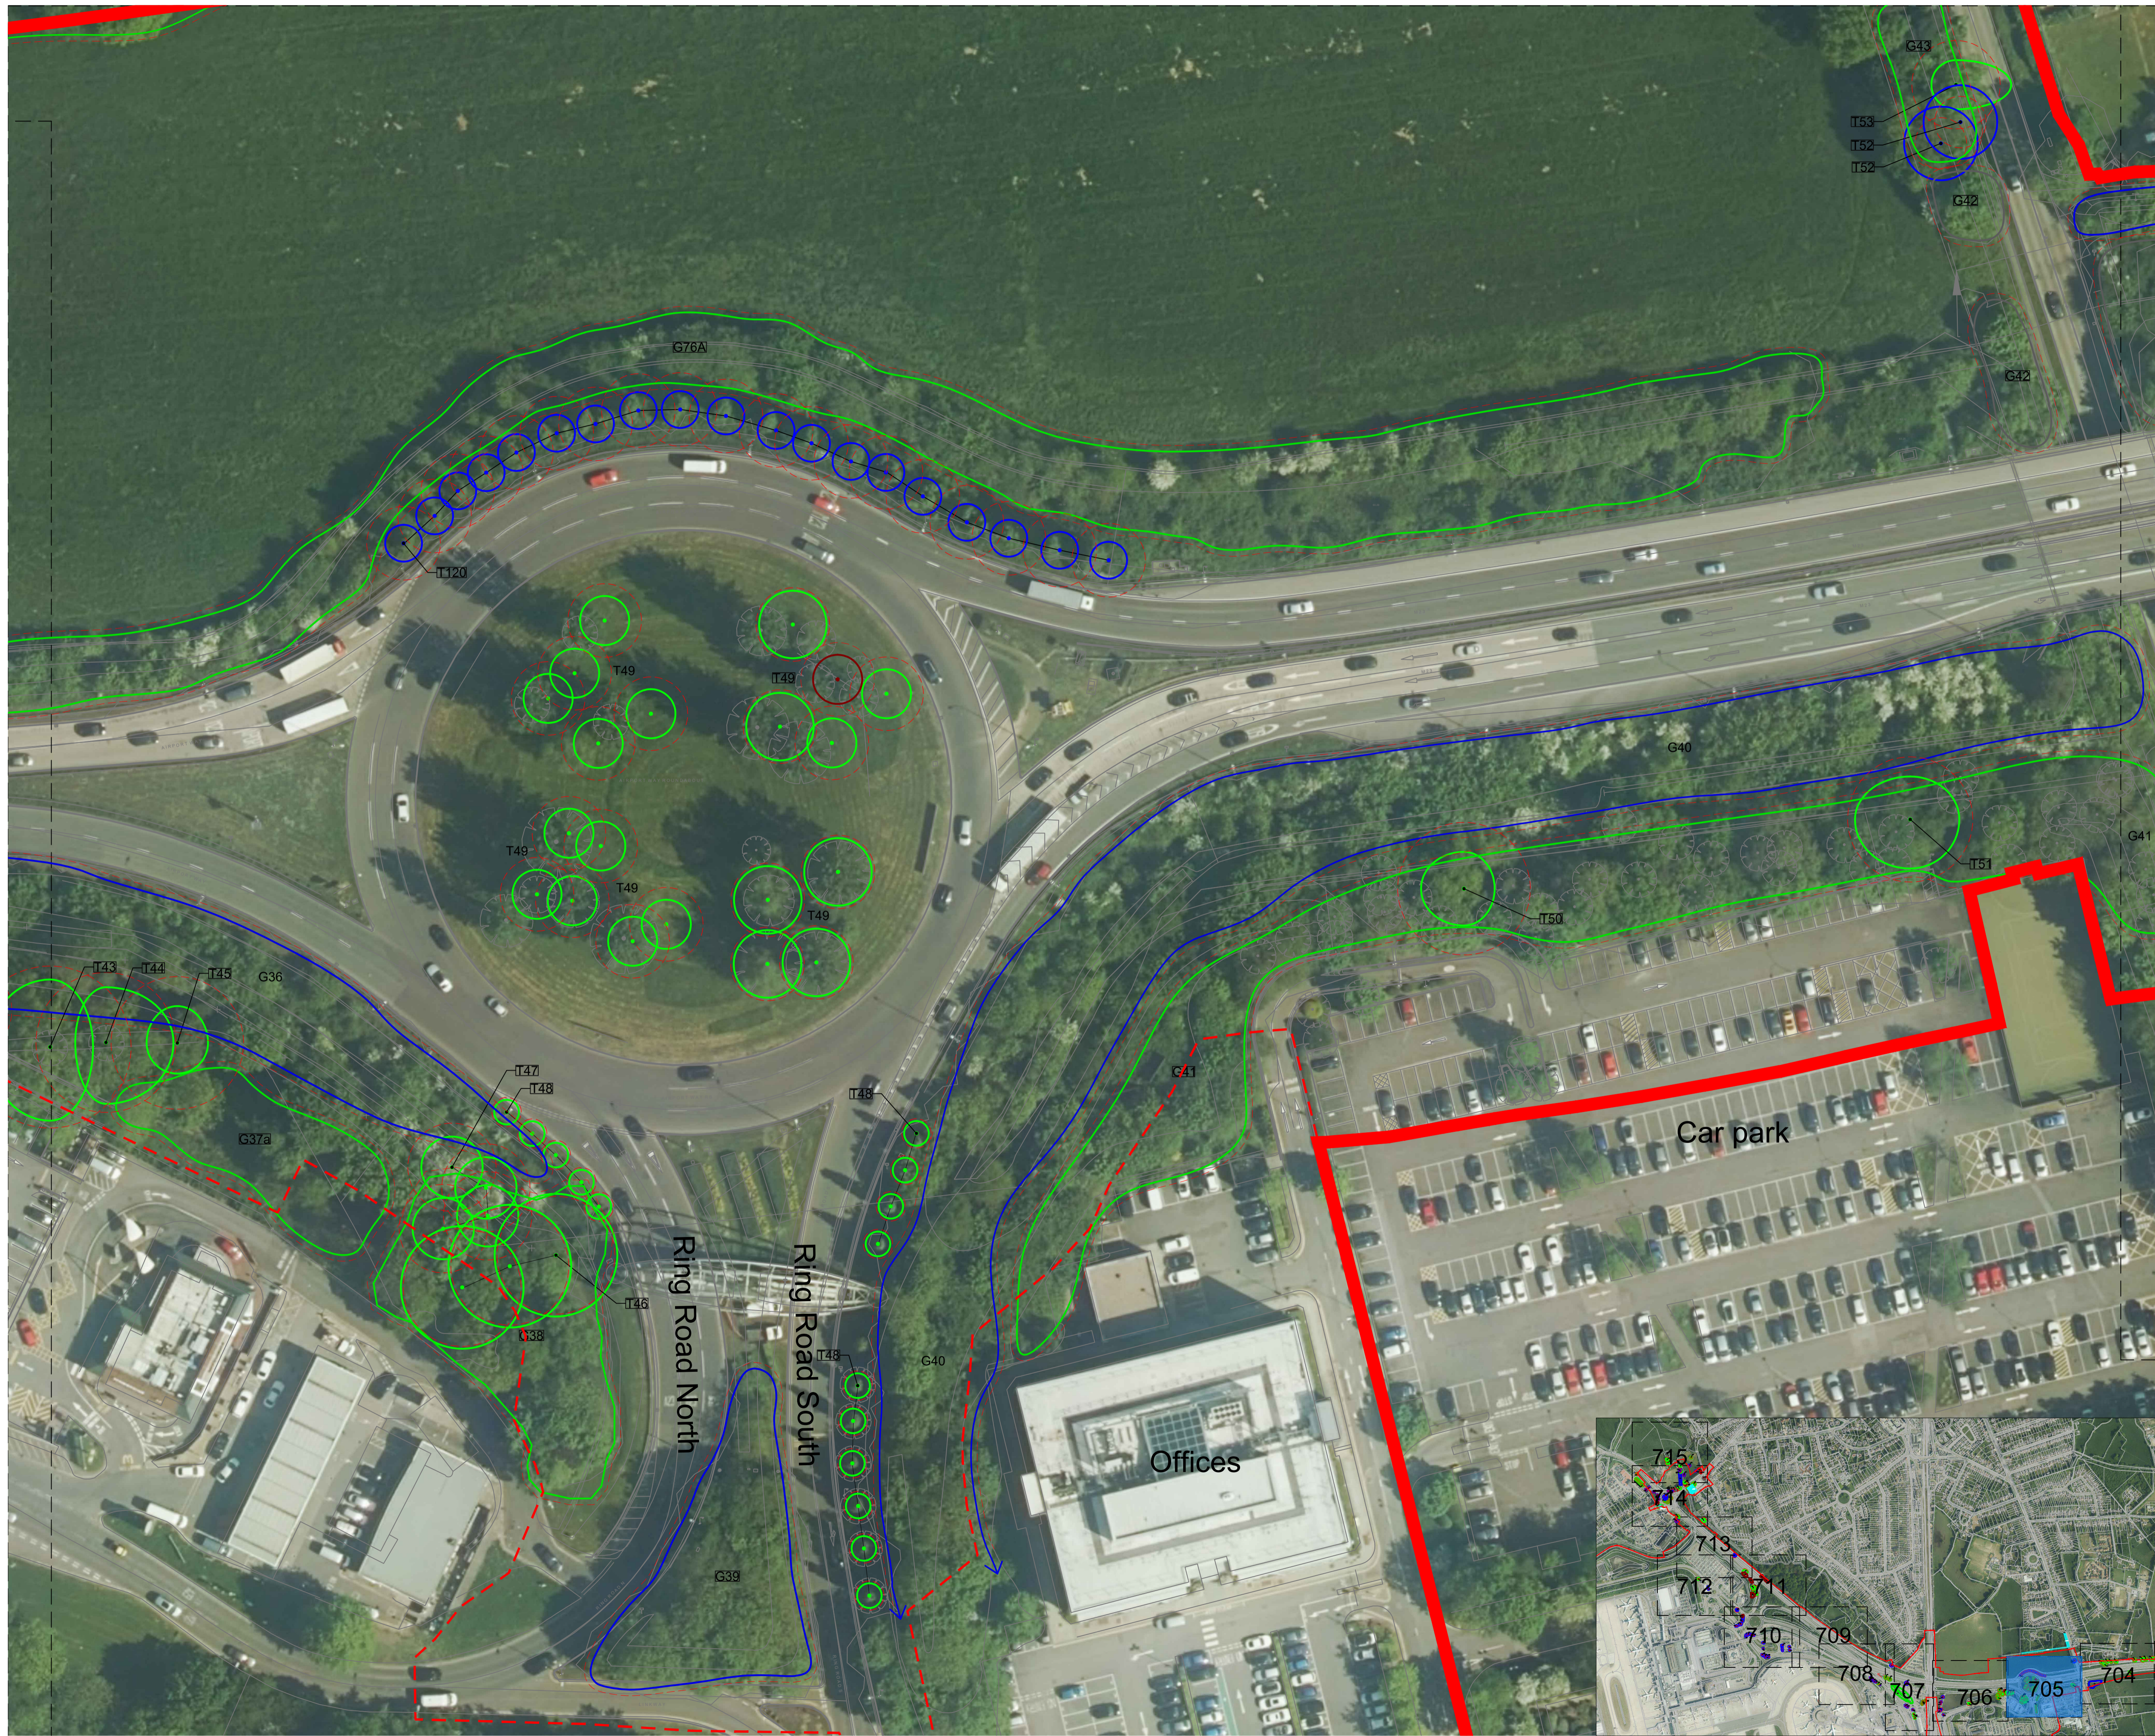
DRAWING TITLE
**M23 & A23 Tree Survey Plans
Appendix 8.10.1
Sheet 5 of 15**

- NOTES:**
- Refer to ES Appendix 8.10.1: Tree Survey Report and Arboricultural Impact Assessment for further details.
 - Survey based on a visual inspection from the ground and is not intended as a full arboricultural inspection.
 - Plan produced in accordance with recommendations set out in BS 5837:2012 - 'Trees in Relation to design, demolition and construction'.

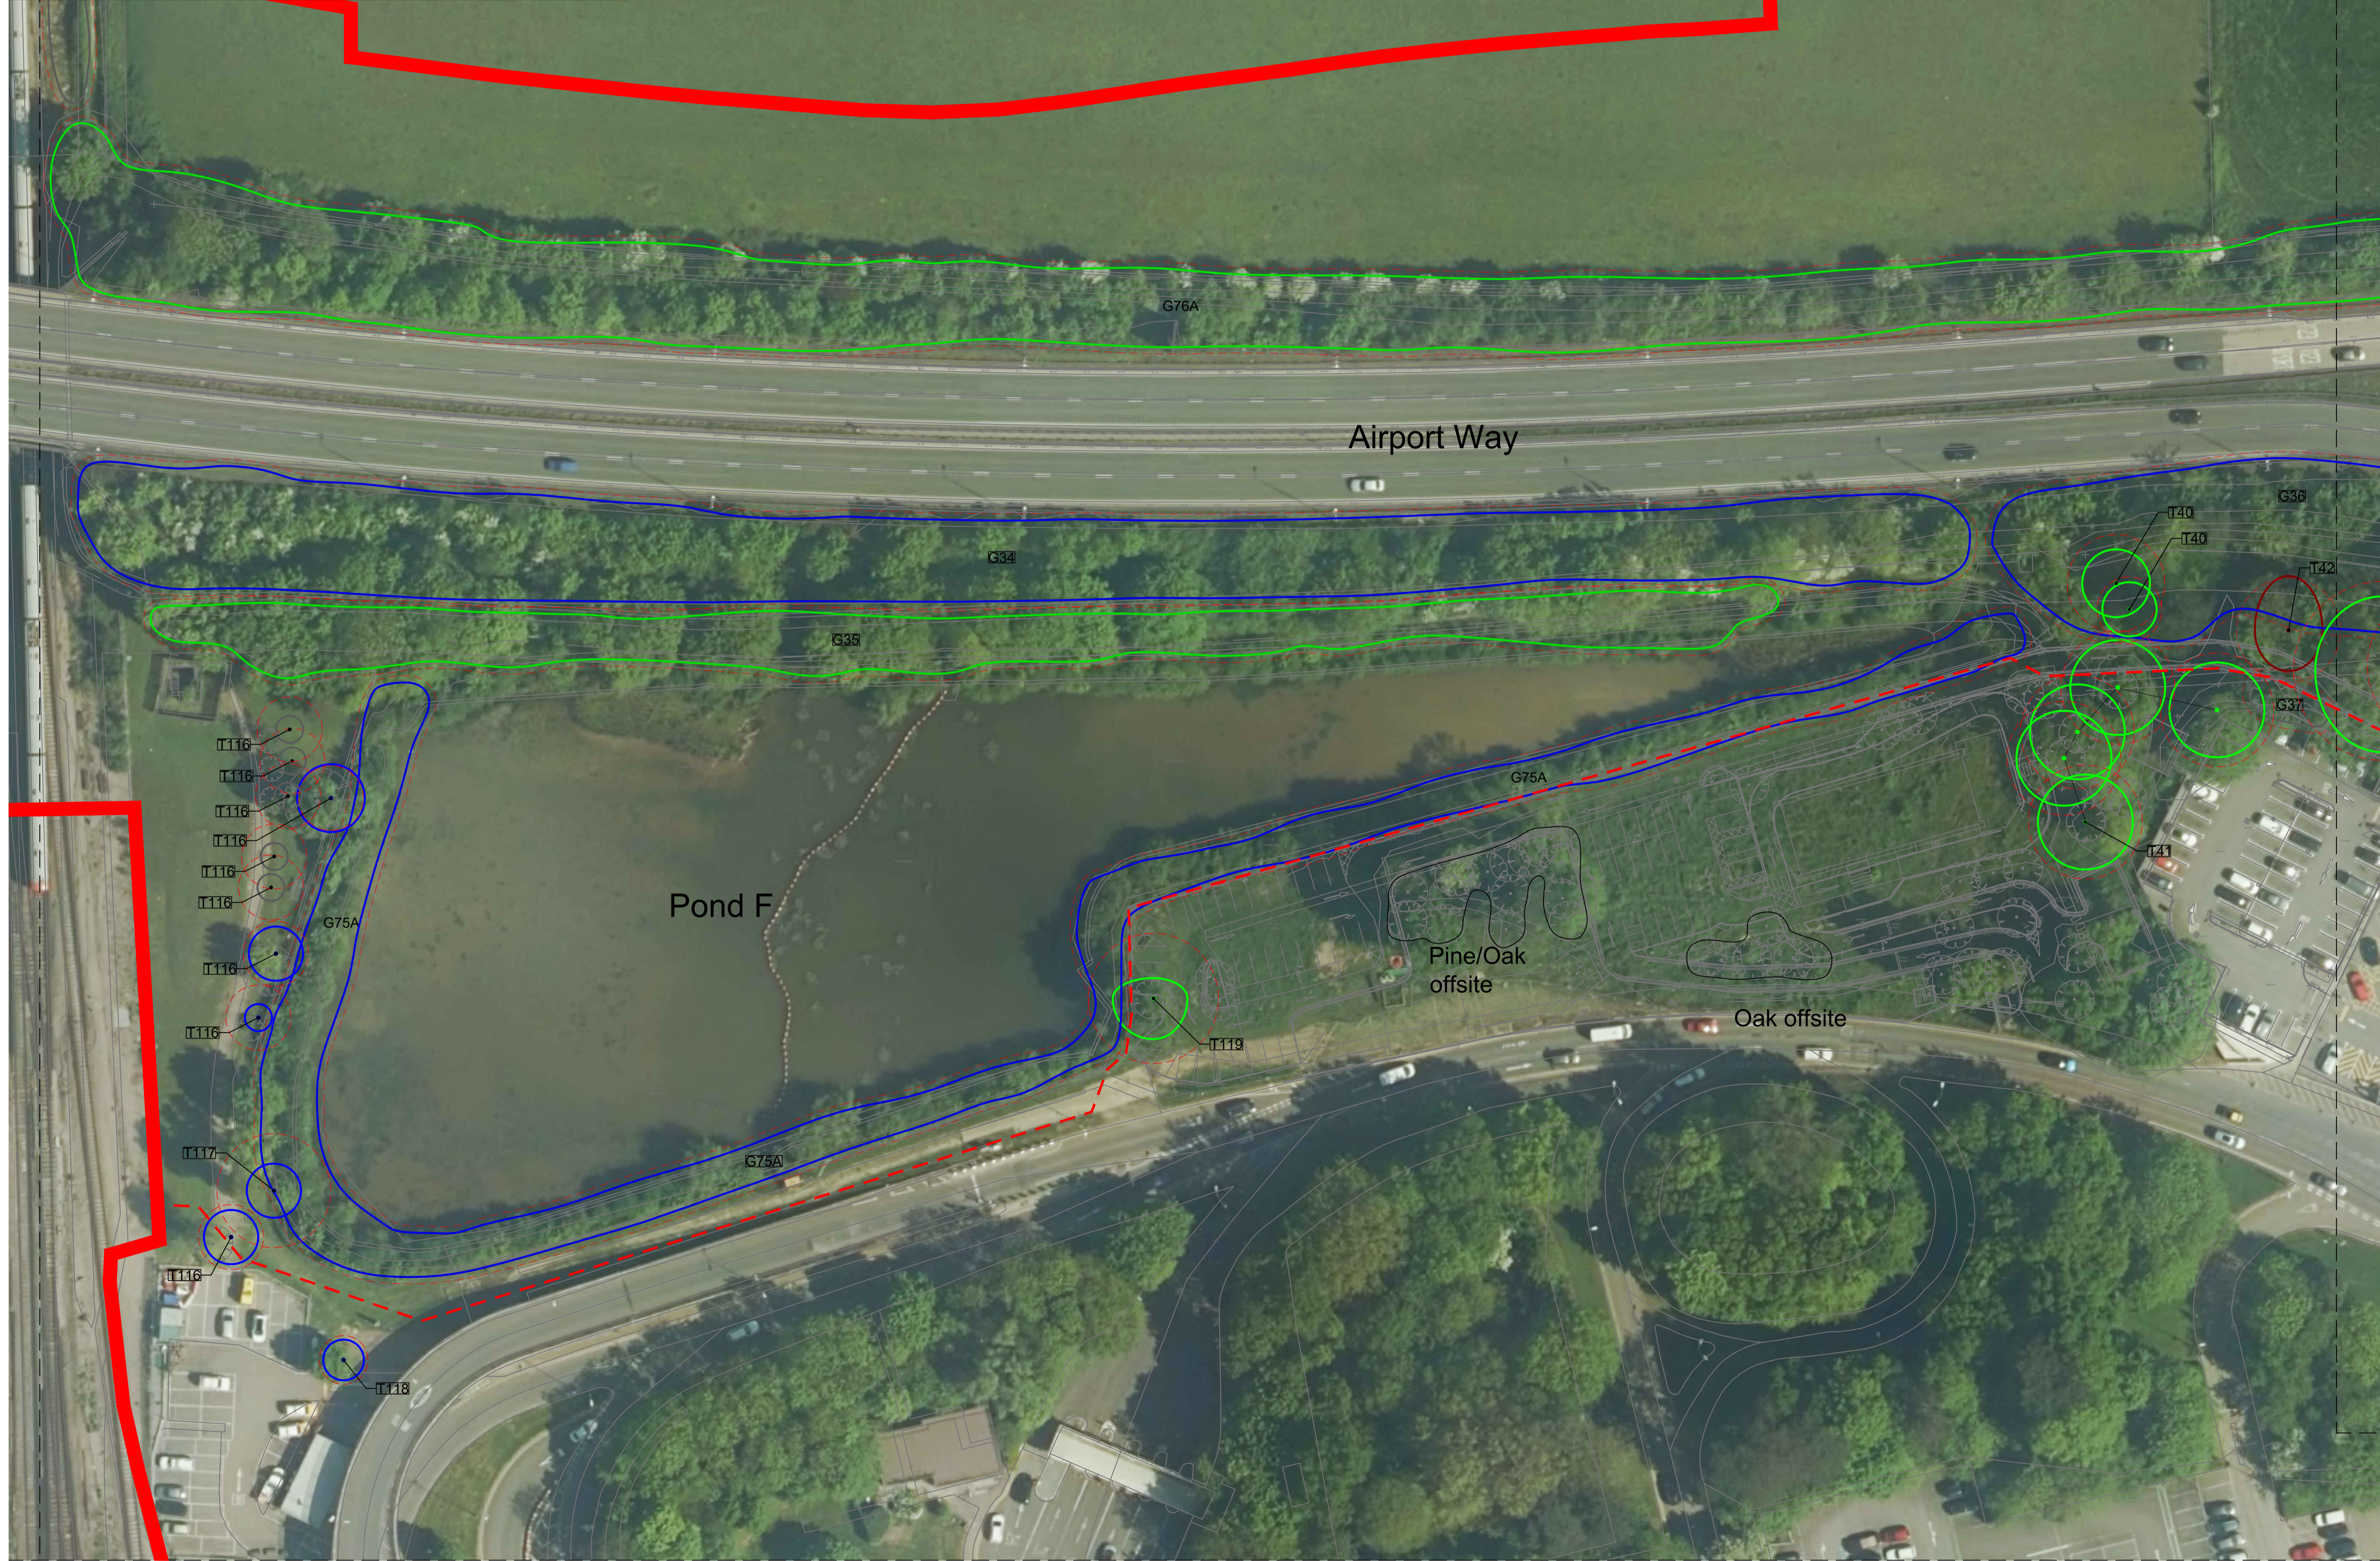
DRAWING TITLE
**M23 & A23 Tree Survey Plans
Appendix 8.10.1
Sheet 6 of 15**

- Refer to ES Appendix 8.10.1: Tree Survey Report and Arboricultural Impact Assessment for further details.
- Survey based on a visual inspection from the ground and is not intended as a full arboricultural inspection.
- Plan produced in accordance with recommendations set out in BS 5837:2012 - 'Trees in Relation to design'.
