# Gatwick Airport Northern Runway Project

Environmental Statement

Appendix 9.9.2: Biodiversity Net Gain Statement – Tracked Version

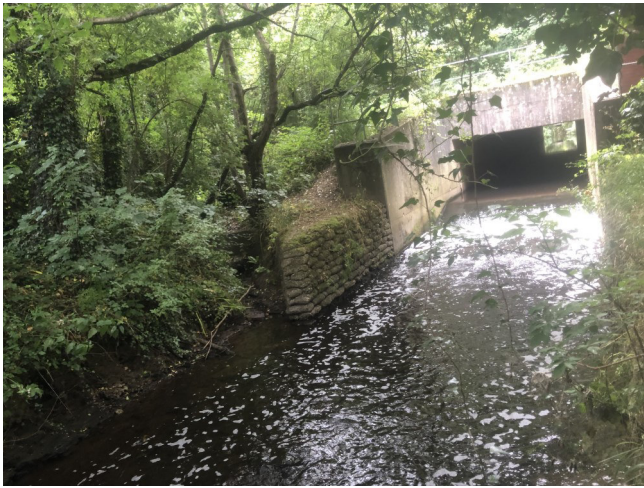
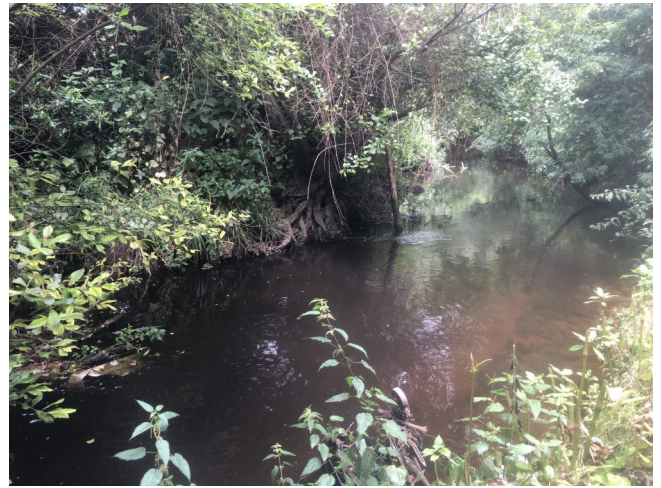
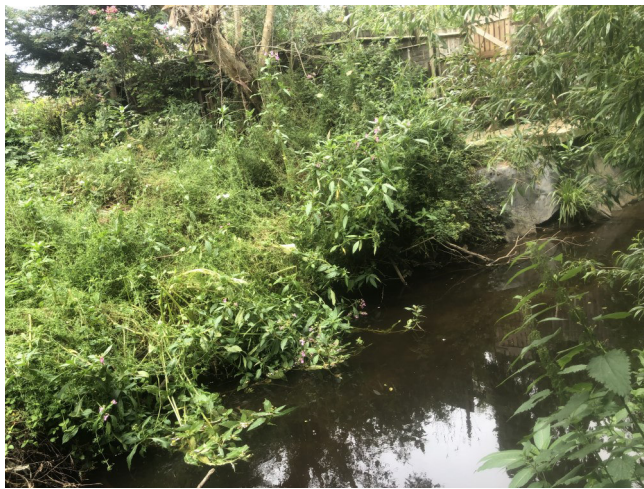
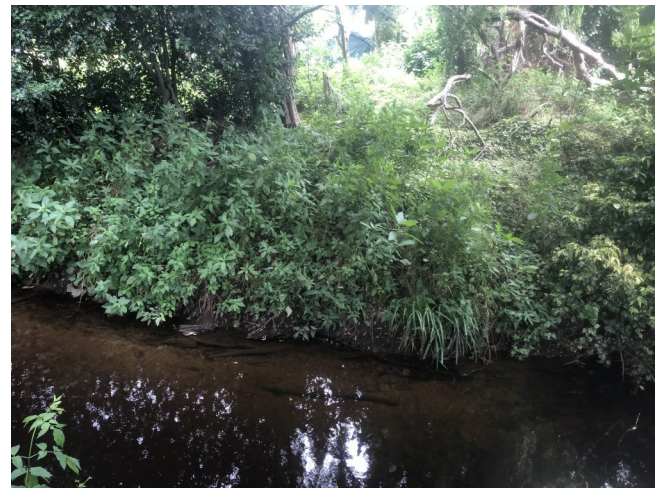
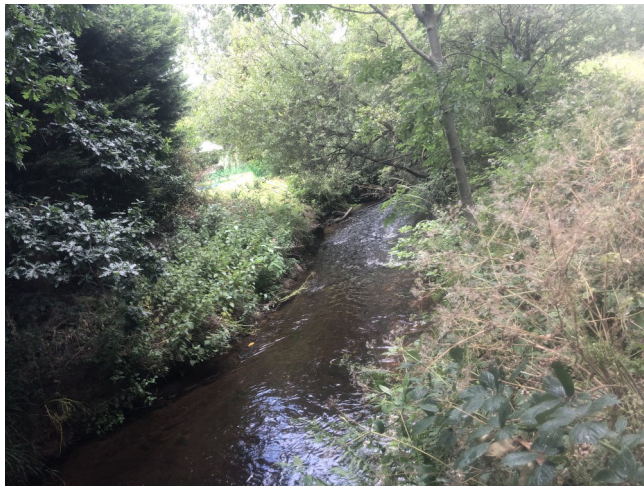
Client	RPS Consulting Services Ltd		Drawing Ref	RPS001-022-001/003/1	
Figure Number	Figure 3a		Drawn	LG	Checked
Figure Title	Photographs of Gatwick Stream				JS
			Date	27/06/2022

Photograph 1:  
Module 1

Photograph 2:  
Module 2

Photograph 3:  
Module 3

Photograph 4:  
Module 4

Photograph 5:  
Module 5

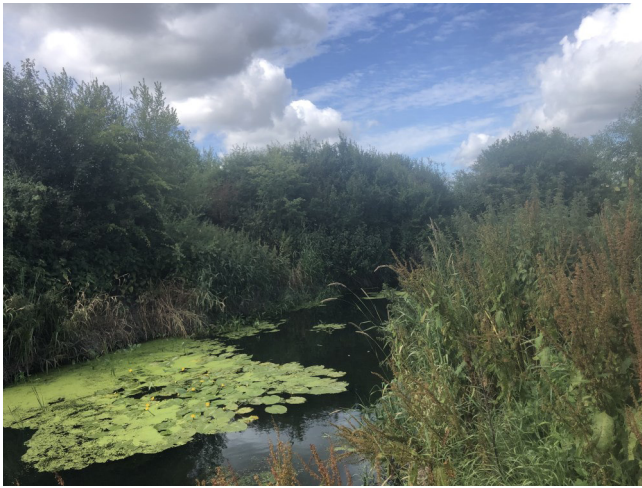
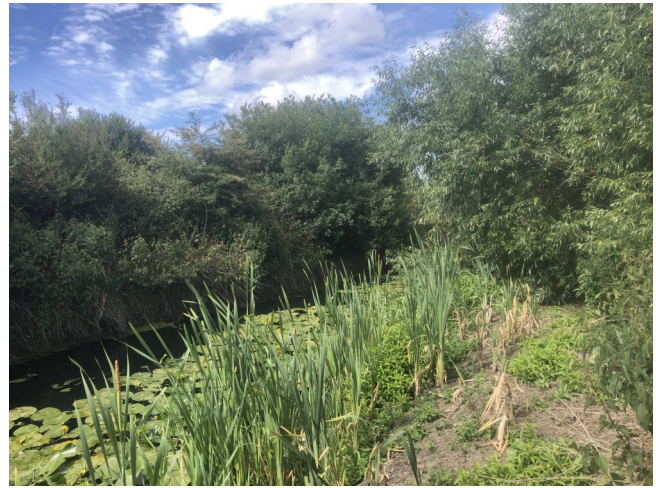
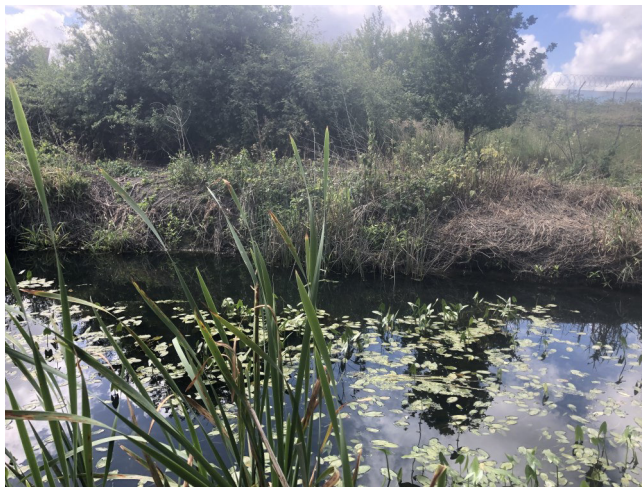
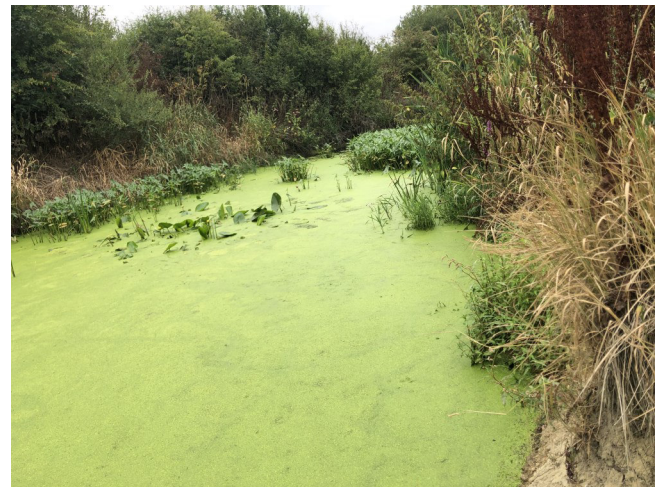
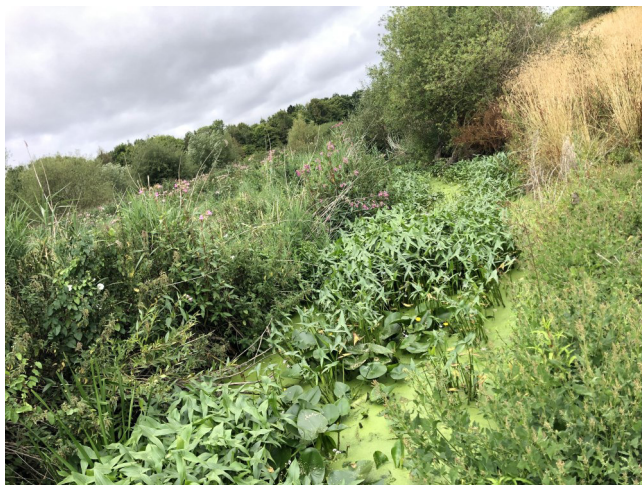
Client	RPS Consulting Services Ltd		Drawing Ref	RPS001-022-001/003/1	
Figure Number	Figure 3b		Drawn	LG	Checked
Figure Title	Photographs of River Mole				JS
			Date	27/06/2022

Photograph 1:  
Module 1

Photograph 2:  
Module 2

Photograph 3:  
Module 3

Photograph 4:  
Module 4

Photograph 5:  
Module 5
