Gatwick Airport Northern Runway Project

The Historical Development of Gatwick Airport Including a Review of the Extent of Past Ground Disturbance

Book 10

Application Document Ref: 10.43

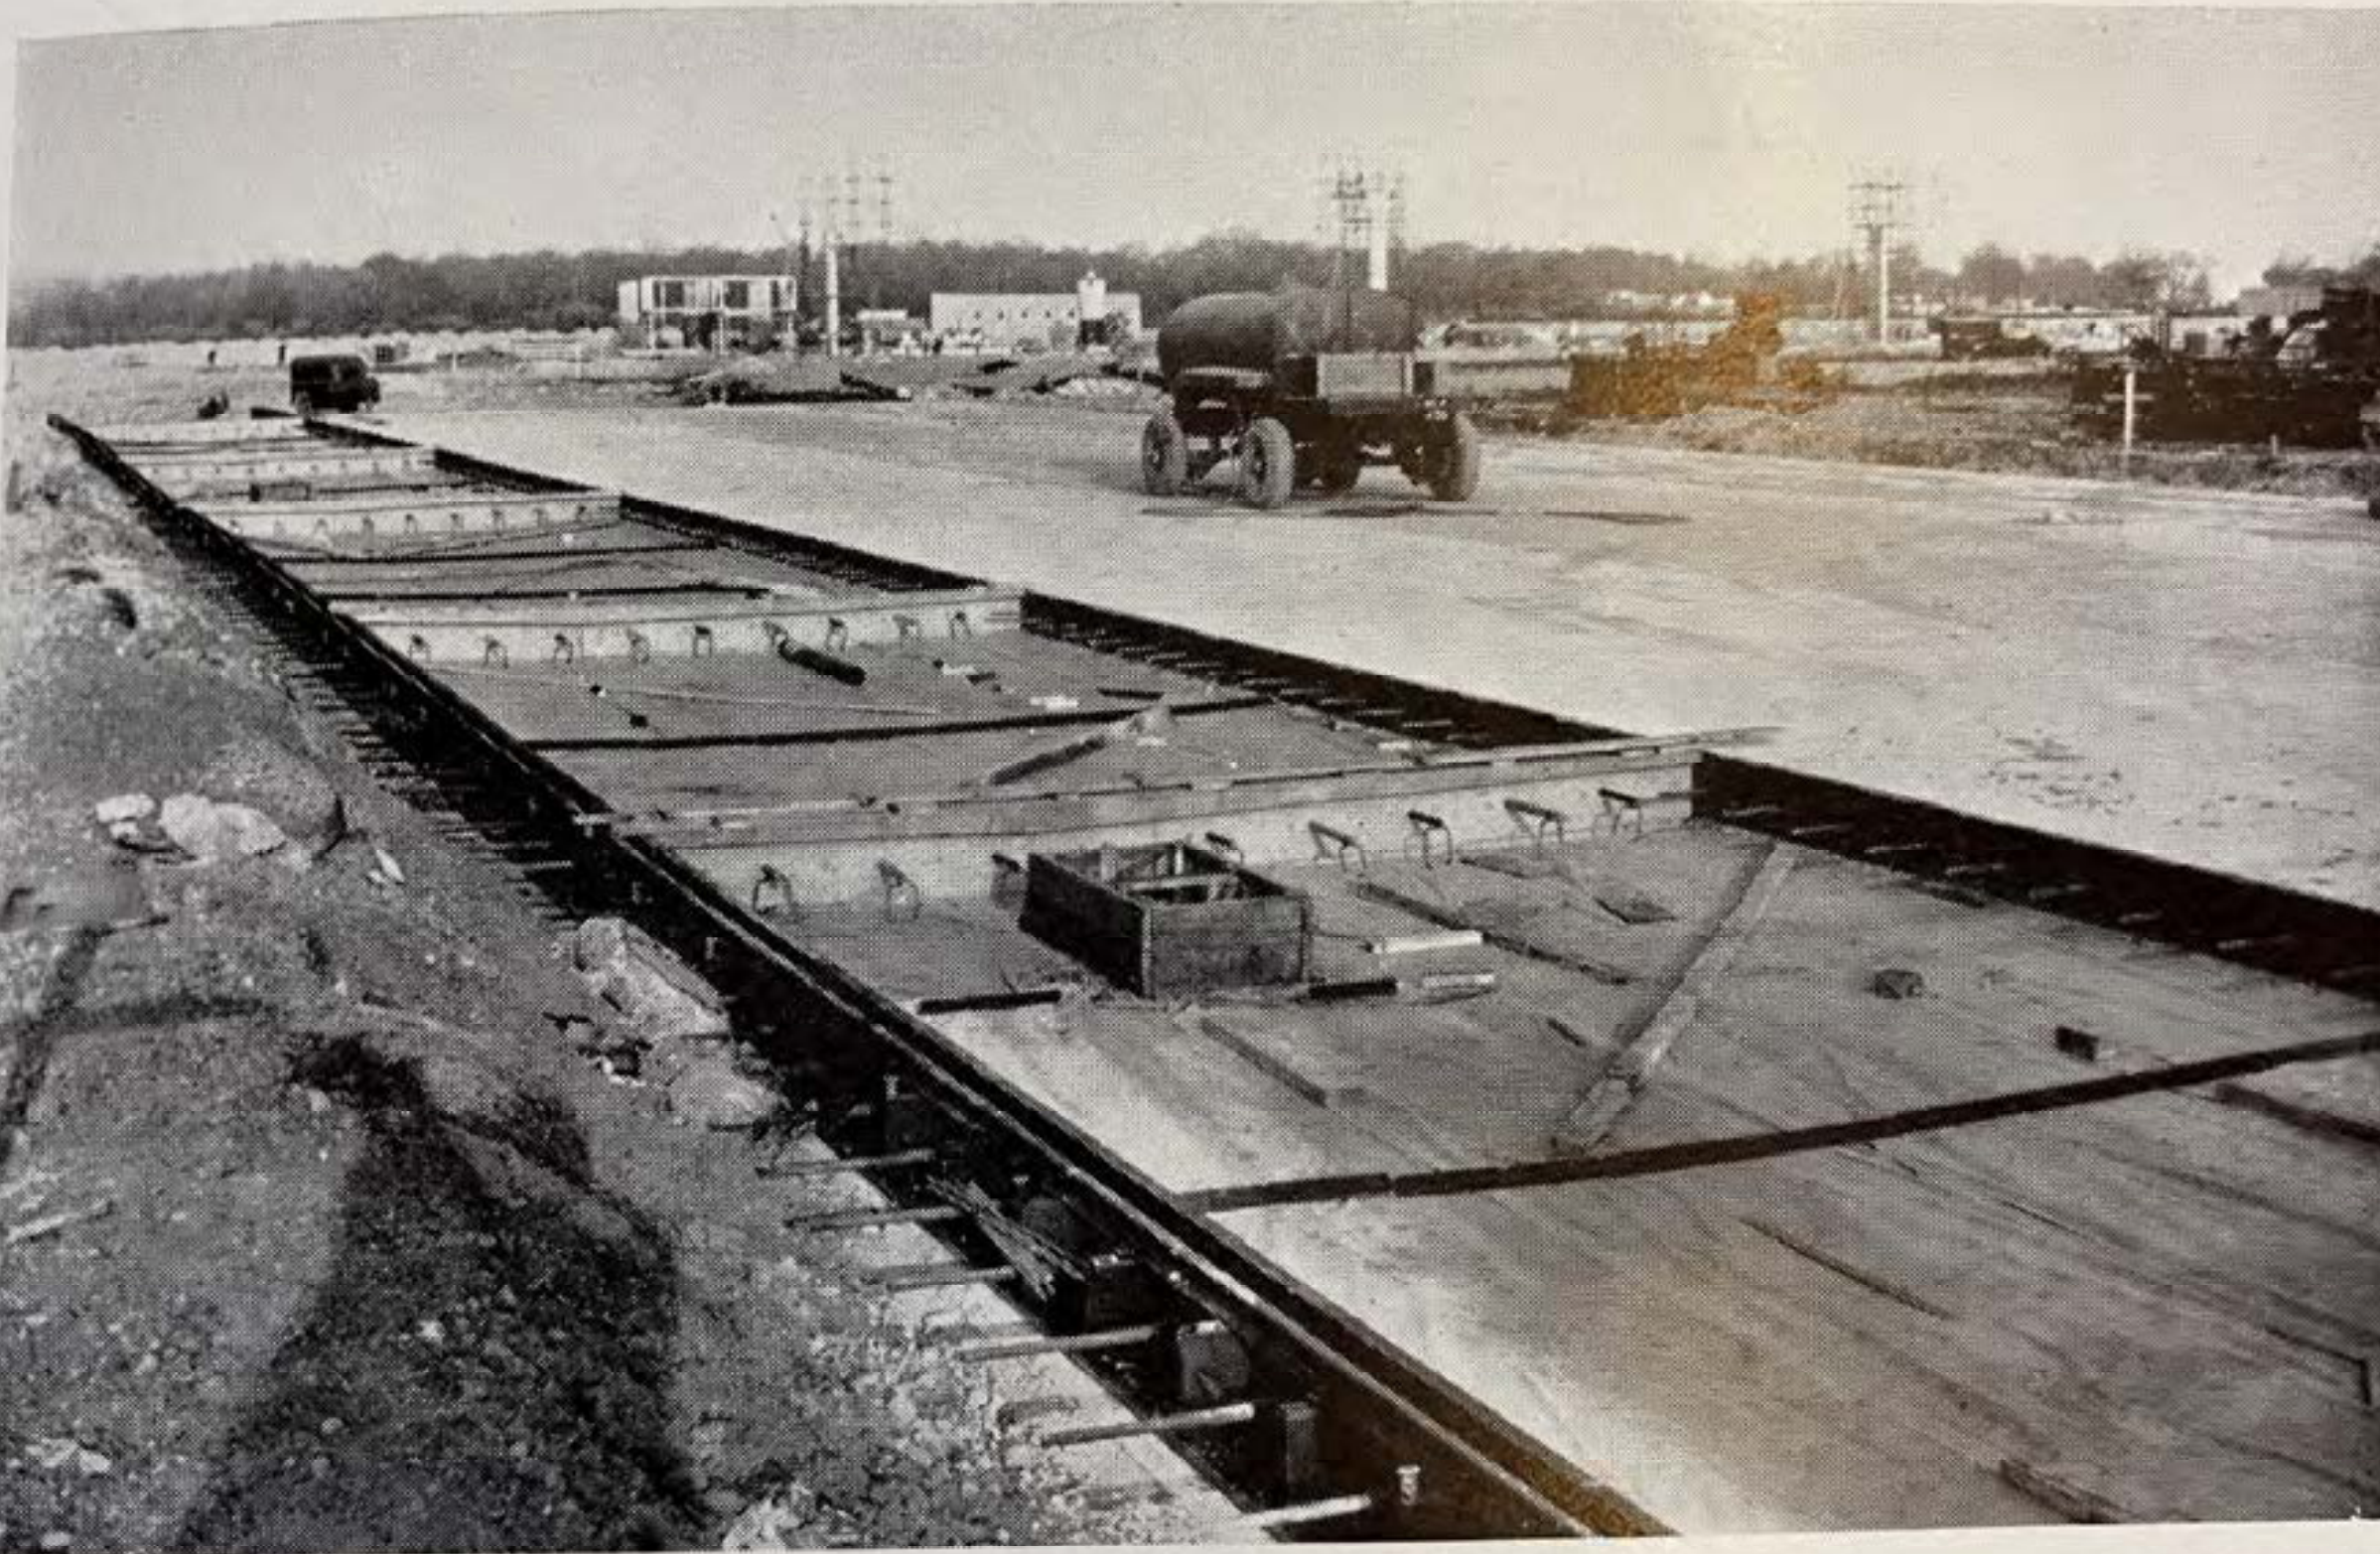
*Forms in position for twelve inch thick concrete surfacing
showing various types of joints*

- 3.30 Between 1956 and 1958, the airport was closed for major redevelopment. The runway construction was awarded to Sir Alfred McAlpine & Sons Ltd. **Figure 12** shows the full extent of the works undertaken here. The runway was c. 7,000 ft long and c. 150 ft wide, with turn-offs to taxiways that allowed aircraft to enter and exit the runway. It was of concrete construction, comprising two layers that were separated by a layer of polythene membrane (**Figure 13**). Below the runway was the foundation layer of the natural clay. The levelling required for the runway meant infilling of areas of lower ground and ground reduction of the more elevated areas. Kerr (c. 1959) records that *'half a million cubic yards of clay once known as Gorse Hill were used as filling underneath the runway'*. The runway's concrete 'shoulders' were of half-strength construction, c. 75 ft wide, and coloured

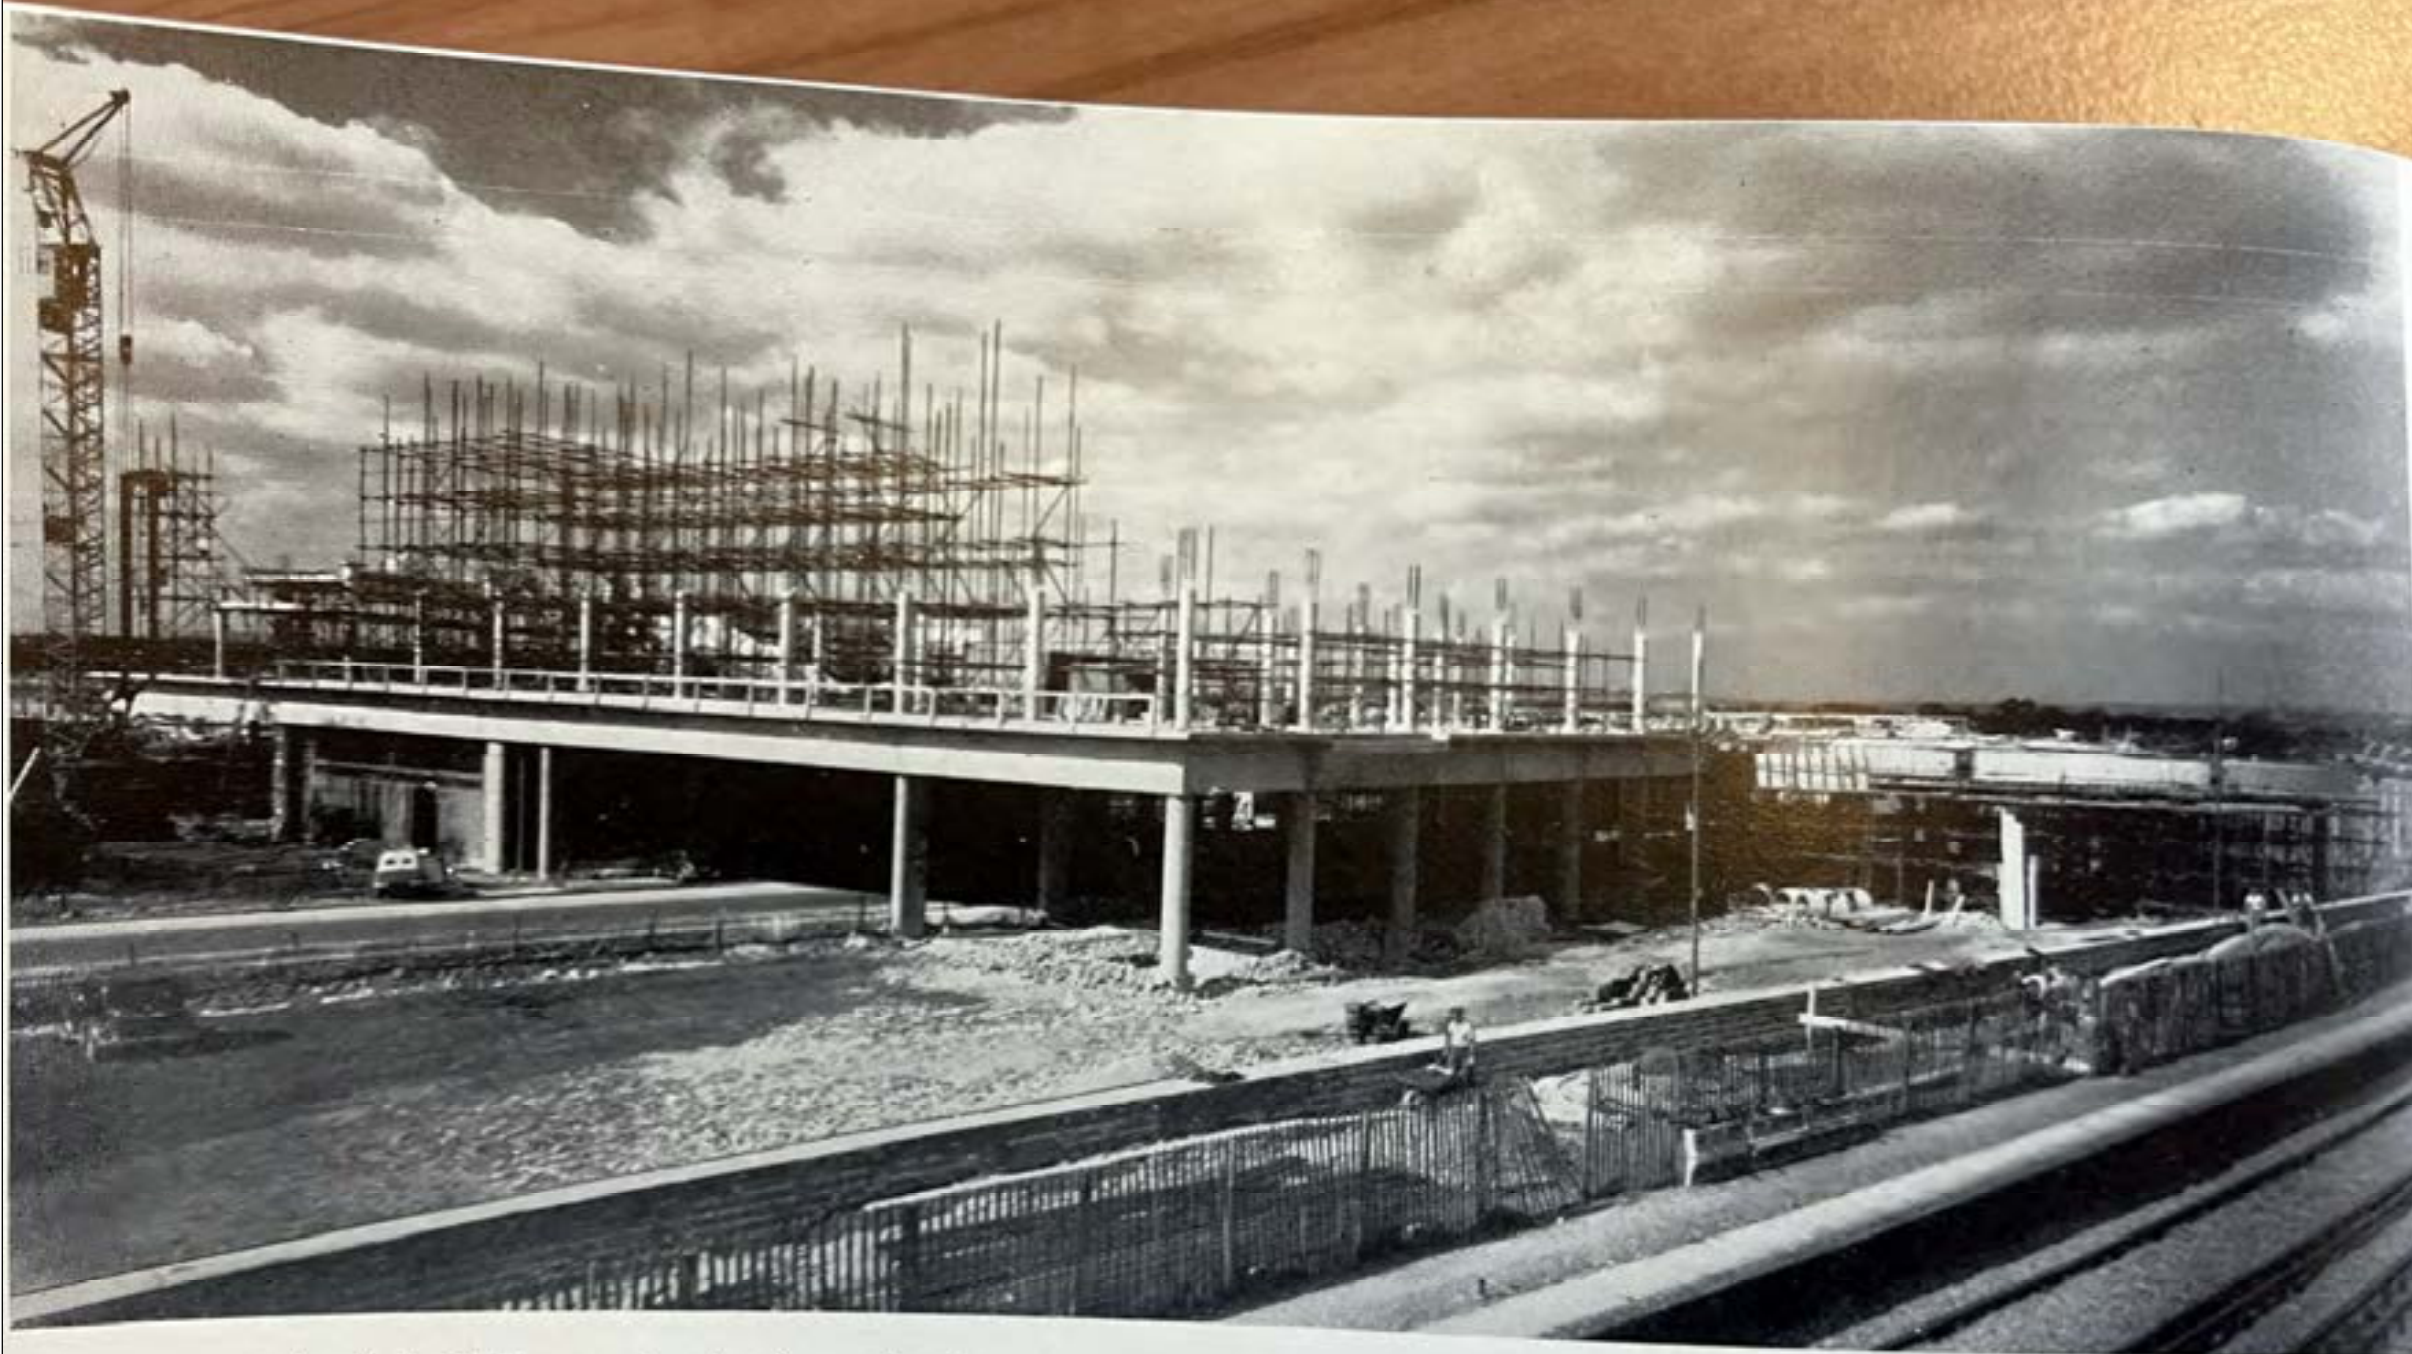
Main terminal building – start of work above concourse level, September 1957

it will be even more so when Stage Two of the plan has been completed. It is built of reinforced and pre-stressed concrete, and is clad with glass and steel. Its surroundings have been landscaped to blend with the countryside. Its plan was determined by the close integration of the road approach. All
