Gatwick Airport Northern Runway Project

Environmental Statement

Appendix 9.9.2: Biodiversity Net Gain Statement – Clean Version

Application Document Ref: 5.3

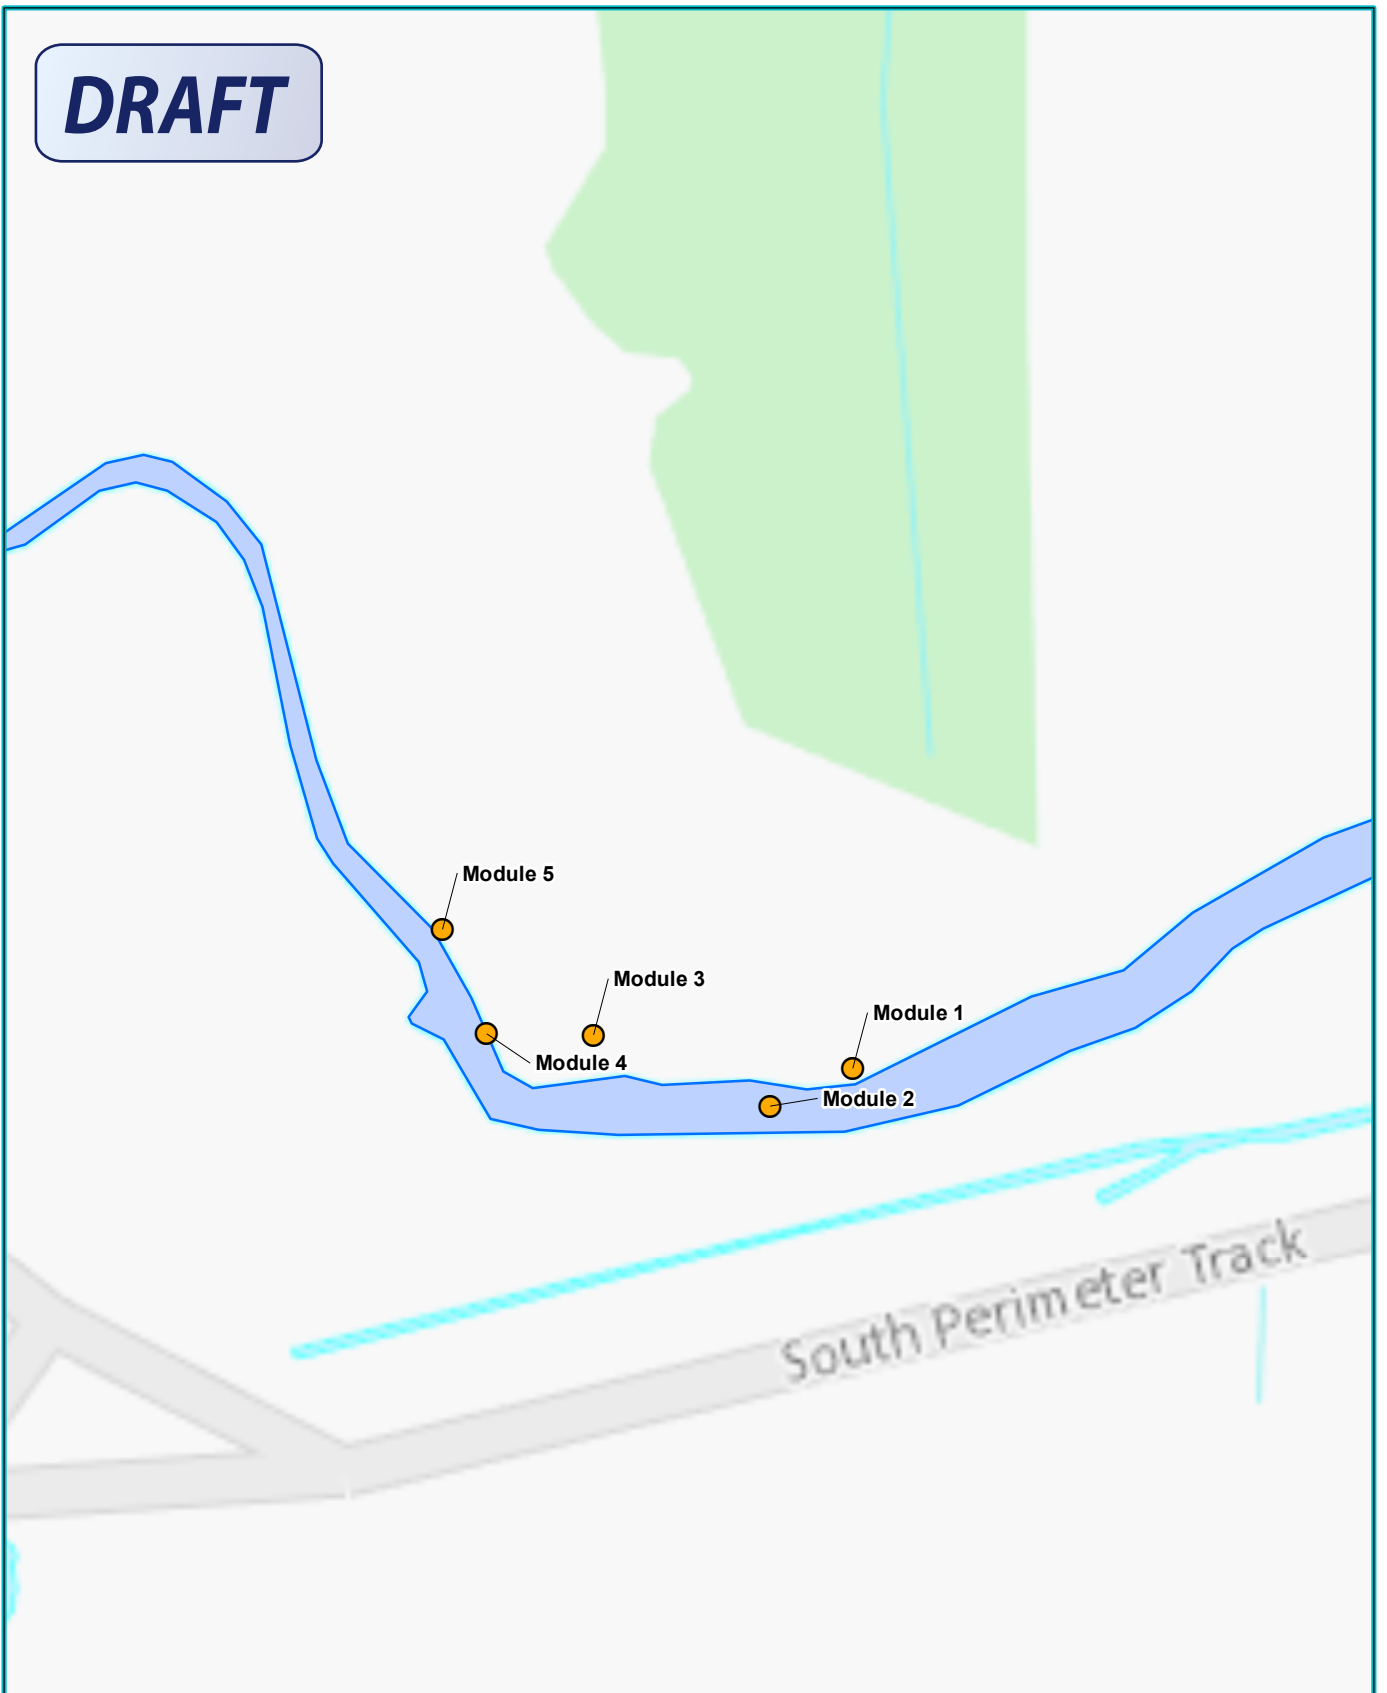
Client	RPS Consulting Services Ltd.		Drawing Ref	RPS001-022/401995/1		
Figure Number	2a		Scale at A4	1:1,000		
Figure Title	River Condition Assessment (River Mole)		Drawn	SC	Checked	AS
			Date	25/01/2023	Date	25/01/2023

- Condition Assessment Module
- River Mole
